## INSPECTION REPORT: GREENS CREEK MINE

Date of Inspection: Thursday October 1, 2020  
Date of Report: Thursday October 15, 2020  
USDA Forest Service Inspector: Richard Dudek

The site inspection included: The A and B access roads, the 1350 area, 920 area, Pond C, Site 23, 7.4 mile B-road Bridge (Killer Creek Bridge), MSE Wall 5.4 mile B-road, 3.4 mile B-road Bridge (Falls Creek Bridge), 3.0 mile B-road Bridge (Zinc Creek Bridge), and the Tailings Disposal Facility (TDF).

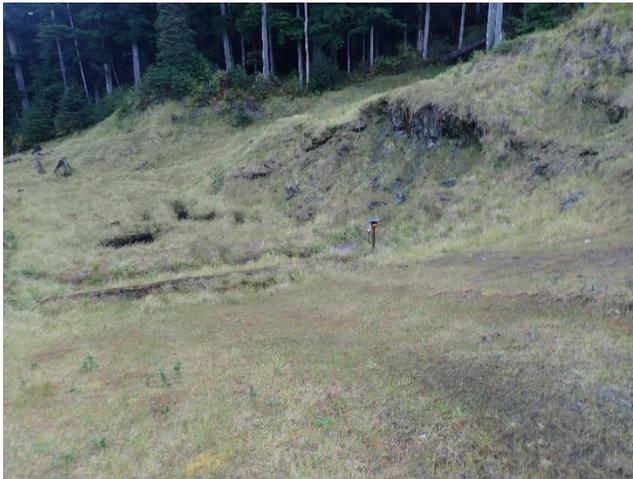
The pump for 1350 trench is functioning as designed (Photo 1).

**Photo 1. The 1350 area trench and pump.**

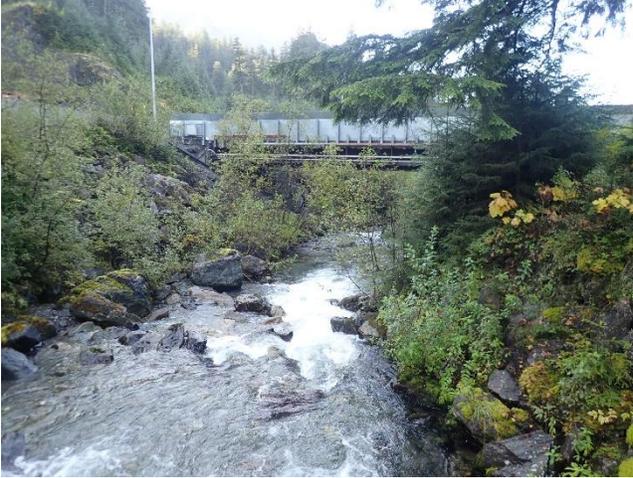
The recorded flow rate for Greens Creek (Photo 2) on 10/1/2020 was 38.2 cubic feet per second (cfs). The 920-area water withdrawal rate from Greens Creek was approximately 1.5-cfs.

**Photo 2. Greens Creek.**

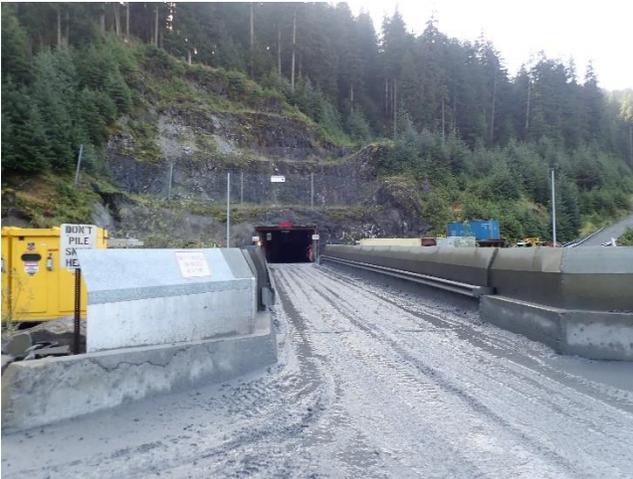
The 920 Bridge's splash guards are working as designed to prevent sediment splash over the bridge from vehicular traffic (Photo 3). Sediment accumulation was observed at the bridge ends, and requires cleaning.

**Photo 3. The 920 Bridge.**

- **The 3.4 and 920 bridges require removal of accumulated sediment at the bridge ends.**

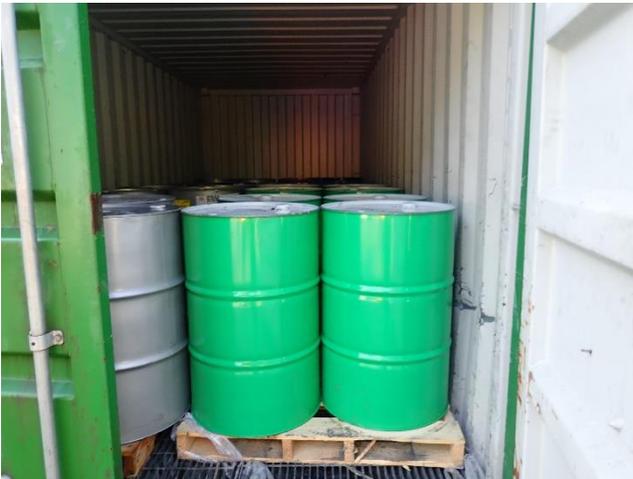
Good housekeeping practices were observed at the 920 warehouse (Appendix 5 BMP Plan page 39). All petroleum/chemicals observed were properly stored within appropriate secondary containment (Photo 4).

**Photo 4. Storage containers at the 920 warehouse.**

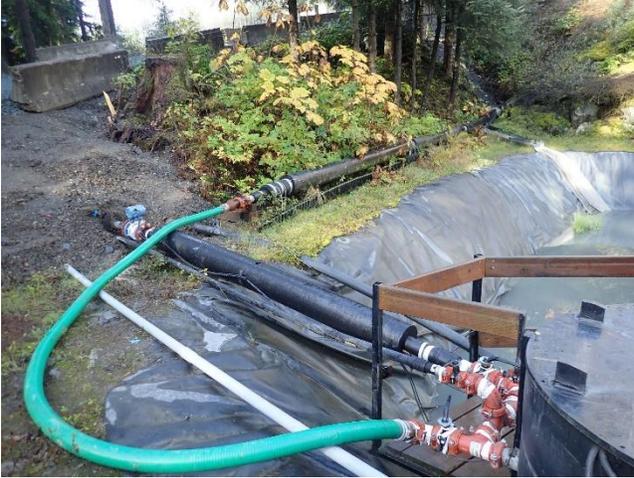
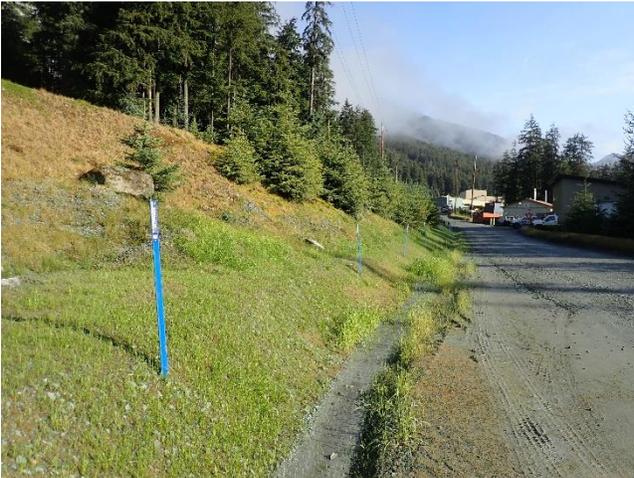
The installation for upper Pond C's arctic pipeline is completed (Photos 5-6).

**Photo 5. The new arctic pipeline for upper C pond.**

**Photo 6. The blue markers show the location for C Pond's buried pipeline.**

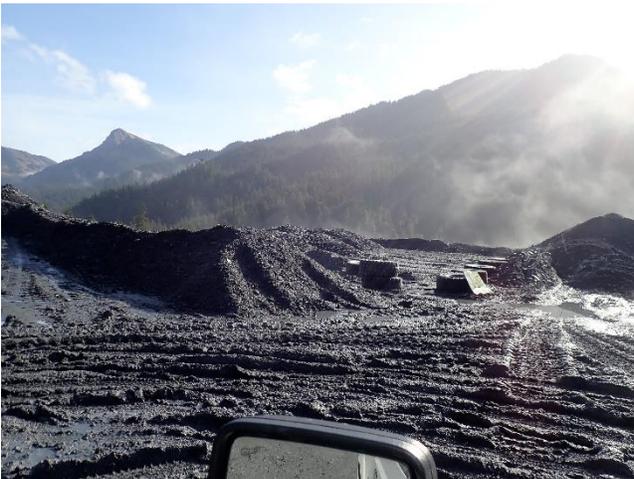
HGCMC continues to separately store Class 1 waste rock from Class 2/3 waste rock (Photo 7). The classification is due to the rock's acid neutralization/generation potential (Appendix 1 §3.1 page 3-1).

**Photo 7. Site 23 Class 2/3 waste rock.**

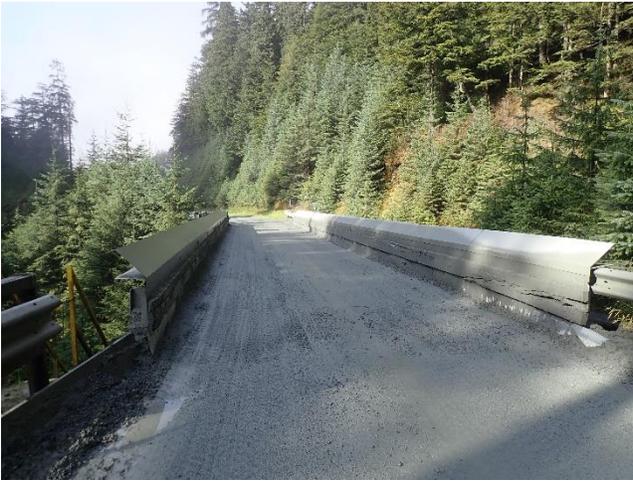
The bridge's splashguards are functioning as designed preventing sediment splashover from vehicular traffic (Photo 8).

**Photo 8. 7.4 B Road Bridge (Killer Creek Bridge).**

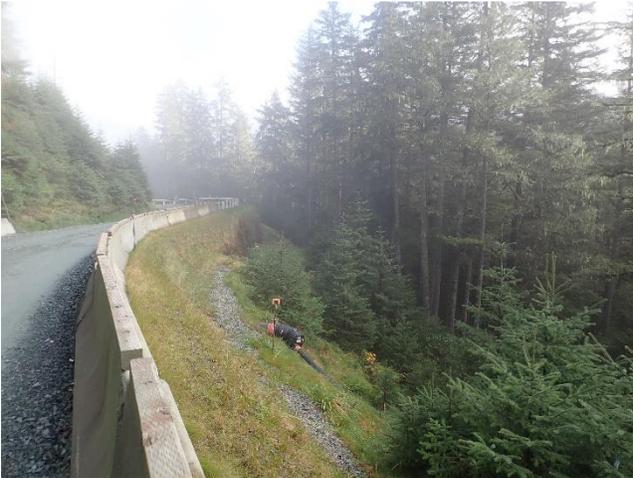
The mechanically stabilized earth (MSE) wall is functioning as intended. The data collected from the surveying instruments, and inclinometers are analyzed by HGCMC Engineering to monitor soil creeping and slope stability (Photo 9).

**Photo 9. The MSE wall.**

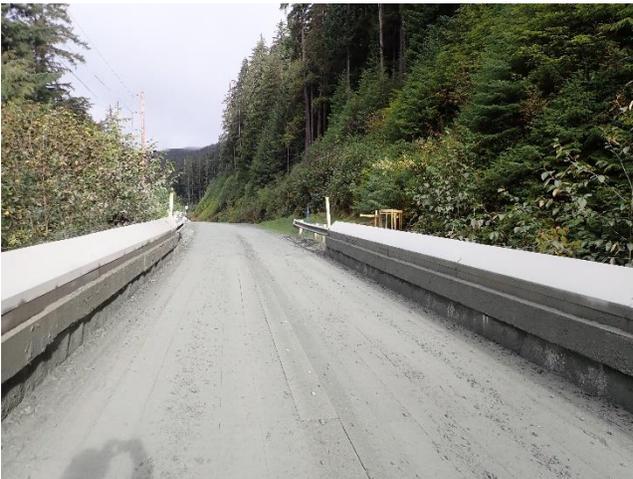
The bridge's splashguards are working as intended by preventing sediment splashover from traffic (Photo 10). Sediment removal is required at the bridge ends (Photo 11).

**Photo 10. 3.4 B Road Bridge (Falls Creek Bridge).**

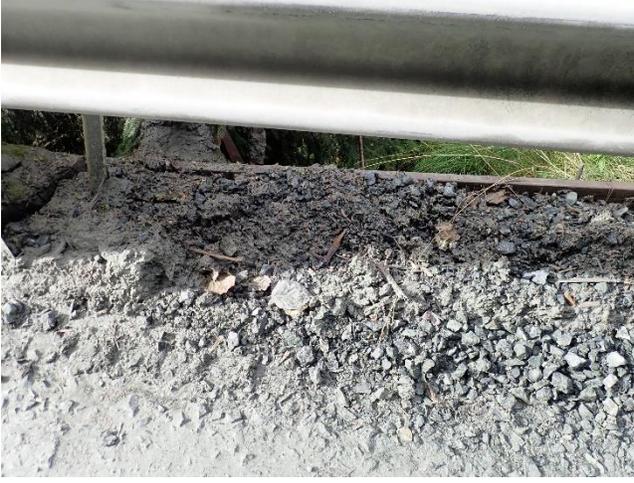
**Photo 11. Sediment removal is required at the bridge ends.**

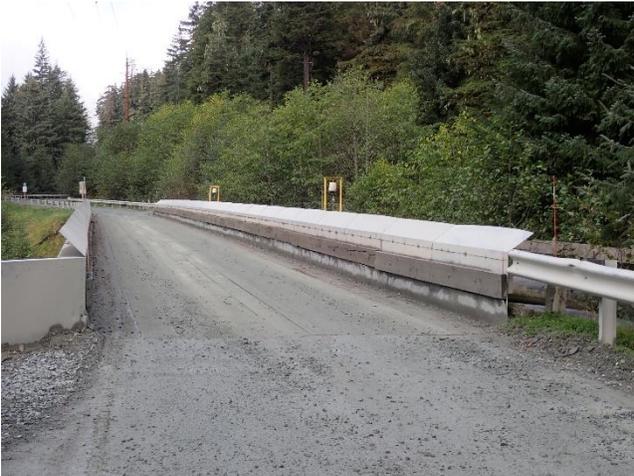
The bridge's splashguards are functioning as designed, preventing sediment splashover from vehicular traffic (Photo 12). The uphill side abutment BMPs are functioning as designed, (Photo 13). Recently, HGCMC Surface Operations removed sediment accumulation underneath the bridge, and re-installed compost wattles (Photo 14). The aluminum precipitate, or white material continues to be observed at the uphill side abutment drain (Photo 15). This drain was cleaned by Surface Operations in August of 2020. HGCMC Surface Operations plan to modify the end of the pipe to keep oxygen out. This

**Photo 12. 3.0 Mile B Road Bridge (Zinc Creek Bridge).**

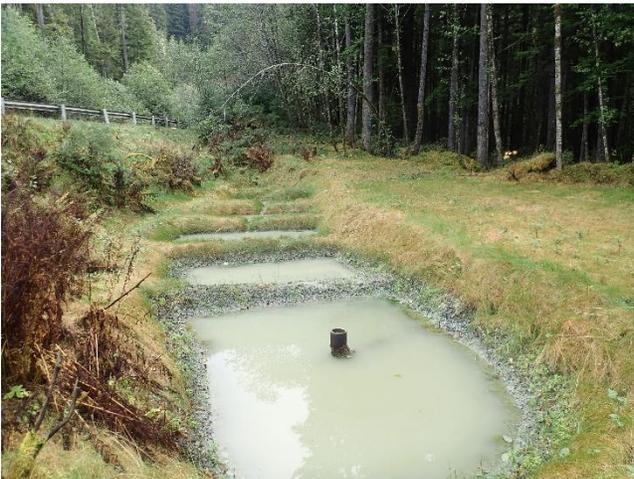
**Photo 13. The 3.0 Mile B Road abutment uphill side BMPs.**

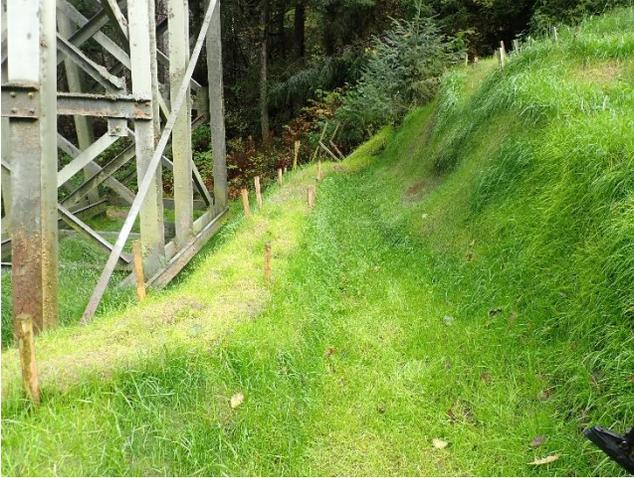
**Photo 14. New compost wattles were placed and seeding undreneath the bridge.**

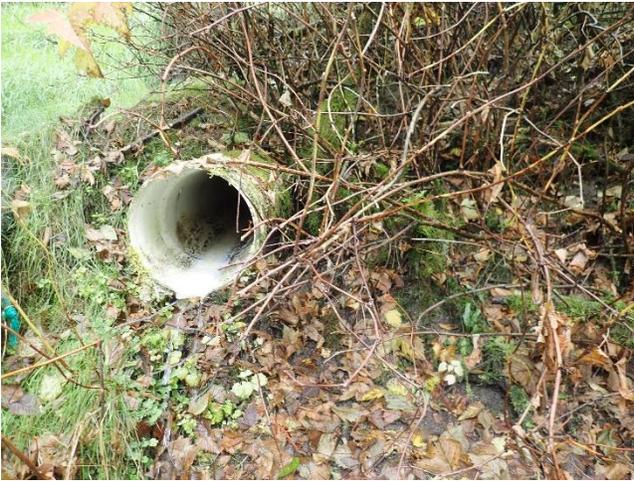
mitigation will not remove the aluminum. However it may help prevent future buildup of precipitate in the pipe.

**Photo 15. The zinc creek abutment drain.**

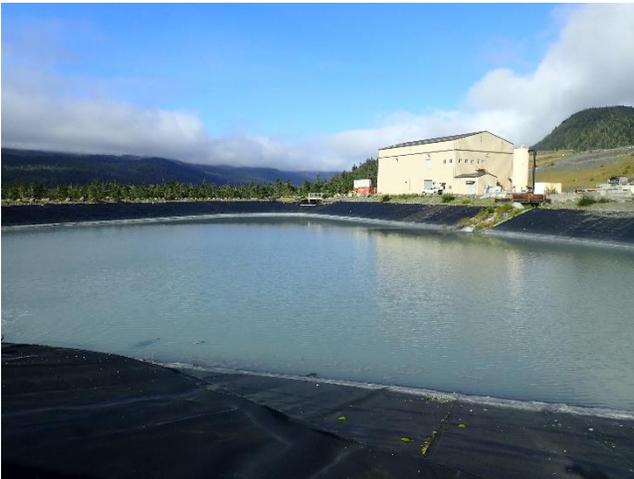
At the time of the inspection, Pond 7 (Photo 16) was collecting mine site water, and Pond 10 (Photo 17) was collecting direct precipitation.

**Photo 16. Pond 7.**

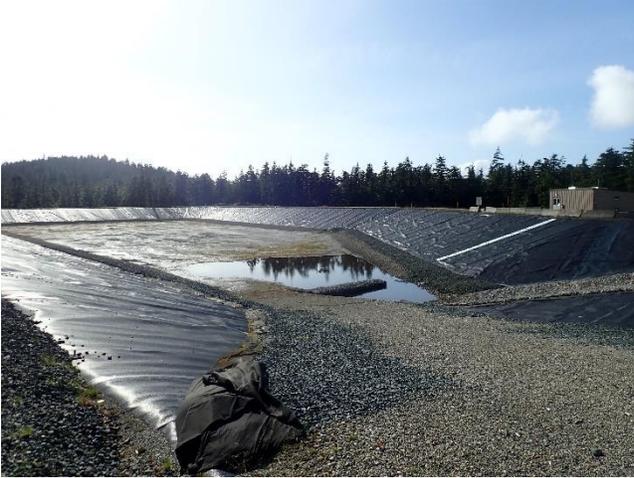
**Photo 17. Pond 10.**

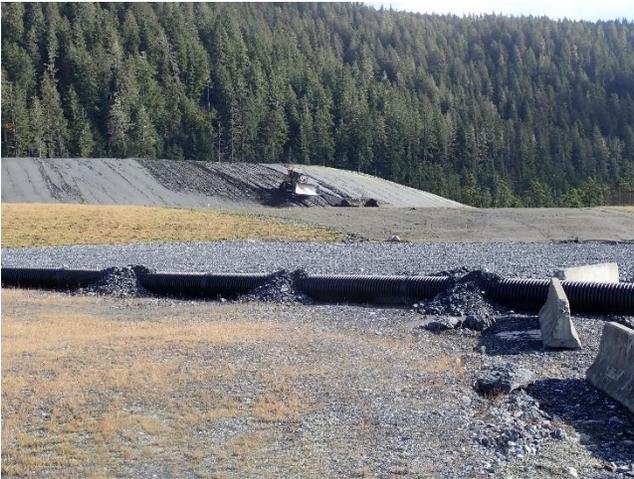
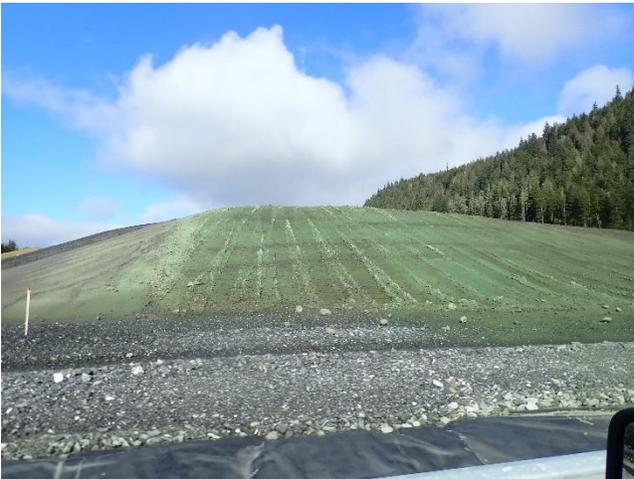
Surface Operations continue to deposit tailings in the S3P1 expansion area (Photos 18-19).

**Photo 18. The S3P1 area.**

**Photo 19. The southern section of the S3P1 area has been hydroseeded.**
