INSPECTION REPORT: GREENS CREEK MINE

Tongass National Forest Minerals Group
8510 Mendenhall Loop Rd
Juneau, AK 99801
(907) 789-6276 – office
(907) 586-8808 – fax

Date of Inspection: Thursday, January 20, 2022
Date of Report: 02/03/2022
USDA Forest Service Inspector: Casey Loofbourrow

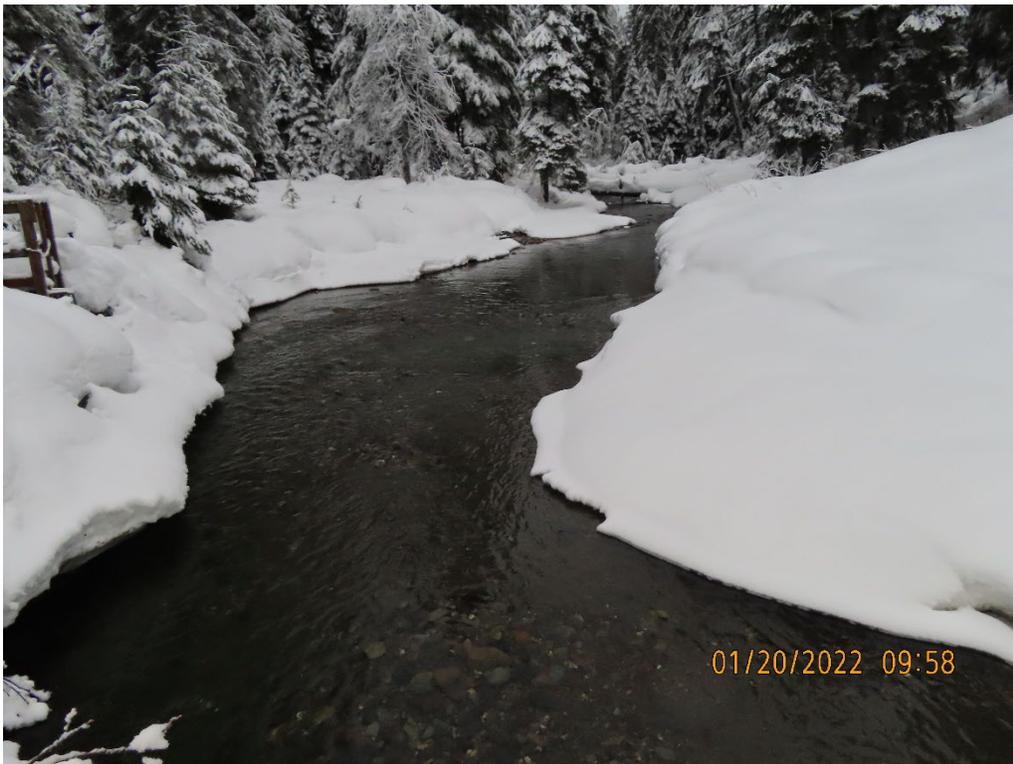
The recorded discharge for Greens Creek (Photos 1-2) was 9.5 cubic feet per second (cfs) at the weir. The 920-area water withdrawal rate from Greens Creek was approximately 1.5 cfs.

Photo 1. Greens Creek looking upstream from the weir at the 920 Area.

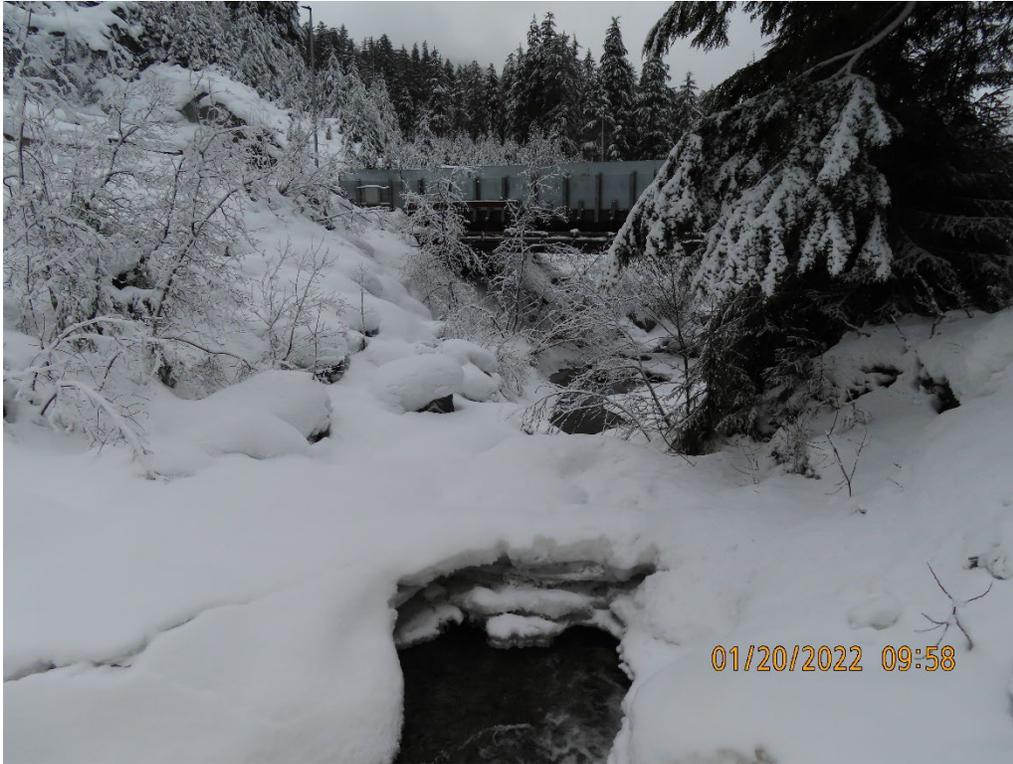
Photo 2 Greens Creek looking downstream from the weir at the 920 Area.

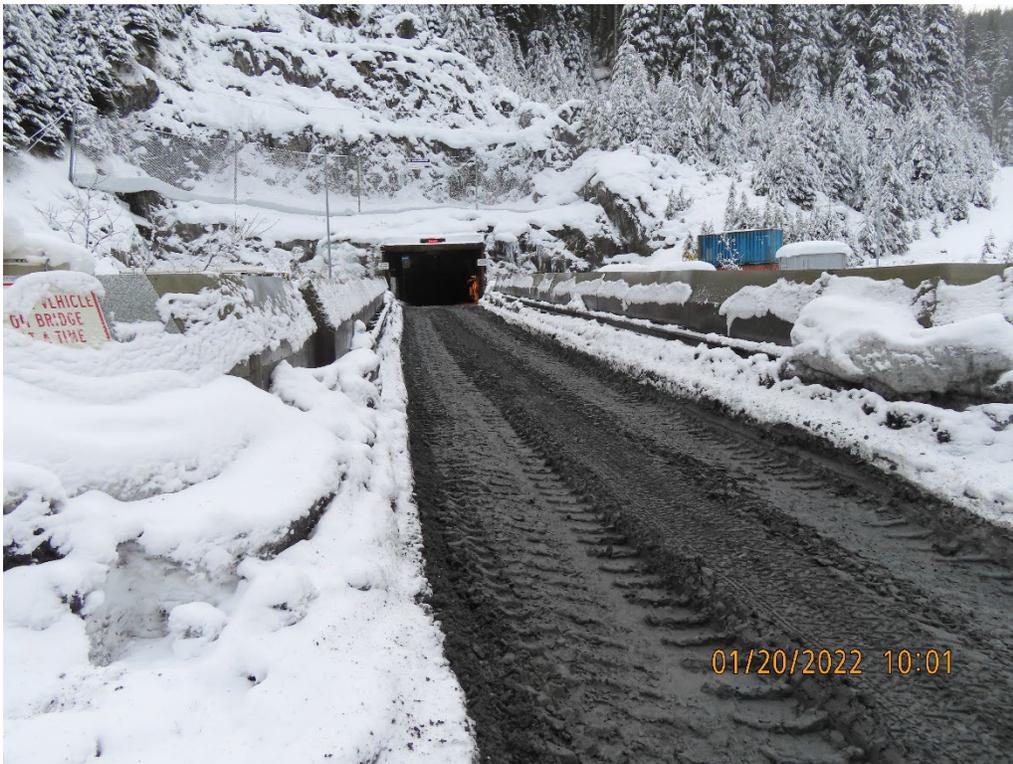
The Greens Creek Bridge splash guards are working as designed to prevent sediment splash over from vehicular traffic (Photo 3).

Photo 3. Greens Creek Mine portal and 920 bridge, showing functioning splash guards.

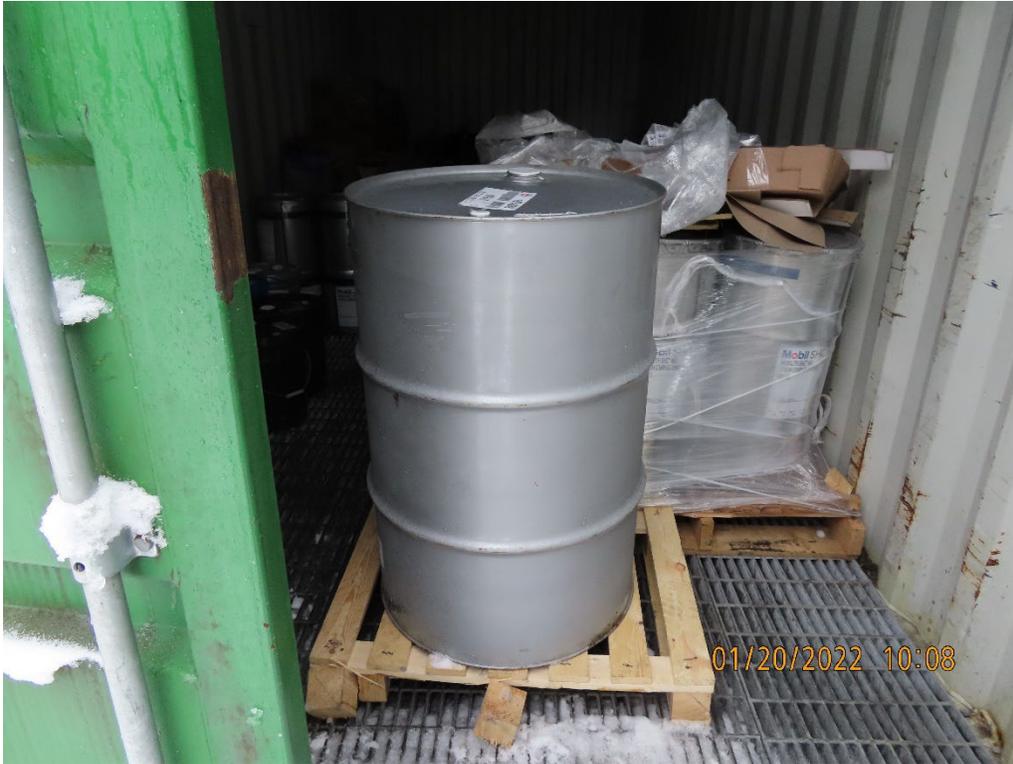
Good housekeeping practices were observed at the 920 warehouse (Appendix 5 BMP Plan page 39). All petroleum/chemicals observed were properly stored within secondary containment (Photo 4).

Photo 4. Chemicals in appropriate secondary containment at the 920 area warehouse.

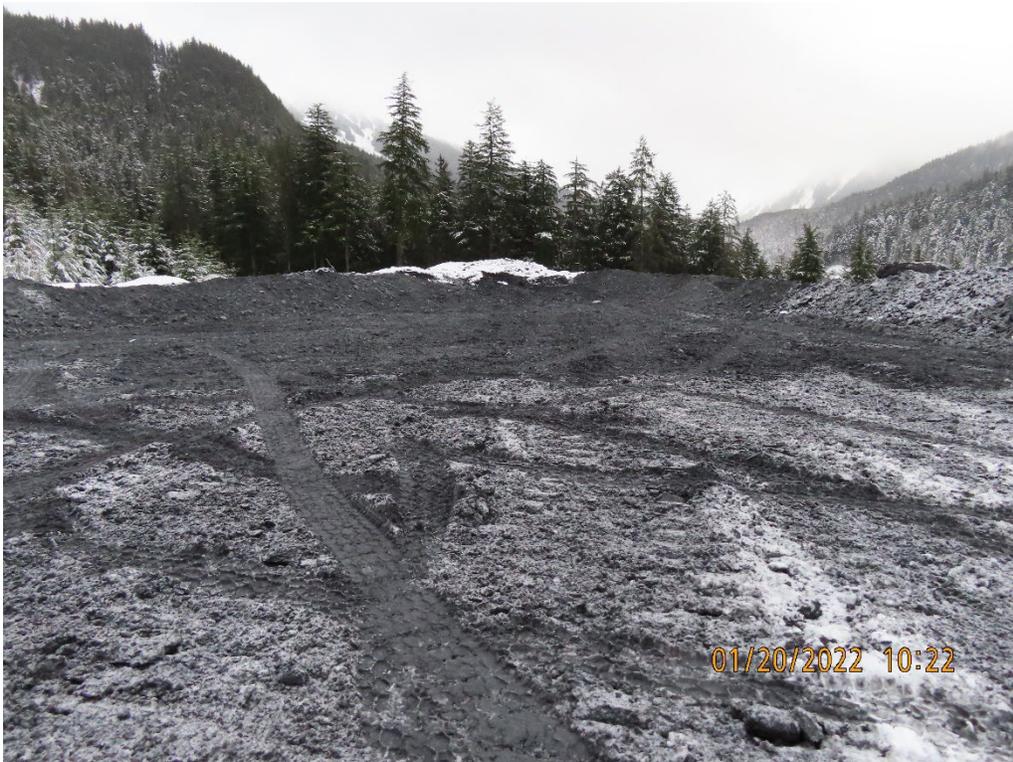
Class 1 and 2/3 waste rock continues to be placed at this location (Photo 5). Pond 23 was in good condition with adequate capacity (Photo 6).

Photo 5. Site 23 waste rock active placement area.

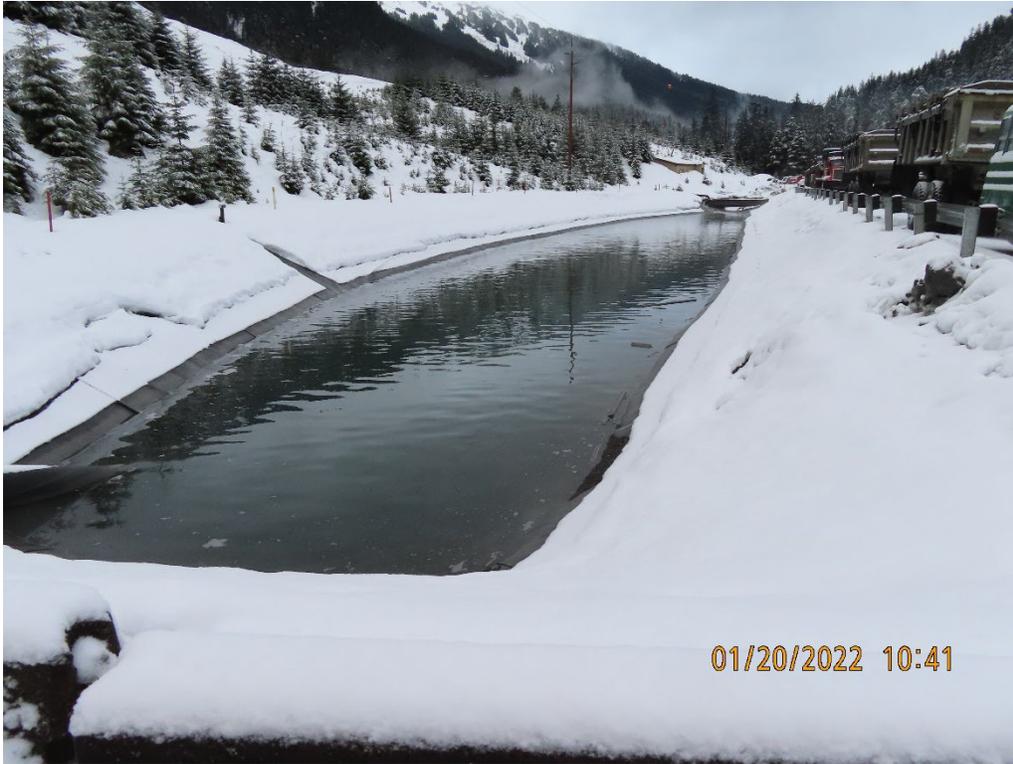
Photo 6. Pond 23 receiving contact water.

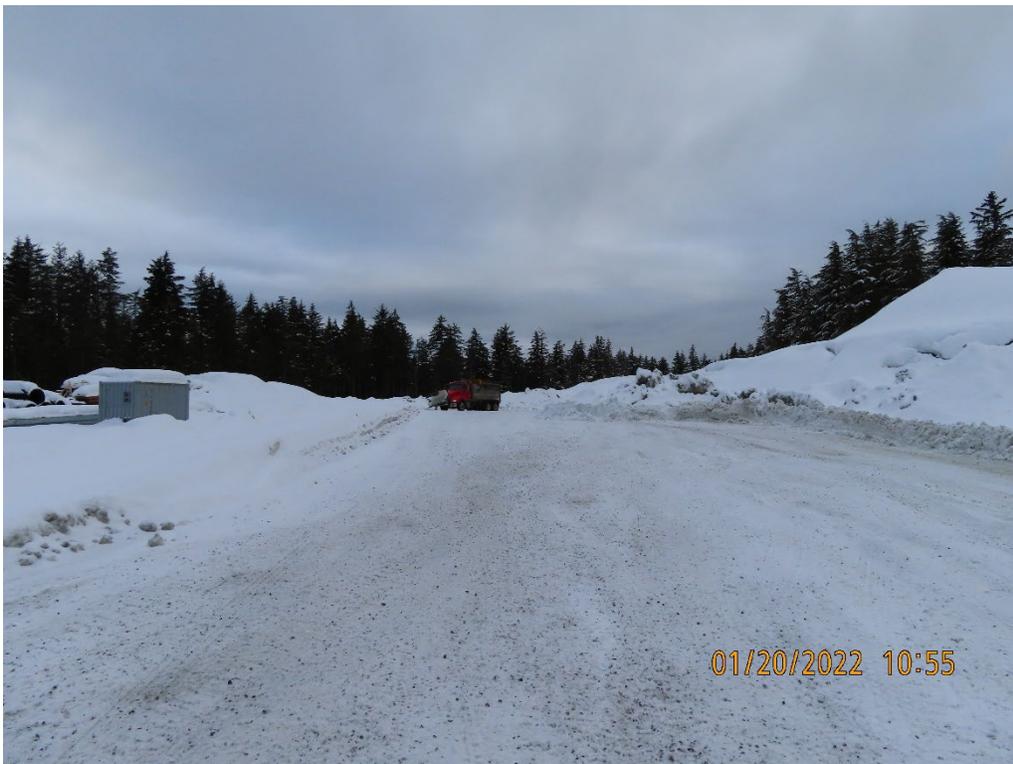
Site E is currently being used as a storage and distribution point for sand and gravel used for road maintenance and traction on snow covered roads (Photo 7).

Photo 7. Site E, where sand and gravel is actively being stored and distributed for road maintenance.

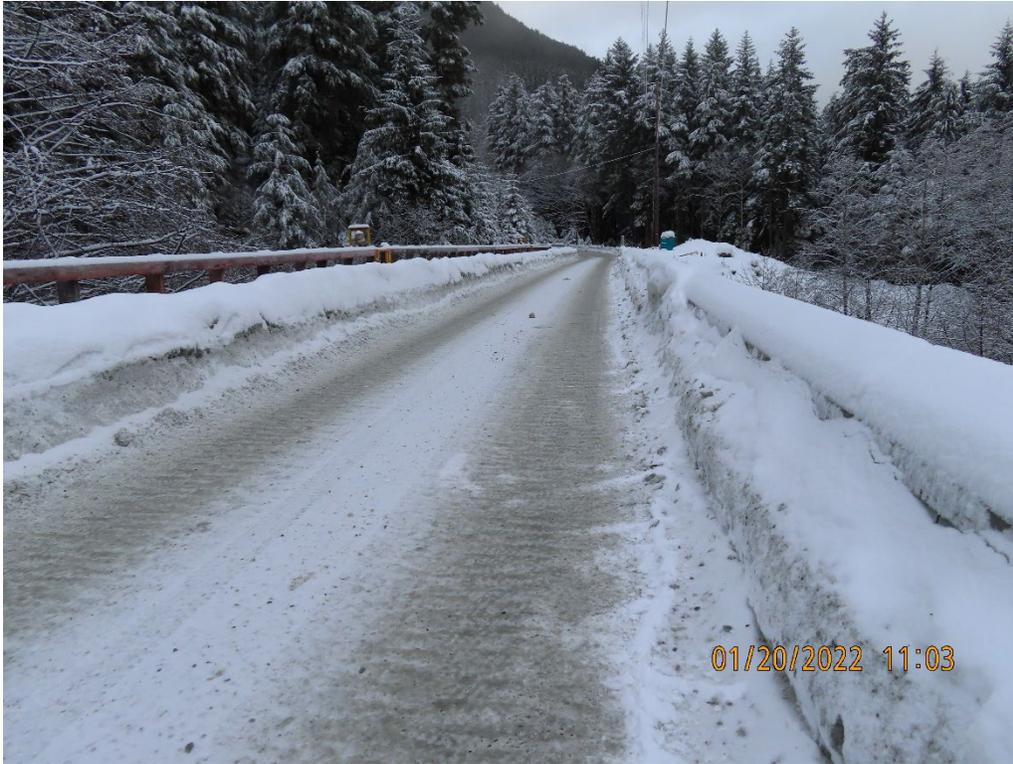
PENDING ACTION ITEM 417-2: Conditions at the time of inspection were compacted snow and ice on the driving surface (Photo 8). No ponding or drainage issues were observed. The new surface of the bridge will be monitored to determine effectiveness of drainage and splash guards under different conditions.

Photo 8. Zinc Creek Bridge surface.

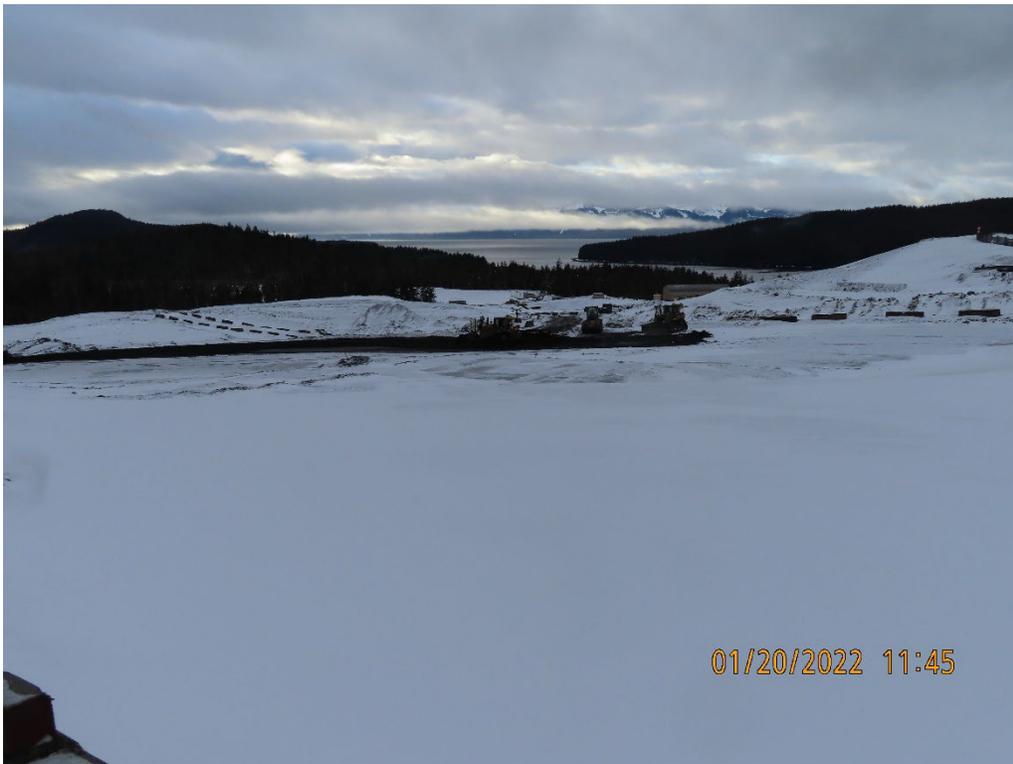
The current active tailings deposition location is the northern S3P1 expansion area, adjacent to 1.0 mile B-Road (Photo 9).

Photo 9. Active tailings deposition area within the TDF.

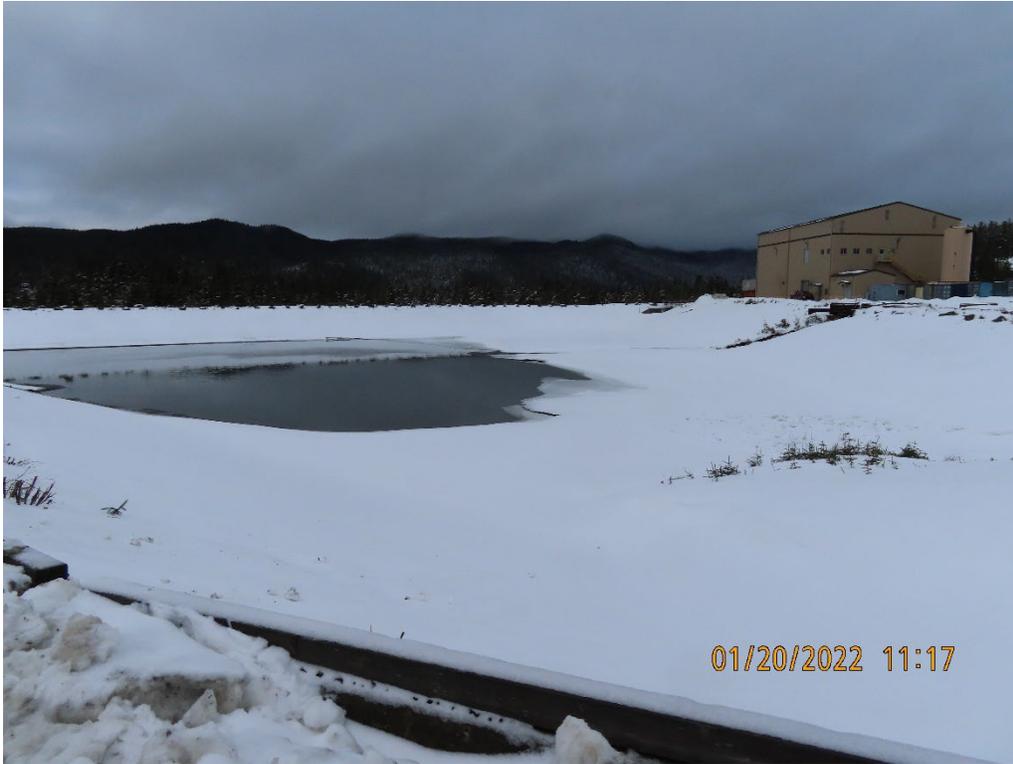
At the time of the inspection, Pond 7 (Photo 10) was collecting contact and process water, and Pond 10 (Photo 11) was not receiving water. The water treatment plant was discharging 672 gpm to Outfall 002.

Photo 10. Pond 7 receiving mill process water and site contact water.

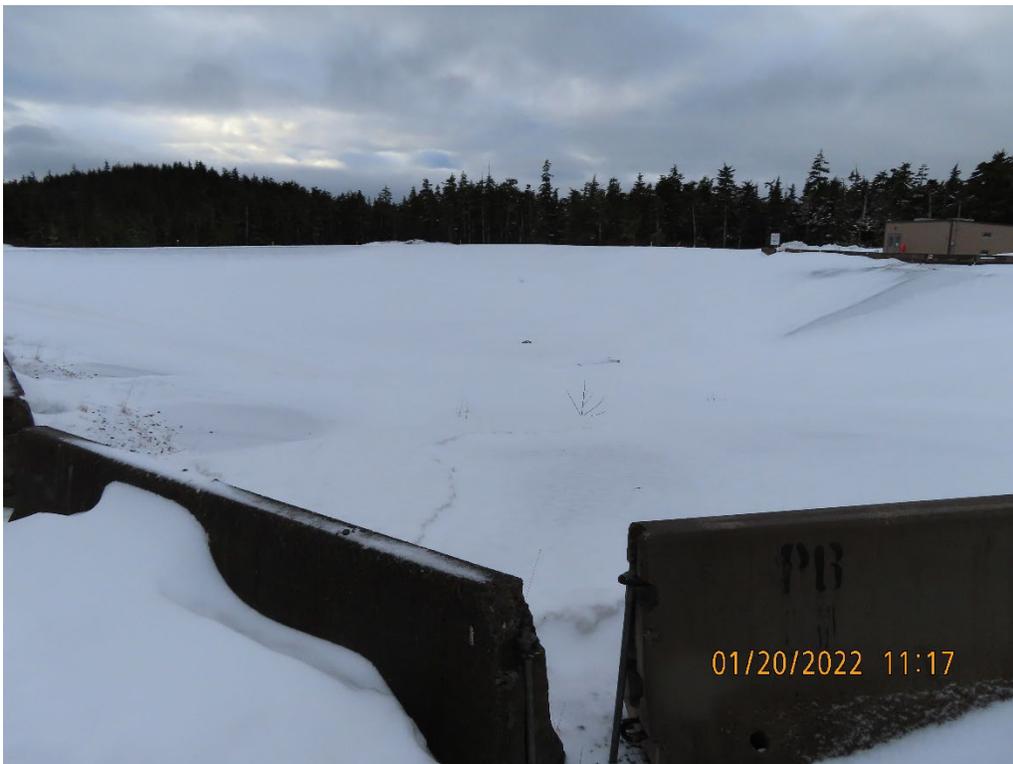
Photo 11. Pond 10, currently not being used.

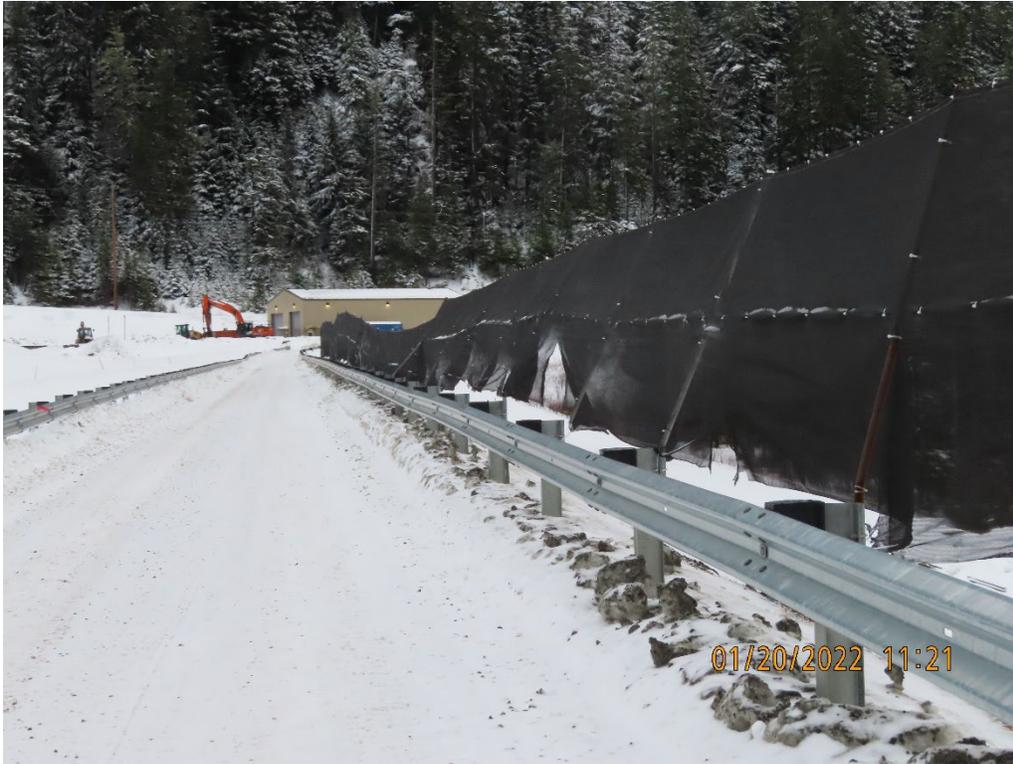
NEW ACTION ITEM 418-1: The fugitive dust fencing along the southern S3P1 area was damaged by wind and requires maintenance (Photo 12).

Photo 12. Damaged fugitive dust fencing along southern edge of the TDF.

418-1: Dust fencing along the southern perimeter of the TDF is damaged and requires repair (Photo 12).
