INSPECTION REPORT: GREENS CREEK MINE

Date of Inspection: Wednesday, March 16, 2022
Date of Report: 4/5/2022
USDA Forest Service Inspector: Casey Loofbourrow

Ranger District: Admiralty National Monument, Juneau Ranger District
Weather Conditions: Overcast, light rain Temperature: Mid 30's (°F).

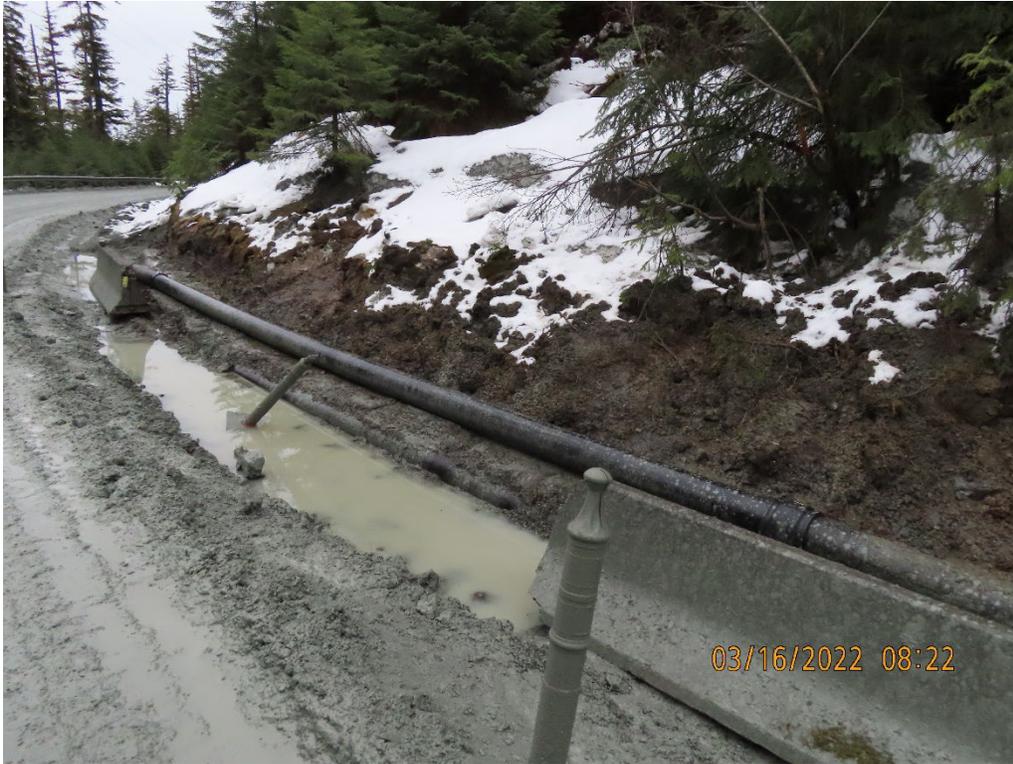
Two sections of pipe along the B-Road that were damaged during recent snow removal operations were documented. This included the 10" HDPE pipeline at approximately 5.1-mile B-Road (Photo 1), which

resulted in the accidental discharge of an estimated 12,600 gallons of treated process water and was reported to the Alaska Department of Environmental Conservation on March 8, 2022.

Photo 1. Repaired section of 10" HDPE pipe at approximately 5.1-mile B-Road.

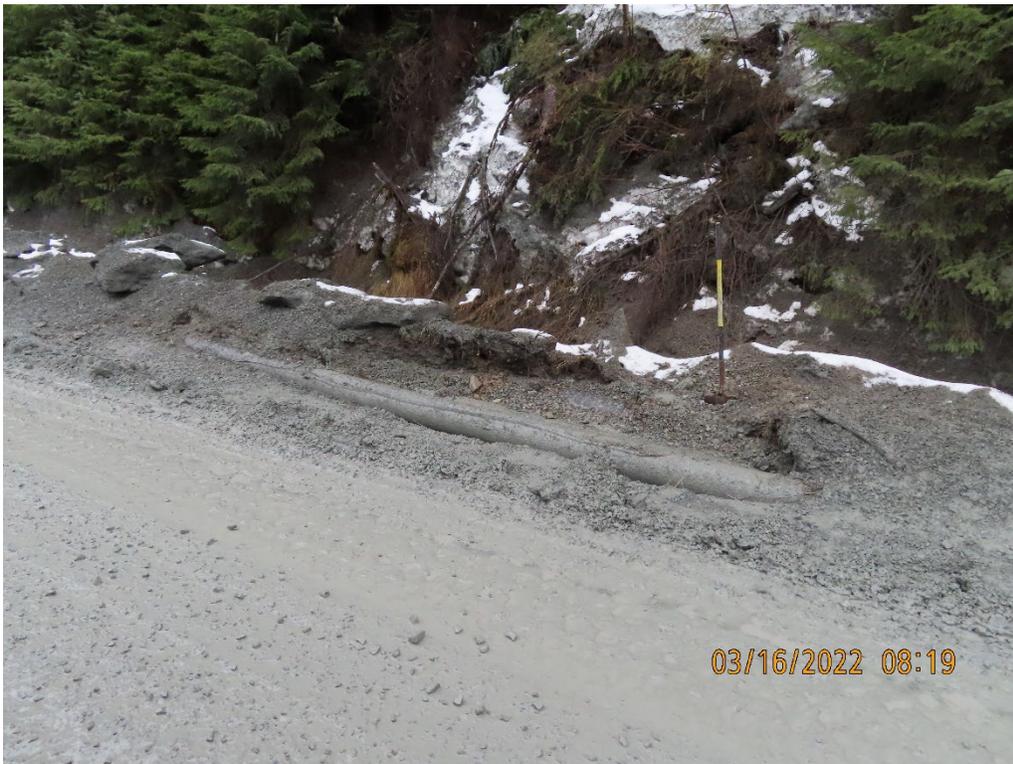
Also damaged was the 8" HDPE pipeline at approximately 5.7-mile B-Road (Photo 2), which resulted in the accidental discharge of an estimated 9,000 gallons of mine drainage and storm water and was reported to the Alaska Department of Environmental Conservation on March 10, 2022.

Photo 2. Damaged section of 8" HDPE pipe at approximately 5.7-mile B-Road.

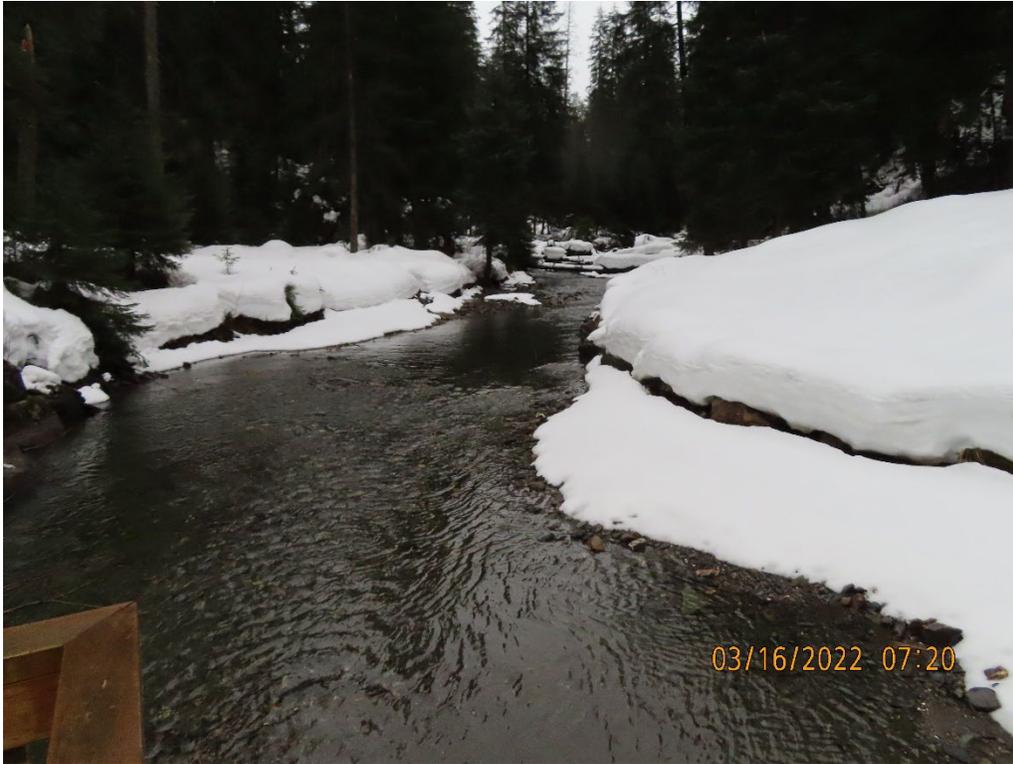
The discharge data for Greens Creek (Photos 3-4) at the time of visit was unavailable due to equipment malfunction. The 920-area water withdrawal rate from Greens Creek was approximately 1.35 cfs.

Photo 3. Greens Creek looking upstream from the weir at the 920 Area.

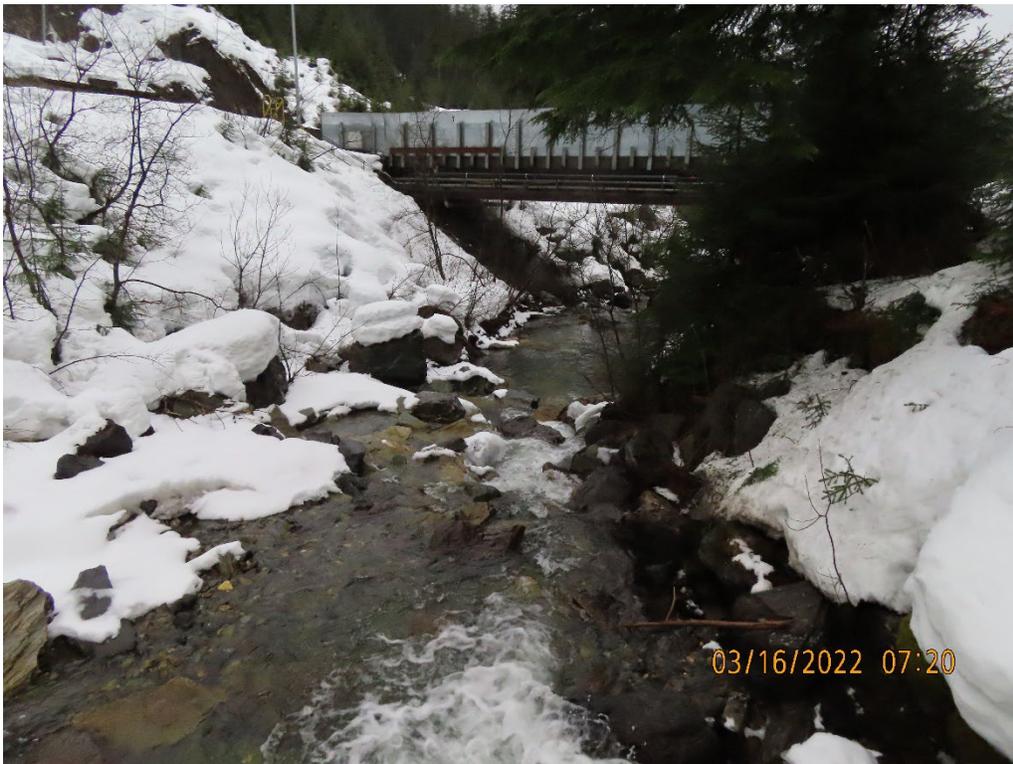
Photo 4. Greens Creek looking downstream from the weir at the 920 Area.

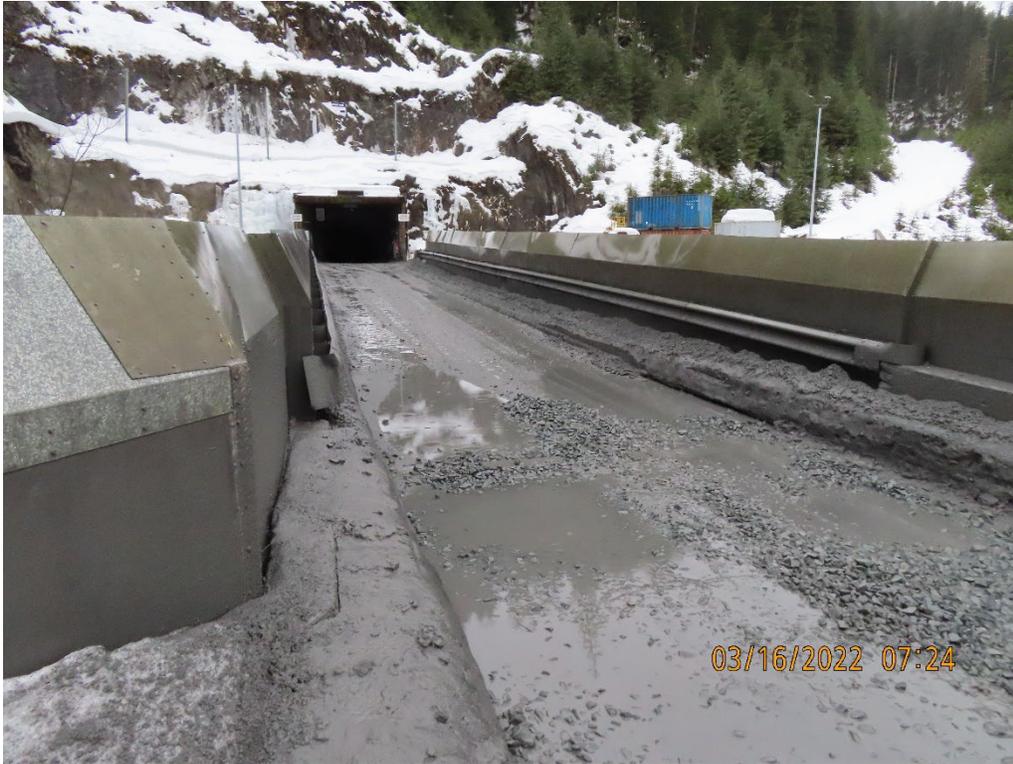
The Greens Creek Bridge splash guards are working as designed to prevent sediment splash over from vehicular traffic (Photo 5).

Photo 5. Greens Creek Mine portal and 920 bridge, showing functioning splash guards.

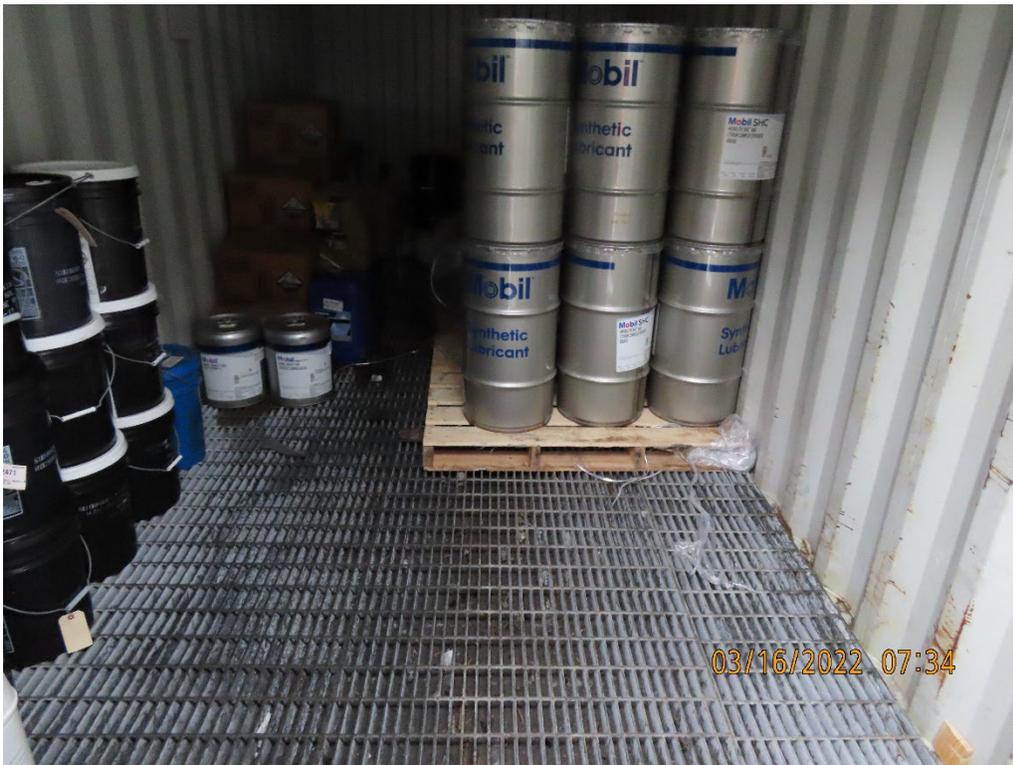
Good housekeeping practices were observed at the 920 warehouse (GPO, Appendix 5 BMP Plan, page 39). All petroleum/chemicals observed were properly stored within secondary containment (Photo 6).

Photo 6. Chemicals in appropriate secondary containment at the 920 area warehouse.

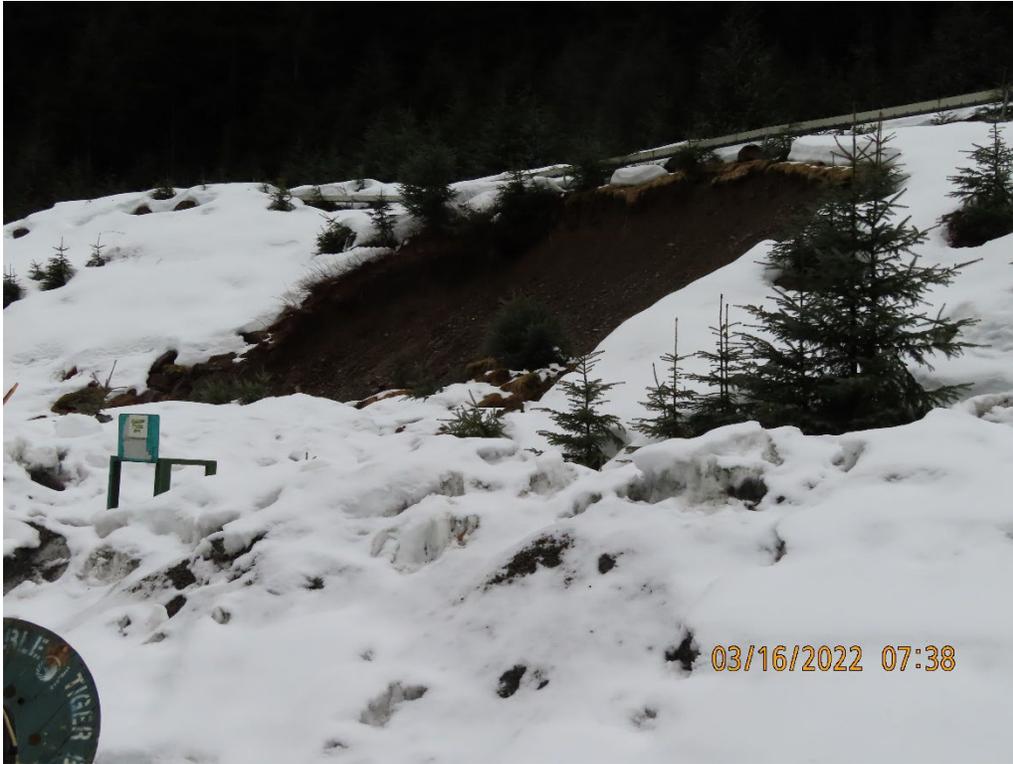
A slump/hillslope failure below the access road north of the warehouse area was observed (Photo 7). This slump is west of a similar feature documented on May 12, 2021, in inspection report 414. The newly observed slump is substantially larger than the one previously observed (Photo 8).

Photo 7. New slump observed below access road north of the warehouse area.

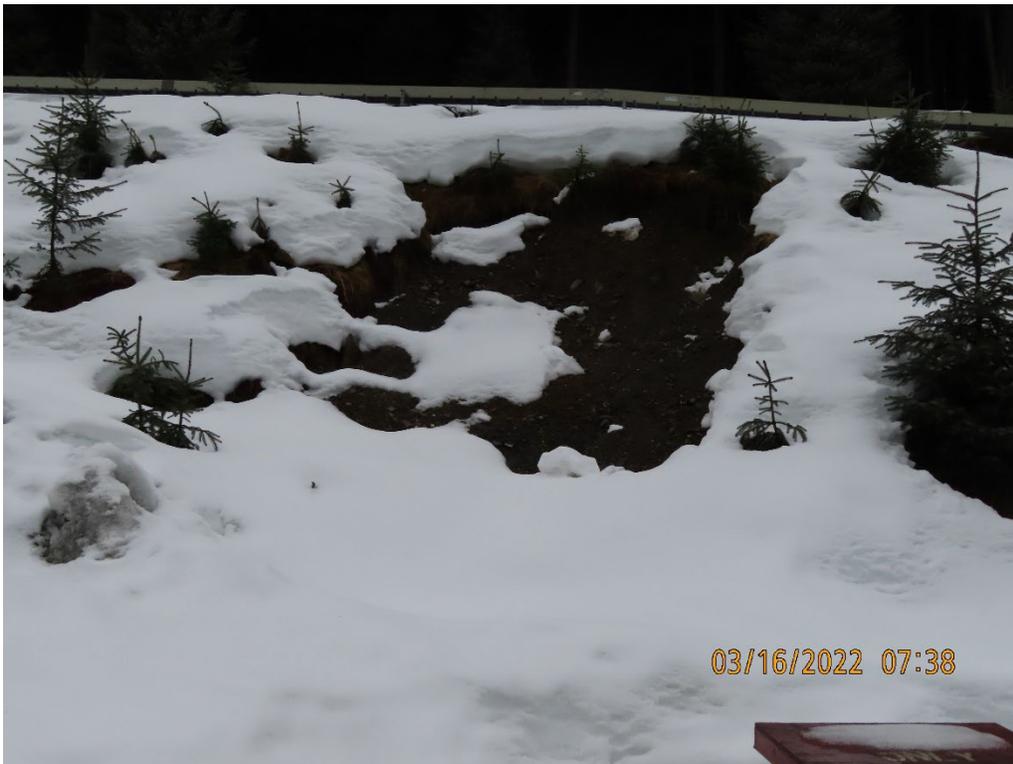
Photo 8. Slump below access road north of the warehouse area that was first observed on March 12, 2021.

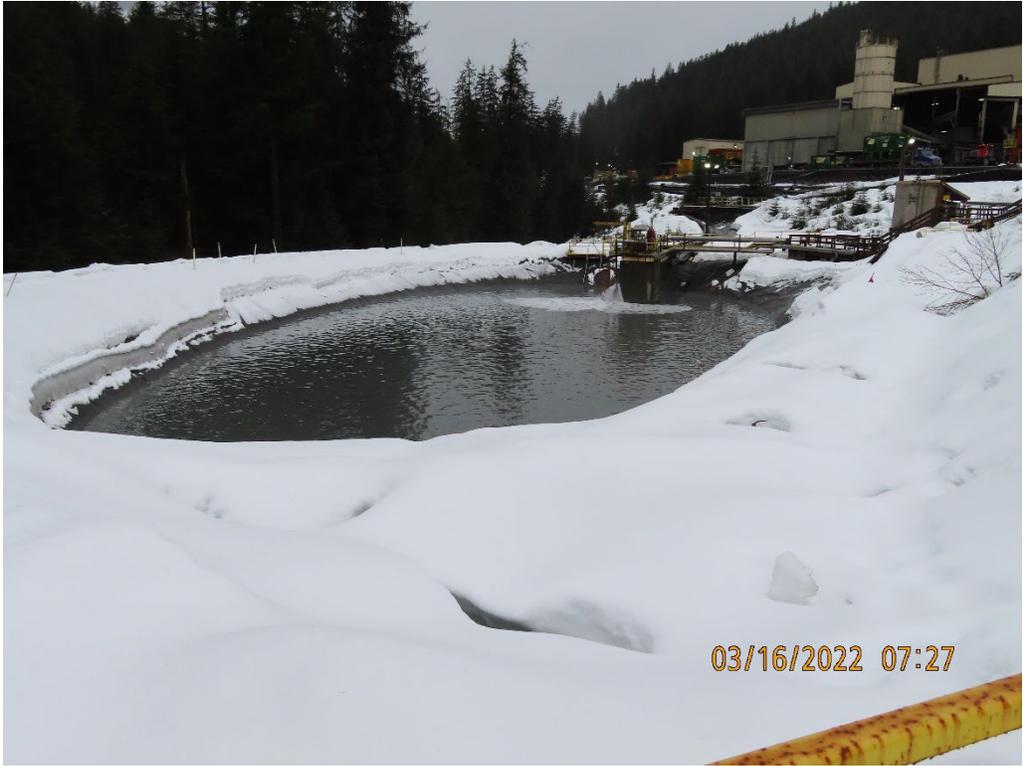
Pond A appeared in good condition with substantial available capacity (Photo 9).

Photo 9. Pond A.

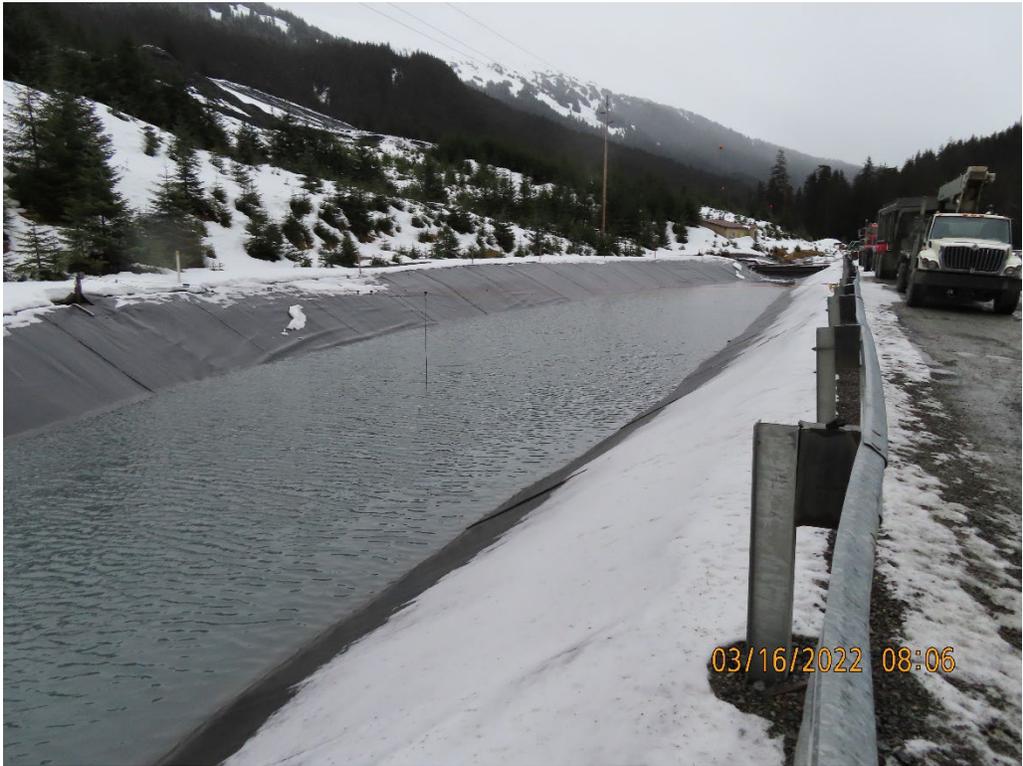
Class 1 and 2/3 waste rock continues to be placed at this location. Pond 23 was in good condition with substantial available capacity (Photo 10).

Photo 10. Pond 23 receiving contact water from Site 23.

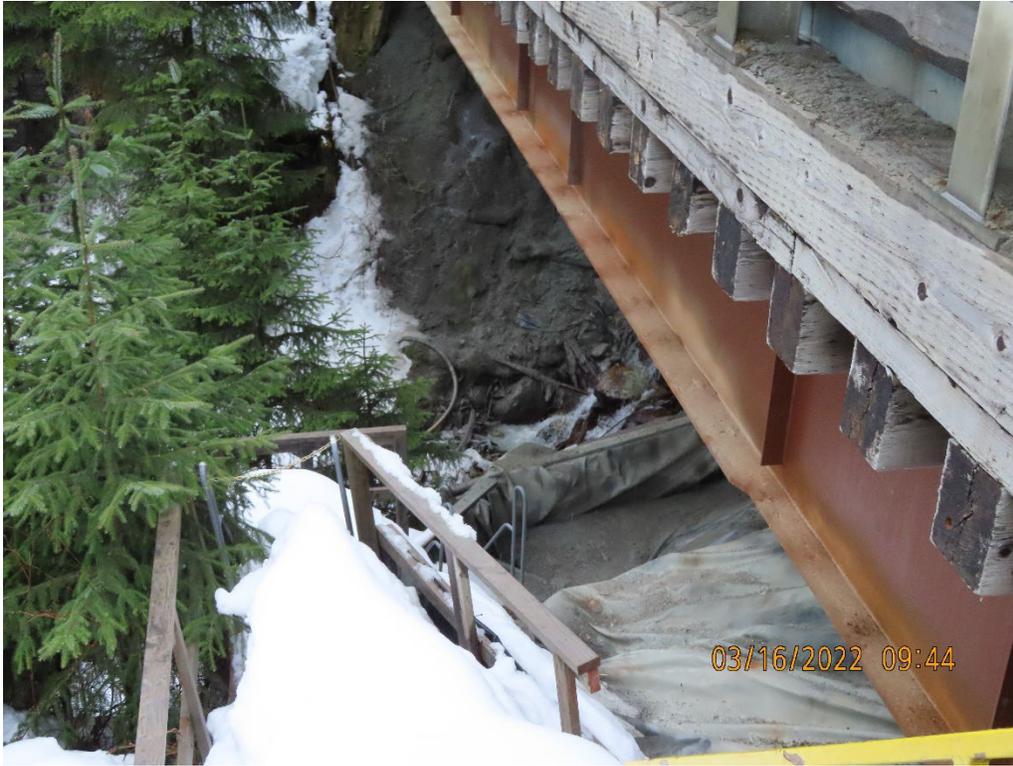
Date/Item No.	Item Description	Status
5/12/2021; 414-1	Perform maintenance on the Killer Creek Bridge downhill side abutment sedimentation BMPs	Pending. Sediment BMPs are in disrepair on the bridge abutments to Killer Creek. Requires repair or replacement of BMPs to minimize sediment release to Killer Creek. HGCMC GPO Appendix 5 lists approved BMPs along B-Road Bridges.

REQUIRES ACTION - PENDING ACTION ITEM 414-1: The downhill side abutment BMPs are not optimally functioning as intended and should be maintained or replaced (Photo 11, requirements at GPO, Appendix 5 BMP Plan, page 10). Bridge replacement is scheduled for May 2022, during which time BMPs will be replaced. Prior to replacement, BMPs should be repaired to the extent necessary to prevent impacting surface waters.

Photo 11. Killer Creek Bridge downhill side abutment showing BMPs in disrepair.

Bridge decking replacement is scheduled for May 2022 during which time BMPs will be replaced
5/12/2021; 414-3	Monitor aluminum precipitate accumulating from abutment drain at Zinc Creek Bridge.	Pending. During reconstruction of the Zinc Creek Bridge, HGCMC excavated and replaced material that is suspected of being the source of the aluminum precipitate. This site was not visible in this inspection due to snow cover and will be monitored in future inspections to determine whether this measure was successful.
11/11/2021; 417-1	Bridge abutment sediment BMPs are not functioning optimally at the Falls Creek Bridge. Sediment BMPs should be repaired or installed to prevent sediment from entering Falls Creek.	Pending. Abutment BMPs continue to be in disrepair. Bridge replacement is planned for May 2022 which will provide an opportunity for construction and/or maintenance of BMPs.
11/11/2021; 417-2	Monitor conditions on the newly resurfaced Zinc Creek Bridge to ensure sediment control BMPs including splash guards are operating effectively.	Resolved. Surface ponding is present at the bridge ends, which allows water to overtop the liner and fall to the ground below. However, the ground surface underlying the ends of the bridge includes BMPs that should capture sediment transported from the roadbed.

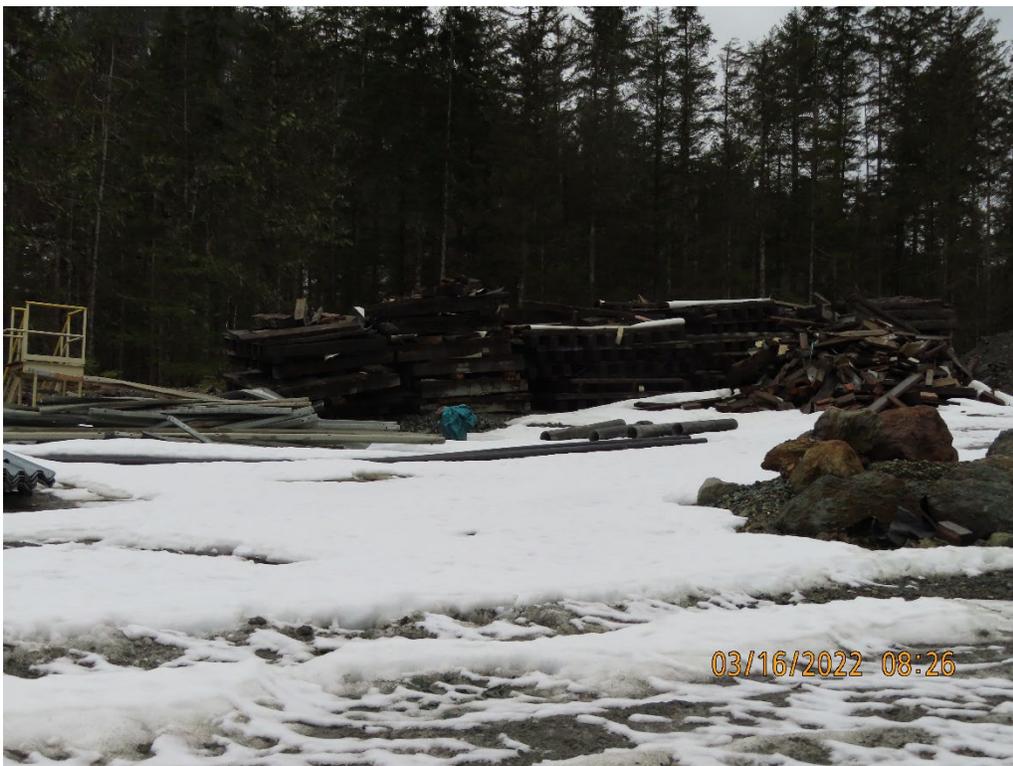
Site E is currently being used as a storage and distribution point for sand and gravel used for road maintenance and traction on snow covered roads. The old bridge decking from the Zinc Creek Bridge is currently being stored at this location (Photo 12).

Photo 12. Demolished Zinc Creek Bridge decking staged at Site E.

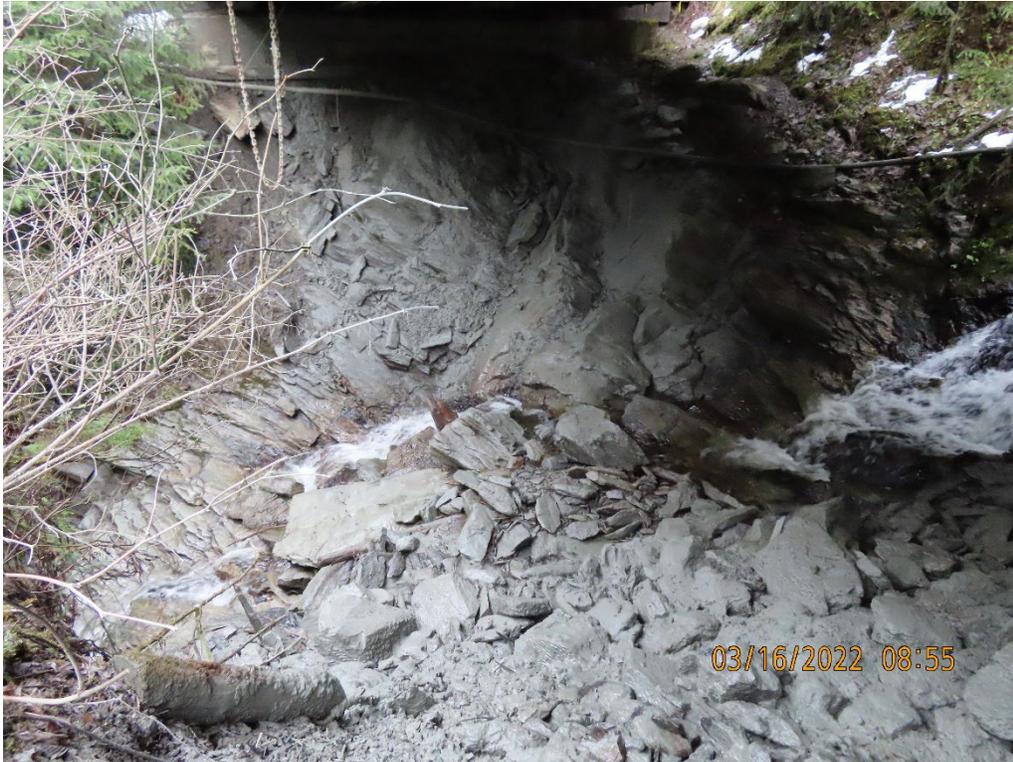
REQUIRES ACTION - PENDING ACTION ITEM 417-1: Bridge abutment sediment BMPs are not optimally functioning. A high sediment load is present on the banks of Falls Creek under the bridge, indicating sediment has directly entered the water as well as being a potential source of sediment entering the stream if it were to experience a significant water level rise (Photo 13). Sediment BMPs should be repaired or installed to prevent causing increased turbidity in Falls Creek (Requirements at GPO, Appendix 5 BMP Plan, page 10). Replacement of this bridge is planned for May 2022, providing an opportunity to complete this work. Prior to replacement, BMPs should be repaired to the extent necessary to prevent impacting surface waters.

Photo 13. Below Falls Creek Bridge, showing excessive sediment accumulation without BMPs to prevent impacting surface waters with sedimentation and/or turbidity.

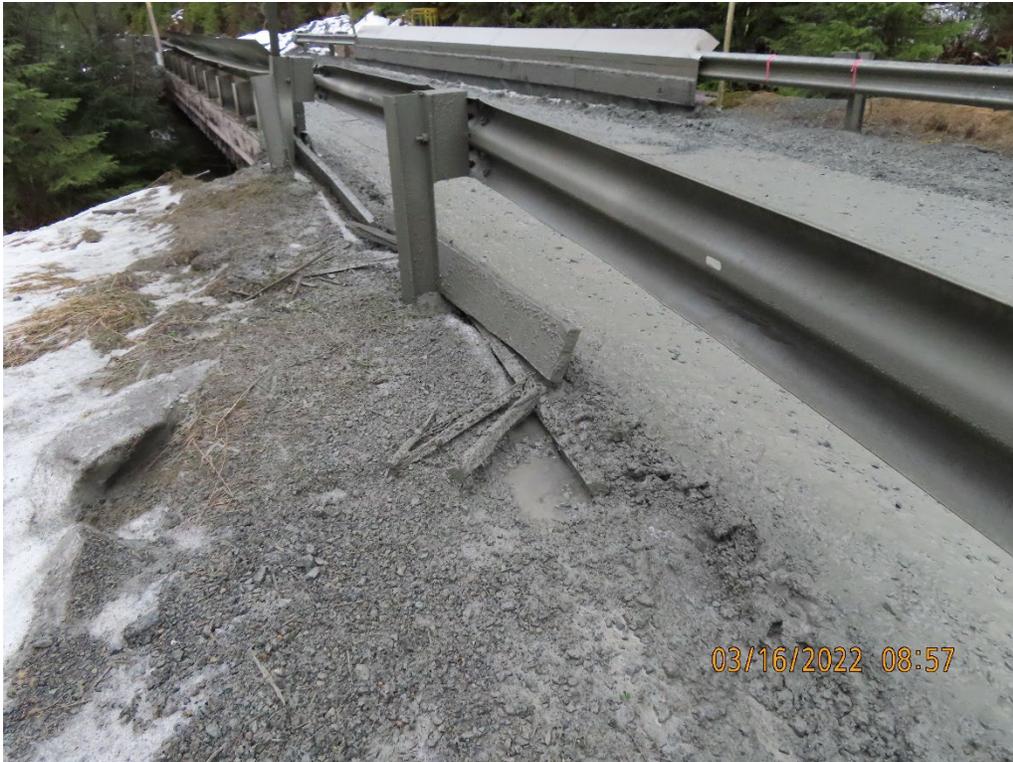
NEW ACTION ITEM 419-1: Sediment deflection boards at the uphill bridge end of Falls Creek Bridge are damaged and require replacement (Photo 14, requirements at GPO, Appendix 5 BMP Plan, page 10).

NEW ACTION ITEM 419-1: Sediment deflection boards at the uphill bridge end are damaged and require replacement (Photo 14, requirements at GPO, Appendix 5 BMP Plan, page 10).

Photo 14. Damaged sediment deflection boards at Falls Creek Bridge.

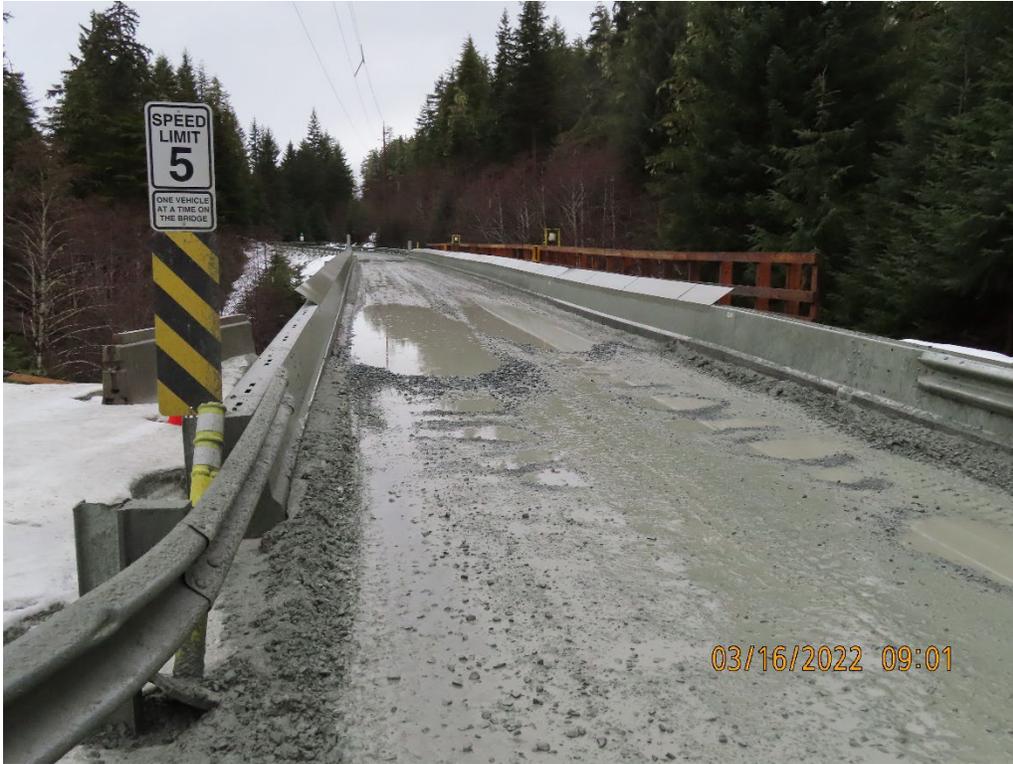
RESOLVED ACTION ITEM 417-2: Ponding was observed on the road surface at both ends of the bridge (Photo 15). This source of water, and the limited vertical extent of the HDPE liner installed below the new bridge decking, allows turbid water to overtop the liner when disturbed by vehicle traffic and fall to the ground below, as was observed in this inspection during the passage of a Max Haul truck (Photo 16). The ground below the ends of the bridge where this occurs contain sediment and stormwater BMPs (Photo 17) that should effectively mitigate sediment or turbid water entering Zinc Creek.

Photo 15. Surface of Zinc Creek Bridge showing ponding at bridge end.

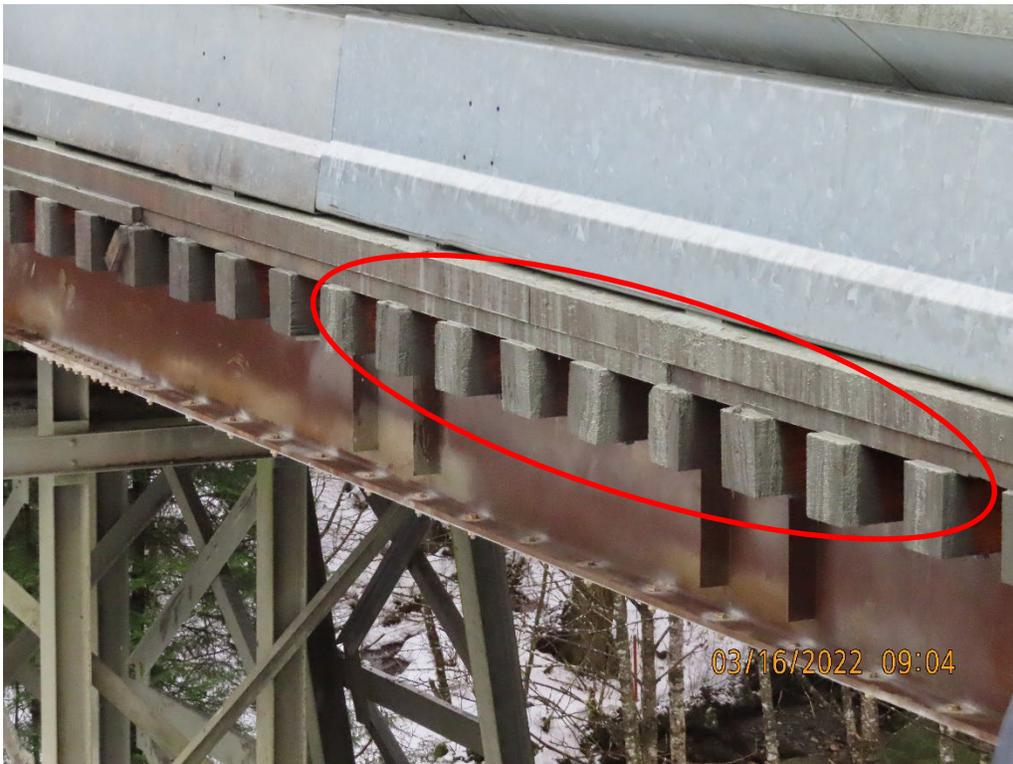
Photo 16. Closeup of turbid water overtopping bridge liner at Zinc Creek Bridge. Photo was taken immediately following the passage of a Max Haul truck, which produced the water in this photo, circled in red.

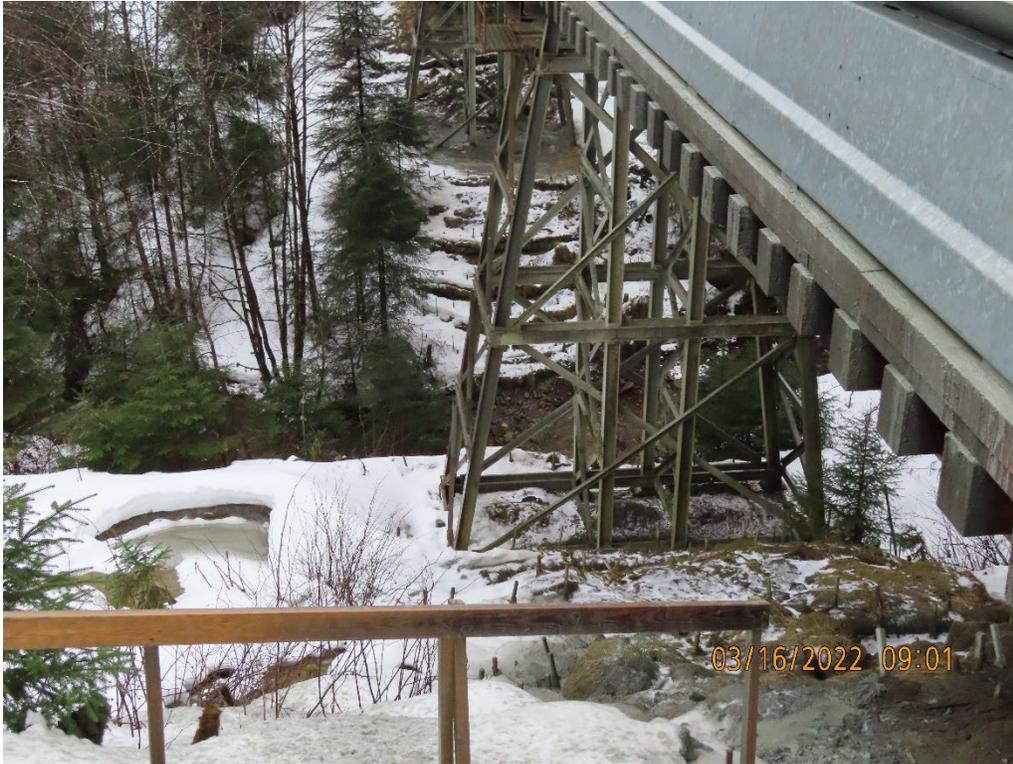
Photo 17. Stormwater BMPs below Zinc Creek Bridge that are below the overtopping water in photo 16, also visible on the right of this photo.

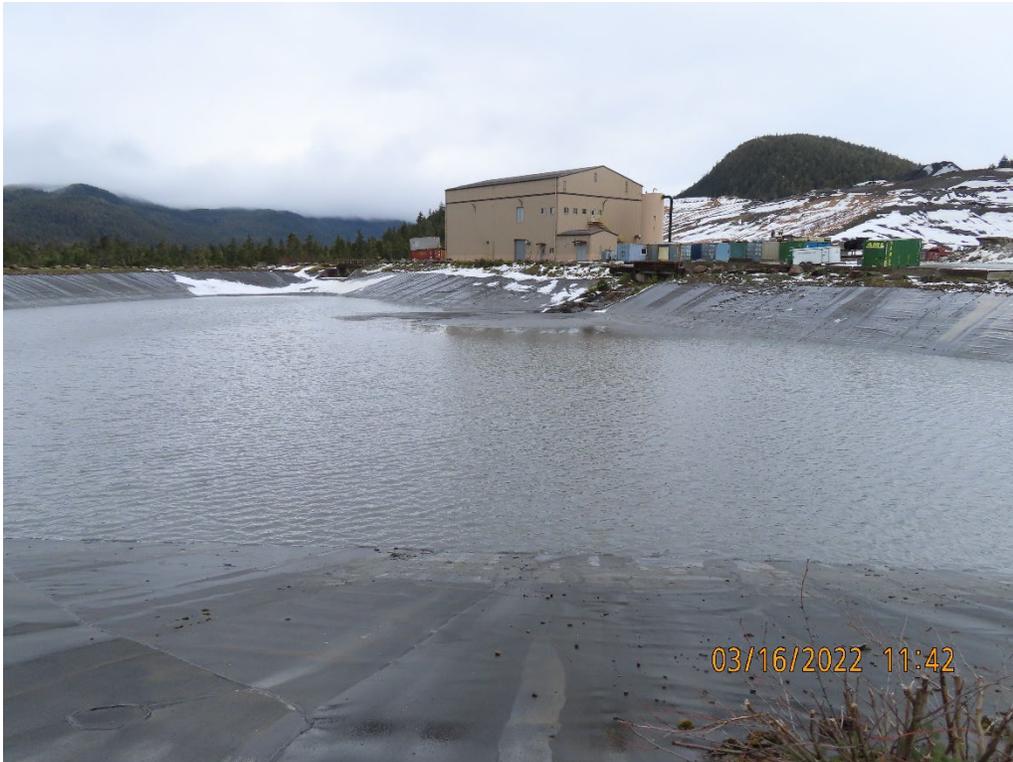
At the time of the inspection, Pond 7 (Photo 18) was collecting contact and process water, and Pond 10 (Photo 19) was not receiving water. The water treatment plant was discharging 1003 gpm to Outfall 002.

Photo 18. Pond 7.

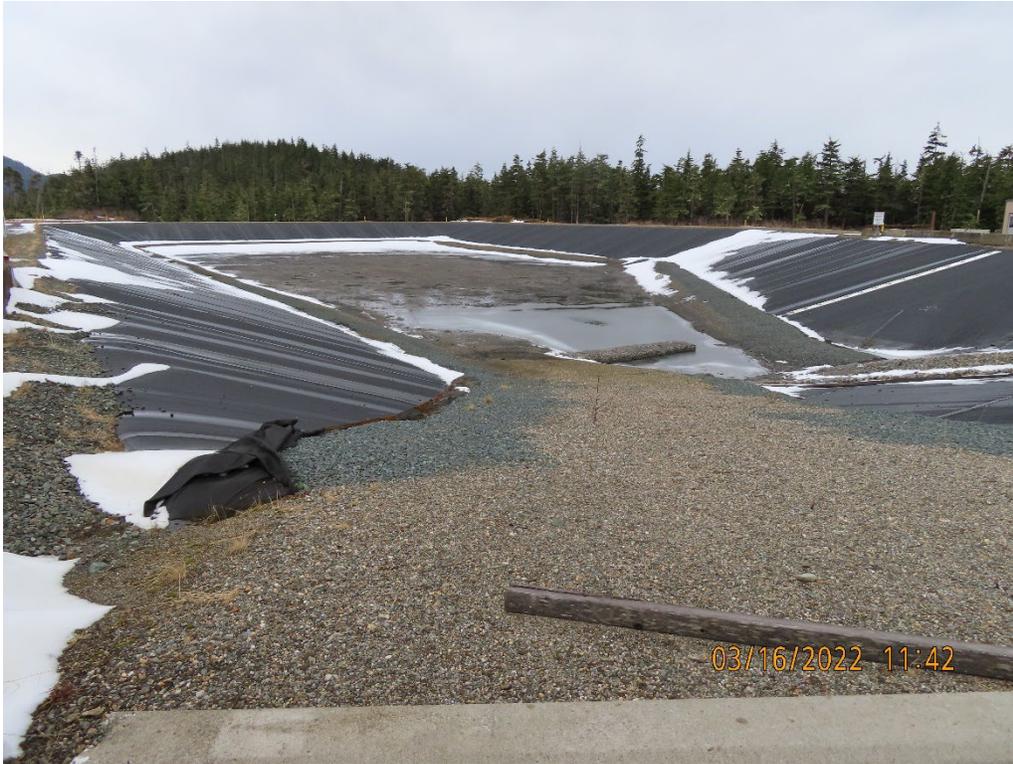
Photo 19. Pond 10.

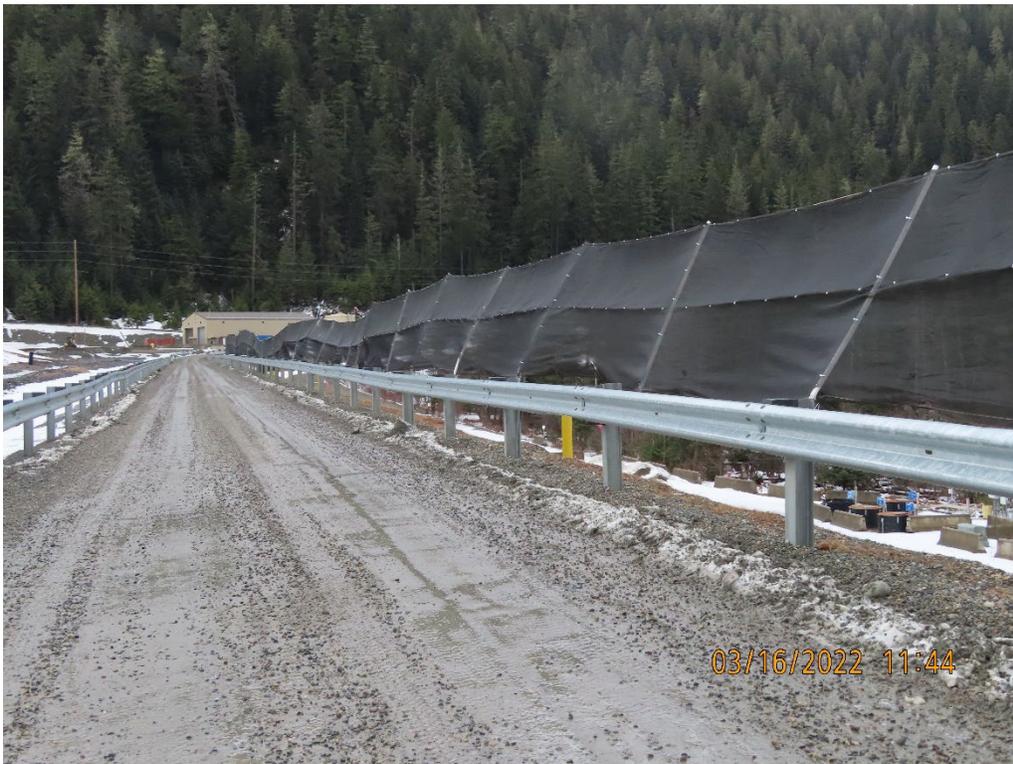
01/20/2022; 418-1	Dust fencing along the southern perimeter of the TDF is damaged and requires repair	Pending. Fencing remains in disrepair.

PENDING ACTION ITEM 418-1: REQUIRES ATTENTION - The fugitive dust fencing along the southern S3P1 area was damaged by wind and requires maintenance (Photo 20).

Photo 20. Damaged fugitive dust fencing south of the TDF.
