INSPECTION REPORT: GREENS CREEK MINE

Tongass National Forest Minerals Group
8510 Mendenhall Loop Rd
Juneau, AK 99801
(907) 789-6276 – office
(907) 586-8808 – fax

Date of Inspection: Wednesday, September 28, 2022
Date of Report: October 12, 2022
USDA Forest Service Inspector: Pat Dryer

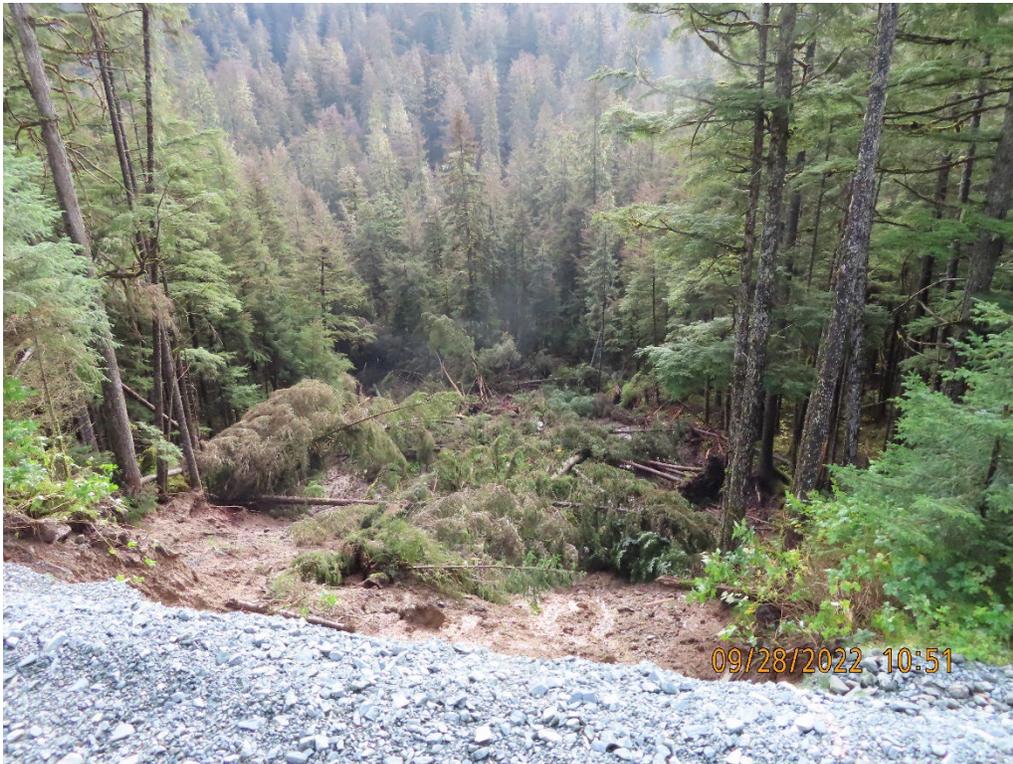
A landslide occurred on Tuesday 27 September at the 5.6 mile of the B-road (Photos 1-3). The road was closed during the inspection to allow contractors to make emergency repairs to the road. The contractors were placing clay materials in the roadside ditch to reduce infiltration under the section of the road effected by the landslide (Photo 3). The B-road was being undercut by the head scarp and Hecla engineers were attempting to determine the most appropriate way to conduct repairs (Photos 2-3). Small seeps along the bedrock outcroppings were visible in the disturbed area below the roadway

Photo 1. The 5.6 mile B-road landslide viewed from the road surface.

(Photo 3). Road repairs were recently completed in this area under the 5.6 mile deep patch project. There were no culverts located in the section of the road where the landslide has compromised the roadway. The FS requested Hecla provide a plan for the emergency repairs to be considered under a road maintenance CE. The plan for a rockfill buttress was submitted on 10/3/2022 to the Forest Service, and approval was given on 10/5/2022.

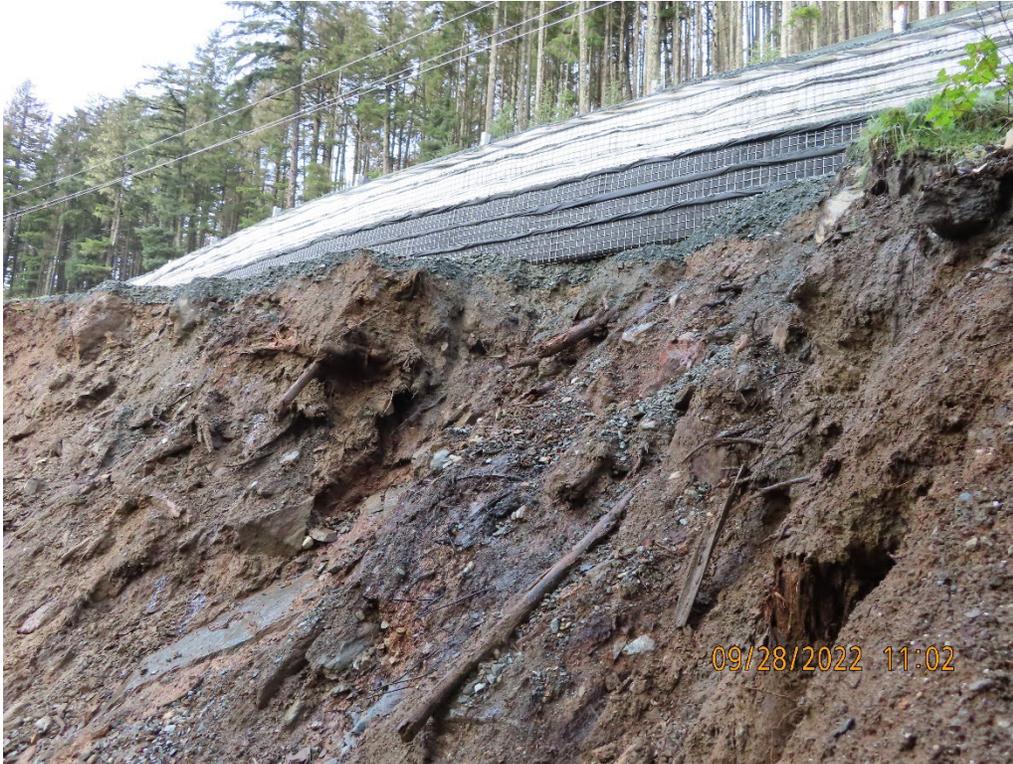
Photo 2. The head scarp of the 5.6 mile B-road landslide undercutting the roadway.

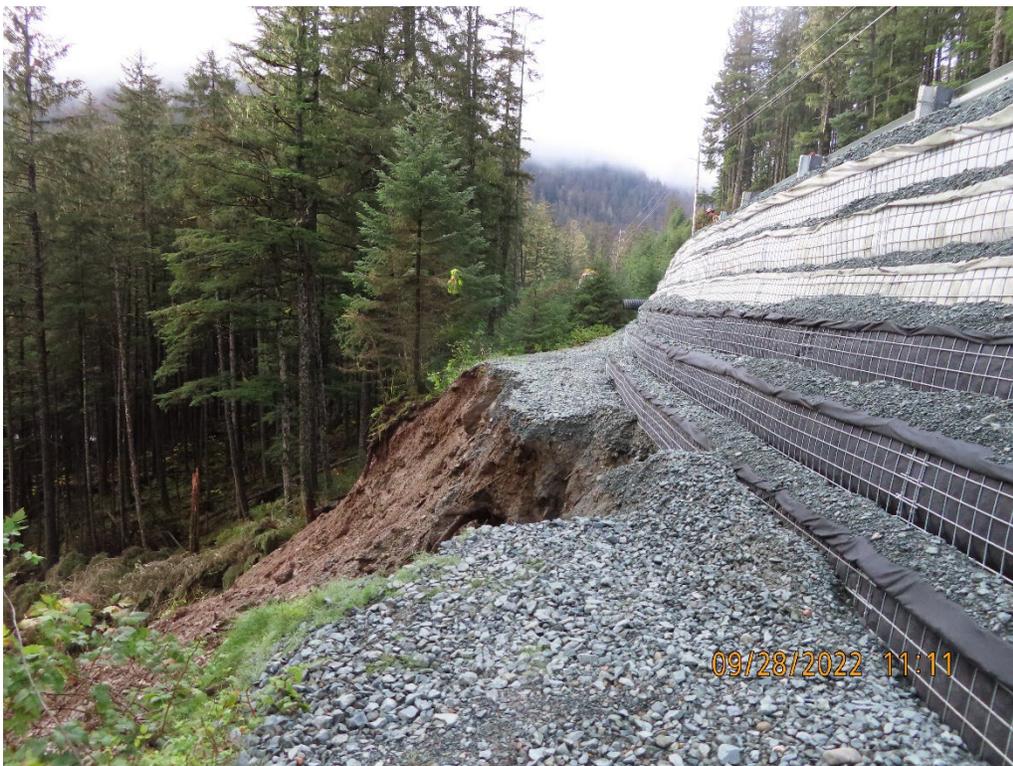
Photo 3. The head scarp of the 5.6 mile B-road landslide undercutting the roadway.

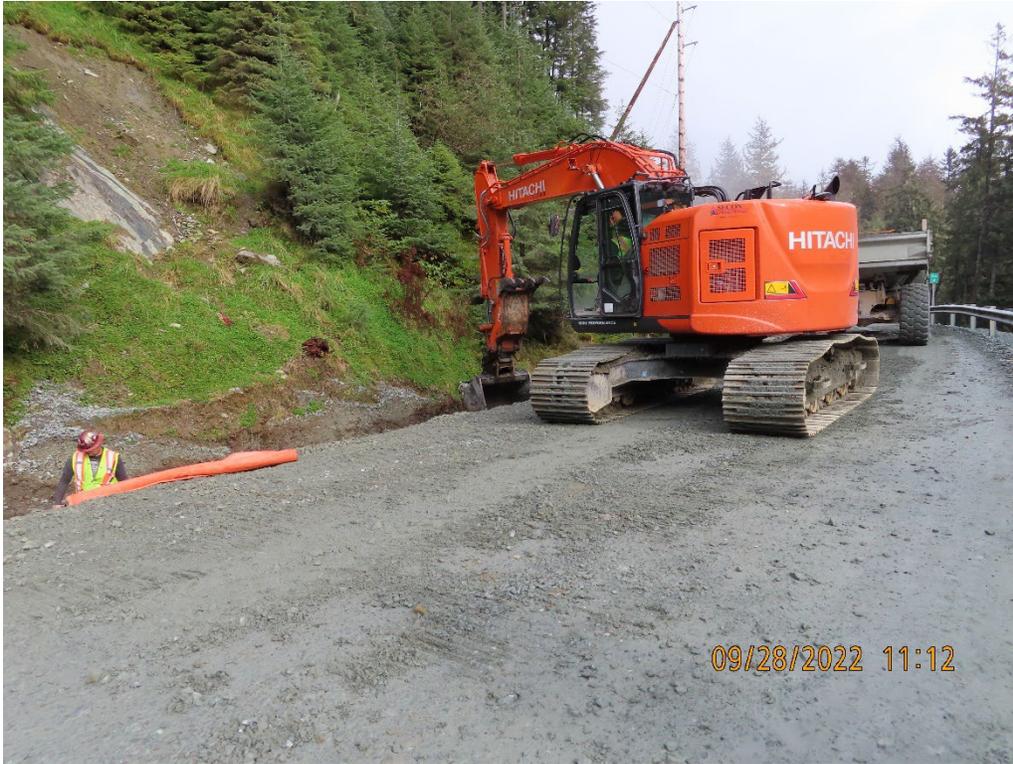
Photo 4. Contractors making emergency repairs to the drainage ditches at the site of the 5.6 mile B-road landslide.

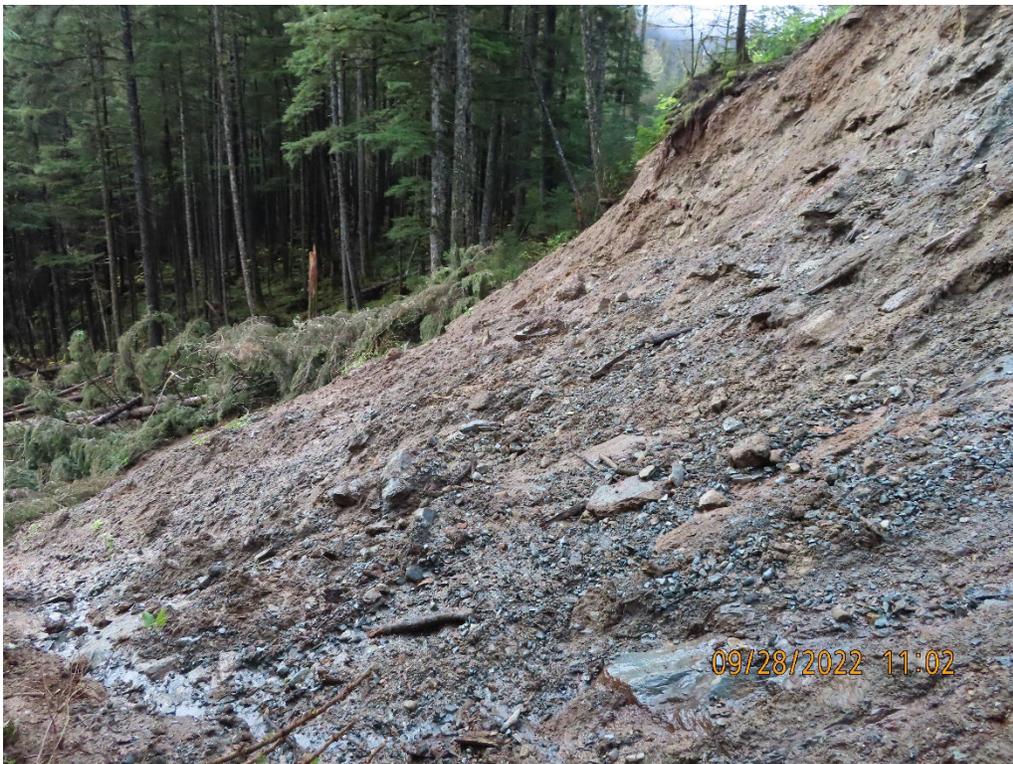
Photo 5. Water seeps visible on the exposed bedrock in the 5.6 mile B-road landslide.

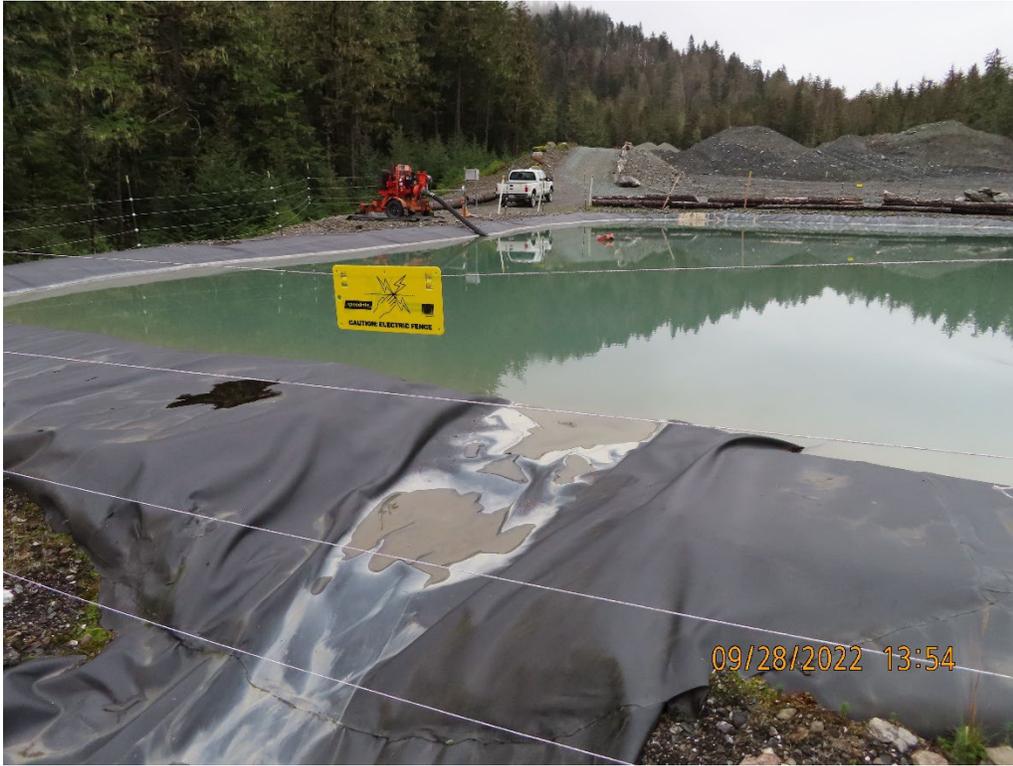
Site E continues to be used as a laydown area for storing road surface rock, equipment, explosives, and materials excavated and/or used for projects including bridge replacement and repair, and the 5.6 B-Road slope stabilization project. The settling pond appeared in good condition but was full, limiting the available surge capacity (Photo 6). HGCMC planned to pump the pond in preparation for a forecasted precipitation event.

Photo 6. Site E stormwater pond. HGCMC planned to pump water out of the pond.

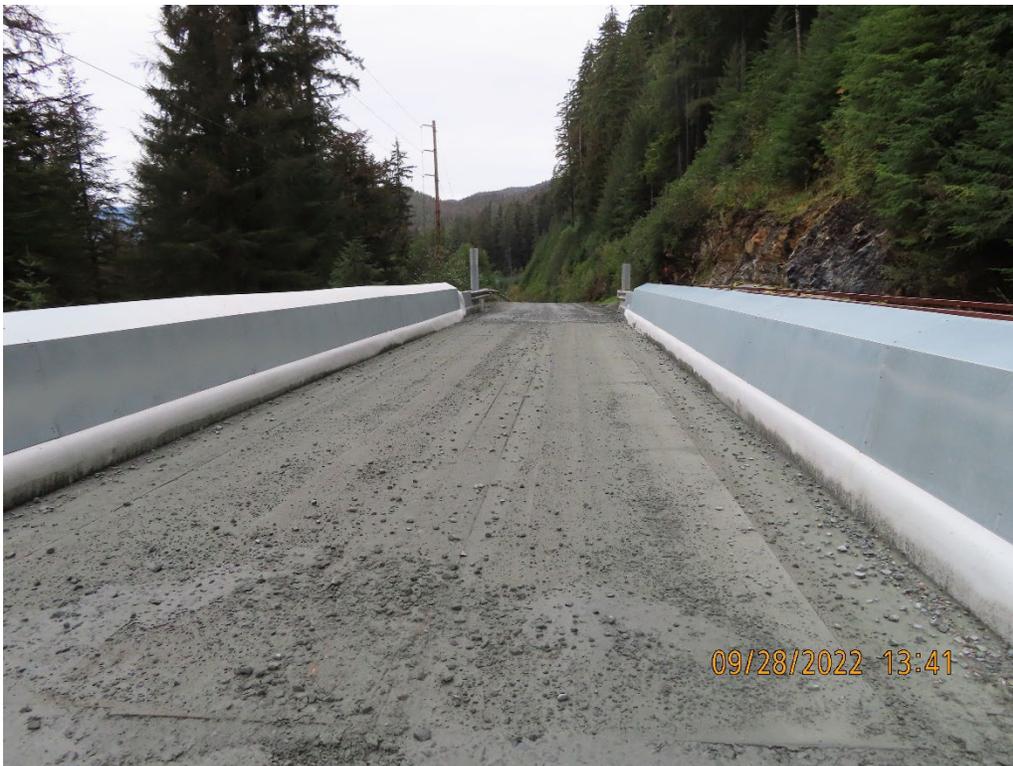
This bridge was replaced earlier this year. The new bridge wear surface was installed higher than the adjacent roadbeds which is intended to prevent excessive ponding of water on the bridge surface (Photo 7). No evidence of ponding water or sediment accumulation on the bridge from the recent heavy rainfall was observed during this inspection.

Photo 7. New Falls Creek Bridge surface.

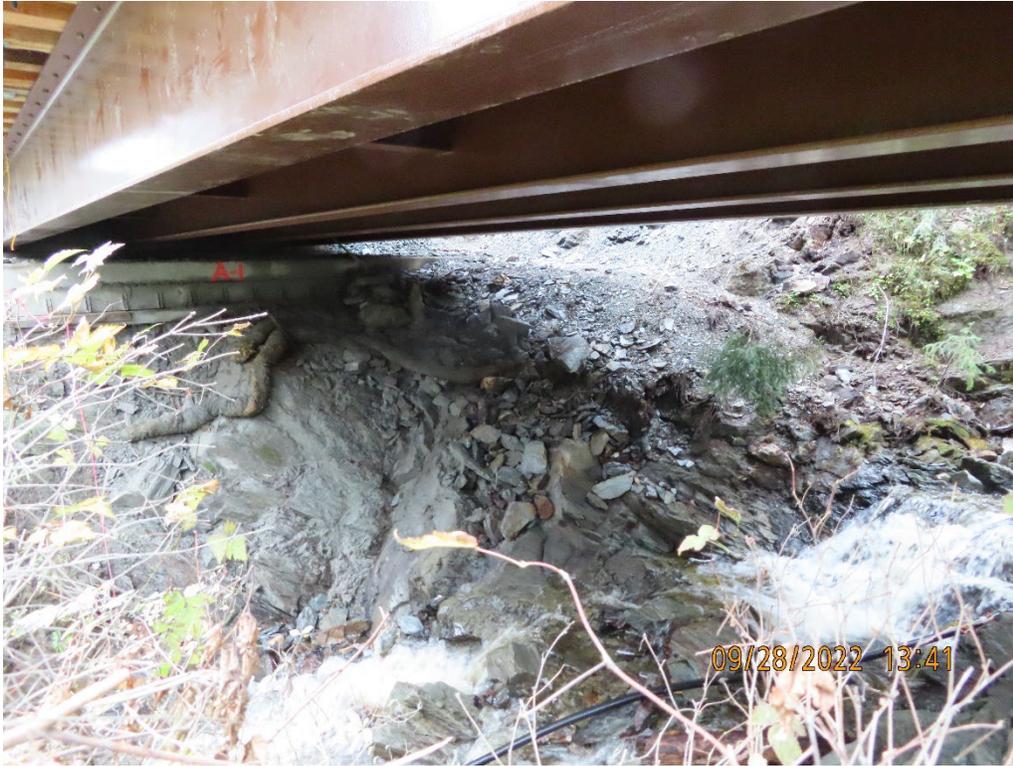
424-1: 8/31/2022	Absorbent pads at the 1350 area require disposal.	RESOLVED. Hecla staff reports that the items at the 1350 area have been removed.
424-2: 8/31/2022	Stormwater sediment BMPs on the downhill side Falls Creek Bridge abutment are in disrepair (Photo 8). BMPs require improvement to effectively contain sediment or prevent sediment from accumulating on the abutment.	PENDING.
424-3: 8/31/2022	Sumps that precede the "Gnome Pond" along the B-Road are filled with sediment that should be removed to improve BMP efficiency (Photo 11).	PENDING. Recent heavy rains have filled sumps along the B-road. Hecla staff was conducting maintenance on roadside BMP's during the inspection.

PENDING ACTION ITEM 424-2: Stormwater sediment BMPs on the downhill side bridge abutment are in disrepair (Photo 8). These BMPs require improvement to effectively contain sediment or prevent sediment from accumulating on the abutment.

Photo 8. Falls Creek Bridge downhill side abutment BMPs in disrepair.

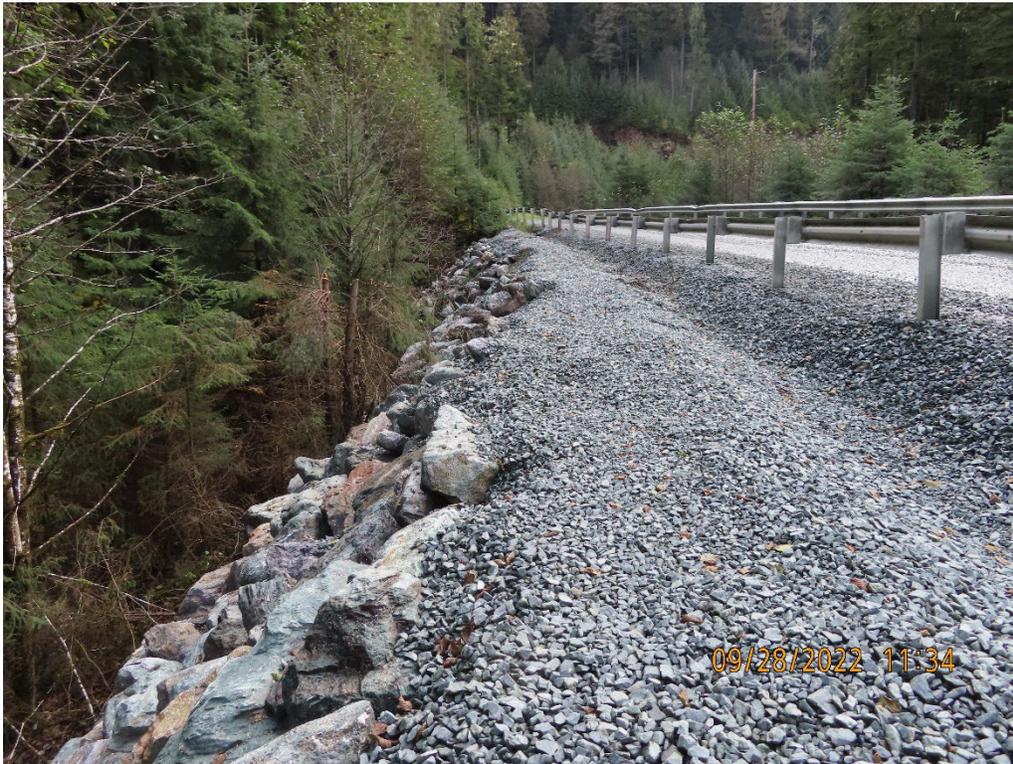
The 3.2-mile B-road slope stabilization project was completed since the last inspection (Photo 9). These repairs were conducted following a slope failure during December 2020.

Photo 9. Roadside repairs were completed at the 3.2 mile of the B-Road where a slope failure occurred during the December 2020 storm event.

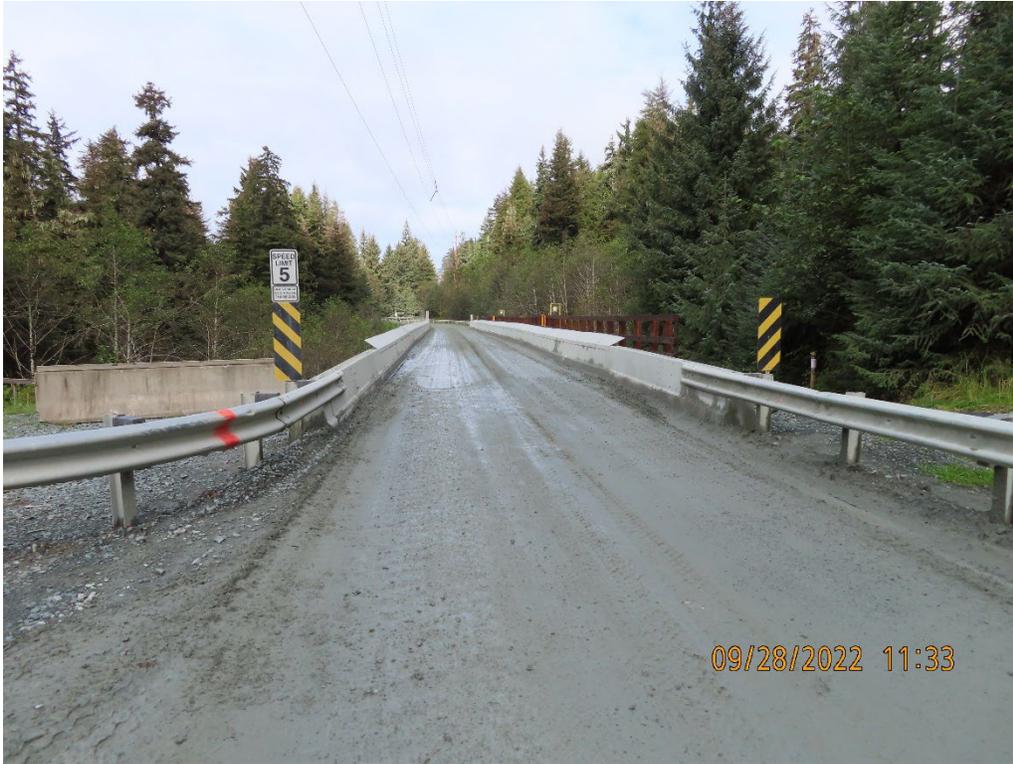
The Zinc Creek Bridge abutment BMPs are in good condition and functioning as intended (Photo 10).

Photo 10. Zinc Creek Bridge abutment BMPs in good condition.

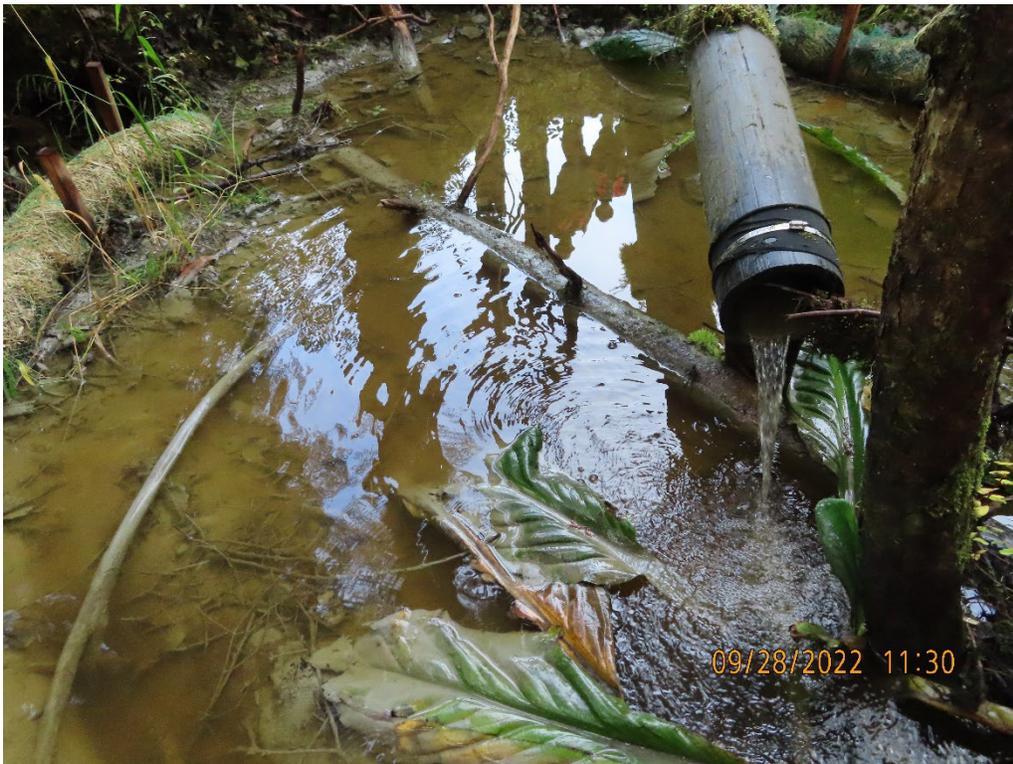
Date/Item No.	Item Description	Status
423-1; 7/28/2022	Increased turbidity of surface water runoff was observed at the 3.0 mile B-Road Zinc Creek Bridge uphill side stormwater BMPs.	PENDING. Hecla requested to use anionic polymers or “floc logs” to reduce turbidity in stormwater BMP’s on 9/26/2022. In a subsequent meeting with ADEC, ADF&G, ADNR, Hecla was approved to test the polymers for use in BMP’s.

PENDING ACTION ITEM 423-1: Turbid water was observed being discharged from the stormwater BMP colloquially known as the “Gnome Pond” in the previous inspection (Photo 11).

Photo 11. Outlet pipe of the "Gnome Pond" BMPs located adjacent to the Zinc Creek Bridge.

HGCMC staff has submitted a request to test anionic polymers or “floc logs” to reduce turbidity in roadside BMP’s. Due to limited available space to increase the size of settling ponds the anionic polymers will be tested to determine if appropriate for use in the BMP’s. Hecla will conduct laboratory and field testing this fall to determine the effectiveness of the polymers and provide a report to the Forest Service on effectiveness and how the polymers could be used on the mine site.

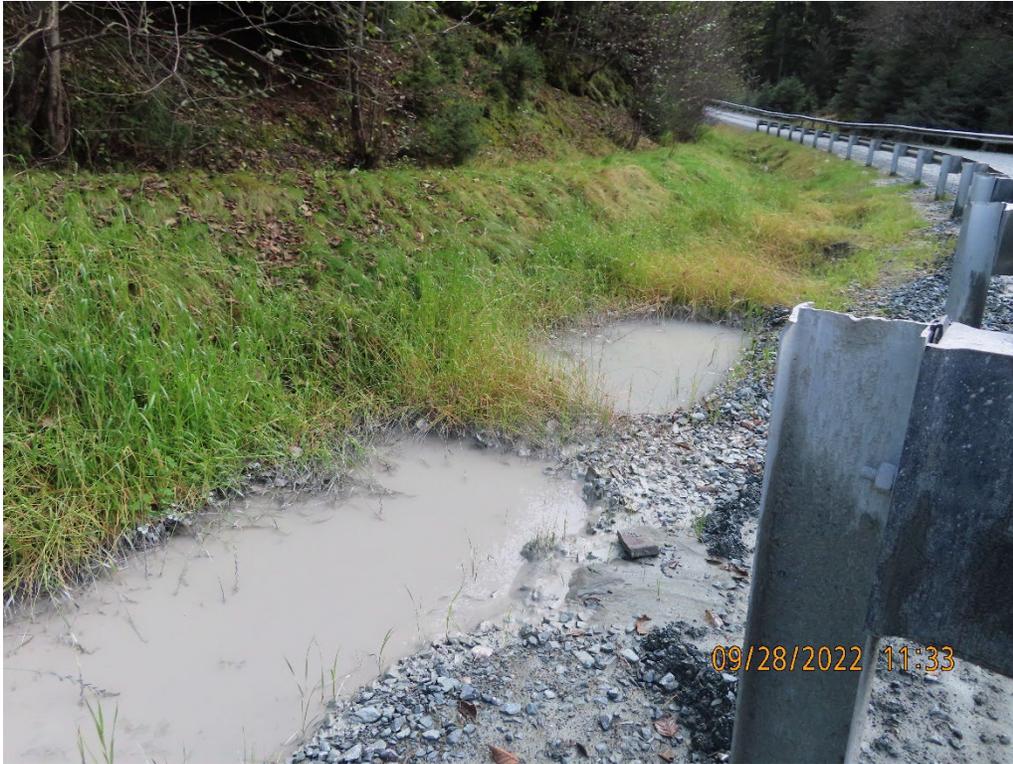
PENDING ACTION ITEM 424-3: Sumps that precede the “Gnome Pond” along the B-Road were filled with sediment that requires removal (Photo 12). Recent heavy rainfall has caused additional sedimentation. Maintenance was ongoing at several BMPs along the roadway during the inspection.

Photo 12. Small sumps above the Gnome Ponds that require sediment removal.

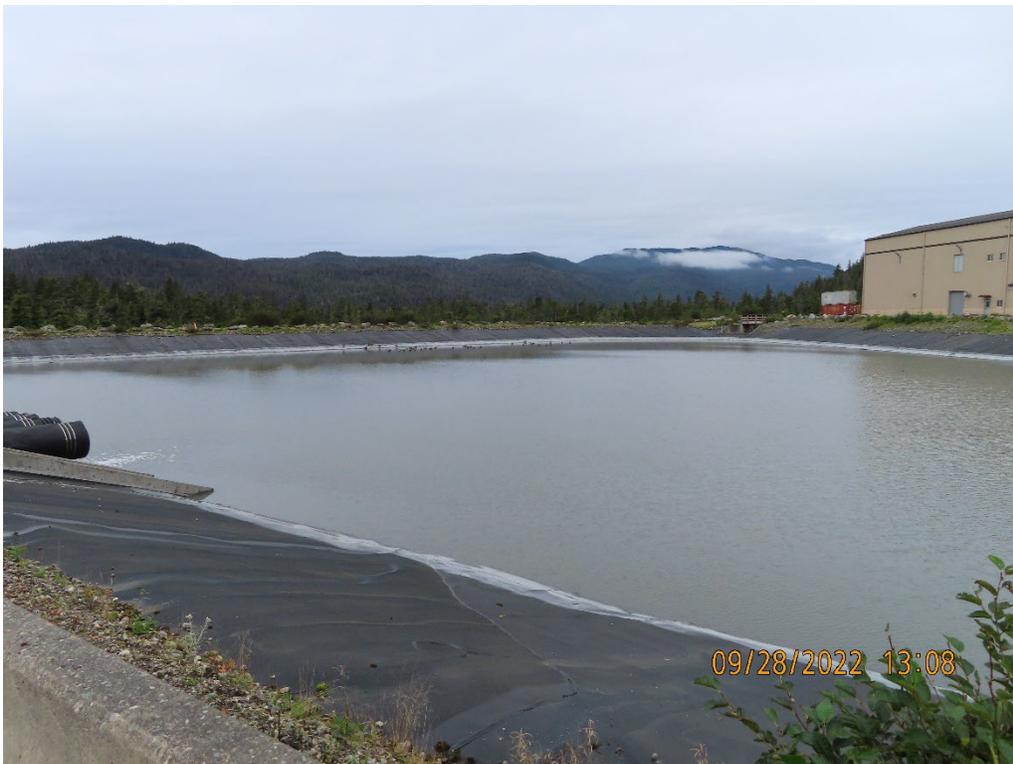
Photo 13. Pond 7.

At the time of the inspection, Pond 7 (Photo 13) was collecting contact and process water, and Pond 10 (Photo 14) was storing waters collected during the recent heavy rainfall event.
