INSPECTION REPORT: GREENS CREEK MINE

Date of Inspection: Wednesday, February 1, 2023
Date of Report: Monday, February 27, 2023
USDA Forest Service Inspector: Casey Loofbourrow

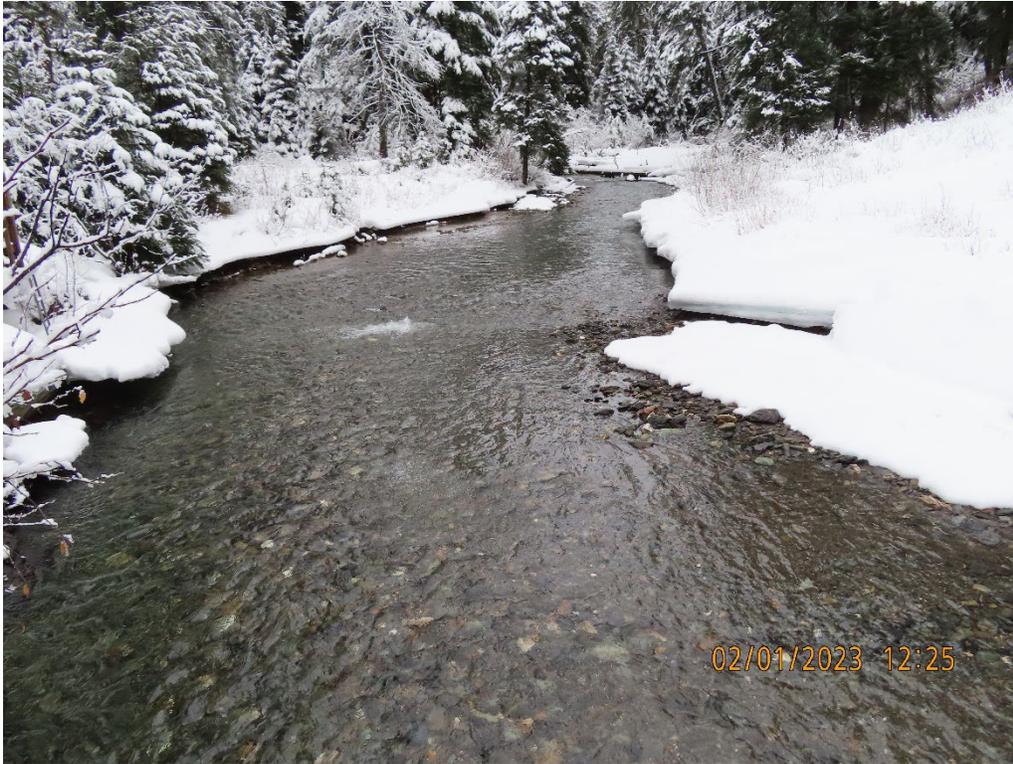
The Greens Creek discharge was 19.5 cfs (Photos 1-2) and 1.3 cfs was being withdrawn for operational use.

Photo 1. Greens Creek looking upstream from the 920 weir.

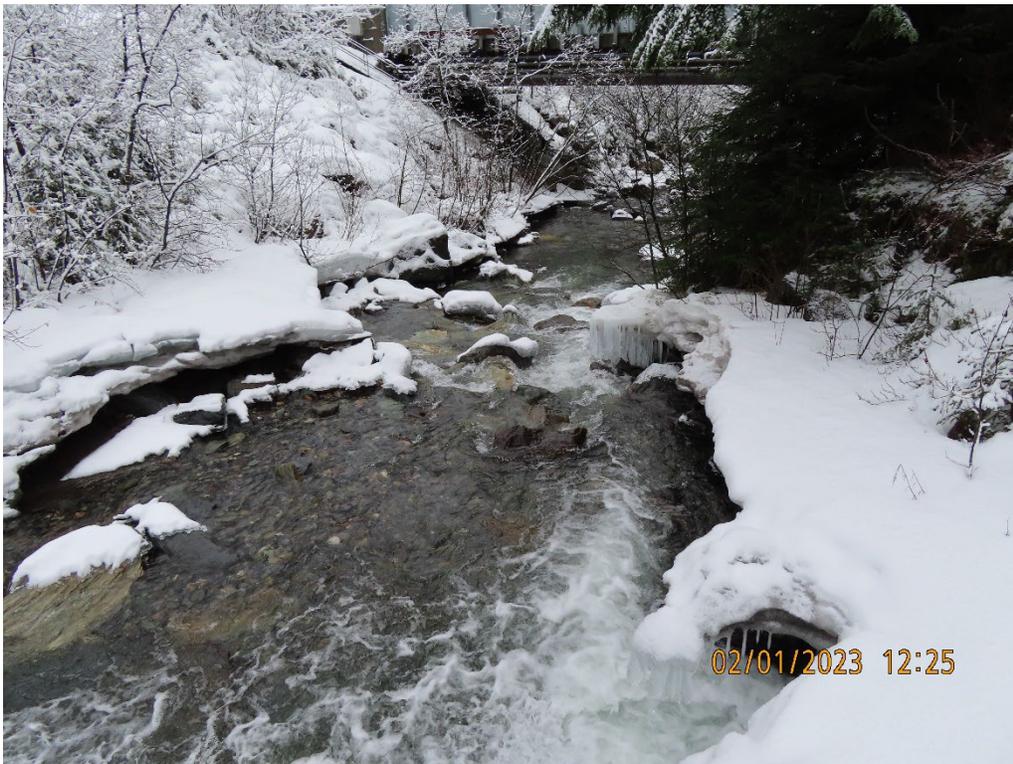
Photo 2. Greens Creek looking downstream from the 920 weir.

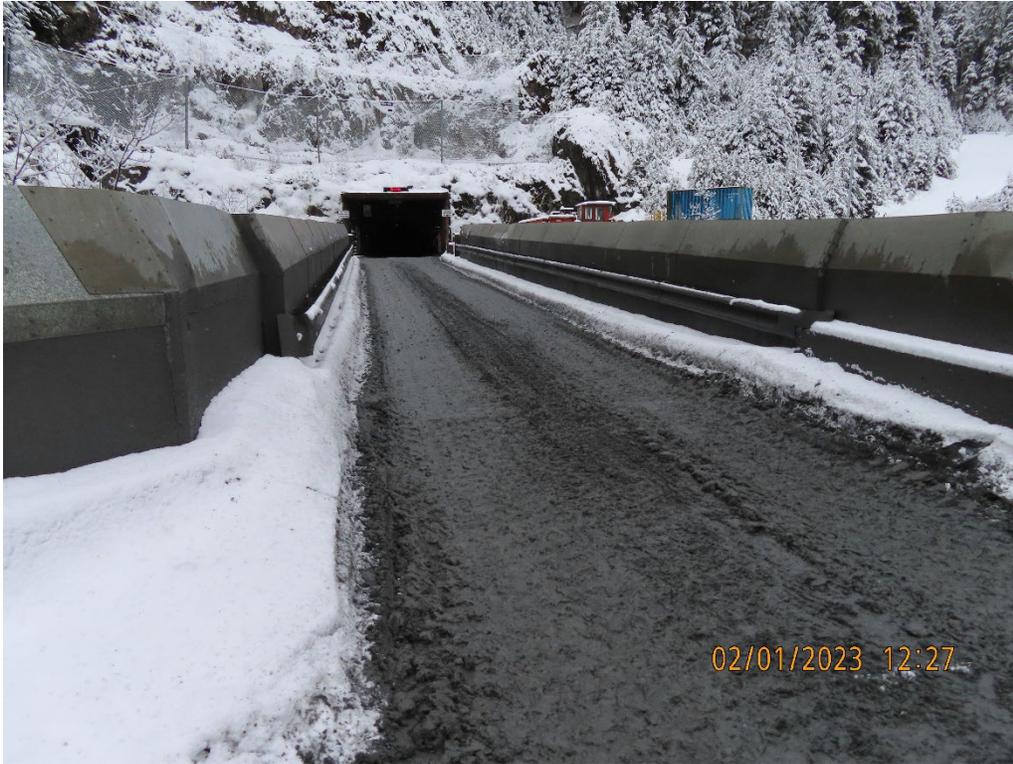
The Greens Creek bridge appeared in good condition, with sediment deflection concrete barriers preventing sediment from reaching bridge abutments, and metal splash guards preventing sediment from being transported over the bridge edge due to traffic (Photo 3).

Photo 3. Greens Creek bridge and 920 portal.

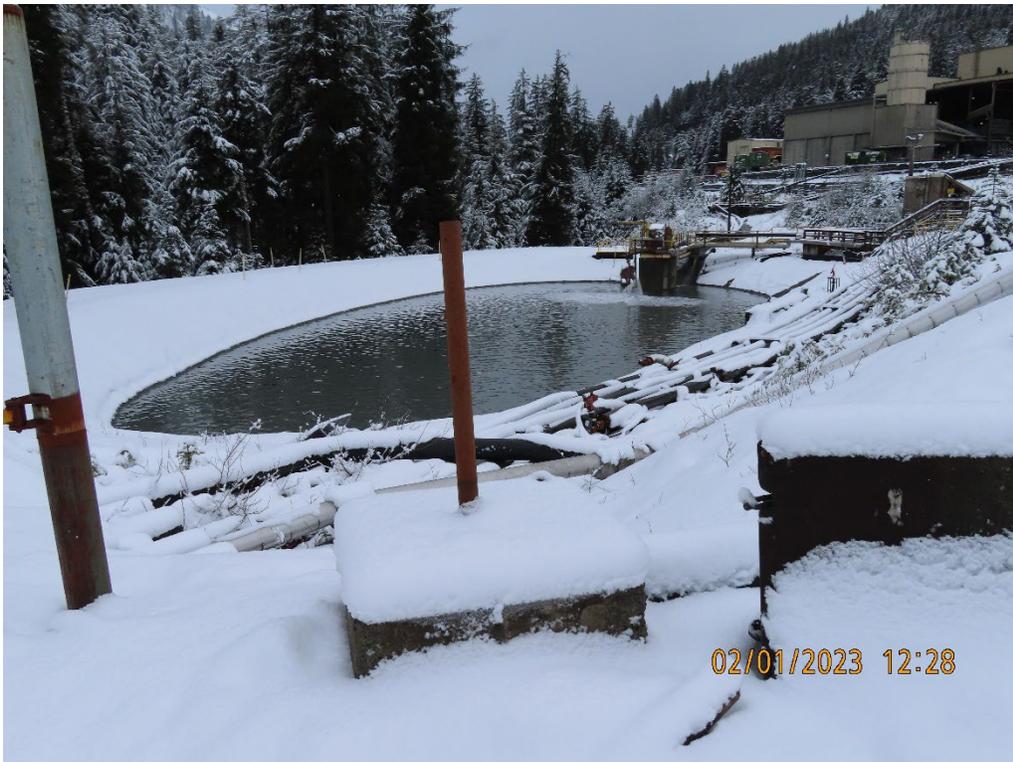
Pond A was in good condition with substantial surge capacity (Photo 4).

Photo 4. Pond A, below the 920 area.

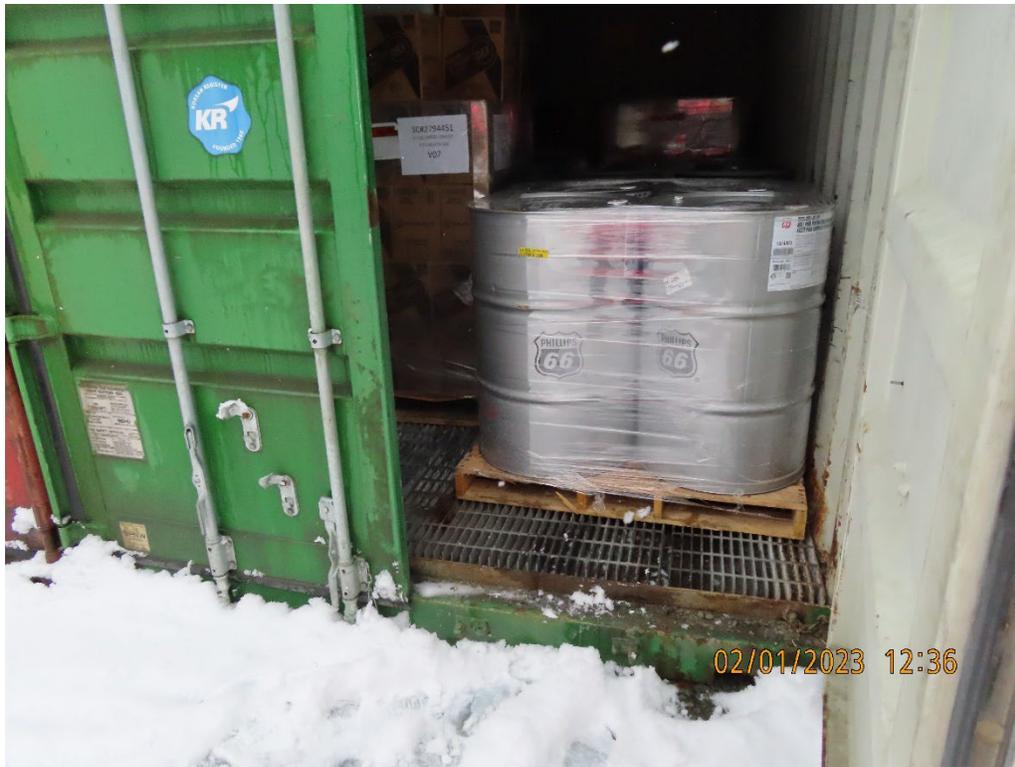
Good housekeeping practices were observed at the 920 warehouse (GPO, Appendix 5 BMP Plan, page 39). All petroleum/chemicals observed were properly stored within secondary containment (Photo 5).

Photo 5. Chemicals stored in appropriate secondary containment at the 920 warehouse area.

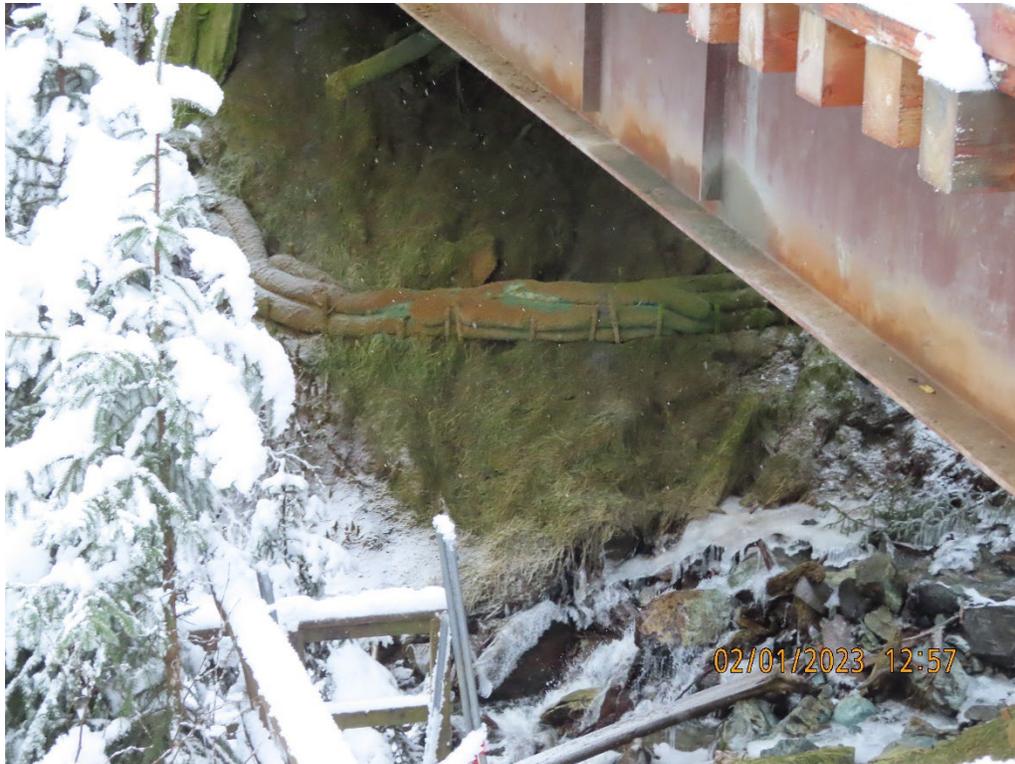
The Killer Creek Bridge appeared in good condition, with sediment deflection concrete barriers preventing sediment from reaching bridge abutments, and the abutments appeared stable with functioning sediment BMPs (Photo 6).

Photo 6. Killer Creek Bridge abutment.

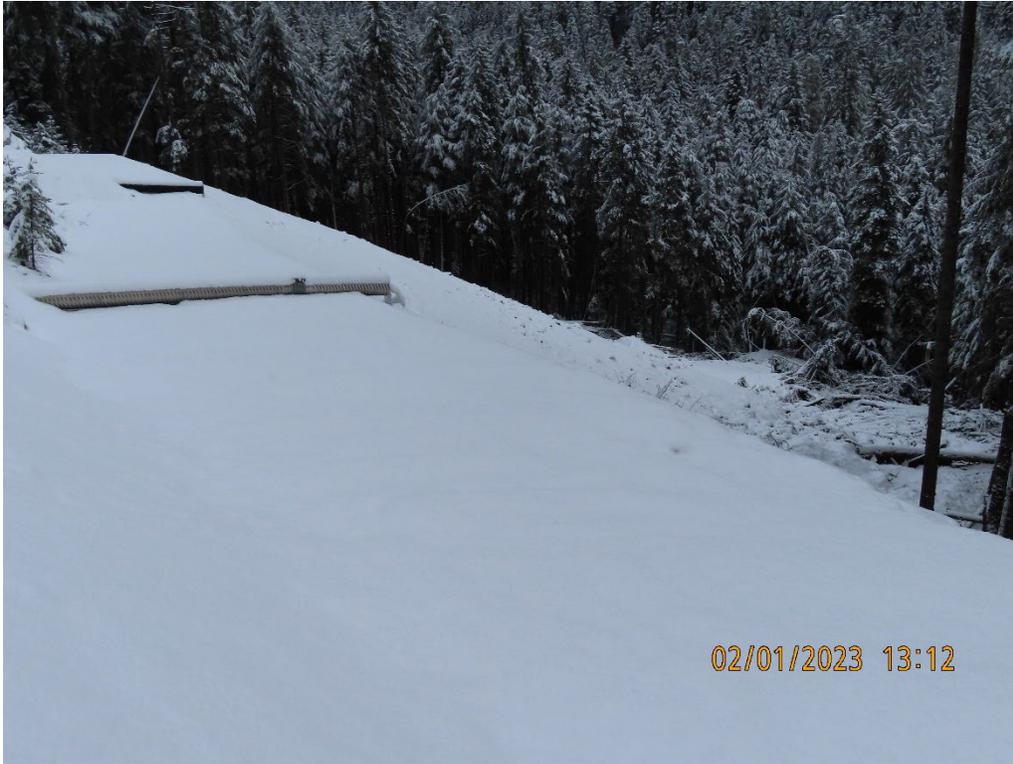
Snow covered the slope during this inspection (Photo 7), future inspections will document the completed repairs.

Photo 7. 5.6 mile B-Road landslide repair.

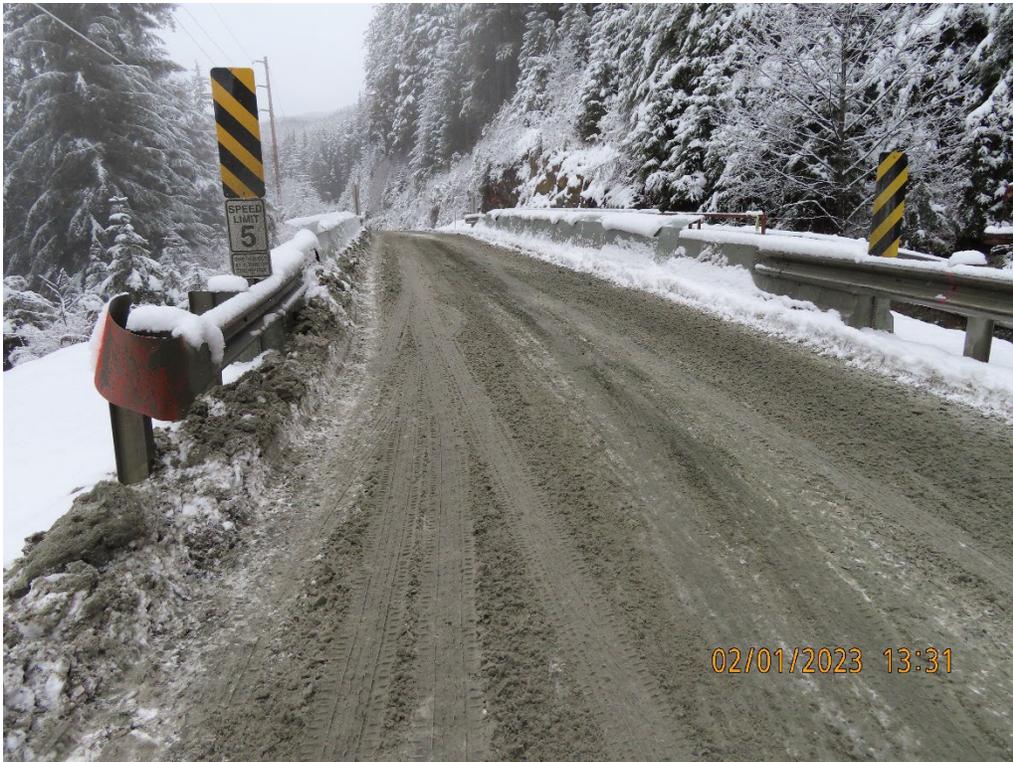
The bridge surface appeared in good condition with functioning sediment deflection barriers and no ponding water (Photo 8).

Photo 8. Falls Creek Bridge surface.

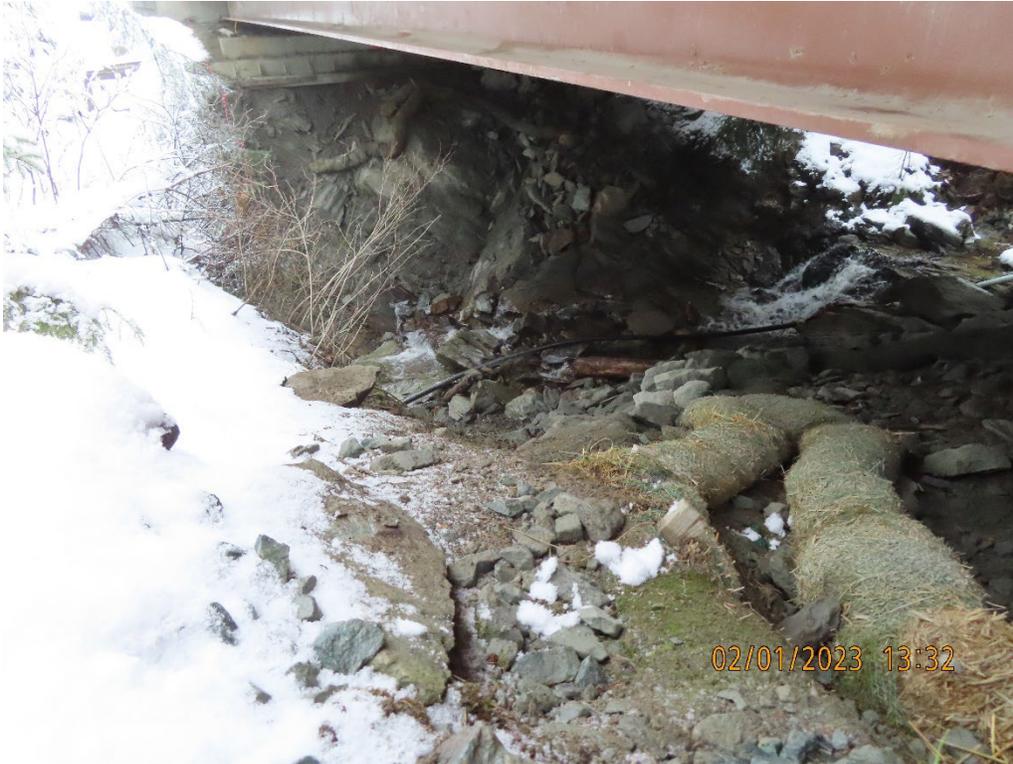
PENDING ACTION ITEM 424-2: Stormwater sediment BMPs on the downhill side bridge abutment are in disrepair (Photo 9). These BMPs require improvement to effectively contain sediment or prevent sediment from accumulating on the abutment.

PENDING ACTION ITEM 426-1: Stormwater sediment BMPs on the uphill side of the Falls Creek Bridge abutment are not functioning as designed. BMPs require improvement to reduce turbidity of runoff prior to discharge into Falls Creek. No turbid discharge was observed during this inspection but freezing temperatures have reduced surface water runoff (Photo 9).

Photo 9. Falls Creek Bridge abutment BMP's.

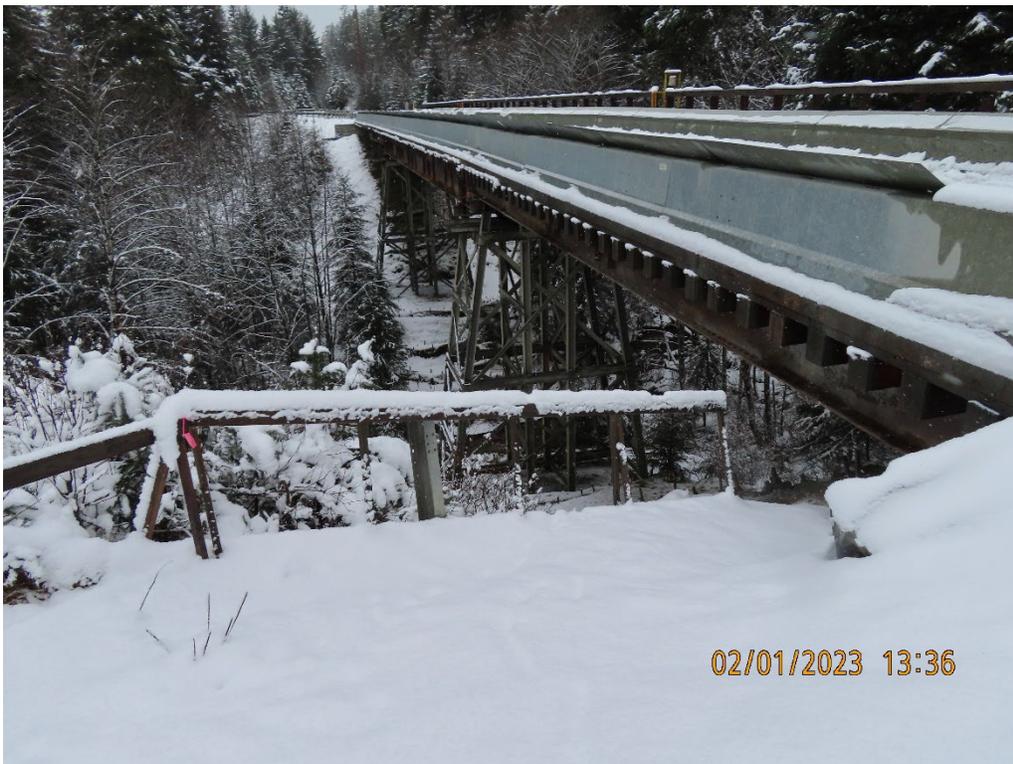
The Zinc Creek bridge appeared in good condition, with sediment deflection concrete barriers preventing sediment from reaching bridge abutments (Photo 10).

Photo 10. Zinc Creek Bridge.

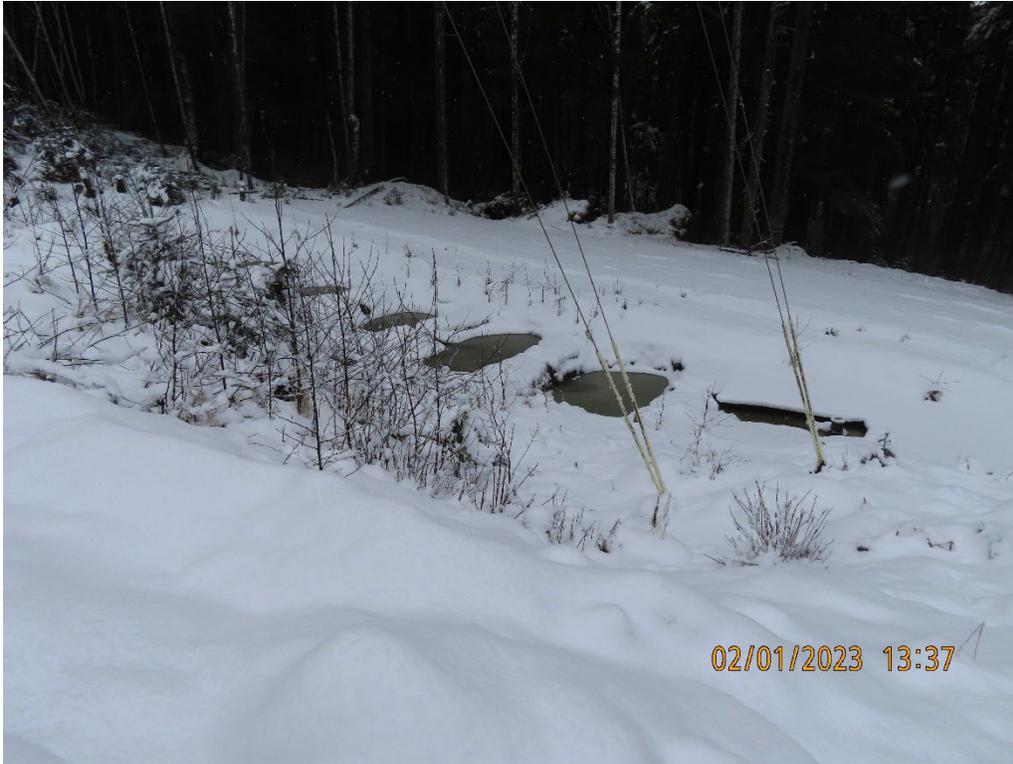
RESOLVED ACTION ITEM 424-3: Sumps that precede the “Gnome Pond” along the B-Road were previously filled with sediment that required removal. Sumps appeared to have adequate capacity (Photo 11) and will be monitored through the melt season for effectiveness.

Photo 11. Sediment sumps preceding the “Gnome Pond” stormwater pond.

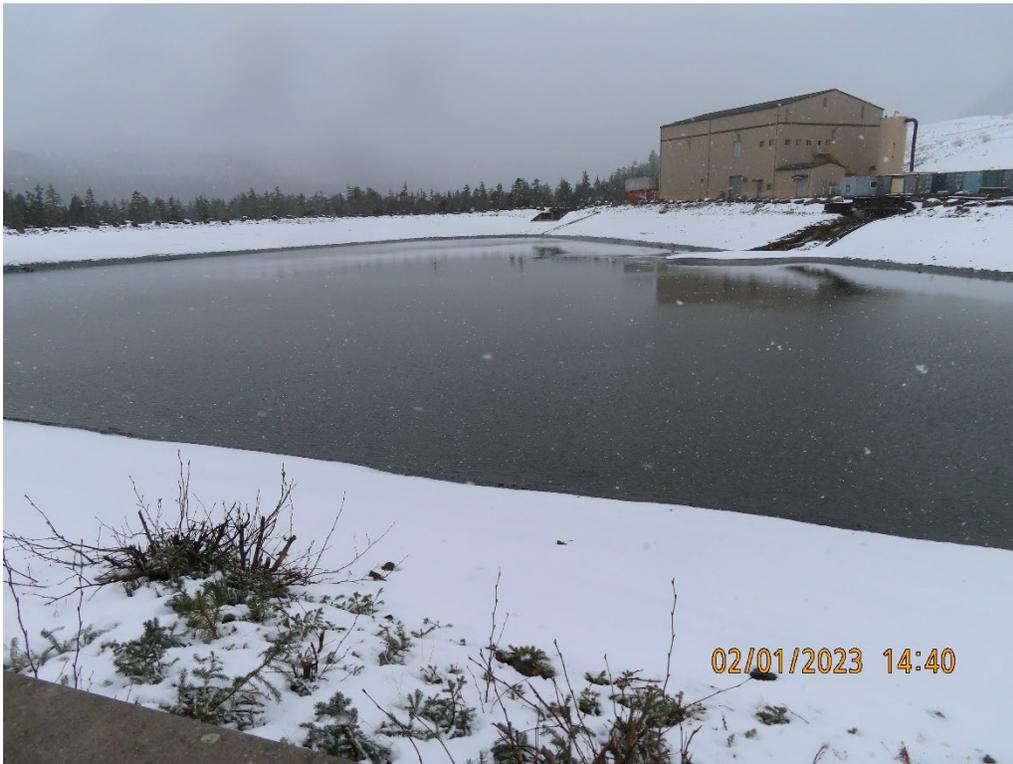
Photo 12. Pond 7.

At the time of the inspection, Pond 7 (Photo 12) was collecting contact and process water, and Pond 10 (Photo 13) was not receiving water.

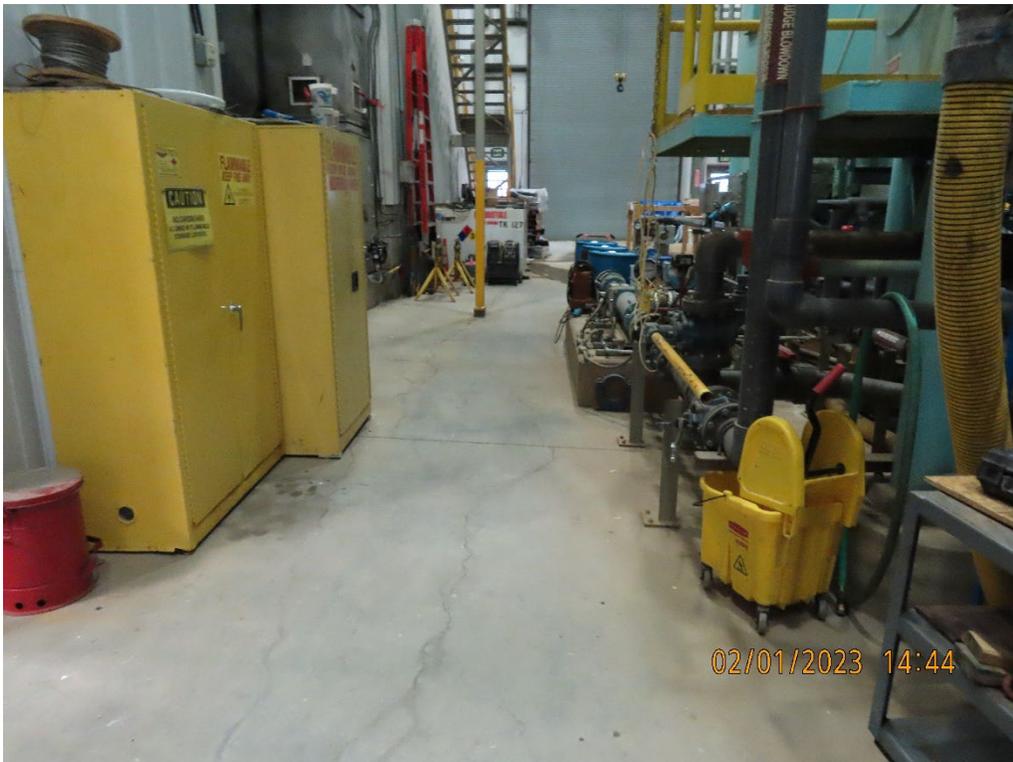
The water treatment plant was discharging approximately 1291 gpm to Outfall 002. The interior of the plant was orderly (Photo 14).

Photo 14. TDF Water Treatment Plant interior.
