## INSPECTION REPORT: GREENS CREEK MINE

Date of Inspection: Wednesday, February 25, 2026  
Date of Report: March 11, 2026  
USDA Forest Service Inspector: Scott Leslie

Ranger District: Admiralty National Monument, Juneau Ranger District  
Weather Conditions: Overcast, light snow. Temperature: lower 30's (°F).

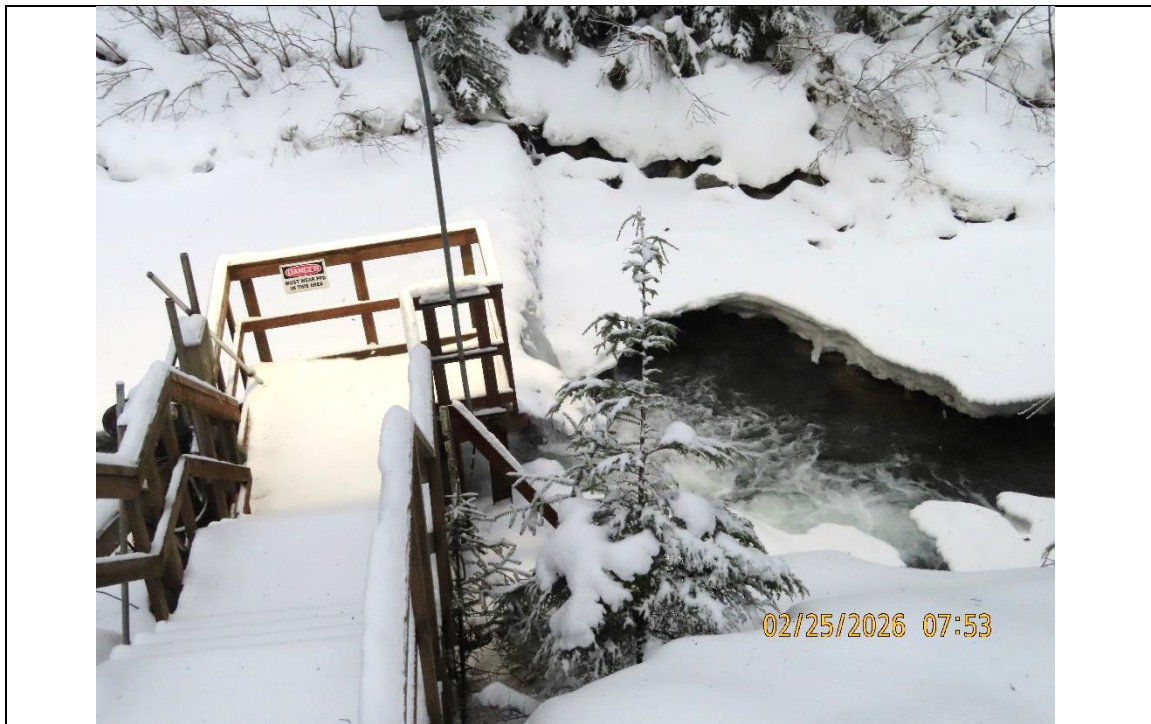
**Photo 1: Greens Creek Weir.**

**Greens Creek Weir** (Photo 1).

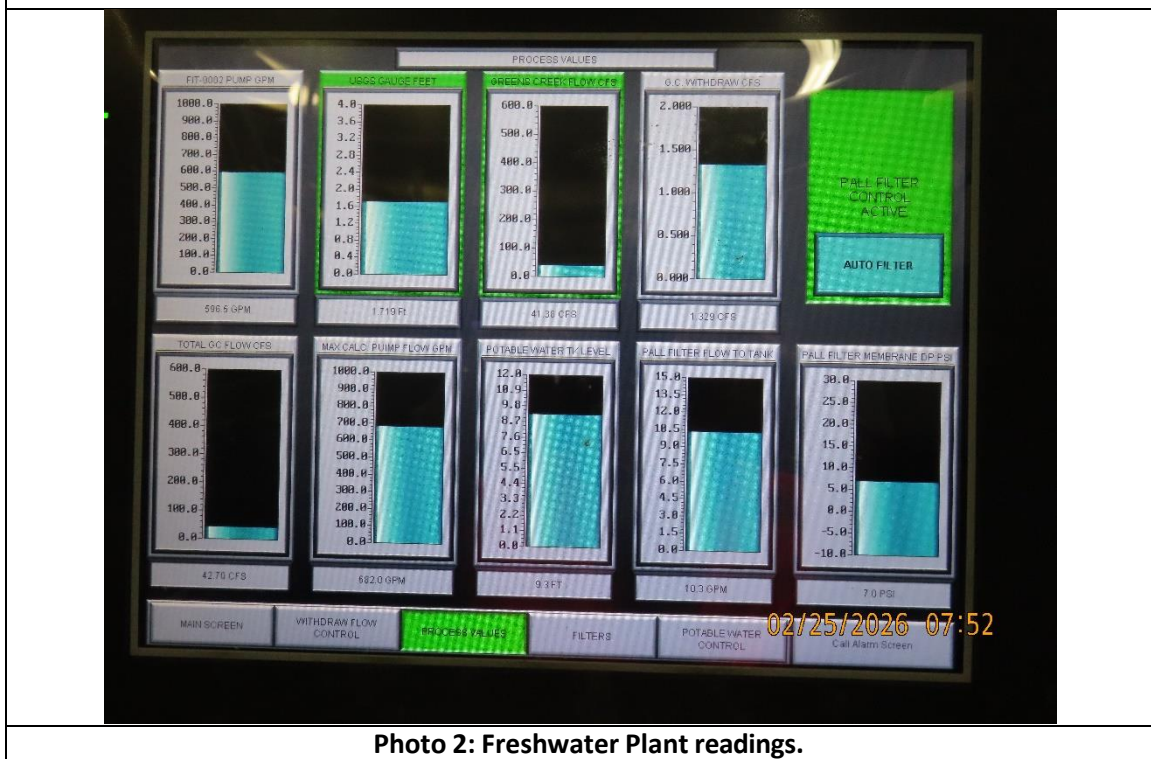
**Photo 2: Freshwater Plant readings.**

**Freshwater Plant**, Greens Creek weir discharge flow at 45.25 cfs and 1.35 cfs being withdrawn for the 920 facilities. Plant clean and orderly (Photo 2).

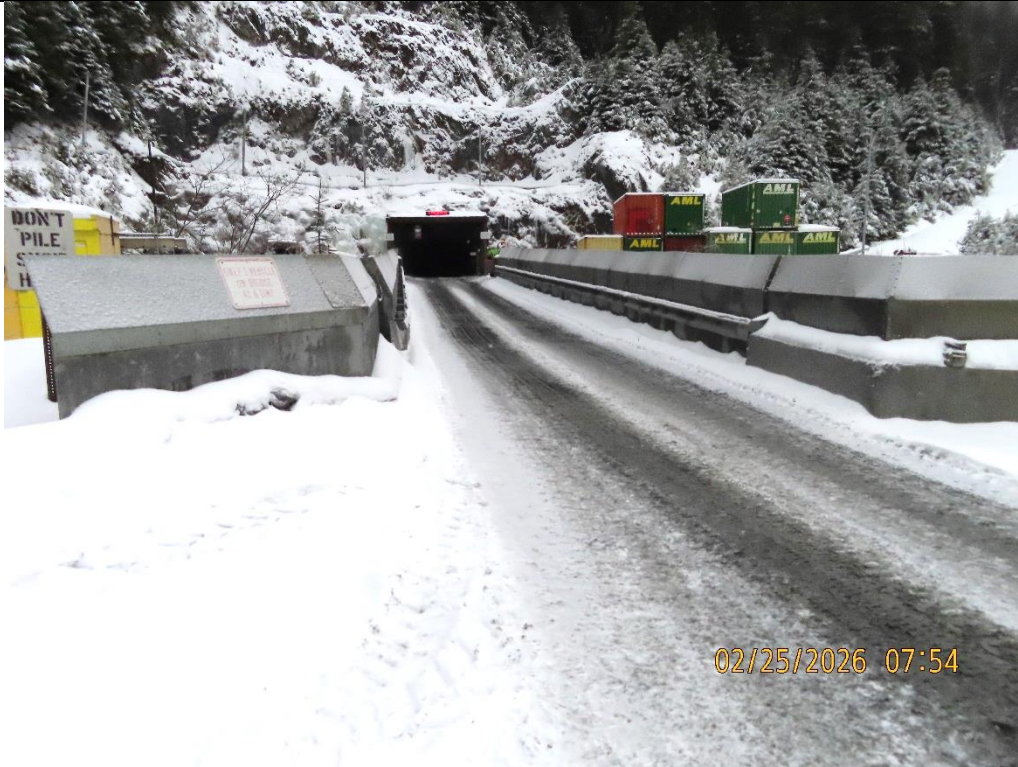
**Photo 3: 920 Bridge.**

**920 Bridge** in good condition. Metal sheeting placed along the bridge decking to mitigate for smoother surface transition at abutment joints (Photo 3).

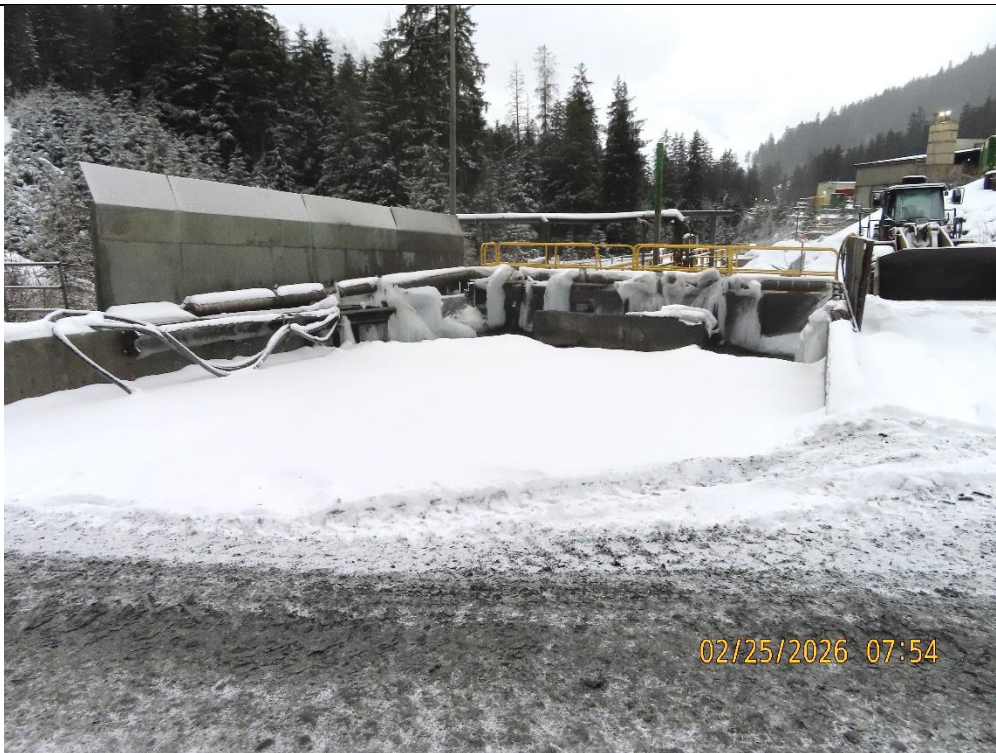
**Photo 4: Degrit Basin (DB-01).**

**Degrit Basin (DB-01)** snow covered at time of inspection (Photo 4 ).

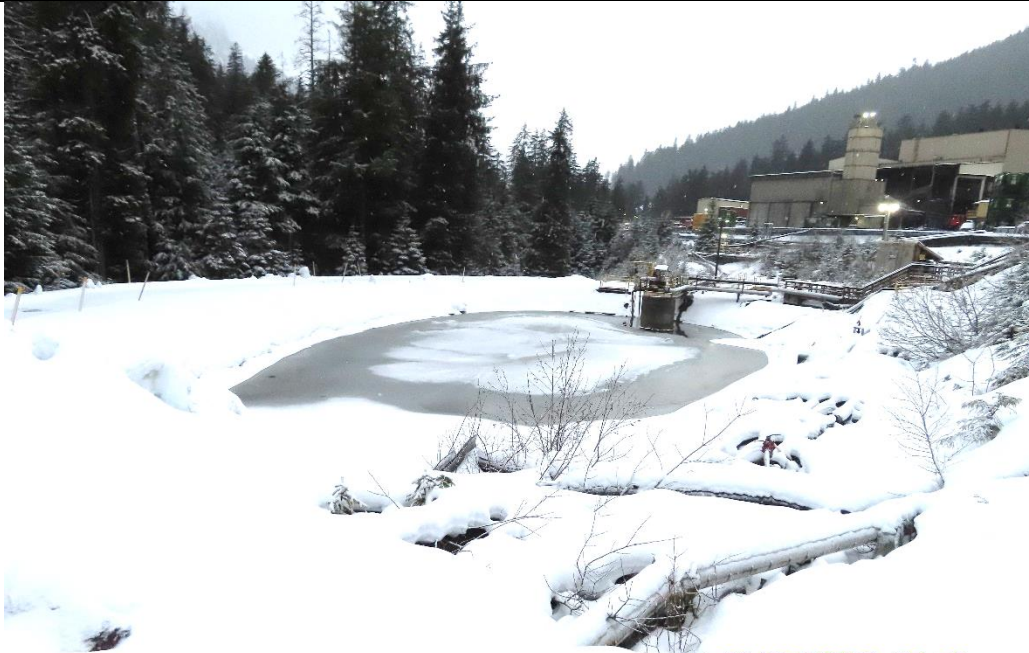
Photo 5: A Pond.

**Pond A** Frozen with no visible overflow (Photo 5).

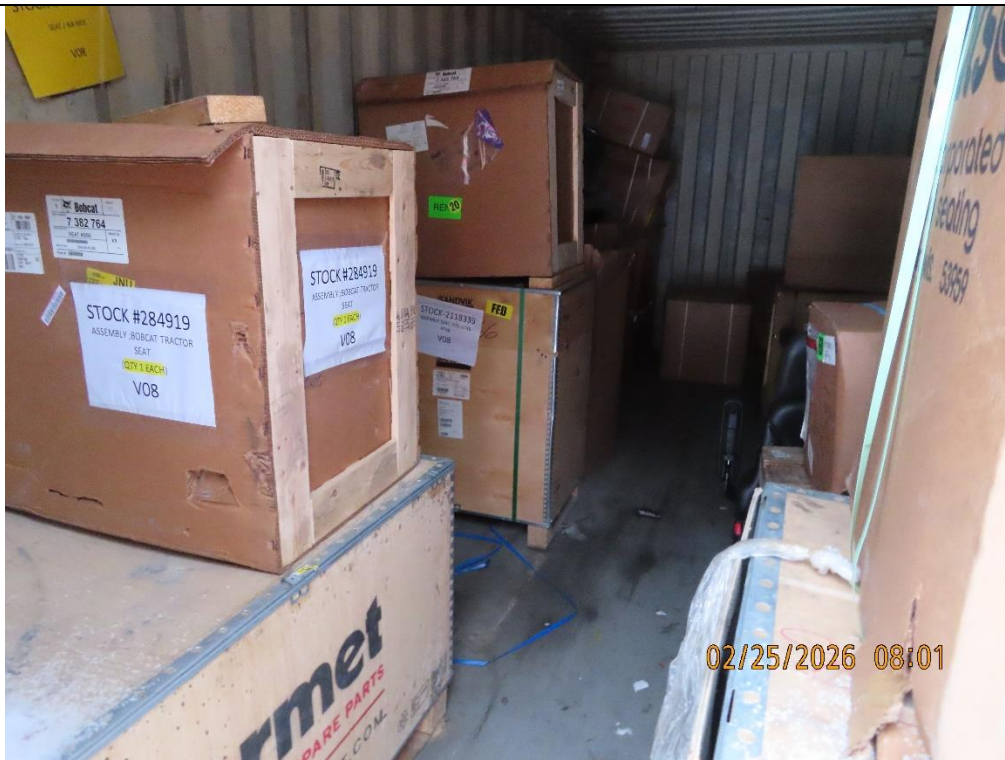
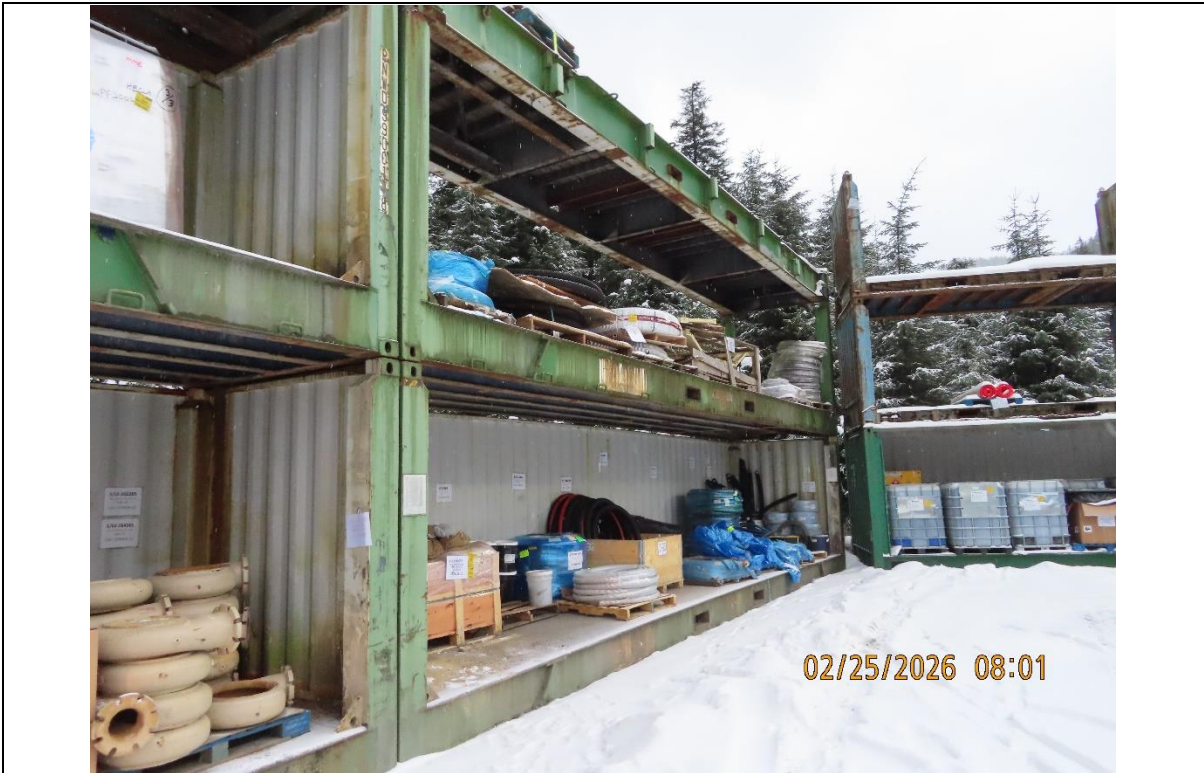
**920 Warehouse** Good housekeeping practices were observed at the storage containers with petrochemicals properly stored with secondary containment (Appendix 5 BMP Plan, page 37) (Photos 6 & 7).

Photo 6: 920 warehouse storage container.

Photo 7: 920 warehouse area.

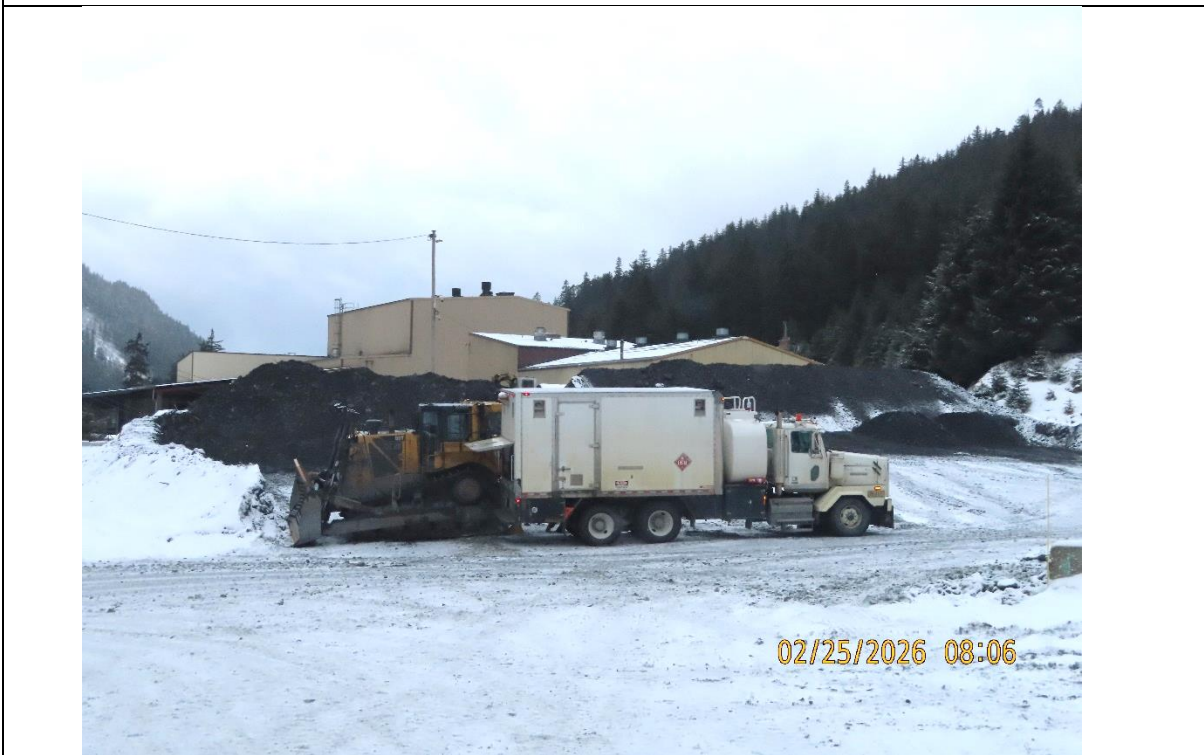
Photo 8: Ore pad.

**Ore Pad** in use staging ore from 920 adit ready to transport to mill (Photo 8).

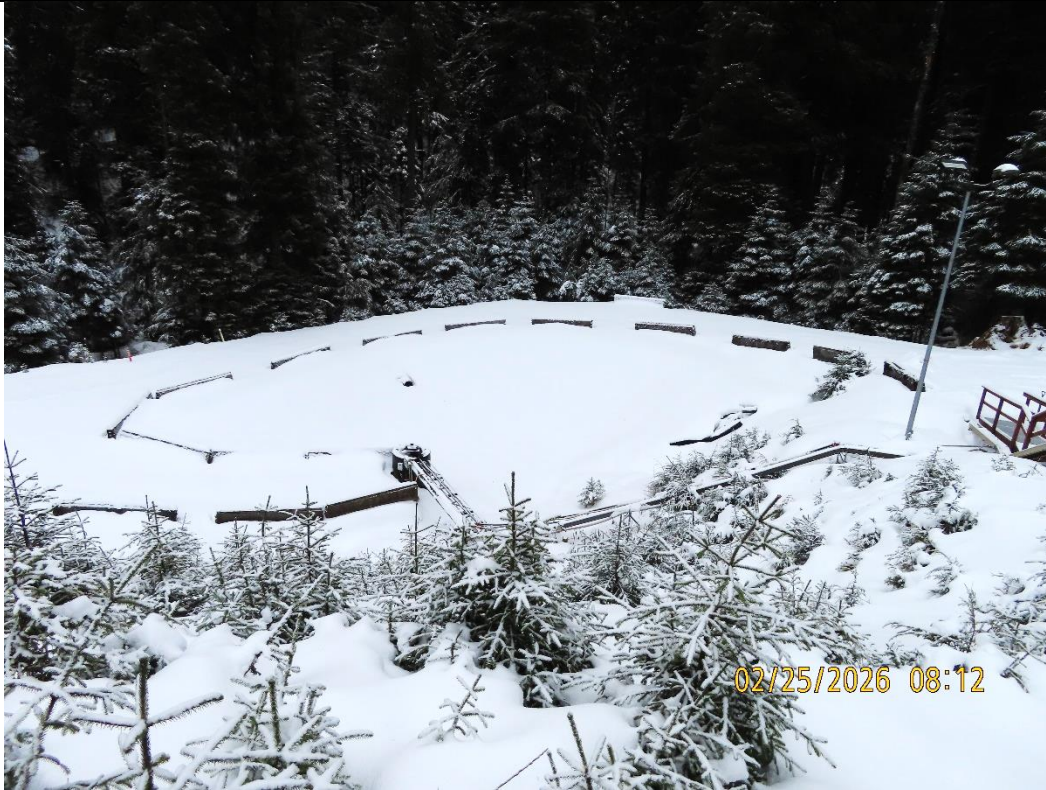
Photo 9: Lower C Pond.

The upper and lower ponds frozen with no visible signs of overflow (Photos 9 & 10).

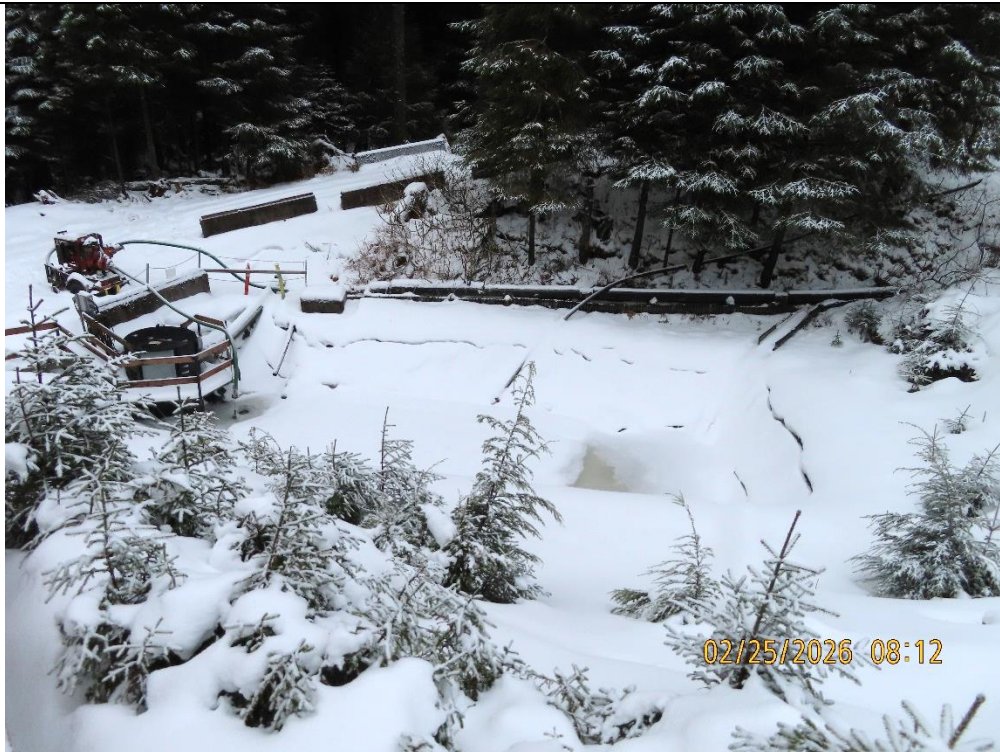
Photo 10: Upper C Pond. Evidence of raised pond level but no overflow outside of the pond.

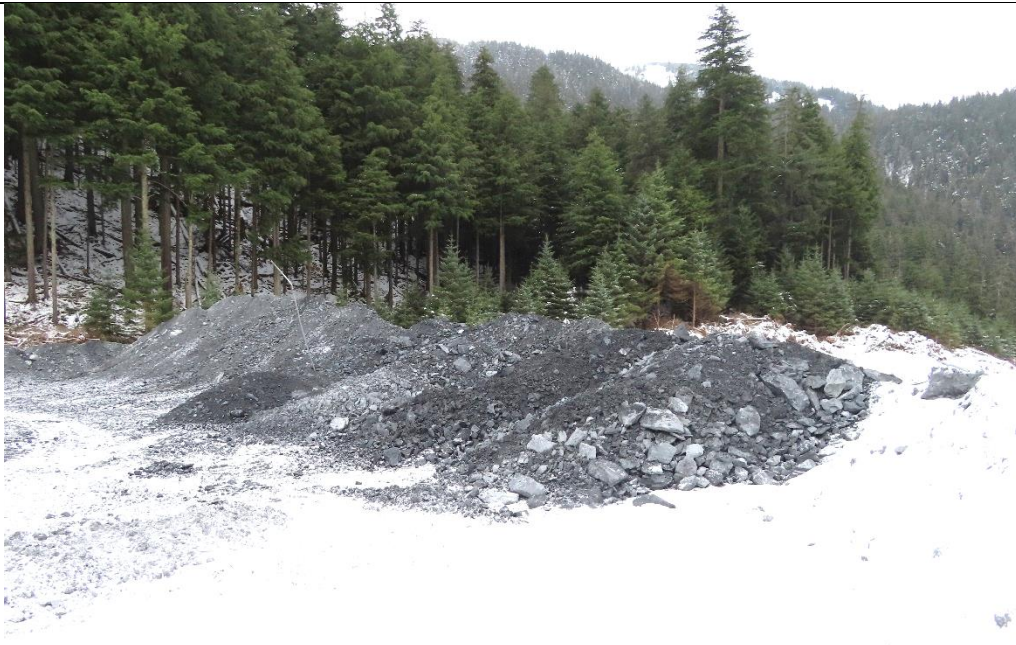
HGCMC continues to stage Class 1, 2, and 3 waste rock at this location. Class 4 waste rock is kept and disposed of underground (Appendix 11 Waste Rock Management Plan, page 11). Class 1 rock (argillite) is used as an inert capping material over top of Class 2 and 3. (Photo 11).

**Photo 11: Site 23 Class 2 & 3 Material on top of storage area.**

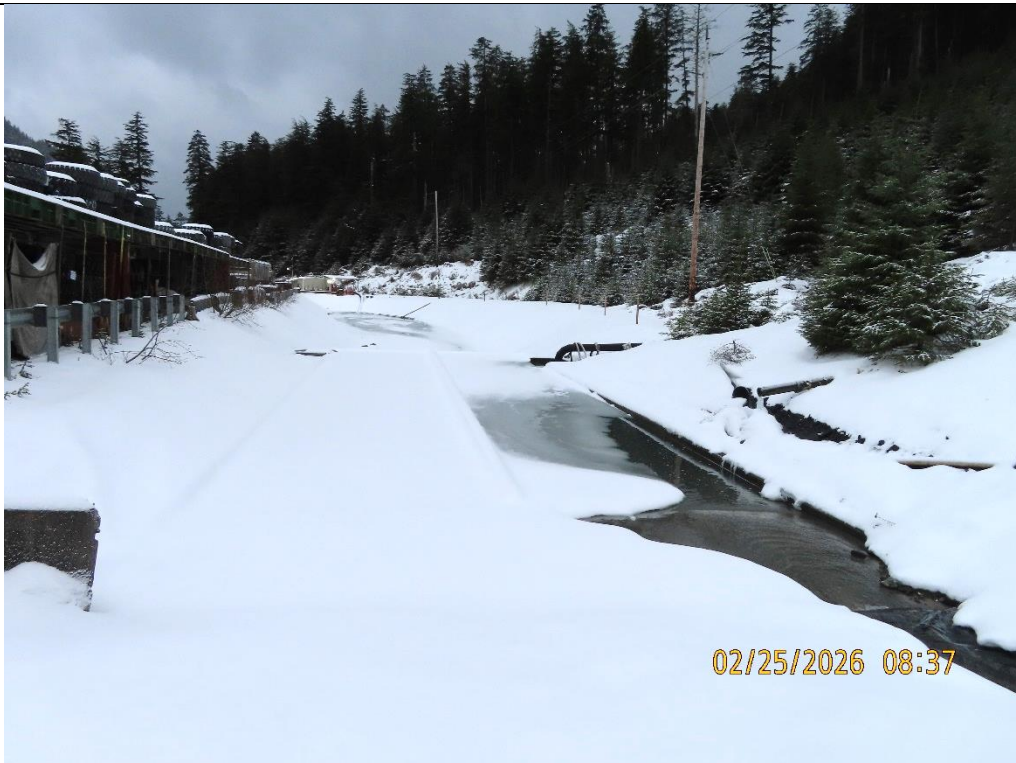
**Degrit Basin BD-03** Runoff entering basin as designed and appears to be functioning as intended. The 23 Pond can be seen in the background (Photo 12).

**Photo 12: DB-03 and 23 Pond and Pump in background.**

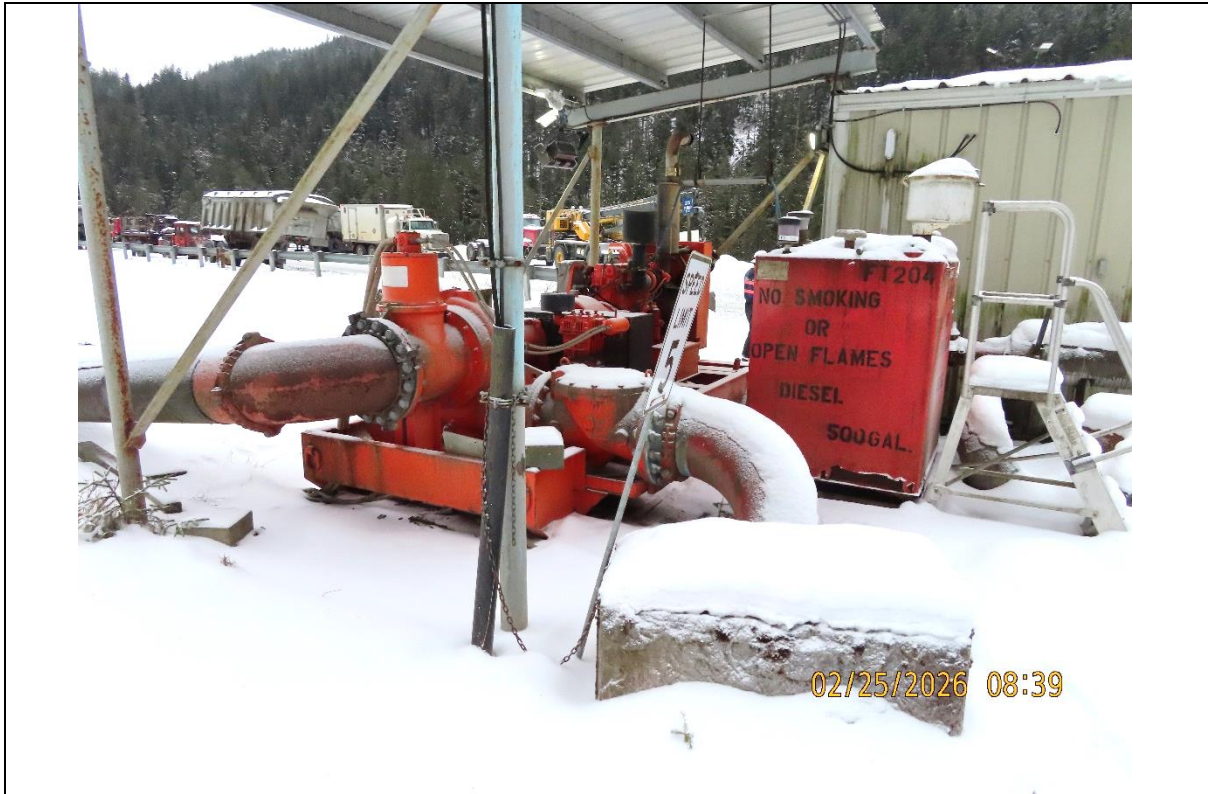
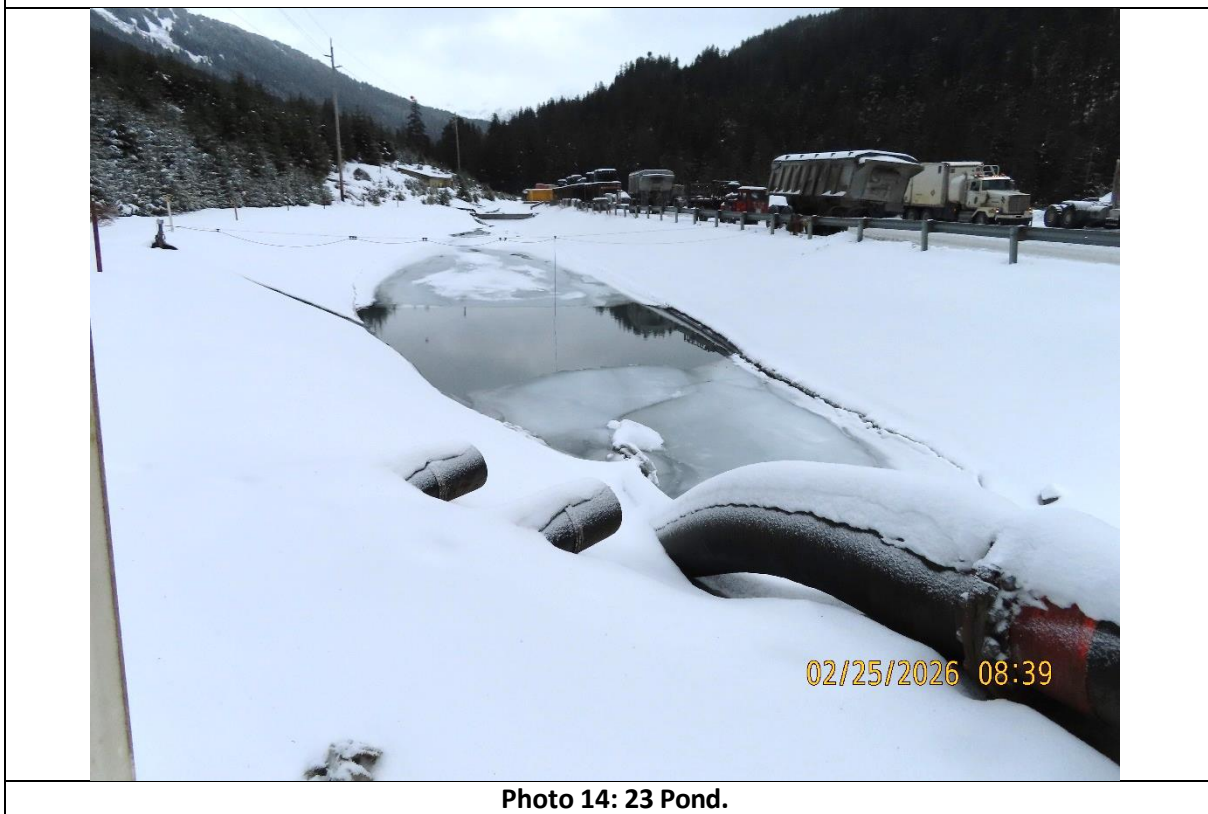
The pump area area was clean and orderly. Pond appeared to be operable with no visible signs of pond overflowing (Photos 13 & 14).

Photo 13: 23 Pond Pump.

Photo 14: 23 Pond.

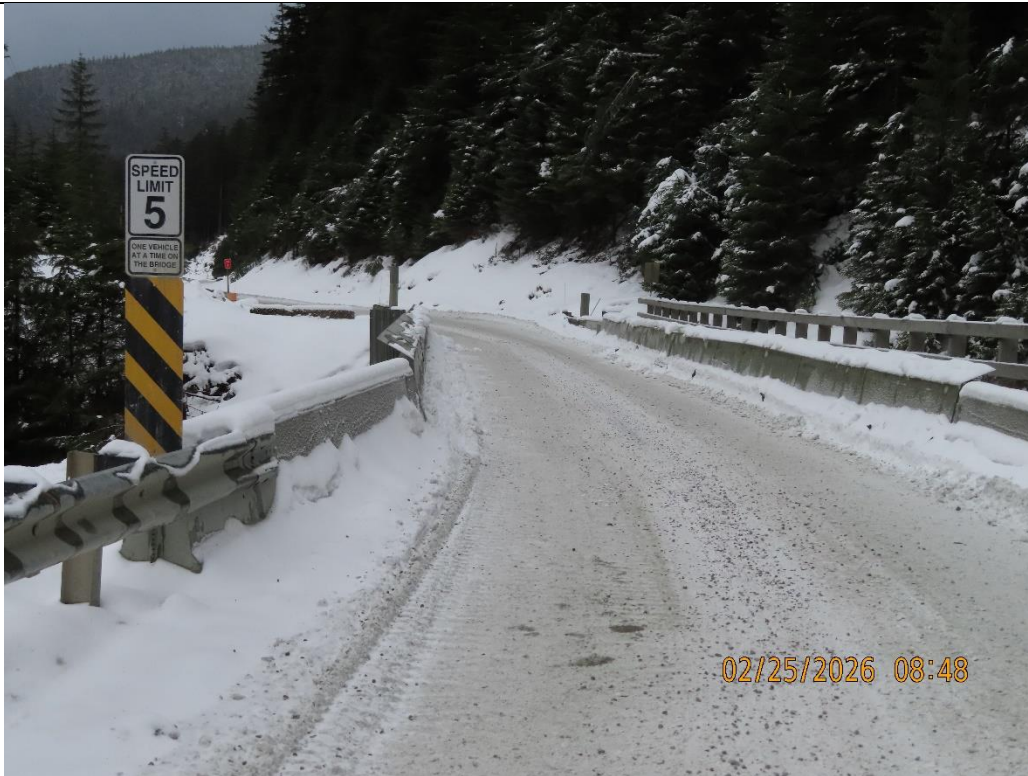
Photo 15: 7.4 Mile Bridge.

| Date/Item No. | Item Description | Status |
|---|---|---|
| 07/24/2025 – 446-1 | 7.4, 3.4, and 3.0-MILE B-ROAD BRIDGES:<br>Sediment draining in several places from beneath bridge to creek and area around abutments.<br>Bridge deck liner appears to be failing. | HGCMC looking at scheduling bridge resurfacing in April. |

The bridge surface appeared in good condition, but sediment is still leaking out below the bridge (Photos 15 - 17).

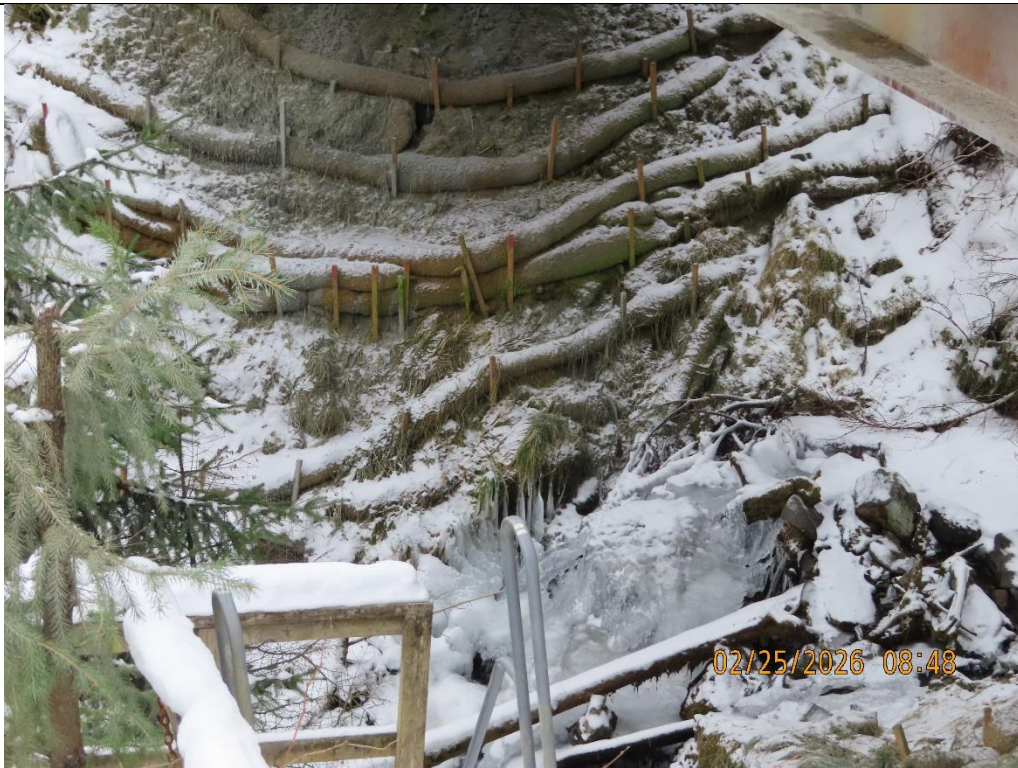
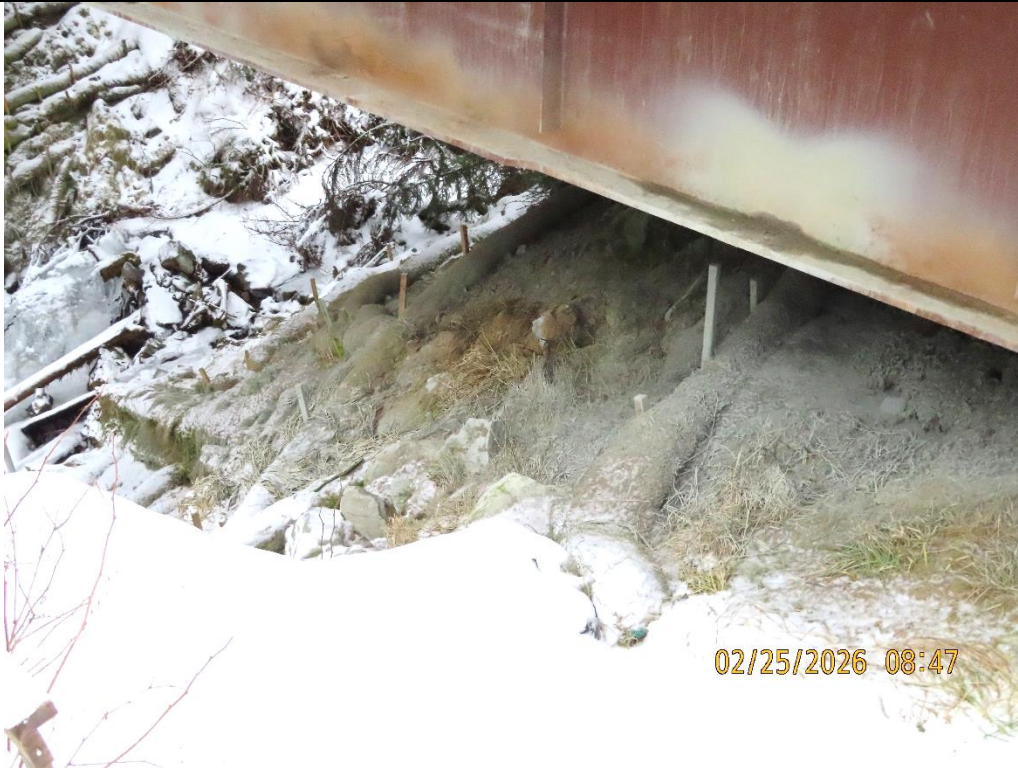
Photo 16: 7.4 Mile Bridge (Killer Creek) waddles and hydroseed present collecting sediment.

**Photo 17: 7.4 Mile Bridge (Killer Creek) waddles and hydroseed present collecting sediment.**

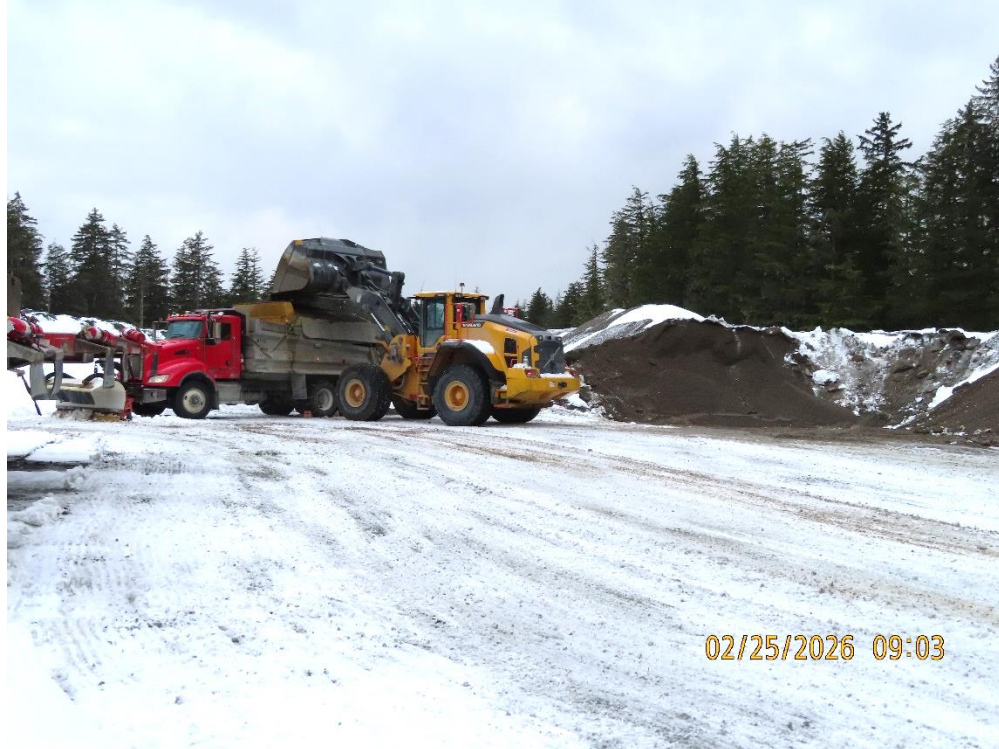
This is an old, early unclassified waste rock site. Material is being stored here to be moved to Tailings Disposal Facility (TDF). Much of the material has been moved to the TDF already. The site is now mostly used for road maintenance gravel and equipment storage (Photo 18).

**Photo 18: Disposal Site E showing road maintenance activity and gravel storage.**

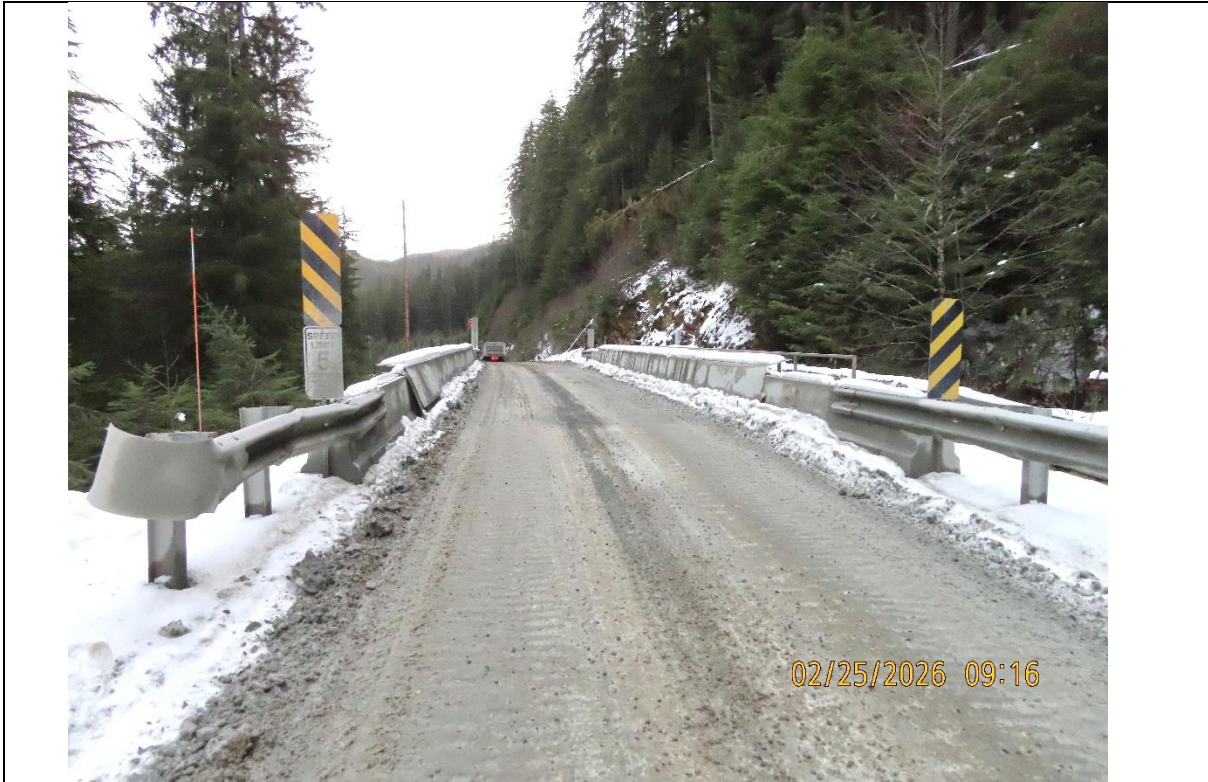
**Photo 19: 3.4 Mile B-Road Bridge (Falls Creek).**

The bridge surface appeared to be in good condition, but sediment is leaking through and collecting beneath the bridge. (Photos 19 & 20).

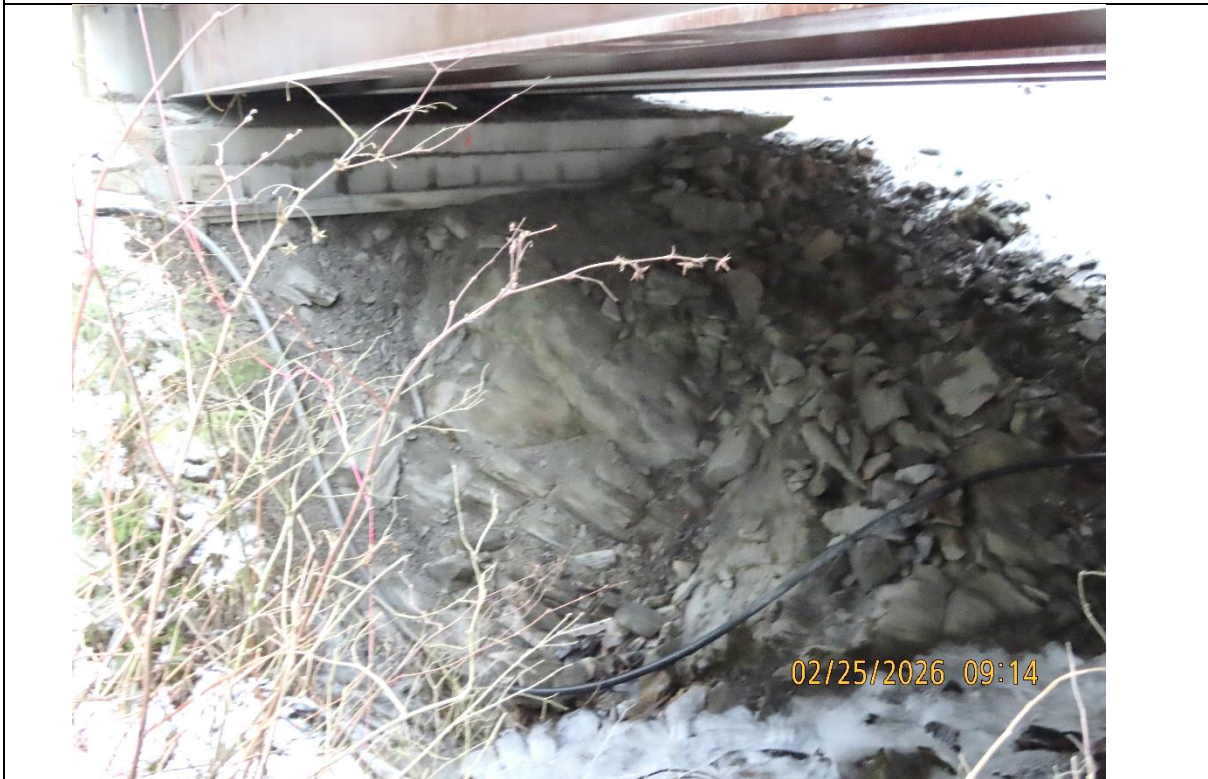
**Photo 20: 3.4 Mile B-Road Bridge (Falls Creek) sediment leaking through from under decking.**

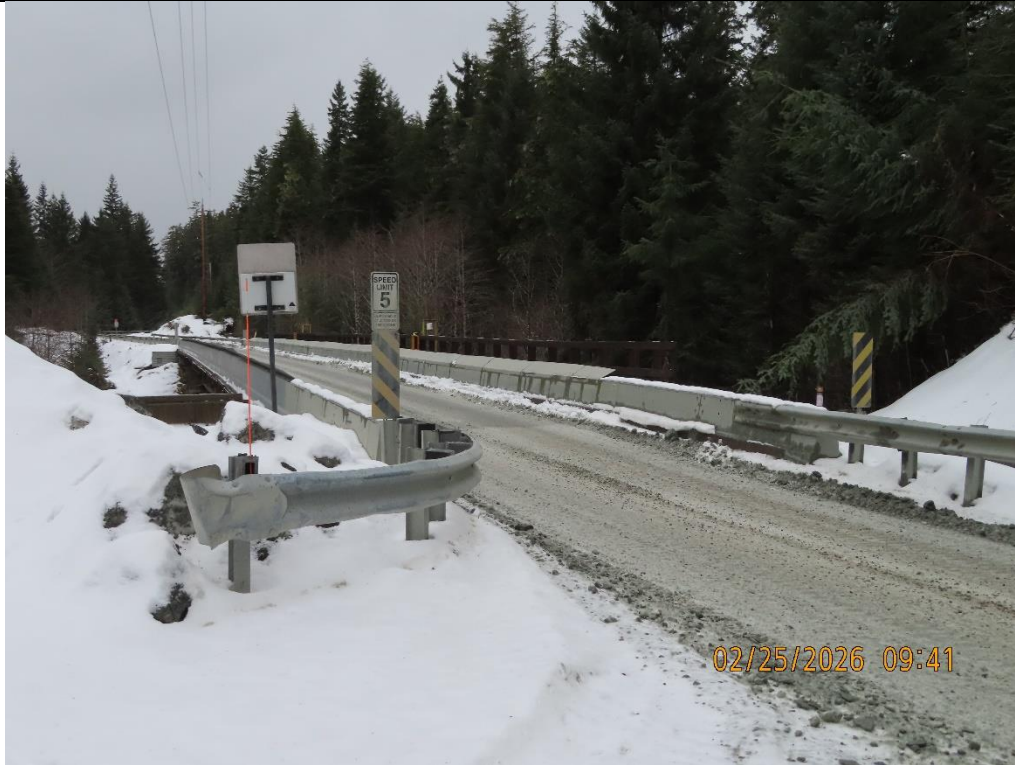
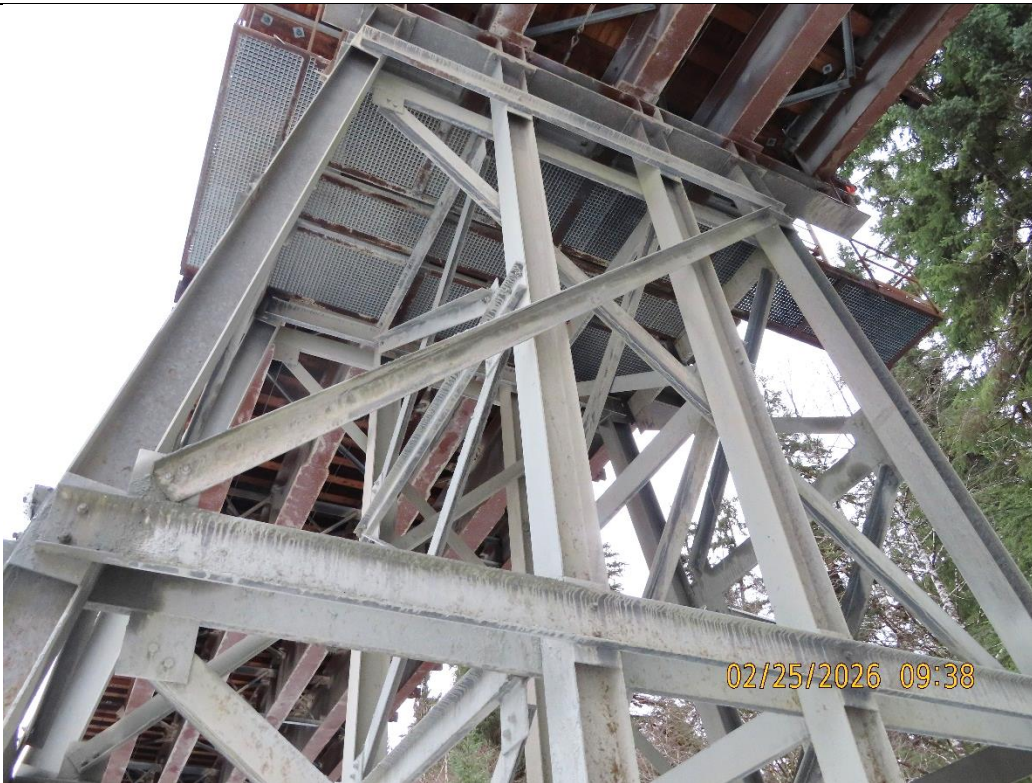
The bridge decking appeared to be in good condition, but sediment is leaking through the entire span of the bridge. Waddles in place and collecting sediment (Photos 21 - 23).

**Photo 21: 3.0 Mile B-Road Bridge (Zinc Creek).**

**Photo 22: 3.0 Mile B-Road Bridge structure (Zinc Creek).**

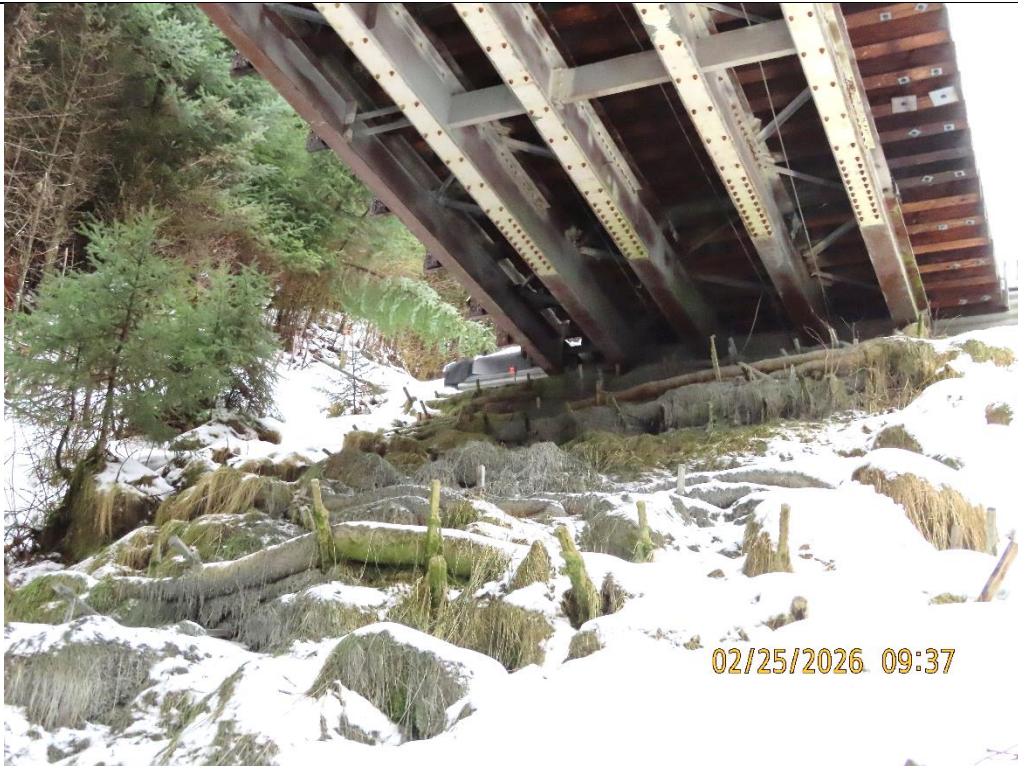
**Photo 23: 3.0 Mile B-Road Bridge (Zinc Creek) showing sediment catchment features.**

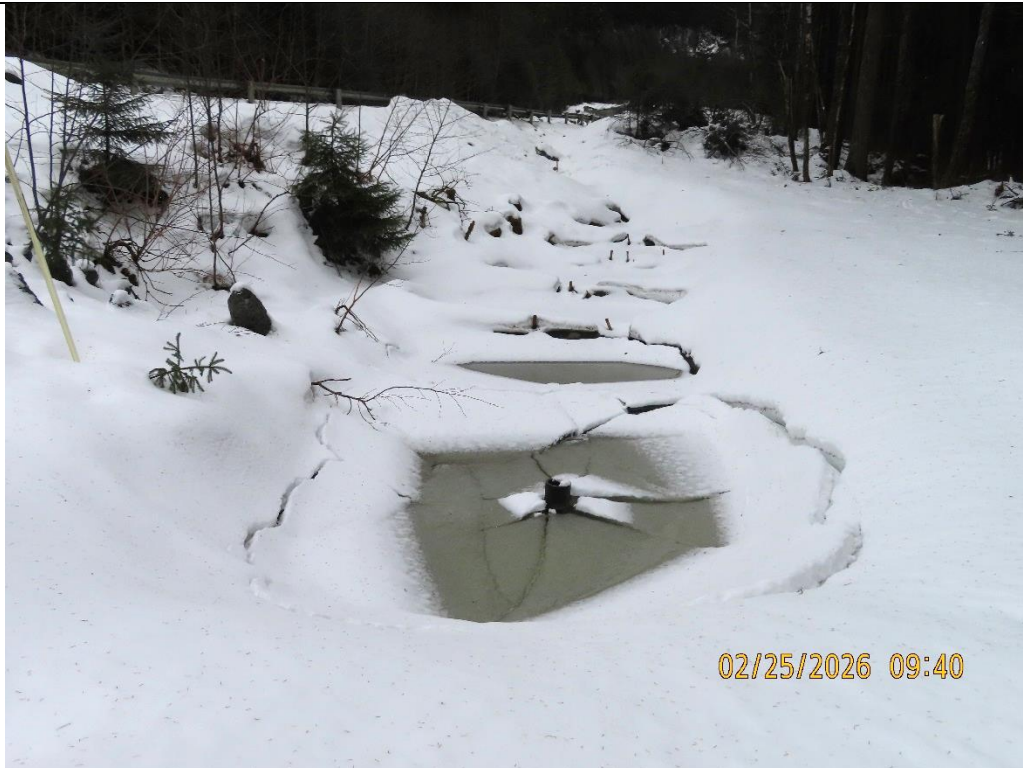
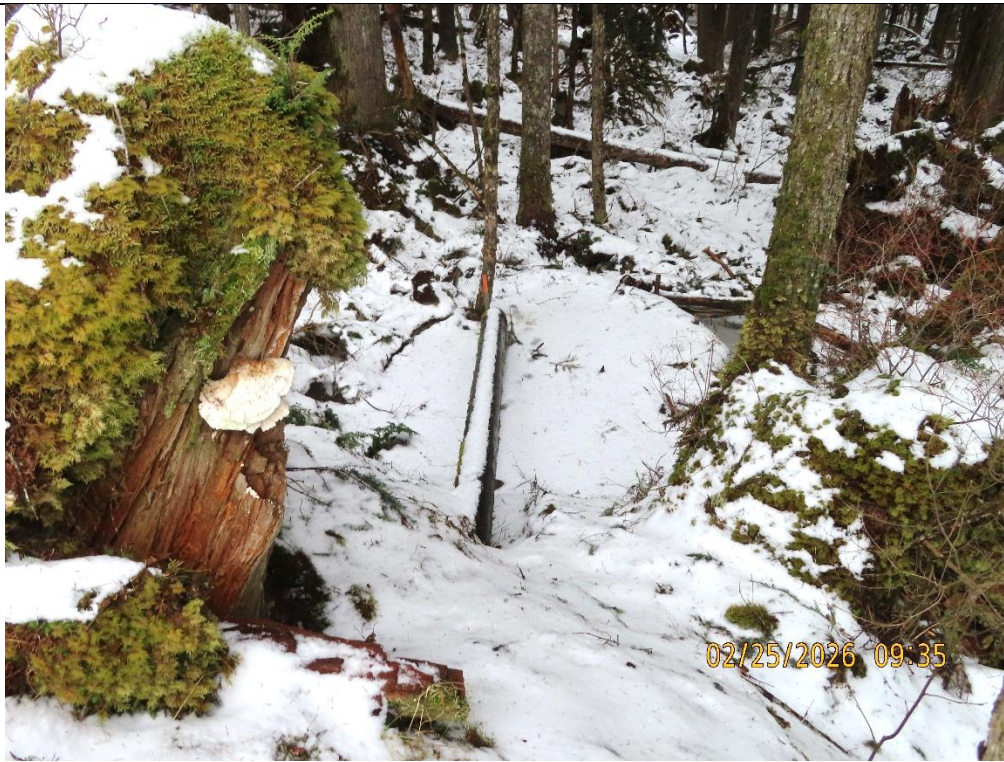
Ponds mostly froze over but still draining as designed (Photos 24 & 25).

**Photo 24: 3.0 Mile B-Road Gnome Ponds.**

Photo 25: 3.0 Mile B-Road Gnome Ponds outfall.

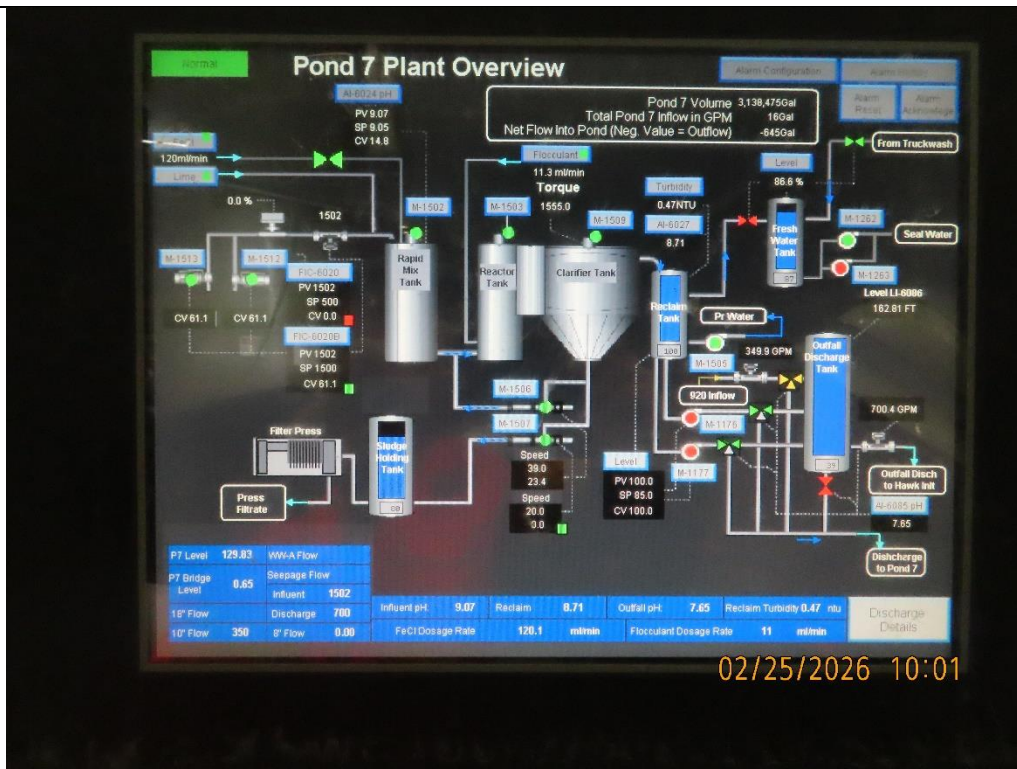
Photo 26: TDF water treatment plant readings.

Good housekeeping practices were observed in the TDF water treatment plant (Appendix 5 BMP Plan, page 37). The water treatment plant was discharging approximately 714 gpm to Outfall 002 with a pH of 7.65, and turbidity of .48 NTU (Photo 26).
