## INSPECTION REPORT: GREENS CREEK MINE

Date of Inspection: Wednesday, February 25, 2026  
Date of Report: March 11, 2026  
USDA Forest Service Inspector: Scott Leslie

Ranger District: Admiralty National Monument, Juneau Ranger District  
Weather Conditions: Overcast, light snow. Temperature: lower 30's (°F).

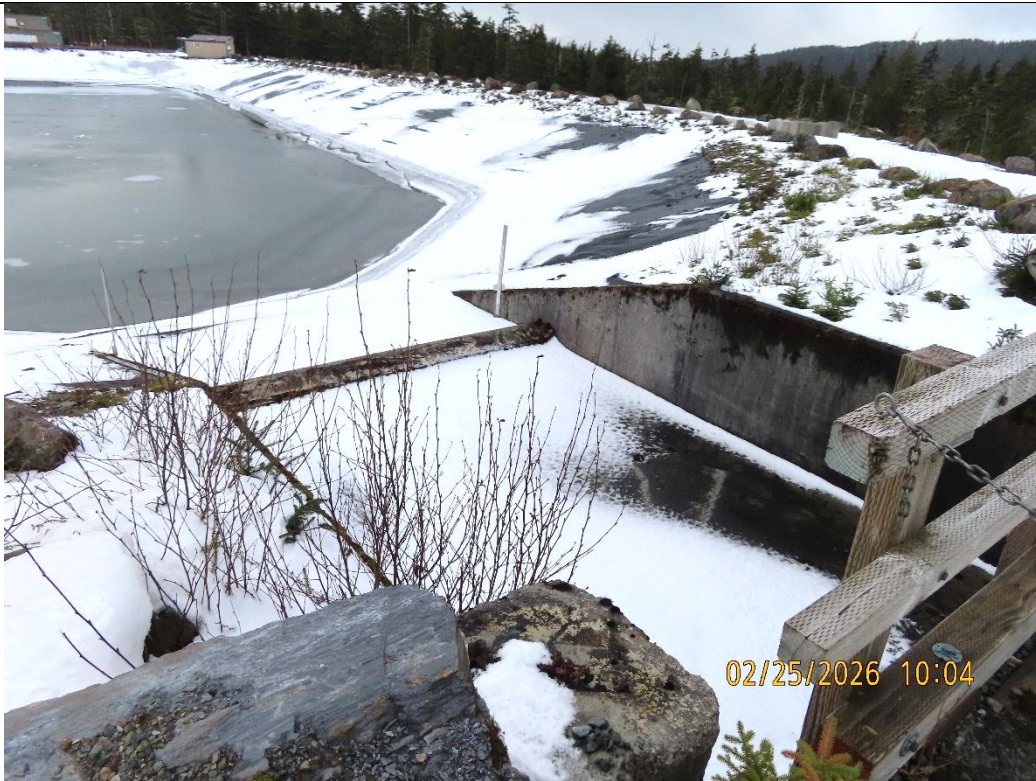
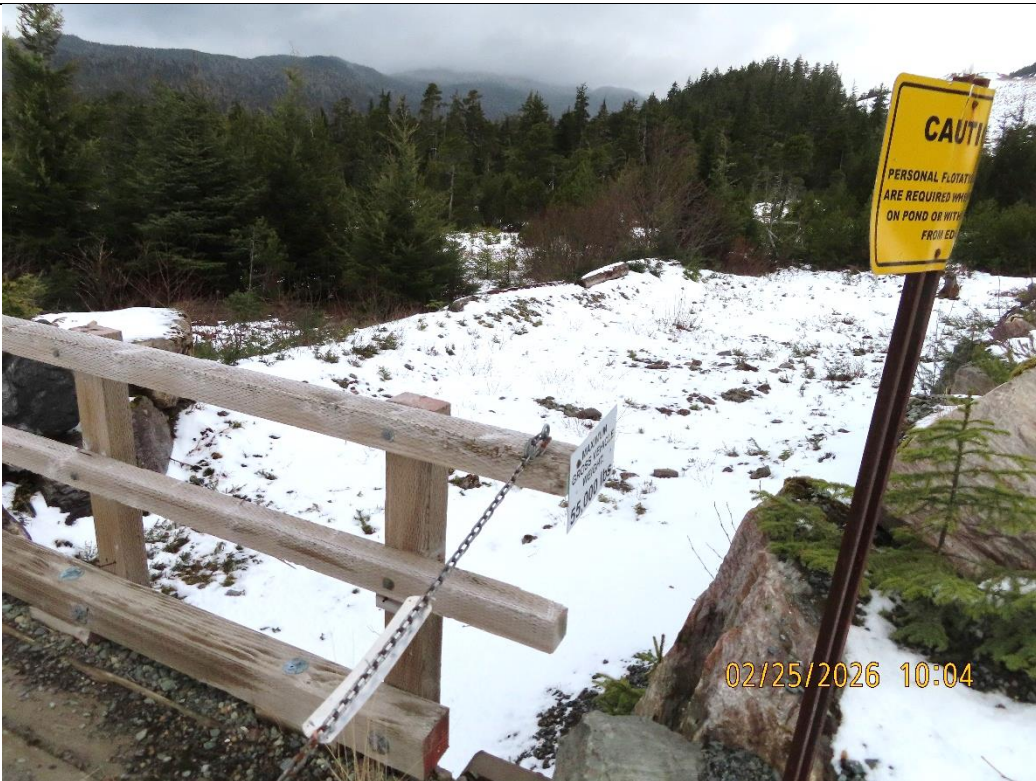
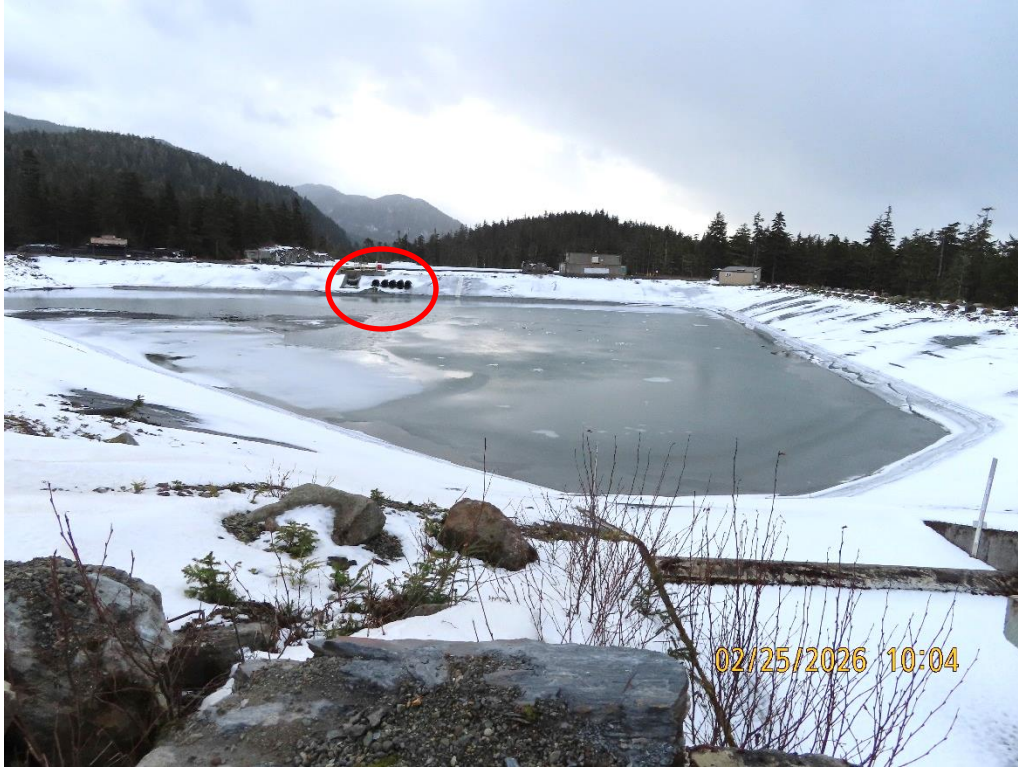
Pond 7 and Spillway. No evidence of water overflow (Photos 27 - 29).

Photo 27: Spillway at Pond 7. No evidence of water overflow.

Photo 28: Pond 7 spillway outfall. No signs of overflow entering this area.

Photo 29: Pond 7 from spillway with culverts connecting Pond 7 to 10 in the background

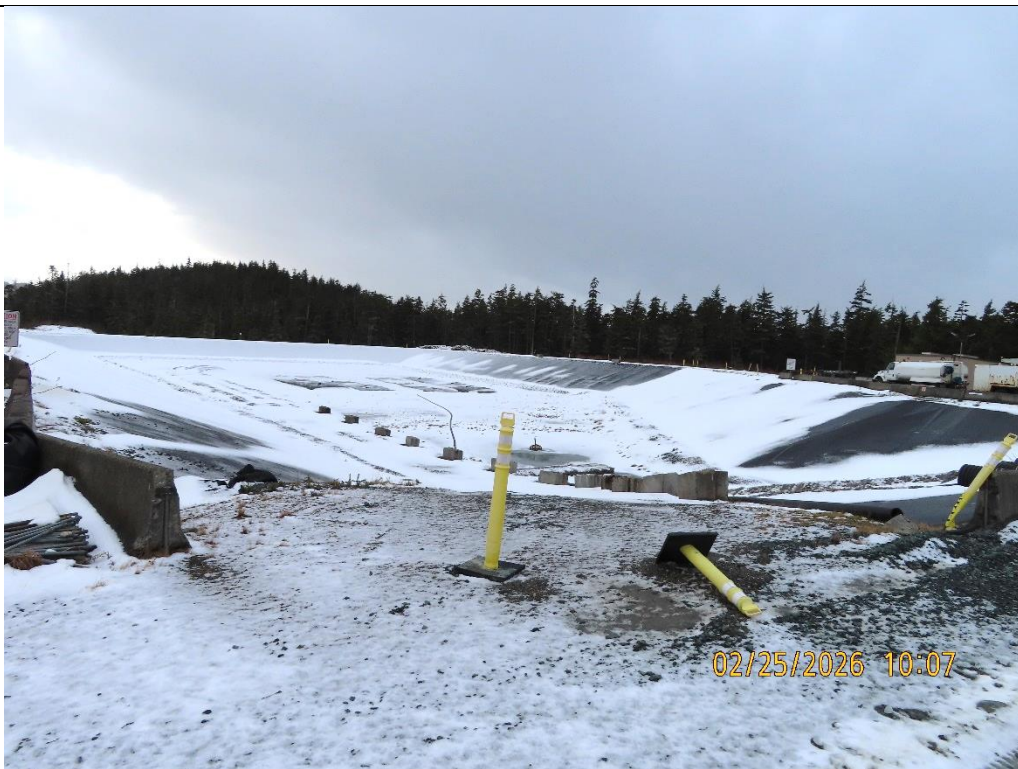
Photo 30: Overview of Pond 10.

Pond 10 Overflow culverts in the foreground entering pond. Water collected in Pond 10 is pumped directly into the TDF water treatment plant (Photo 30).

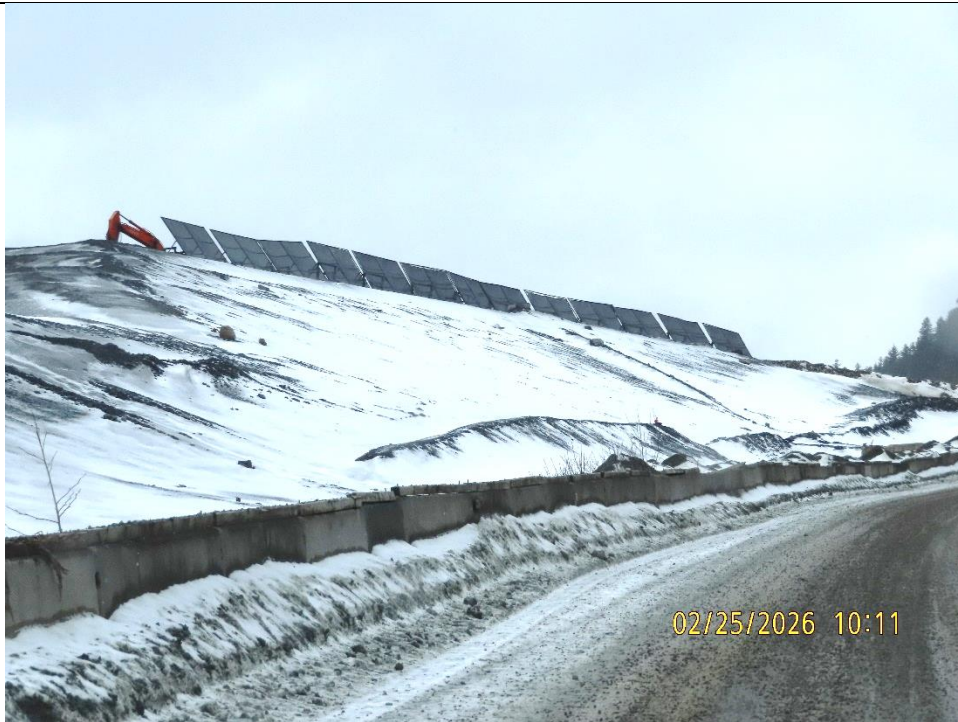
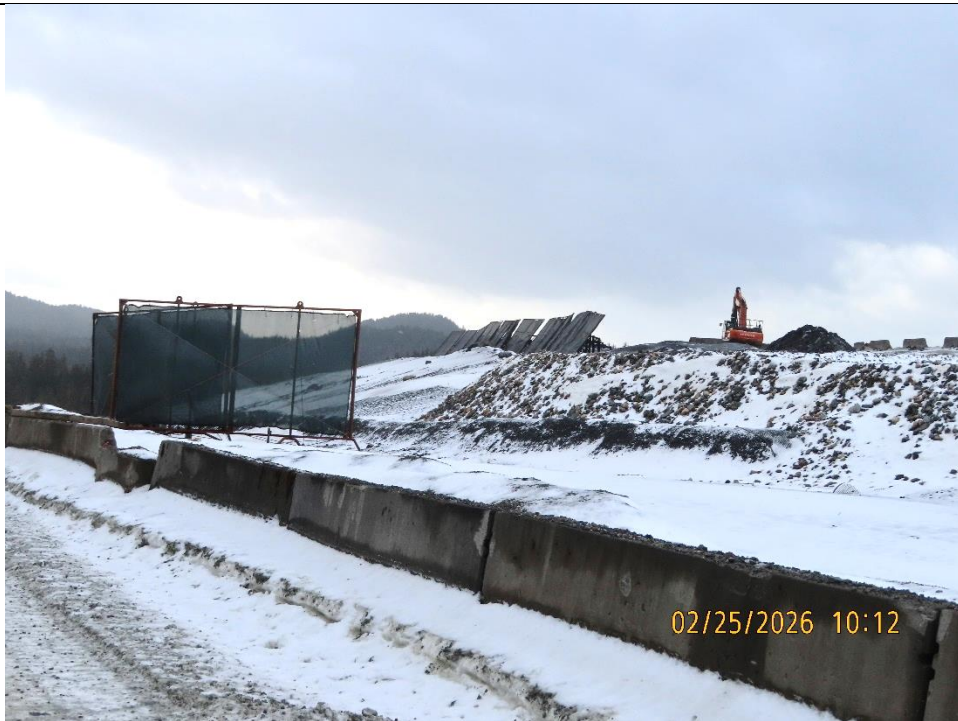
Portable Fugitive Dust Mitigation at the Tailings Facility (Photos 31 & 32).

**Photo 31: Portable Fugitive Dust Mitigation at the Tailings Disposal Facility.**

**Photo 32: Portable Fugitive Dust Mitigation at the Tailings Disposal Facility.**

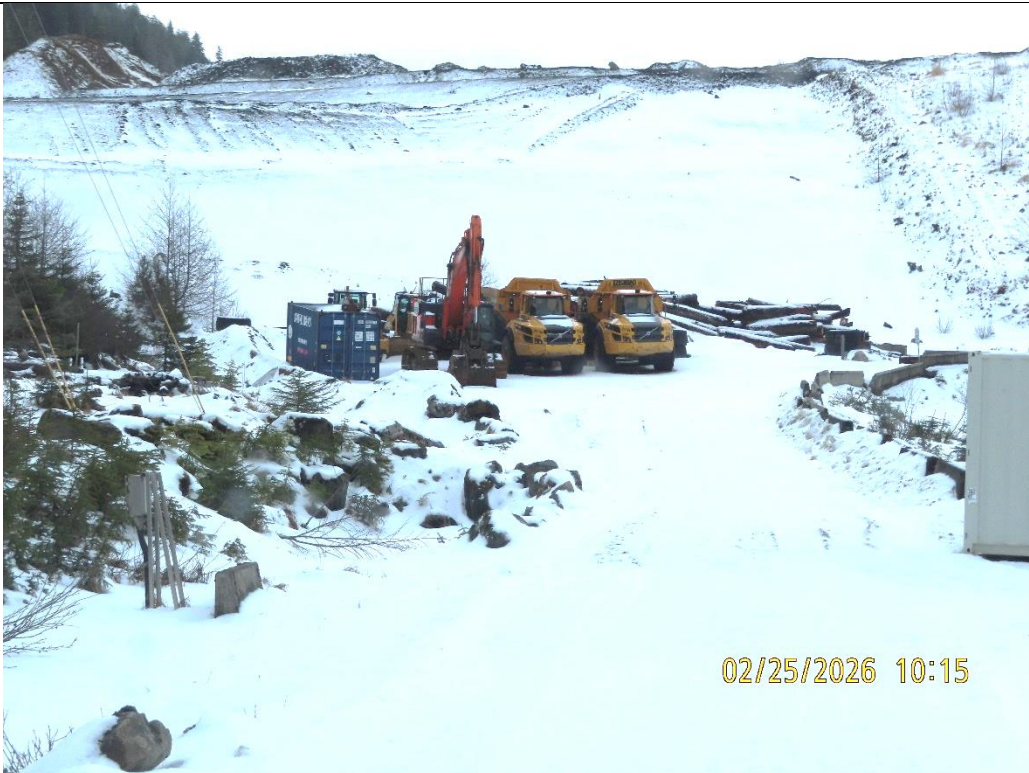
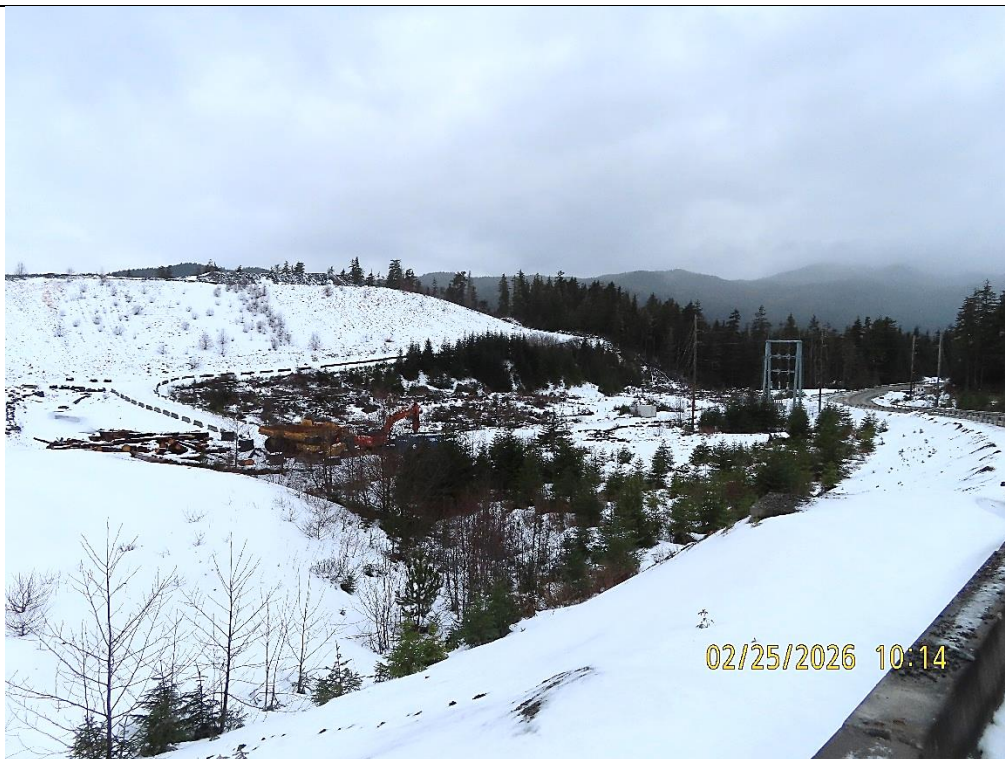
North Expansion Project prework storage area and overview (Photos 33& 34).

**Photo 33: North Expansion Project prework storage area.**

**Photo 34: North Expansion Project area from the B-Road.**
