## INSPECTION REPORT: GREENS CREEK MINE

Date of Inspection: Thursday May 7, 2026  
Date of Report: June 30, 2026  
USDA Forest Service Inspector: Scott Leslie

Ranger District: Admiralty National Monument, Juneau Ranger District Weather Conditions: Partly sunny, light breeze.  
Temperature: mid to upper 40's (°F).

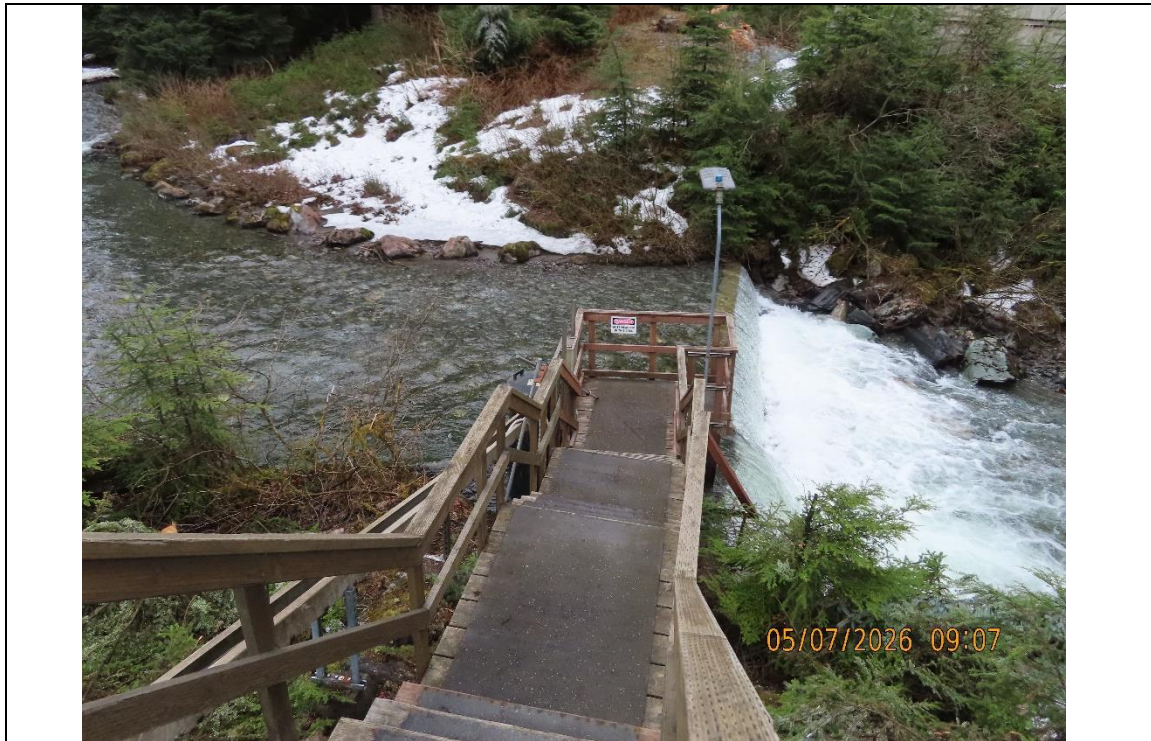
**Photo 1: Greens Creek Weir.**

**Greens Creek Weir** (Photo 1).

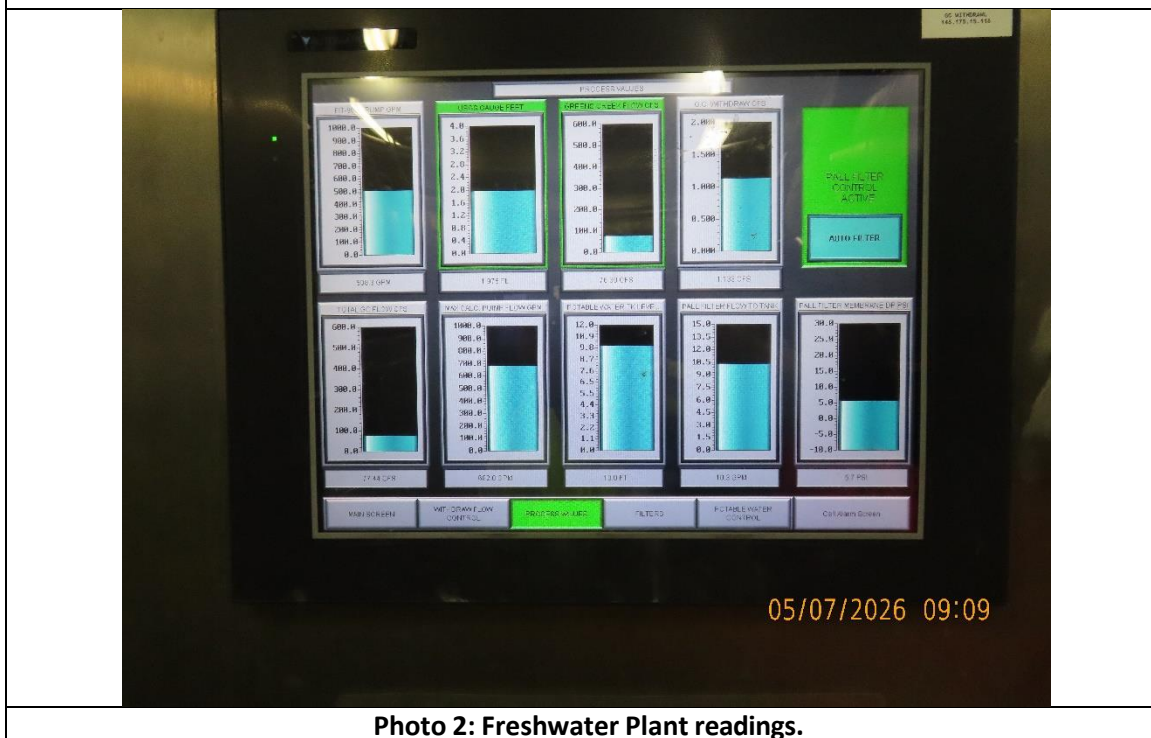
**Photo 2: Freshwater Plant readings.**

**Freshwater Plant**, Greens Creek weir discharge flow at 76 cfs and 1.13 cfs being withdrawn for the 920 facilities. Plant clean and orderly (Photo 2).

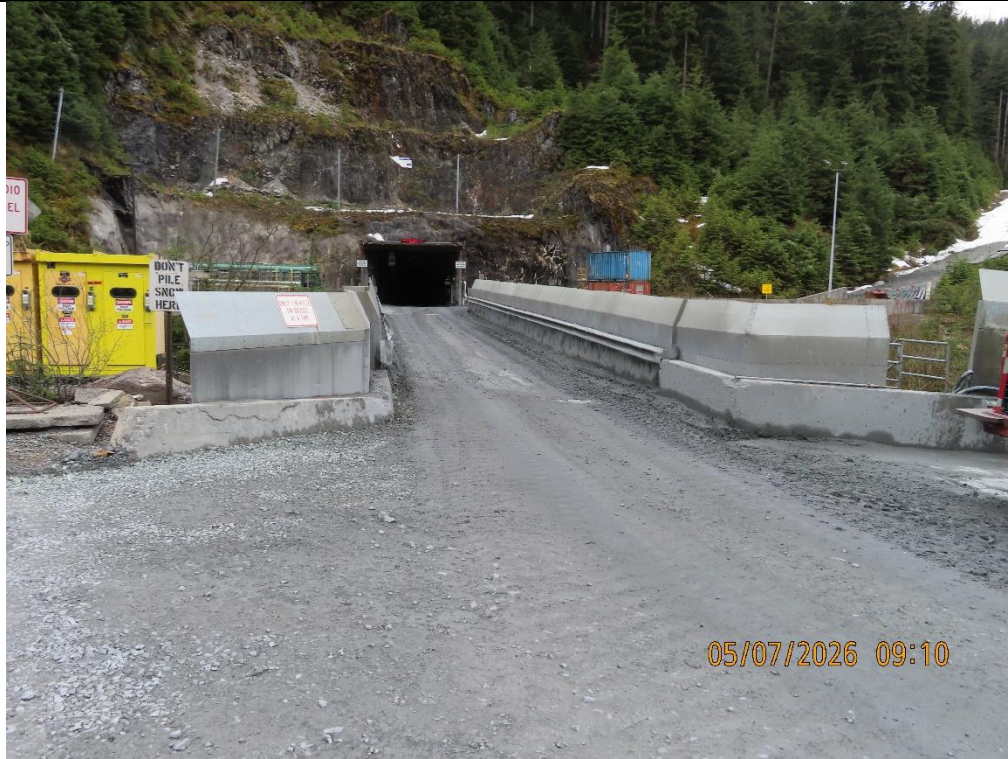
**Photo 3: 920 Bridge.**

**920 Bridge** in good condition. Metal sheeting placed along the bridge decking to mitigate for smoother surface transition at abutment joints (Photo 3).

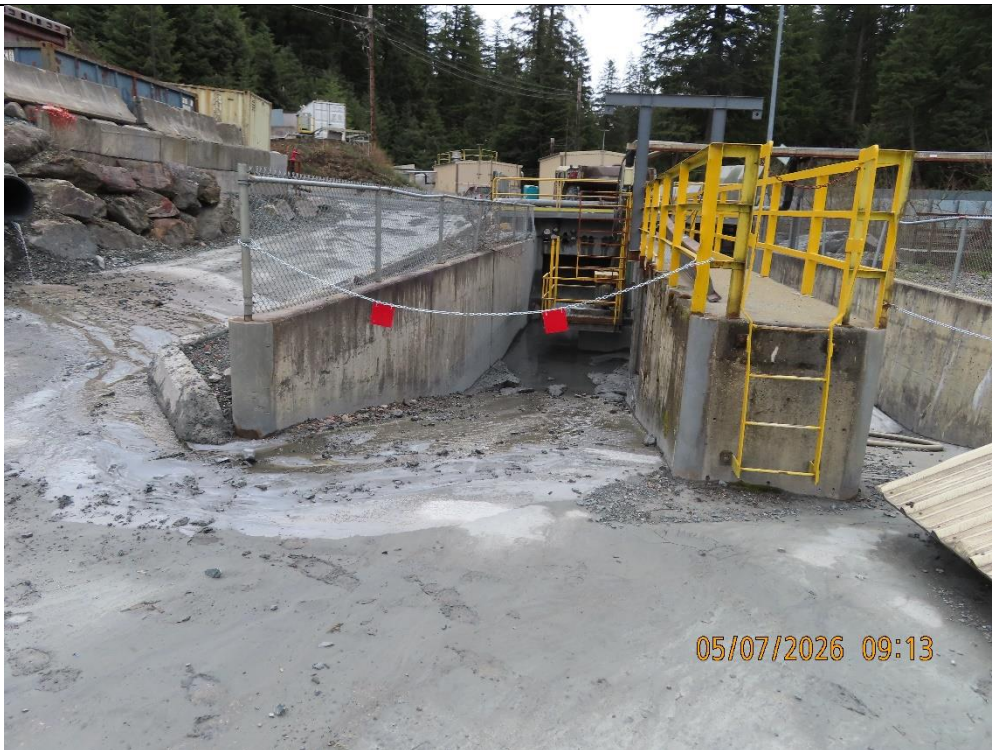
**Photo 4: Degrit Basin (DB-01) back side.**

**Degrit Basin (DB-01)** Appears to be functioning as intended. Could use some mucking out soon. (Photo 4 ).

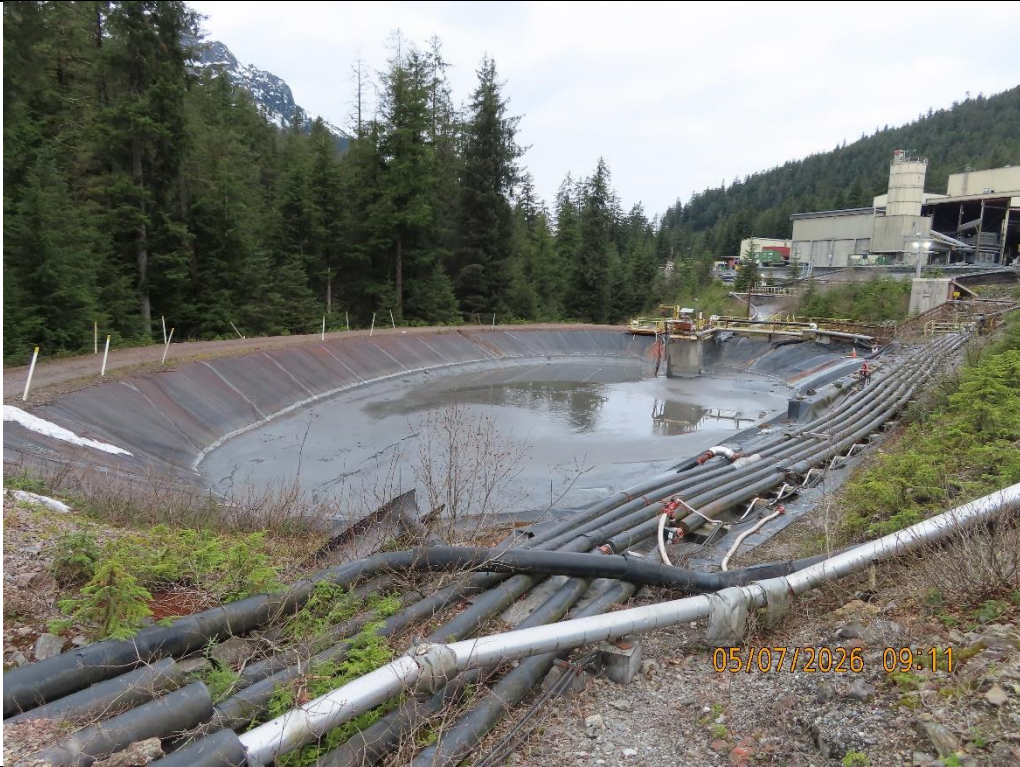
Photo 5: A Pond.

**Pond A** A=Liner appears in order with no visible overflow (Photo 5).

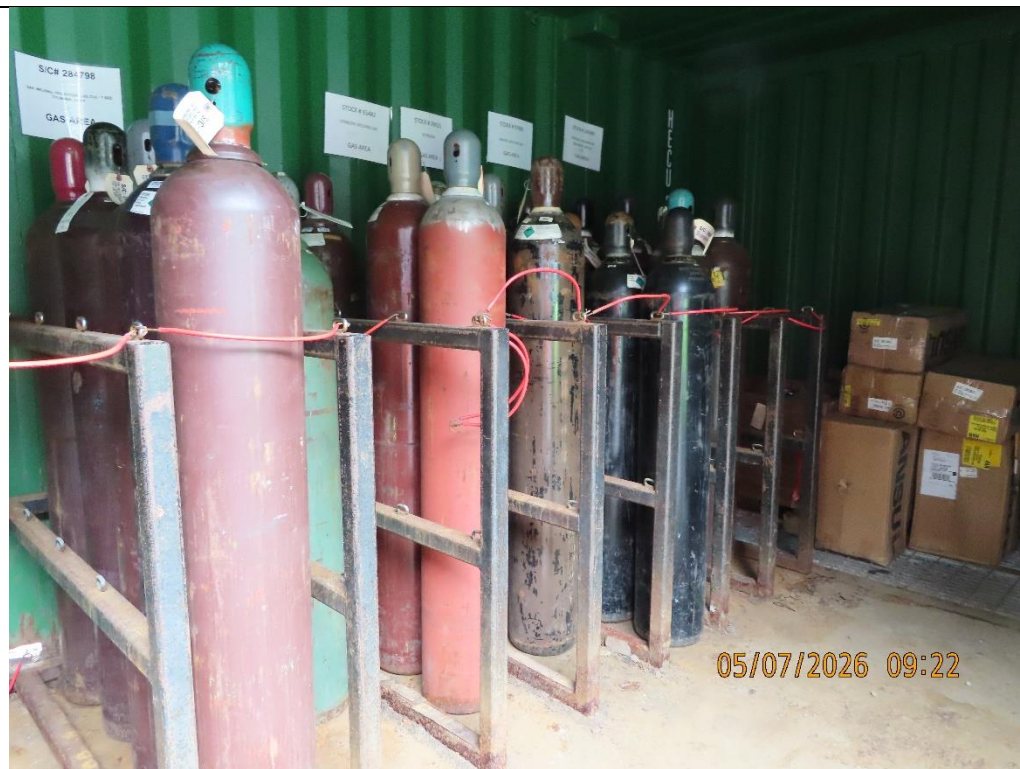
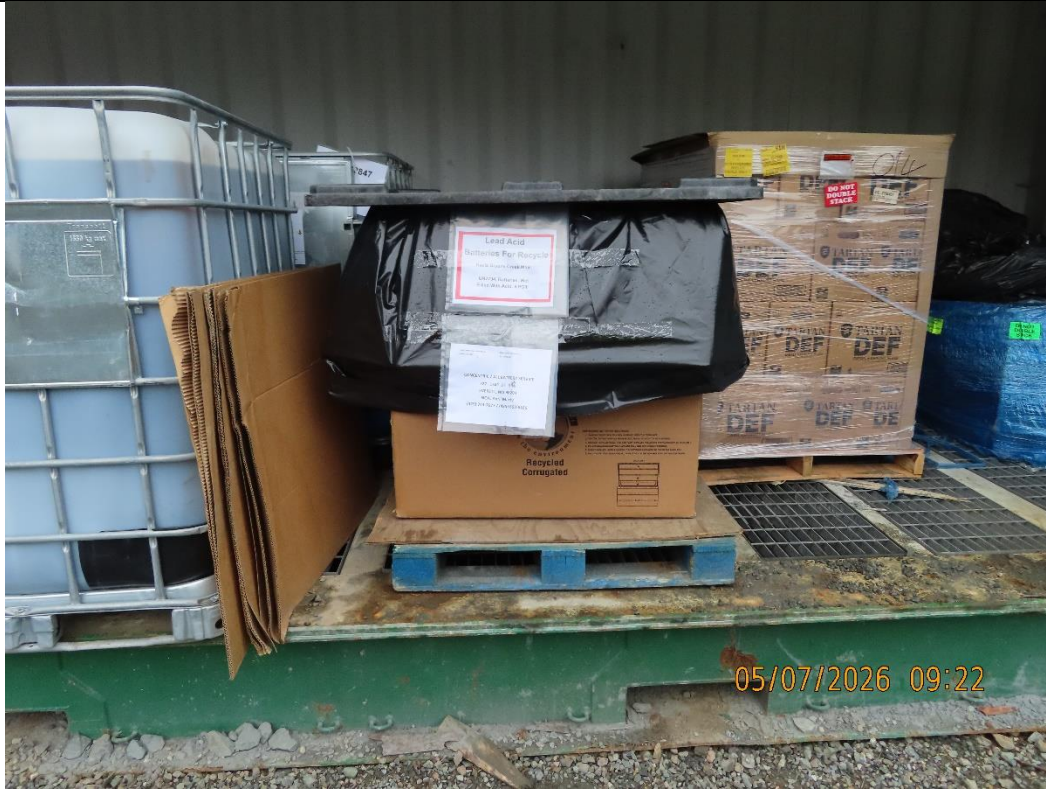
**920 Warehouse** Good housekeeping practices were observed at the storage containers with petrochemicals properly stored with secondary containment (Appendix 5 BMP Plan, page 37) (Photos 6 & 7).

Photo 6: 920 warehouse storage container.

Photo 7: 920 warehouse area.

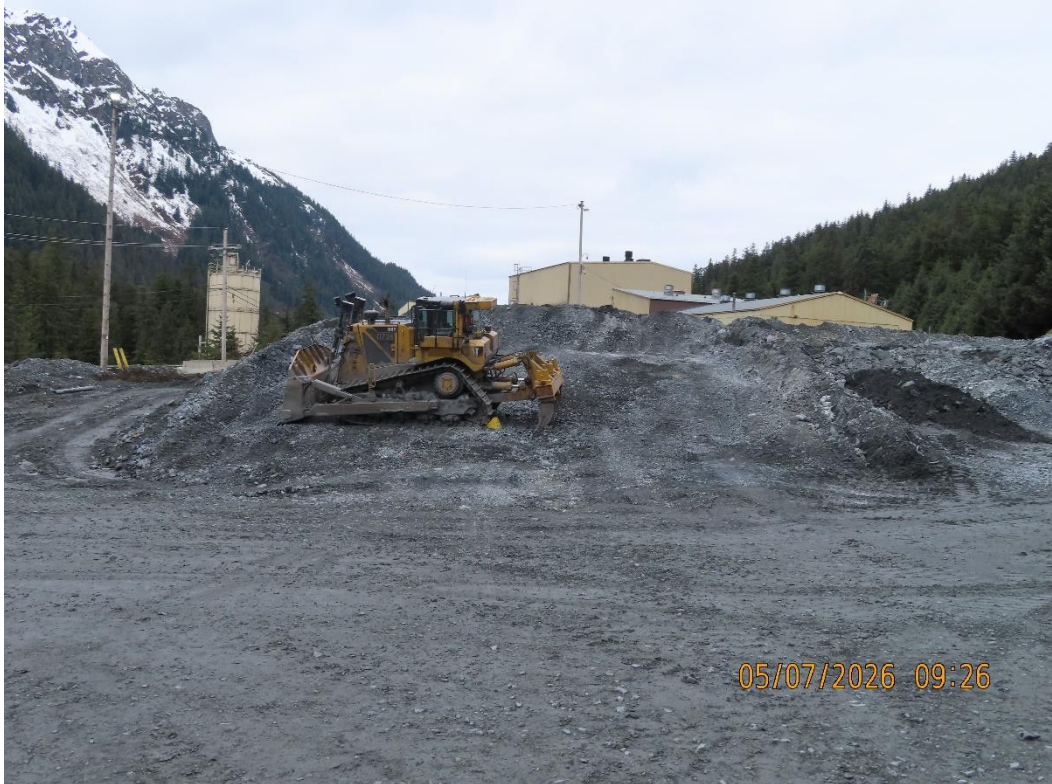
Photo 8: Ore pad.

**Ore Pad** in use staging ore from 920 adit actively being contoured to transport ore to mill (Photo 8).

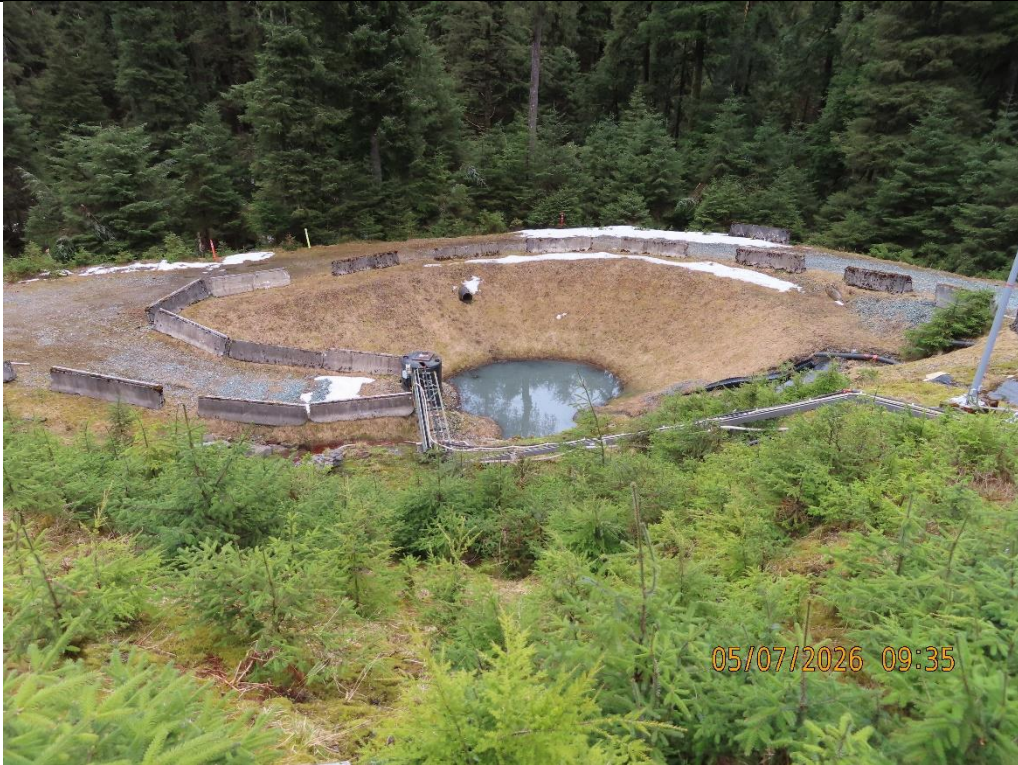
Photo 9: Lower C Pond.

The upper and lower pond liners are intact and with no visible signs of overflow (Photos 9 & 10).

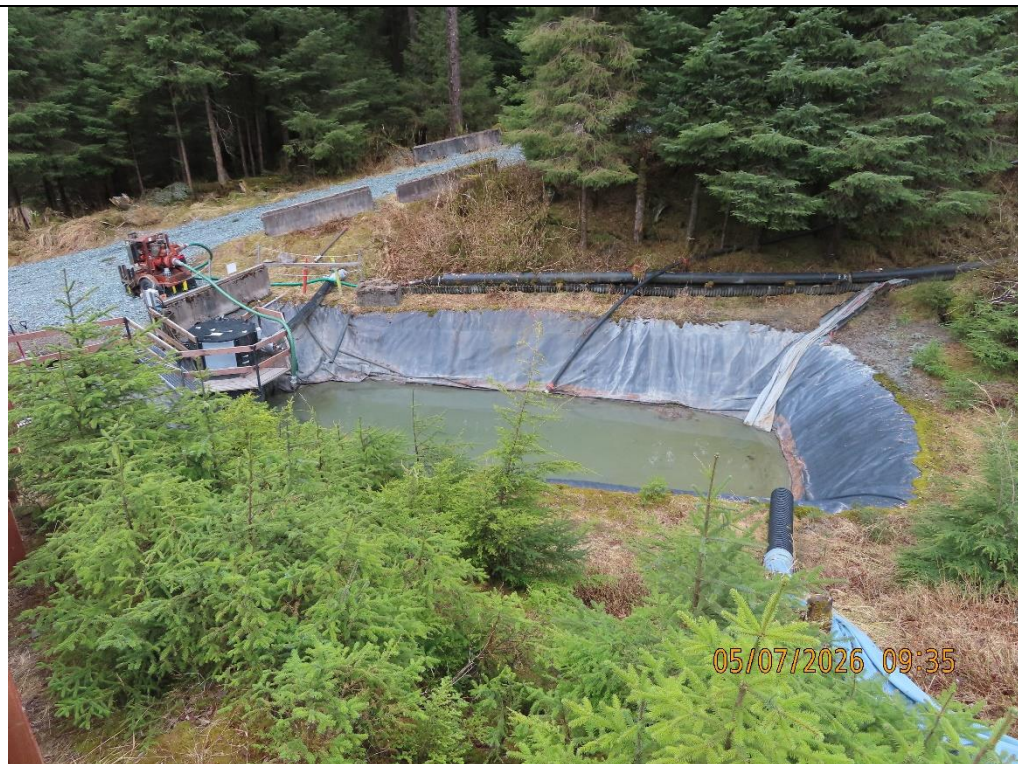
Photo 10: Upper C Pond. Evidence of raised pond level but no overflow outside of the pond.

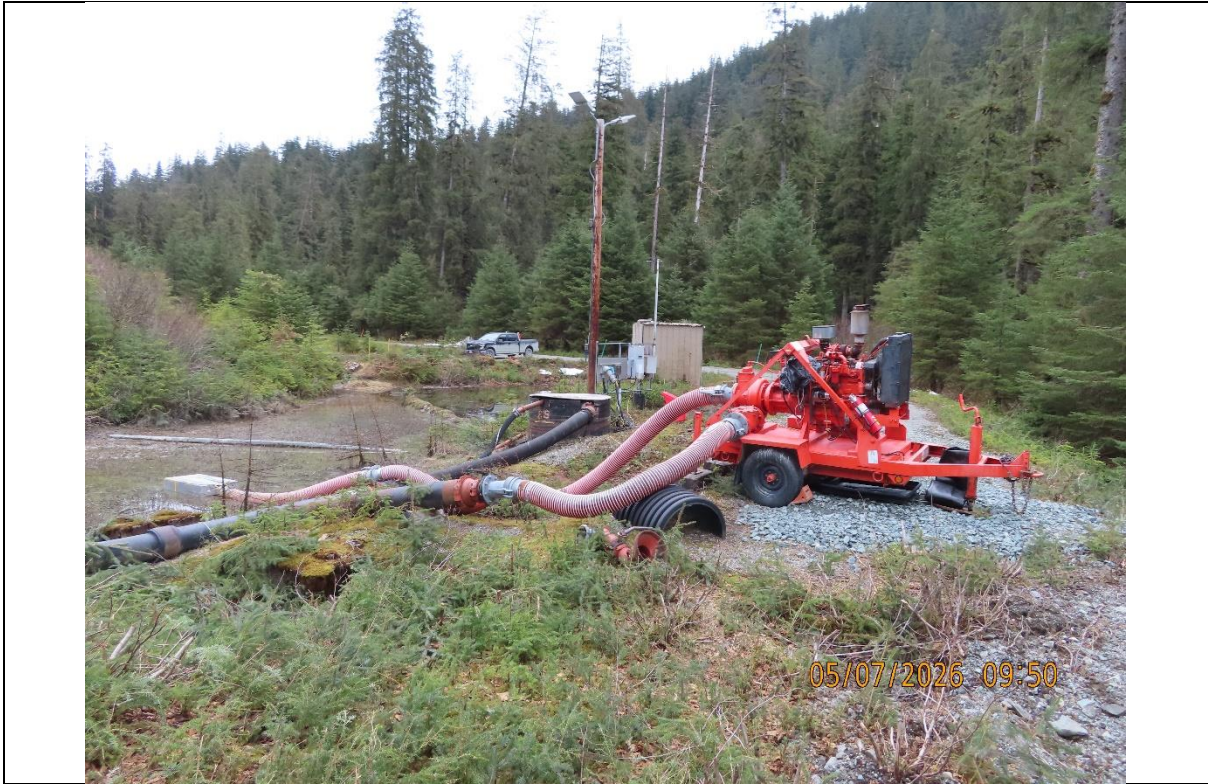
Photo 11: D Pond and pump.

Intact and no visible signs of overflow (Photo 11).

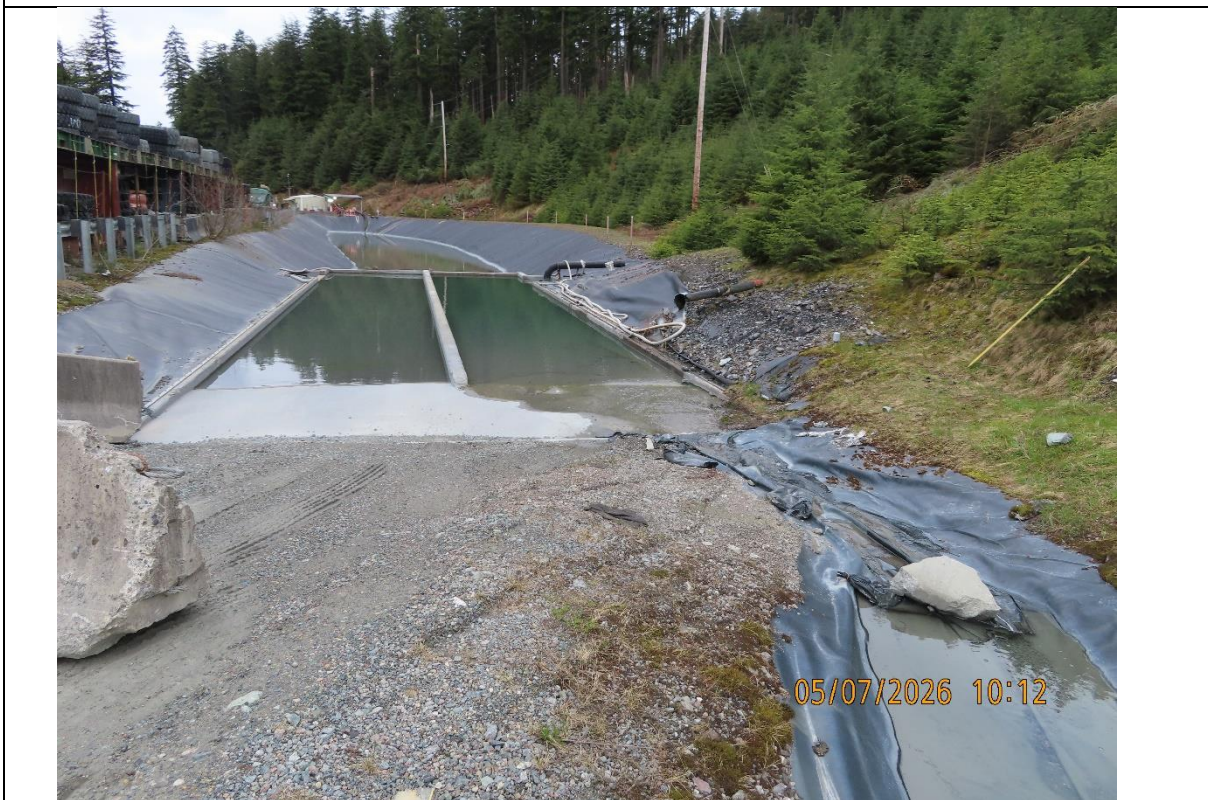
Photo 12: DB-03 and 23 Pond and Pump in background.

**Degrit Basin BD-03** Runoff entering basin as designed and appears to be functioning as intended. The 23 Pond can be seen in the background (Photo 12).

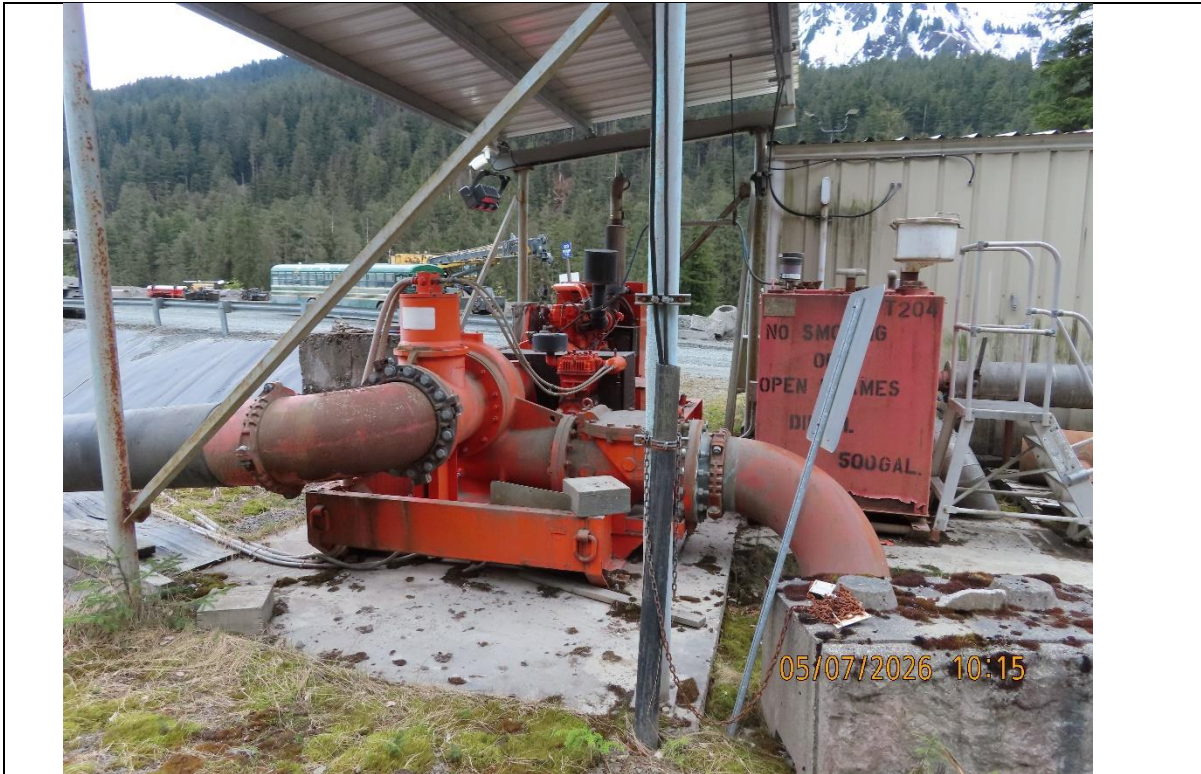
Photo 13:

The pump area was clean and orderly. Appeared to be operable with no visible signs of pond overflow or liner damage (Photos 13).

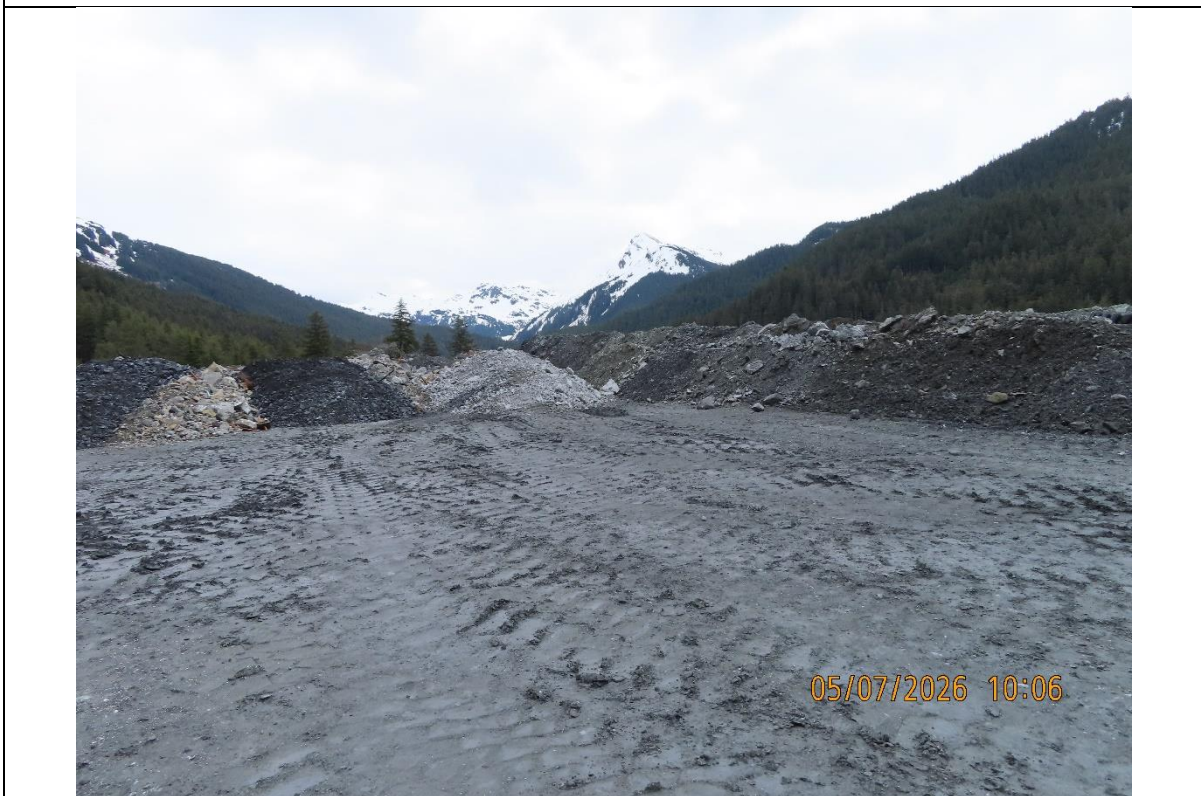
HGCMC continues to stage Class 1, 2, and 3 waste rock at this location. Class 4 waste rock is kept and disposed of underground (Appendix 11 Waste Rock Management Plan, page 11). Class 1 rock (argillite) is used as an inert capping material over top of Class 2 and 3. (Photo 14).

Photo 14: Site 23 Class 2 & 3 Material on top of storage area.

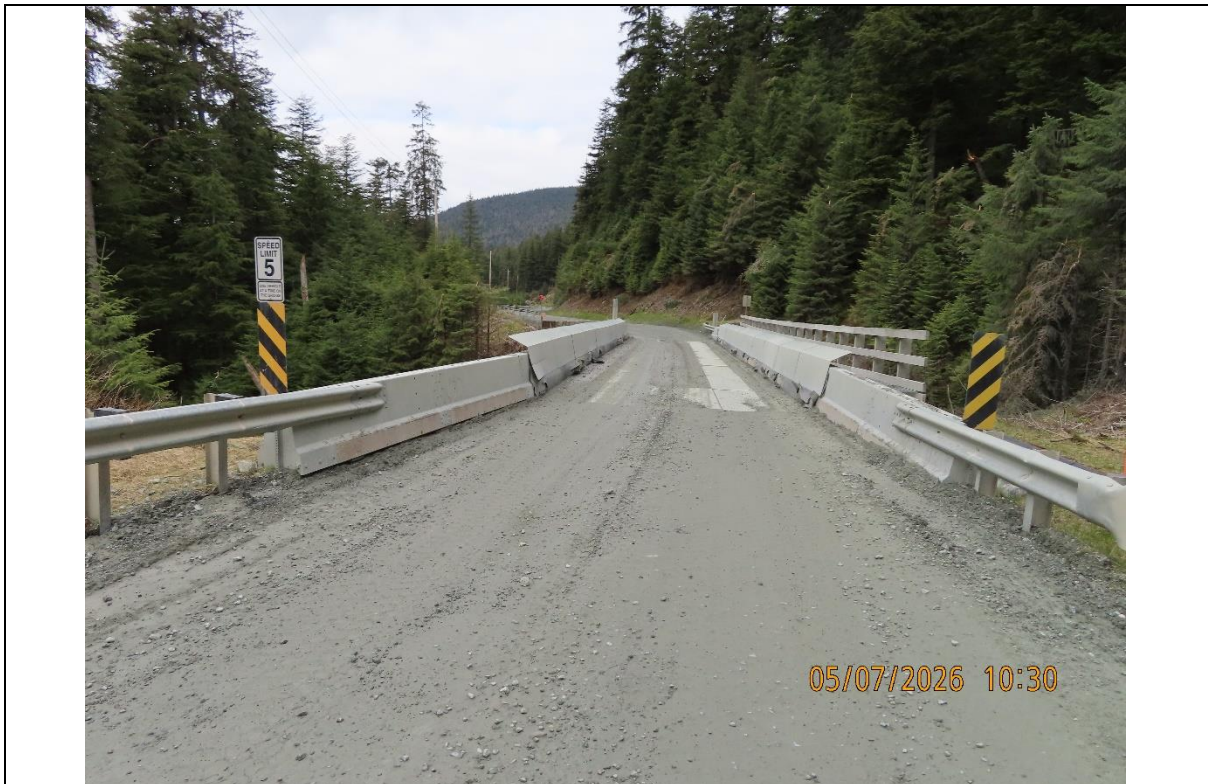
**Photo 15: 7.4 Mile Bridge.**

| Date/Item No. | Item Description | Status |
|---|---|---|
| 07/24/2025 – 446-1 | 7.4, 3.4, and 3.0-MILE B-ROAD BRIDGES:<br>Sediment draining in several places from beneath bridge to creek and area around abutments.<br>Bridge deck liner appears to be failing. | HGCMC looking at scheduling bridge resurfacing in July. 3.0-Mile B-Road bridge was completed in April. |

The bridge surface appeared in good condition, but sediment is still leaking out below the bridge and captured in waddles (Photos 15 & 16).

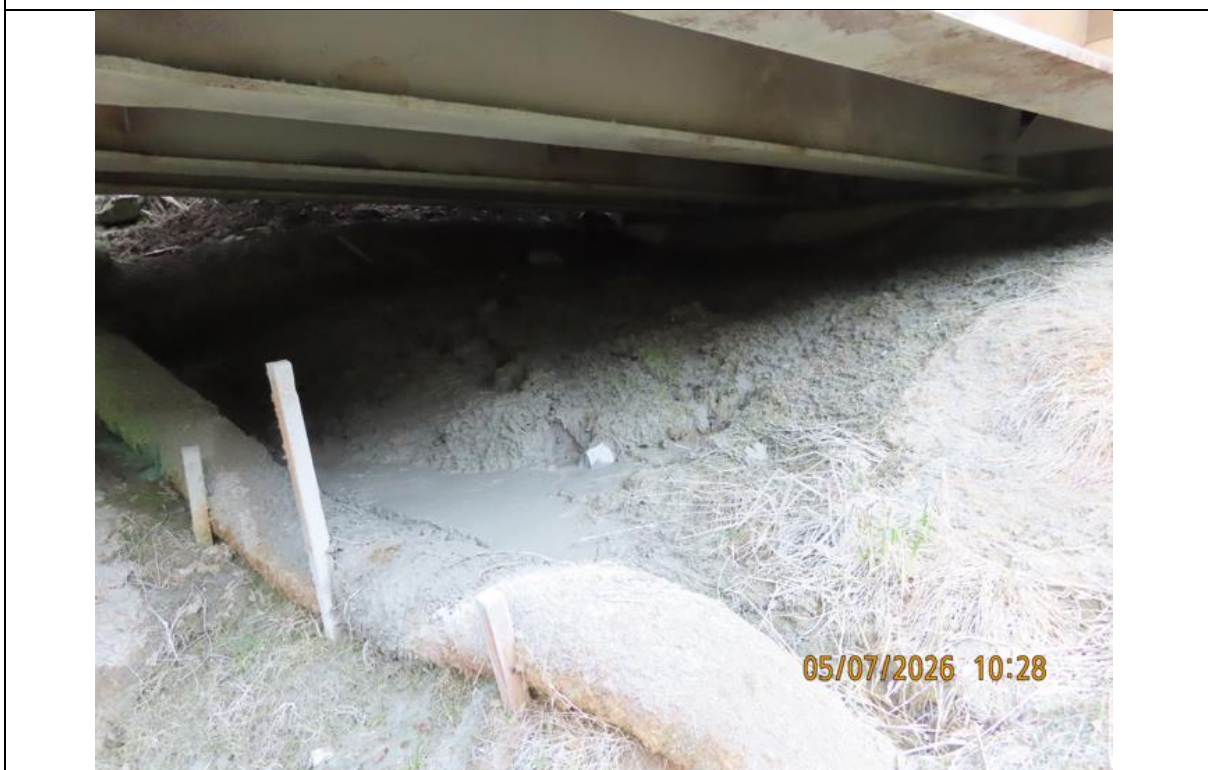
**Photo 16: 7.4 Mile Bridge (Killer Creek) waddles and hydroseed present collecting sediment.**

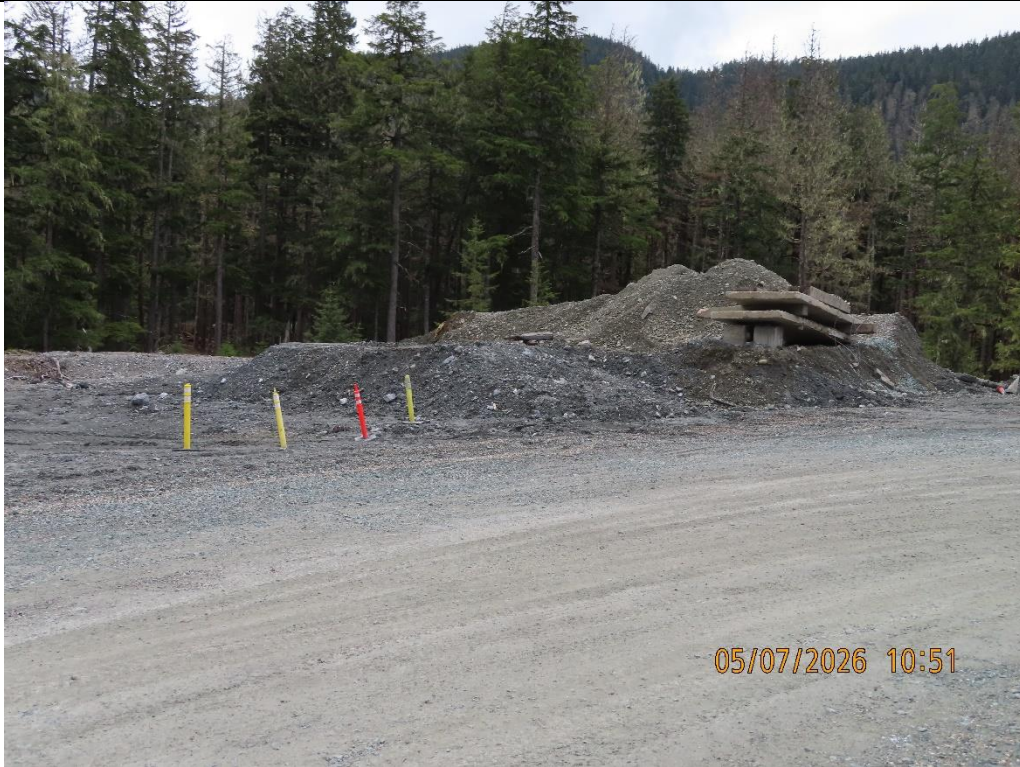
This is an old, early unclassified waste rock site. Material is being stored here to be moved to Tailings Disposal Facility (TDF). Much of the material has been moved to the TDF already. The site is now mostly used for road maintenance gravel and equipment storage. Pond liner intact with no signs of overflow (Photos 17 & 18).

**Photo 17: Waste Site E. Much of the material has been moved to the TTF.**

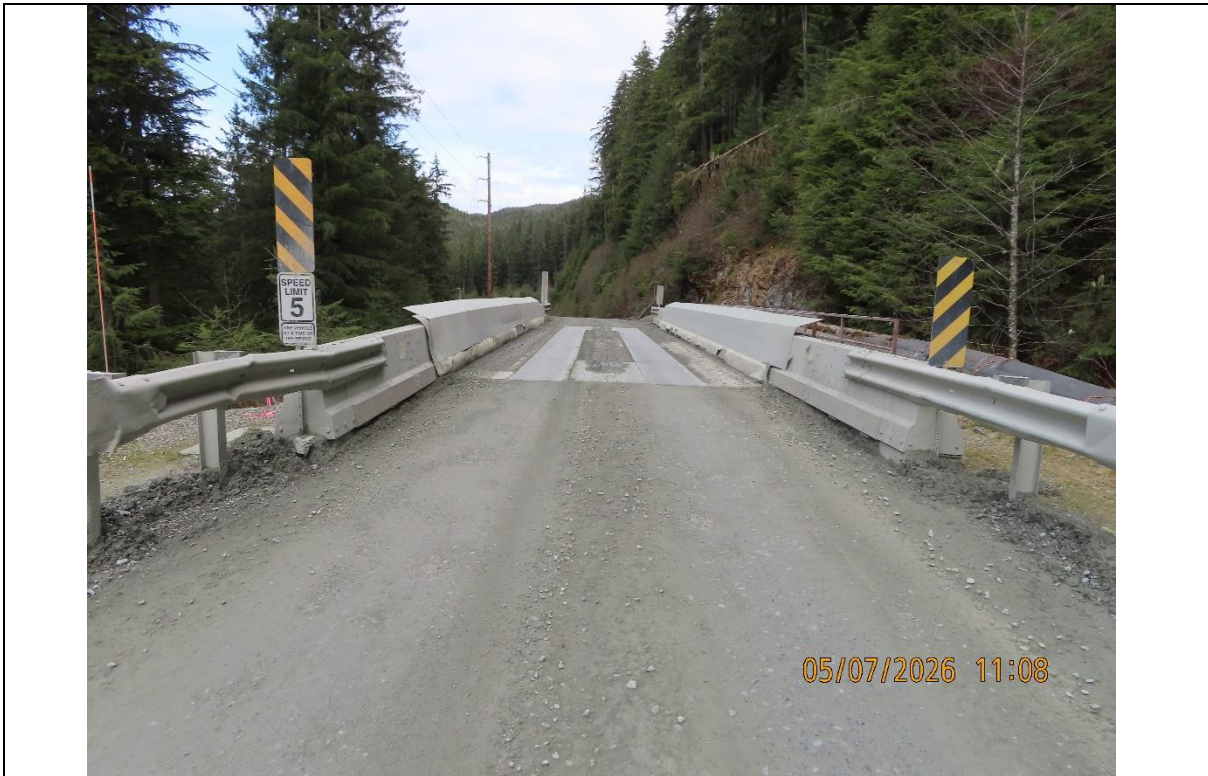
Photo 19: 3.4 Mile B-Road Bridge (Falls Creek).

The bridge surface appeared to be in good condition, but sediment leaks through and collecting beneath the bridge. (Photos 19 & 20).

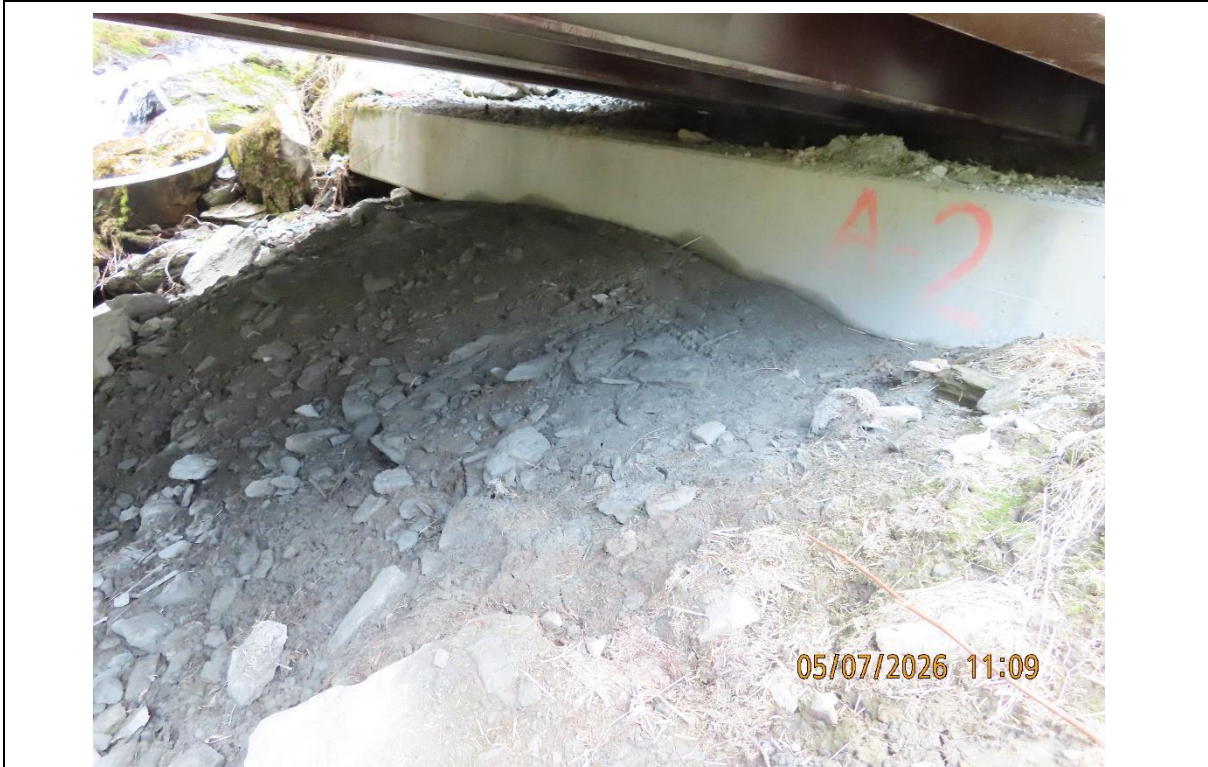
Photo 20: 3.4 Mile B-Road Bridge (Falls Creek) sediment leaking through from under decking.

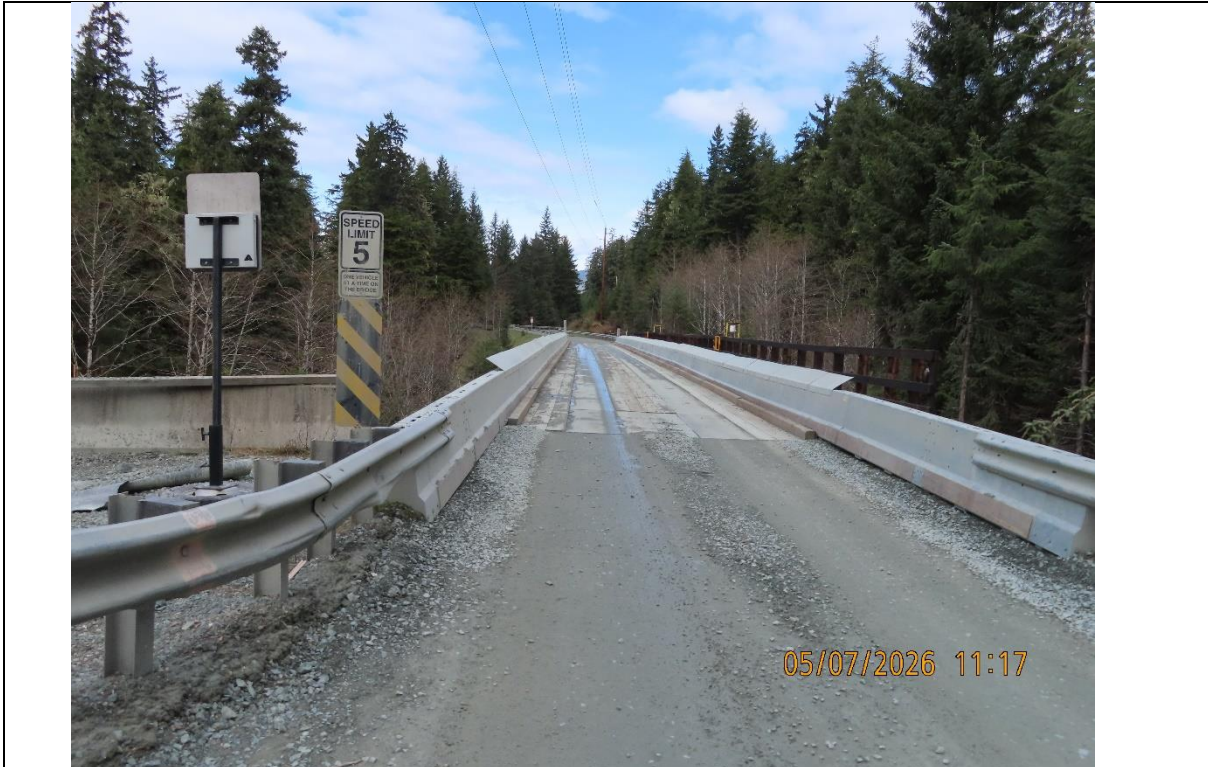
**Photo 21: 3.0 Mile B-Road Bridge (Zinc Creek).**

Bridge was redecked in April. No new sediment observed below bridge. Waddles in place with sediment collected prior to redecking. HGCMC should clean out the collected sediment. (Photos 21 & 22).

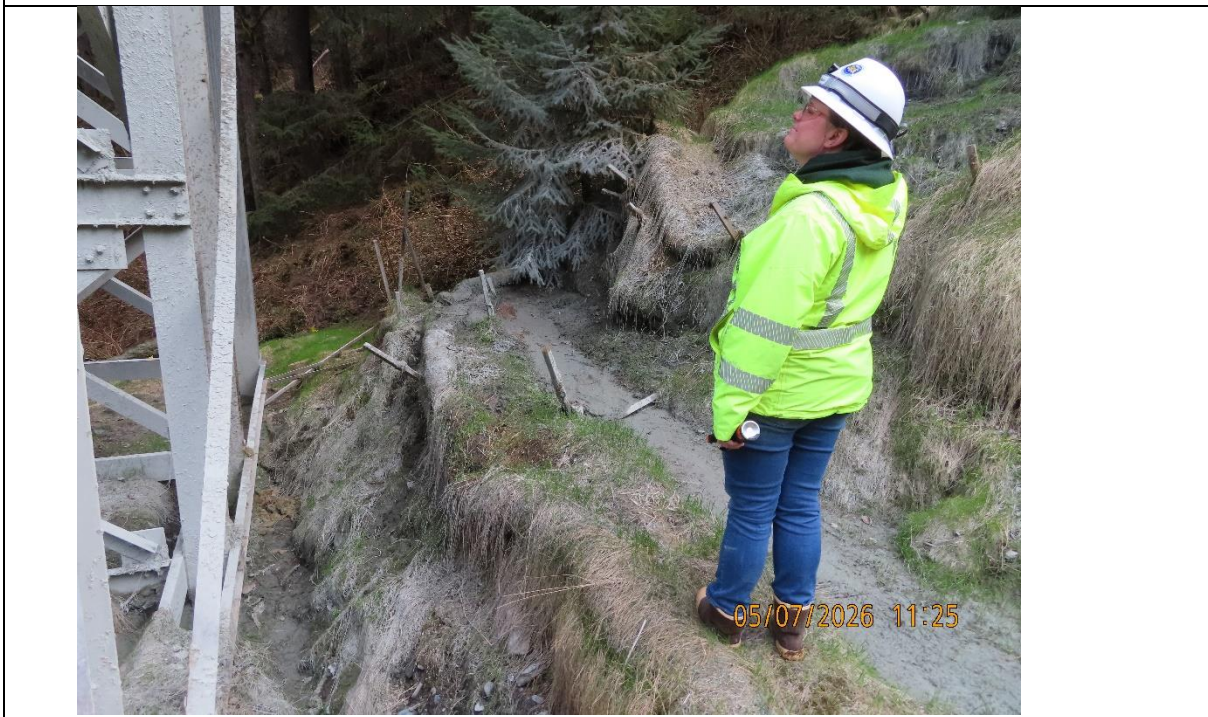
**Photo 22: 3.0 Mile B-Road Bridge (Zinc Creek) sediment leaking through from under decking.**

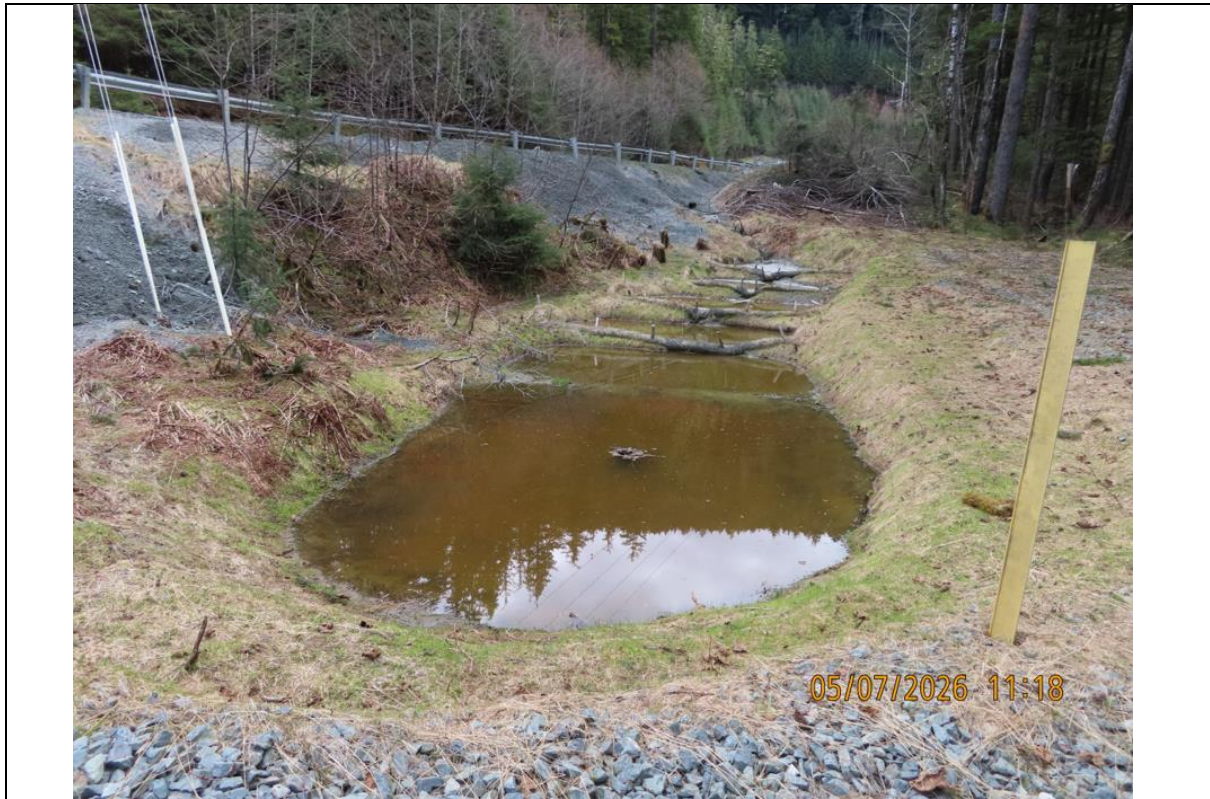
**Photo 23: Gnome Ponds**

Ponds functioning as intended and draining as designed utilizing flocculant logs to pull sediment out of the flow of water into the ponds (Photos 23 & 24).

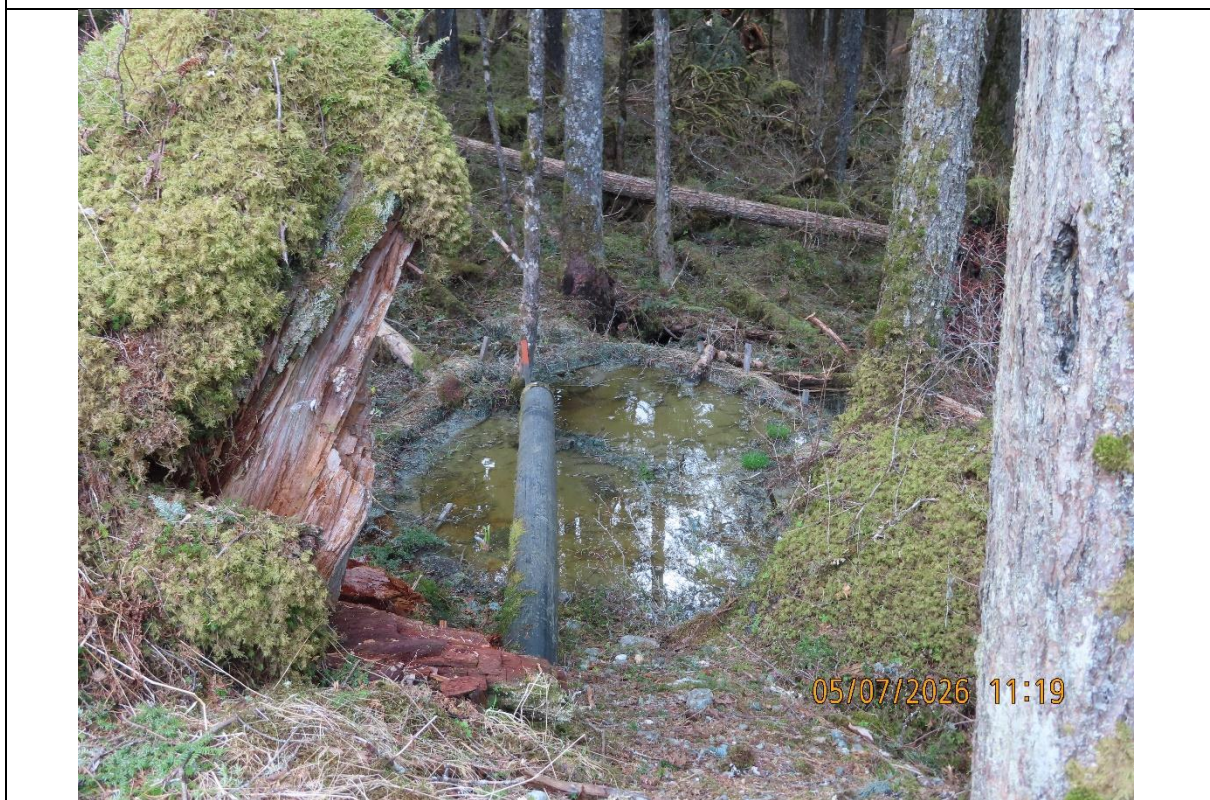
**Photo 24: Gnome Ponds outfall.**

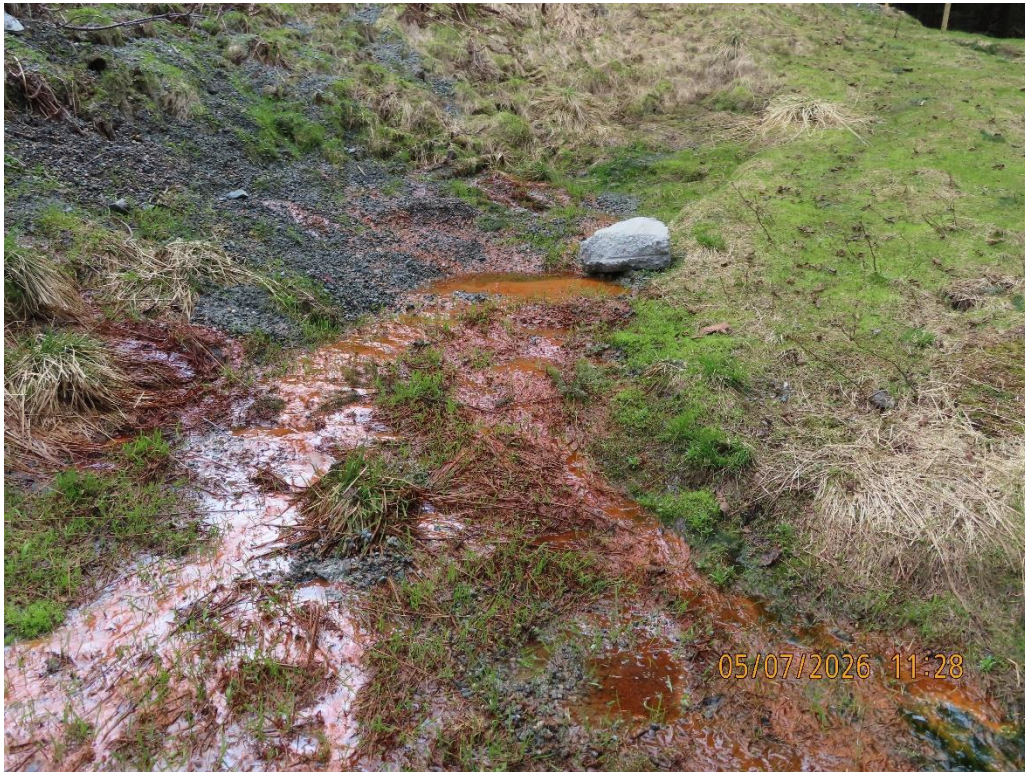
Note: Small iron-rich surface drainage or seep flowing downslope down from gnome pond. Gelatinous material at end of seep near Gnome Ponds (Photos 25 & 26).

**Photo 25: Small iron rich surface drainage or seep flowing downslope down from gnome pond.**

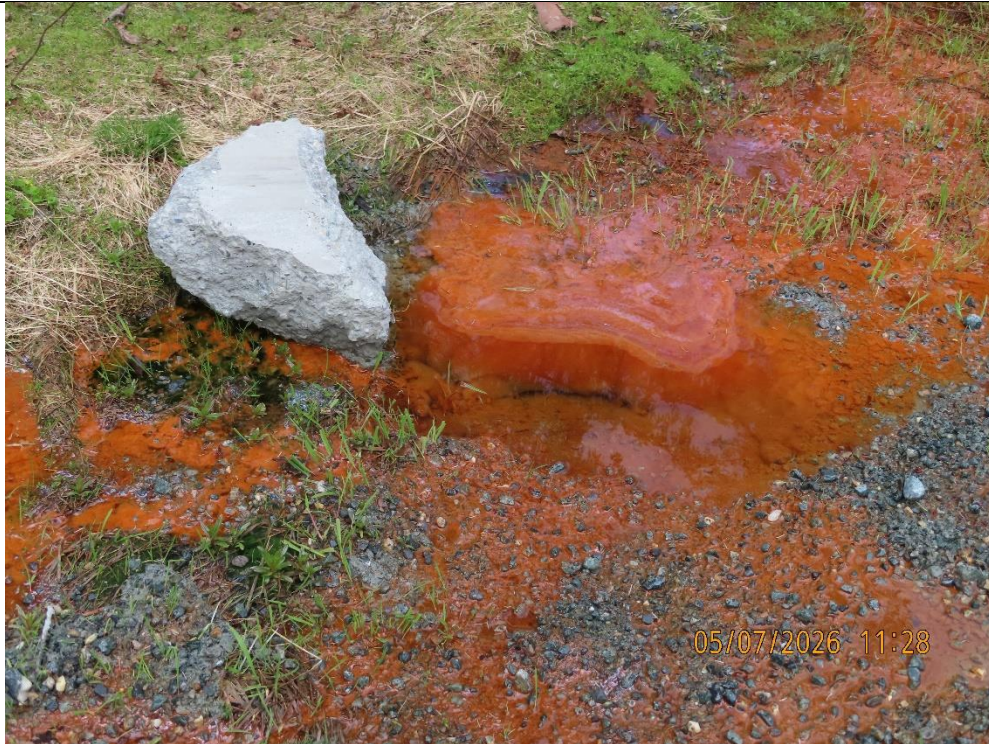
**Photo 26: Gelatinous material at end of seep near Gnome Ponds.**
