## INSPECTION REPORT: GREENS CREEK MINE

Date of Inspection: Thursday May 7, 2026  
Date of Report: June 30, 2026  
USDA Forest Service Inspector: Scott Leslie

Ranger District: Admiralty National Monument, Juneau Ranger District Weather Conditions: Partly sunny, light breeze.  
Temperature: mid to upper 40's (°F).

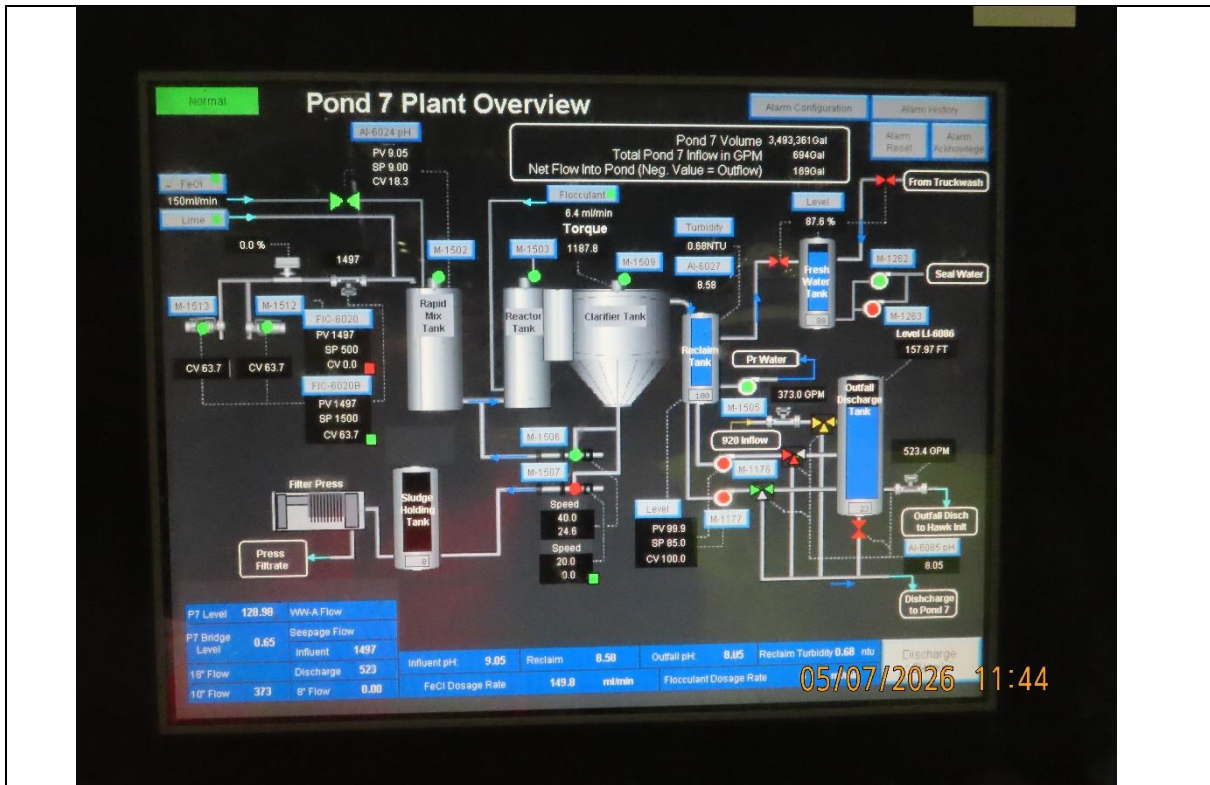
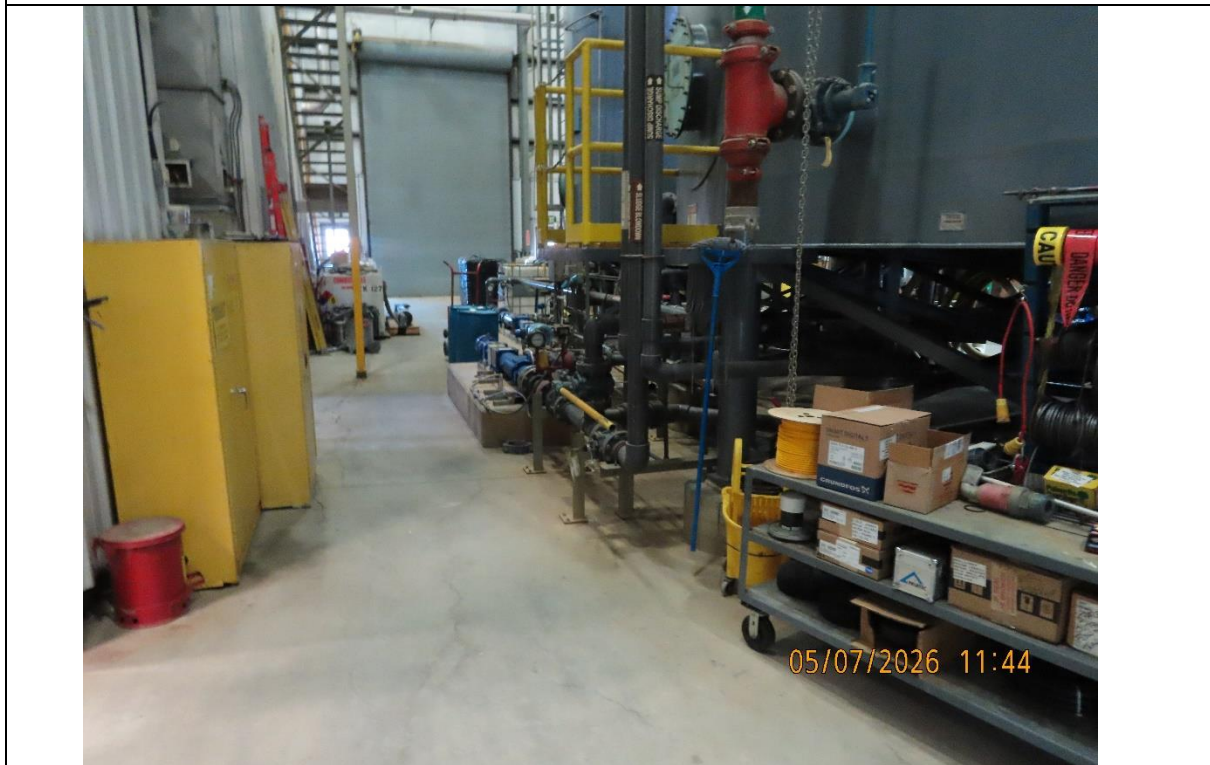
Good housekeeping practices were observed in the TDF water treatment plant (Appendix 5 BMP Plan, page 37). The water treatment plant was discharging approximately **520 gpm** to Outfall 002 with a pH of **8.06**, and turbidity of **.67** NTU (Photo 27 & 28).

Photo 27: TDF Water Treatment Plant readings

Photo 28: TDF Water Treatment Plant.

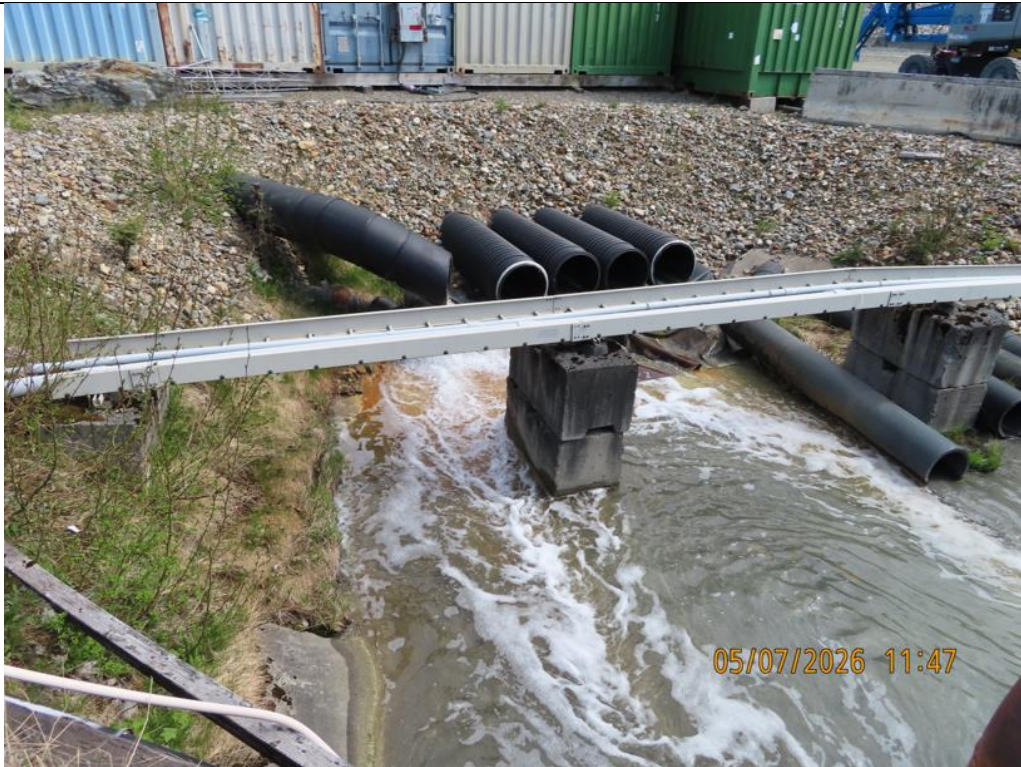
**Pond 7** and Spillway. No evidence of water overflow (Photos 29 & 30).

**Photo 29: Pond 7 receiving tailings and water from tailings pile and Pond 9.**

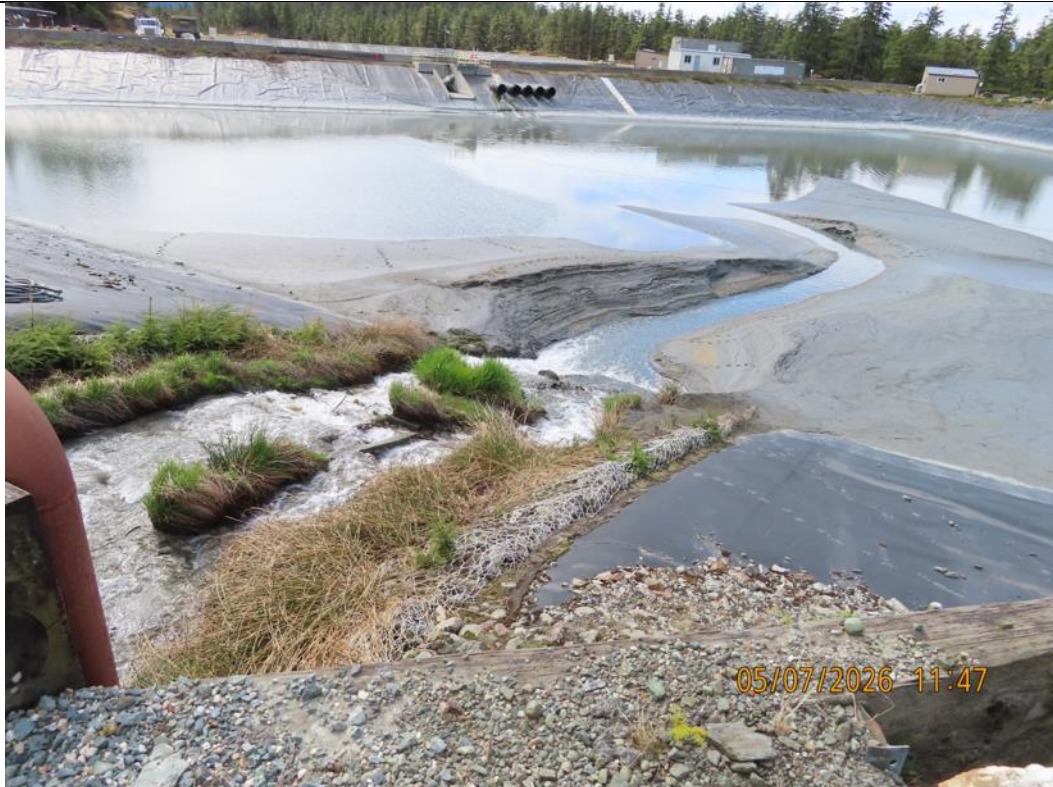
**Photo 30: Pond 7 tails to be dredged and pumped to bags in Pond 10.**

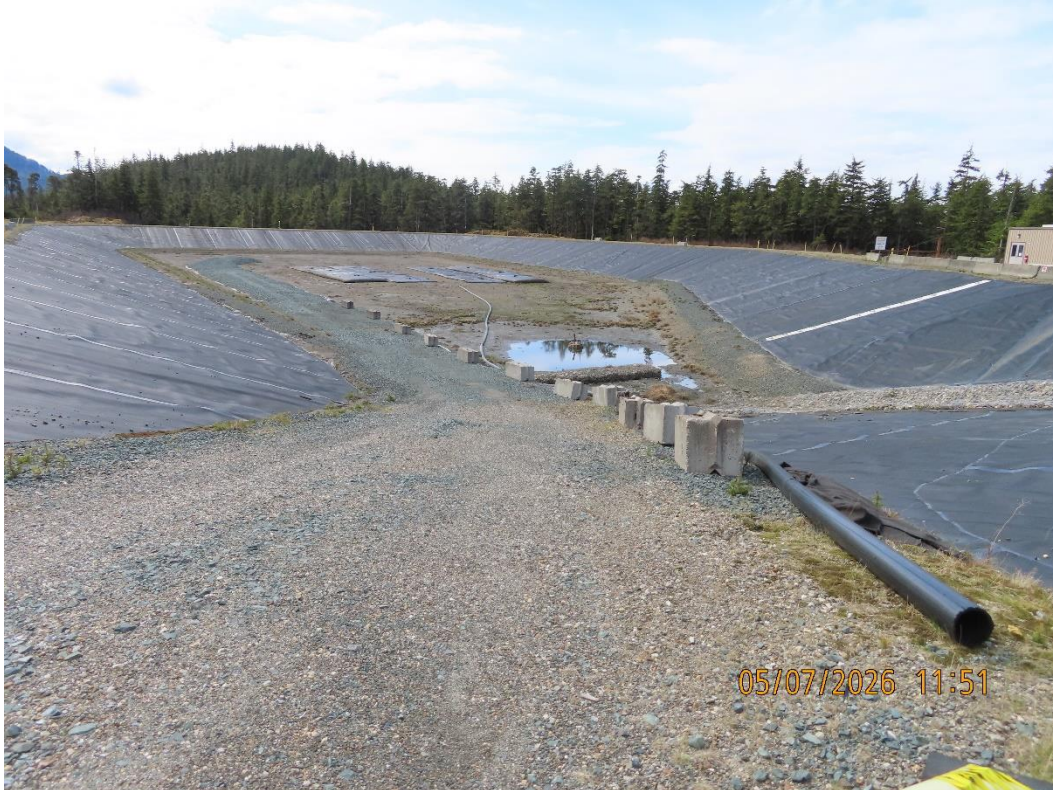
**Pond 10** Overview with tails bags in background and fill pipe in foreground. (Photo 31).

**Photo 31: Overview of Pond 10 with tails bags in background and fill pipe in foreground.**

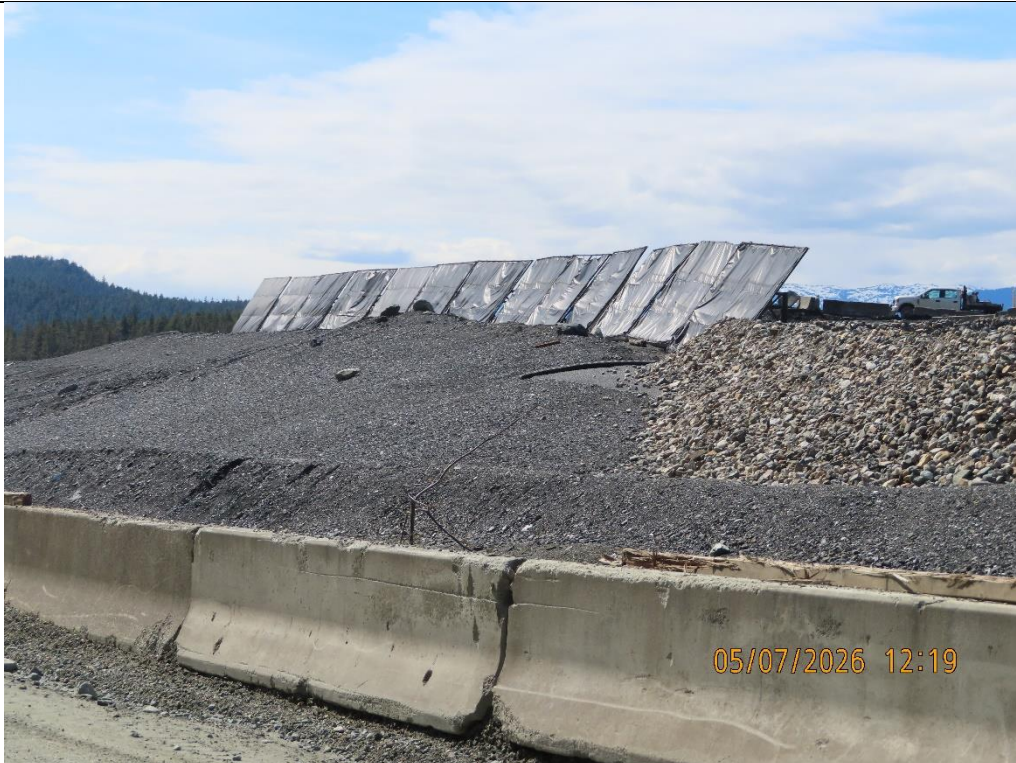
**Portable Fugitive Dust Mitigation** at the Tailings Facility (Photos 32).

**Photo 32: Portable Fugitive Dust Mitigation at the Tailings Disposal Facility.**

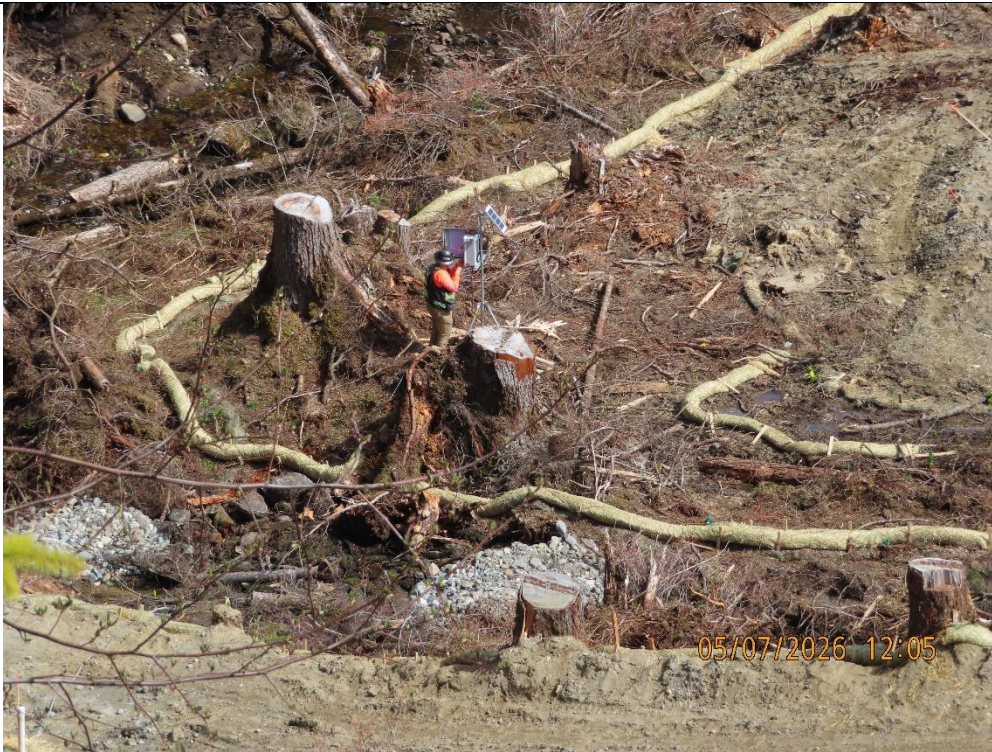
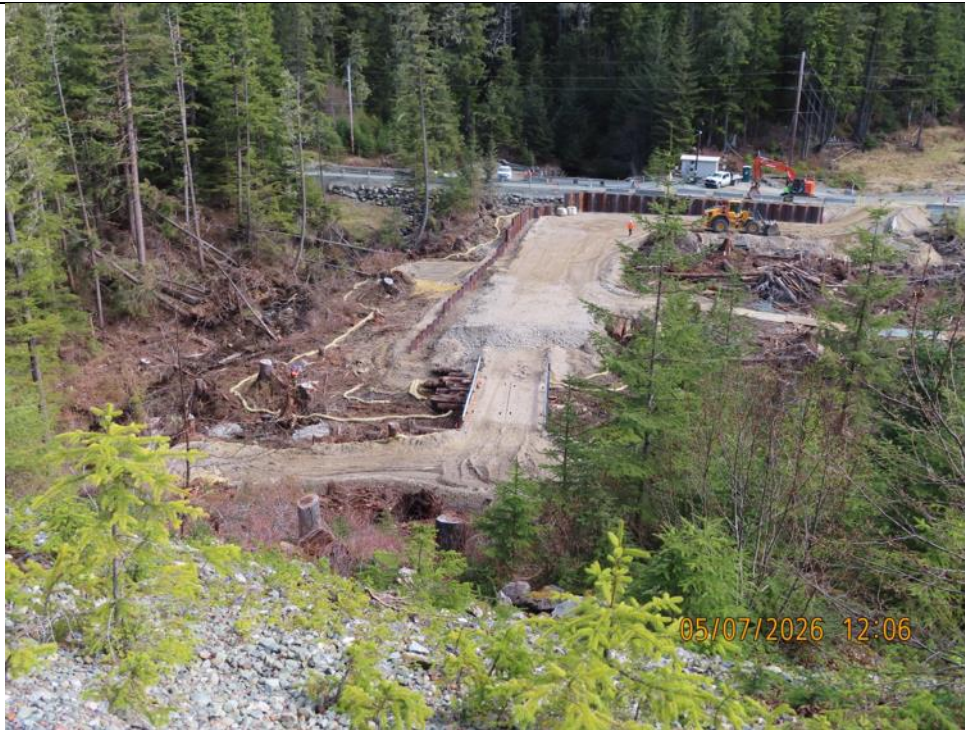
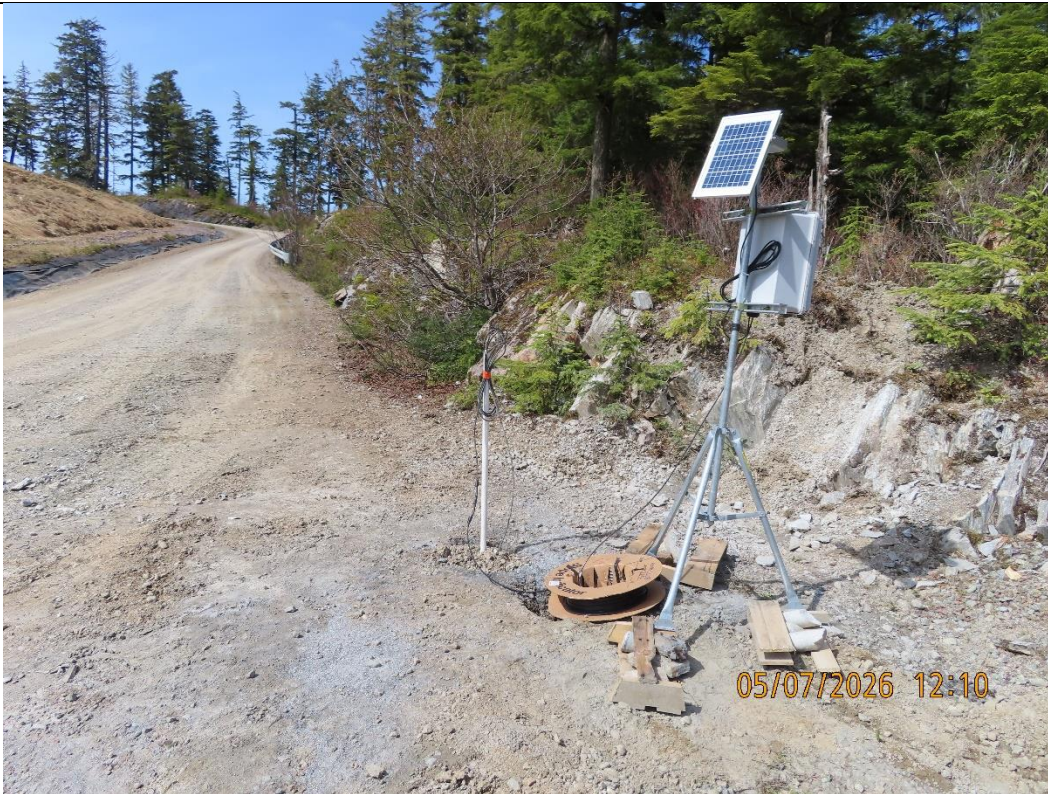
**North Expansion Project** prework area, overview, and Vibrating wire piezometer (VWP) VWP PZ-T\_26\_01A (Photos 33 - 35).

**Photo 33: North Expansion Project area.**

**Photo 34: North Expansion Project area looking back at B Road.**

**Photo 35: Vibrating wire piezometer (VWP) VWP PZ-T\_26\_01A at the North Expansion Project area.**
