## INSPECTION REPORT: GREENS CREEK MINE

Date of Inspection: June 25, 2026  
Date of Report: July 6, 2026  
USDA Forest Service Inspector: Scott Leslie

The site inspection included the A and B access roads, Freshwater Plant, DB-01, A Pond, 920 Area, C Ponds, Site 23, DB-03, 23 Pond and pump building, 7.4-mile B-Road Bridge (Killer Creek Bridge), Waste Site E, 3.4-mile B-Road bridge (Falls Creek Bridge), Gnome Ponds, 3.0-mile B-Road bridge (Zinc Creek Bridge), Tailings Disposal Facility (TDF), Pond 10, and Pond 7.

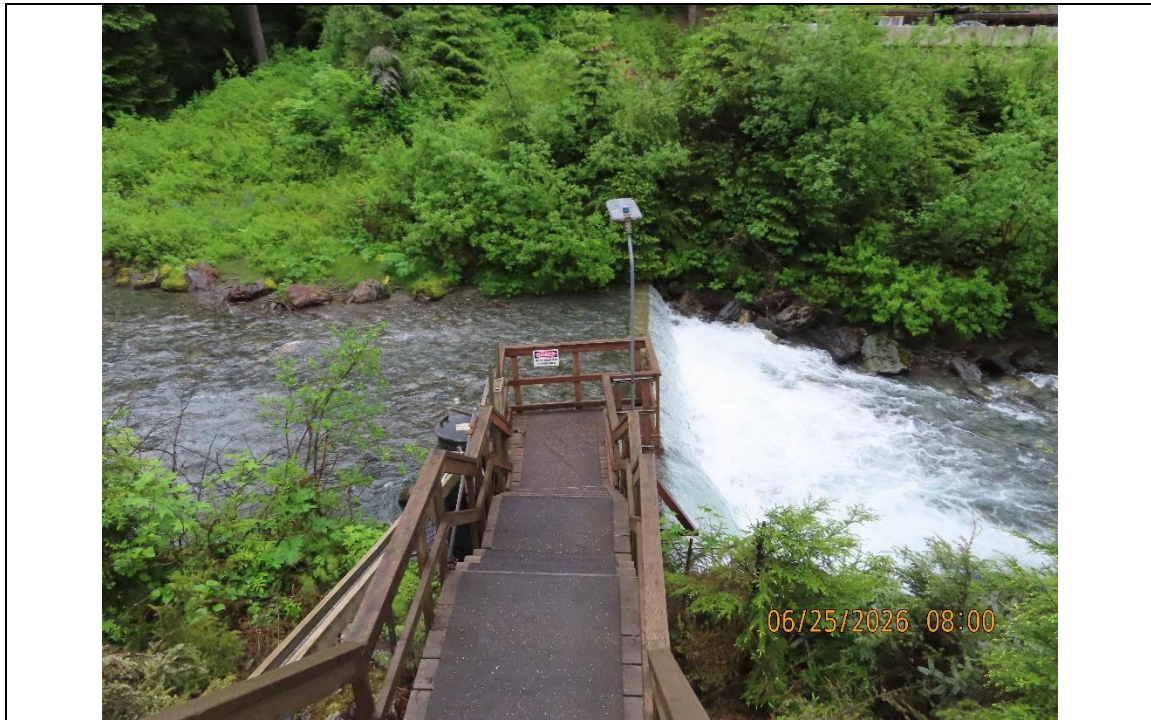
**Photo 1: Greens Creek Weir.**

**Greens Creek Weir** (Photo 1).

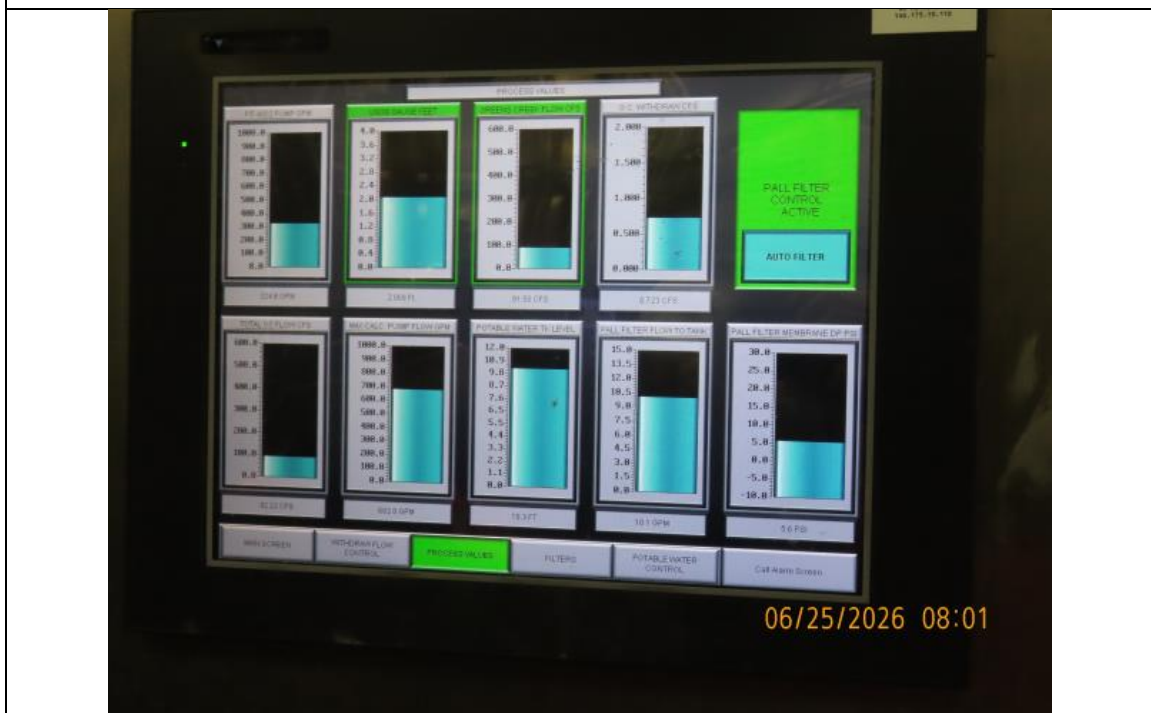
**Photo 2: Freshwater Plant readings.**

**Freshwater Plant**, Greens Creek weir discharge flow at 93 cfs and .75 cfs being withdrawn for the 920 facilities. Plant clean and orderly (Photo 2).

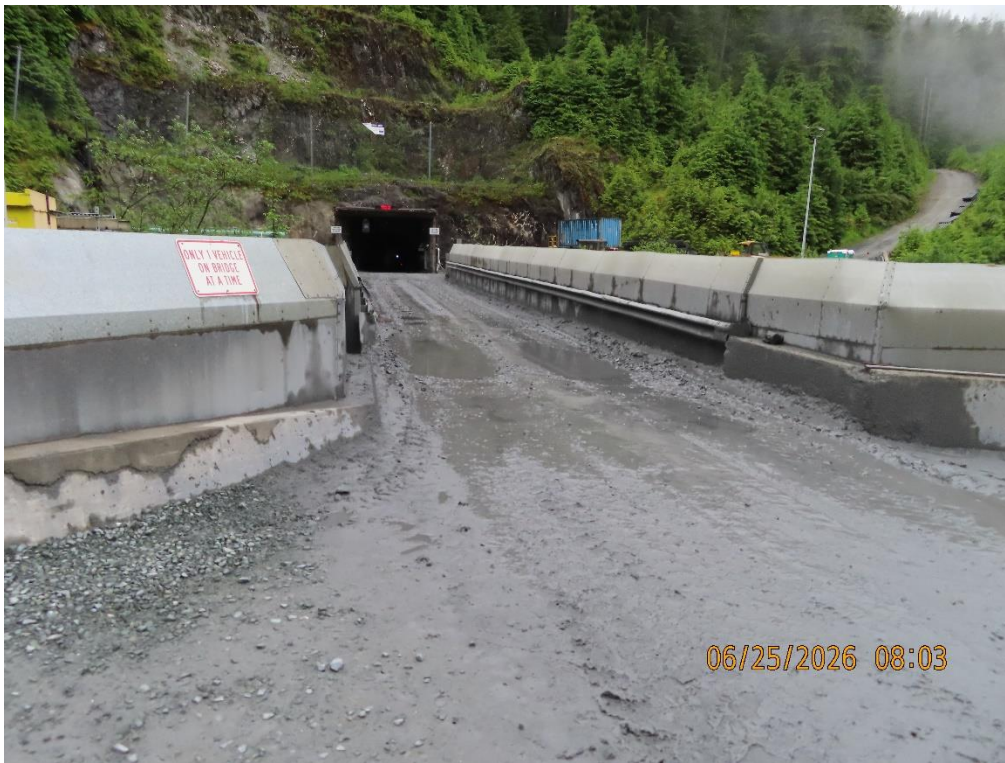
**Photo 3: 920 Bridge.**

**920 Bridge** in good condition. New abutments and concrete Belzona repairs to be completed this summer (Photo 3).

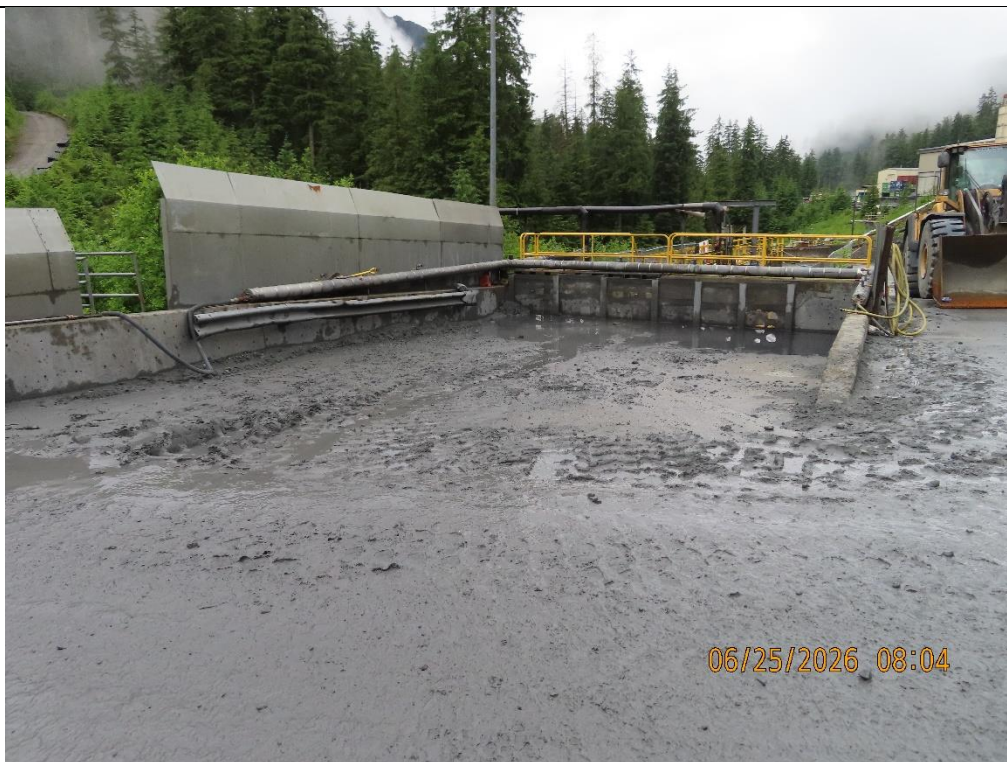
**Photo 4: Degrit Basin (DB-01).**

**Degrit Basin (DB-01)** Appears to be functioning as intended. (Photo 4 ).

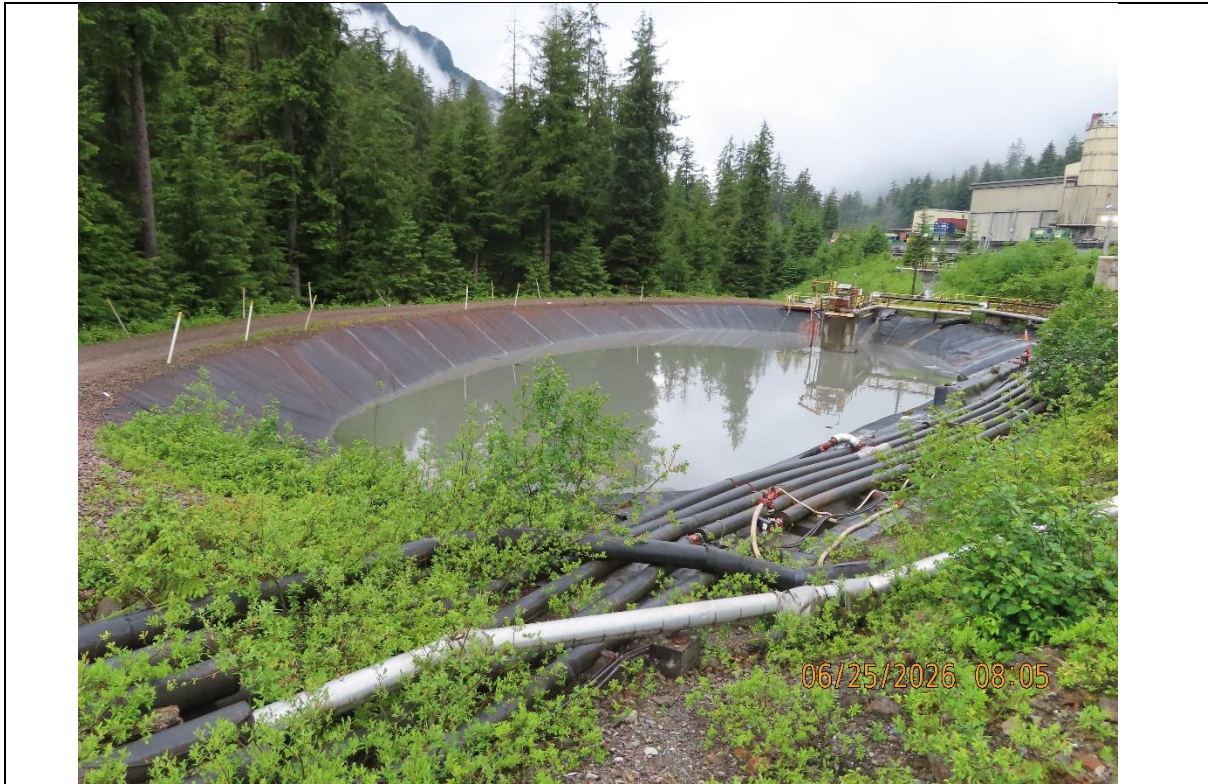
Photo 5: A Pond.

**Pond A** This pond collects 920 Area runoff and pumps it to Mill water treatment plant. Liner appears in order with no visible overflow (Photo 5).

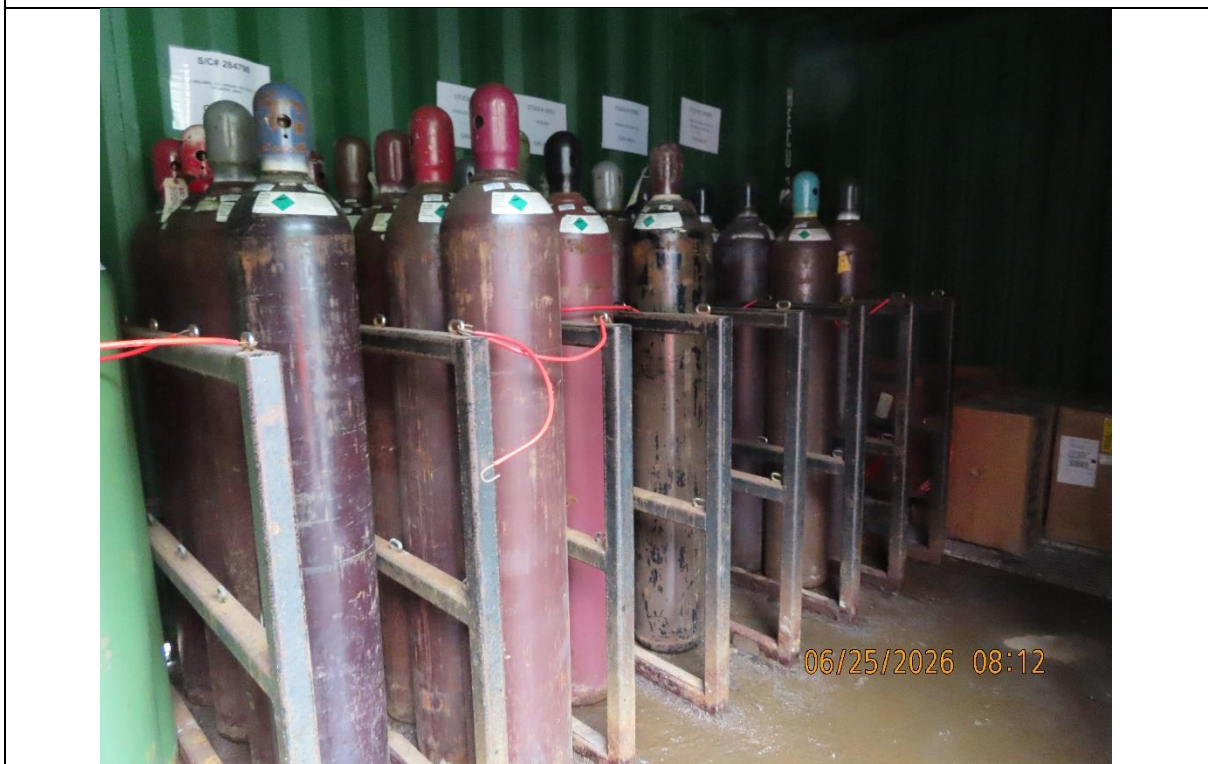
**920 Warehouse** Good housekeeping practices were observed at the storage containers with petrochemicals properly stored with secondary containment (Appendix 5 BMP Plan, page 37) (Photos 6 & 7).

Photo 6: 920 warehouse storage container.

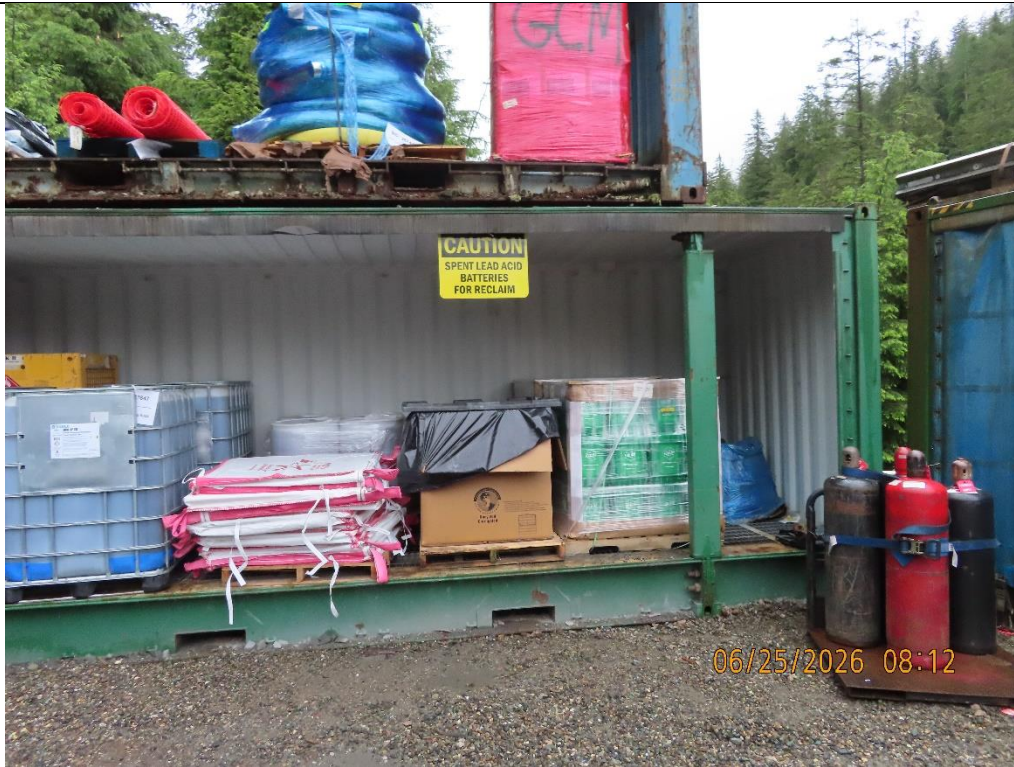
Photo 7: 920 warehouse area.

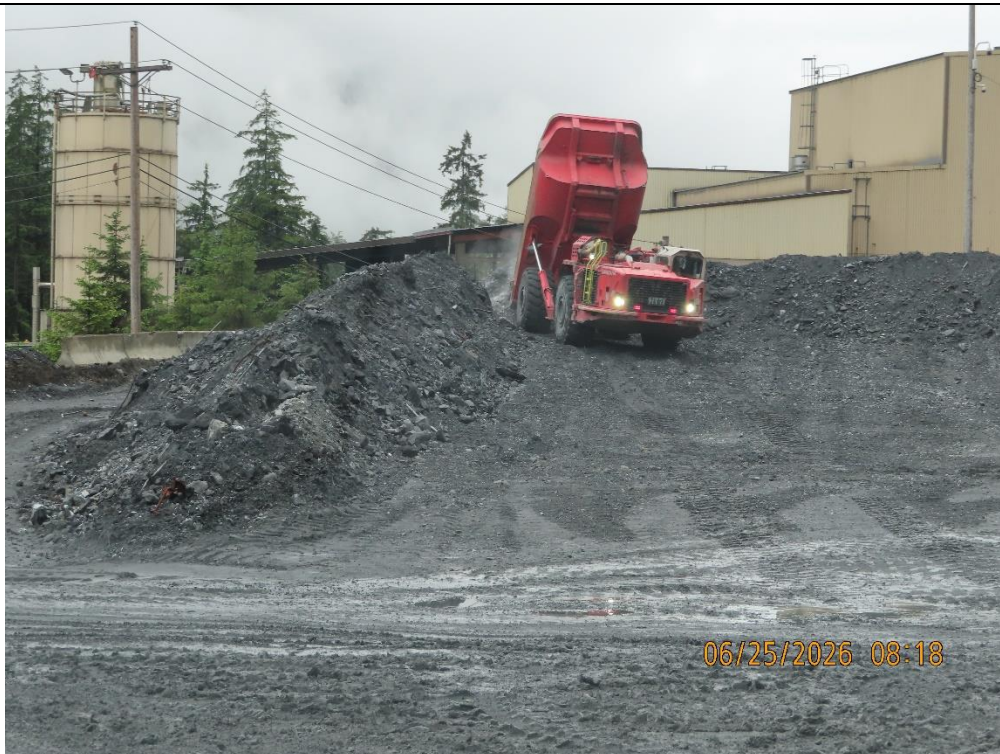
Photo 8: Ore pad.

**Ore Pad** in use staging ore from 920 adit actively being contoured to transport ore to mill (Photo 8).

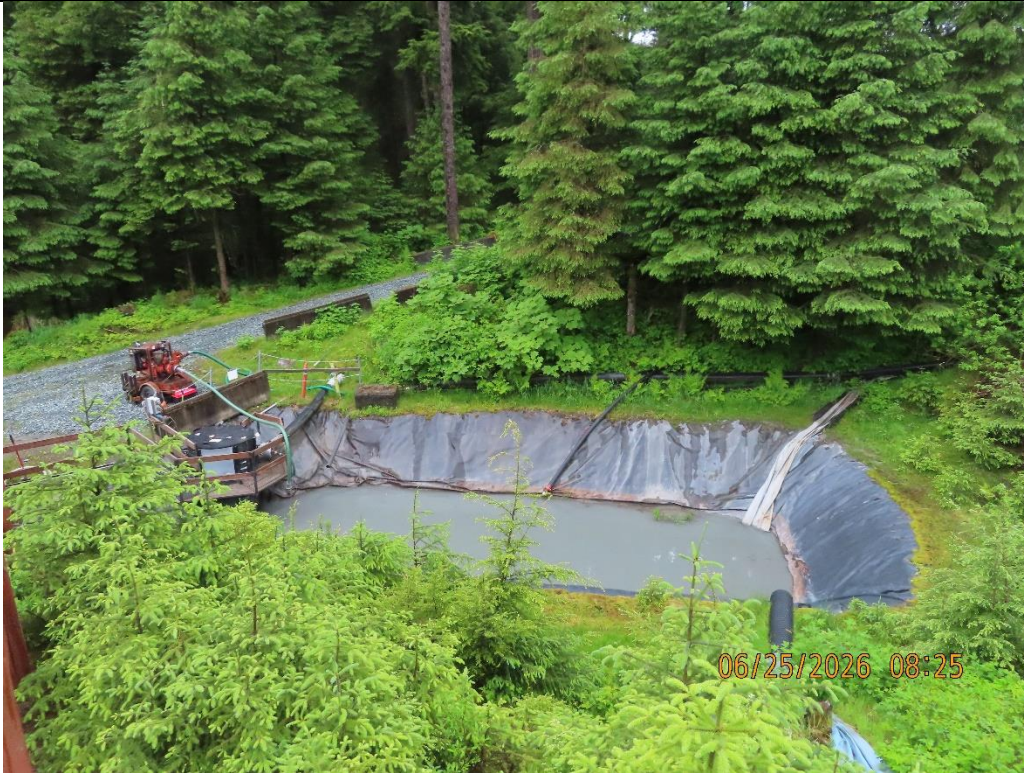
Photo 9: Lower C Pond.

The upper and lower pond liners are intact and with no visible signs of overflow (Photos 9 & 10).

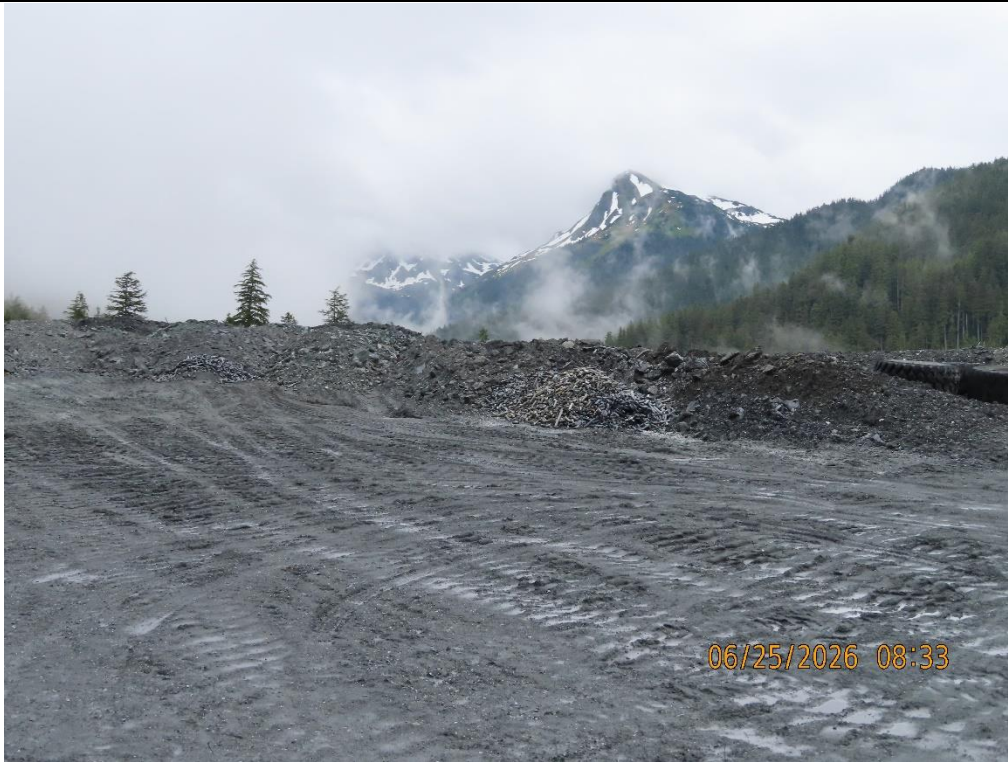
HGCMC continues to stage Class 1, 2, and 3 waste rock at this location. Class 4 waste rock is kept and disposed of underground (Appendix 11 Waste Rock Management Plan, page 11). Class 1 rock (argillite) is used as an inert capping material over top of Class 2 and 3. (Photos 11 & 12).

**Photo 11: Site 23 Class 2 & 3 Material on top of storage area.**

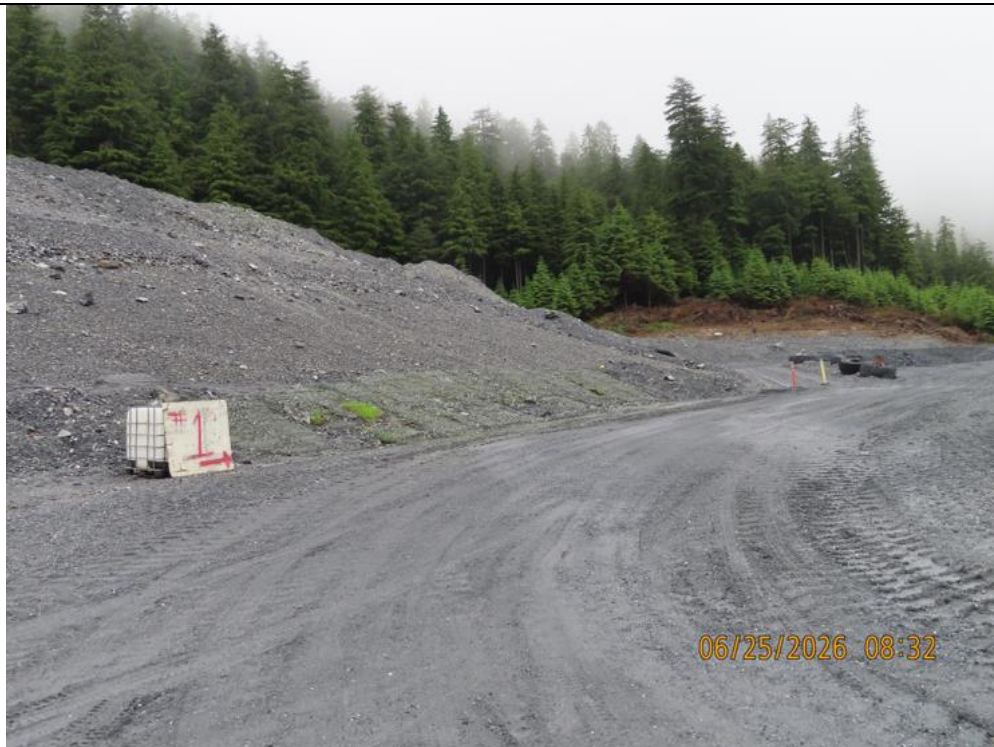
**Photo 12: Site 23 Class 1 Material at base of storage area.**

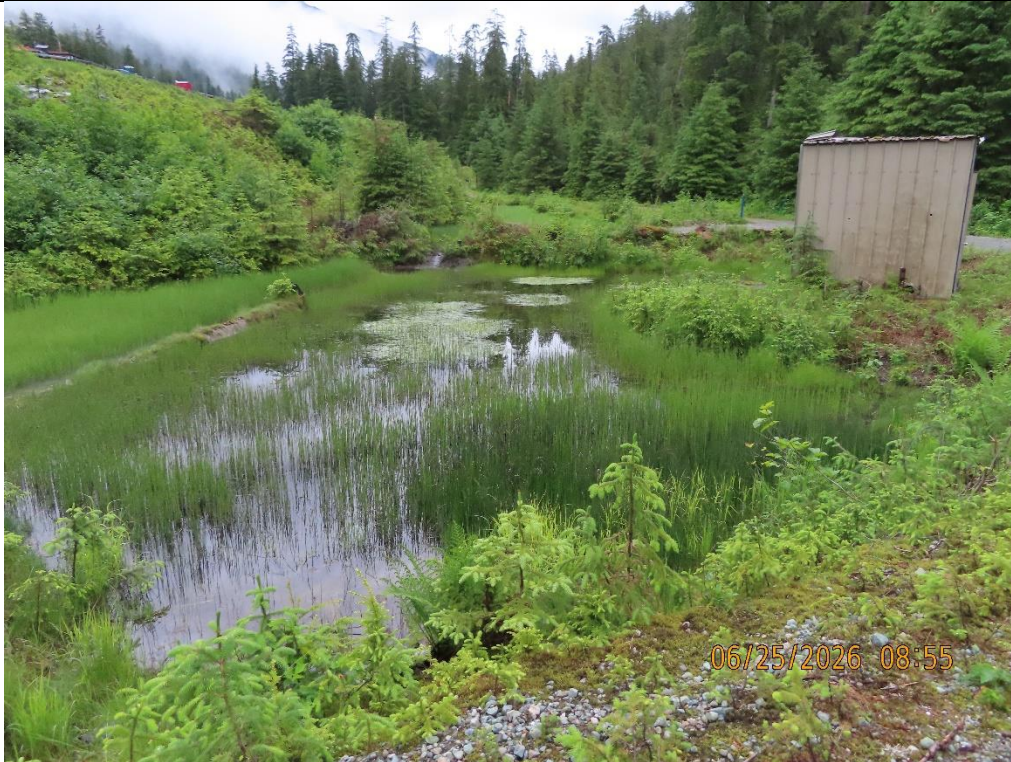
**Photo 13: D Pond.**

Intact and no visible signs of overflow (Photos 13 & 14).

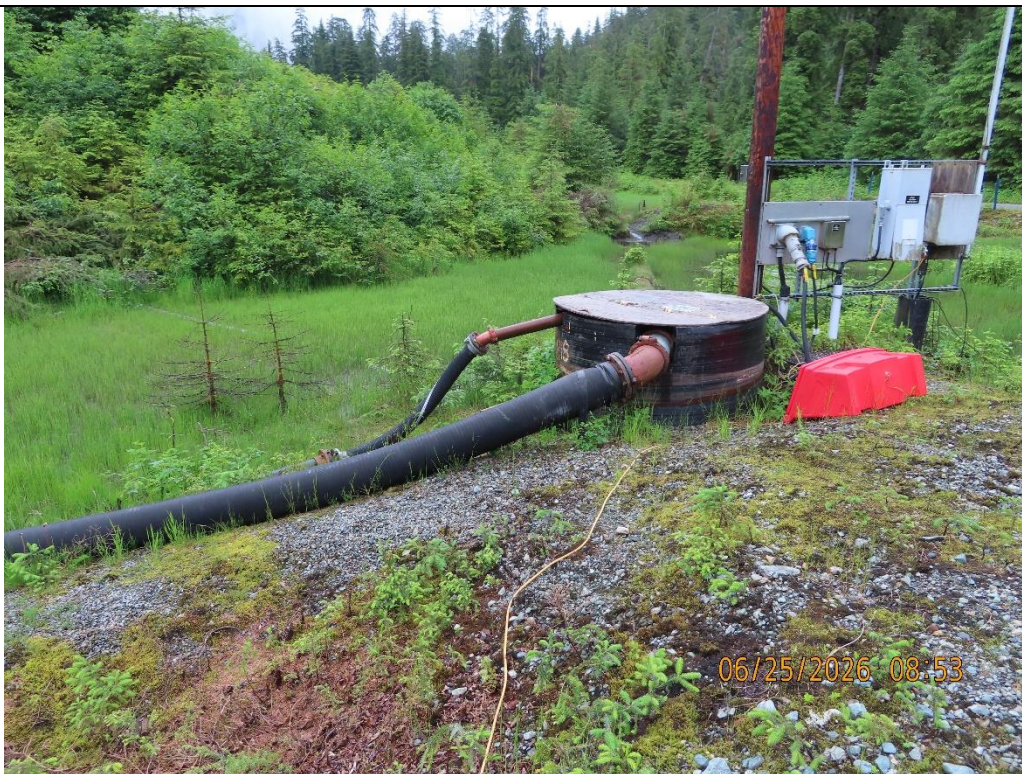
**Photo 14: D Pond pump that moves water to Pond 7.**

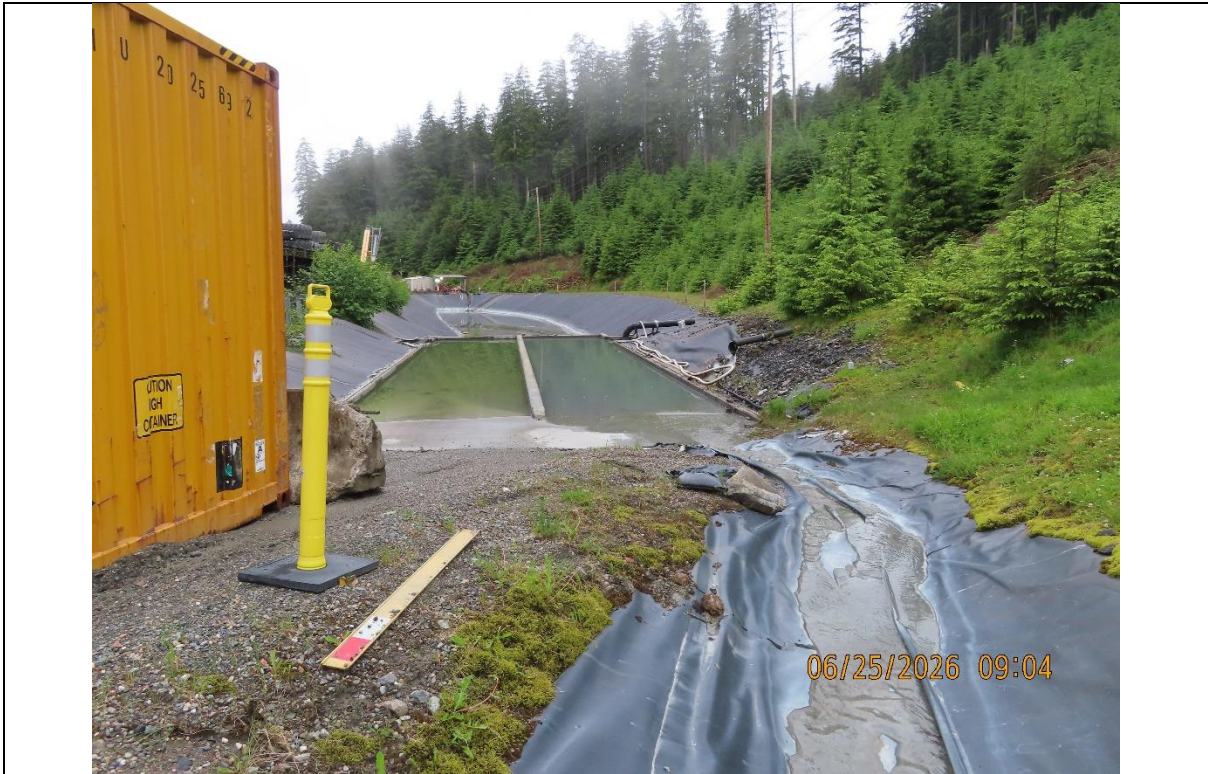
**Degrit Basin BD-03** Runoff entering basin as designed and appears to be functioning as intended. The 23 Pond can be seen in the background (Photo 15).

Photo 15: DB-03 and 23 Pond and Pump in background.

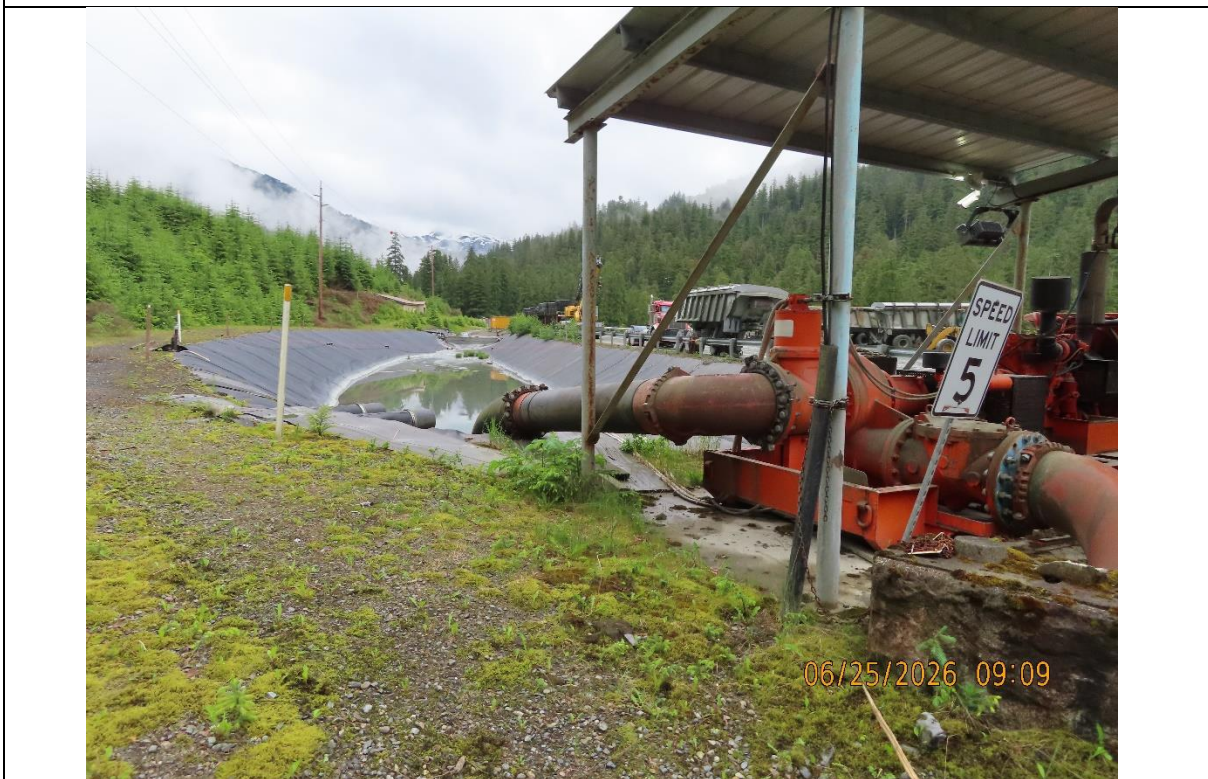
Photo 16: 23 Pond and Pump.

The pump area was clean and orderly. Appeared to be operable with no visible signs of pond overflow or liner damage (Photos 16).

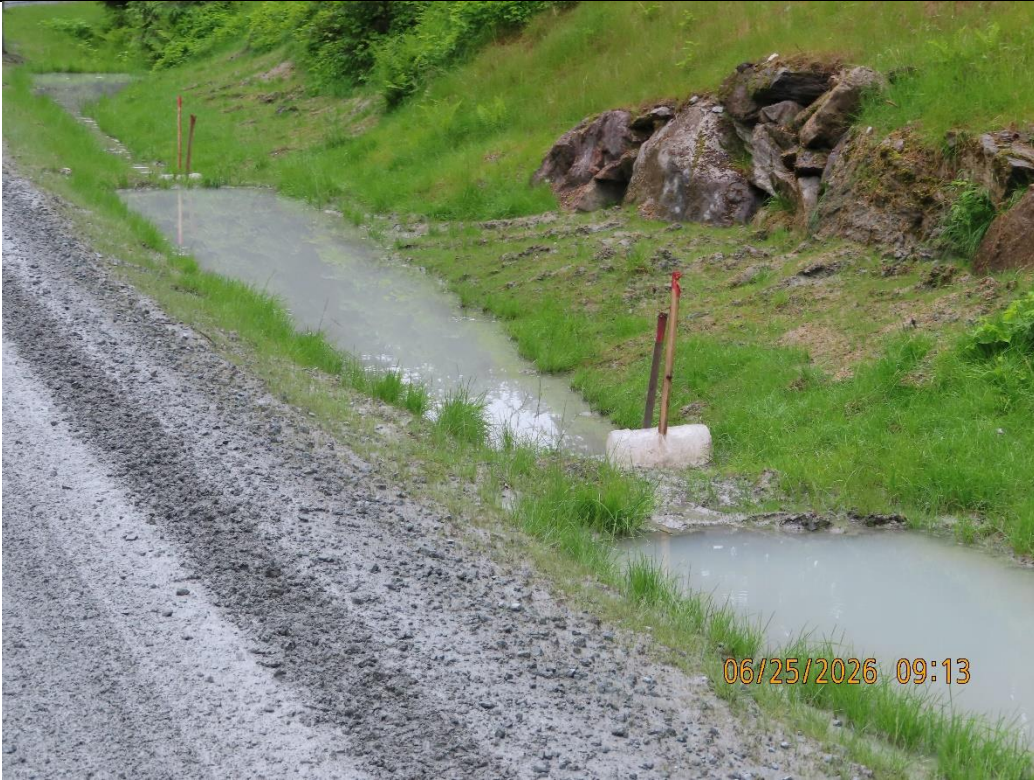
Ditches in area have been mucked out with new flocculate logs installed for sediment control. The bridge surface appeared in good condition, but sediment is still leaking out below the bridge and captured in waddles (Photos 17 - 20).

**Photo 17: Flocculant log in ditch near 7.4 Mile Bridge.**

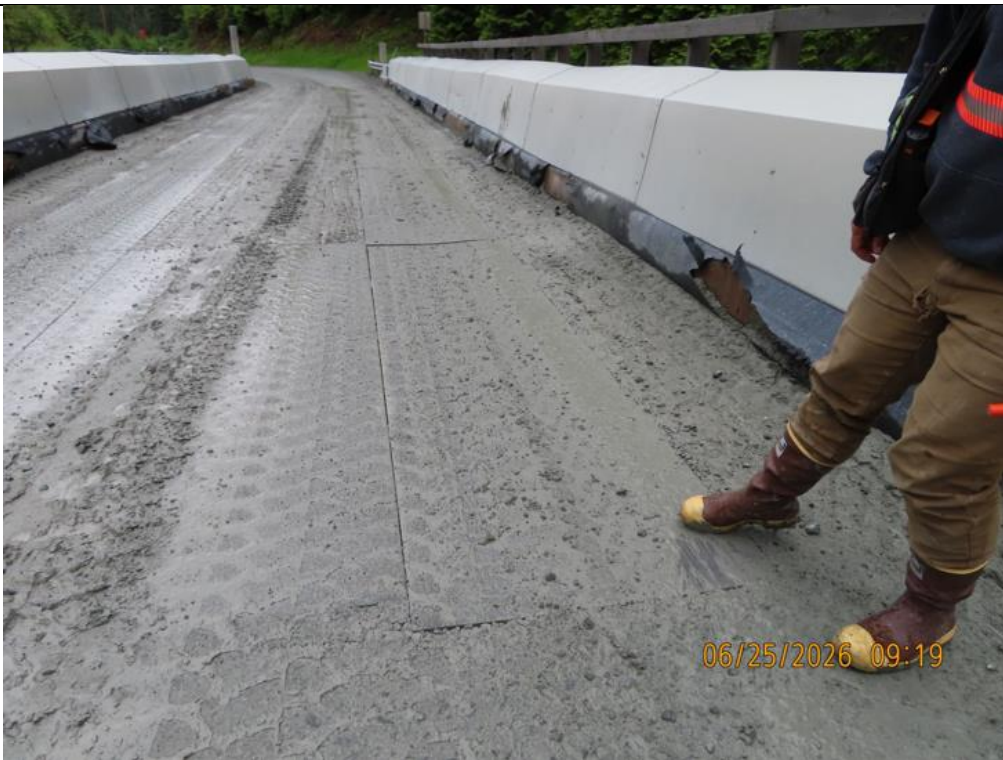
**Photo 18: 7.4 Mile Bridge.**

| Date/Item No. | Item Description | Status |
|---|---|---|
| 07/24/2025 – 446-1 | 7.4, 3.4, and 3.0-MILE B-ROAD BRIDGES:<br>Sediment draining in several places from beneath bridge to creek and area around abutments.<br>Bridge deck liner appears to be failing. | HGCMC looking at scheduling bridge resurfacing in July. 3.0- Mile B- Road bridge was completed in April. |

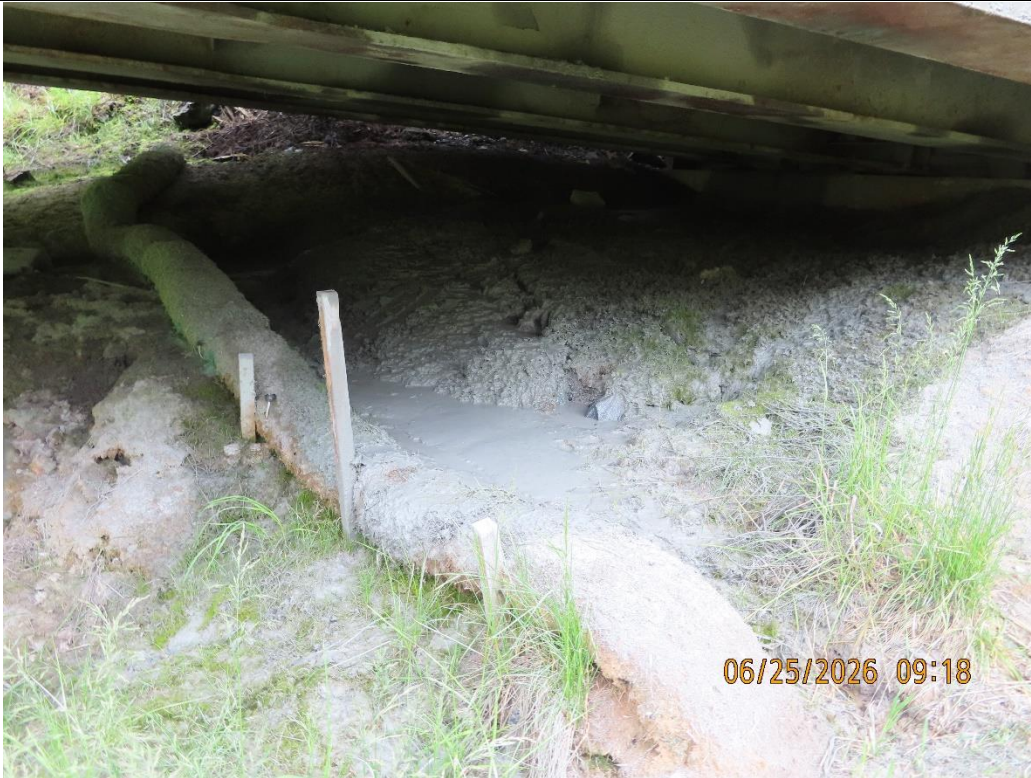
**Photo 19: 7.4 Mile Bridge (Killer Creek) waddles and hydroseed present collecting sediment.**

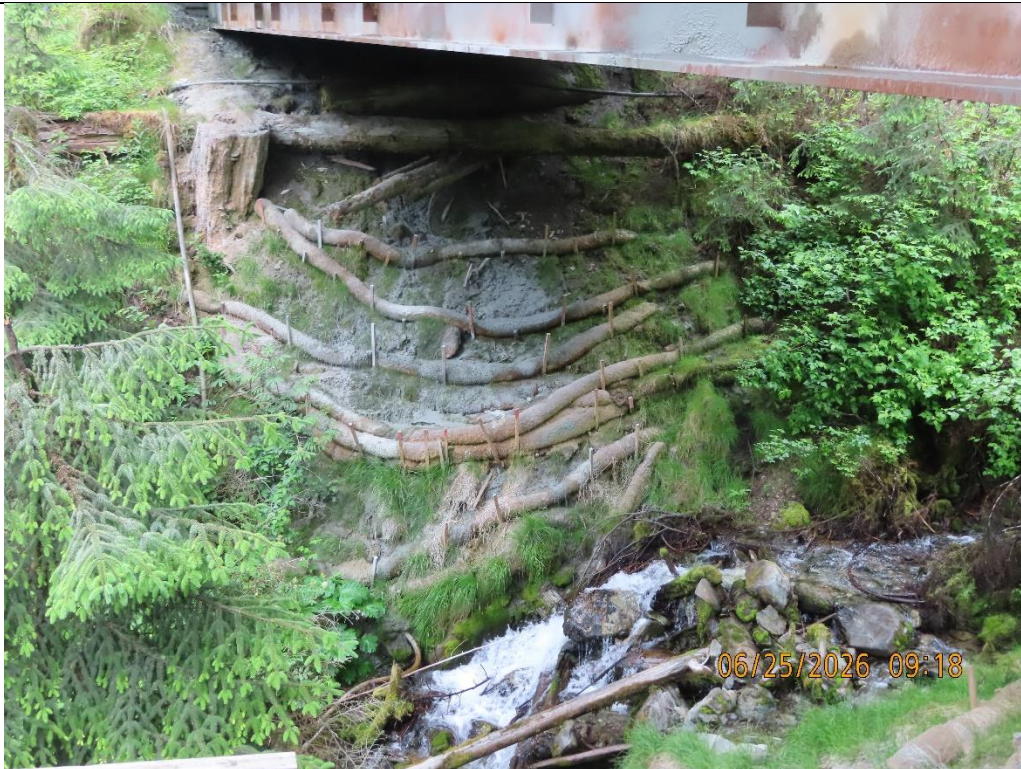
**Photo 20: 7.4 Mile Bridge (Killer Creek) waddles collecting sediment (far side of creek).**

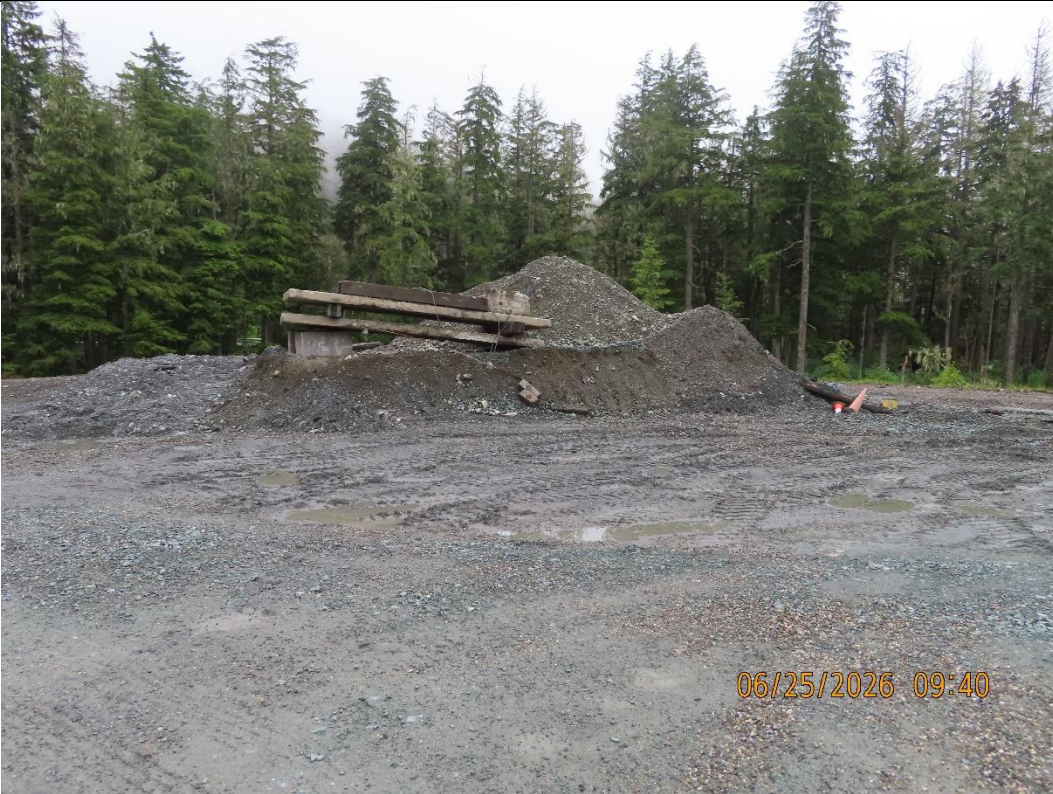
This is an old, early unclassified waste rock site. Material is being stored here to be moved to Tailings Disposal Facility (TDF). Much of the material has been moved to the TDF already. Approximately 20,000 tons left on site to transfer to TDF. The site is now mostly used for road maintenance gravel and equipment storage. E Pond liner intact with no signs of overflow (Photos 21 & 22).

**Photo 21: Waste Site E. Much of the material has been moved to the TTF.**

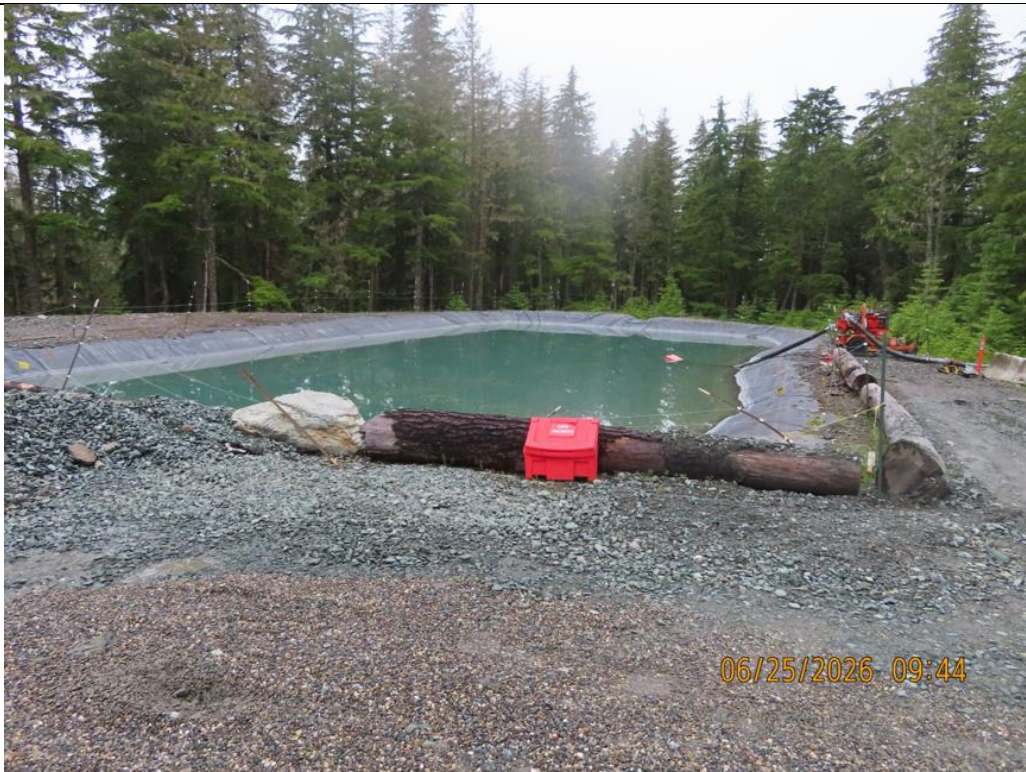
**Photo 22: E Pond and pump**

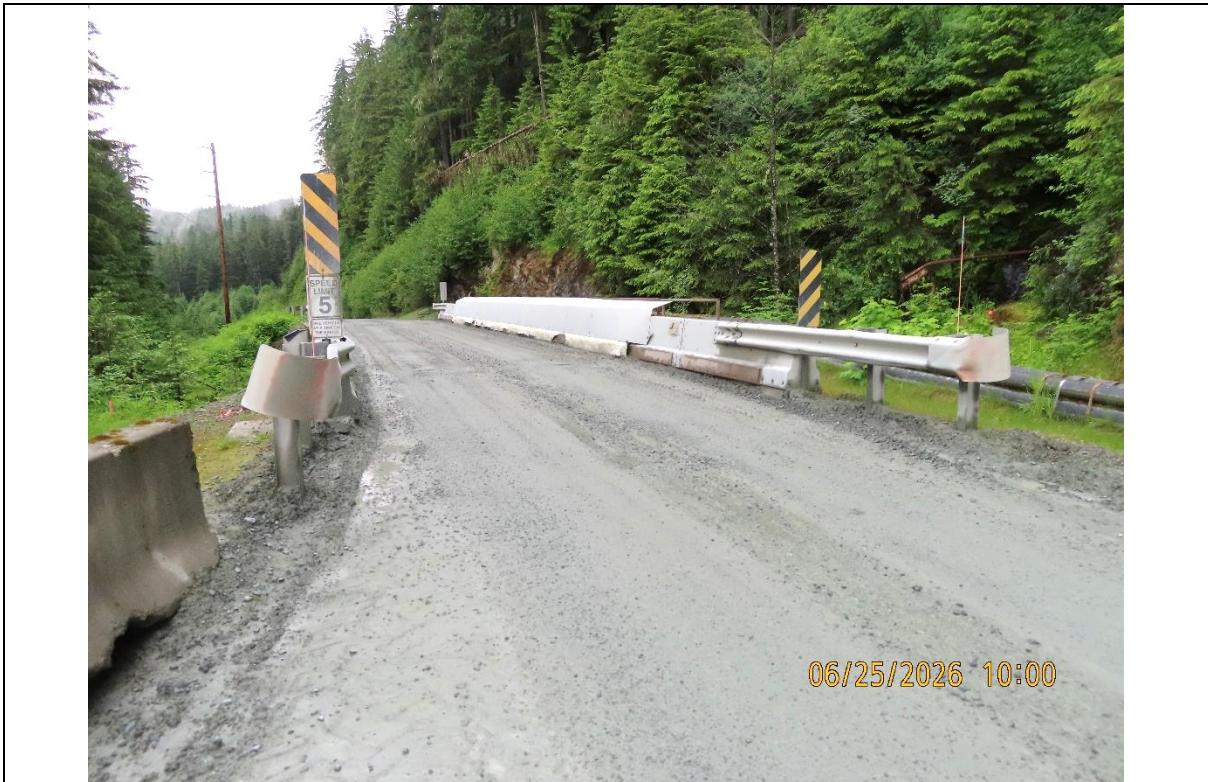
Photo 23: 3.4 Mile B-Road Bridge (Falls Creek).

The bridge surface appeared to be in good condition, but sediment leaks through and collecting beneath the bridge. New, self-healing liner and decking planned for this summer (Photos 23 & 24).

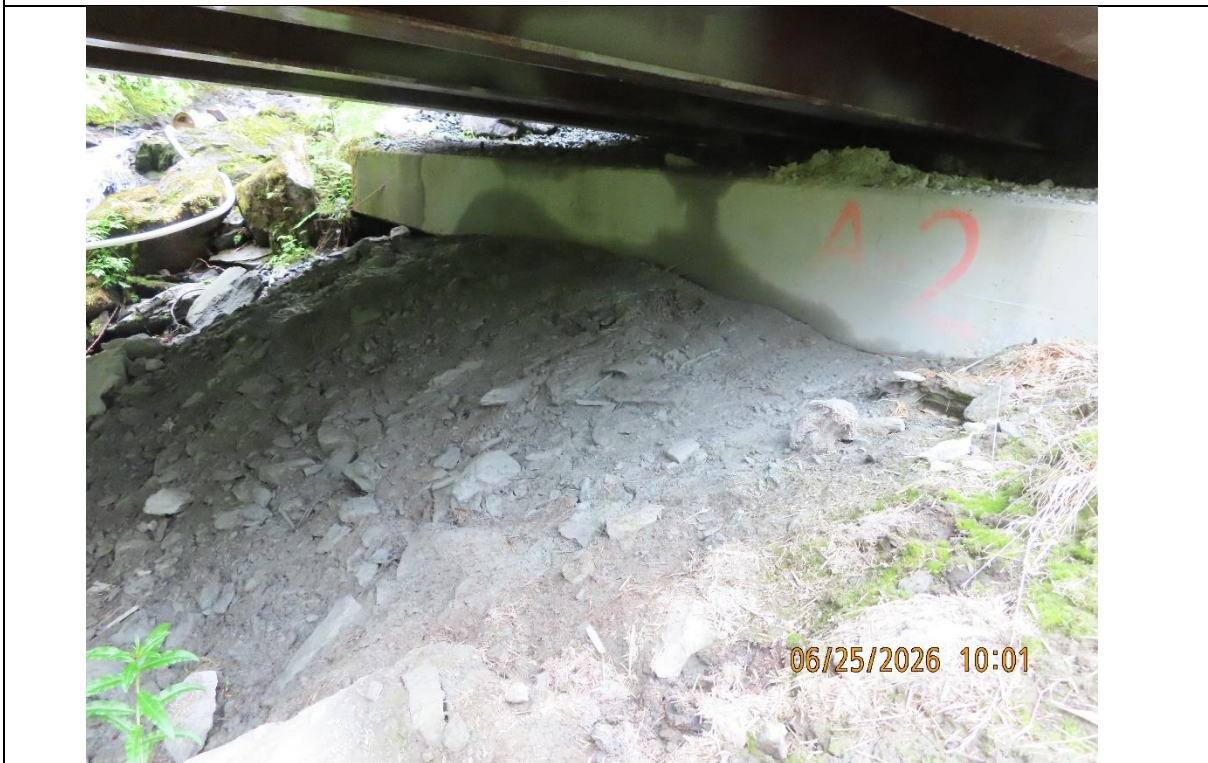
Photo 24: 3.4 Mile B-Road Bridge (Falls Creek) sediment leaking through from under decking.

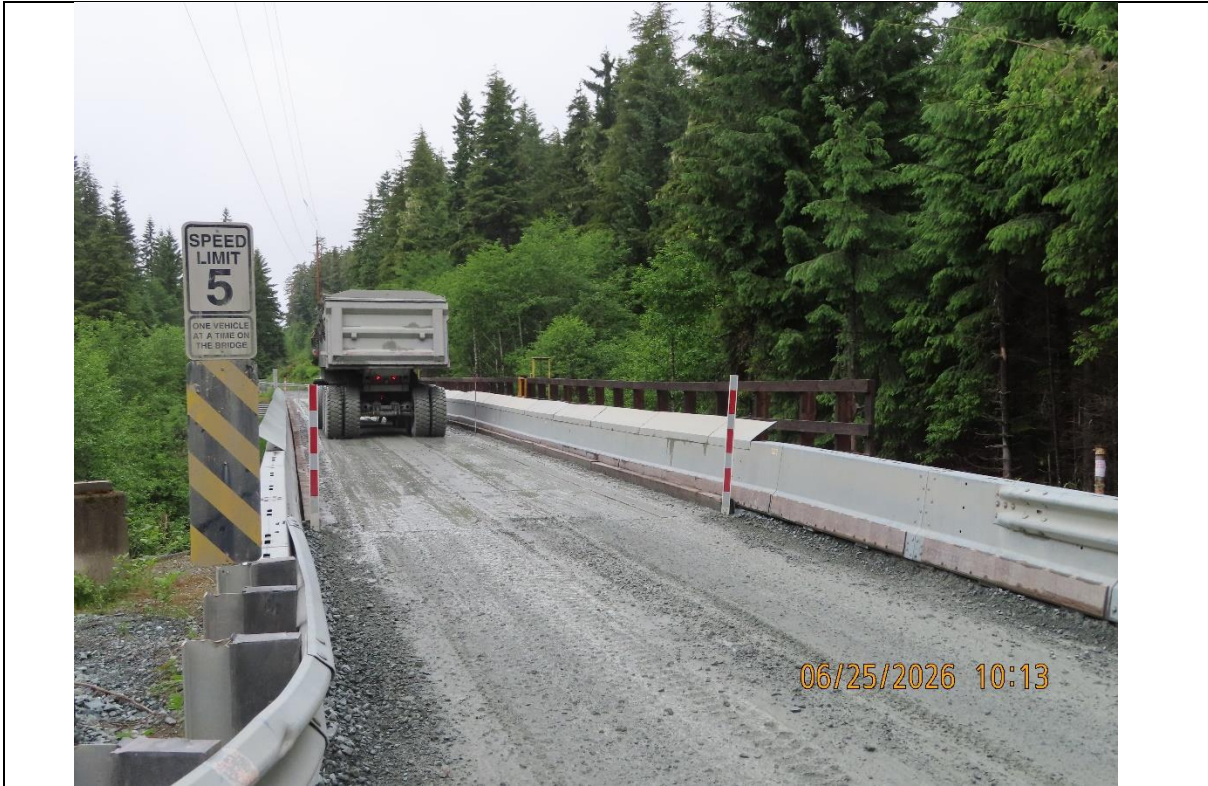
**Photo 25: 3.0 Mile B-Road Bridge (Zinc Creek).**

Bridge was redecked with new liner in April. No new sediment observed below bridge. Waddles in place with sediment collected prior to redecking. HGCMC should clean out the collected sediment. (Photos 25 & 26).

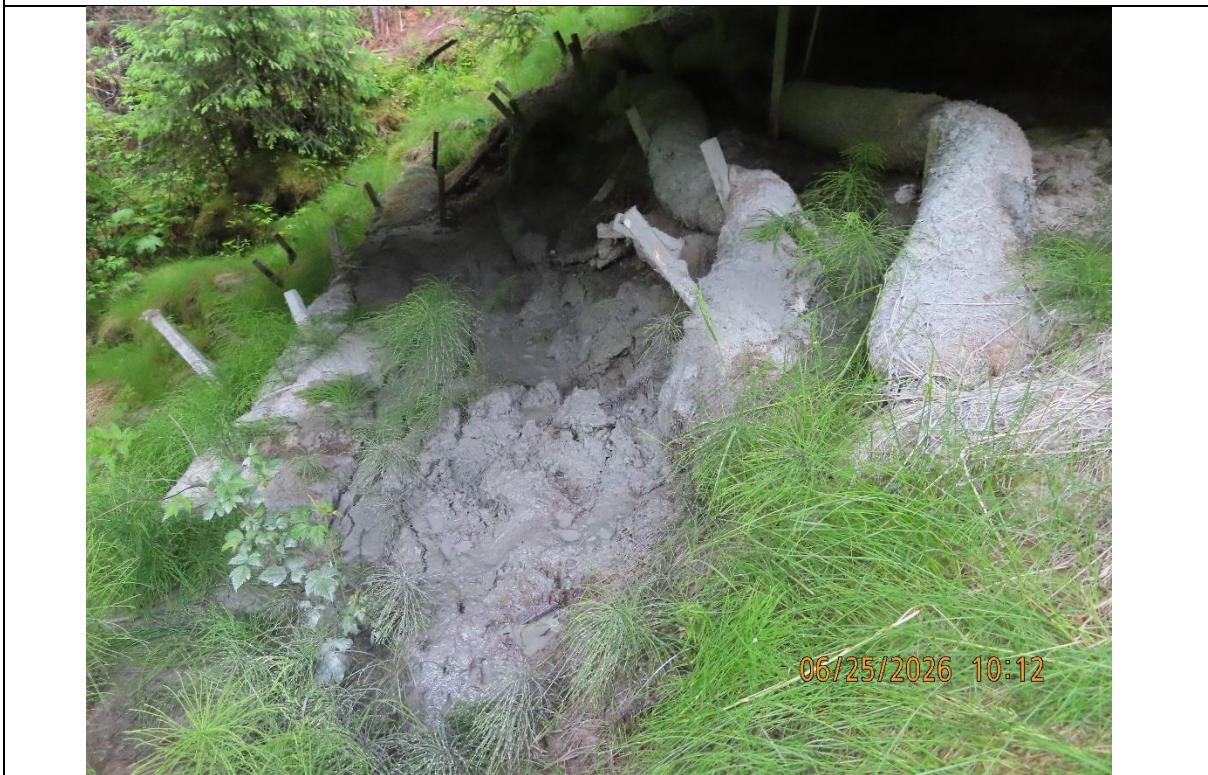
**Photo 26: 3.0 Mile B-Road Bridge (Zinc Creek) sediment collected before decking replacement.**

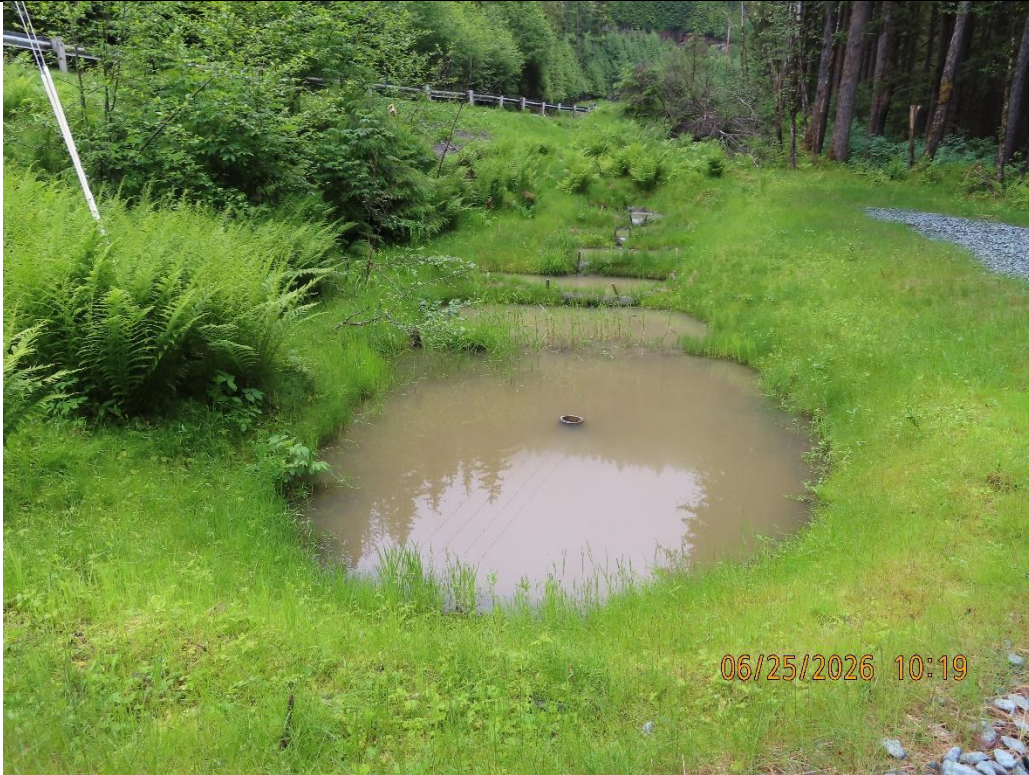
**Photo 27: Gnome Ponds**

Ponds working as intended and draining as designed utilizing flocculant logs to pull sediment out of the flow of water into the ponds. Outfall looks clean and functioning properly (Photos 27 & 28).
