## INSPECTION REPORT: GREENS CREEK MINE

Date of Inspection: June 25, 2026  
Date of Report: July 6, 2026  
USDA Forest Service Inspector: Scott Leslie

The site inspection included the A and B access roads, Freshwater Plant, DB-01, A Pond, 920 Area, C Ponds, Site 23, DB-03, 23 Pond and pump building, 7.4-mile B-Road Bridge (Killer Creek Bridge), Waste Site E, 3.4-mile B-Road bridge (Falls Creek Bridge), Gnome Ponds, 3.0-mile B-Road bridge (Zinc Creek Bridge), Tailings Disposal Facility (TDF), Pond 10, and Pond 7.

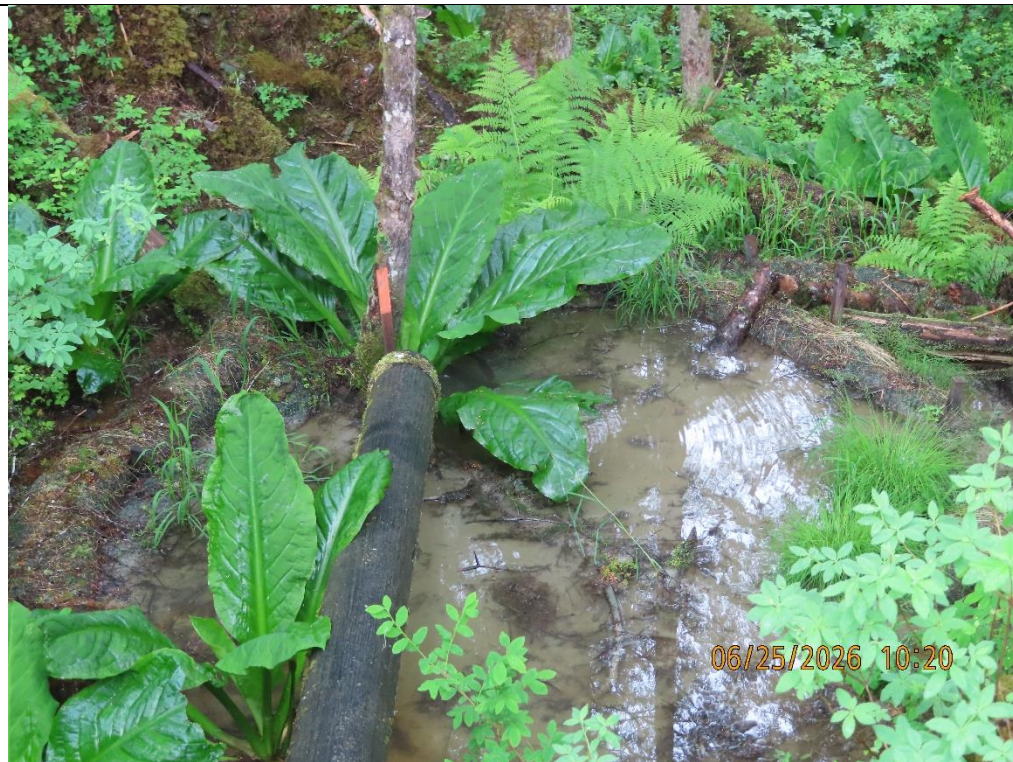
Ponds working as intended and draining as designed utilizing flocculant logs to pull sediment out of the flow of water into the ponds. Outfall looks clean and functioning properly (Photos 27 & 28).

**Photo 28: Gnome Ponds outfall.**

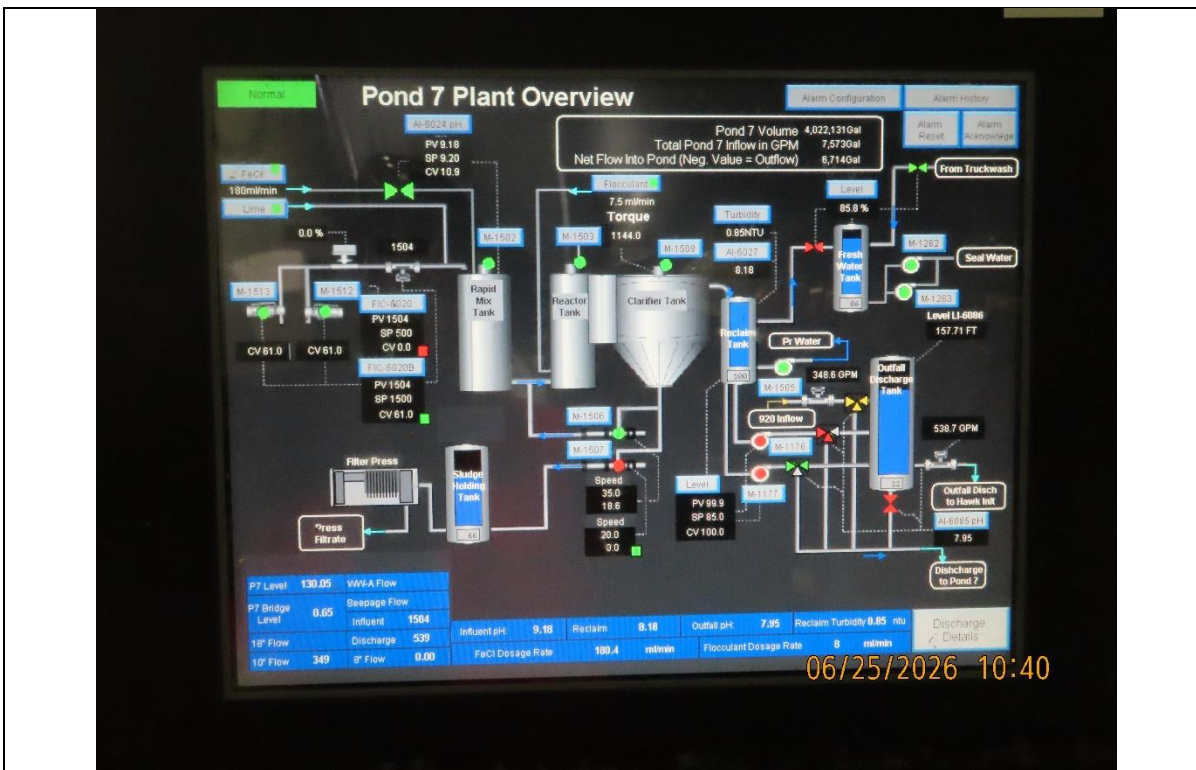
Photo 29: TDF Water Treatment Plant readings

Good housekeeping practices were observed in the TDF water treatment plant (Appendix 5 BMP Plan, page 37). The water treatment plant was discharging approximately **540 gpm** to Outfall 002 with a pH of **7.95**, and turbidity of **.85** NTU (Photo 29 & 30).

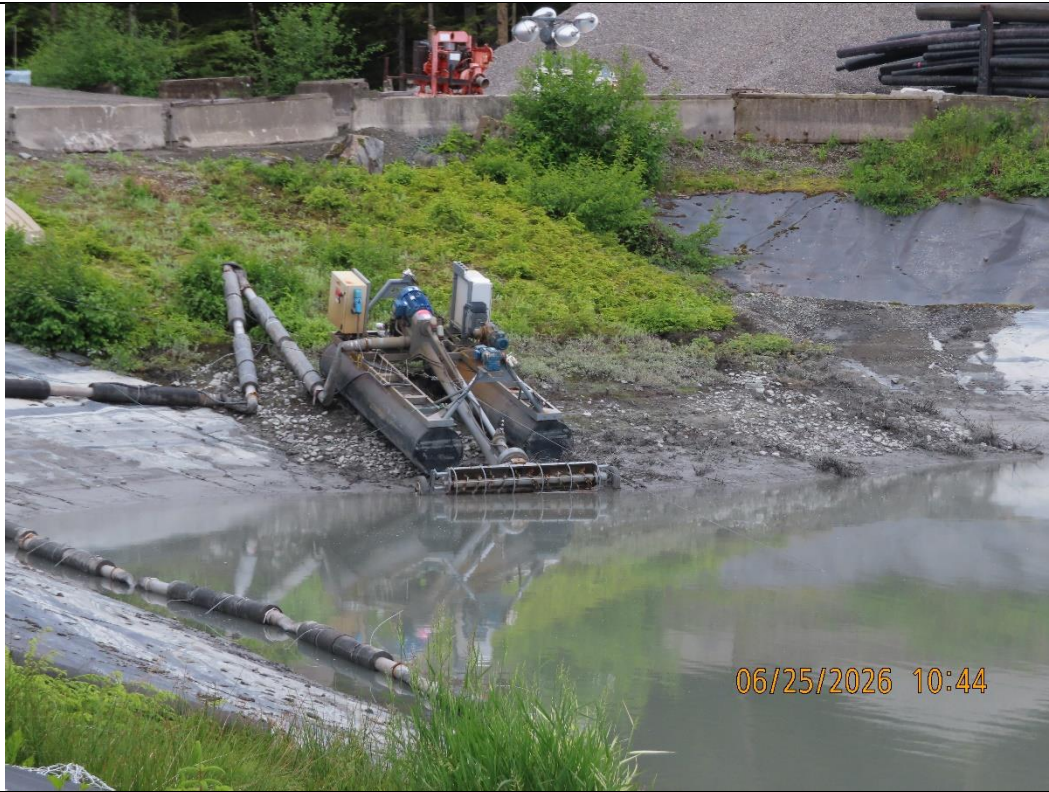
**Pond 7** Tails ready to be dredged and pumped to bags in Pond 10. No evidence of water overflow (Photos 31 & 32).

**Photo 31: Pond 7 dredge staged.**

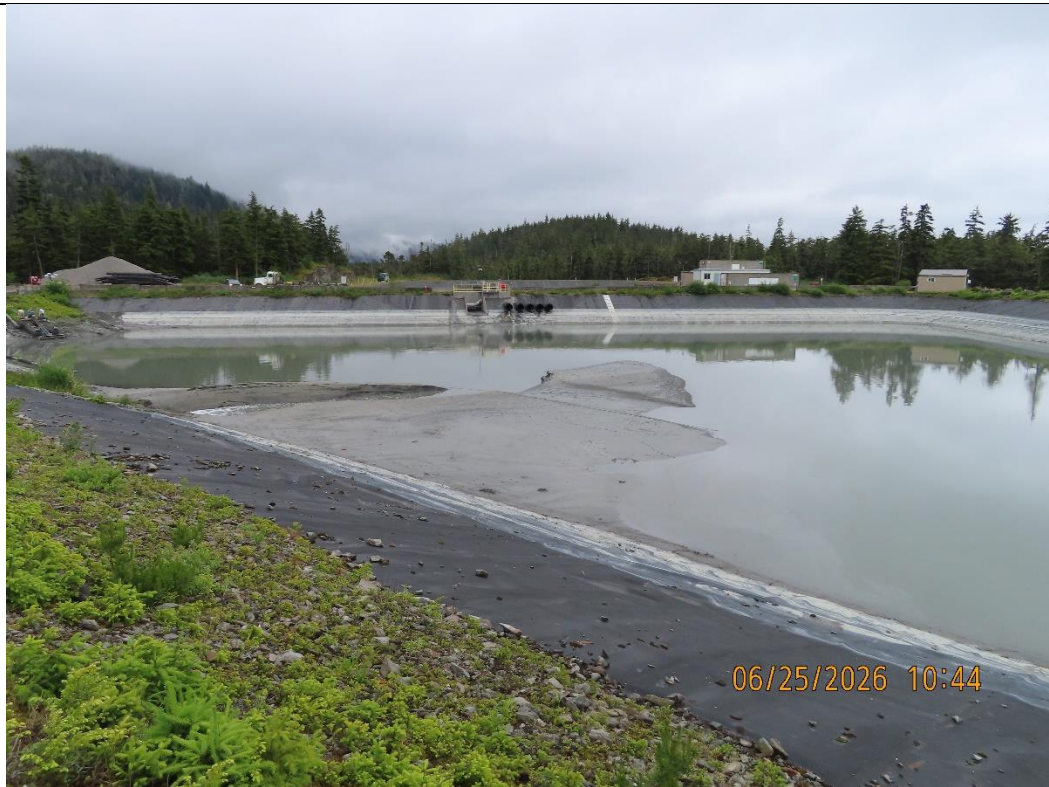
**Photo 32: Pond 7 tails to be dredged and pumped to bags in Pond 10.**

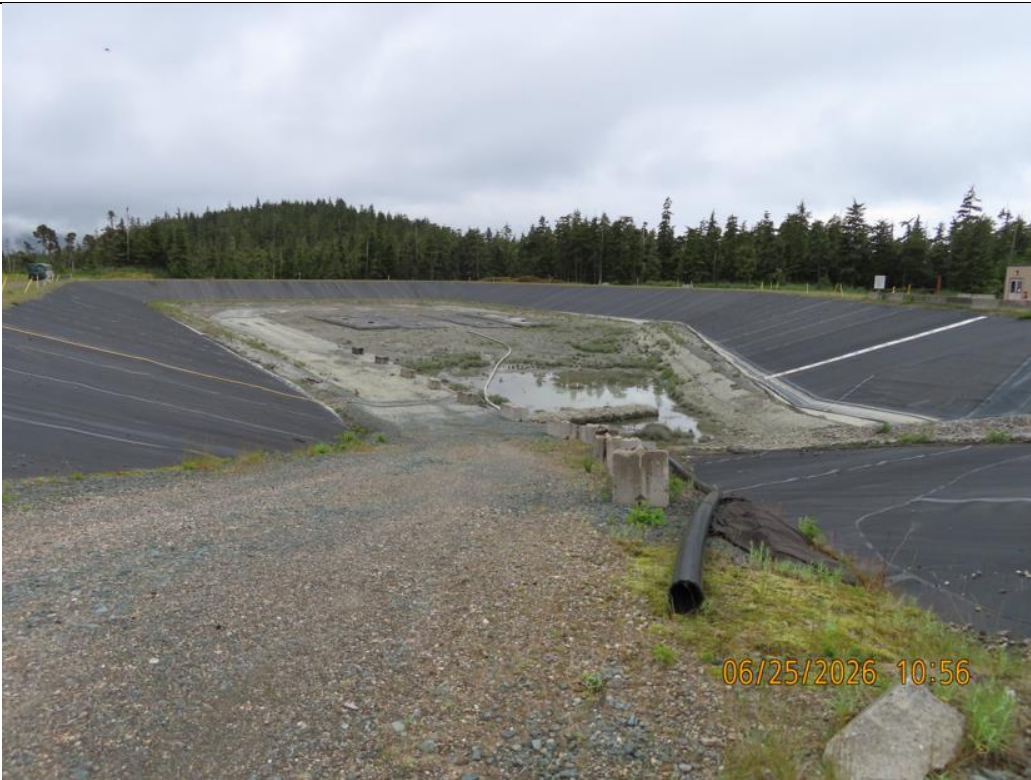
**Pond 10** Overview with tails bags in background and fill pipe in foreground (Photo 33).

**Photo 33: Overview of Pond 10 with tails bags in background and fill pipe in foreground.**

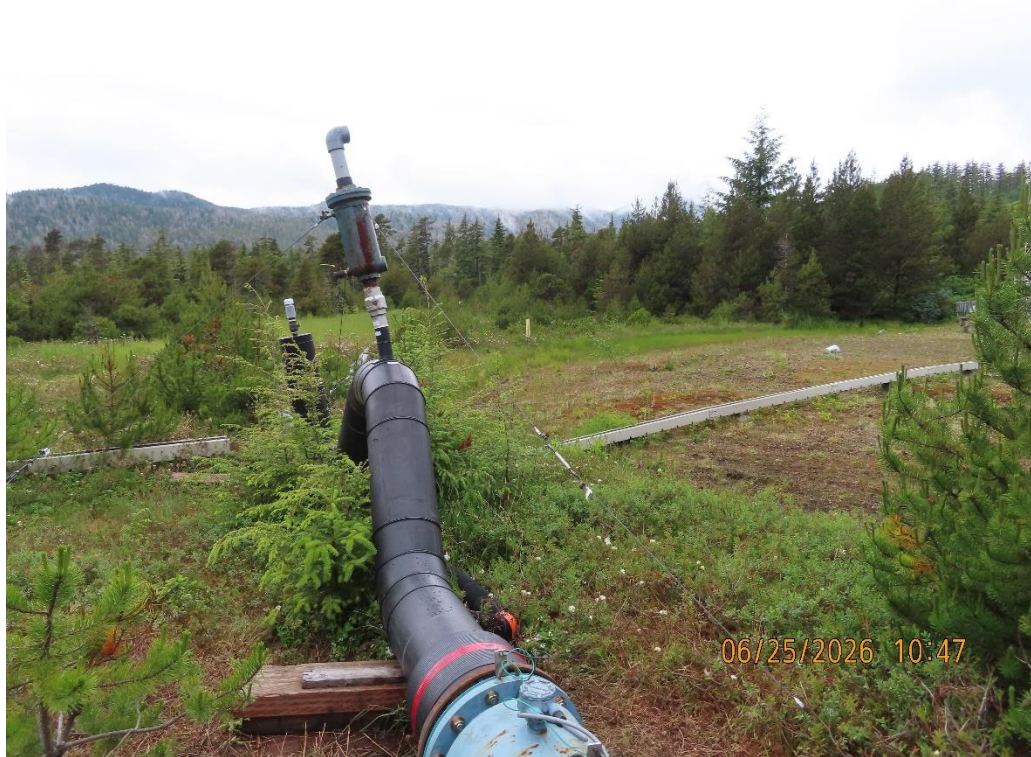
**Photo 34: Outfall 002.**

**Outfall 002** The area has not been cleared for the addition of 002A Outfall yet (Photo 34).

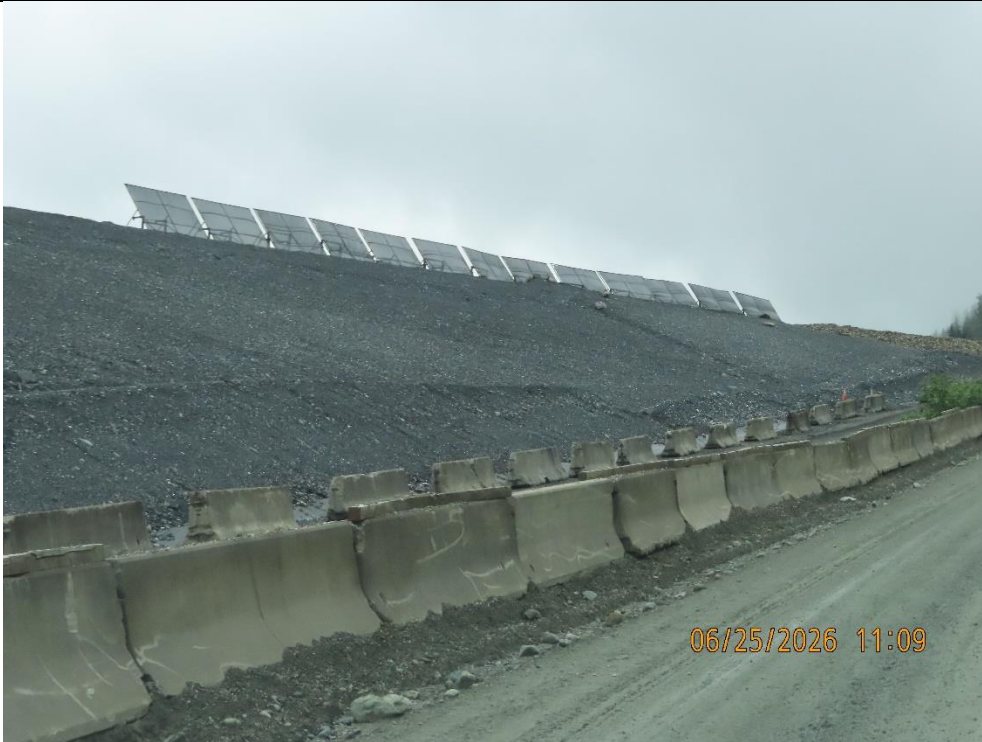
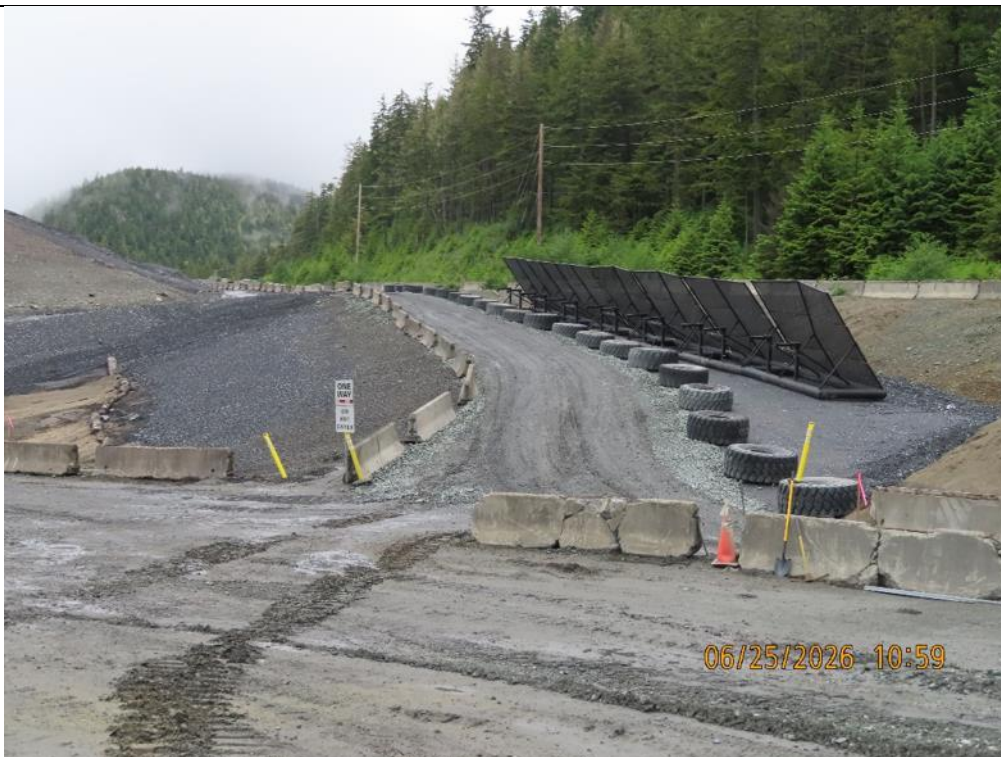
**Portable Fugitive Dust Mitigation** at the Tailings Facility (Photos 35 & 36).

**Photo 35: Portable Fugitive Dust Mitigation at the Tailings Disposal Facility.**

**Photo 36: Portable Fugitive Dust Mitigation at the Tailings Disposal Facility.**
