## INSPECTION REPORT: GREENS CREEK MINE

Date of Inspection: July 15th, 2026  
Date of Report: July 31, 2026  
USDA Forest Service Inspector: Scott Leslie

Ranger District: Admiralty National Monument, Juneau Ranger District Weather Conditions: Overcast, light breeze.  
Temperature: mid to upper 50's (°F).

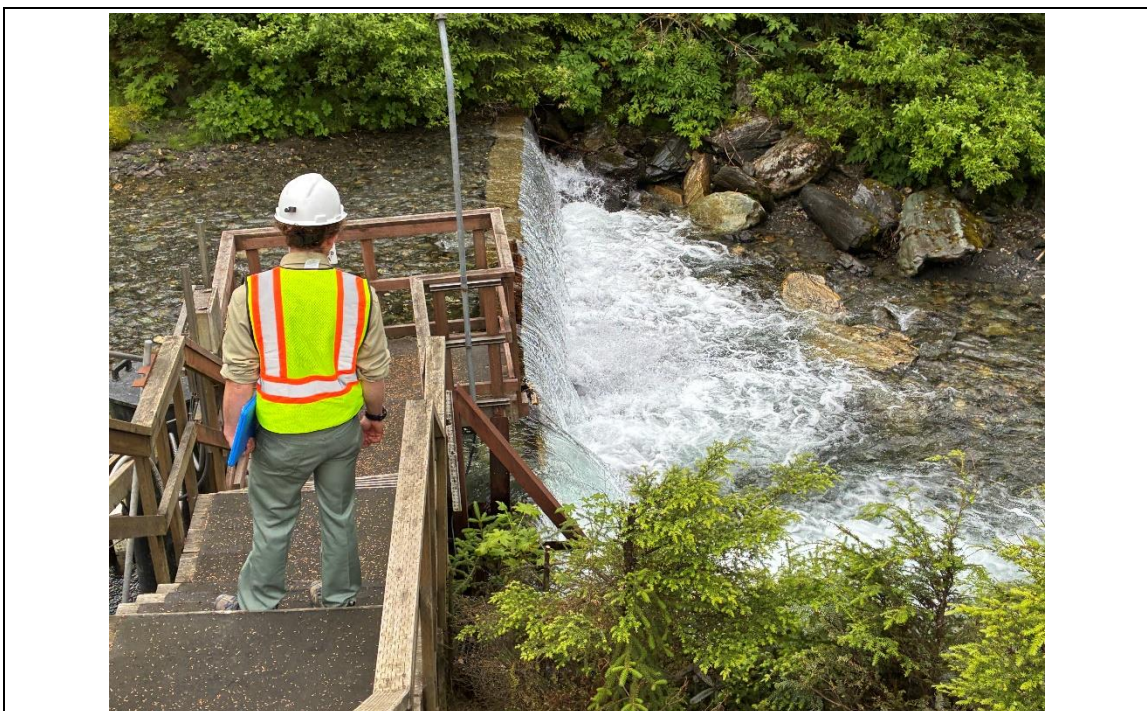
**Greens Creek Weir** (Photo 1).

**Photo 1: Greens Creek Weir.**

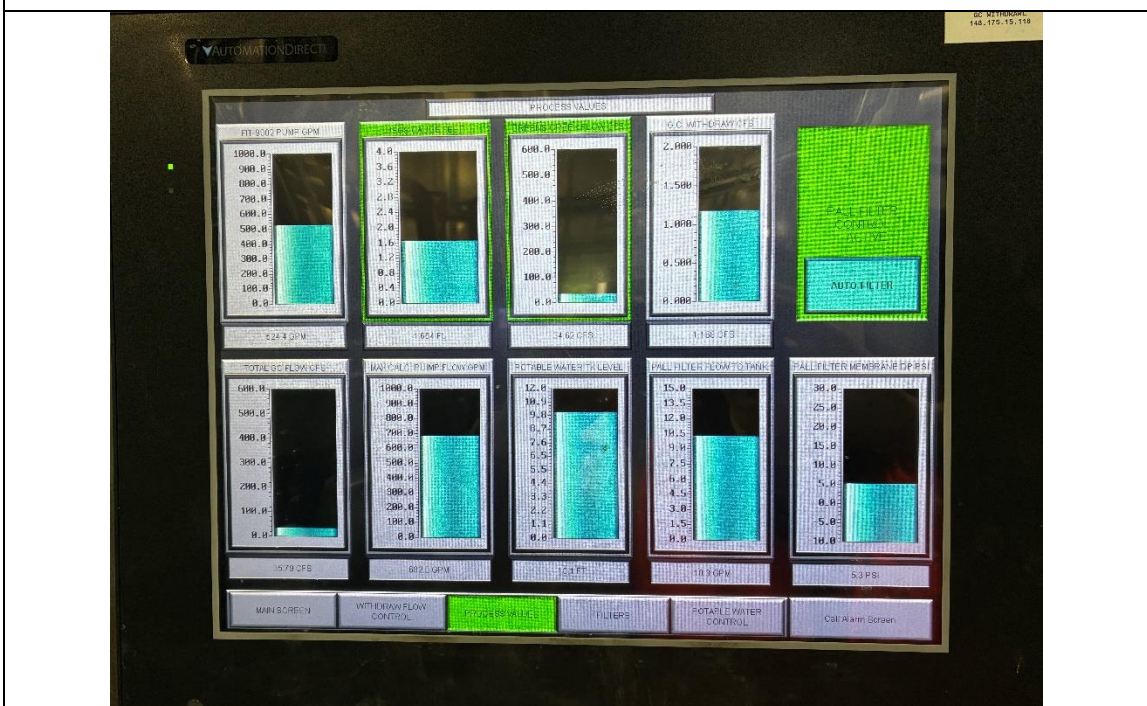
**Freshwater Plant**, Greens Creek weir discharge flow at 35 cfs and 1.17 cfs being withdrawn for the 920 facilities. Plant clean and orderly (Photo 2).

**Photo 2: Freshwater Plant readings.**

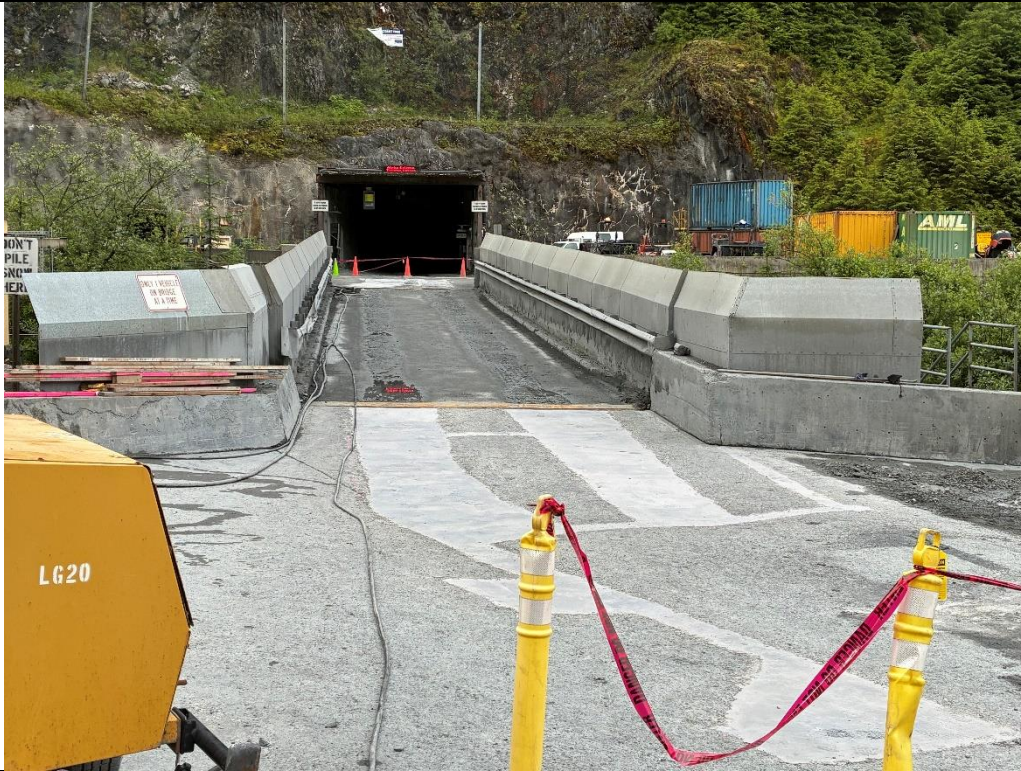
**920 Bridge** in good condition. New abutments and concrete Belzona repairs near completion (Photo 3).

Photo 3: 920 Bridge.

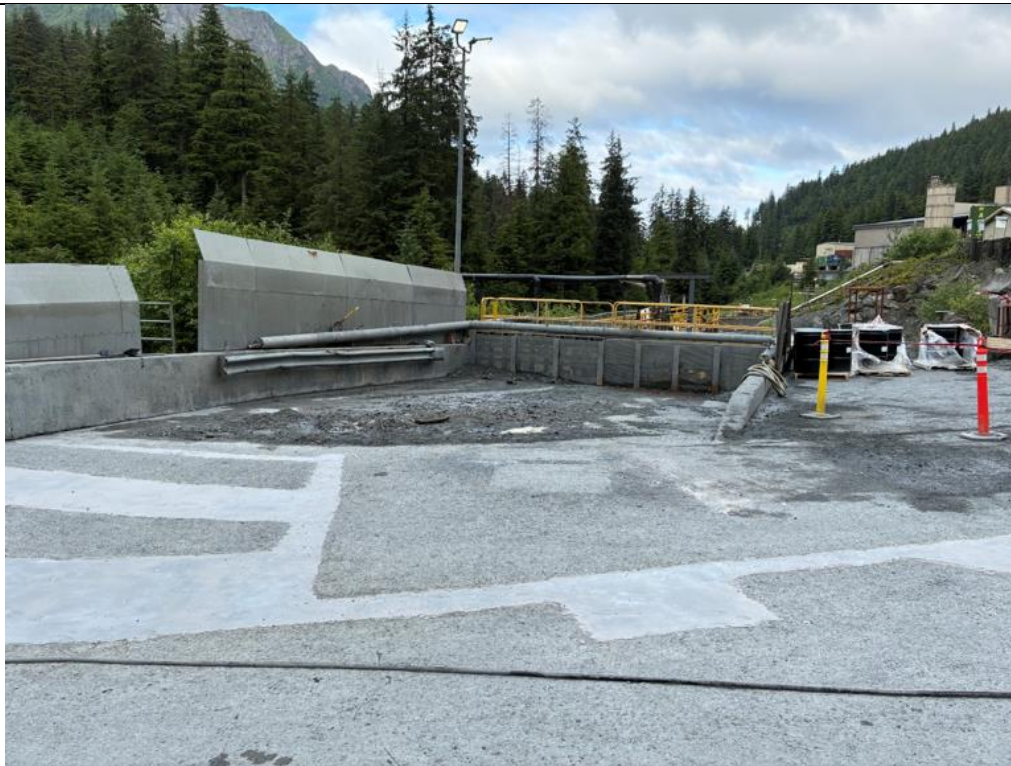
**Degrit Basin (DB-01)** Appears to be functioning as intended. (Photo 4 ).

Photo 4: Degrit Basin (DB-01).

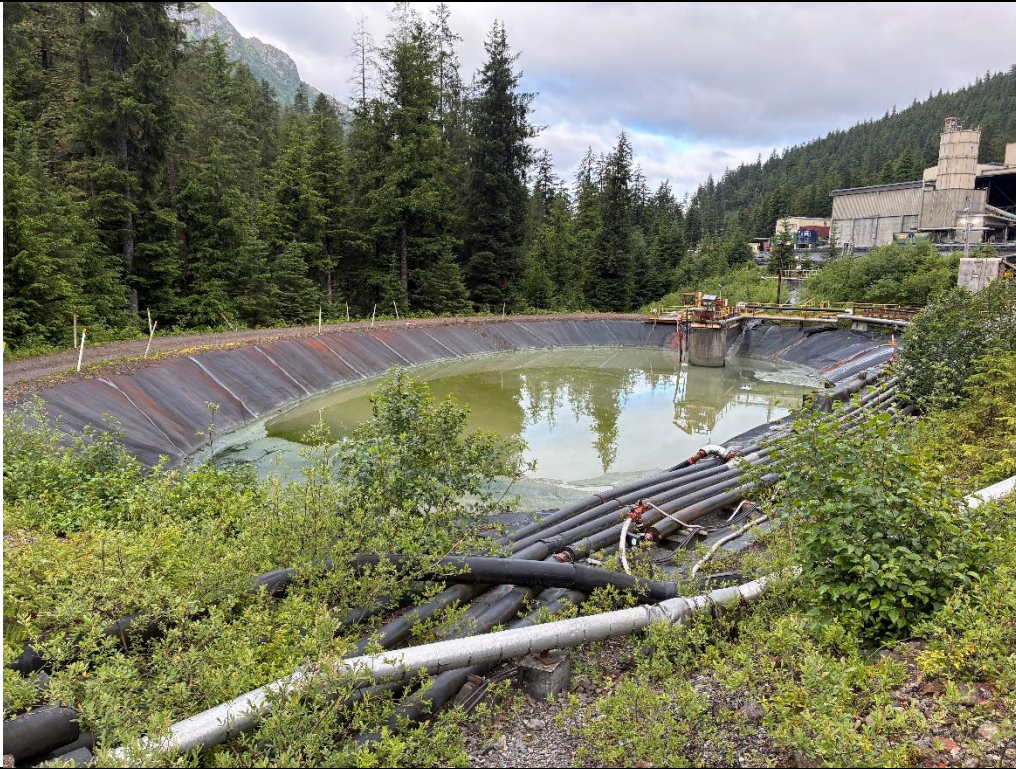
**Pond A** This pond collects 920 Area runoff and pumps it to Mill water treatment plant. Liner appears in order with no visible overflow (Photo 5).

Photo 5: A Pond.

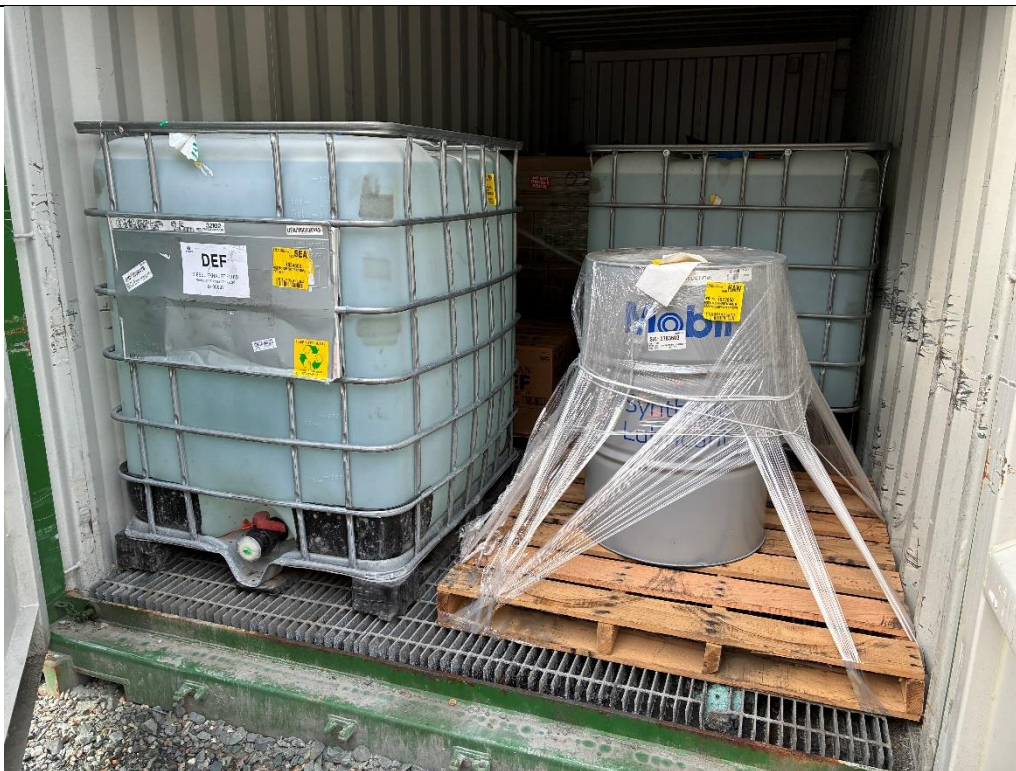
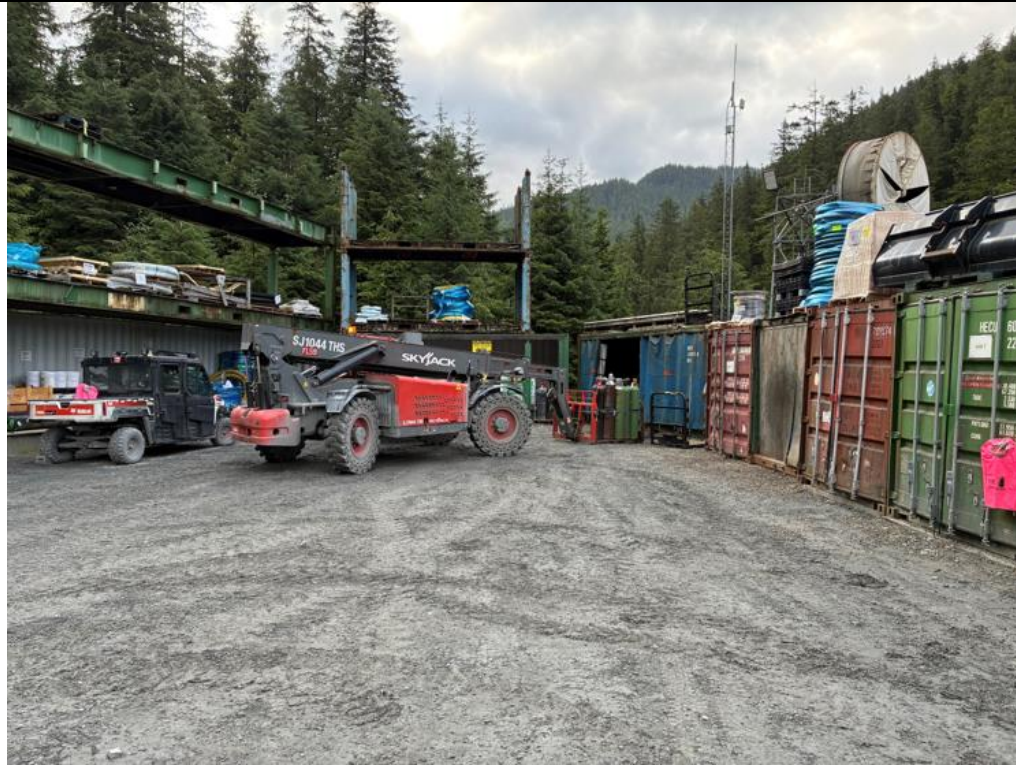
**920 Warehouse** Good housekeeping practices were observed at the storage containers with petrochemicals properly stored with secondary containment (Appendix 5 BMP Plan, page 37) (Photos 6 & 7).

Photo 6: 920 warehouse storage container.

Photo 7: 920 warehouse area.

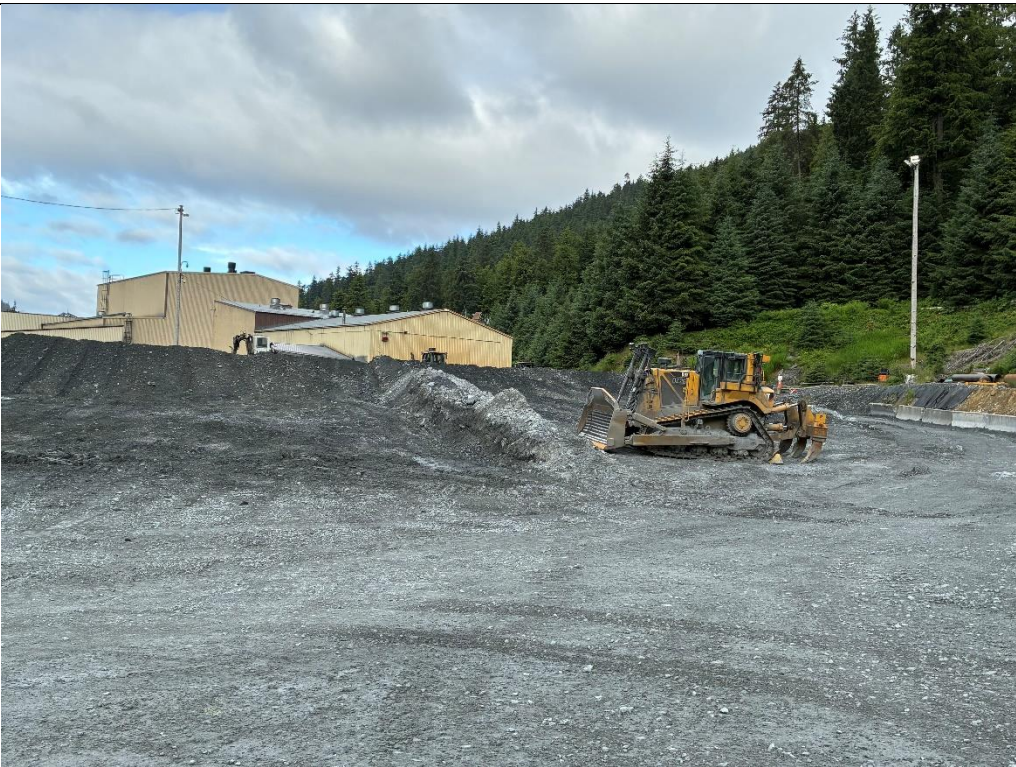
**Ore Pad** in use staging ore from 920 adit actively being contoured to transport ore to mill (Photo 8).

Photo 8: Ore pad.

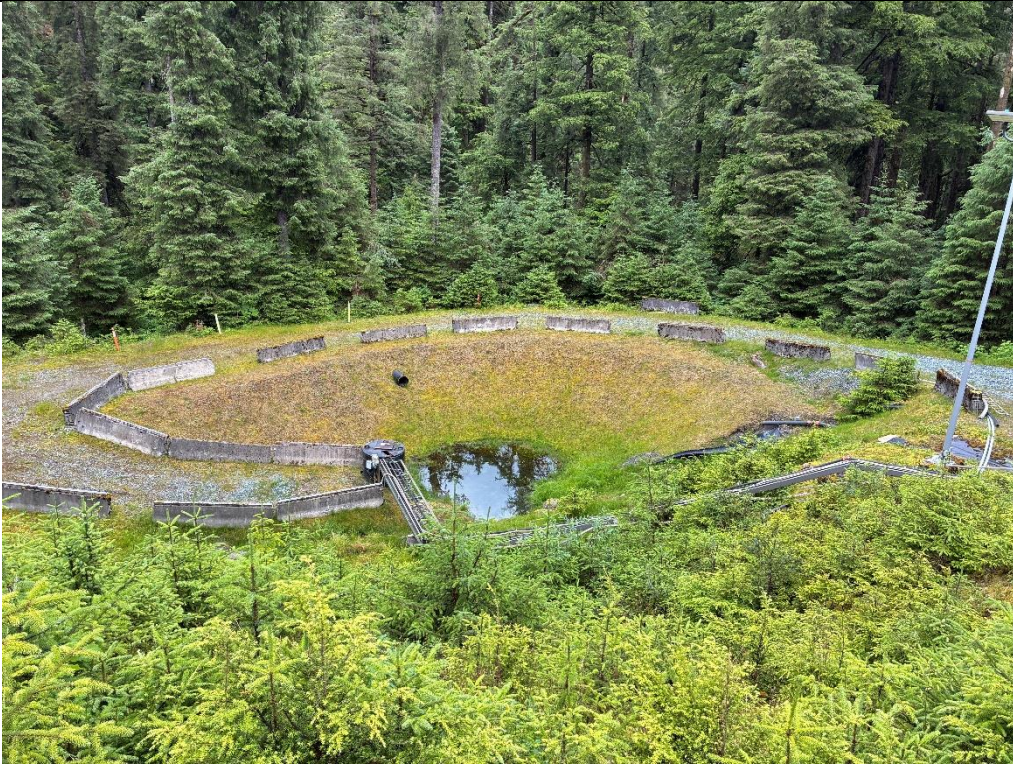
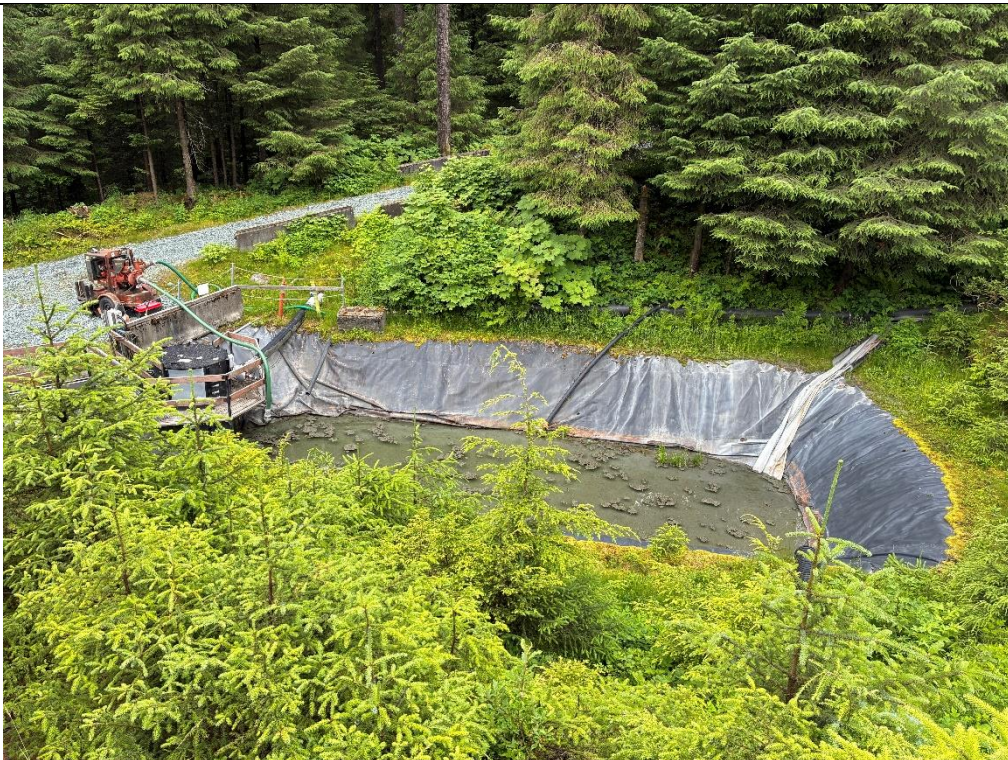
The upper and lower pond liners are intact and with no visible signs of overflow (Photos 9 & 10).

**Photo 9: Lower C Pond.**

**Photo 10: Upper C Pond.**

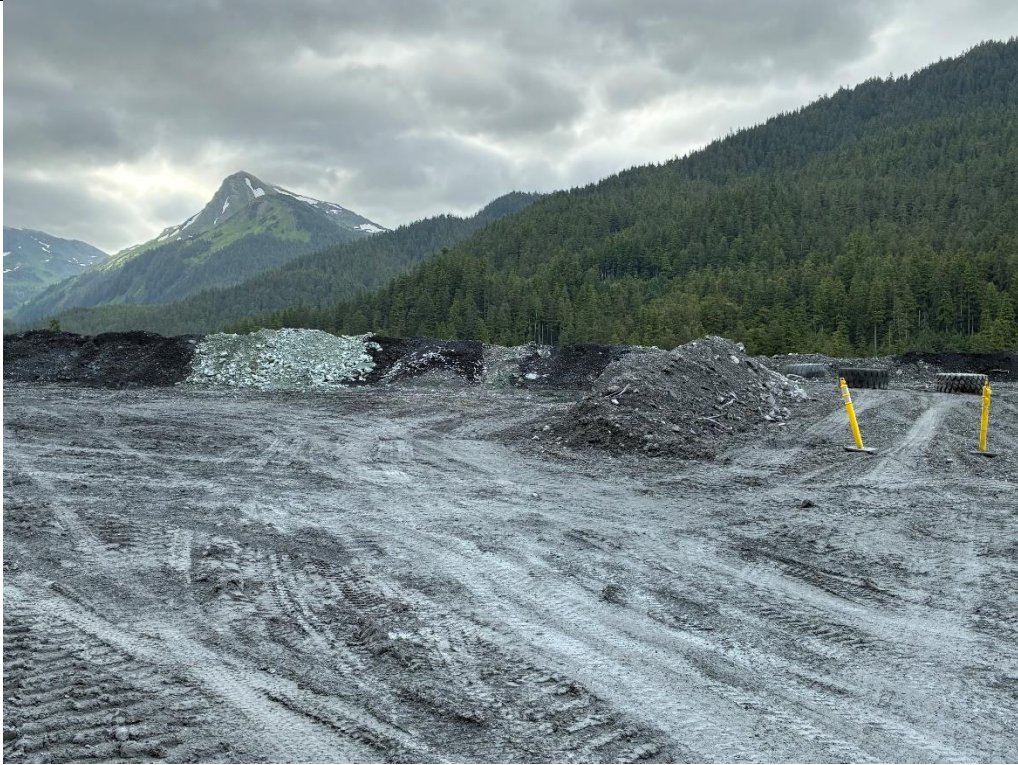
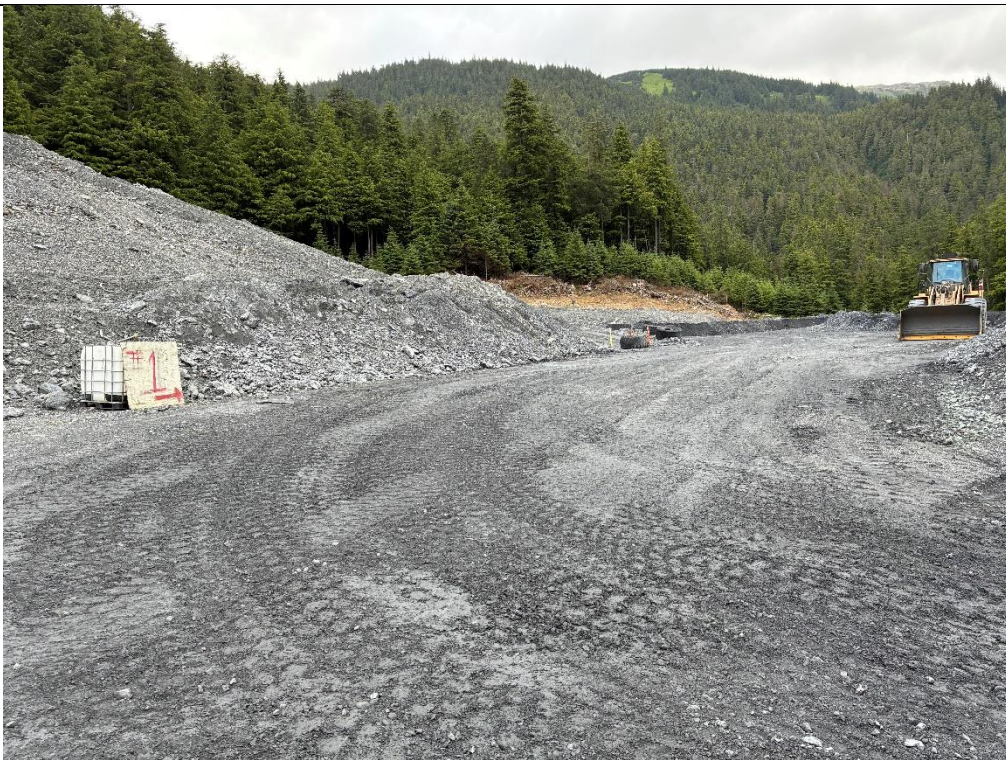
HGCMC continues to stage Class 1, 2, and 3 waste rock at this location. Class 4 waste rock is kept and disposed of underground (Appendix 11 Waste Rock Management Plan, page 11). Class 1 rock (argillite) is used as an inert capping material over top of Class 2 and 3. (Photos 11 & 12).

**Photo 11: Site 23 Class 2 & 3 Material on top of storage area.**

**Photo 12: Site 23 Class 1 Material at base of storage area.**

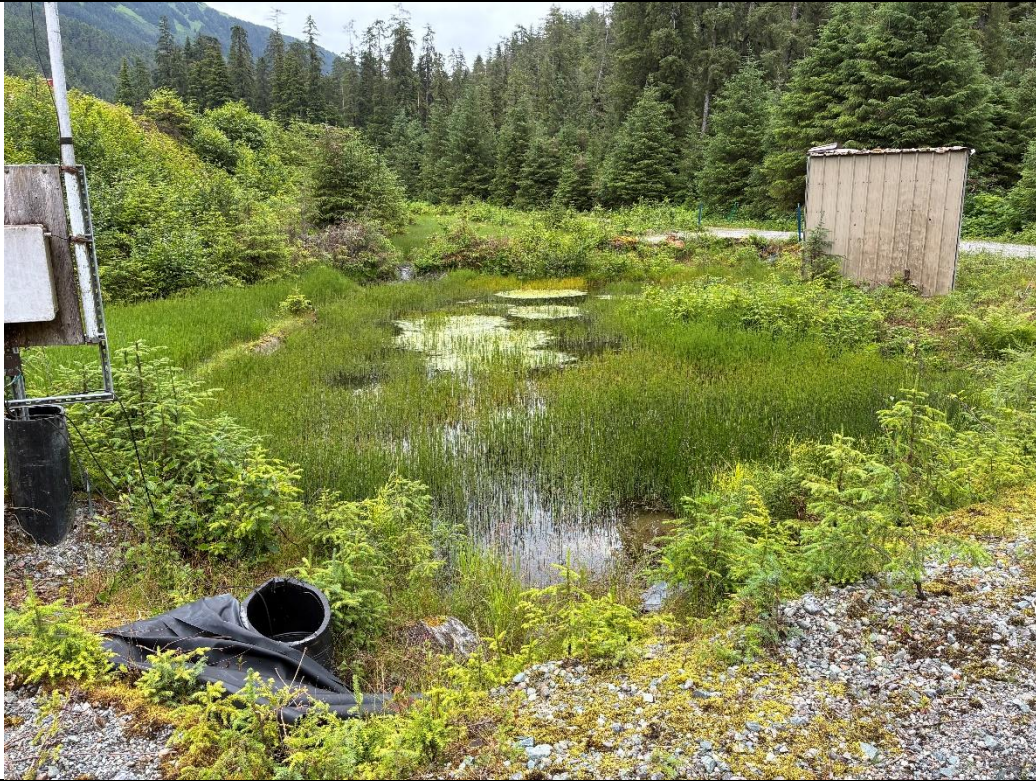
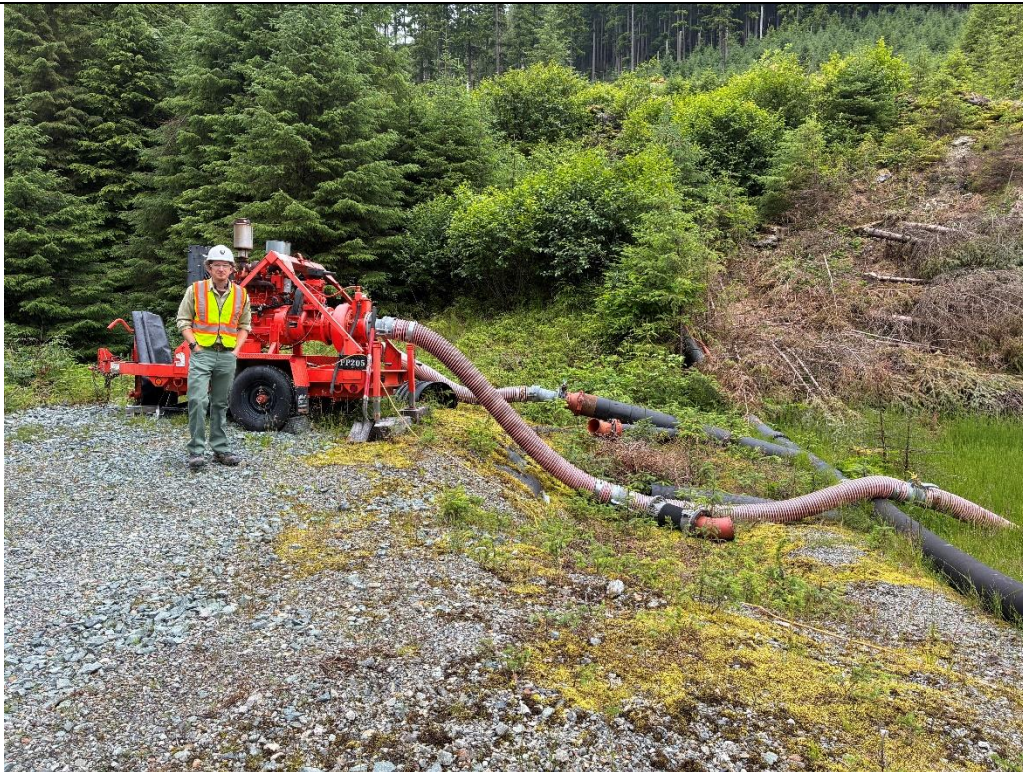
Intact and no visible signs of overflow (Photos 13 & 14).

Photo 13: D Pond.

Photo 14: D Pond pump that moves water to Pond 7.

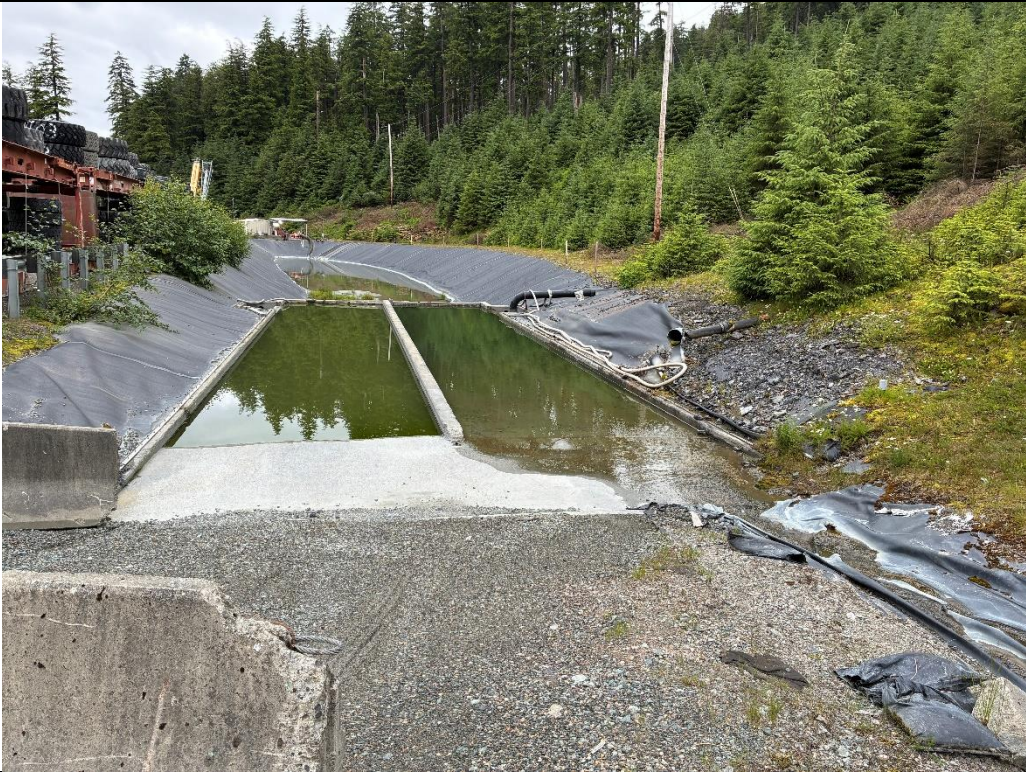
**Degrit Basin BD-03** Runoff entering basin as designed and appears to be functioning as intended. The 23 Pond can be seen in the background. Bear tracks noticed on the ditch liner and a small tear in the liner on the upper edge. No sign of runoff entering the tear (Photo 15-17).

**Photo 15: DB-03 and 23 Pond and Pump in background.**

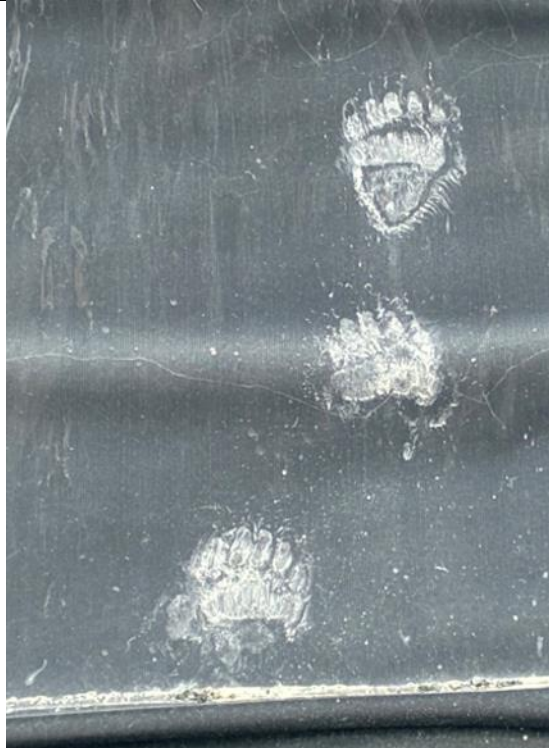
**Photo 16: Bear tracks on ditch liner from DG-03 to Pond 23.**

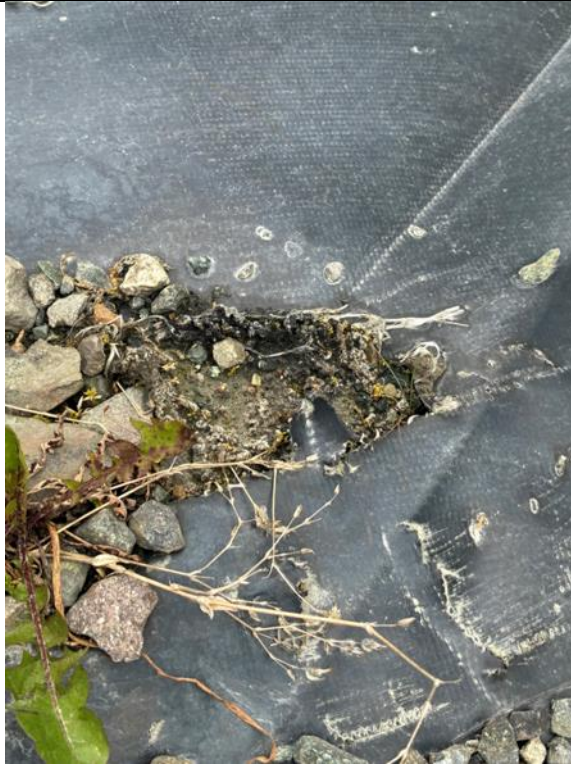
Photo 17: Small tear approximately 6 inches on upper edge of ditch liner from DG-03 to Pond 23.

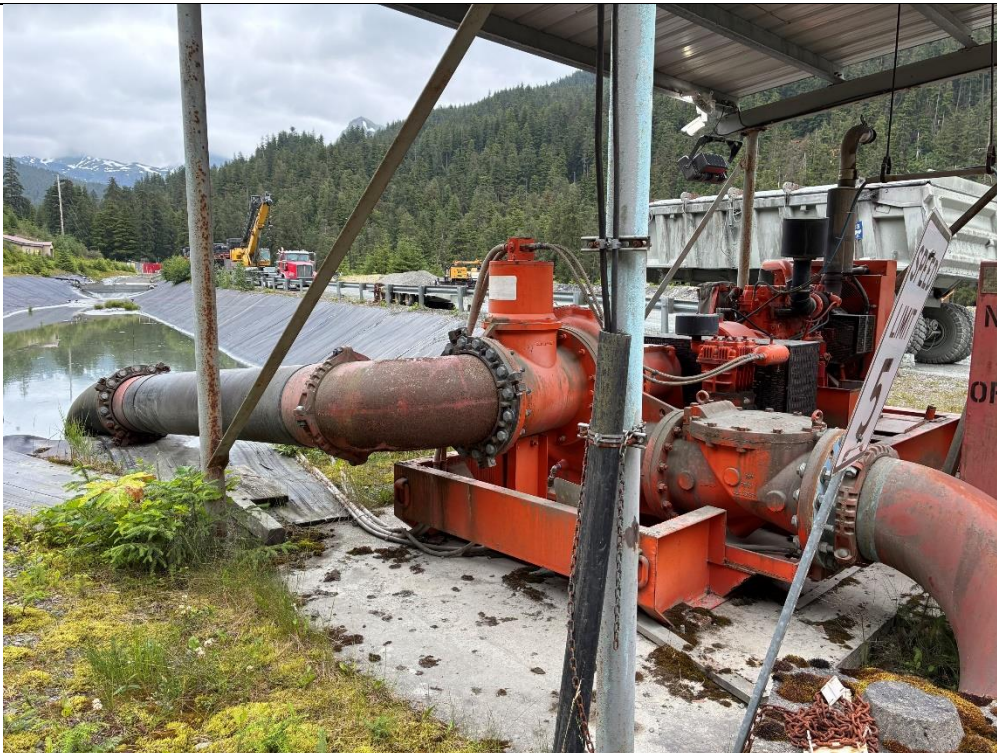
The pump area was clean and orderly. Appeared to be operable with no visible signs of pond overflow or liner damage (Photos 18).

Photo 18: 23 Pond and Pump.

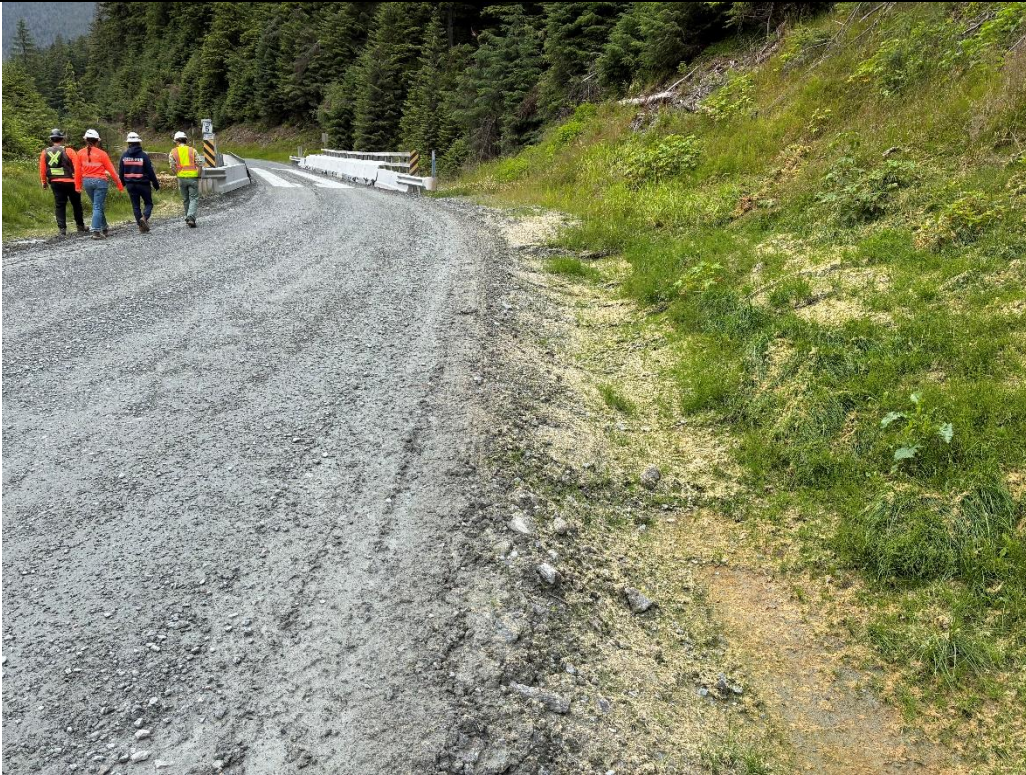
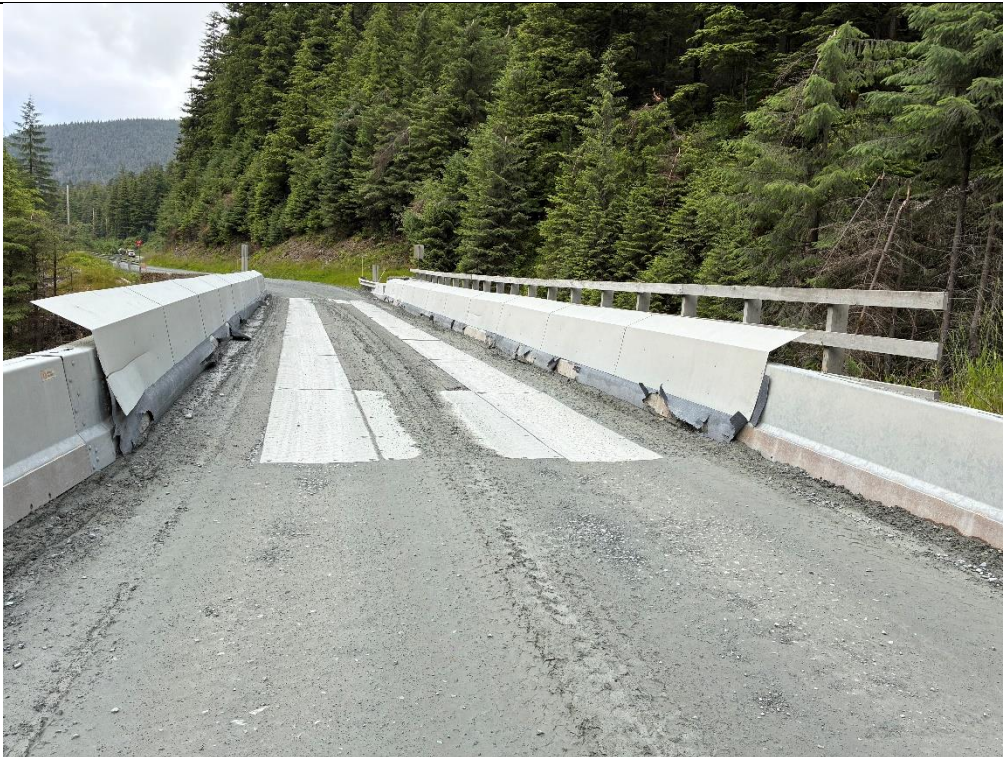
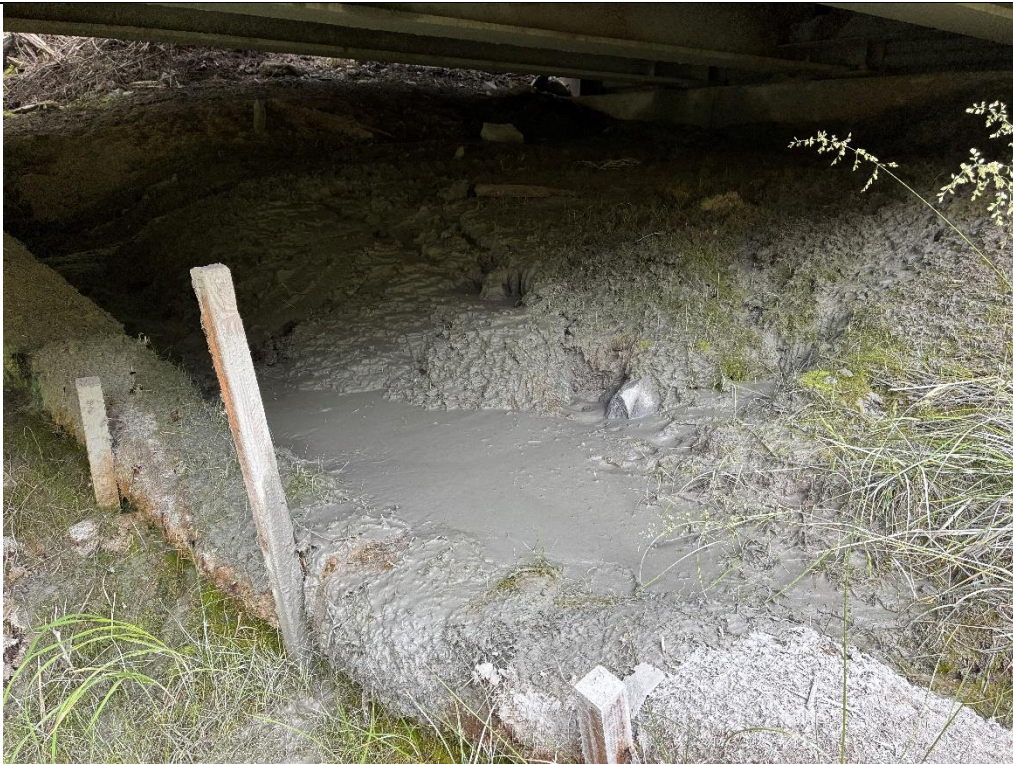
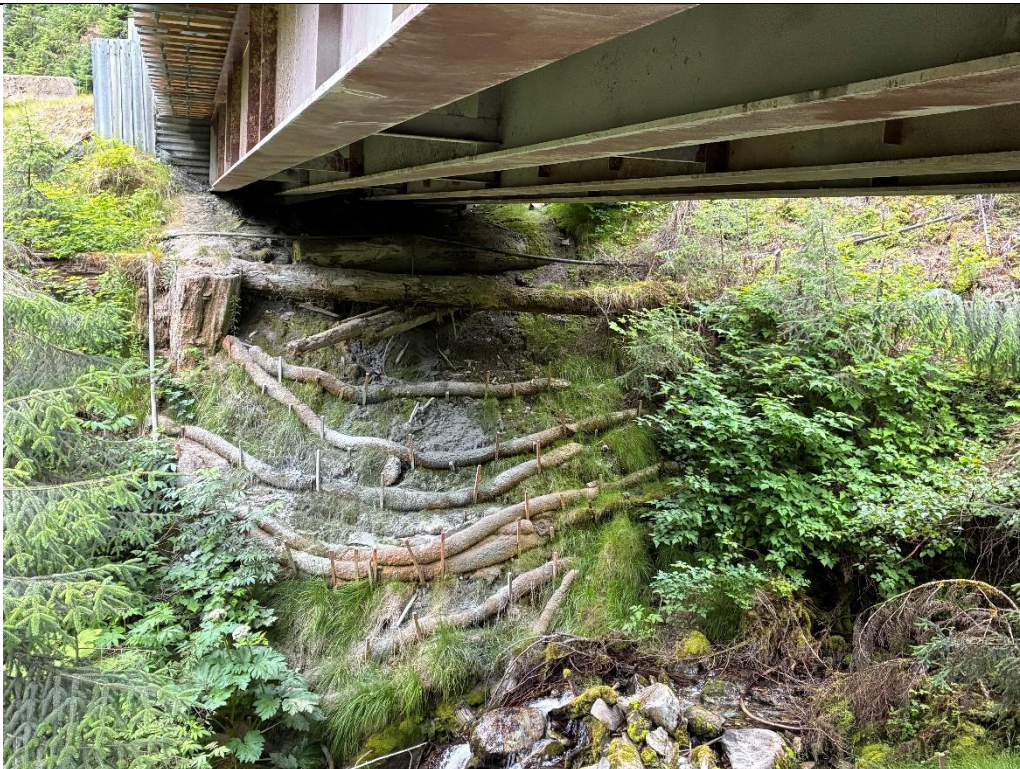
Ditches in area have been mucked out and hydroseeded for sediment control. The bridge surface appeared in good condition, but sediment is still leaking out below the bridge and captured in waddles (Photos 19 - 22).

**Photo 19: Mucked out and hydroseeded ditch near 7.4 Mile Bridge.**

**Photo 20: 7.4 Mile Bridge.**

**Photo 21: 7.4 Mile Bridge (Killer Creek) waddles and hydroseed present collecting sediment.**

**Photo 22: 7.4 Mile Bridge (Killer Creek) waddles collecting sediment (far side of creek).**

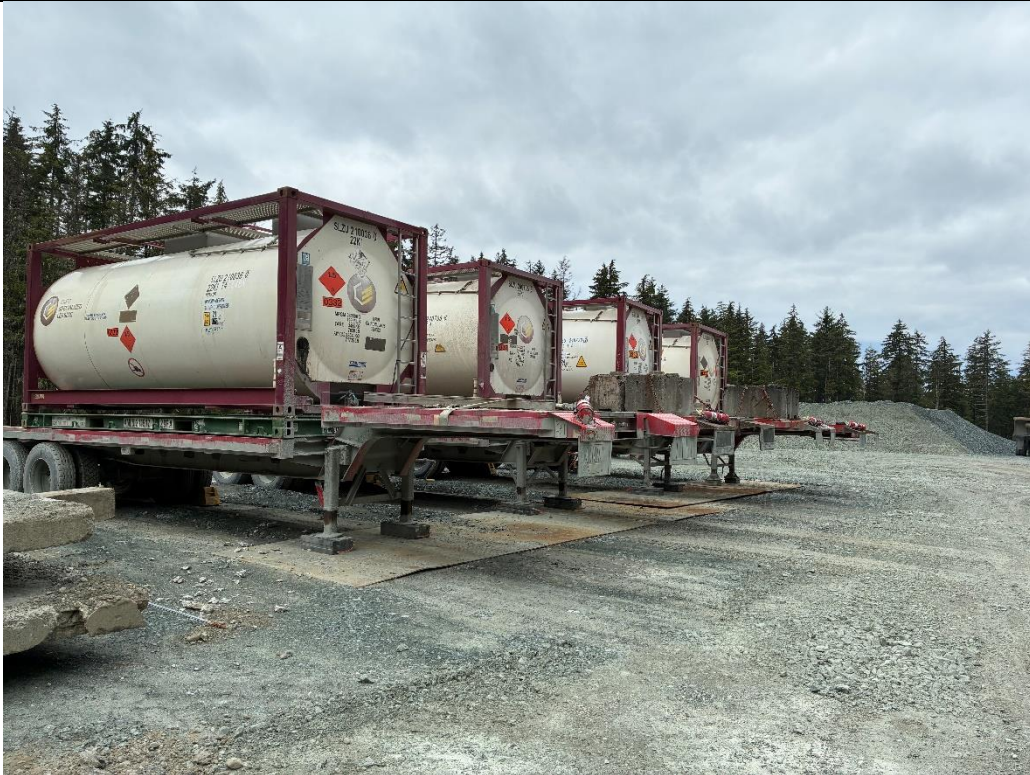
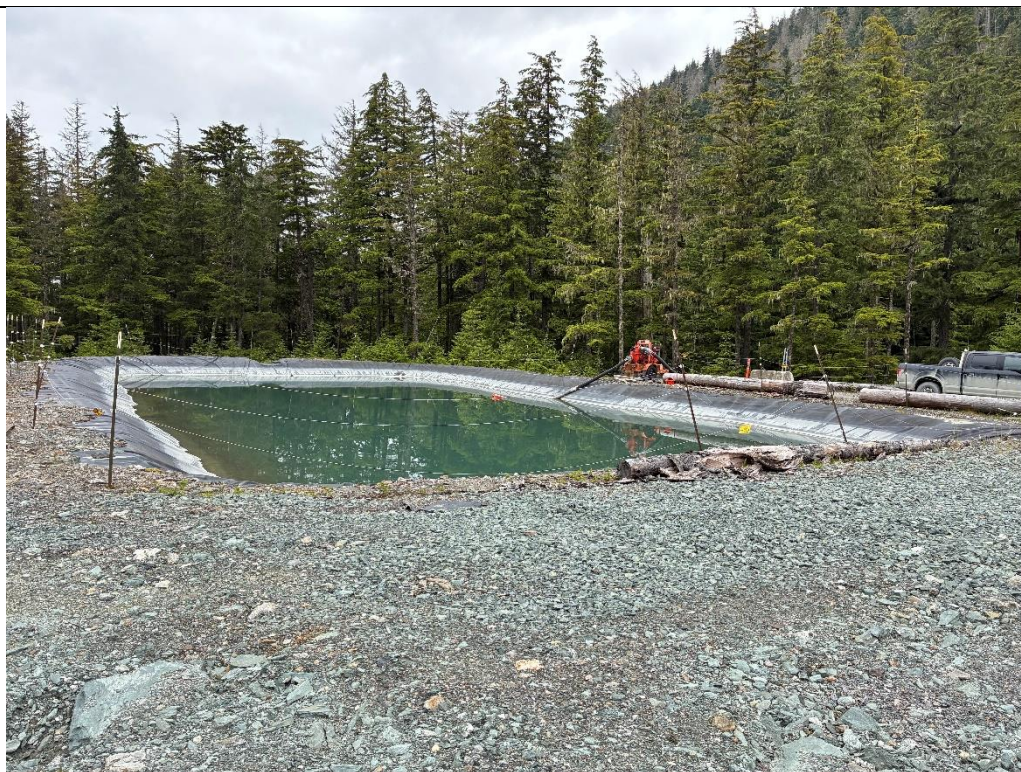
This is an old, early unclassified waste rock site. Material is being stored here to be moved to Tailings Disposal Facility (TDF). Much of the material has been moved to the TDF already. Approximately 10,000 tons left on site to transfer to TDF. The site is now mostly used for road maintenance gravel and equipment storage. E Pond liner intact with no signs of overflow (Photos 23 & 24).

**Photo 23: Waste Site E. Most of the material has been moved to the TTF.**

**Photo 24: E Pond and pump.**

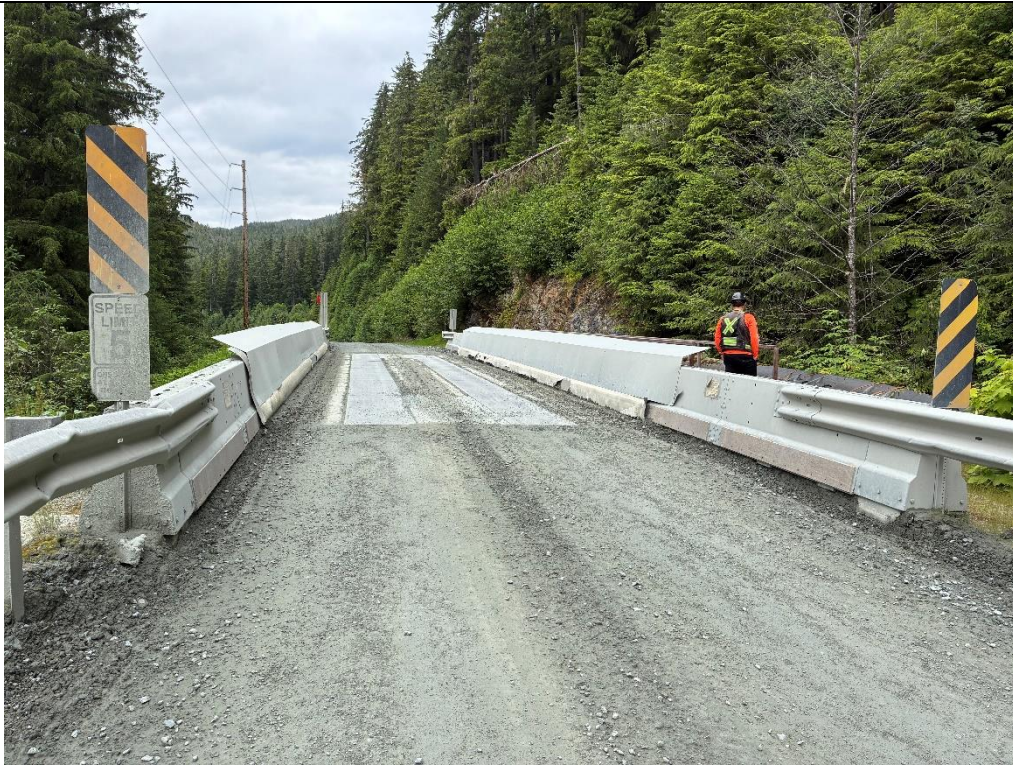
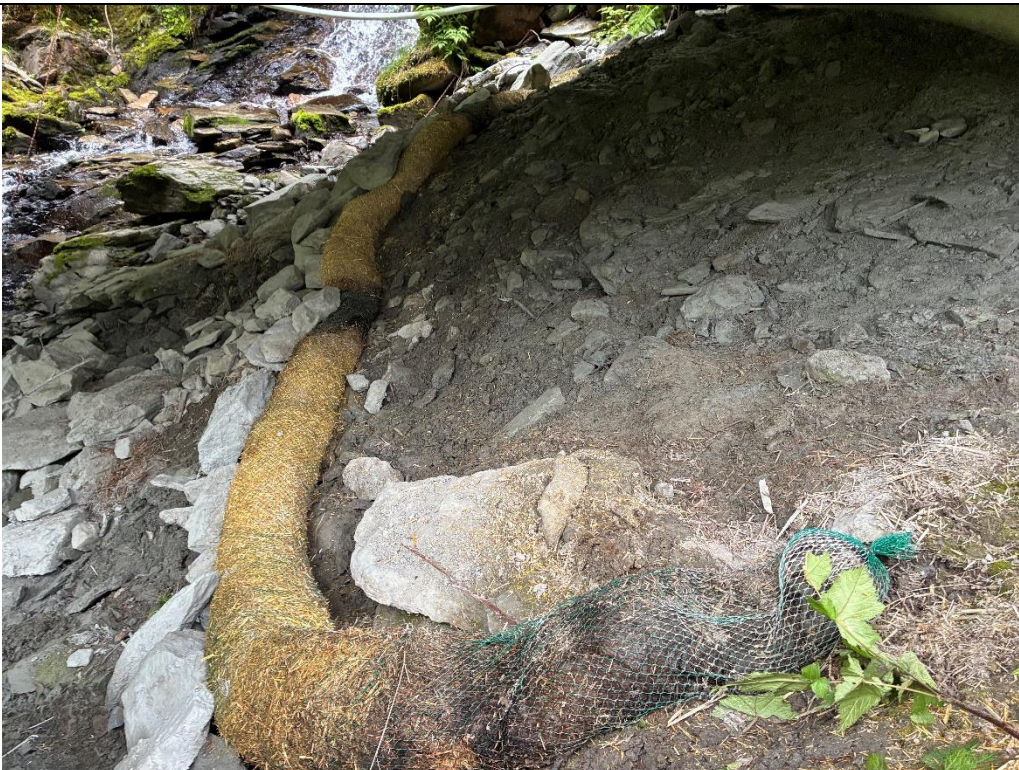
| Date/Item No. | Item Description | Status |
|---|---|---|
| 07/24/2025 – 446-1 | 7.4, 3.4, and 3.0-MILE B-ROAD BRIDGES:<br>Sediment draining in several places from beneath bridge to creek and area around abutments.<br>Bridge deck liner appears to be failing. | HGCMC looking at scheduling bridge resurfacing in July. 3.0- Mile B- Road bridge was completed in April. |

The bridge surface appeared to be in good condition, but sediment leaks through and collecting beneath the bridge. New waddles installed for sediment containment. New, self-healing liner and decking planned for this summer (Photos 25 & 26).

**Photo 25: 3.4 Mile B-Road Bridge (Falls Creek).**

**Photo 26: 3.4 Mile B-Road Bridge (Falls Creek) sediment leaking through from under decking.**
