## INSPECTION REPORT: GREENS CREEK MINE

Date of Inspection: July 15th, 2026  
Date of Report: July 31, 2026  
USDA Forest Service Inspector: Scott Leslie

Ranger District: Admiralty National Monument, Juneau Ranger District Weather Conditions: Overcast, light breeze.  
Temperature: mid to upper 50's (°F).

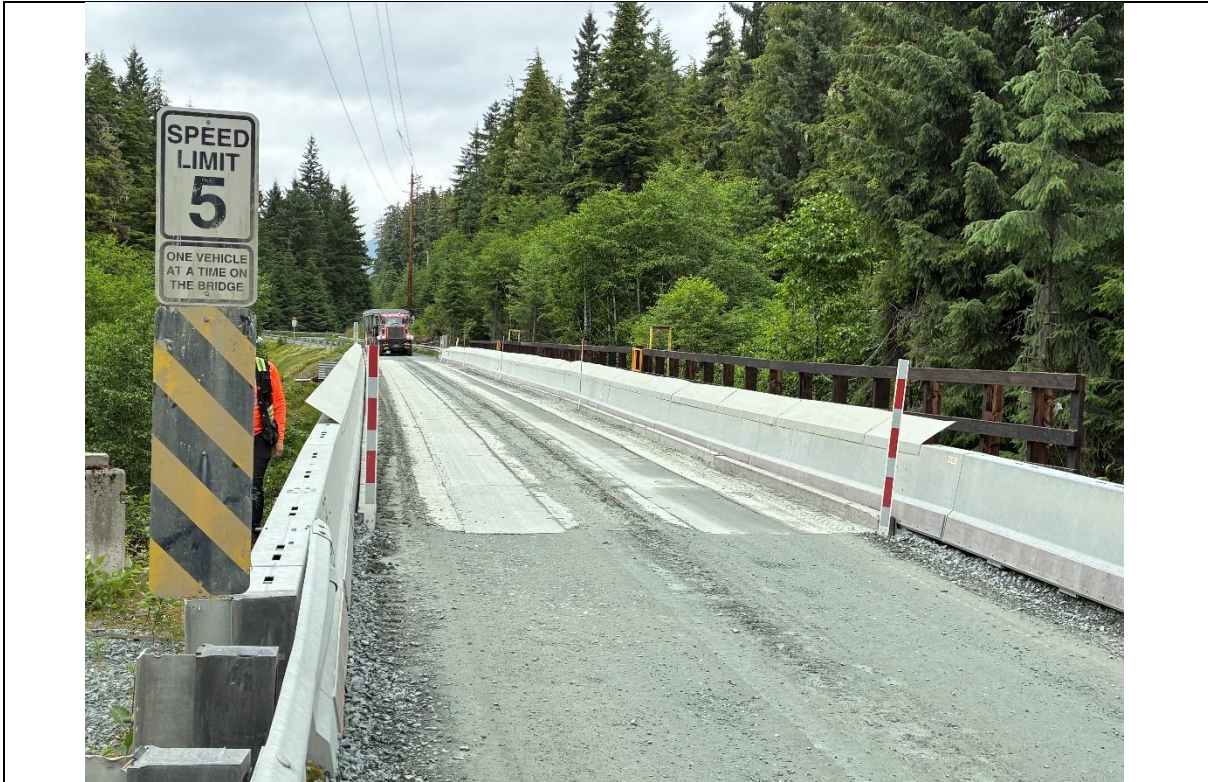
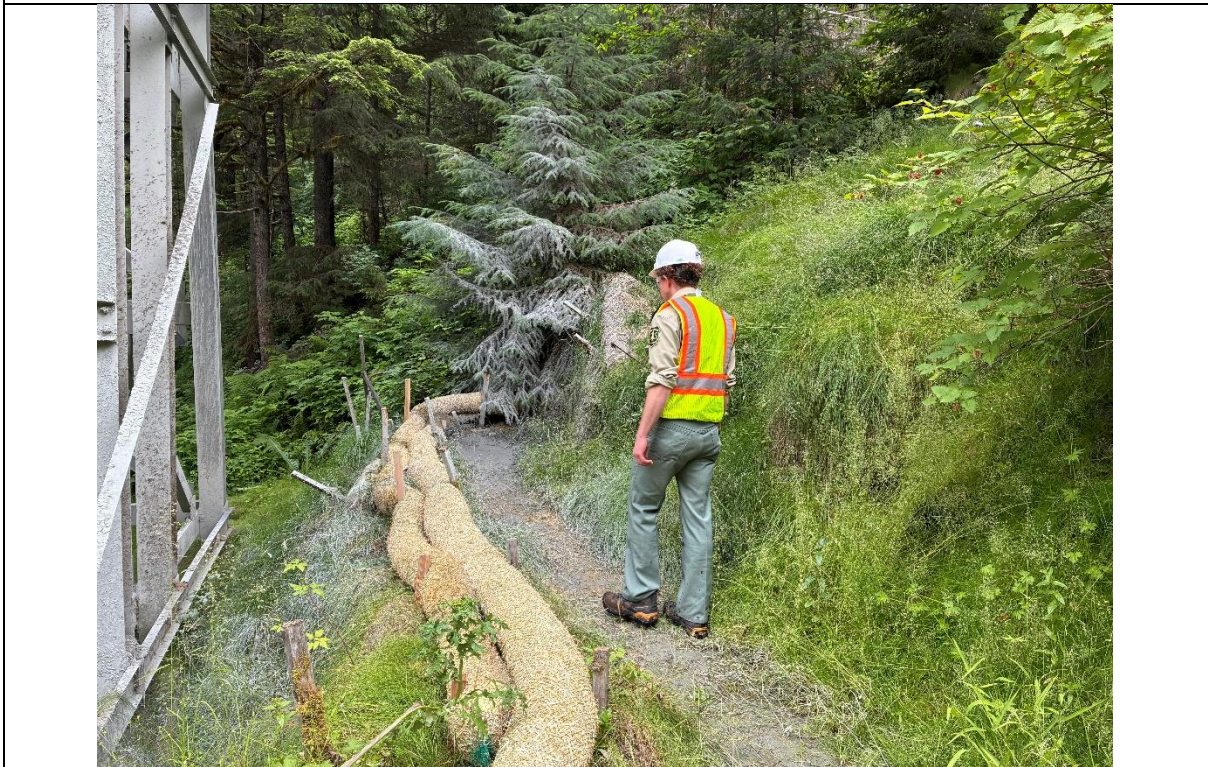
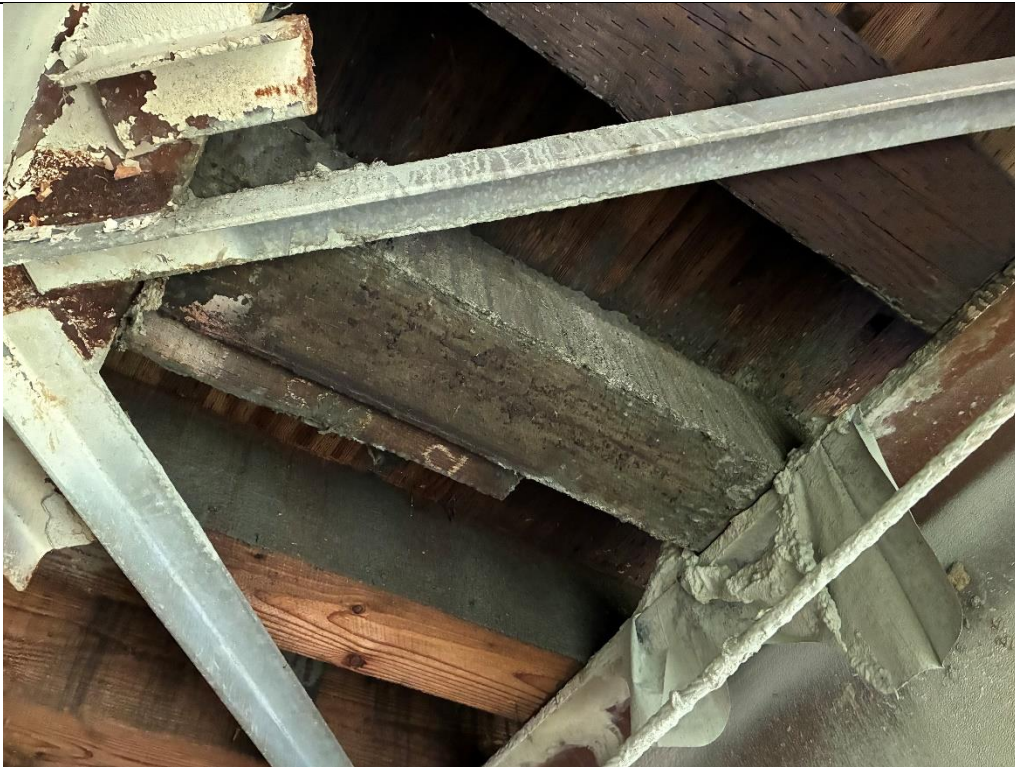
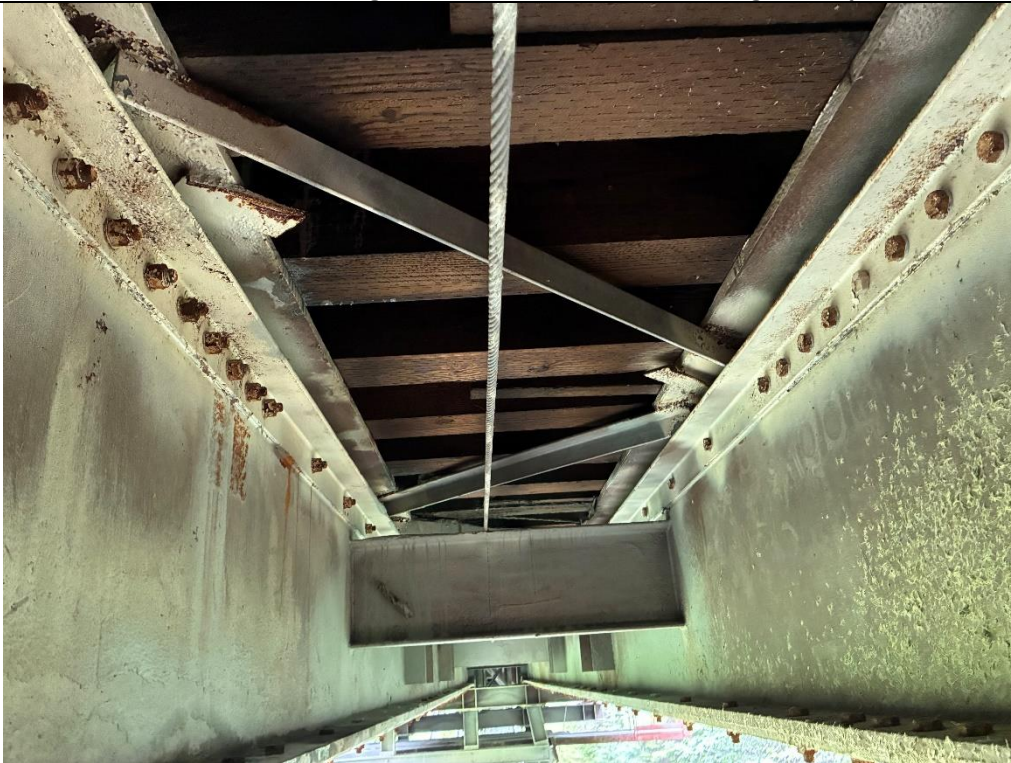
Bridge was redecked with new liner in April 2026. Sediment is potentially leaking through from under the south end decking or maybe residual from before decking was replaced. From the center area of the bridge looking north, the bridge does not appear to be leaking. No new sediment observed below bridge. Waddles in place with sediment collected prior to redecking (Photos 27 & 30).

**Photo 27: 3.0 Mile B-Road Bridge (Zinc Creek).**

**Photo 28: 3.0 Mile B-Road Bridge (Zinc Creek) sediment collected before decking replacement.**

**Photo 29: 3.0 Mile B-Road Bridge (Zinc Creek). Sediment potentially leaking through from under the south end decking or residual from before decking was replaced.**

**Photo 30: 3.0 Mile B-Road Bridge (Zinc Creek) Center area looking north, the bridge does not appear to be leaking.**

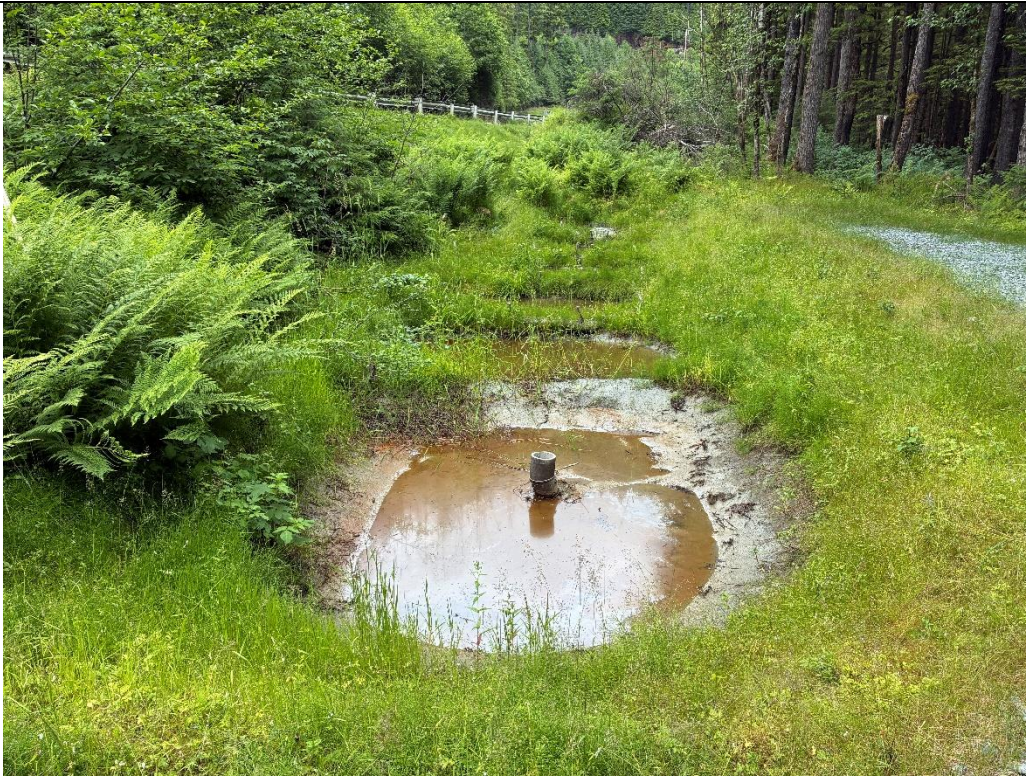
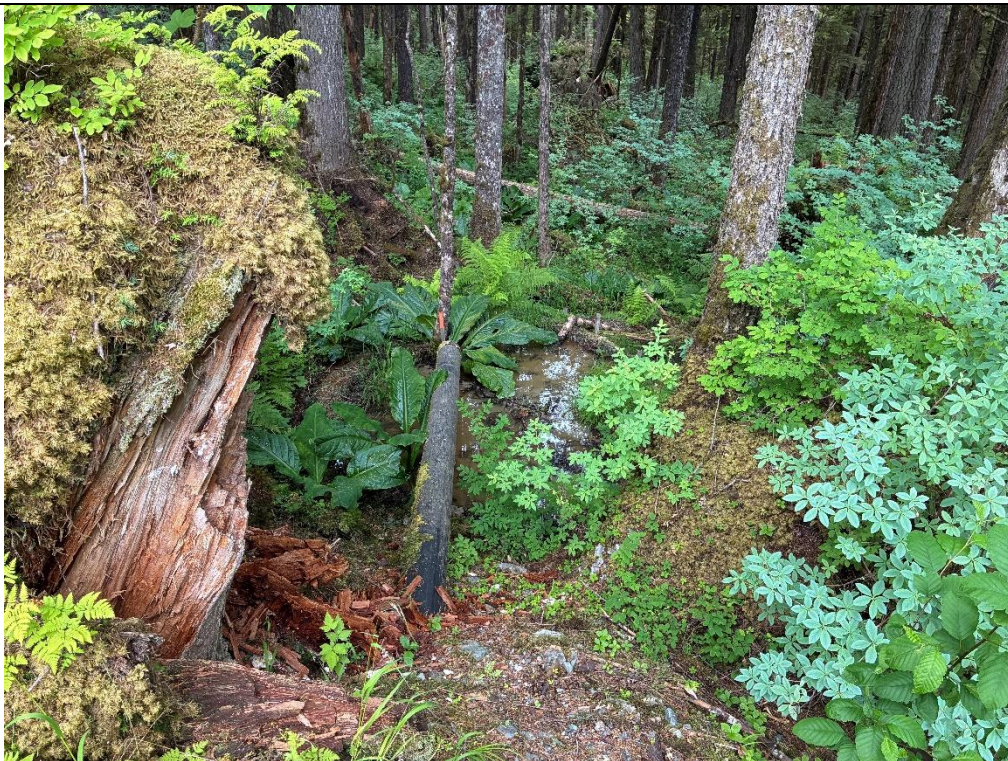
Ponds working as intended and draining as designed utilizing flocculant logs to pull sediment out of the flow of water into the ponds. Outfall looks clean and functioning properly (Photos 31 & 32).

**Photo 31: Gnome Ponds**

**Photo 32: Gnome Ponds outfall.**

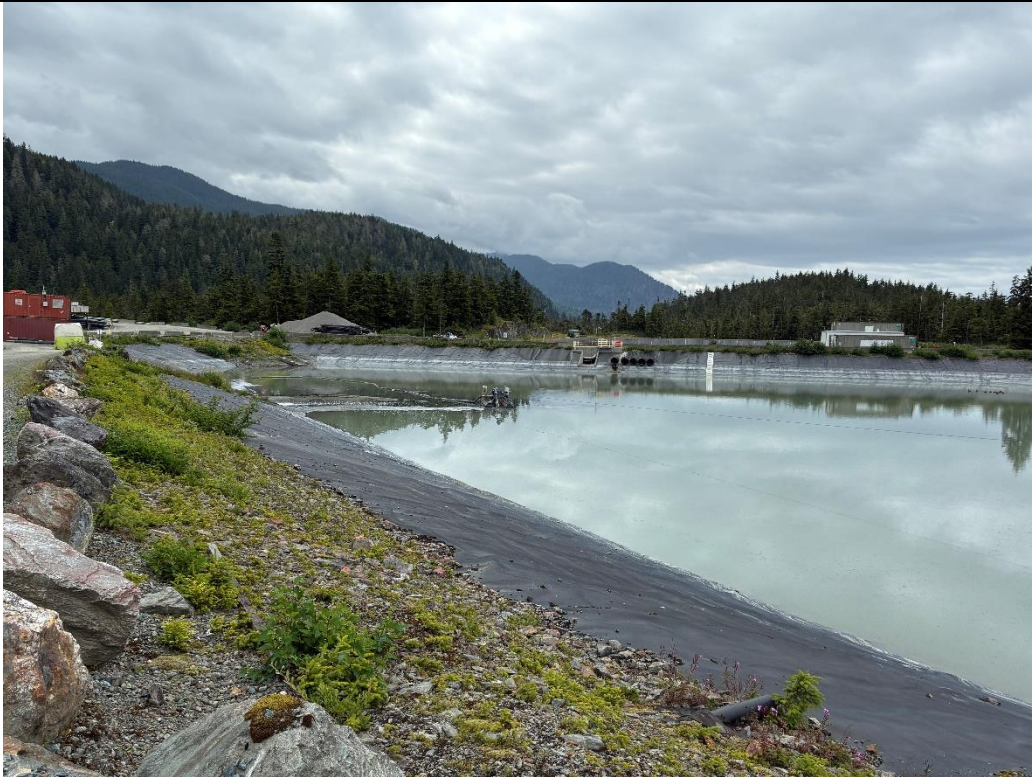
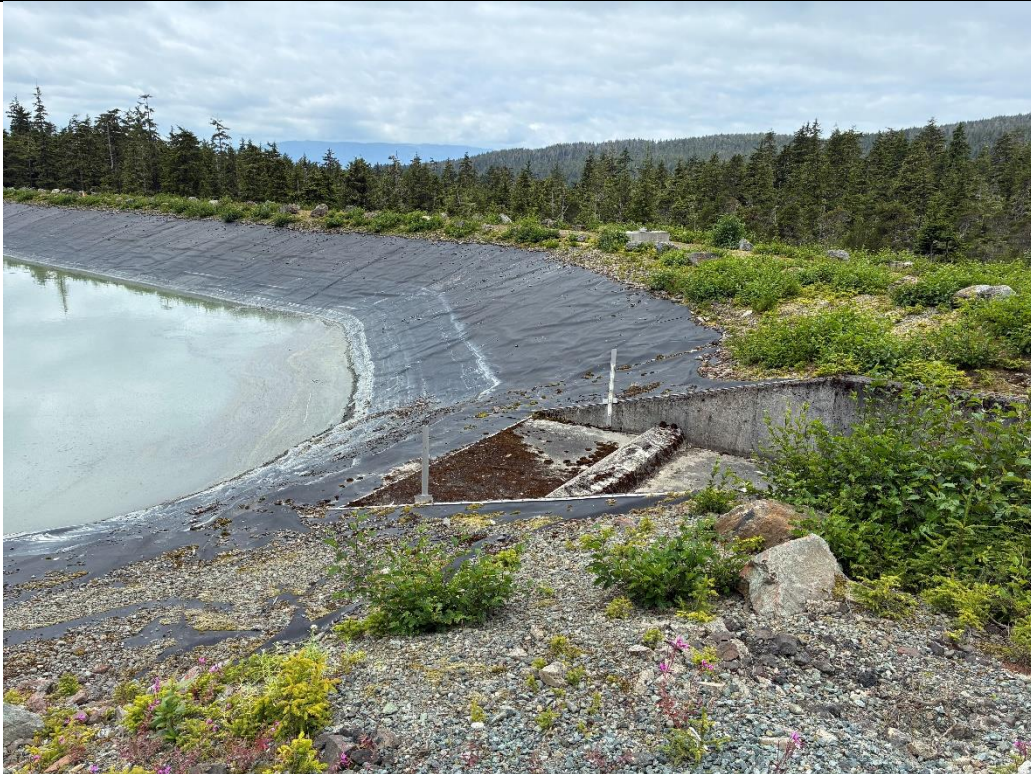
Tails being dredged and pumped to dewatering bags in Pond 10. No evidence of overflow at spillway (Photos 35 & 36).

**Photo 35: Pond 7 dredge working to pump tails to Pond 10 and into dewatering bags.**

**Photo 36: Pond 7 spillway.**

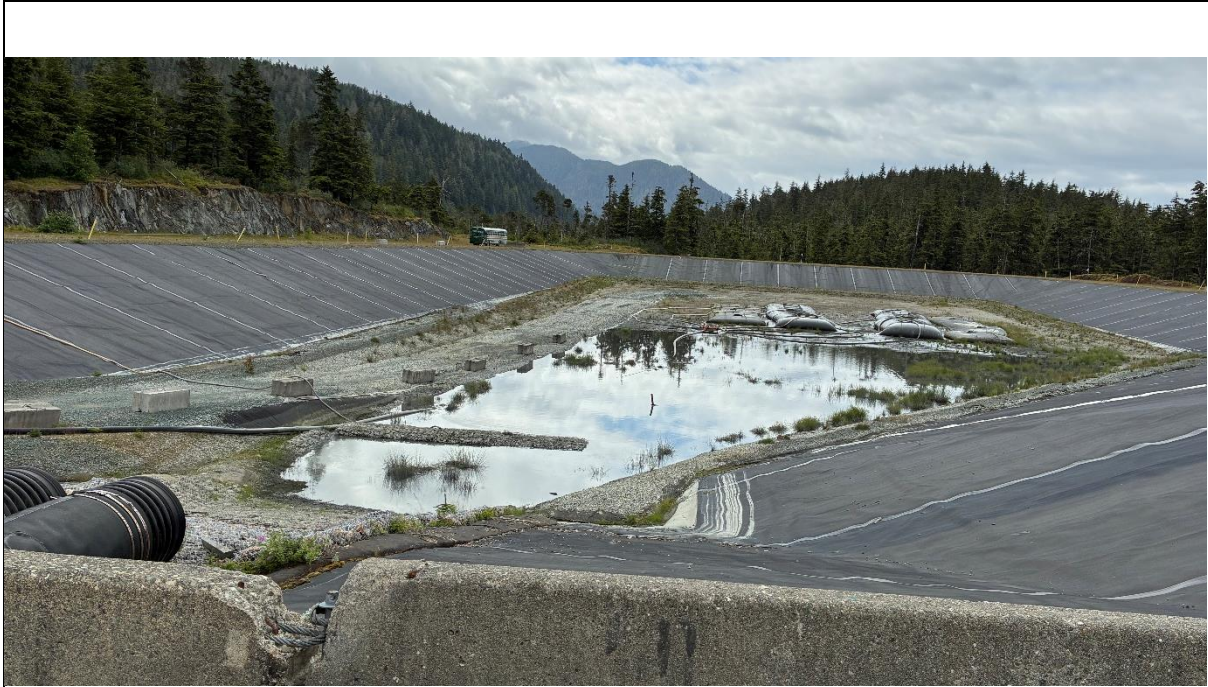
Overview with tails dewatering bags in background and fill pipe in foreground (Photo 37).

**Photo 37: Overview of Pond 10 with tails dewatering bags being filled from dredge in Pond 7.**

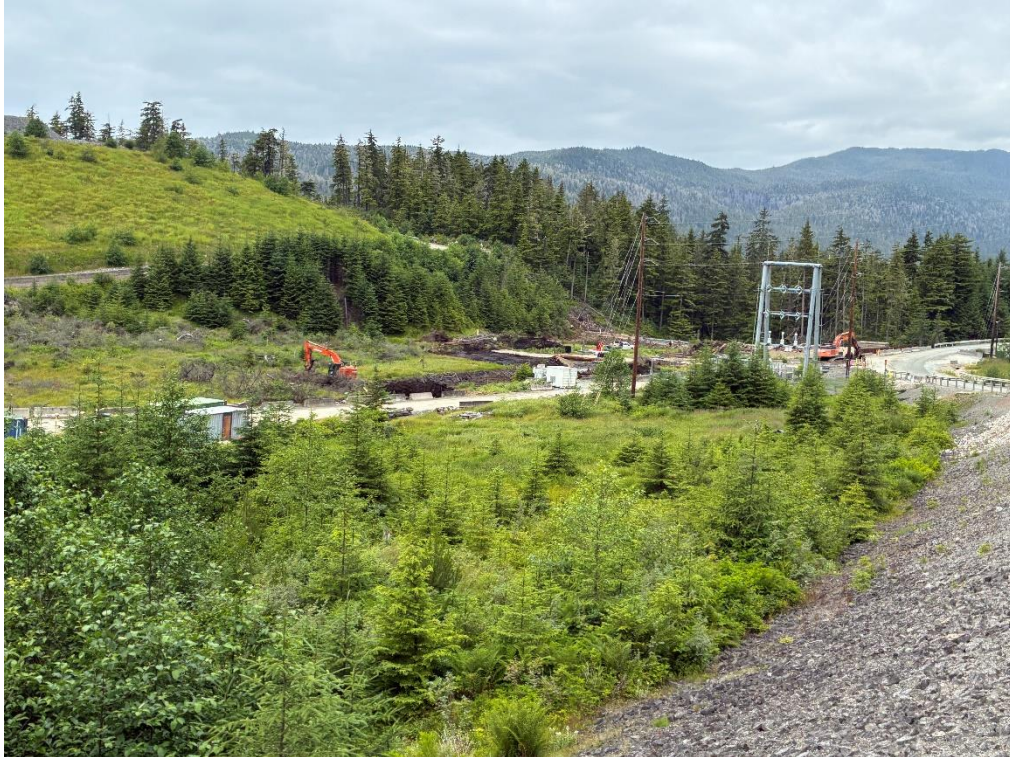
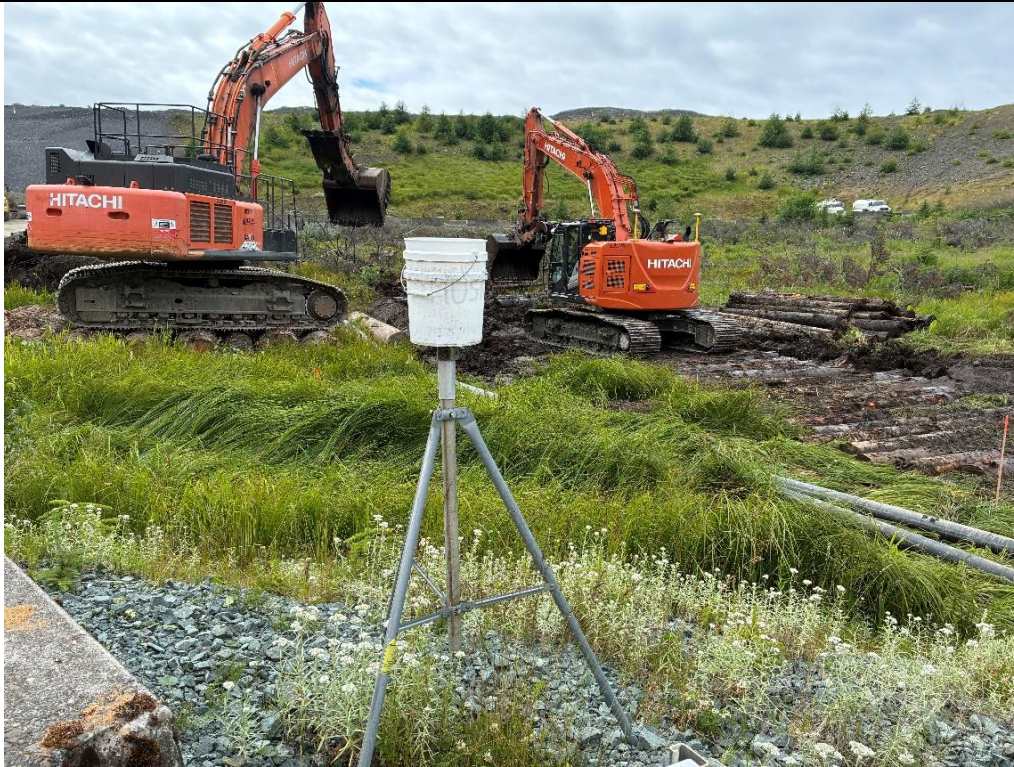
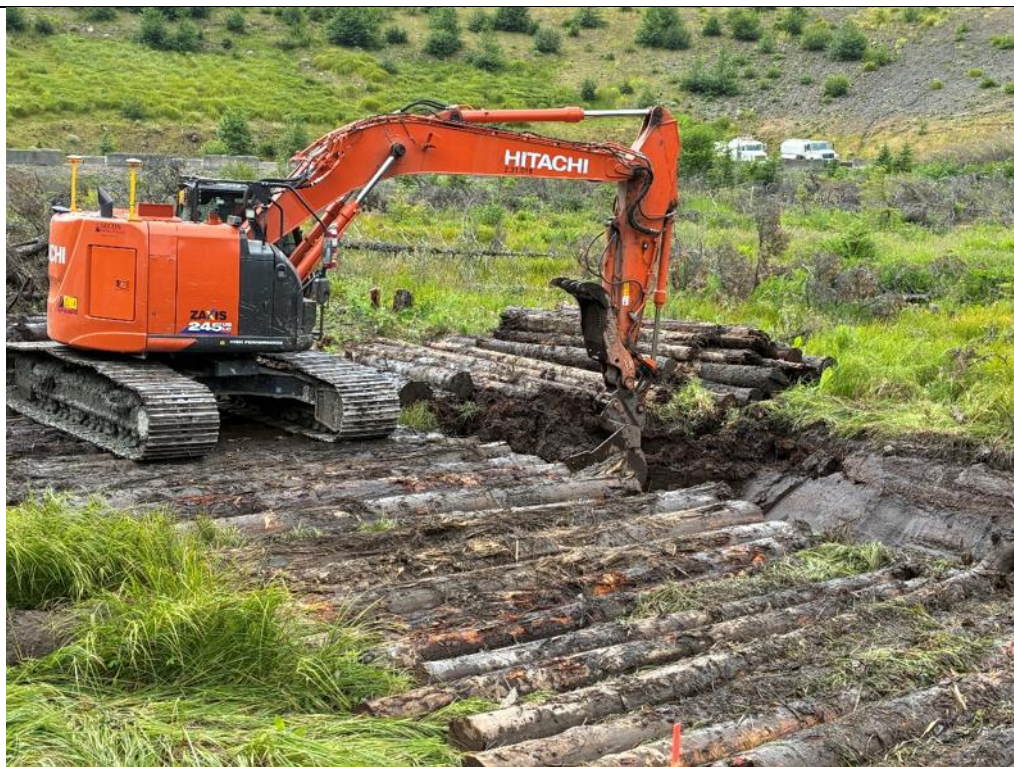
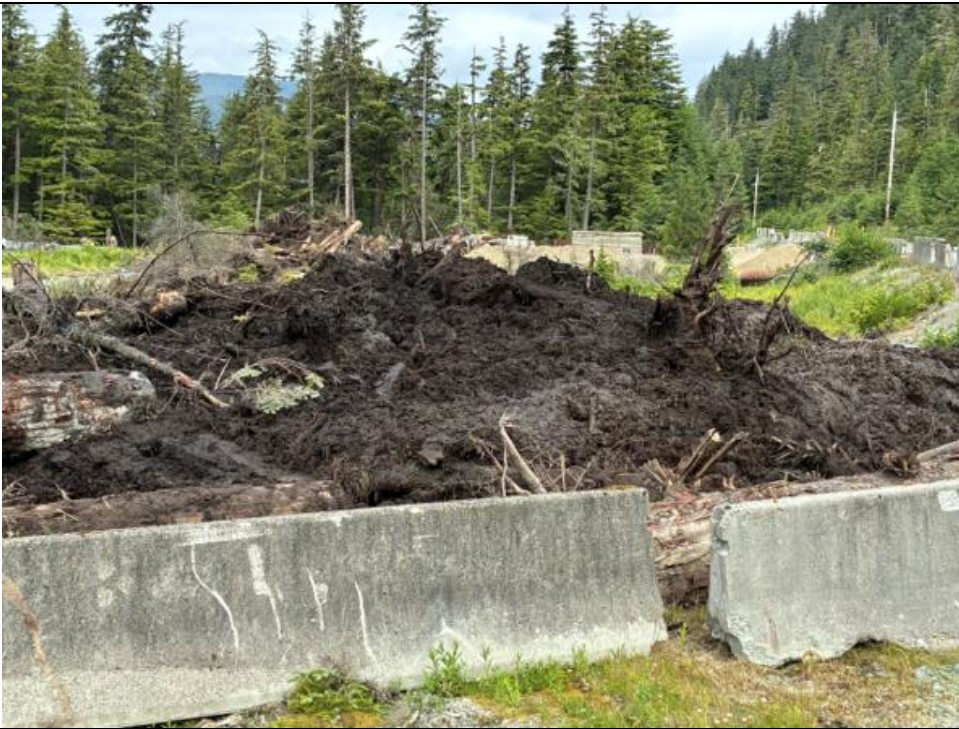
Construction has begun on trenches to drain the area. Peat stored near excavation activity. (Photo 38 - 41).

**Photo 38: Overview of the NEP as seen from B Road.**

**Photo 39: Fugitive Dust collection container near the NEP.**

**Photo 40: Trenching for dewatering of the NEP. Excavator utilizing corduroy road for minimal ground disturbance.**

**Photo 41: Temporary peat storage at the NEP.**

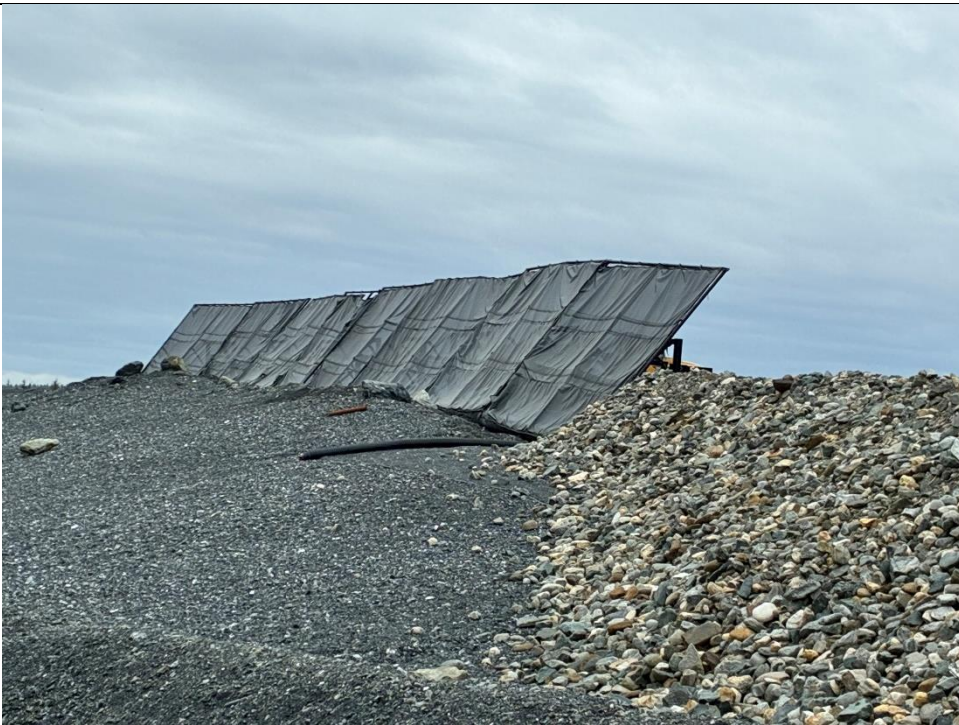
Tailings Disposal Facility (Photo 41).

**Photo 42: Fugitive Dust Mitigation at the Tailings Disposal Facility.**
