INSPECTION REPORT: GREENS CREEK MINE

Date of Inspection: Thursday, January 22, 2026
Date of Report: January 30, 2026
USDA Forest Service Inspector: Scott Leslie

Ranger District: Admiralty National Monument, Juneau Ranger District
Weather Conditions: Clear and Sunny. Temperature: upper 30's (°F).

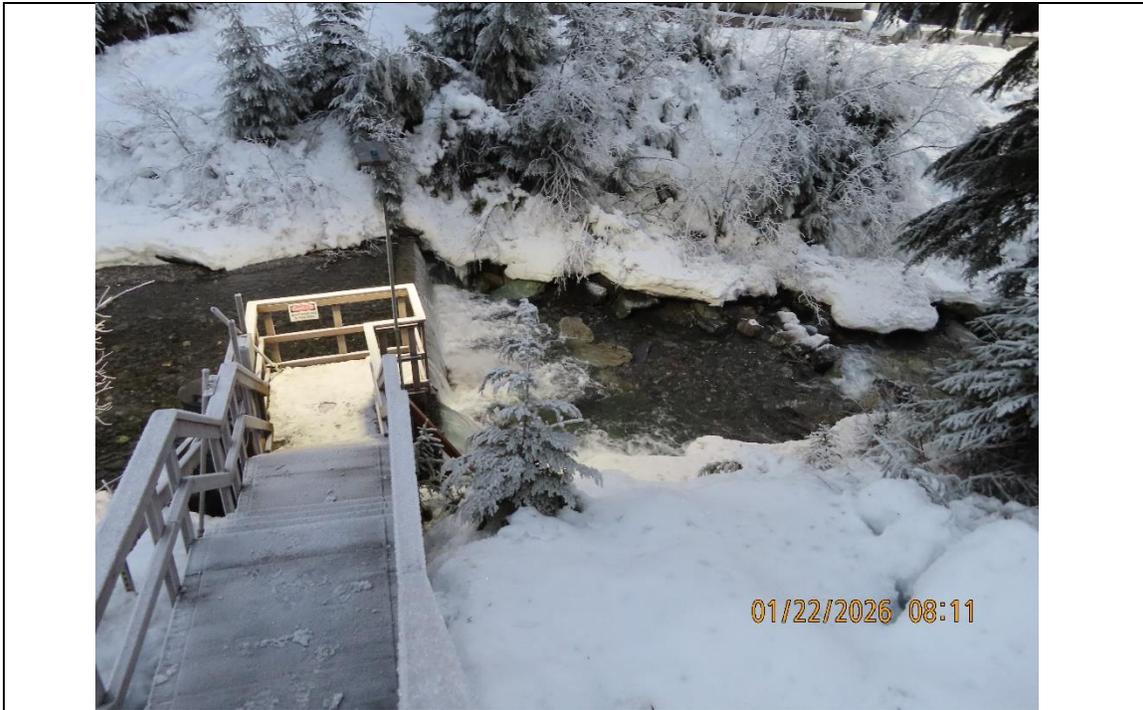
Greens Creek Weir (Photo 1).

Photo 1: Greens Creek Weir.

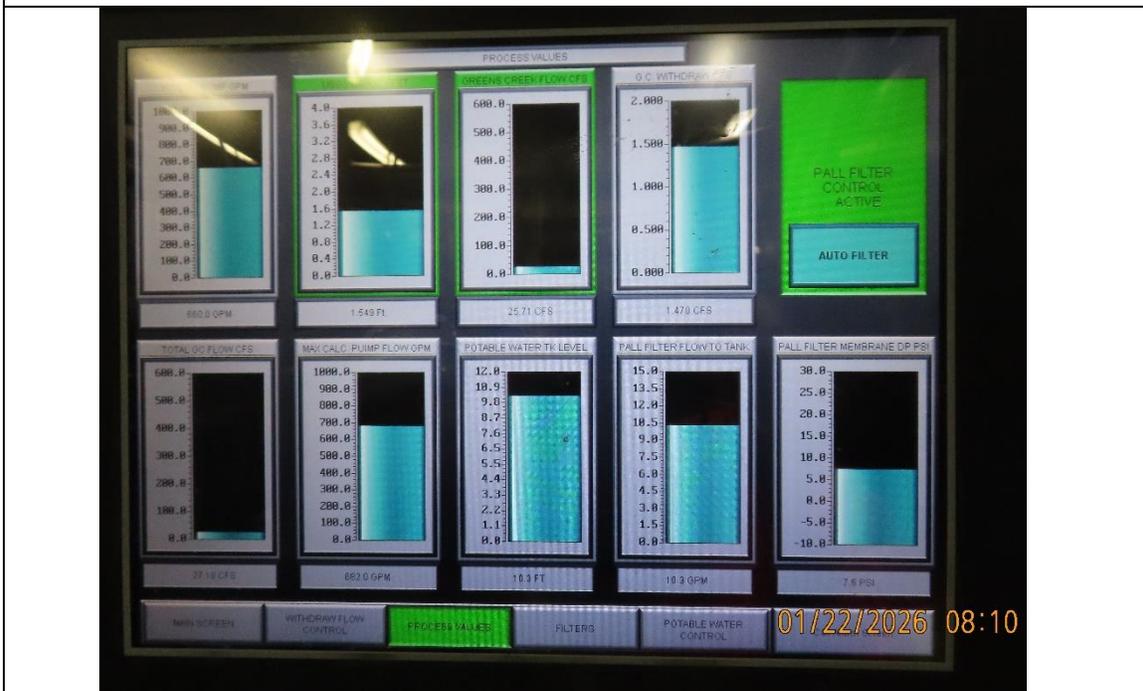
Freshwater Plant, Greens Creek weir discharge flow at **25.15 cfs** and **1.47 cfs** being withdrawn for the 920 facilities. Plant clean and orderly (Photo 2).

Photo 2: Freshwater Plant readings.

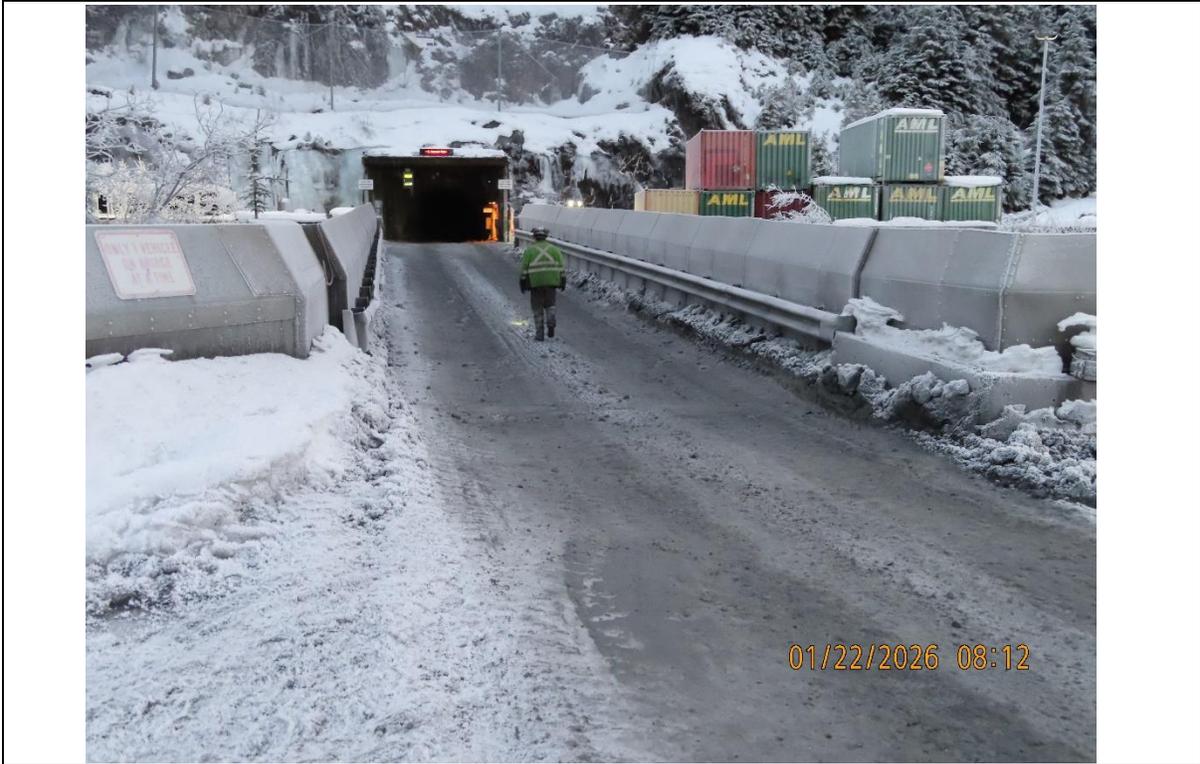
920 Bridge in good condition. Metal sheeting placed along the bridge decking to mitigate for smoother surface transition at abutment joints (Photo 3).

Photo 3: 920 Bridge.

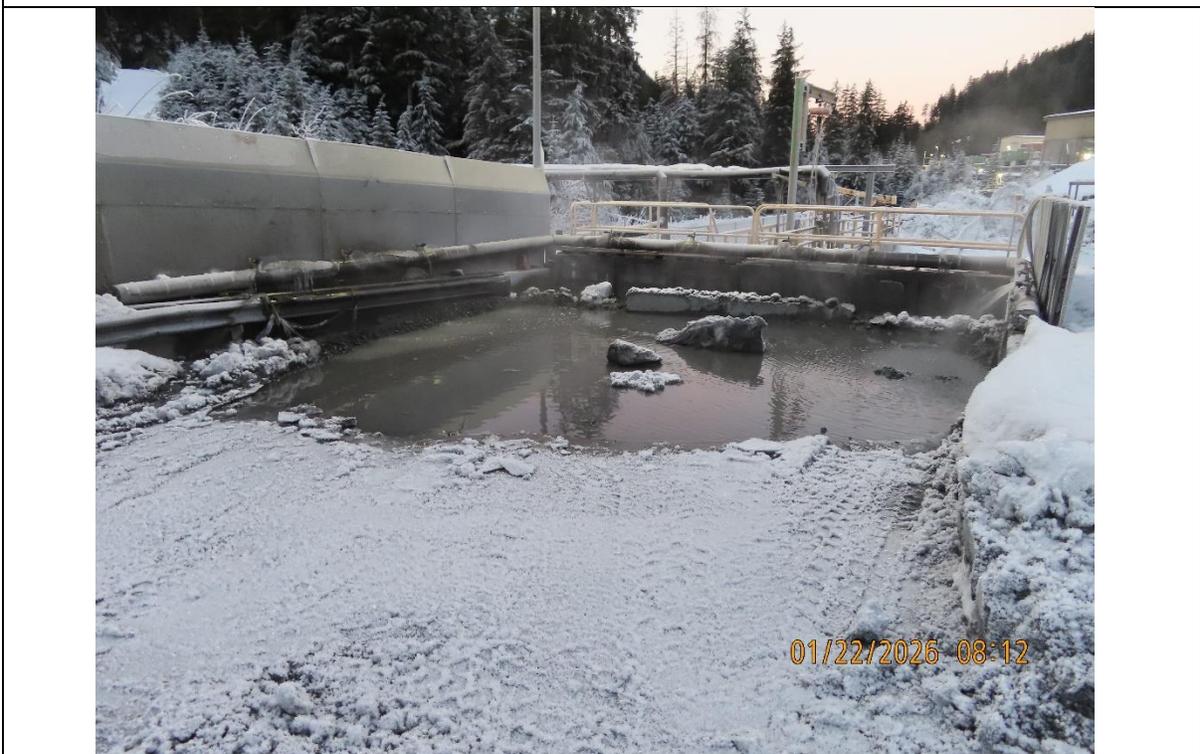
Degrit Basin (DB-01) appears in good working order (Photo 4).

Photo 4: Degrit Basin (DB-01).

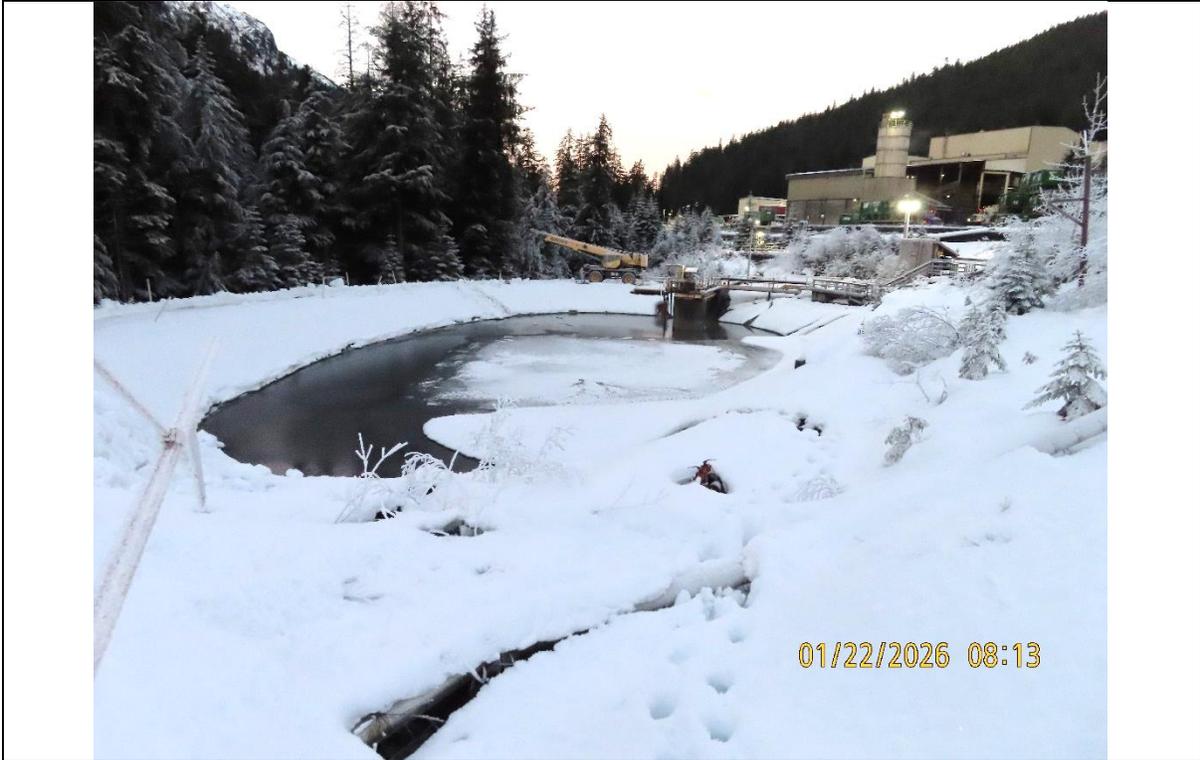
Pond A appears to be in good working condition with no visible overflow (Photo 5).

Photo 5: A Pond.

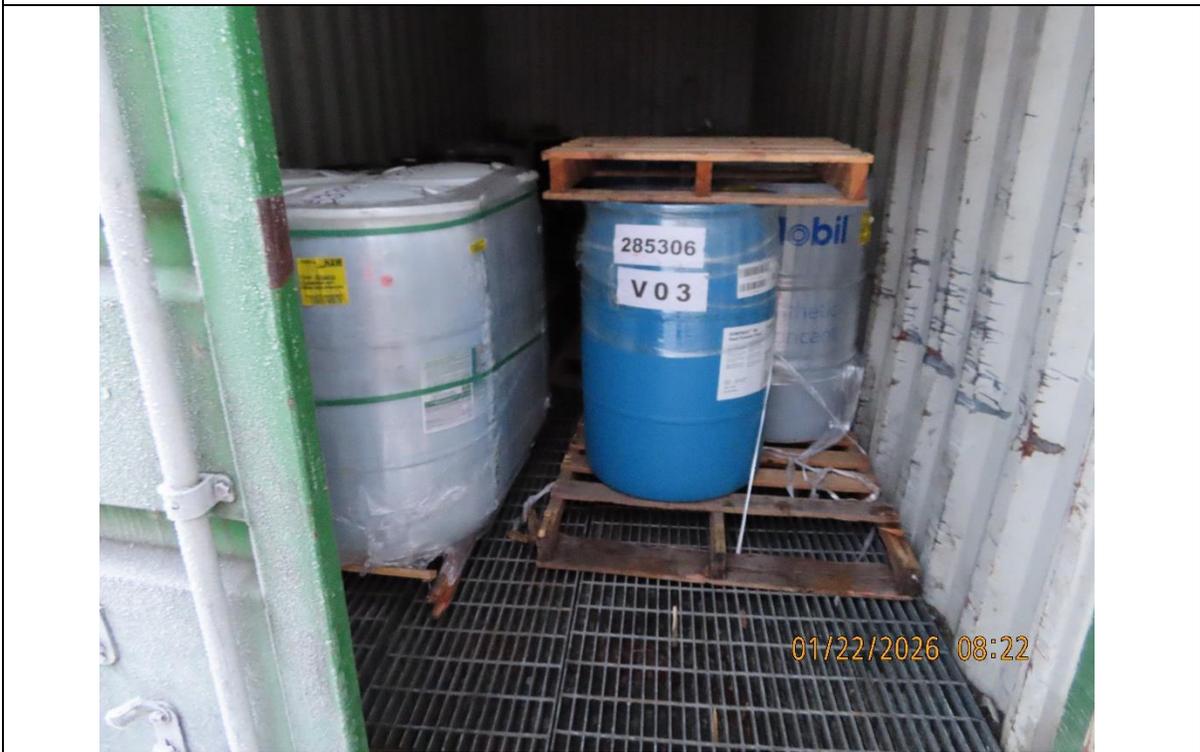
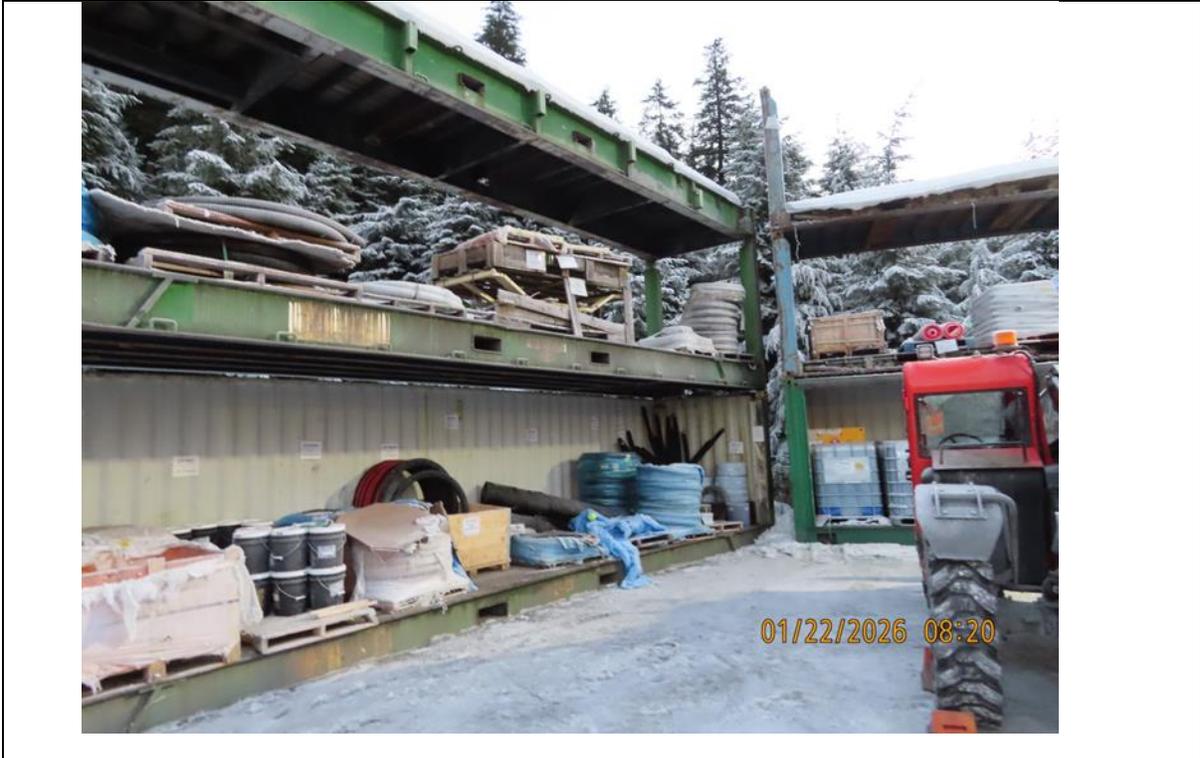
920 Warehouse Good housekeeping practices were observed at the storage containers with petrochemicals properly stored with secondary containment (Appendix 5 BMP Plan, page 37) (Photos 6 & 7).

Photo 6: 920 warehouse storage container.

Photo 7: 920 warehouse area.

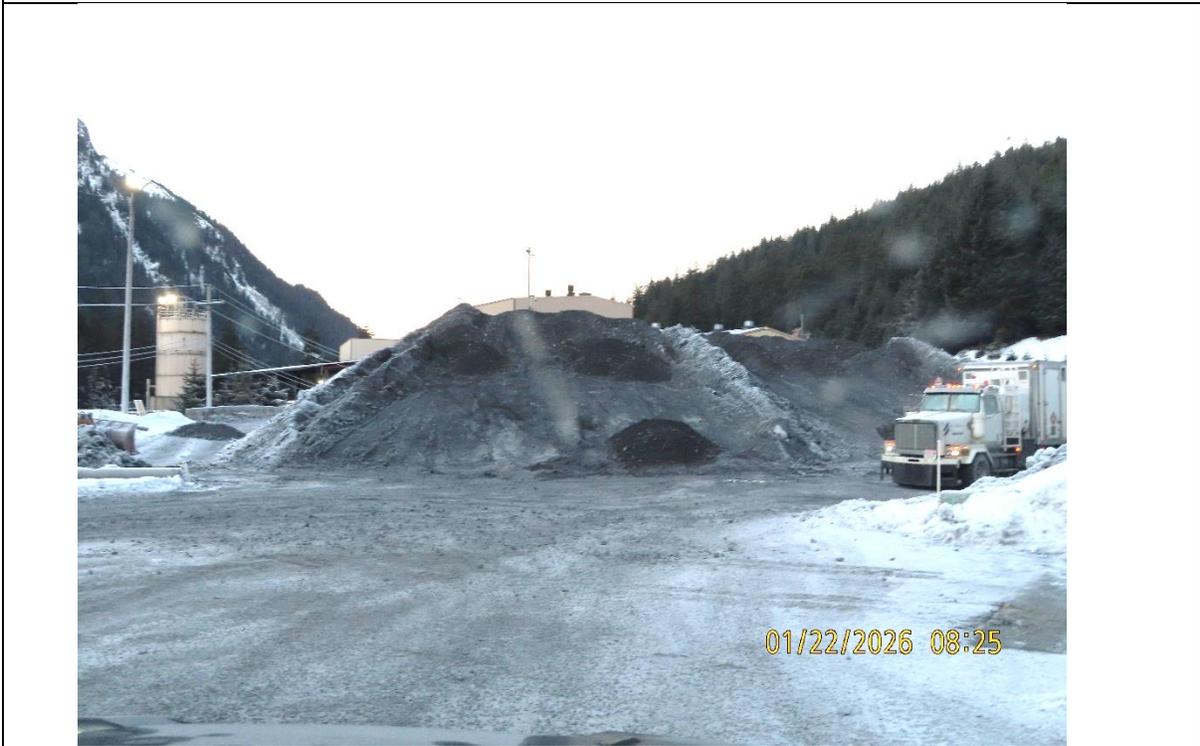
Ore Pad in use staging ore from 920 adit ready to transport to mill (Photo 8).

Photo 8: Ore pad.

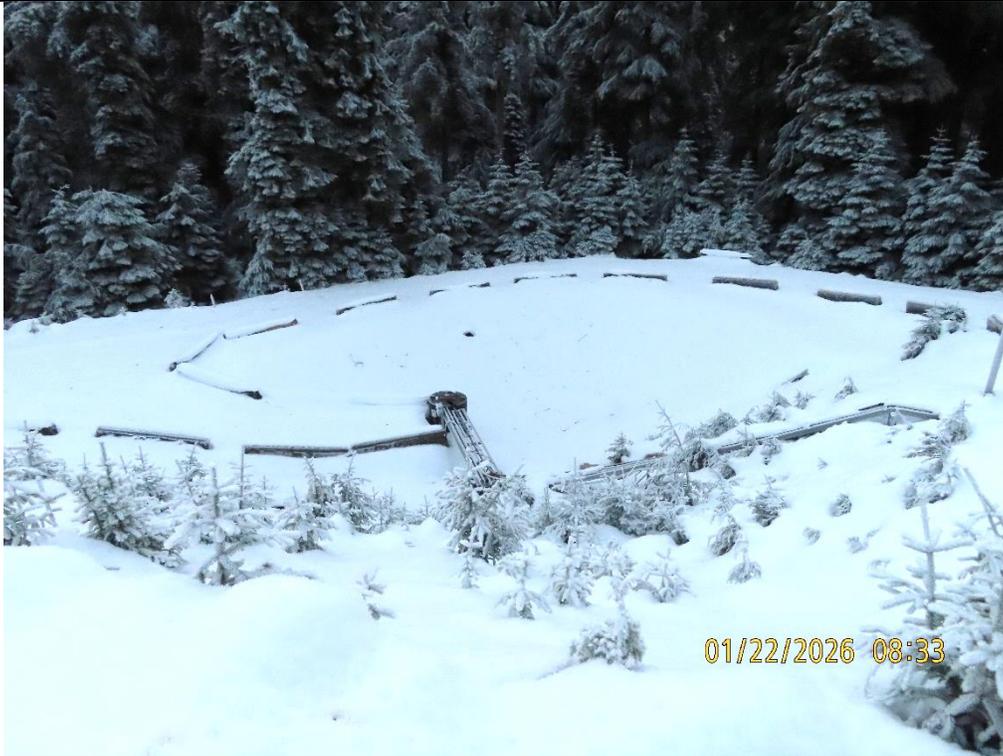
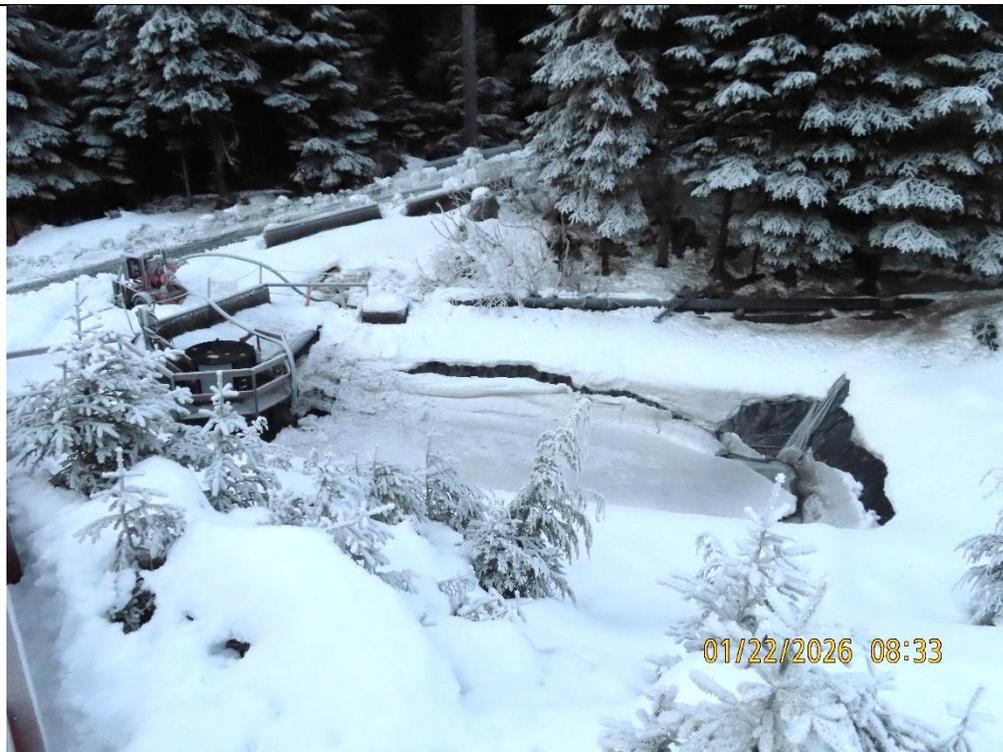
The upper and lower ponds appear to be operable with no visible signs of overflow (Photos 9 & 10).

Photo 9: Lower C Pond.

Photo 10: Upper C Pond. Evidence of raised pond level but no overflow outside of the pond.

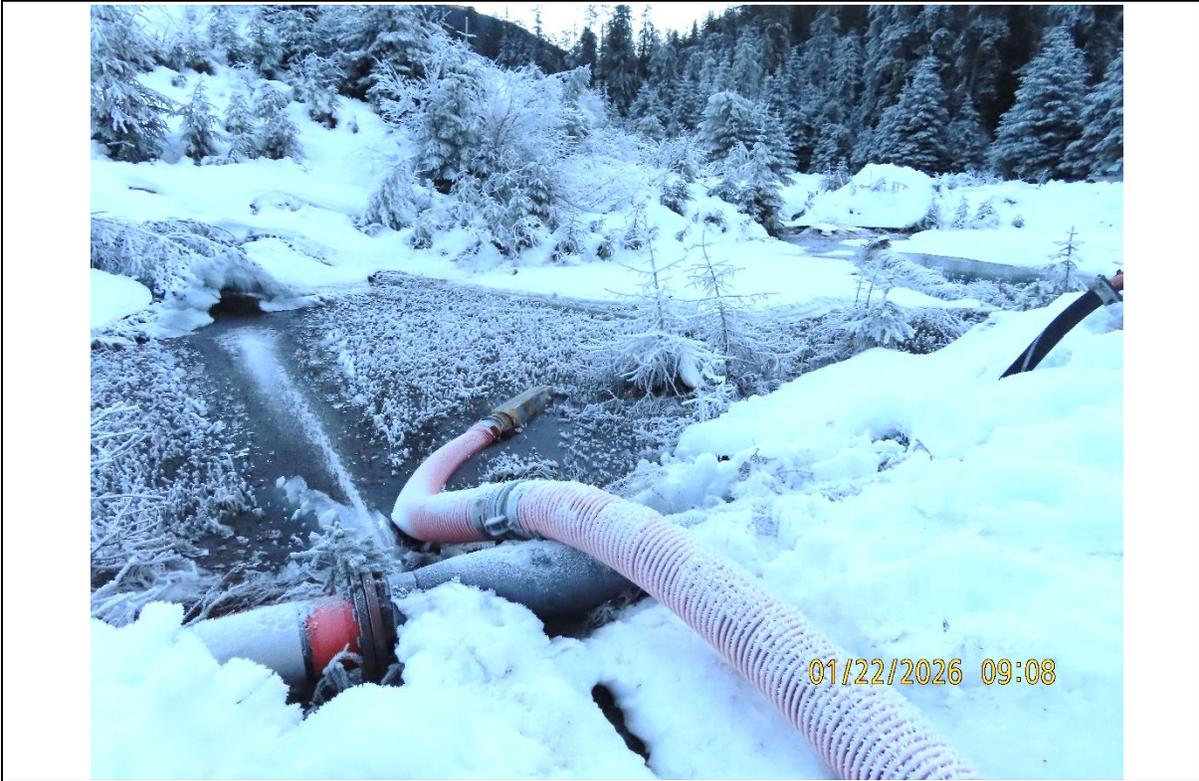
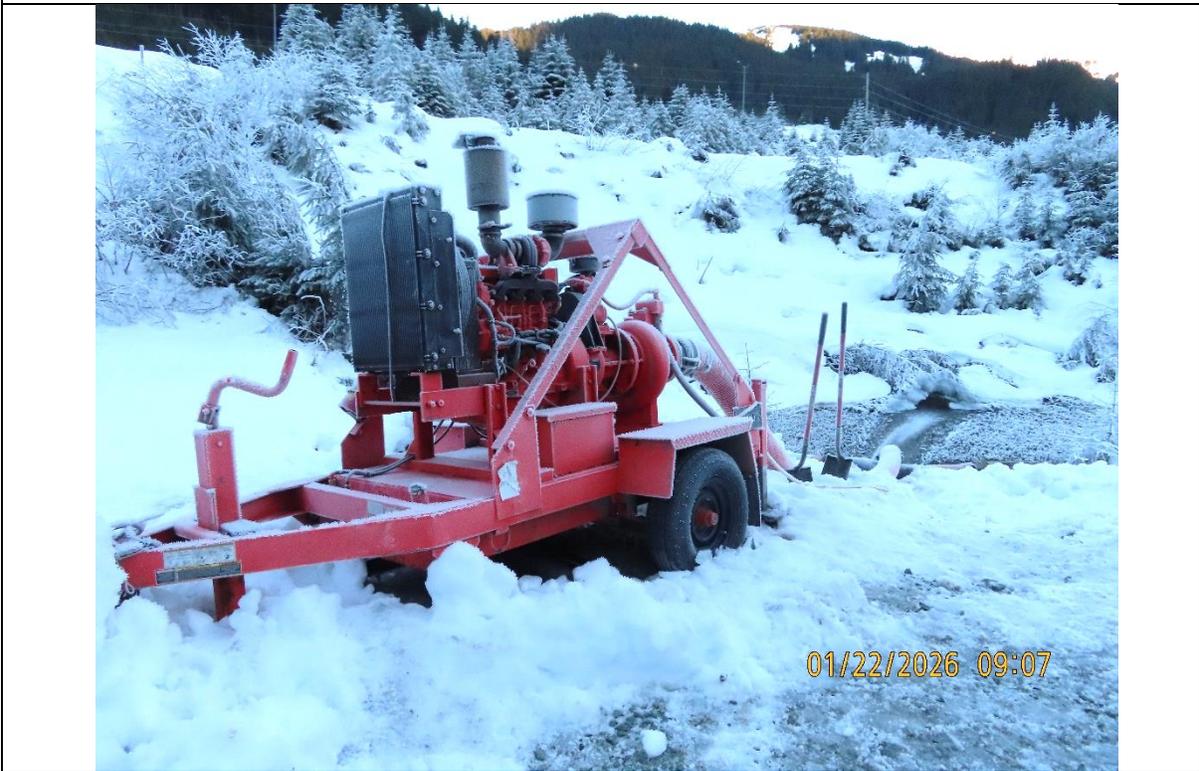
Intact and appears to be functioning as intended (Photo 11 & 12).

Photo 11: D Pond.

Photo 12: D Pond Pump.

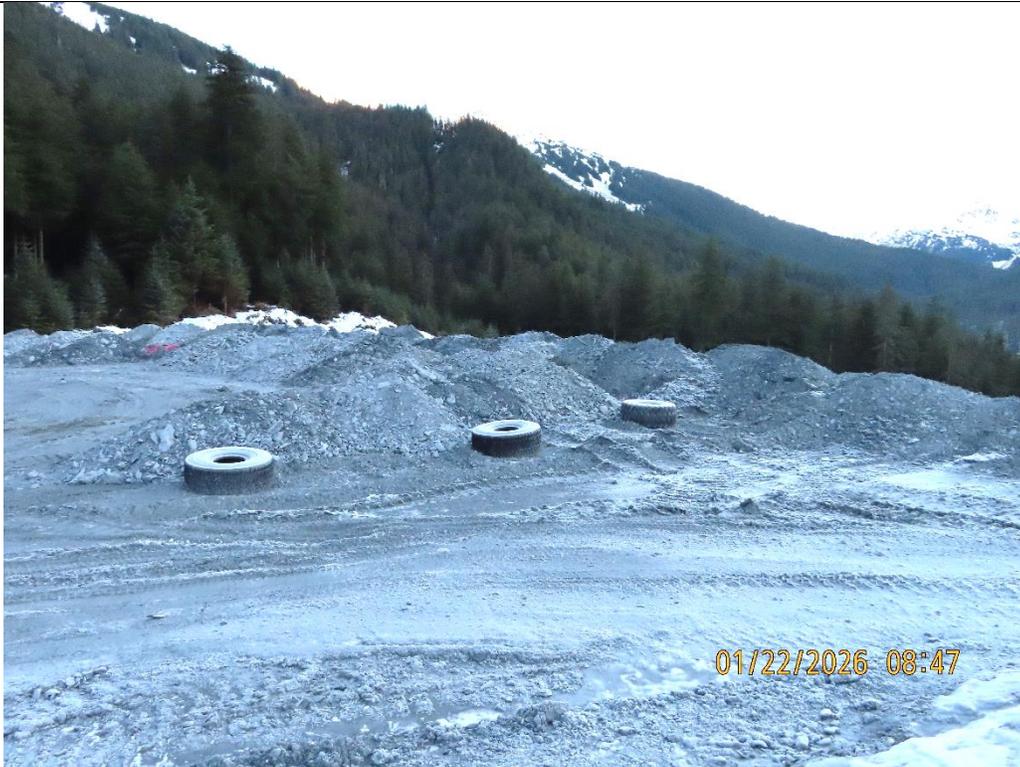
HGCMC continues to stage Class 1, 2, and 3 waste rock at this location. Class 4 waste rock is kept and disposed of underground (Appendix 11 Waste Rock Management Plan, page 11). Class 1 rock (argillite) is used as an inert capping material over top of Class 2 and 3. (Photo 13).

Photo 13: Site 23 Class 2 & 3 Material on top of storage area.

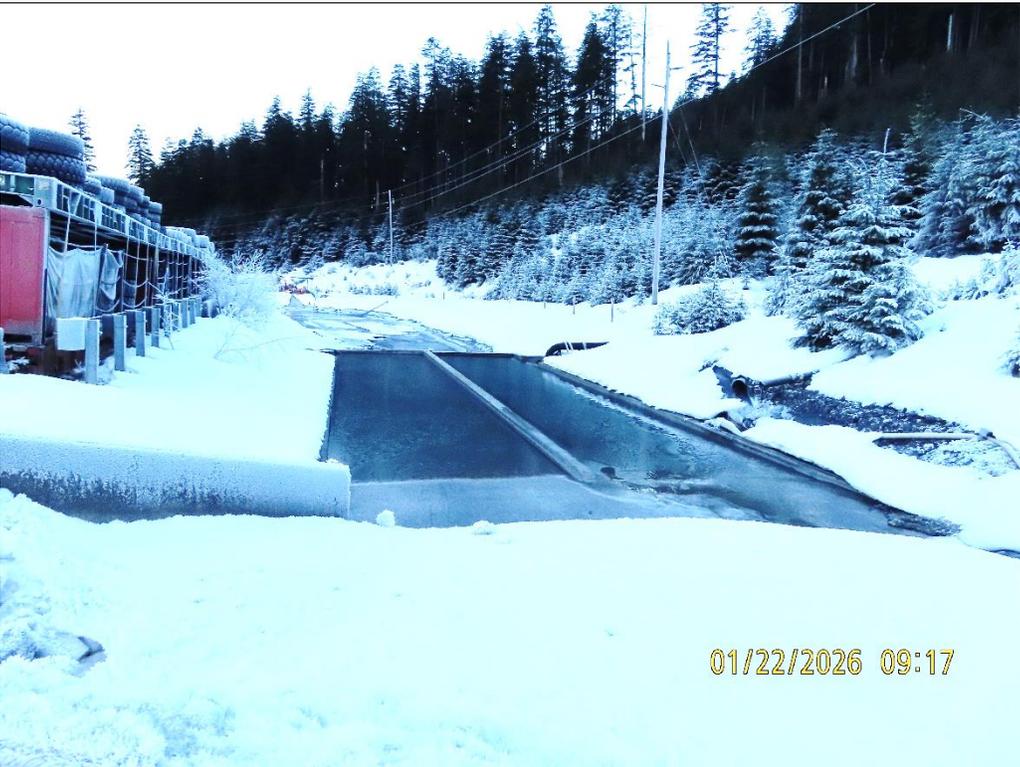
Degrit Basin BD-03 Runoff entering basin as designed and appears to be functioning as intended. The 23 Pond can be seen in the background (Photo 14).

Photo 14: DB-03 and 23 Pond and Pump in background.

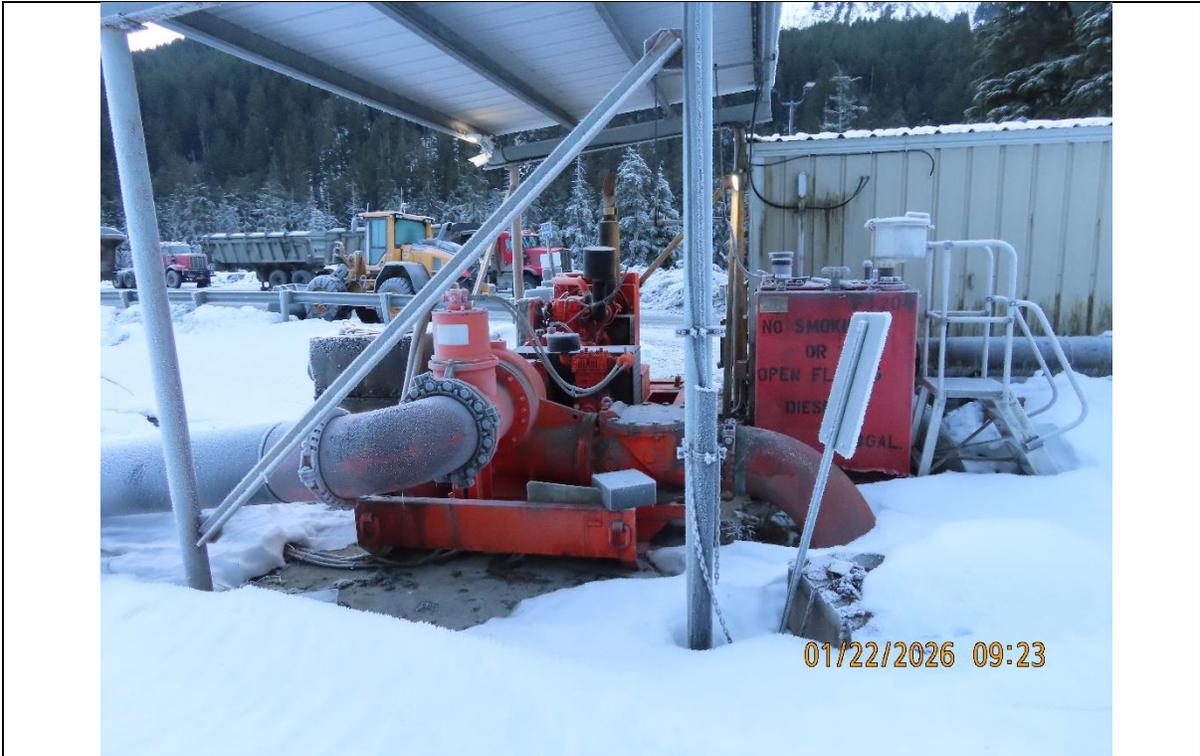
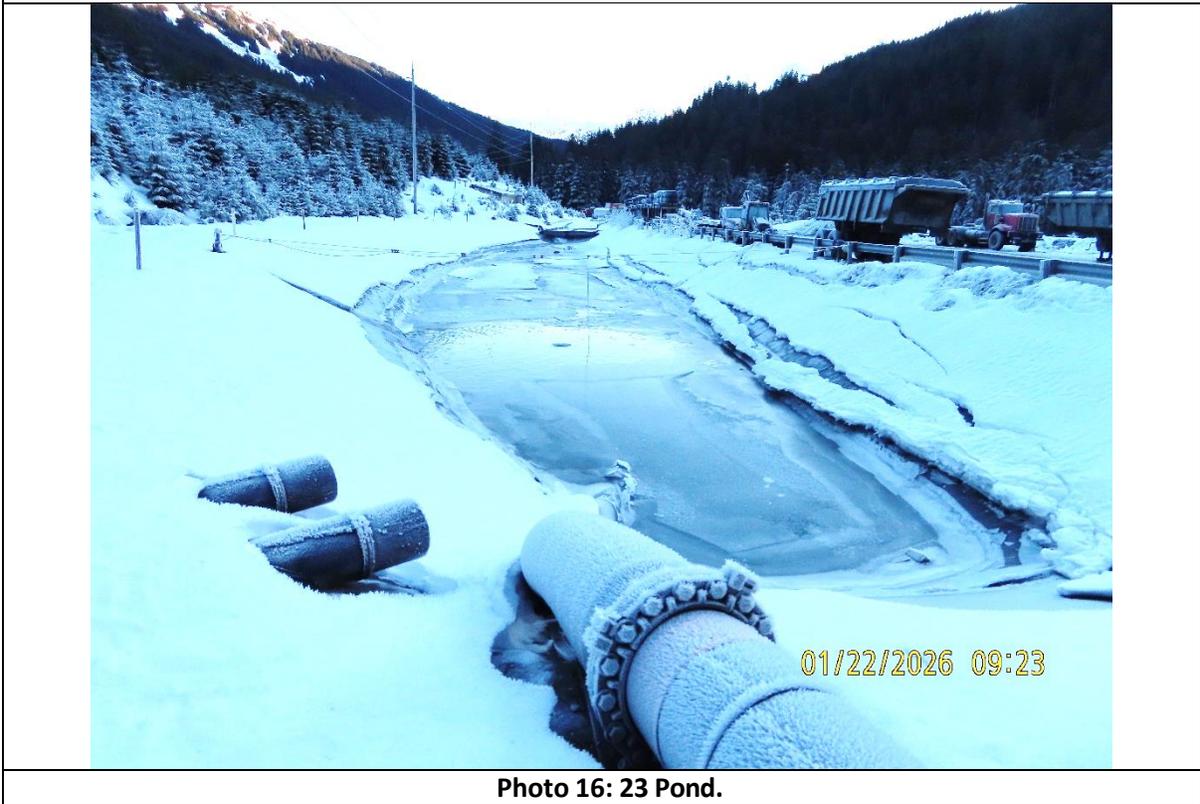
The pump area area was clean and orderly. Pond appeared to be operable with no visible signs of pond overflowing (Photos 15 & 16).

Photo 15: 23 Pond Pump.

Photo 16: 23 Pond.

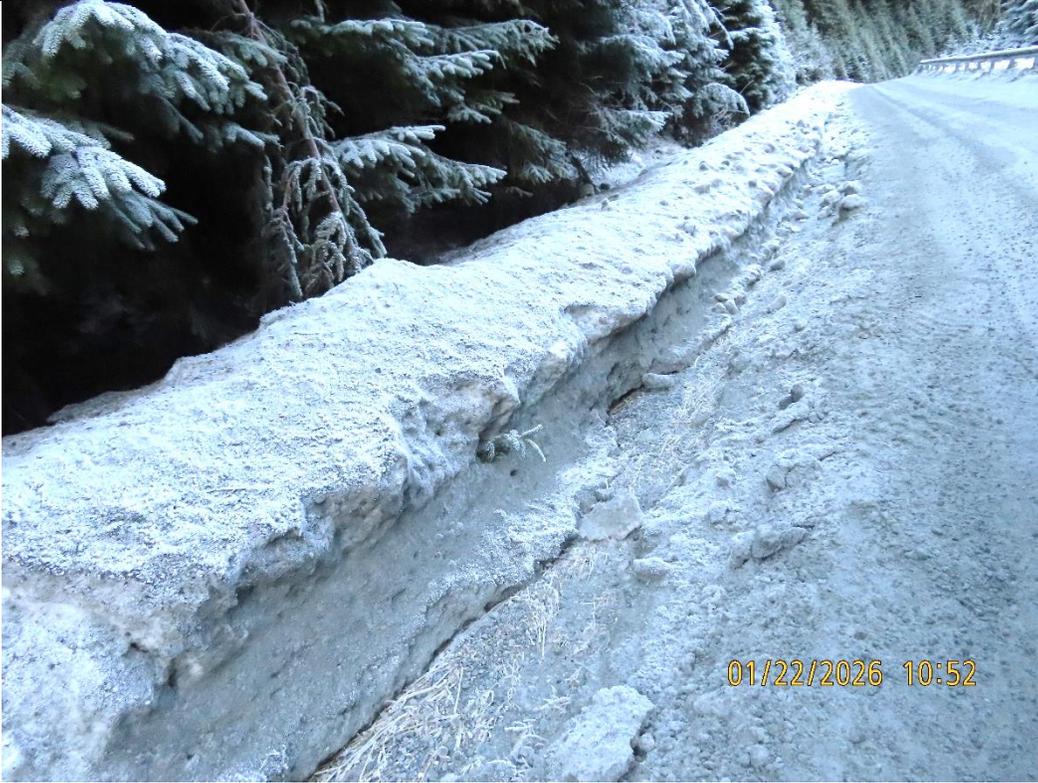
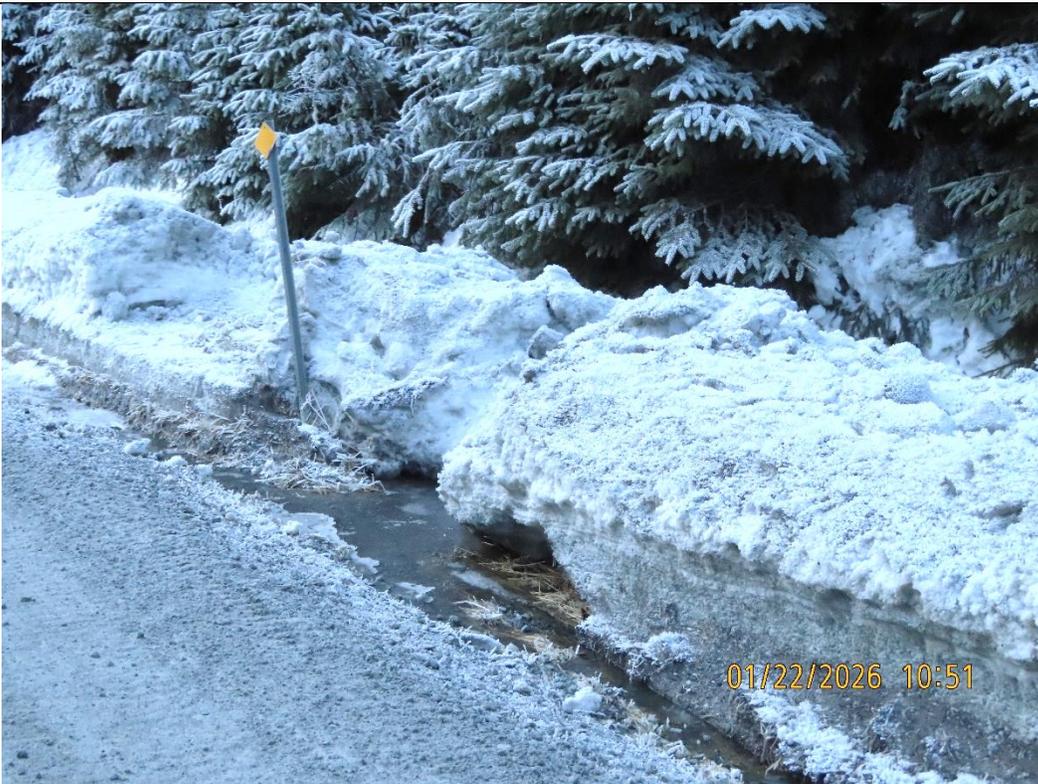
Showing where runoff has occurred in the functioning stormwater ditch and runoff entering culvert as part of the stormwater features along the road. (Photos 17 & 18)

Photo 17: 5.5 Mile B-Road showing where runoff has occurred in the stormwater ditch.

Photo 18: 5.5 Mile B-Road runoff entering culvert as part of the stormwater ditch along road.

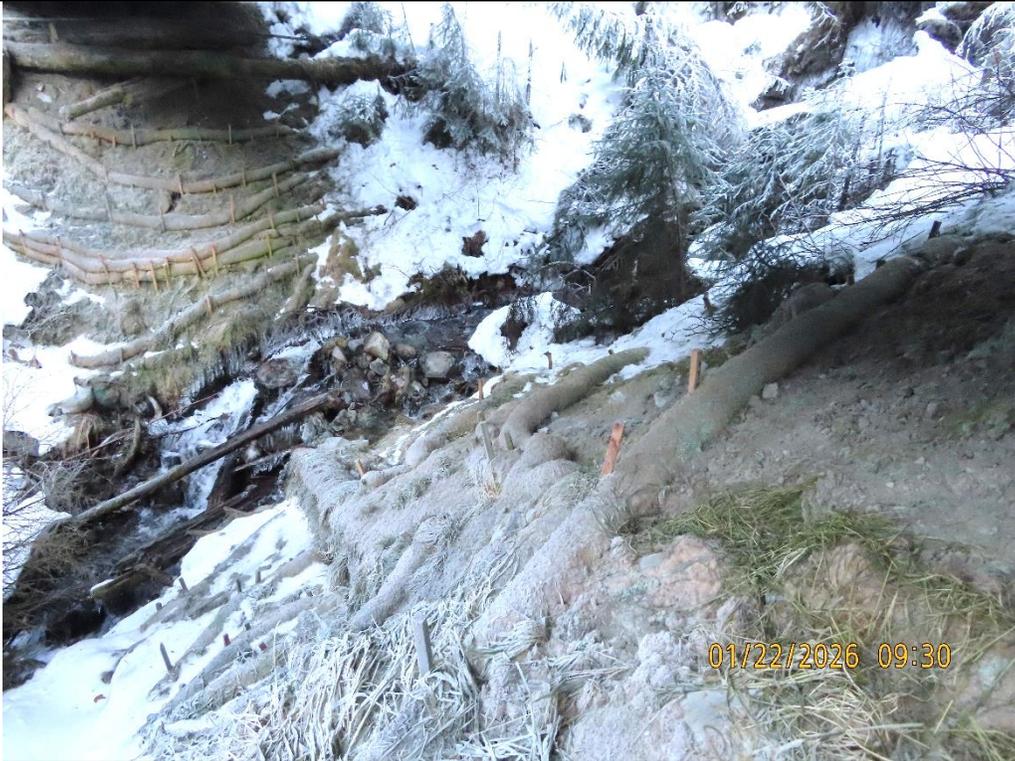
The bridge surface decking was in good condition, but bridge liner is torn in places. HGCMC has had a contractor on site to evaluate corrective measures to the bridge surface. Sediment still leaks from under bridge at abutments. (Photo 19).

Photo 19: 7.4 Mile Bridge (Killer Creek) waddles and hydroseed present collecting sediment.

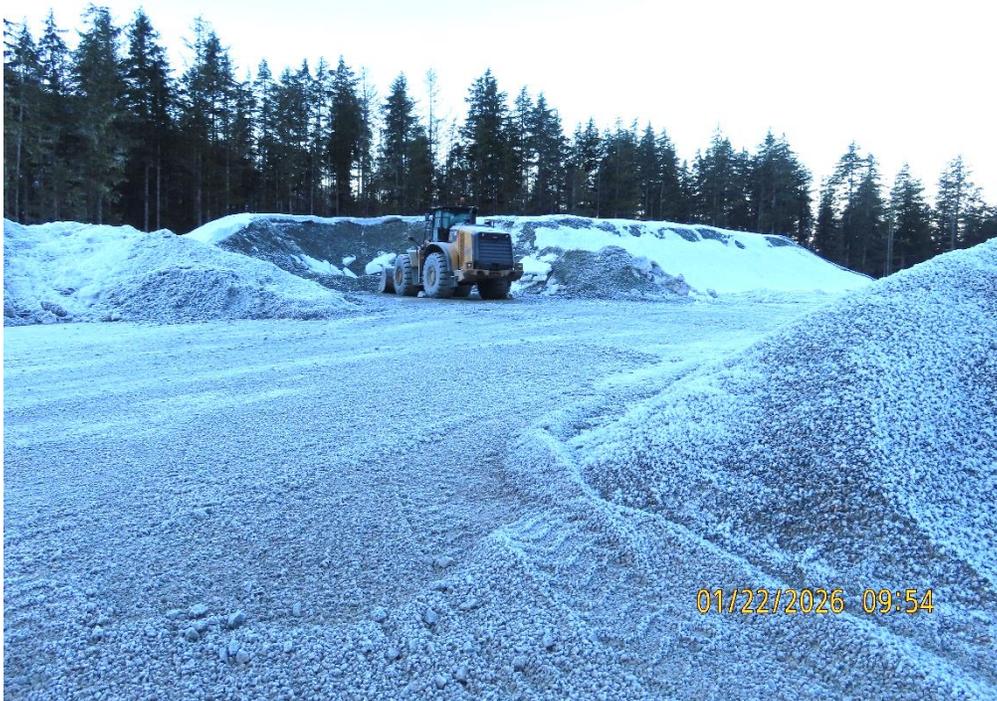
Photo 20: Disposal Site E showing road maintenance gravel storage.

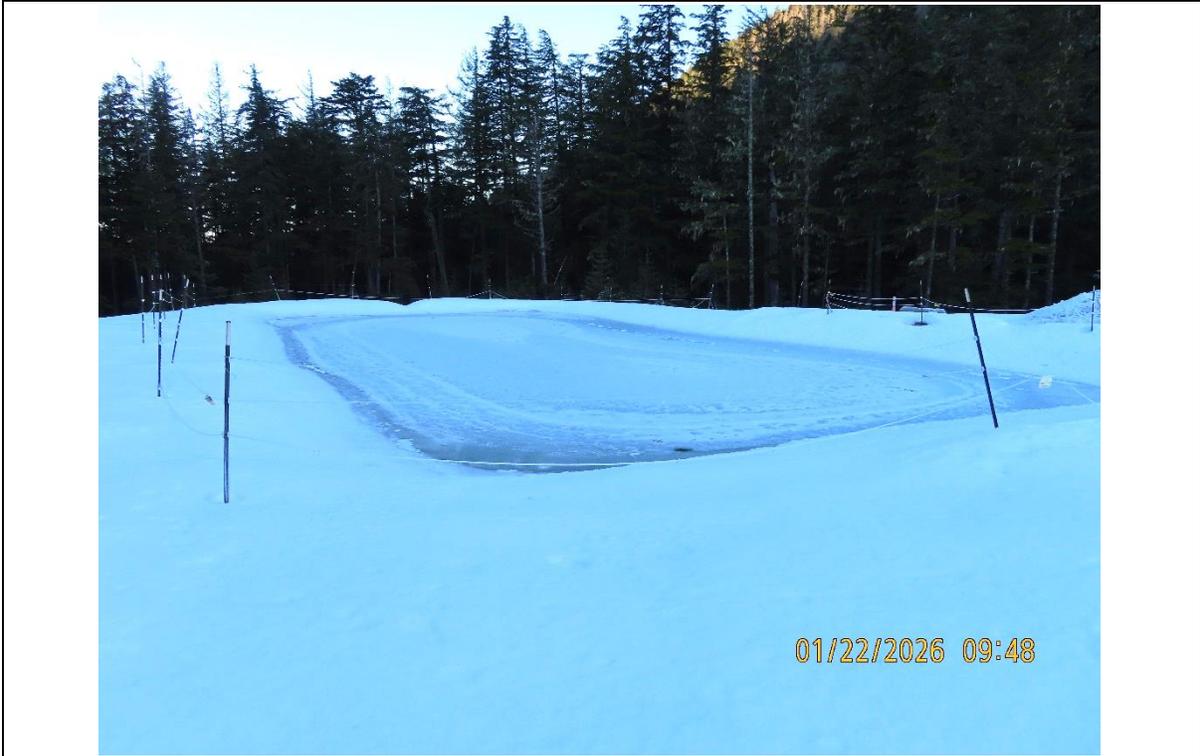
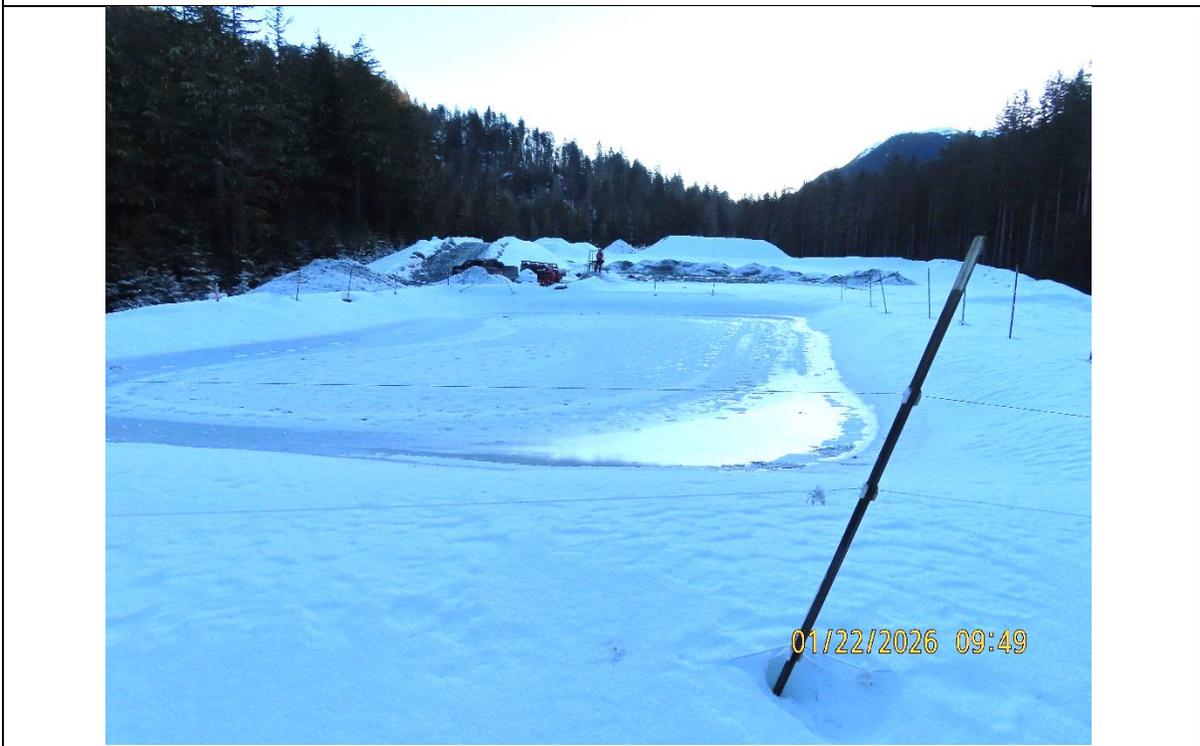
This is an old, early unclassified waste rock site. Material is being stored here to be moved to Tailings Disposal Facility (TDF). Much of the material has been moved to the TDF. The area was in stable condition with active drainage toward the stormwater pond (E POND). The area continues to be used for road rock staging (Photo 20). E pond appeared in good shape but frozen at time of the inspection. Electric bear fence has had one wire pulled out of the post. (Photos 21 & 22).

Photo 21: Disposal Site E Pond looking West.

Photo 22: Disposal Site E Pond looking East.

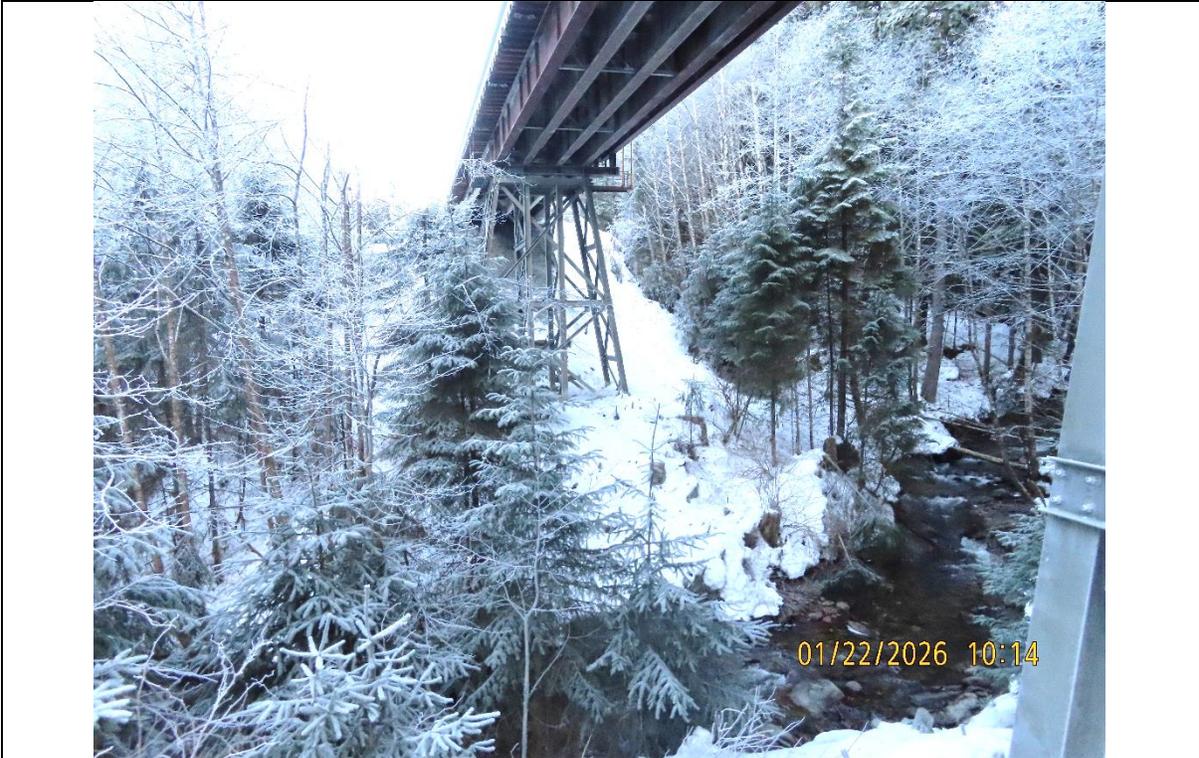
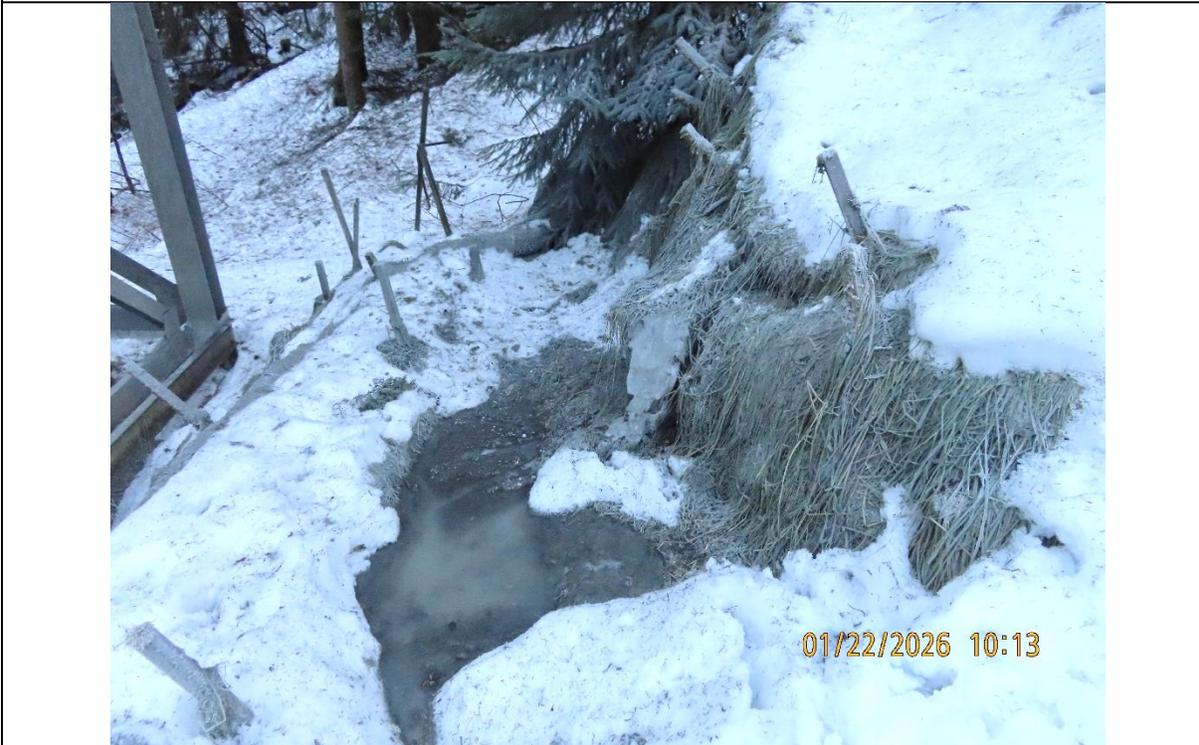
The bridge decking appeared to be in good condition, but sediment is leaking through the entire span of the bridge. Waddles in place and collecting sediment. A contractor is looking at bridges for repair options (Photos 25 & 26).

Photo 25: 3.0 Mile B-Road Bridge structure (Zinc Creek).

Photo 26: 3.0 Mile B-Road Bridge (Zinc Creek) showing sediment catchment features.
