INSPECTION REPORT: GREENS CREEK MINE

Date of Inspection: Thursday, January 22, 2026
Date of Report: January 30, 2026
USDA Forest Service Inspector: Scott Leslie

Ranger District: Admiralty National Monument, Juneau Ranger District
Weather Conditions: Clear and Sunny. Temperature: upper 30's (°F).

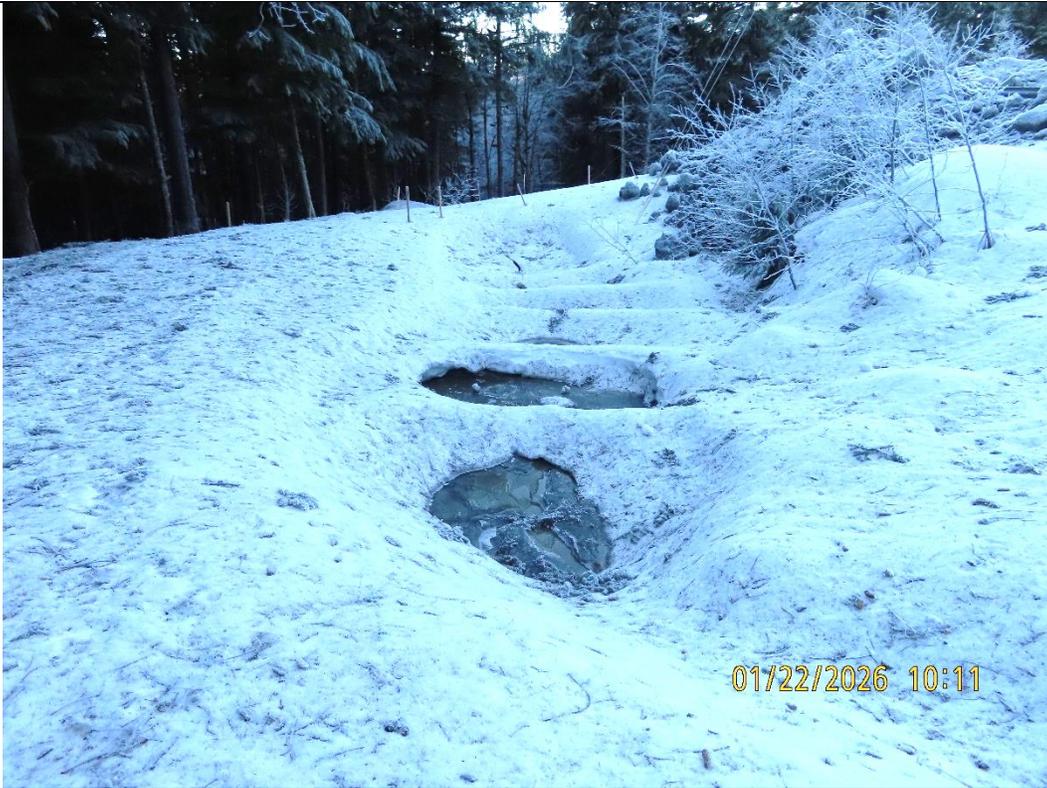
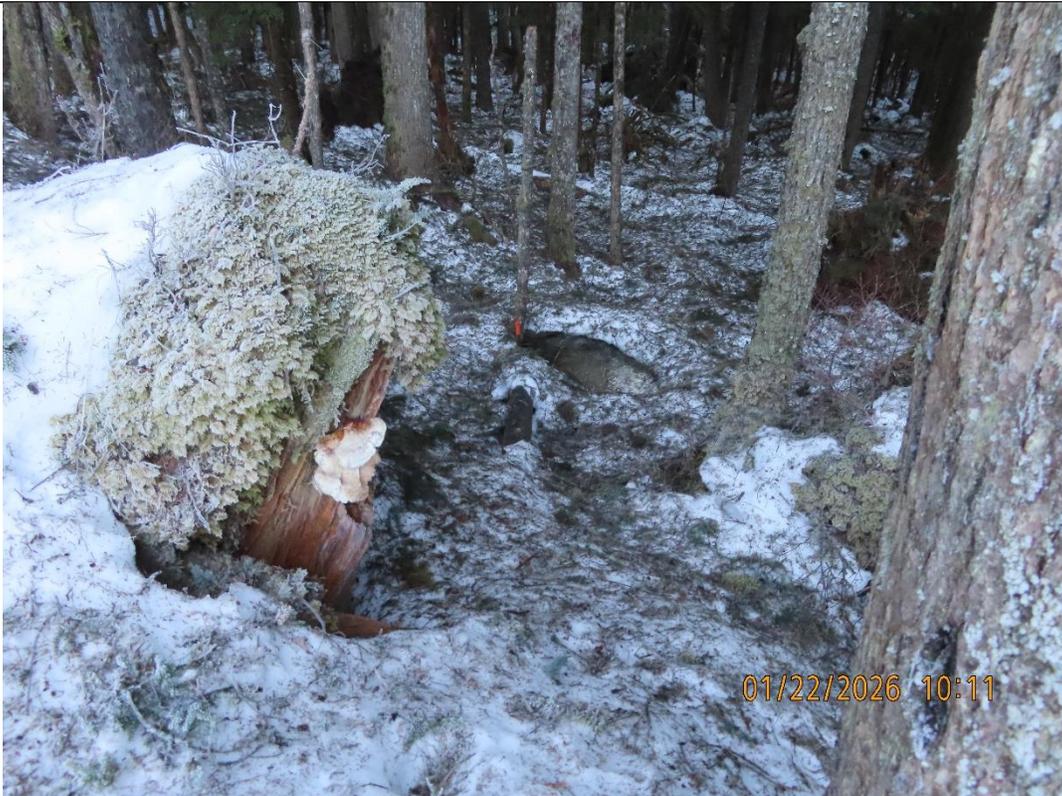
Ponds mostly froze over but still draining as designed (Photos 27 & 28).

Photo 27: 3.0 Mile B-Road Gnome Ponds downstream looking down from road.

Photo 28: 3.0 Mile B-Road Gnome Ponds outfall.

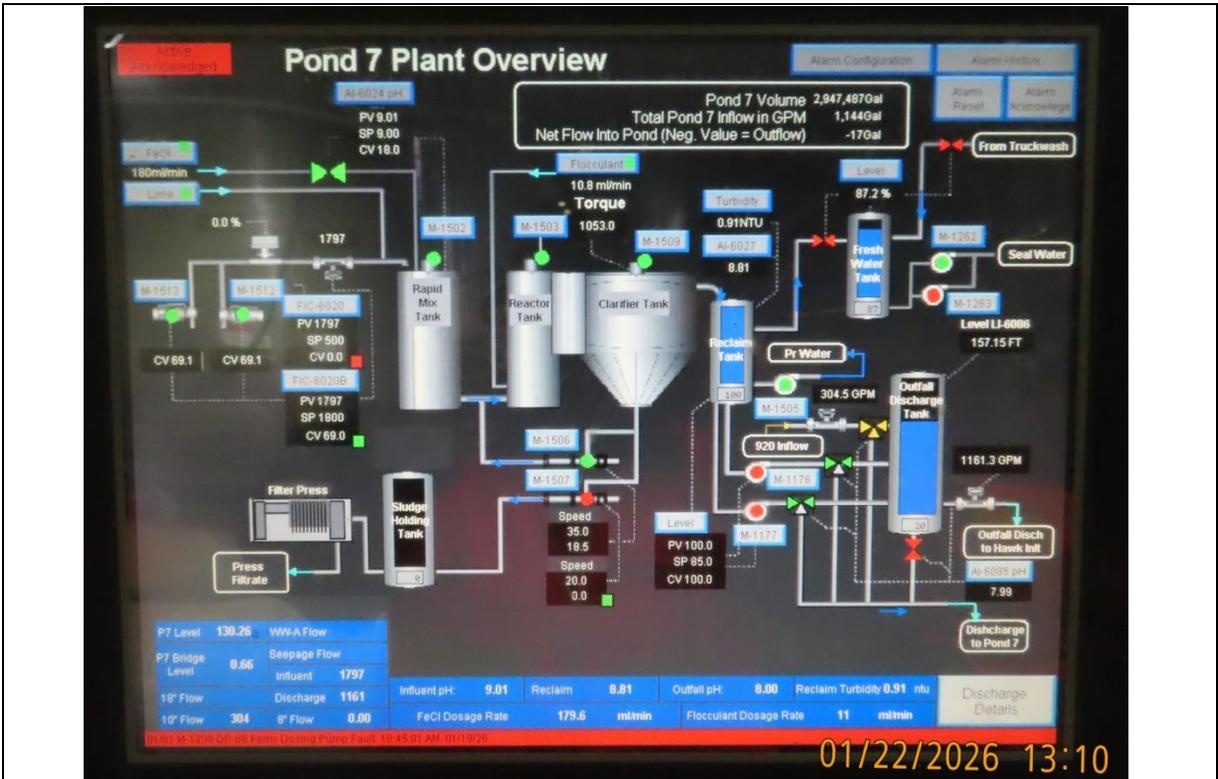
Good housekeeping practices were observed in the TDF water treatment plant (Appendix 5 BMP Plan, page 37). The water treatment plant was discharging approximately 1161 gpm to Outfall 002 with a pH of 8.0, and turbidity of .91 NTU (Photo 29).

Photo 29: TDF water treatment plant readings.

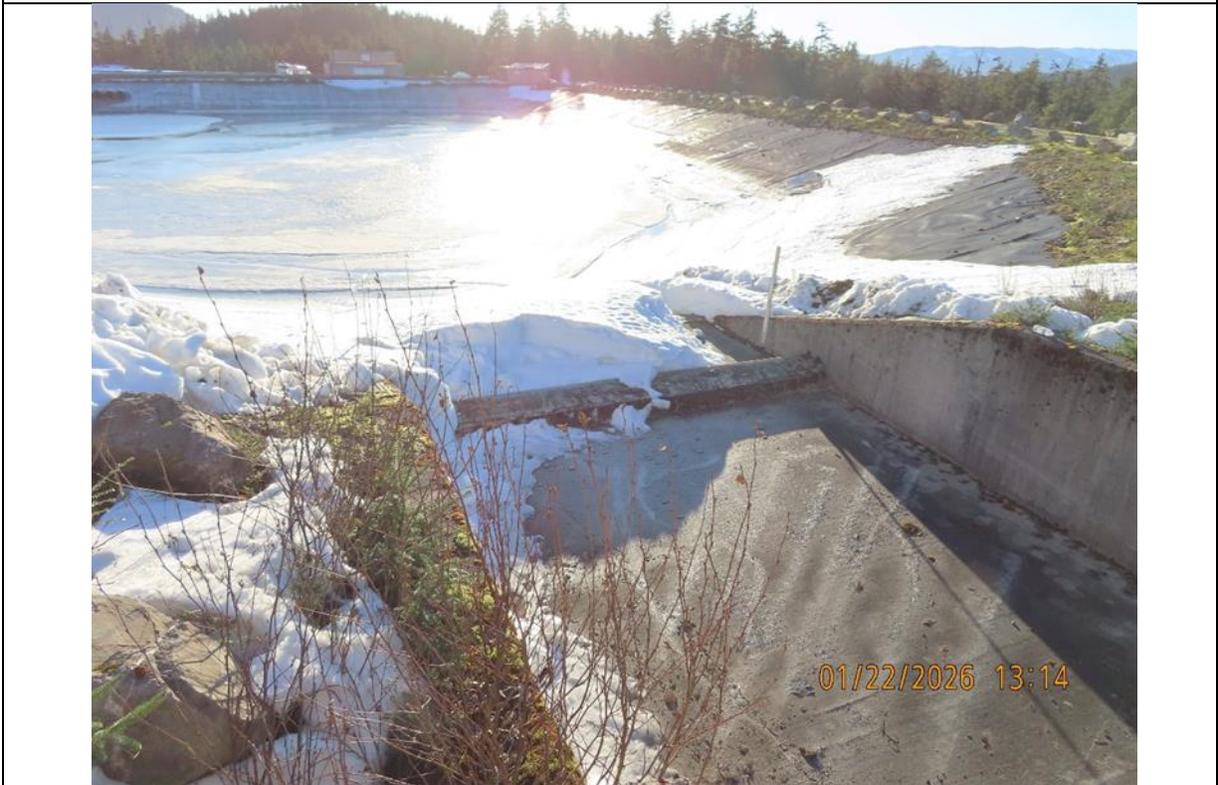
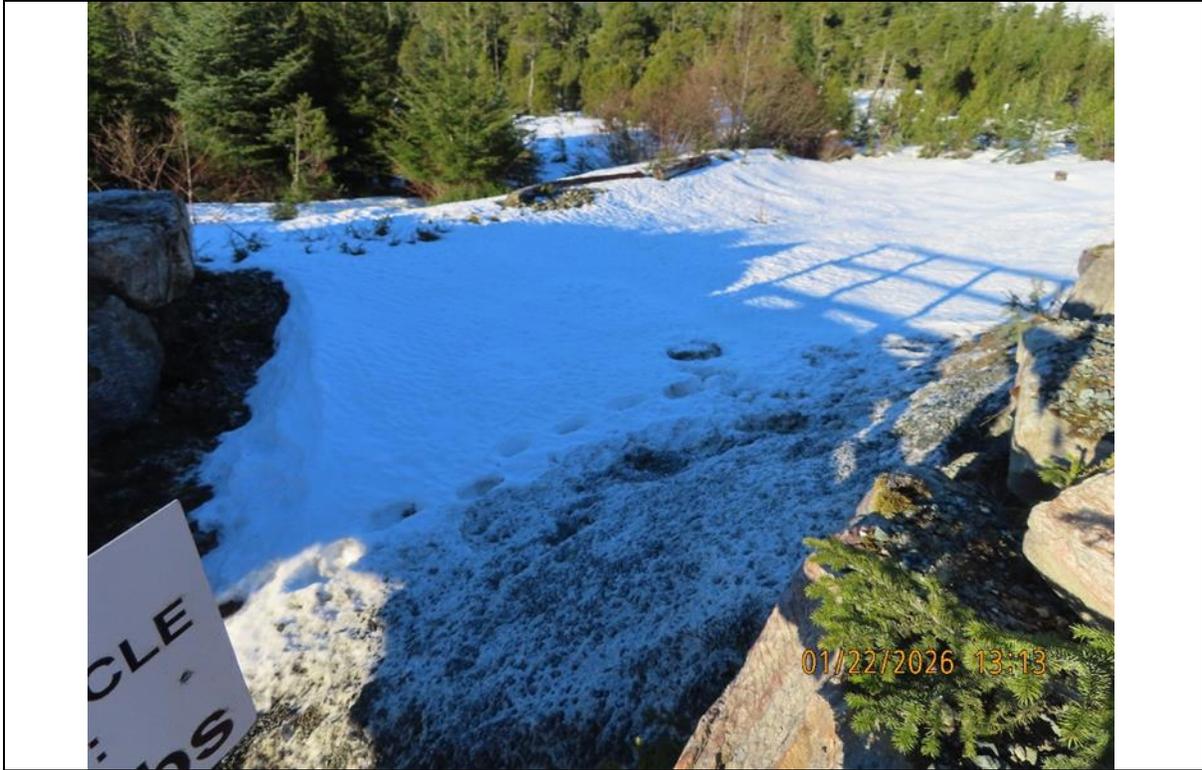
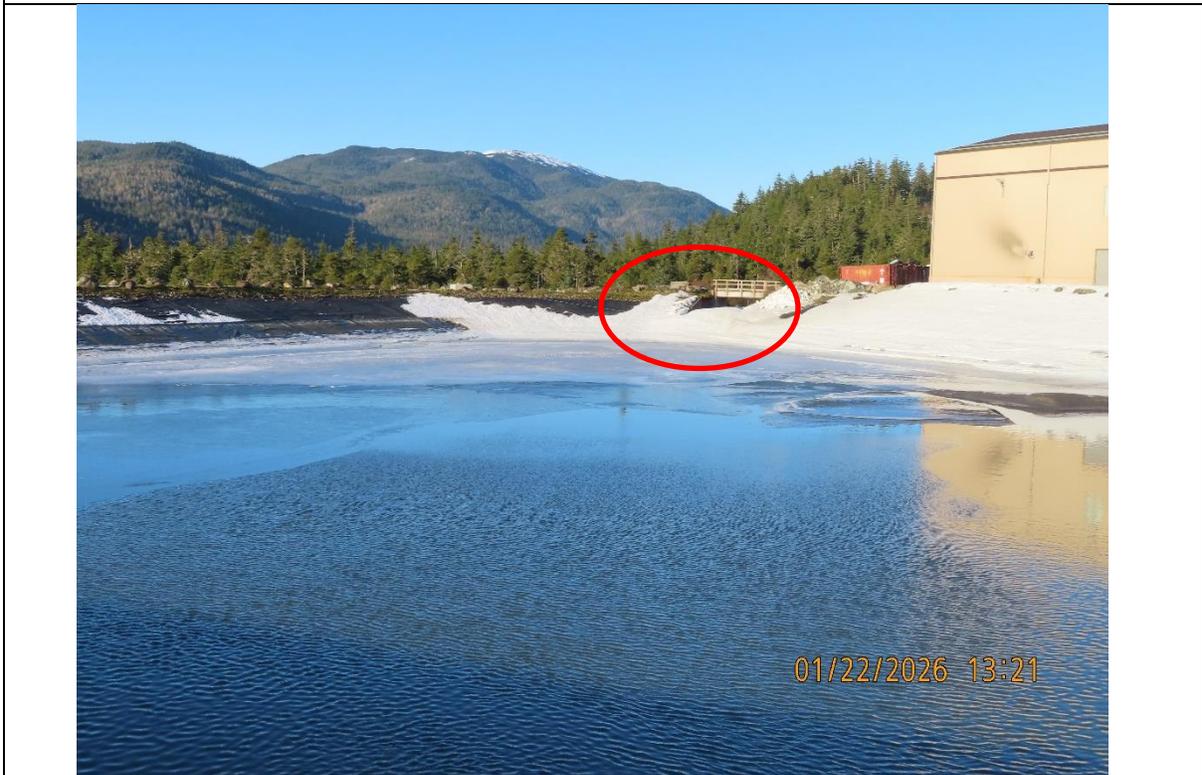
Pond 7 and Spillway. No evidence of water overflow (Photos 30 - 32).

Photo 30: Spillway at Pond 7. No evidence of water overflow.

Photo 31: Pond 7 spillway outfall. No signs of overflow entering this area.

Photo 32: Pond 7 and spillway in the background.

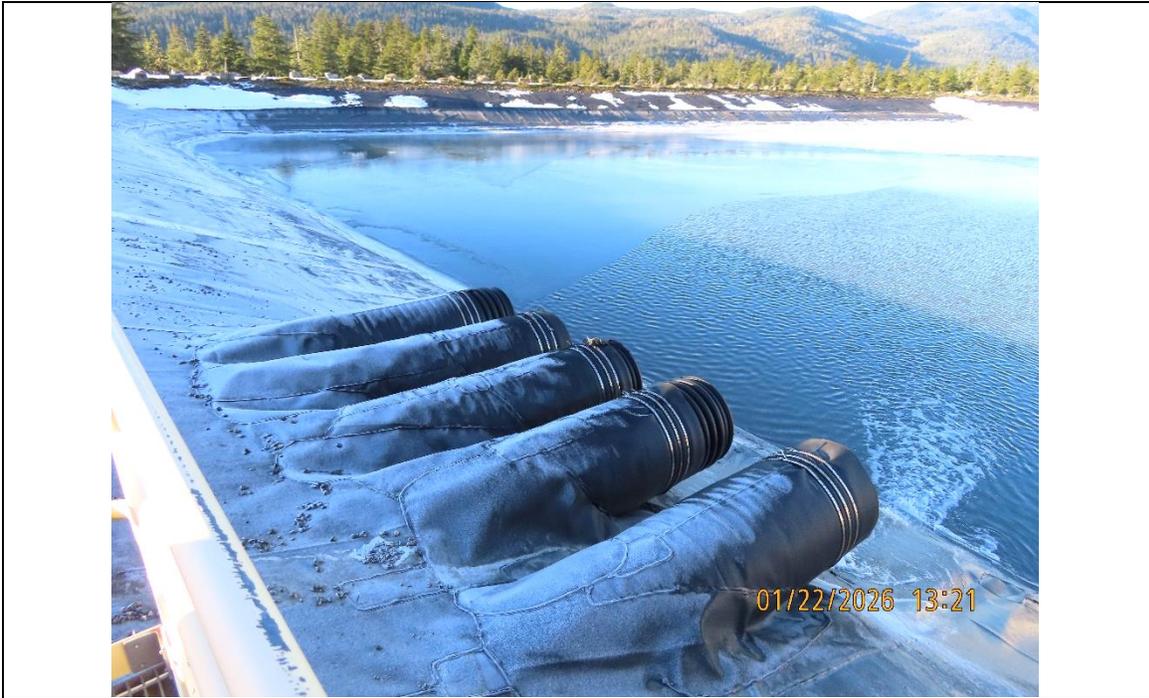
Culvert transporting water from the 920 area entering Pond 7 (lower right pipe) and the 4 culverts that connect Pond 7 to Pond 10 in the event of overflow (Photo 33).

Photo 33: Culvert transporting water from the 920 area entering Pond 7 (lower right pipe) and the 4 culverts that connect Pond 7 to Pond 10 in the event of overflow.

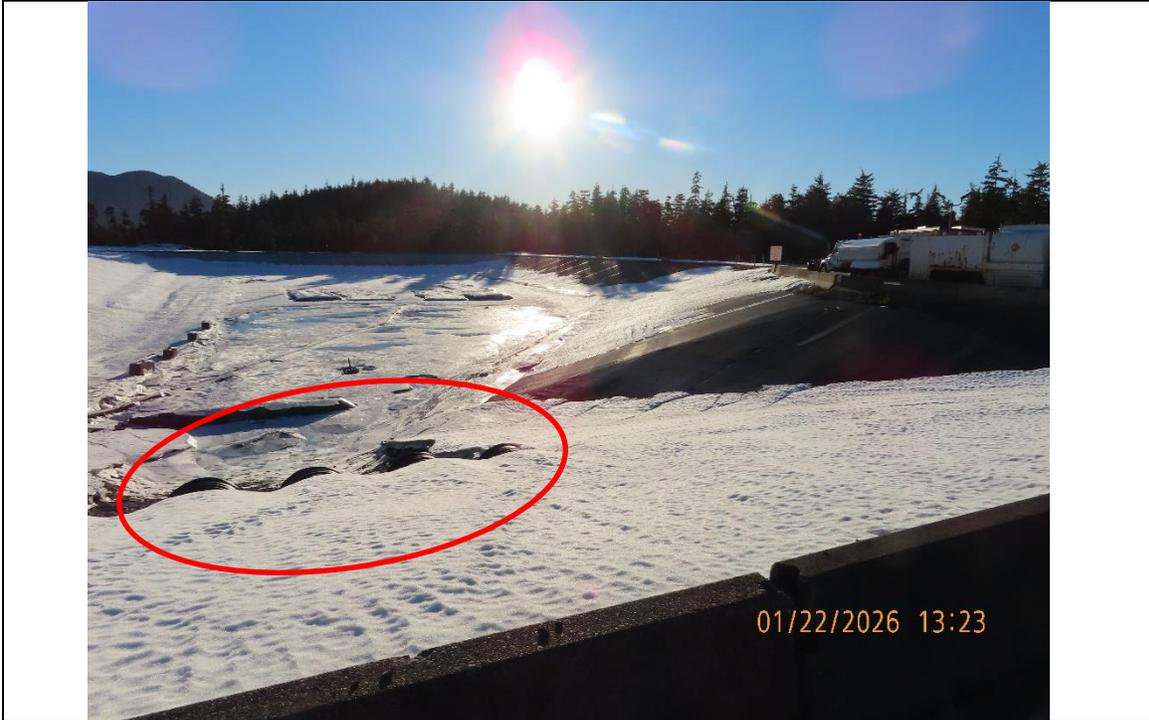
Pond 10 Overflow culverts in the foreground entering pond. Water collected in Pond 10 is pumped directly into the TDF water treatment plant. Photo 34:

Photo 34: Pond 10 Overflow culverts in the foreground entering pond. Water collected in Pond 10 is pumped directly into the TDF water treatment plant.

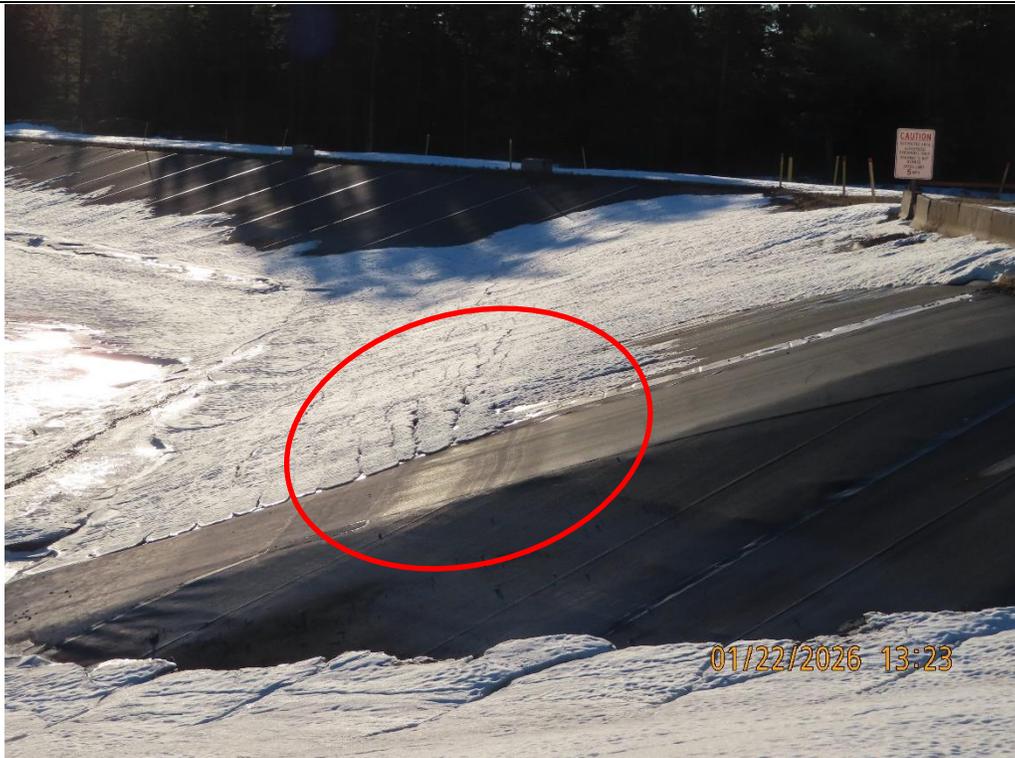
Pond 10 showing “bathtub ring” marking the highest-level water rose in the pond (Photo 35).

Photo 35: Pond 10 showing “bathtub ring” marking the highest-level water rose in the pond.

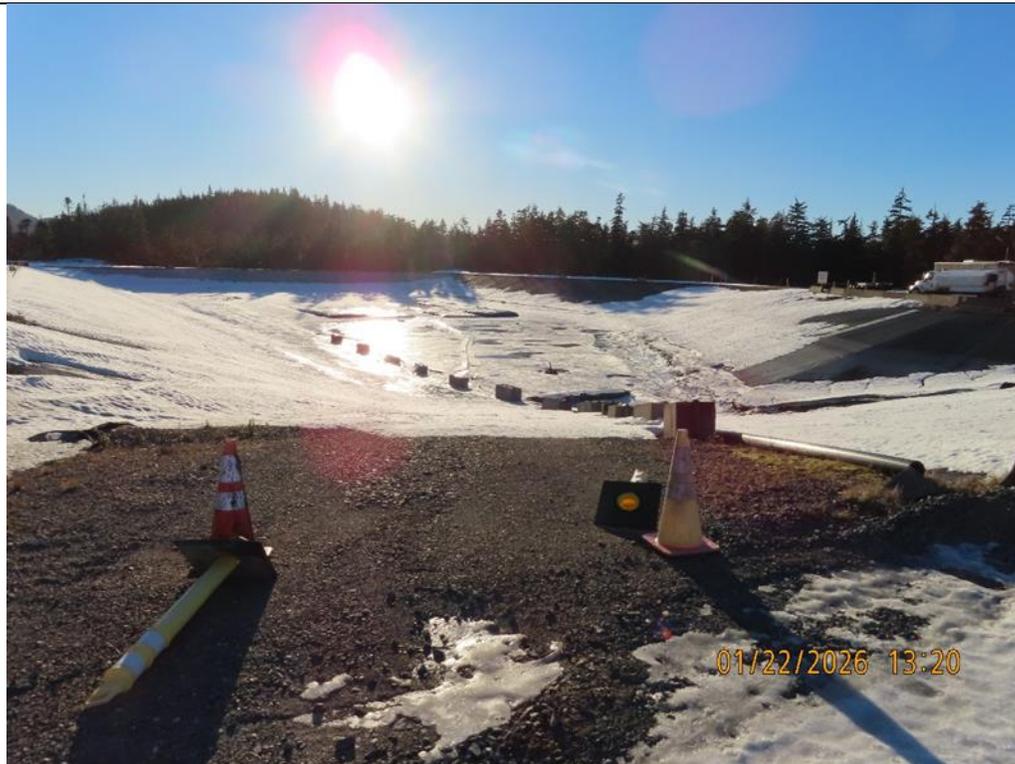
Overview of Pond 10 (Photo 36).

Photo 36: Overview of Pond 10.
