## Greens Creek Mine Field Inspection Report

**Inspection Date:** June 8, 2026  
**Time:** 8:30 AM to 3:30 PM  
**Weather:** Overcast with low clouds in the morning clearing in the afternoon. Slight breeze throughout most of the day with an average temperature of ~55°F.  
**DNR Personnel:** Aaron Kruse, William Groom  
**Hecla Personnel:** Paula Lillesve  
**Inspection Objectives:** Site Inspection

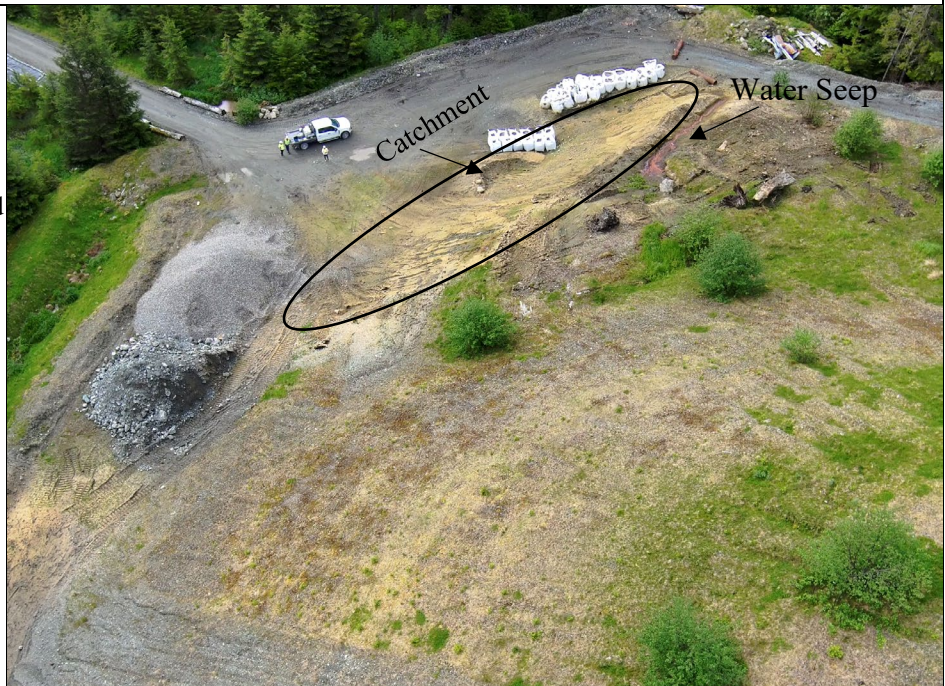
- 1.1. Pit 7 is currently used for storage of stockpiled aggregate, including super sacks filled with finer material for culvert replacement, scrap metal, piping, and construction material (Photo 1). Road construction material was recently excavated from around the base of the slope and has since been contoured and hydroseeded. Minor sloughing of the slope is noted from water draining along a ditch flowing along the top of the excavation and a catchment has been placed at the base of the cut to contain any material sloughing down the slope from the instability (Photo 2). Peat excavated from the TDF expansion is currently stockpiled just below the old highwall at the upper elevations of the facility (Photo 3). The peat will later be used for reclamation requirements. DNR staff observed best management practices (BMP's) to combat invasive plant species that were placed just off the access into Pit 7. These areas were covered with black plastic sheeting tightly pinned along its edges using sandbags (Photo 4).

Photo 1: Stockpiled aggregate, super sacks, and miscellaneous construction materials stored in Pit 7. Recent area of excavation that has been hydroseeded (circled). Water seep ditched above excavation with a catchment below to mitigate soil sloughing.

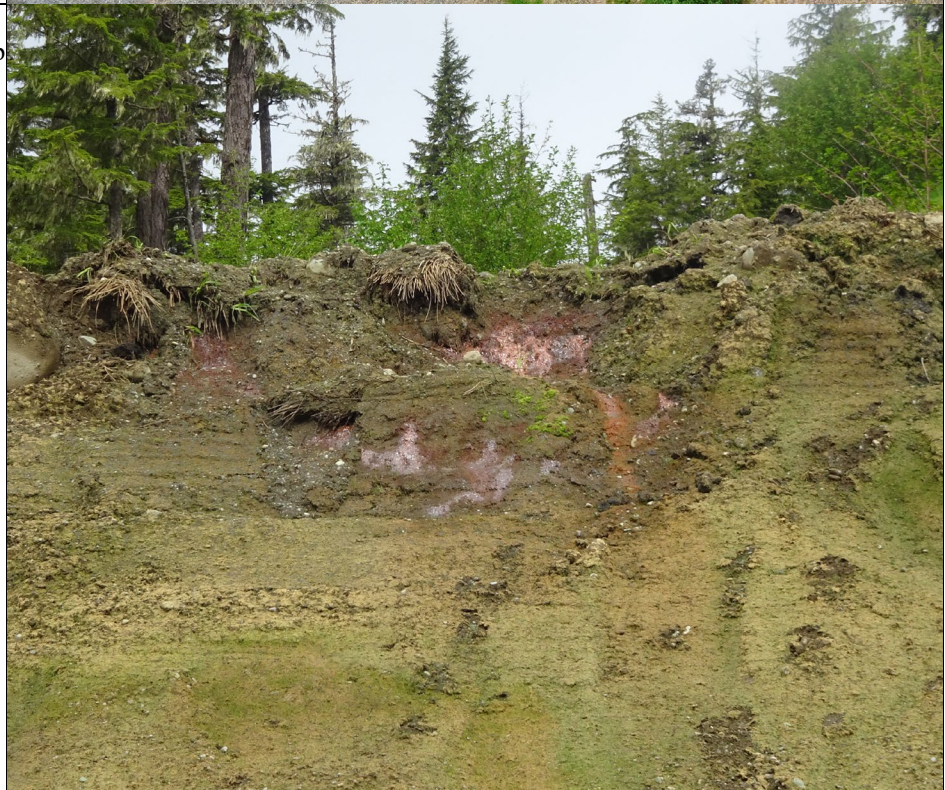
Photo 2: Pit 7 area of excavation looking at the top where water is seeping through from the above flow. Catchment is directly below slope instability.

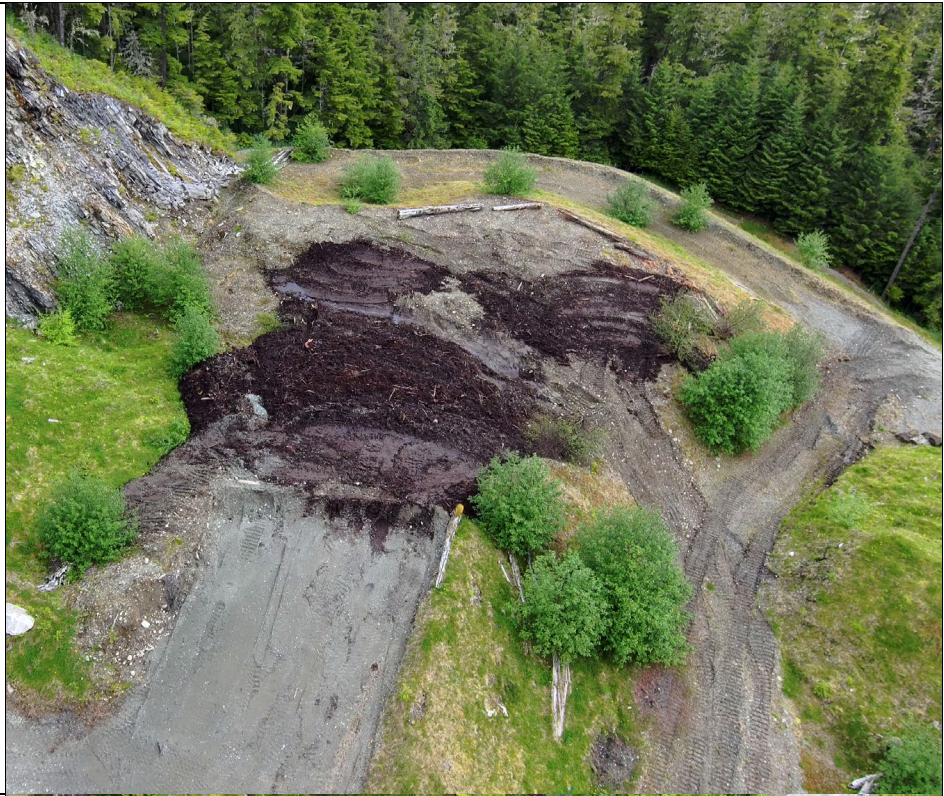
Photo 3: Stockpiled peat excavated from the TDF expansion, stored below the highwall of Pit 7.

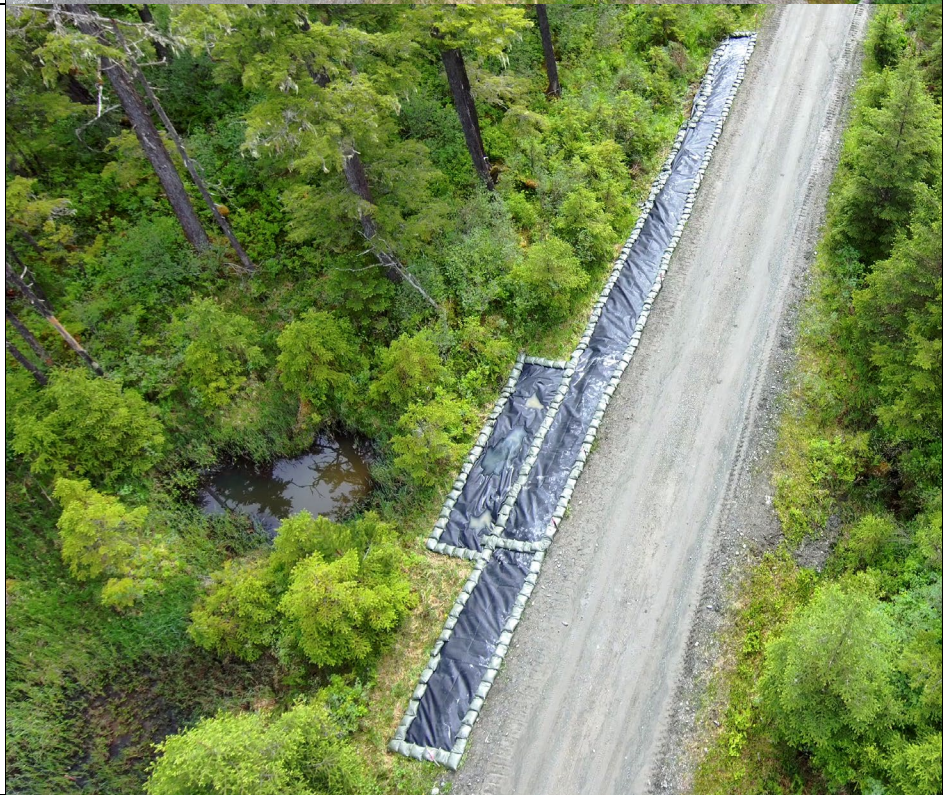
Photo 4: Invasive species BMP's near Pit 7 entrance, using black plastic sheeting pinned with sandbags.

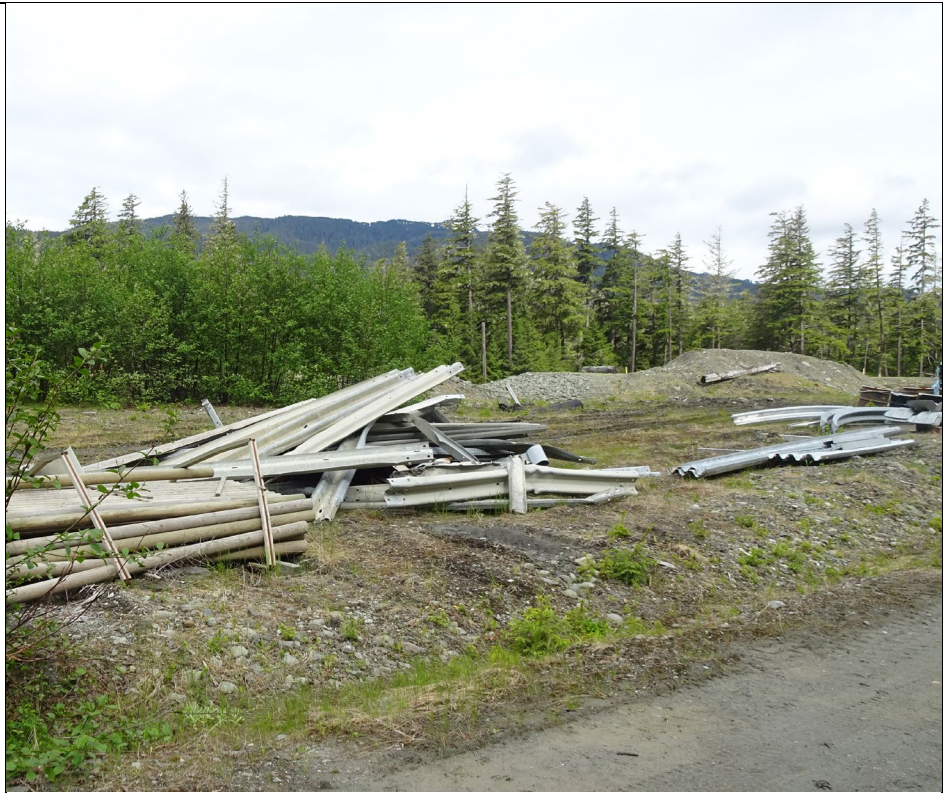
- 1.2. Sand Pit has remained consistent in its footprint with little change from previous inspections. Its primary use is now a laydown yard where culverts, piping, and other construction materials are stored (Photo 5). The surrounding slopes are well vegetated and in stable condition. Currently there is ponded water within the basin, but it is still well below the spillway on the western extent of the facility (Photo 6). This site is also proposed to be used as peat storage from deeper excavations expected to be encountered from the TDF expansion, which contains a higher saturation of water.

Photo 5: Sand Pit laydown yard with stored culverts, piping, and construction materials. Viewed near the entrance looking northwest.

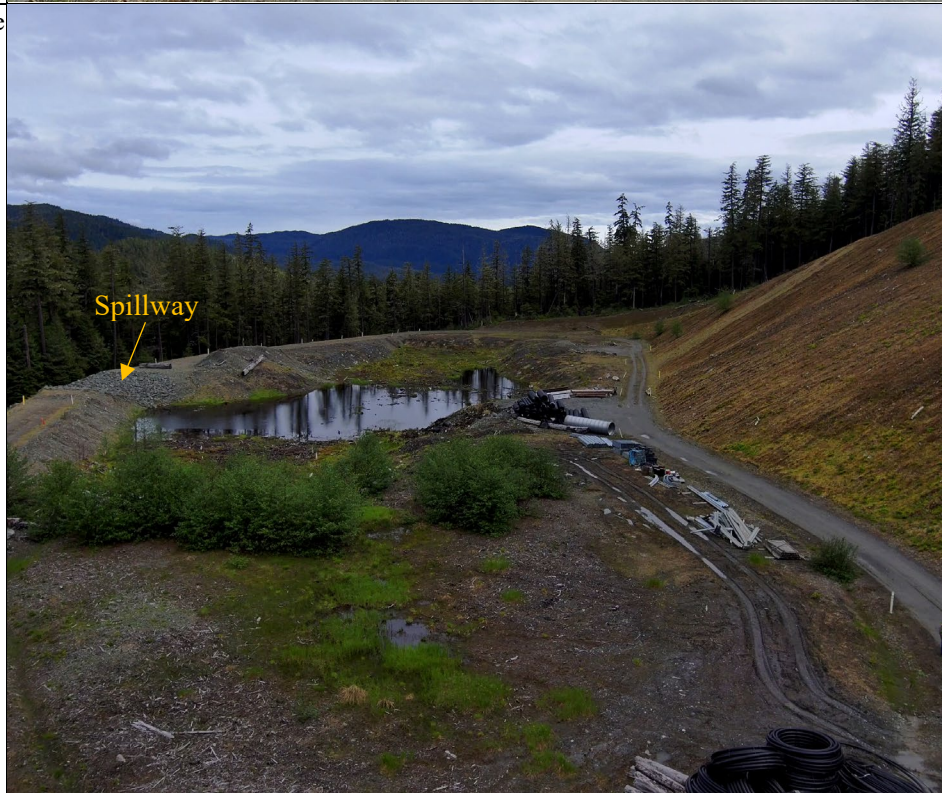
Photo 6: Pondered water in the Sand Pit basin below the spillway elevation. Spillway drains into ditch along A-Road. Well established vegetation on contoured slope. View looking north.

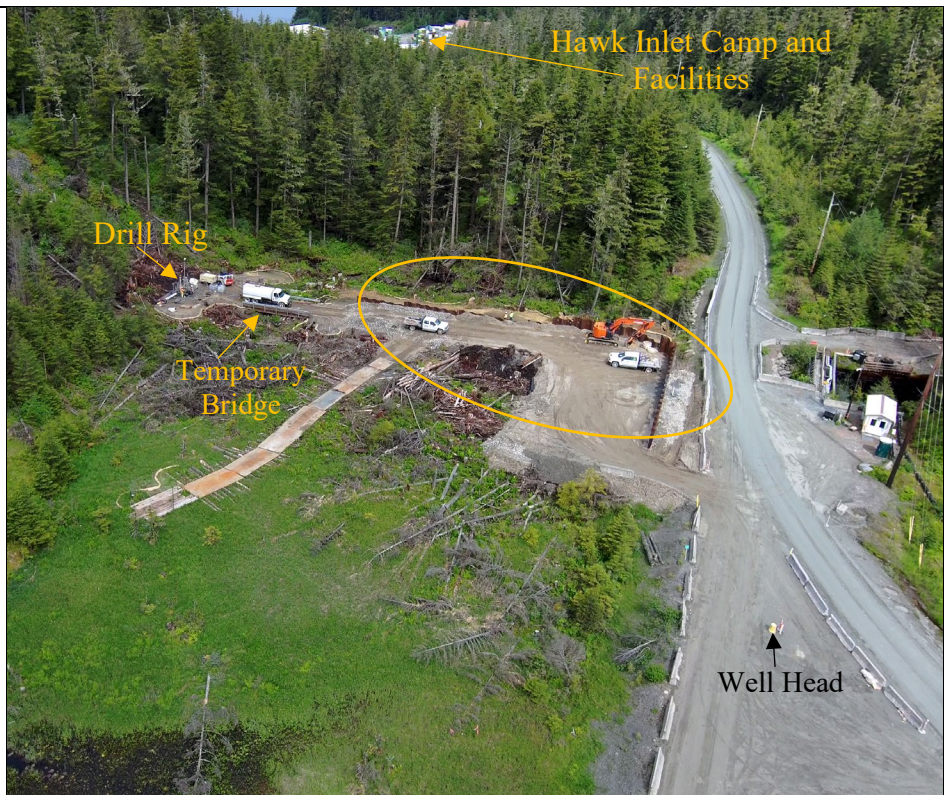
- 1.3. Expansion of the TDF was currently underway at the north end of the facility. Active drilling was observed across a temporary bridge on the western edge of the expansion for the installation of depressurization wells (Photo 7). The bridge will be removed once all the geotechnical drilling has been completed. Installation of the cut-off wall adjacent to B-Road has been finished, which will be used to mitigate ground water (Photo 8). The proposed area for waste rock placement will begin from the western edge of the cut-off wall. The current power station (Photo 9) will be moved onto a newly cleared pad at the junction between A- and B-Roads next to the Hawk Inlet Camp and facilities (Photo 10).

Photo 7: Northern aerial view of the TDF expansion. Active drilling across from the temporary bridge for installation of a depressurization well. The extent of the cut-off wall is circled.

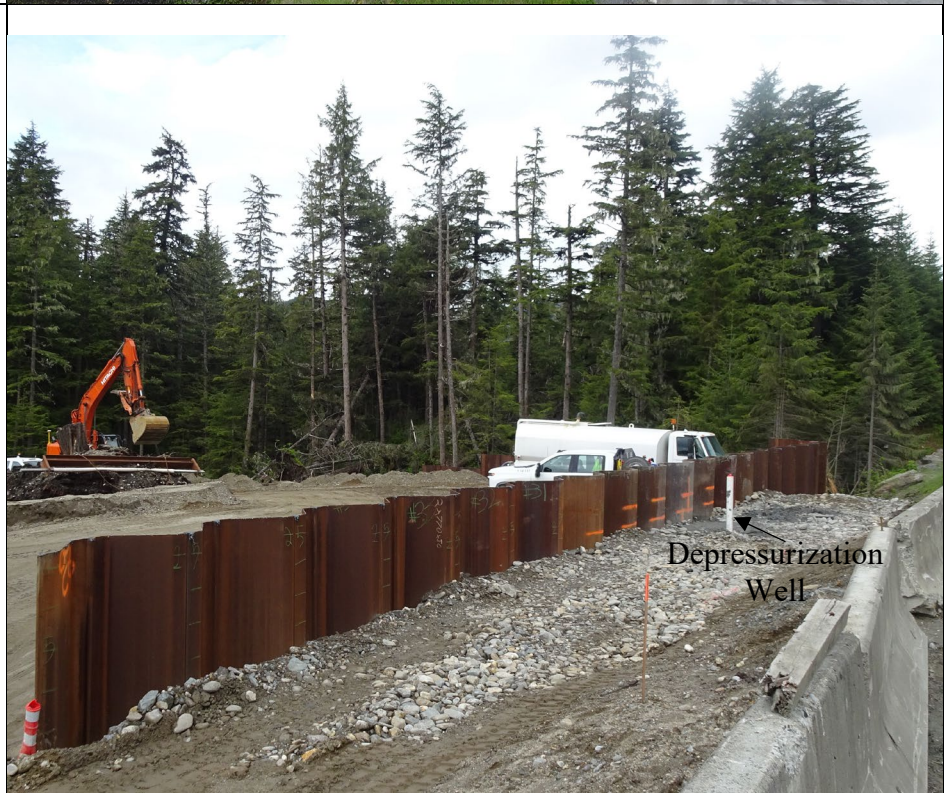
Photo 8: Completed cut-off wall near B-Road for groundwater control.

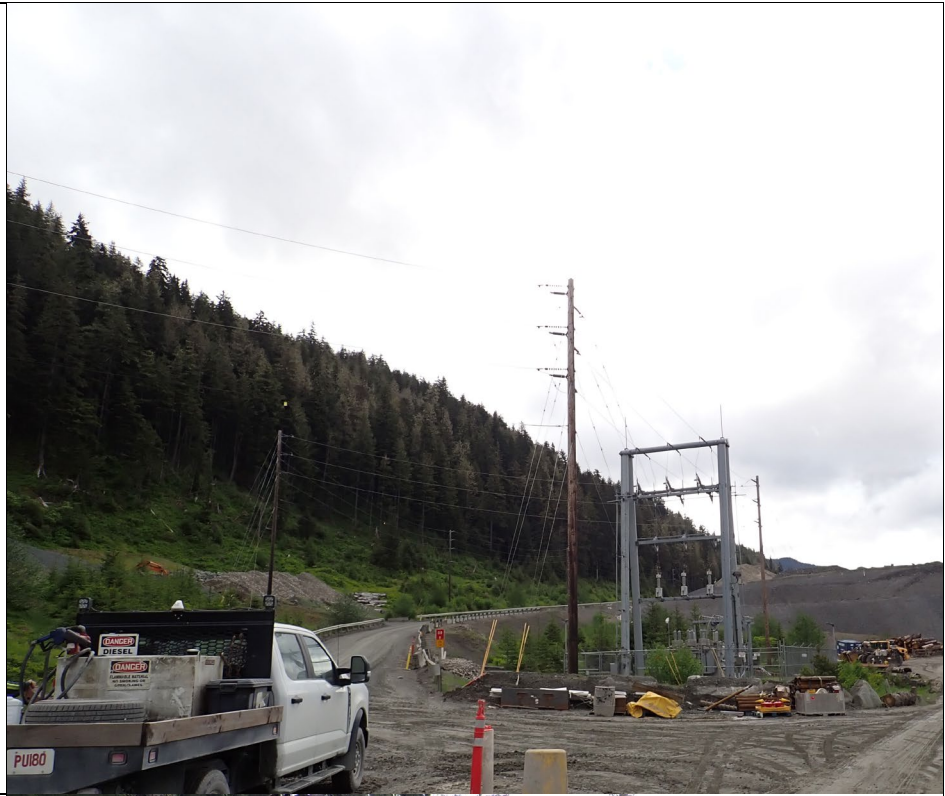
Photo 9: Current power station that will be relocated to a newly cleared pad near A- and B-Roads.

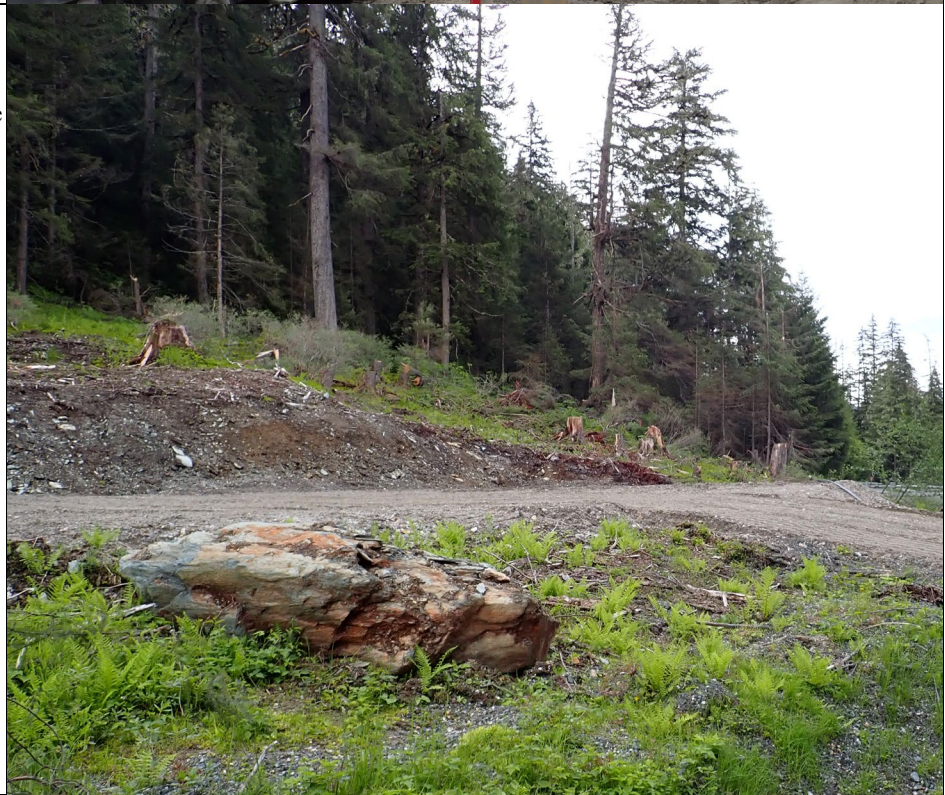
Photo 10: New pad at the junction of A- and B-Roads cleared to construct the new power station. View is to the southeast.

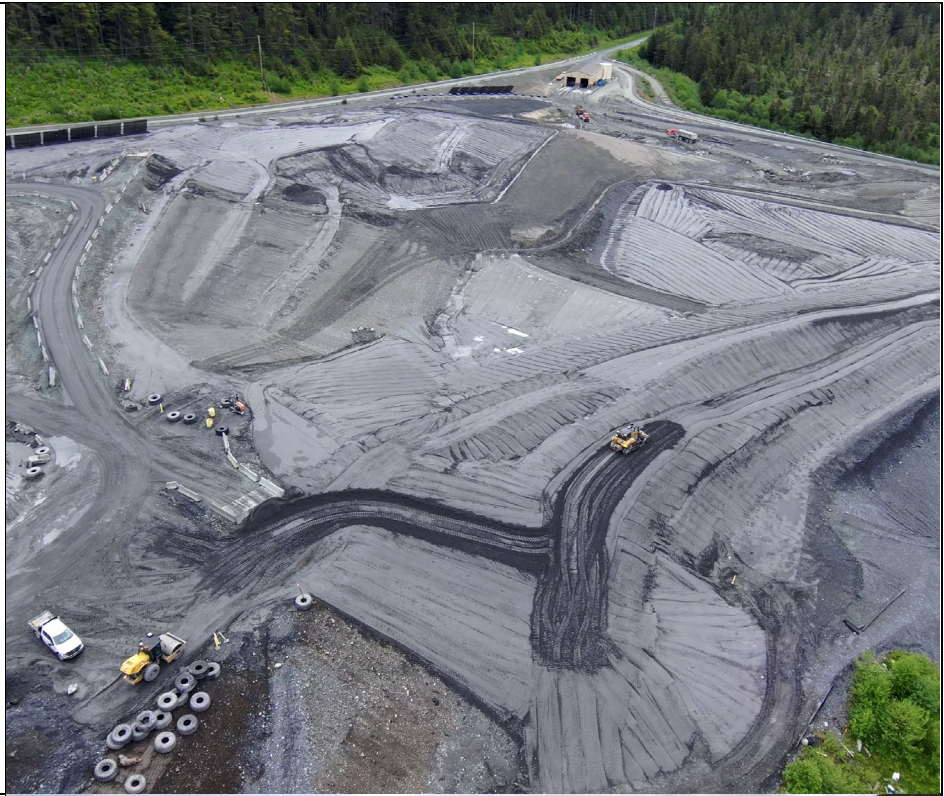
Active tailings deposition was observed from drone imagery within the center of the TDF. A dozer was observed spreading material in constructing a new lift (Photo 11). Slopes along the western extent of the TDF have been graded and contoured with fresh placement of organics above the storm water collection ditches. Organics have only been spread along the lower portions of the slope (Photo 12). Several active material sites were noted to be well kept and organized located within the northeastern end of the TDF and one just to the east side off the B-Road. Most of the material is used for road construction or base material for the TDF expansion (Photo 13).

Photo 11: Active tailings deposition with dozer spreading material to build a new lift within the TDF. Aerial view to the southeast.

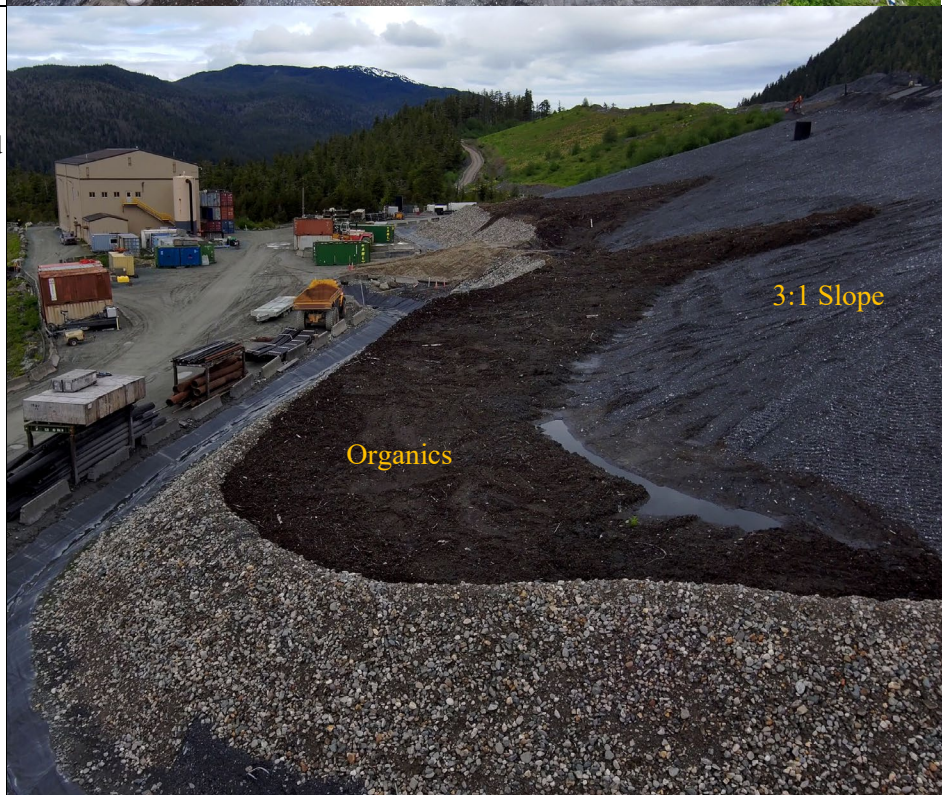
Photo 12: Final grade along the western TDF slope. Fresh organics have been placed on lower slope contours just above the lined stormwater ditch.

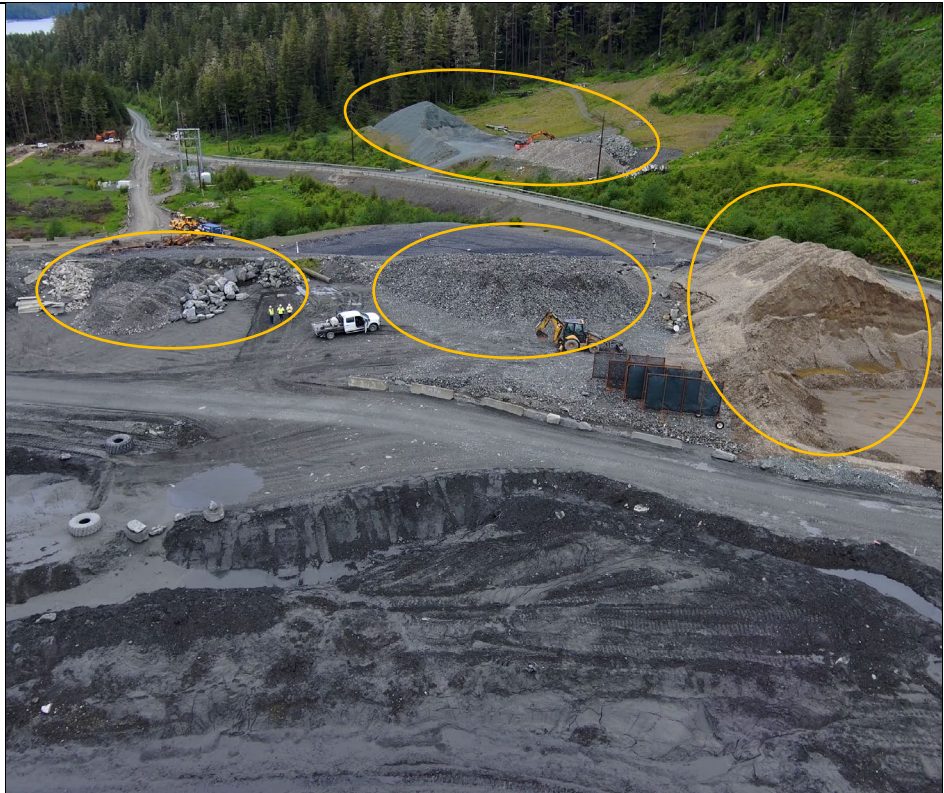
Photo 13: Organized material sites (circled) near the northeastern TDF and along B-Road, used for road construction and base material for TDF expansion area. Aerial view to the north.

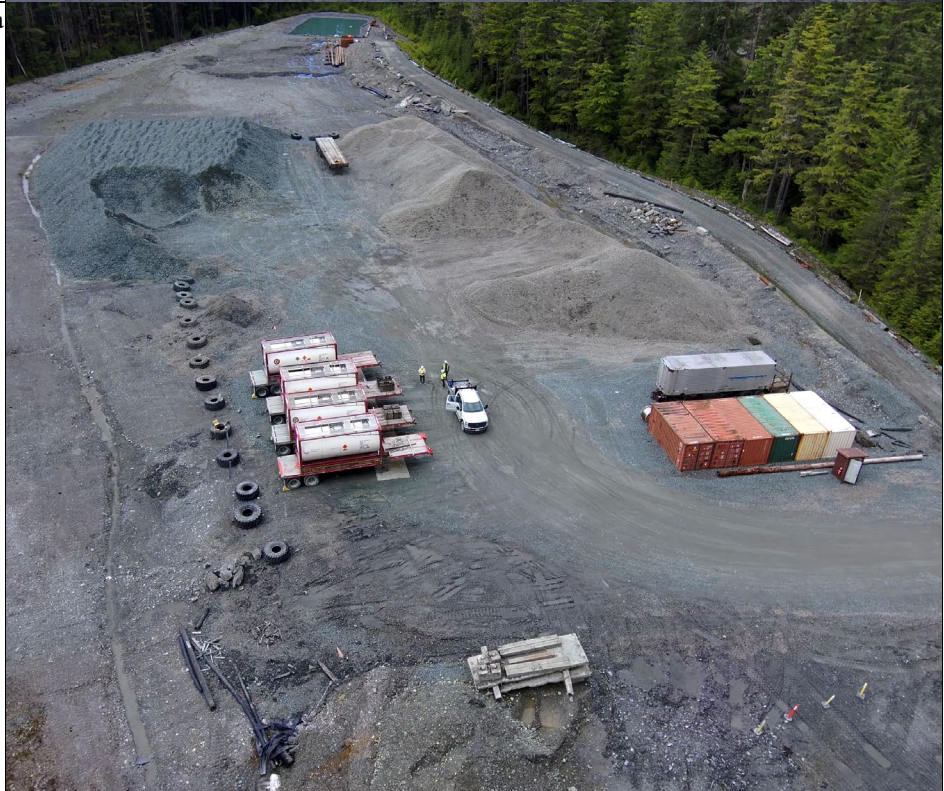
- 1.4 Site E is currently used for storage of aggregate road material, equipment, and explosives (Photo 14). Piping, utility poles, and woody debris has been staged off the access route to the storm water pond located at the northern end of the facility. A pump was observed within the storm water pond which manages runoff water by pumping it into treatment facilities during non-freezing months (Photo 15).<sup>5</sup> The overall site is well maintained and organized. While at Site E, DNR took the opportunity to fly the drone across the B-Road to document an older material site that has been reclaimed. The site has well established vegetative cover, including many saplings taking root providing good stability to slopes (Photo 16).

Photo 14: Site E storage area with aggregate, equipment, and explosives.

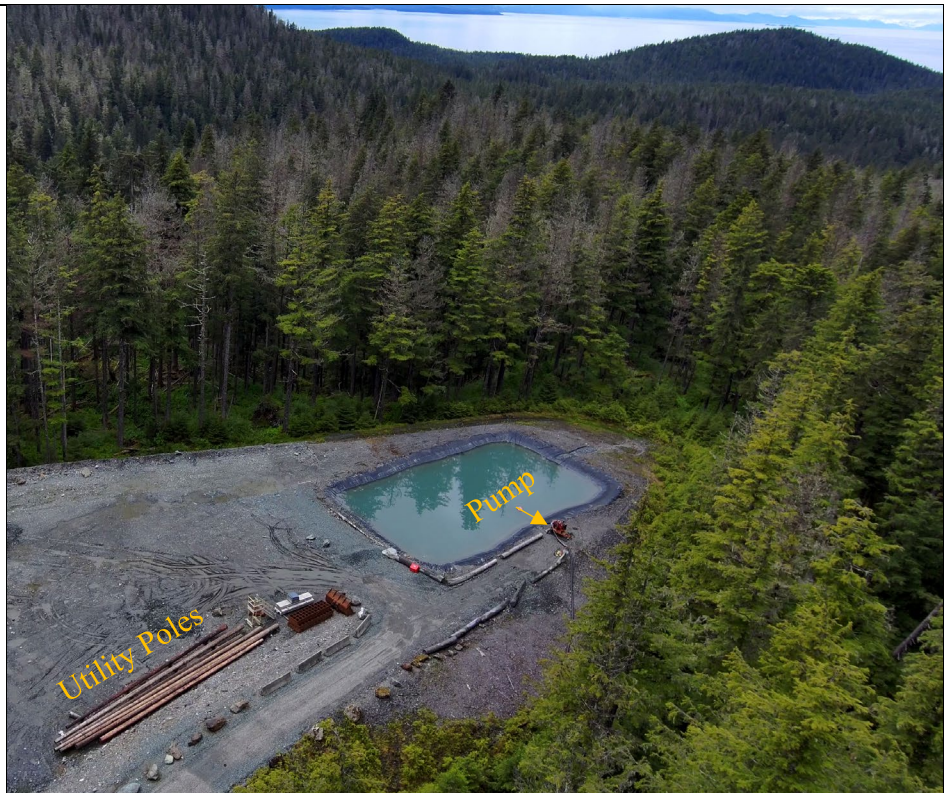
Photo 15: Stormwater pond at Site E with pump used during non-freezing months for runoff management.

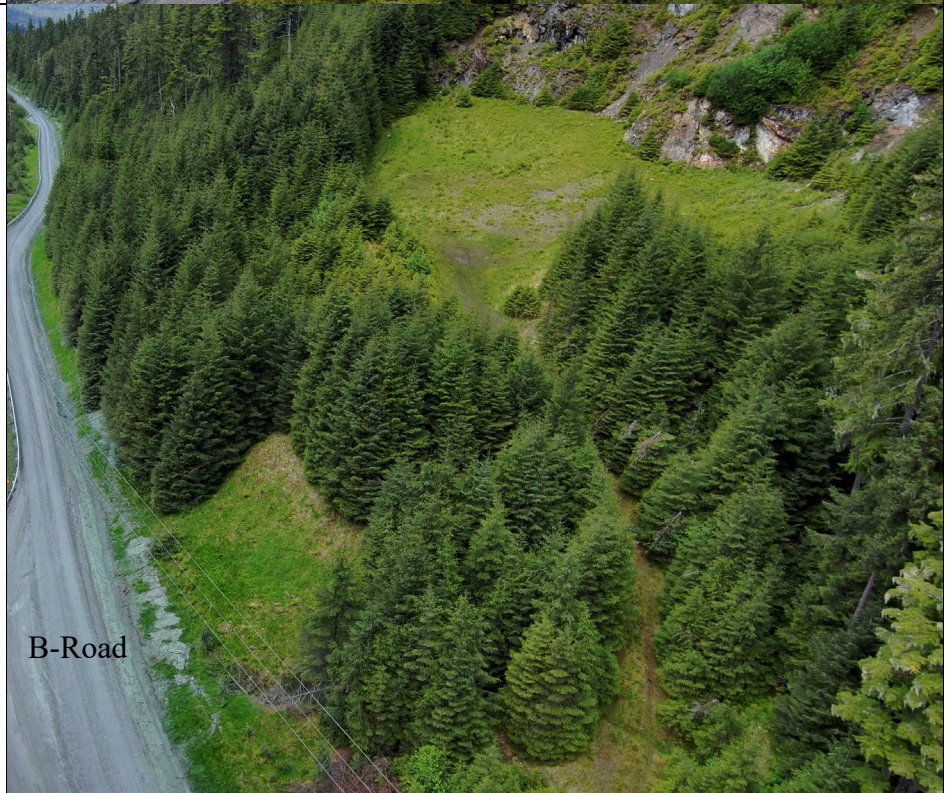
Photo 16: Reclaimed older material site with well-established vegetation and growth of young saplings. Aerial view to the north just off the B-Road across from Site E.

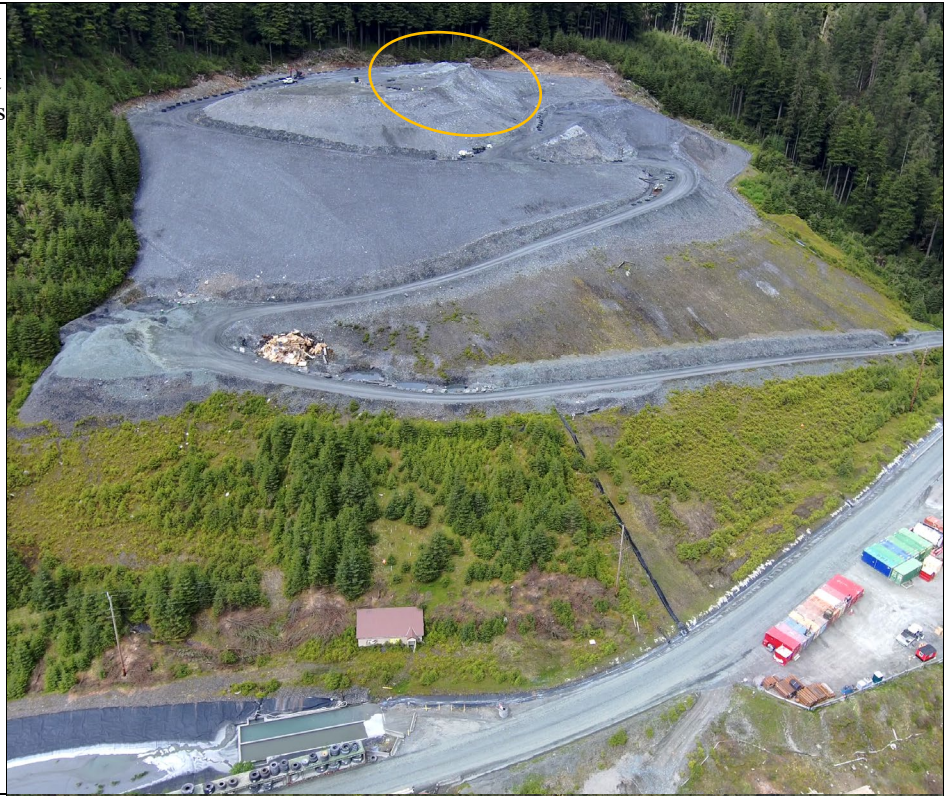
- 1.5 Site 23 Waste Rock Storage (WRS) has reached its maximum footprint of disturbance but not its maximum elevation. Ongoing deposition of class 1, 2, and 3 waste rock placement was noted along the sides with fresh piles of material placed on top of the facility. Waste rock, type 2-3 material, is planned for relocation underground, or transported to the TDF for disposal at mine closure.<sup>6</sup> No active depositional work was observed at time of inspection (Photo 17). Storm water ponds were partially full along the outskirts of the facilities access route which are downslope from a pile of wood debris staged to be burned (Photo 18). Surface water runoff is managed through a series of pipes and ditches which flow to the Site 23 water management pond.<sup>7</sup> Lower slopes along the facility have been contoured to an angle of repose with well-established vegetative growth.

Photo 17: Aerial view looking north of Site 23 Waste Rock Storage. Recent deposition of waste rock was observed on top of the facility (circled). Well-established revegetation has occurred along the base of the facilities southern facing slopes.

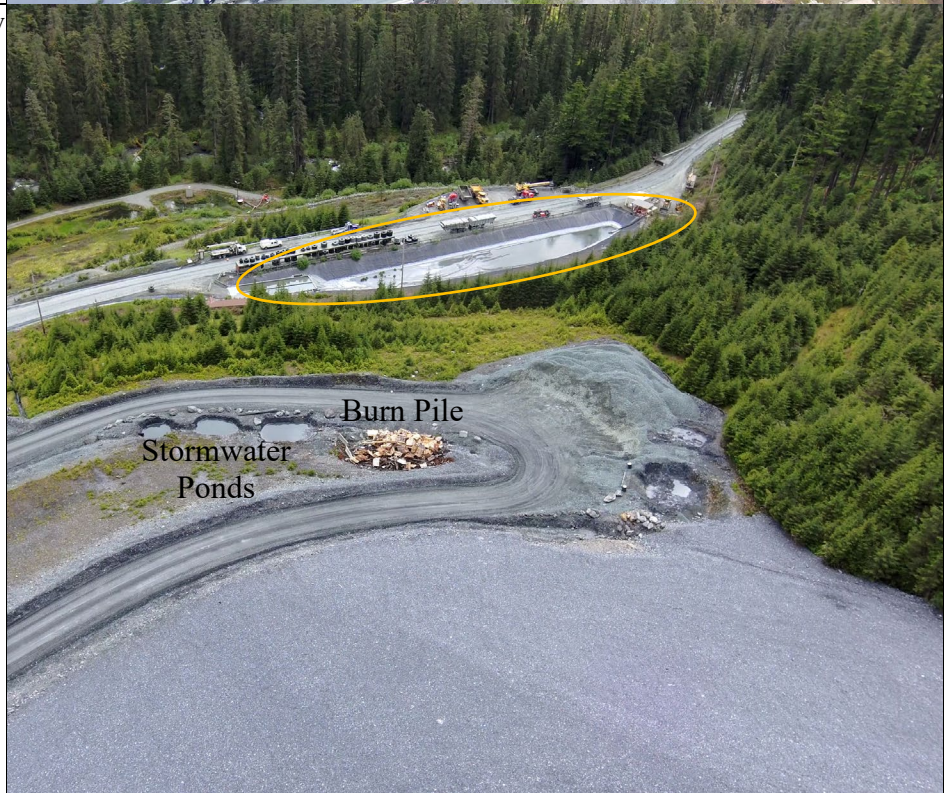
Photo 18: Site 23 aerial view to the south looking at stormwater ponds and staged wood debris planned for burning. Site 23 Water management pond can be seen in the background (circled).

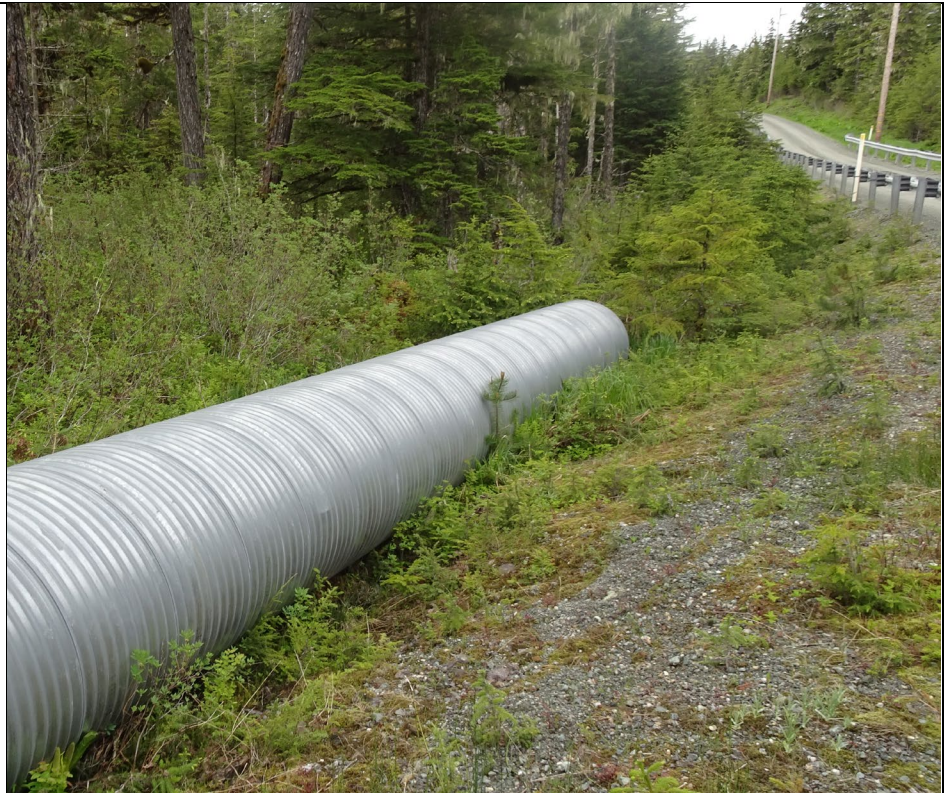
- 2.1. MP 2.2 along the A-Road and access to Pit 7 at MP 1.8 are two locations scheduled for culvert replacement to improve fish habitat. Work has not begun, but replacement culverts have been delivered to each location (Photos 19 and 20).
- 2.2. Lined storm water runoff ditching around the TDF is mostly clean of debris and overall, well maintained. No standing water was observed within ditches along the periphery of the TDF (Photo 21).

Photo 19: Replacement culvert staged at MP 2.2 of A-Road awaiting installation.

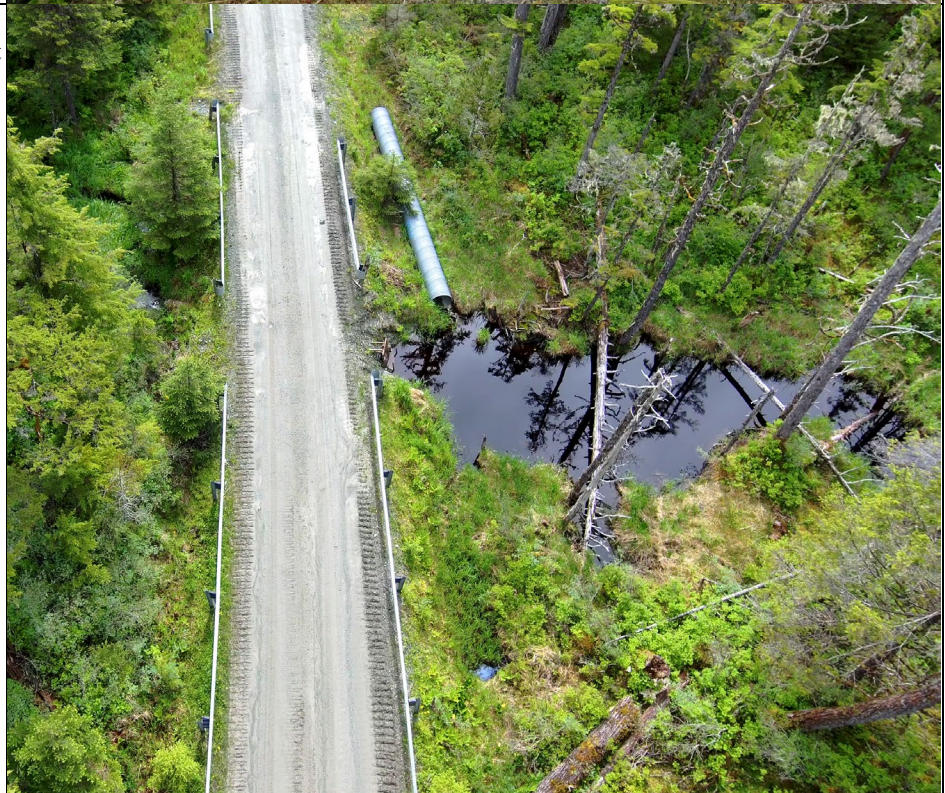
Photo 20: Replacement culvert staged at MP 1.8 just off Pit 7 access road awaiting installation.

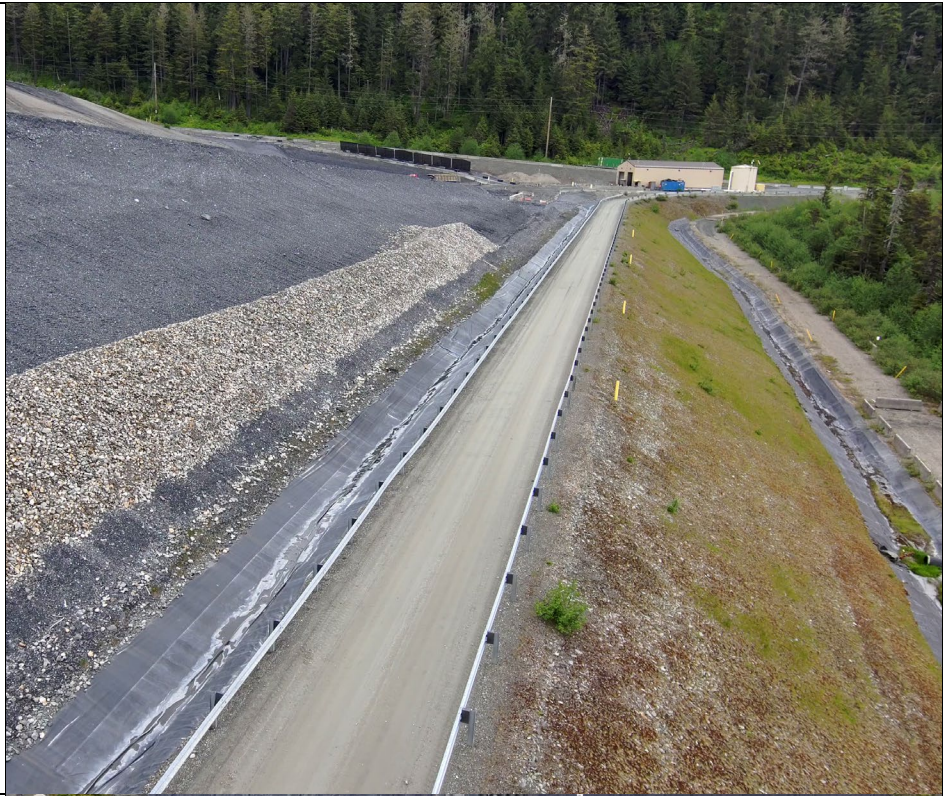
Photo 21: Lined stormwater  
ditches around the TDF.  
Aerial view looking to the  
east.

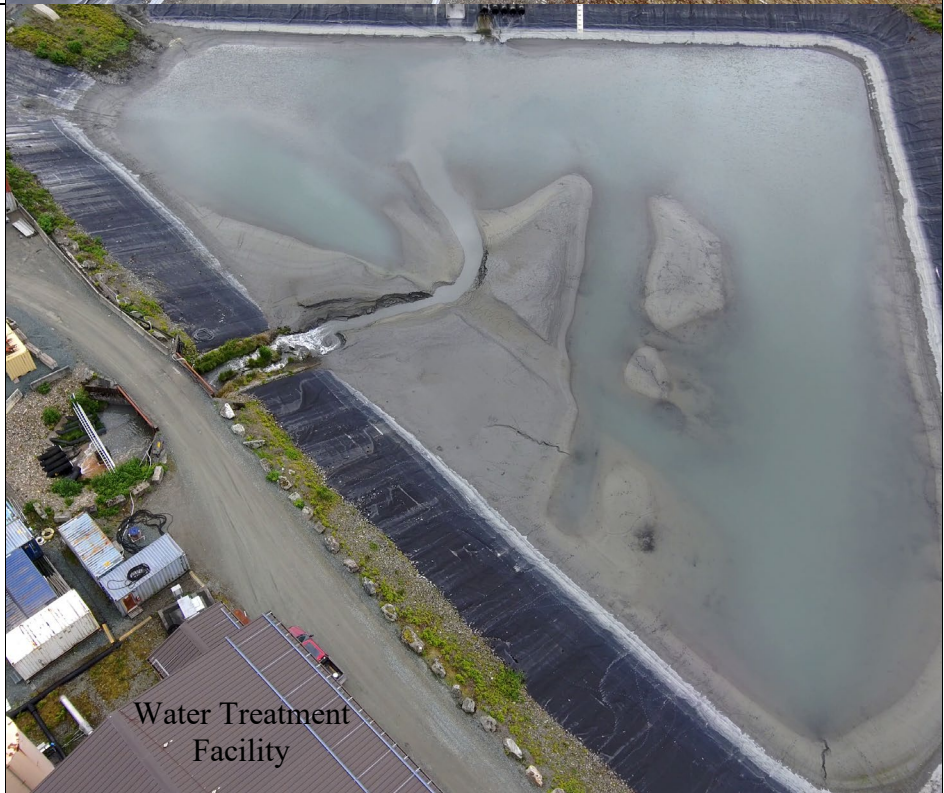
- 2.3. Ponds 7 and 10 were observed with only Pond 7 containing impounded water, which was well below its culvert's spillway into Pond 10. Sediment buildup in Pond 7 was above the water level, most noticeably by the inflow (Photo 22). At time of inspection there was no dredge operating in Pond 7, nor were sediment bags staged in the basin of Pond 10. Old debris had been removed near the north embankment of Pond 10 and was recently hydroseeded (Photo 23).

Photo 22: Pond 7 Inlet  
exhibiting incising into  
sediment delta .

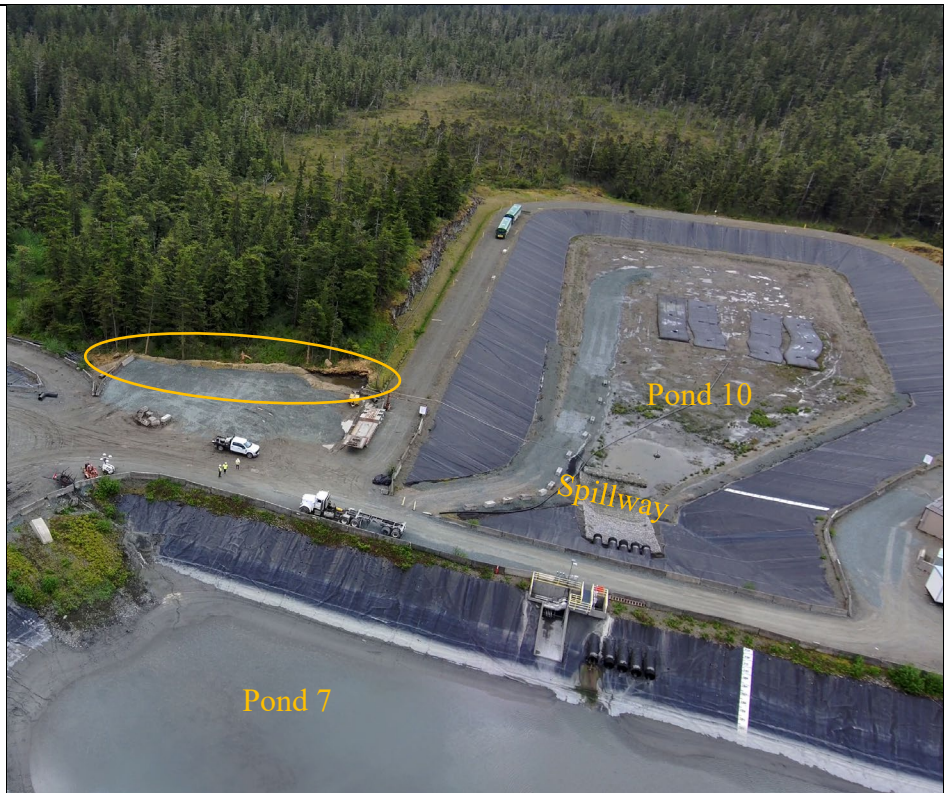
Photo 23: Hydroseeded area just north of Pond 10 embankment where old debris had been removed (Circled). Pond 10 has some standing water just below spillway. Aerial view looking to the south.

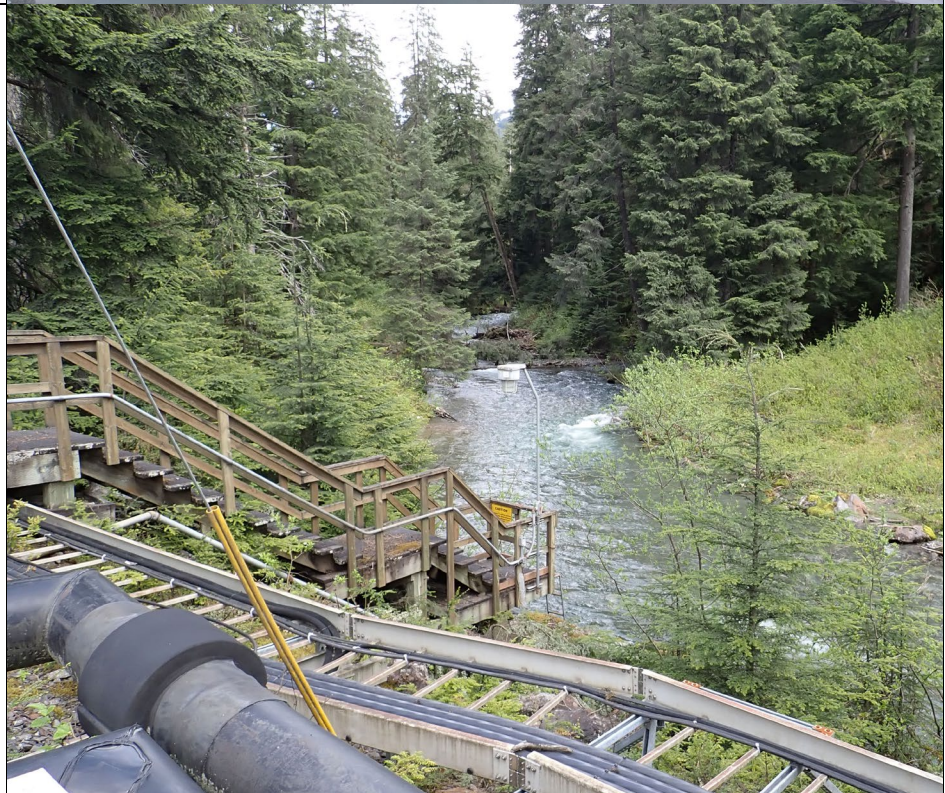
- 2.5. Potable Water Treatment Facility, near the 920 Portal, with walkways to Greens Creek for sampling were in good condition and well maintained (Photo 24). Active treatment matches the documentation emphasis on sustained water treatment needs for the mill and surrounding buildings during operations.

Photo 24: Potable Water Treatment Facility near the 920 Portal. This facility is well maintained. Photo of walkway to one of Greens Creek sampling points.
