## Greens Creek Mine Field Inspection Report

**Inspection Date:** September 23, 2025  
**Time:** 7:30 AM to 2:30 PM  
**Weather:** Overcast with low clouds and scattered rain showers in the morning clearing to broken cloud cover in the afternoon. Slight breeze throughout most of the day with an average temperature of 45°F.  
**DNR Personnel:** Aaron Kruse, William Groom, Erika Alexander, Jonathan Kummer  
**ADF&G Personnel:** Greg Albrecht  
**Hecla Personnel:** Jennifer Stoutamore, Sierra Kryzer  
**Inspection Objectives:** Site Inspection

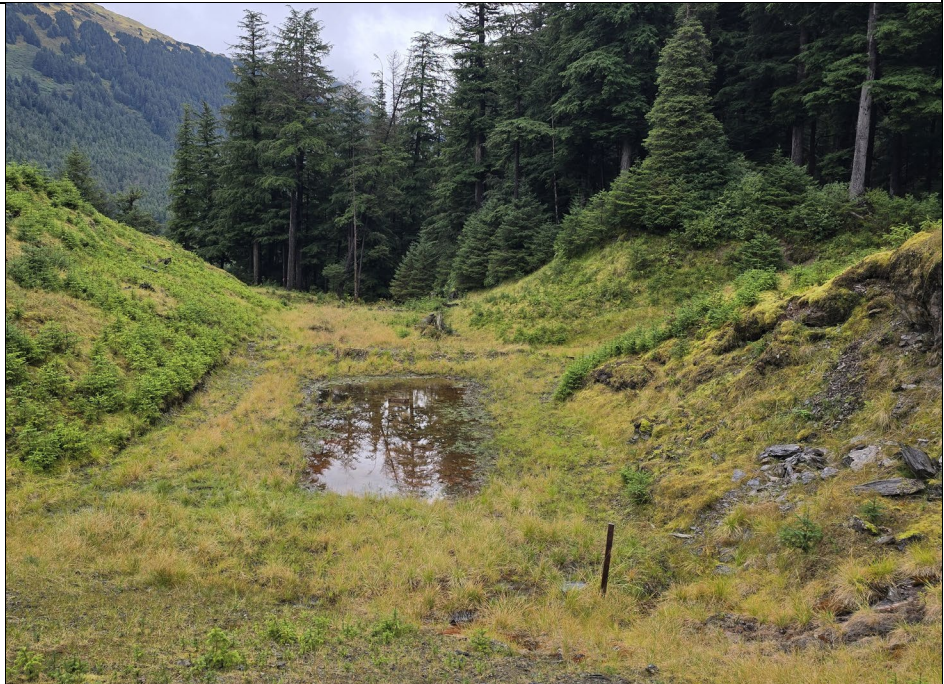
- 1.1. Observations at the 1350 Portal reflect active water management consistent with long-term closure plans for drainage control and portal decommissioning (Photo 1). The collection pond contained standing water at the time of inspection. This water drains into the underground workings and is tested regularly. The portal and related infrastructure appeared in good condition and well maintained; however, there was water ponded within the entrance to the portal (Photo 2).

Photo 1: Water management activities at the 1350 Portal showing the collection pond with standing water.

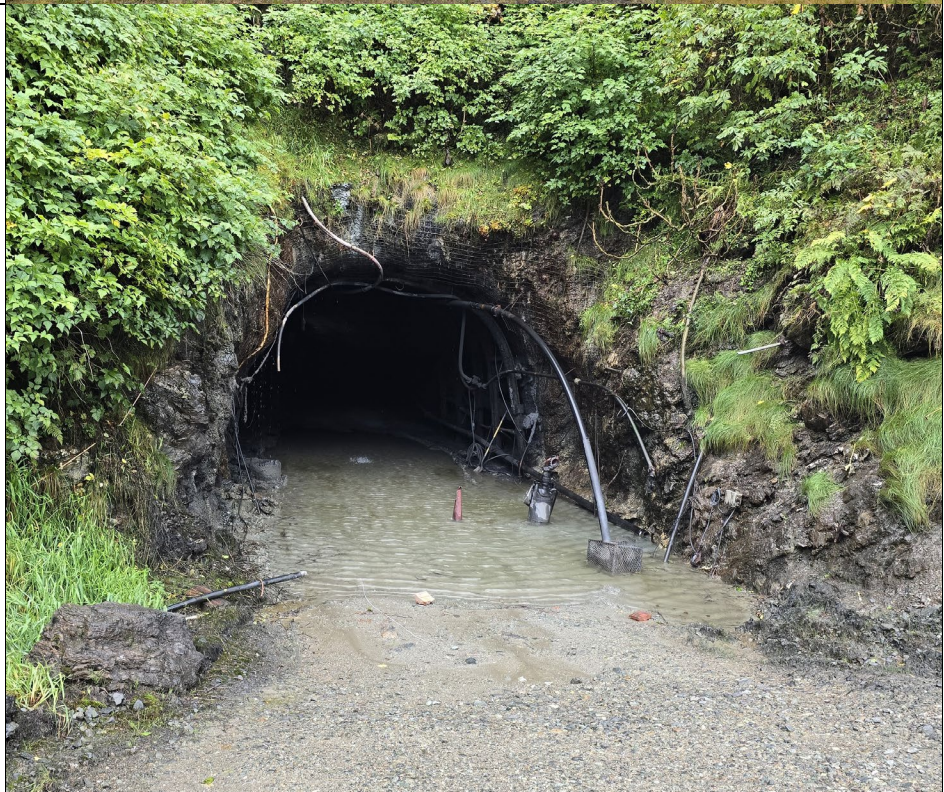
Photo 2: Ponded water observed at the entrance of the 1350 Portal.

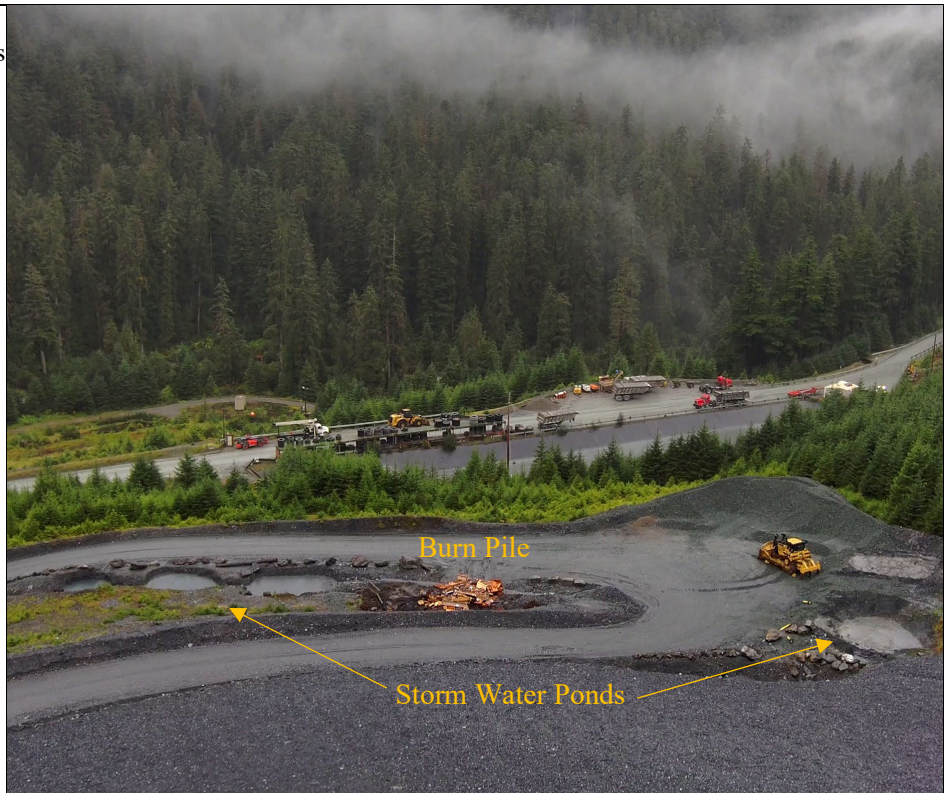
Photo 3: Partially full storm water ponds along the access road for Site 23. View from top waste rock facility looking southeast.

Wood debris staged to be burned in between switch back of access road.

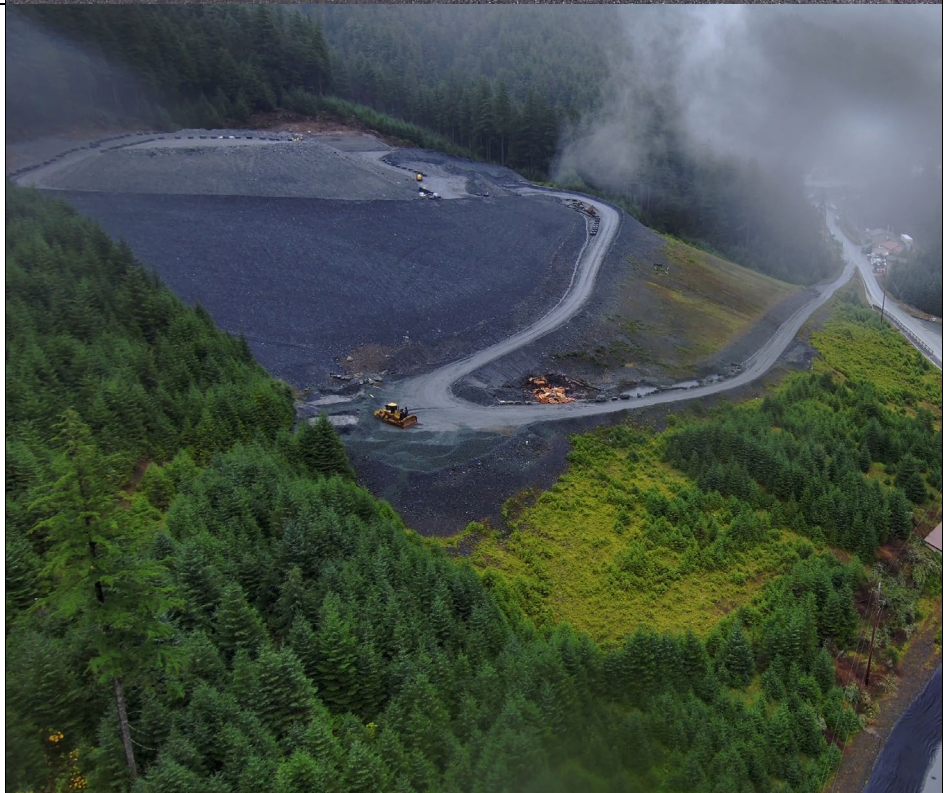
- 1.2. Site 23 Waste Rock Storage (WRS) has had a consistent footprint of disturbance, even with ongoing deposition of class 1, 2, and 3 waste rock. Waste rock, type 2-3 material, is planned for relocation underground, or transported to the TDF for disposal at mine closure.<sup>5</sup> No active depositional work was observed at time of inspection. A dozer was onsite across the access road from a burn pile of pallets and wood shipping container debris (Photo 3). Storm water ponds are partially full along the Site 23 access road. Surface water runoff is managed through a series of pipes and ditches which flow to the Site 23 water management pond.<sup>6</sup> Lower slopes have been contoured to an angle of repose with well-established vegetative growth (Photo 4).

Photo 4: Aerial view of Site 23 looking northeast. Lower contoured slopes at Site 23 with-established vegetative growth.

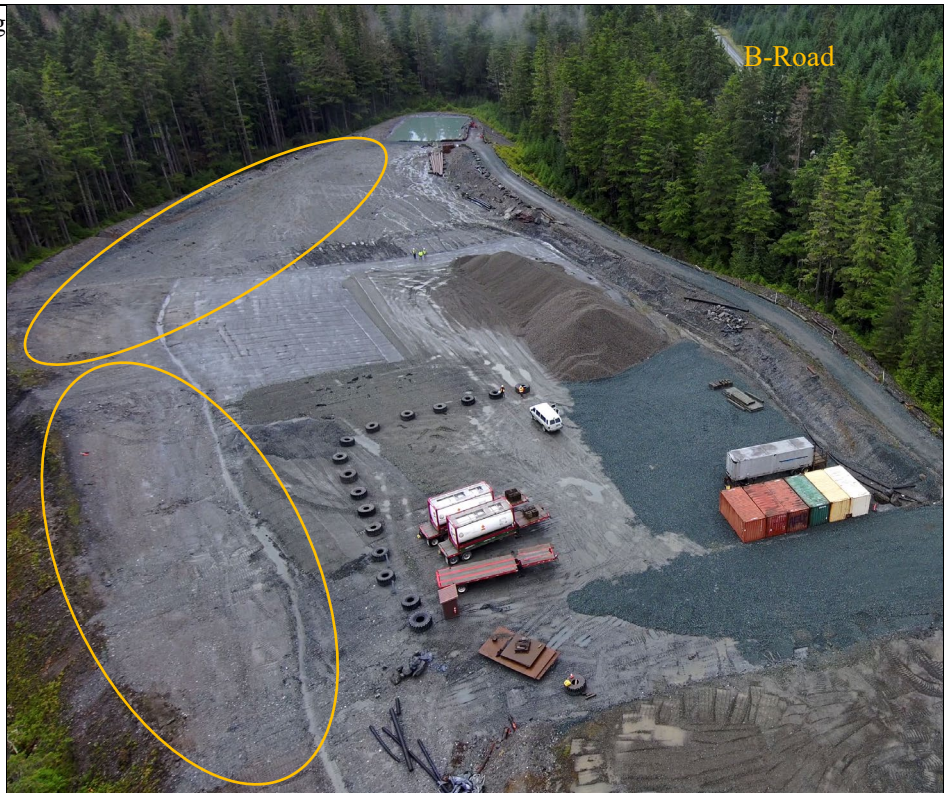
- 1.3. Site E is currently used for storage of aggregate road material, equipment, and explosives. Partial grading was observed along the periphery of the site along its western and northern edges (Photo 5). No seeding was observed along the contoured portions; however, this area may still be used as a future laydown yard.

Photo 5: Aerial view looking west. Partial grading along the western and northern edges of Site E (Circled). Storm water drainage pond near capacity at the far end of the facility. Site E is used as a laydown yard and storage facility.

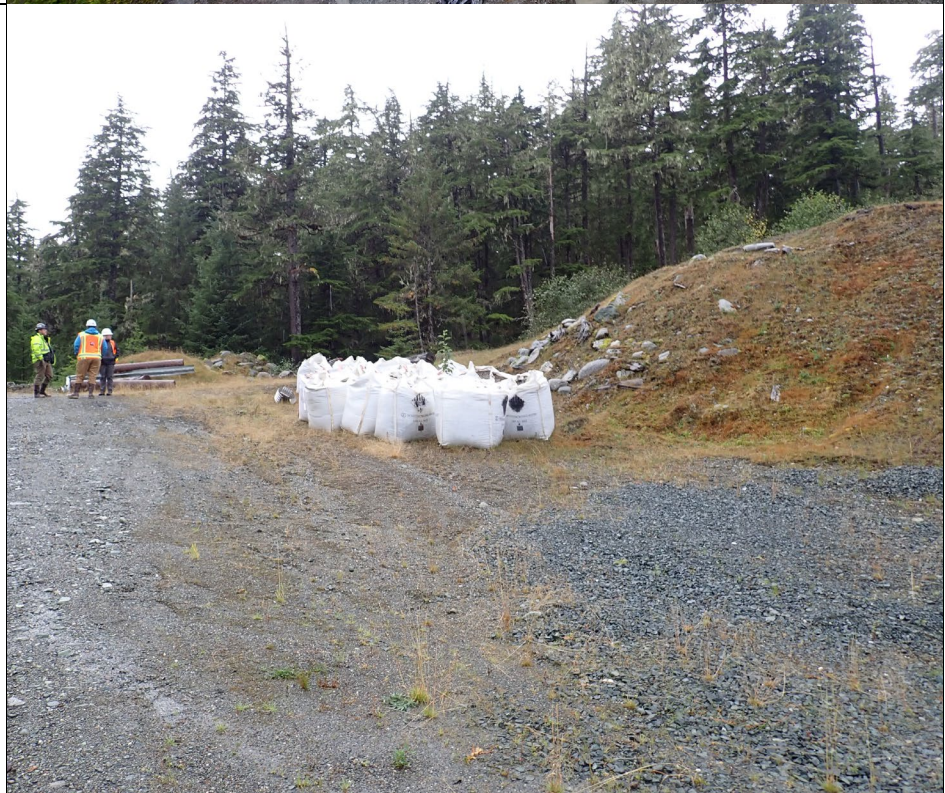
- 1.4. Pit 7 has consistently remained unchanged from previous inspections. Primarily, this site is used for storage of stockpiled aggregate, including super sacks filled with finer material, and metal piping (Photo 6). Reclamation of slopes shows good vegetative growth and are stable. The toe of the slope has been excavated to enlarge the pad area and has remained stable (Photo 7). The overall site condition is well maintained with good vegetative growth on the slopes leading up to the old rock quarry highwall (Photo 8).

Photo 6: Stockpiled aggregate, super sacks, and metal piping stored at Pit 7. View looking south.

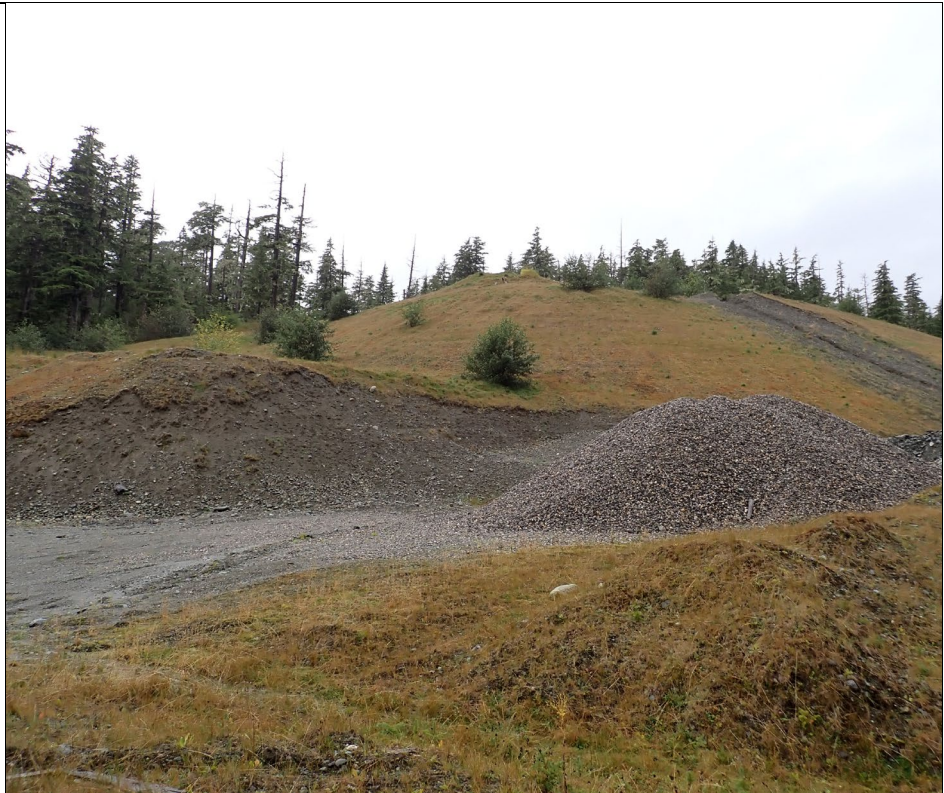
Photo 7: Excavated and stabilized toe of the slope at Pit 7 to enlarge the pad area for aggregate storage. Sloped areas have good vegetative coverage. View looking to the west.

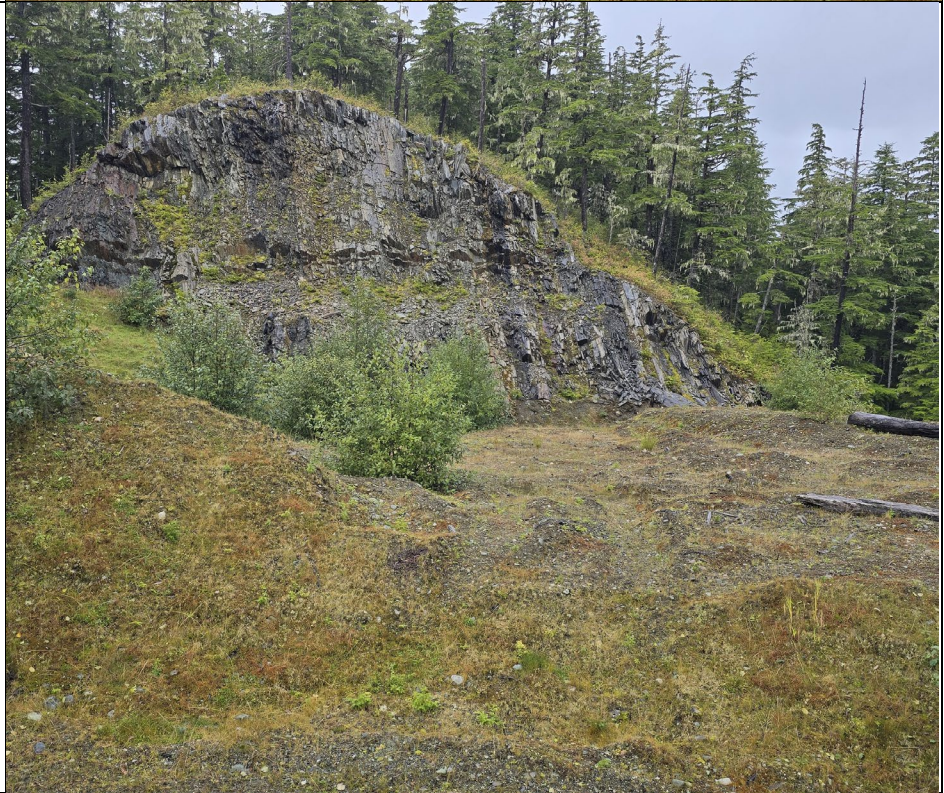
Photo 8: Vegetated slopes leading up to the old rock quarry highwall at Pit 7.

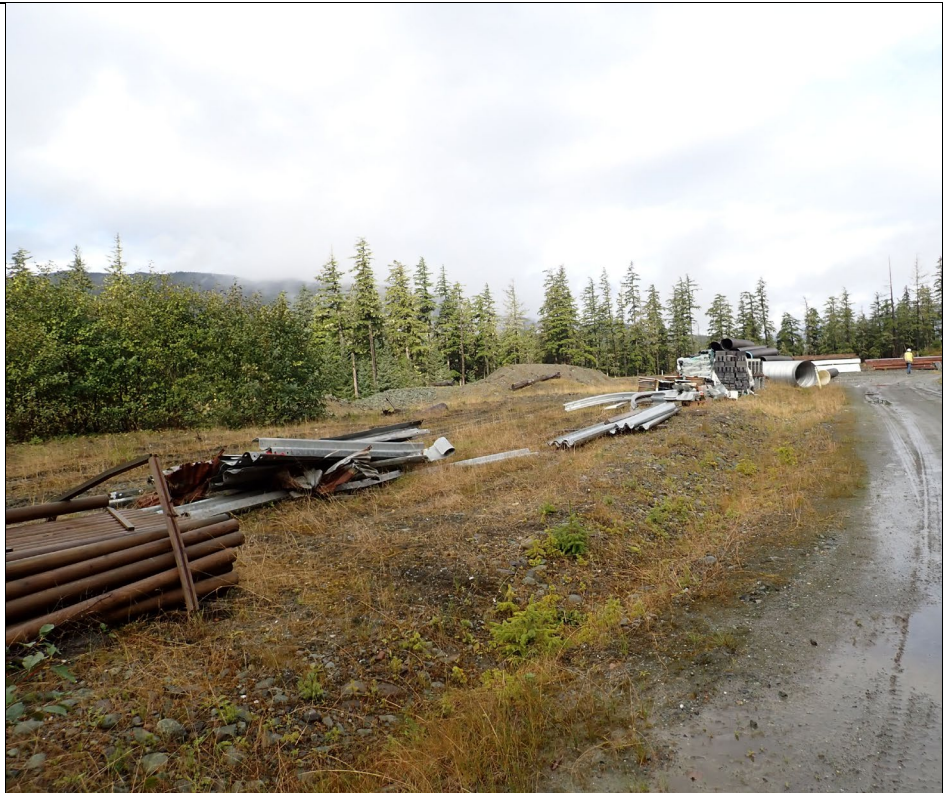
- 1.5. Sand Pit, located at 1.4 A-Road, has remained consistent in size and scope with little change from previous inspections. Its primary use is a laydown yard where culverts, piping, and other construction materials are stored (Photo 9). Partial reclamation along the slopes surrounding the site is well vegetated since they were reseeded over half a decade ago and are in stable condition. Water within the pit was observed to be well below the spillway along the western extent of the facility adjacent to A-Road (Photo 10). Field conditions confirm partial reclamation consistent with the site's operational role as a reclamation-material reserve.<sup>7</sup>

Photo 9: Construction materials stored at Sand Pit laydown yard seen from access looking south.

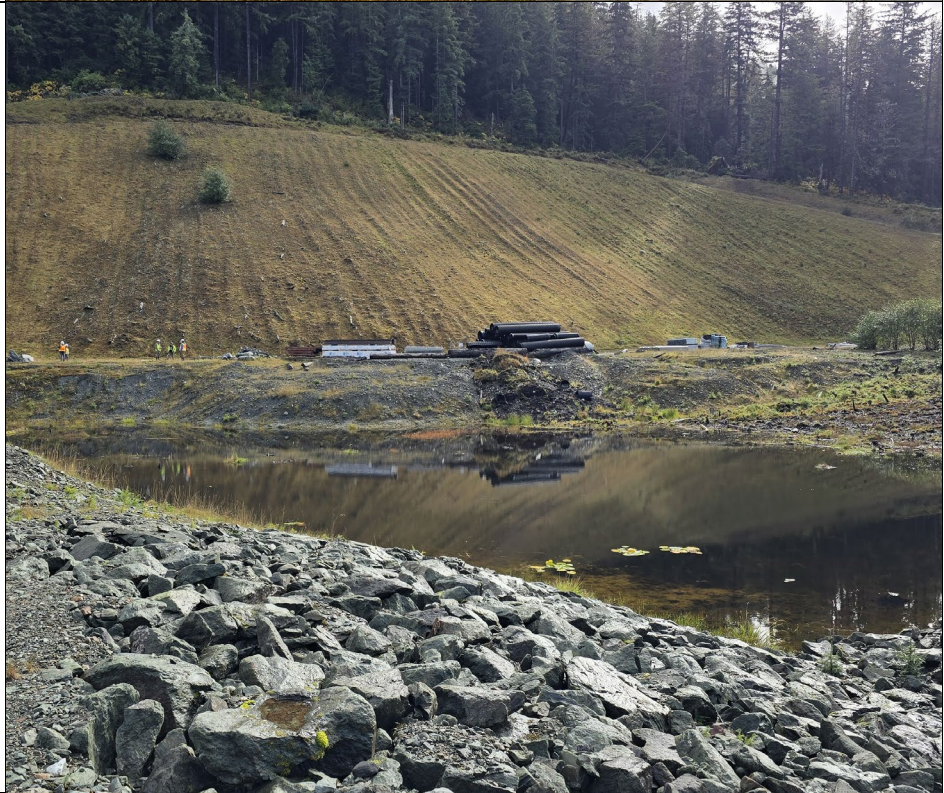
Photo 10: Poned water within Sand Pit observed below the spillway. View of the well vegetated slopes on the eastern side of the facility.

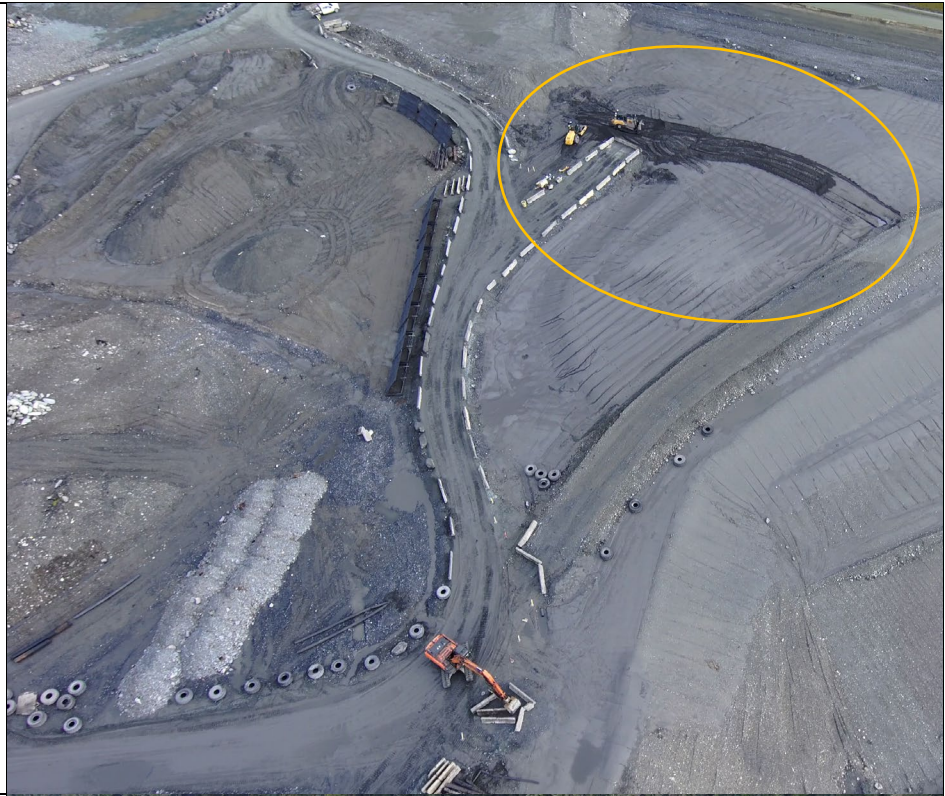
- 1.6. Atop the TDF, active tailings deposition was observed via drone. A dozer was spreading material next to a roller to create the next lift while an excavator moved Jersey barriers lining the access route for haul trucks (Photo 11). Current slope geometry has been graded 3:1 on the east, south, and west faces of the TDF as part of reclamation efforts (Photo 12), matching documented closure design specifications.

Photo 11: Active tailings deposition atop the TDF using a dozer and roller (Circled). Excavator placing Jersey barriers along access road. Ariel view of the central eastern end of the TDF.

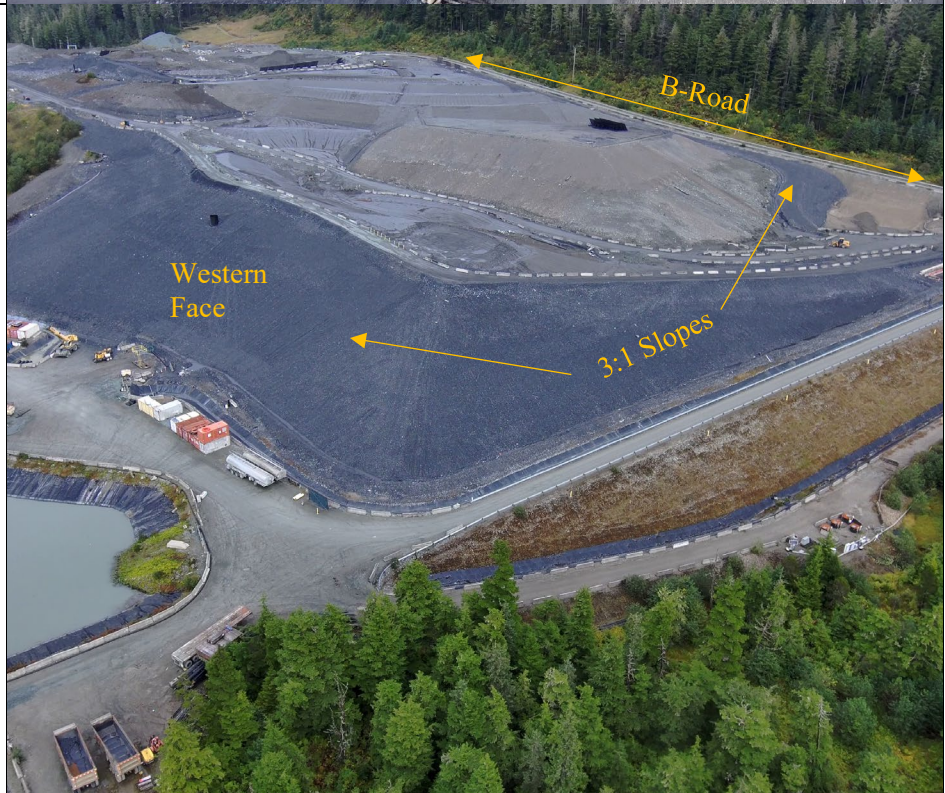
Photo 12: Final grade of 3:1 of slopes on the east and west faces of the TDF per reclamation requirements. Ariel view of TDF looking northeast.

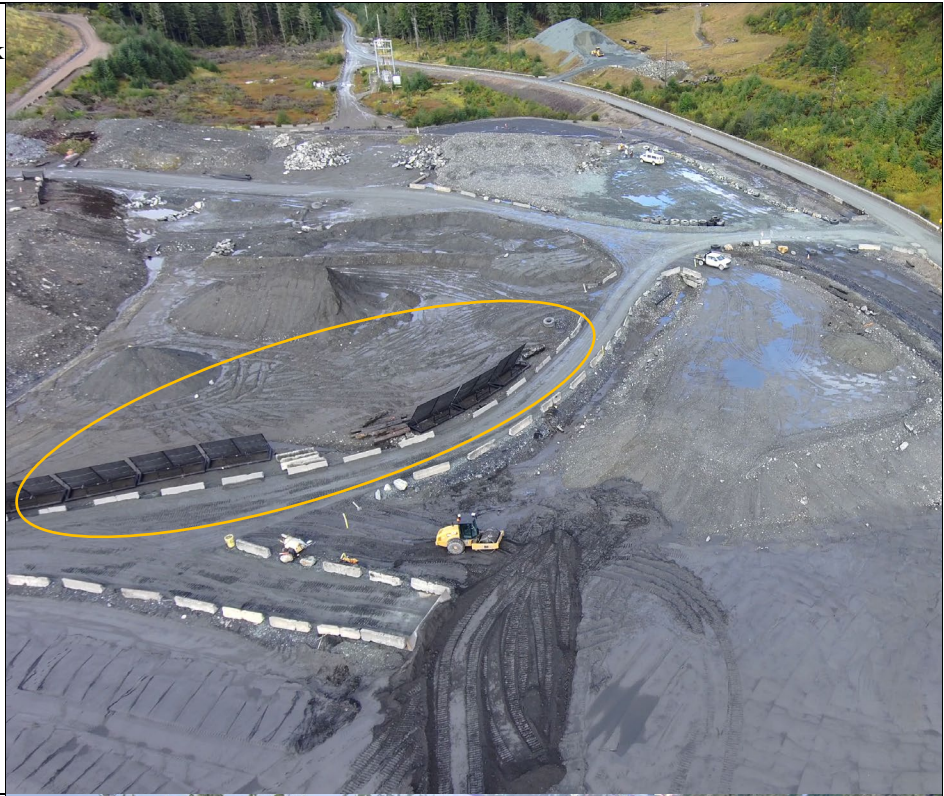
Wind fencing was observed along the haul truck access route and along the eastern edge of the TDF as part of the operations fugitive dust control efforts (Photo 13). Initial grubbing was under way just north of the TDF on the west side of the B-Road in preparation to begin construction for its expansion next season (Photo 14). Several active material sites were observed to be well kept and organized located within the northeastern end of the TDF and one larger stockpile just off the east side of B-Road opposite the TDF (Photo 15).

Photo 13: Wind fencing installed along the haul truck access route and eastern TDF edge (circled) to help mitigate fugitive dust.

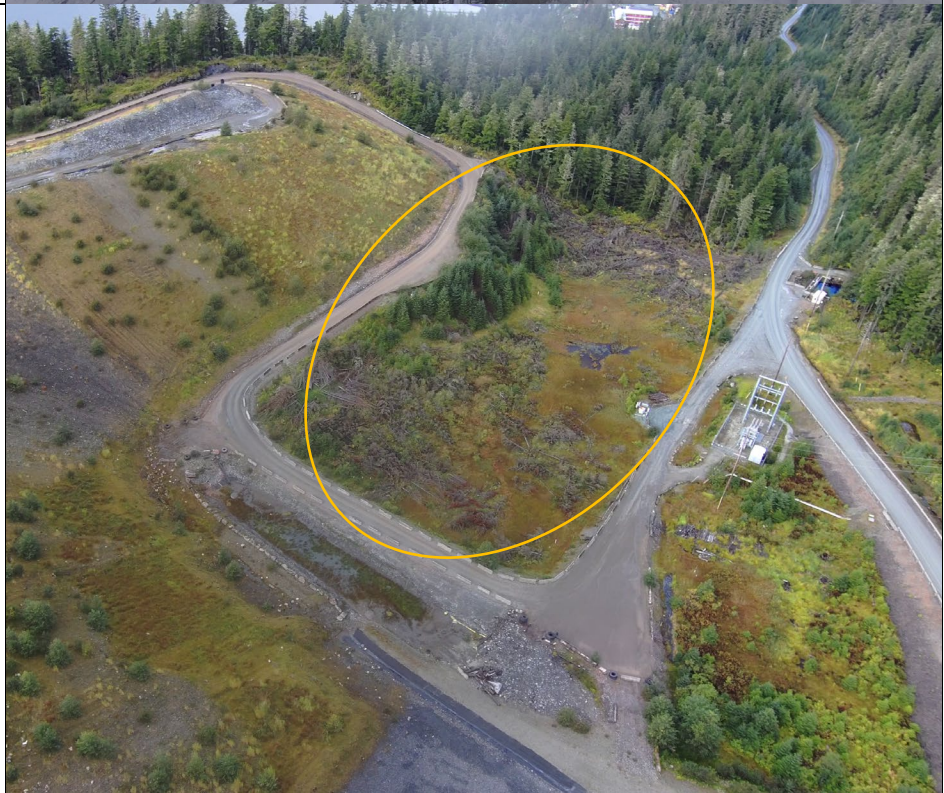
Photo 14: Initial grubbing north of the TDF along B-Road for next season's expansion viewed to the north (circled).

Upper right of image is an older area of the TDF that has been sloped and reseeded.

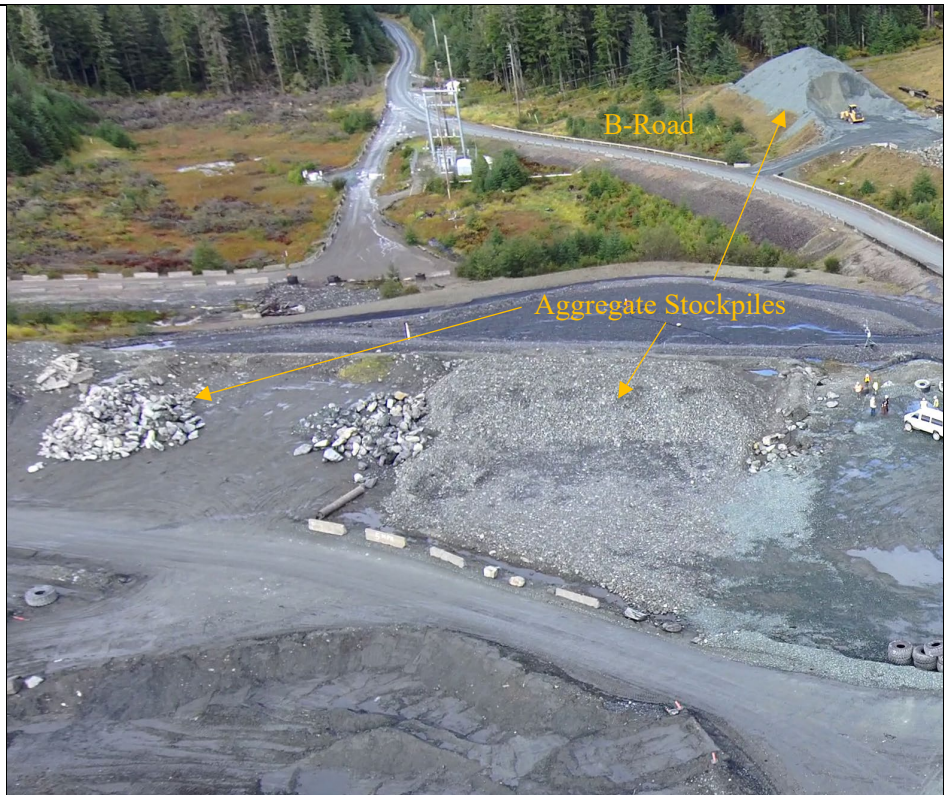
Photo 15: Organized active material sites at the northeastern end of the TDF and adjacent B-Road.

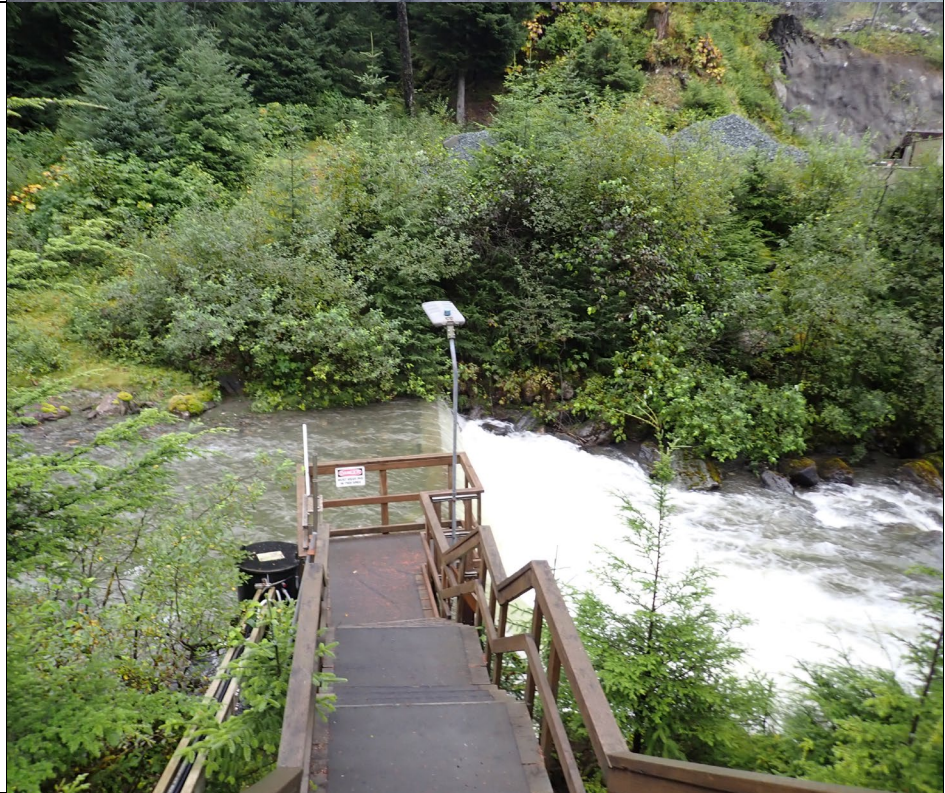
- 2.1. Potable Water Treatment Facility, near the 920 Portal, with walkways to Greens Creek for sampling are in good condition and well maintained (Photo 16). Active treatment matches the documentation emphasis on sustained water treatment needs for the mill and surrounding buildings during operations.

Photo 16: Potable Water Treatment facility next to water draw point near the 920 Portal with maintained walkways to Greens Creek used for water sampling.

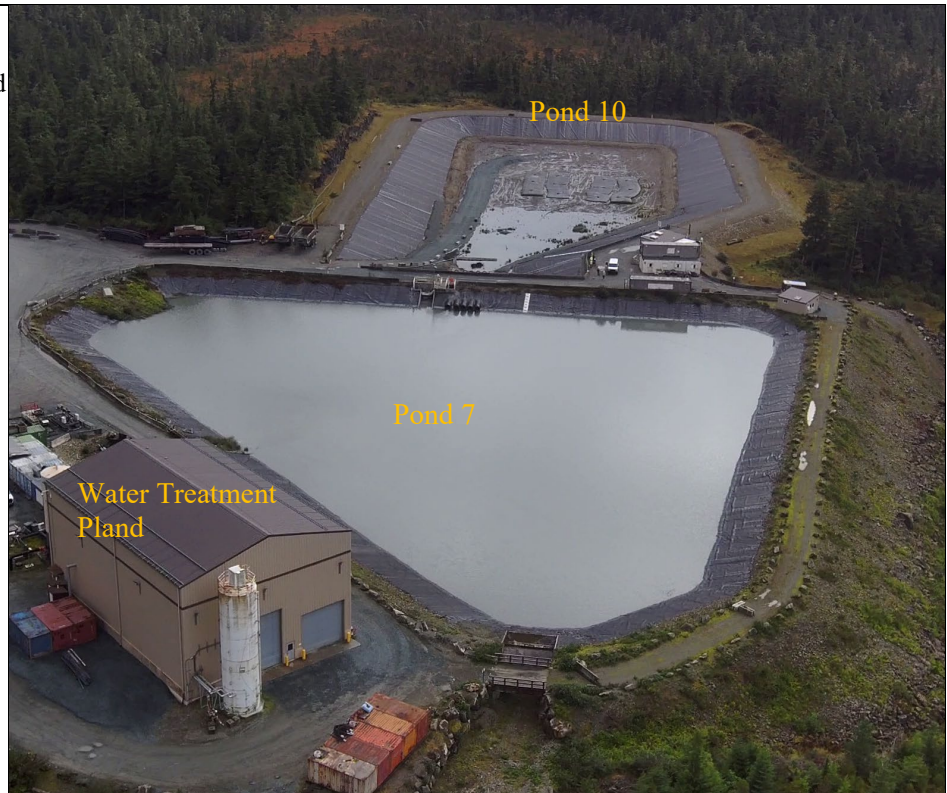
- 2.2. At the time of inspection, a major storm event had precipitated above average rainfall. Pond 7 freeboard was noted to be just below the culverts that connect to Pond 10. Free standing water was seen ponding in half of Pond 10, a fraction of its total storage capacity (Photo 17).

Photo 17: Water storage capacity at Pond 7 is just below culverts that are piped to Pond 10. Ariel view looking south.

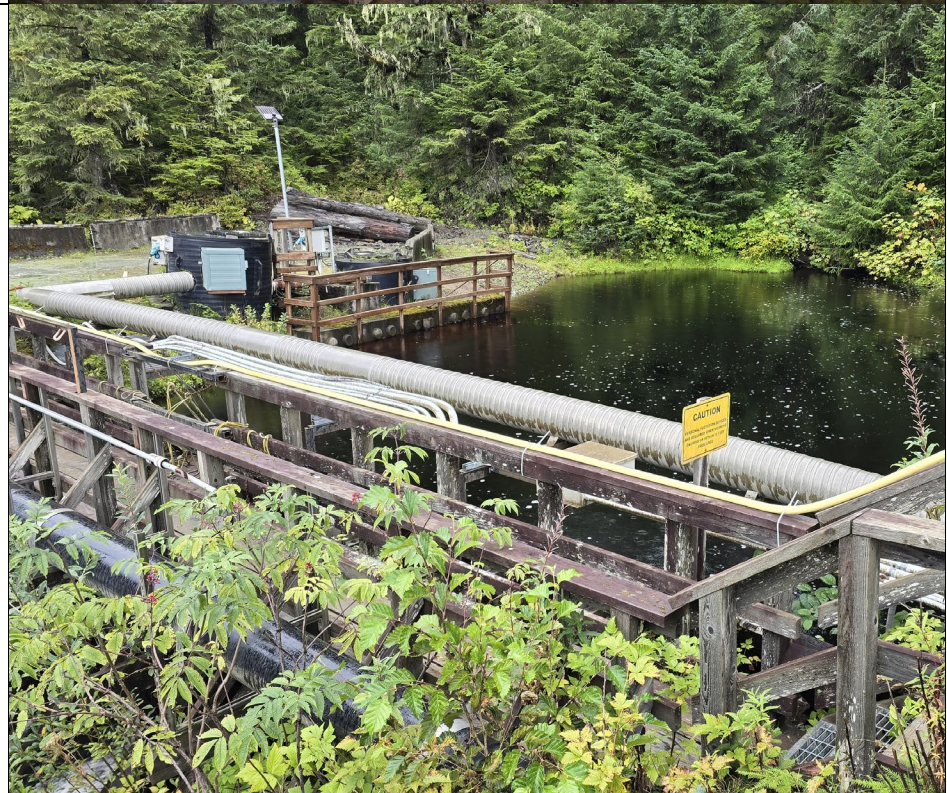
- 2.3. DNR staff stopped briefly at the potable water draw for Hawk Inlet Camp facilities. This area was well kept and maintained with proper signage (Photo 18).

Photo 18: Potable water draw point for Hawk Inlet Camp facilities is well maintained. This area is just off the B-Road along Cannery Creek.

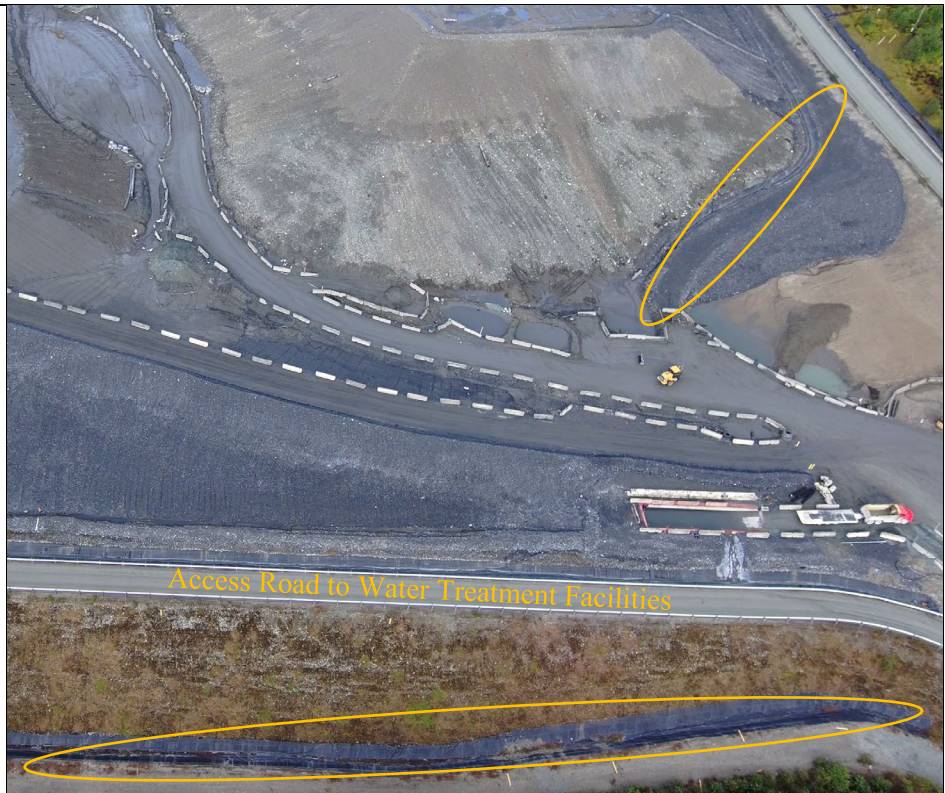
- 2.4. Lined storm water runoff ditching around the TDF is mostly clean of debris and overall, well maintained. No standing water was observed within ditches along the periphery of TDF viewed via drone (Photo 19).

Photo 19: Storm water runoff ditching around TDF are well maintained with no visible standing water (circled). Ariel view of the southern end of the TDF.

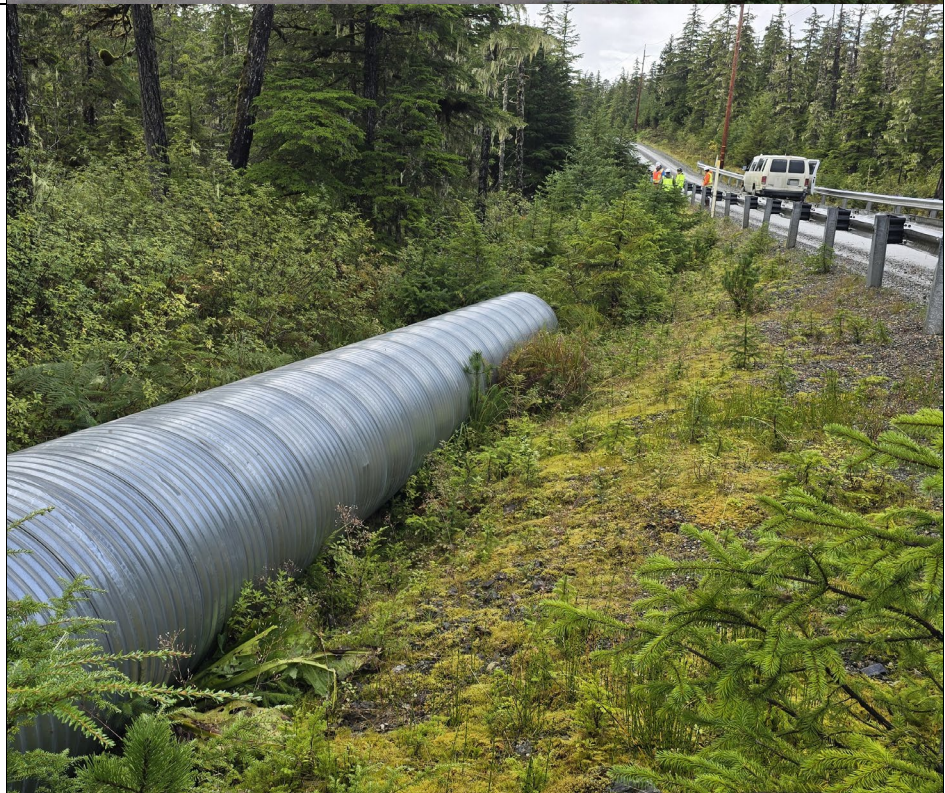
2.5. MP 2.2 along the A-Road and access to Pit 7 are two locations scheduled for culvert replacement to improve fish habitat. Work has not begun, but replacement culverts have been delivered to each location (Photos 20 and 21)

Photo 20: Delivered replacement culvert at MP 2.2 along A-Road for future fish-habitat improvements.

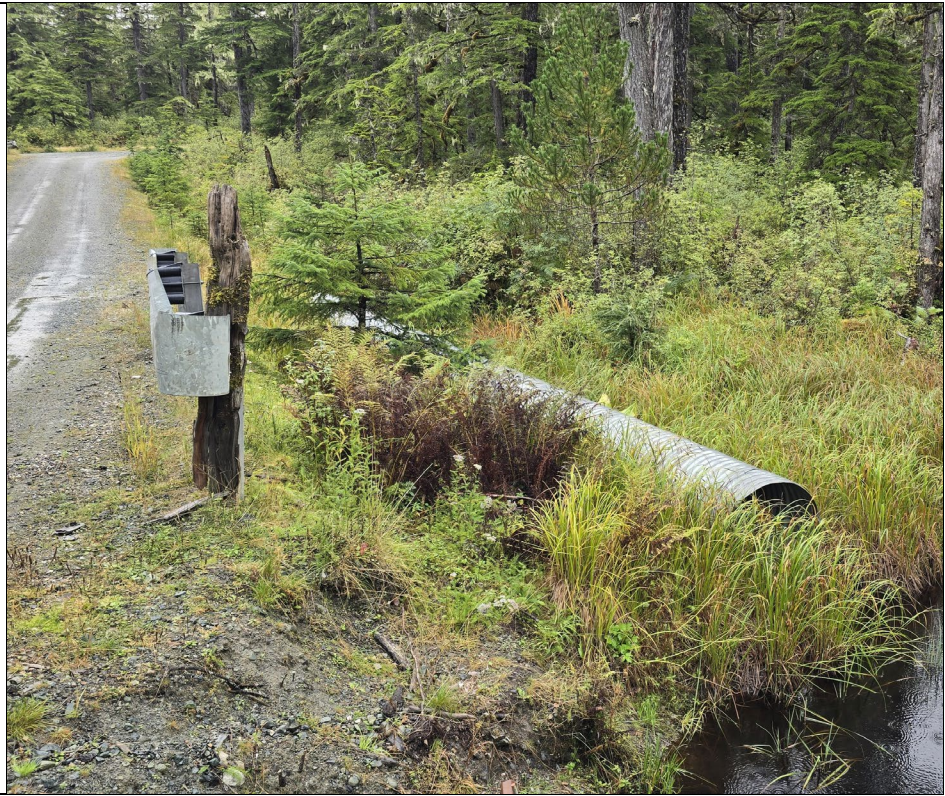
Photo 21: Delivered replacement culvert at Pit 7 access location for planned habitat upgrades.
