DEPARTMENT OF ENVIRONMENTAL CONSERVATION

FIELD INSPECTION REPORT HECLA GREENS CREEK MINING COMPANY

Inspection Date: October 12, 2011, 9:30 AM - 2 PM
Report Date: October 13, 2011

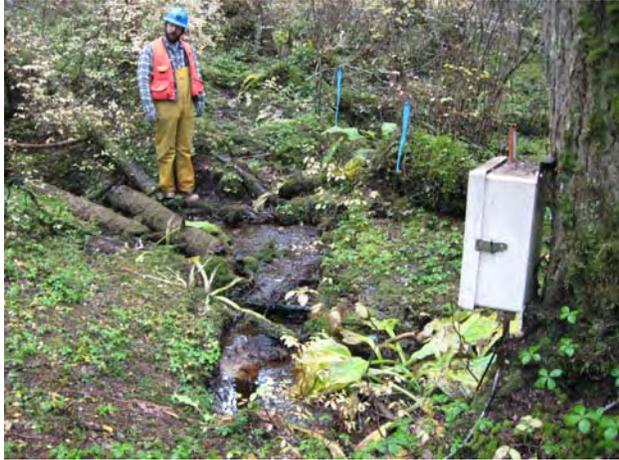
Althea Creek: Brock Tabor, myself, Chris Wallace and Mitch Brooks hiked to Site 60 (~0.8mi from access point at Pond 7) on Althea Creek and then to the location where the creek entered Hawk Inlet. It was noted by Greens Creek staff that the flow in Althea Creek at the monitoring location was about average (the flow at this intermittent site ranges from 0 gpm to 30 gpm, averaging 7 gpm). Althea Creek was given its name by sampling personnel at Greens Creek. A little way below this location additional water entered from a side stream; this side creek did not appear to capture water from the Pond 7 area. There is an unlined drainage collection system at the down-slope side of Pond 7. Chris Wallace deduces from ground and ditch elevations and from water quality analysis in the ditch that drains to the sump that some of the water collected in the ditch comes from the surrounding muskeg. Water also reaches the sump from reclamation materials adjacent to Pond 7, placed there during the construction of Pond 7. During a dry summer the pump-back is around 3000 gpd, and after a 1" storm event approximately 100,000 gallons are pumped back to Pond 7.

Althea Creek (Site 60. 1st instance of concentrated flow)

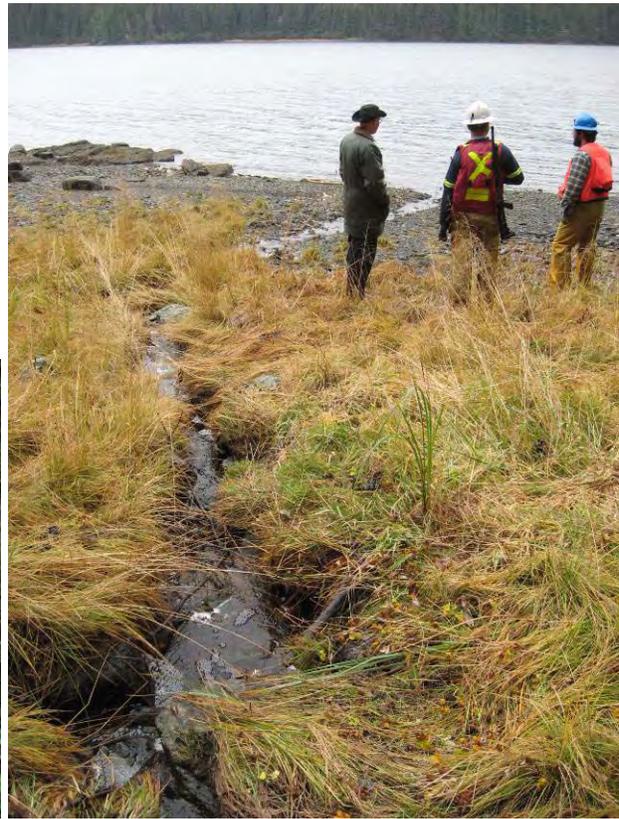
Althea Creek entering Hawk Inlet

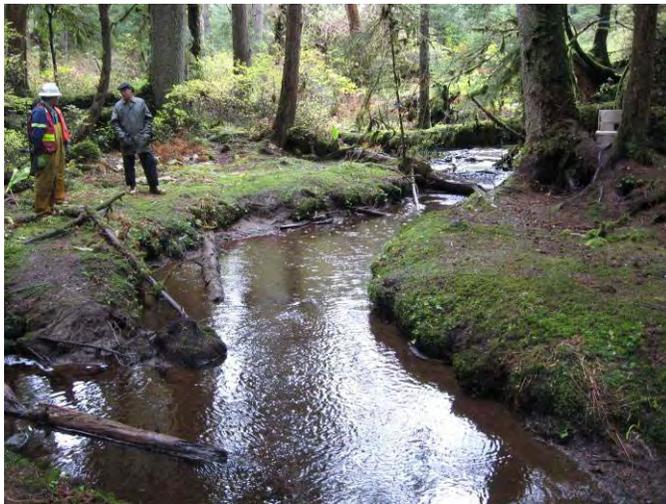
Tributary Creek: We next hiked in to Site 9 on Tributary Creek (~ 100yds from access road), past a pond upstream of the monitoring point where conductivity, stage and sometimes turbidity are measured. Tributary Creek also had an average flow, estimated by eye at around 1-2 cfs. Fry were observed at this site. After viewing this site we returned to the Environmental building and were then given a tour of the 1350 site and a stop at Site E by Jennifer Saran.

Tributary Creek at Site 9

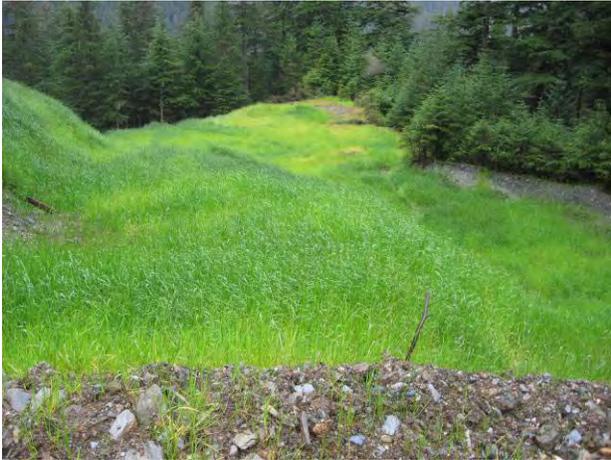
Site 1350: Approximately 20,000 cy of material were removed from this site in 2011. There is another approximately 20,000 cy of material to be removed. This is scheduled to occur in 2012.

Much of the top area will then drain to the mine portal and will eventually go to treatment and discharge to Hawk Inlet.

1350 down-slope area from which material was removed in 2011. This area was hydro seeded, with rapid growth occurring.

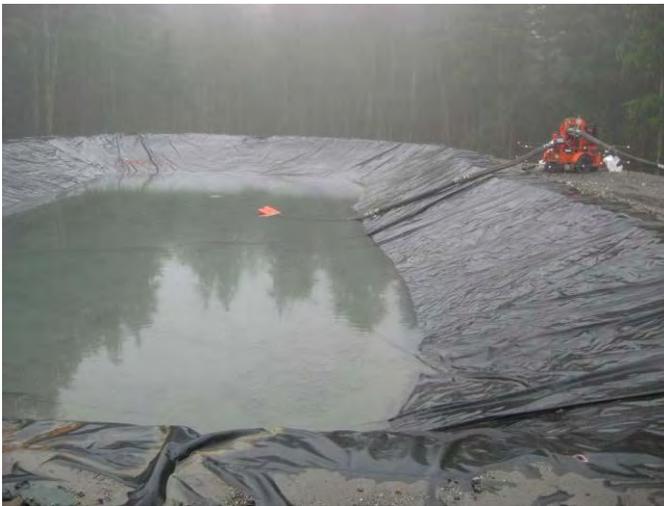
Site E: Greens Creek had planned on moving approximately 40,000 cy a year from this site. However, more resources were dedicated to removing material from the 1350 site in 2011, so only approximately 7000-8000 cy of material have been removed so far from Site E in 2011.

Site E pond. This water is pumped to the main waste water transmission line for treatment and discharge to Hawk Inlet.

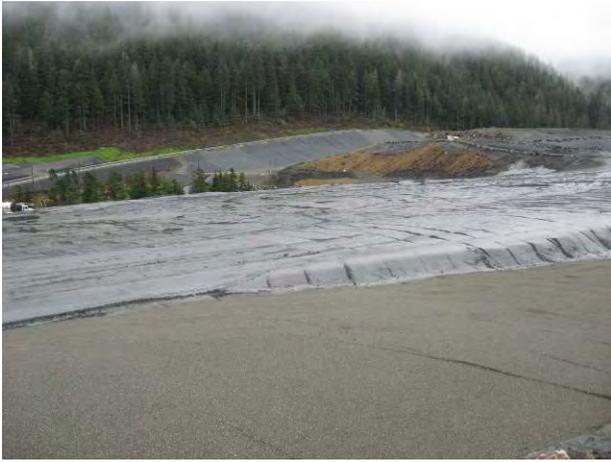
Tailings showing east expansion in the distance.

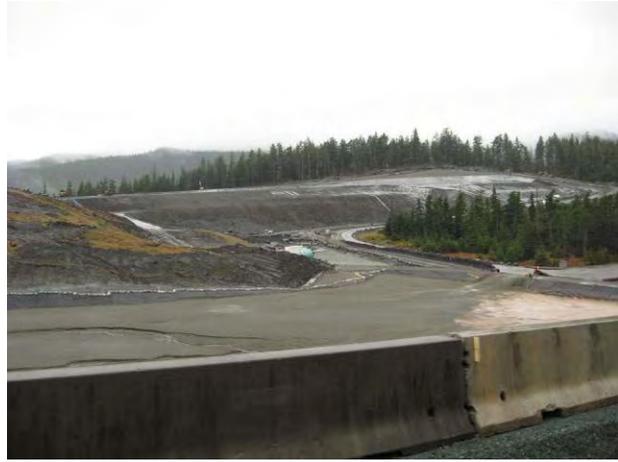
Tailings facility: The liner has been completed for the East expansion and sand placed on the shallower slopes. Water was seen to be ponding at the north end, and a pump was there to remove the water. Water in this area should drain by gravity to Pond 9, where it then travels by gravity to the west side of the tailings facility to a ditch and to Pond 7 for treatment before discharge to Hawk Inlet. It is thought that fine material from the service sand layer has washed down to the low spot and clogged the drain. The HGCMC Surface Operations and Technical Services groups are working on a solution to this issue. Greens Creek intends to remove material from the top of the main tailings pile and place it in the bottom portion of the east expansion area in order to make a larger, well drained working surface for future tailings placement.

Water collecting on the sand liner in the NE far corner of the East expansion area.
