FIELD INSPECTION REPORT HECLA GREENS CREEK MINING COMPANY

Inspection Date: June 12, 2012, 8:30 AM - 3 PM

Report Date: June 27, 2012

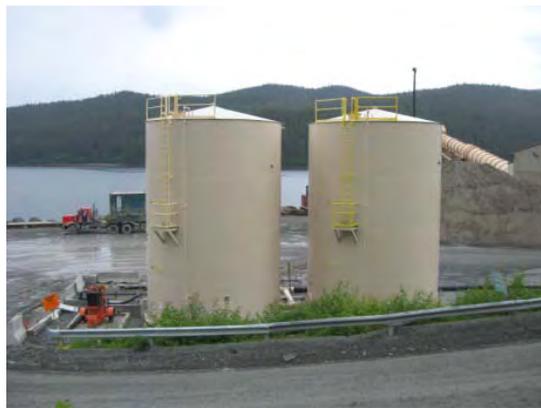
Concentrate storage area: Two new tanks have been installed to store excess storm water during high rainfall events when existing pumps would be unable to pump the storm water at peak flows to Pond 7. The tanks are located between the cannery and the concentrate building that enable storage of storm water from this area.

Stormwater Collection Tanks at Concentrate Building

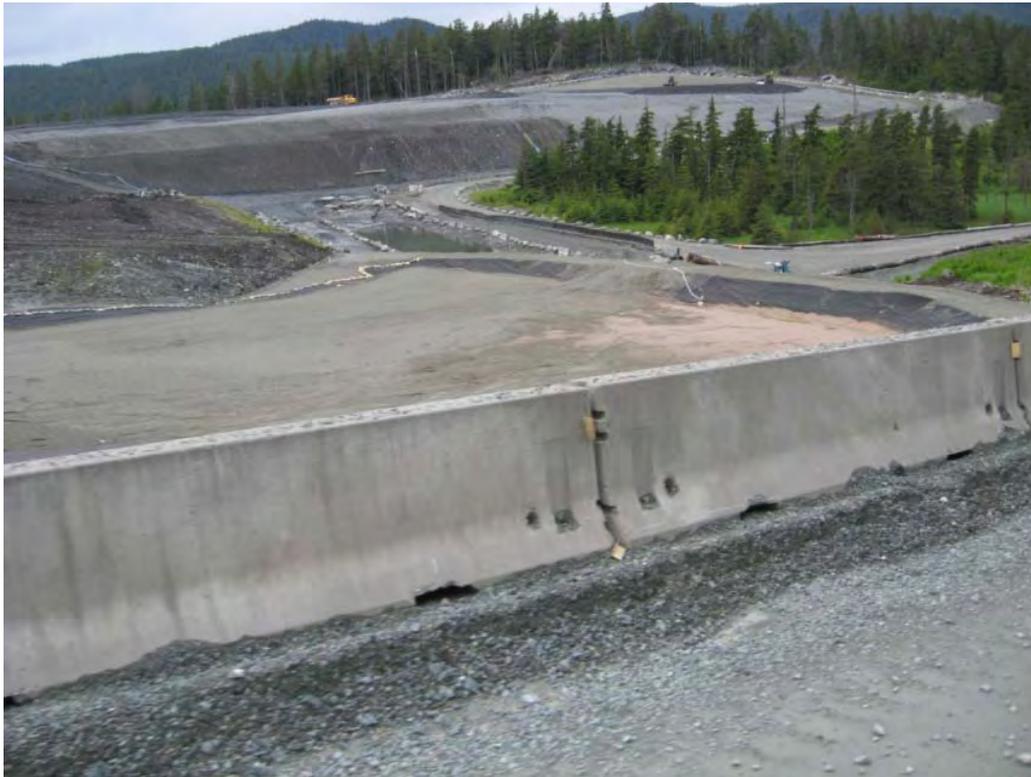
Tailings Disposal Facility. The systems observed at the tailings disposal facility appeared to be in place and in good working order. The old “Pond 6”, where Wet Well A is located, has been filled with tailings. All tailings seepage water and ground water entering the under-drain system is pumped from Wet Well “A” to wastewater storage Pond 7. Tailings placement was actively taking place in the northwest Pit 5 expansion area. Tailings have not been placed in the East Ridge Expansion Area. A drain in the east expansion area that conducts contact water to Pond 9 was not operational. This will need to be repaired prior to placing tailings in this area.

Tailings placement in the distance on the Northwest Pit 5 expansion area (distance). Note, the inoperable drain in the East Ridge Expansion Area in the foreground where brownish/pinkish silt has settled out.

1. A drain in the east ridge tailings expansion area that conducts contact water to Pond 9 was not operational. This will need to be repaired prior to placing tailings in this area.

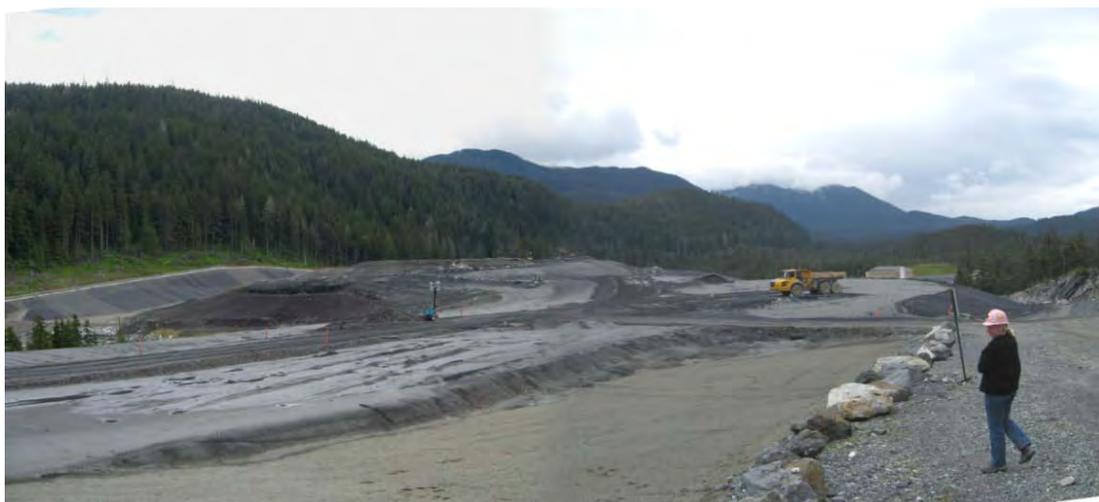
Northwest Pit 5 Area Looking Southeast. Note initial tailings placement lift and area on the right where the service layer is exposed.

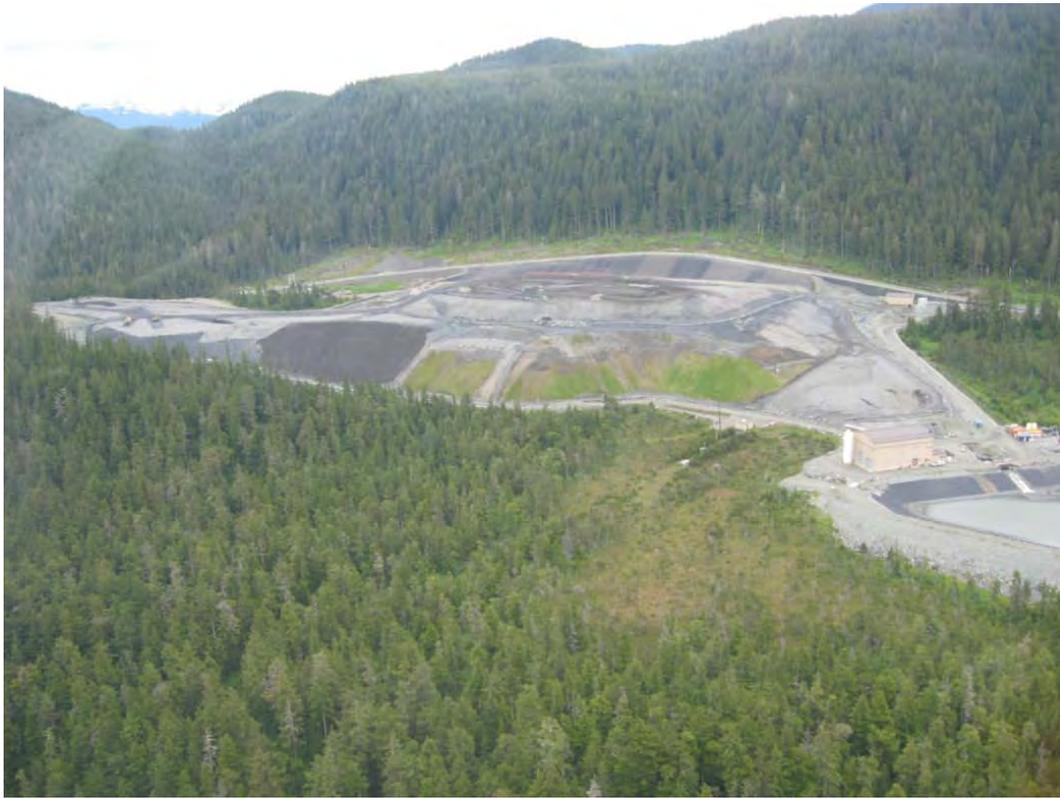
Aerial View of the Tailings Disposal Facility Looking NE. Note eastern expansion area in distance and compliance monitoring drainage area in the foreground.

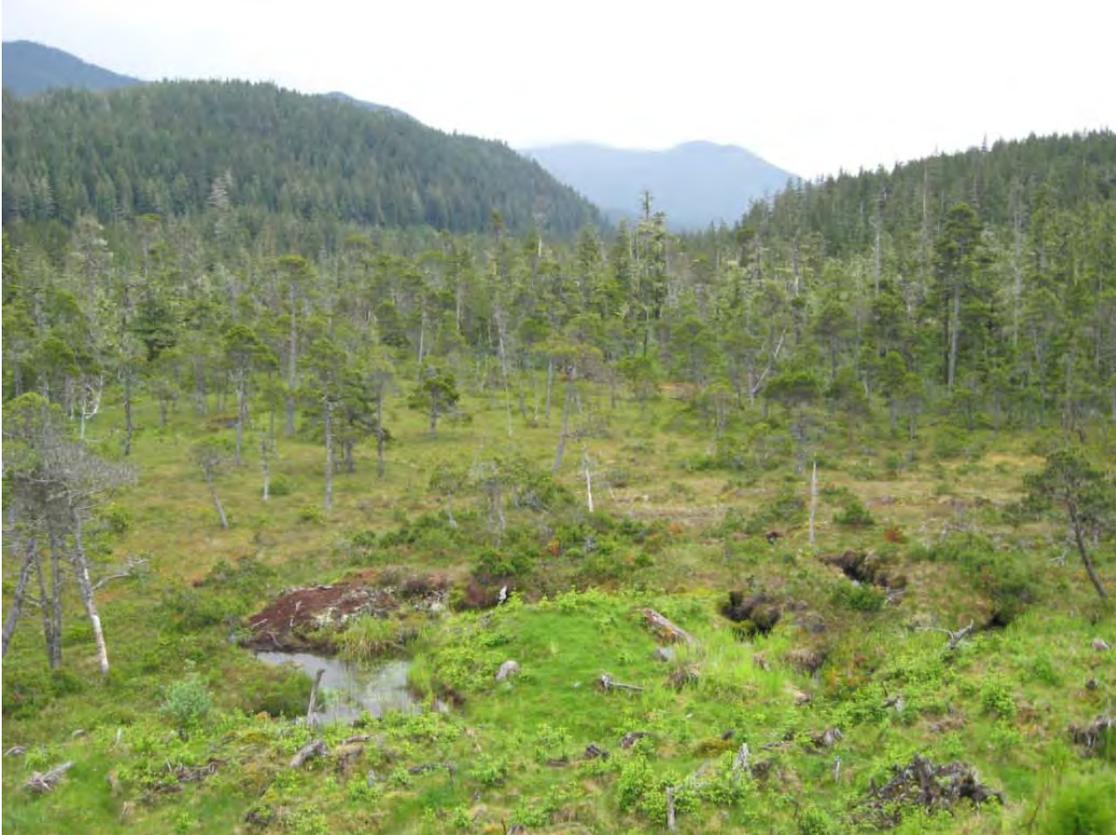
We walked to the top of a pile of reclamation storage material at the southwestern end of the facility. This provided a good vantage point for viewing a potential expansion to the south of the existing tailings area into the Tributary Creek drainage. The vantage point was also a good place to view various other features and issues having to do with the existing tailings disposal facility. We discussed issues having to do with fugitive dust transmission and intrawell comparison and compliance monitoring of surface water.

Possible Southern Tailings Expansion Area (Tributary Creek drainage). Note wetlands and muskeg.

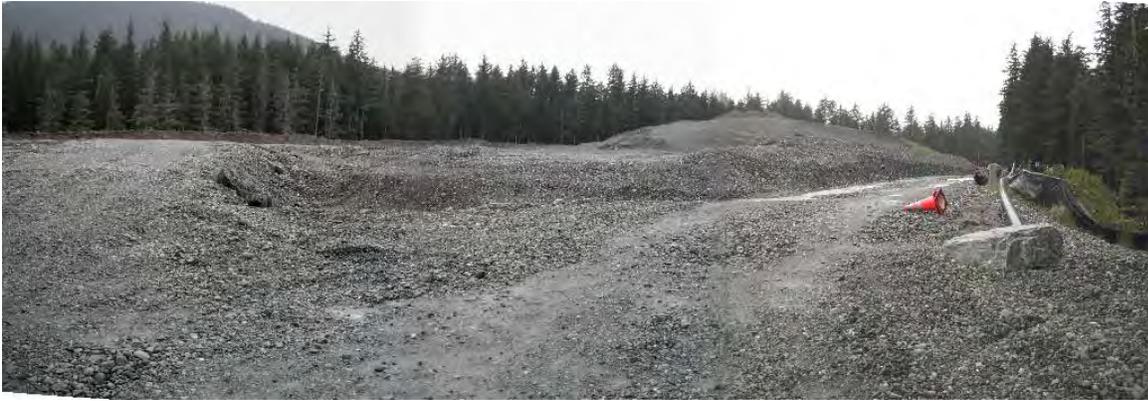
Site E: Approximately 365,000 cy of waste rock was disposed at this site of which about 200,000 cy was acid generating and metals leaching. This will eventually be moved to the tailings facility. Approximately 85,000 cy have been removed so far at around 40,000 cy a year. However, until there is an approval for the tailings expansion the amount of material removed from the site will be minimal in order to give preference to tailings from mill operations. We walked around to the north end of the site where a large sedimentation pond was constructed. The pond helped to catch storm water run-off and pipe it to the water line from the mill to Pond 7 and the water treatment plant at the tailings disposal facility. There were separate clean road and dirty road systems set up at Site E to cut down on contaminants being tracked off site. The contact water sump was nearly empty and appeared to be functional.

Site E Southern Aspect. Note clean road on left.

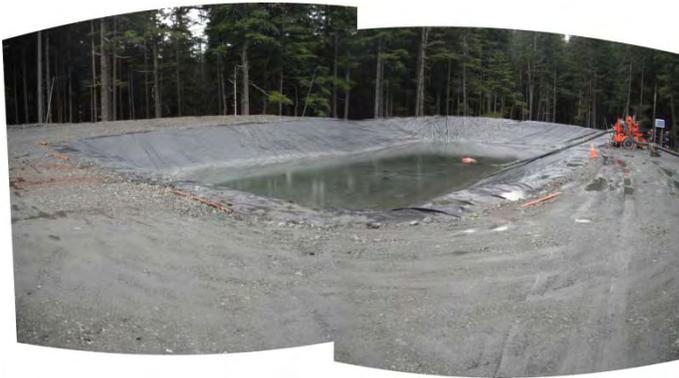
Site E surface drainage collection pond.

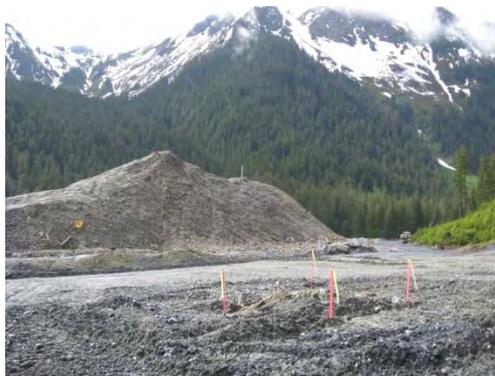
The temporary storage area is presently full of ARD and metals leaching waste rock from Site 1350, awaiting disposal underground. Until underground disposal capacity for this waste can be found there will be no more excavation at Site 1350.

Site 1350 Waste Rock Stored At Contained Area of Site 23

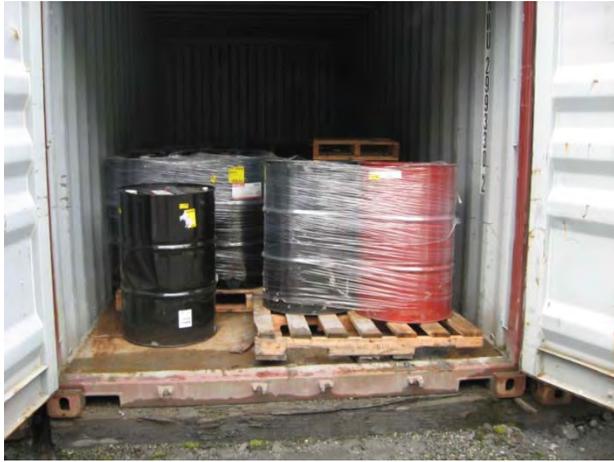
Mill – 920 area: In the materials storage area to the east of the mill there is a temporary storage area for unloaded supplies; there were six containers with solutions such as naphthalene sulfonate (Daracem 19), a concrete superplasticiser. In this area a container had previously been punctured by a forklift truck. This area should have a secondary containment structure in case of leakage or spills. Beyond the building structure there were drums of oil in a steel shipping container without secondary containment. There was also an unmarked blue drum and a number of High Performance Backing Material drums, for which the MSDS says “Avoid runoff into storm water and ditches that lead to natural waterways” on a superstructure in the storage area. This area, or the containers, should also have secondary containment.

Oil drums in container

9. Provide secondary containment or move liquids to secondary containment as previously described in this report.

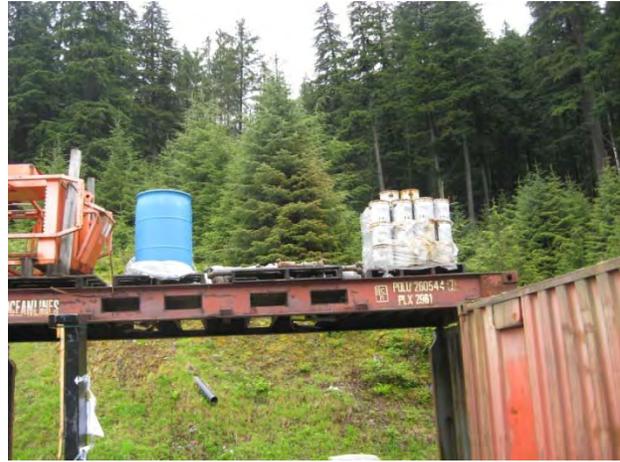
Blue drum and Backing Material drums

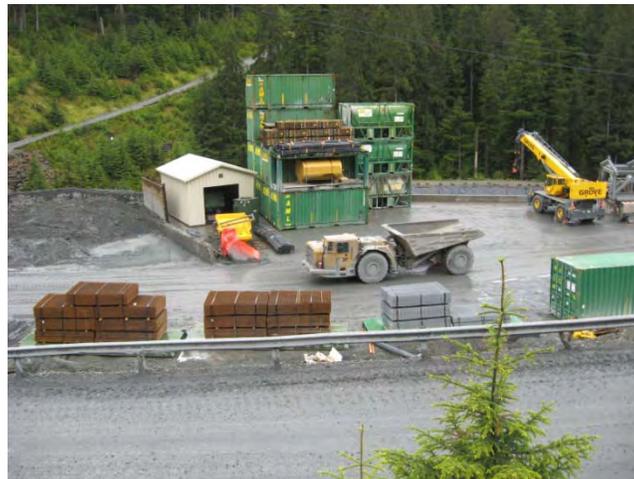
A new unit was in the process of being installed that will enable the removal of large material from grit chambers and ditches for re-use, with the remaining fine material going to the mill. The unit is on a concrete pad adjacent to the road from the mill to the mine portal and is immediately above Pond A. (At the right side of the photograph below).

Concrete Pad Above Pond A

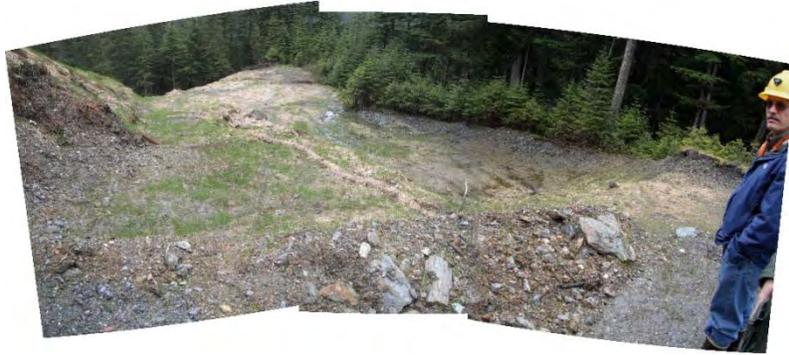
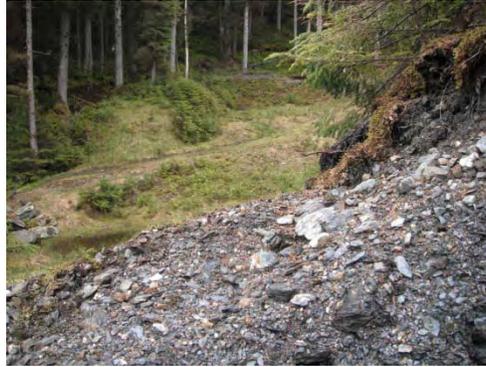
Site 1350: No excavation in this area has taken place this season due to the lack of disposal space underground. There is still about 10-15,000 cy of acid generating material to be removed, possibly this year, depending on stope space underground. We are aware of two exceedances of sulfate at Site 13 that are slightly above AWQS at Site 13 (below the East Lobe of Site 1350). Operational techniques and Best Management Practices (BMP's) should be carefully employed to ensure releases do not cause water quality exceedances during the time waste rock is removed in the Site 13 drainage. This should be observed during site inspections.

East Lobe of Site 1350 Awaiting Excavation and Placement Underground

6. Operational techniques and Best Management Practices (BMP's) should be carefully employed to ensure releases do not cause water quality exceedances during the time waste rock is removed from the East Lobe of Site 1350 in the Site 13 drainage. This should be observed during site inspections.
