DEPARTMENT OF ENVIRONMENTAL CONSERVATION

FIELD INSPECTION REPORT / ANNUAL MEETING TOUR HECLA GREENS CREEK MINING COMPANY

Inspection Date: July 10, 2013 6:00 AM – 4:00 PM

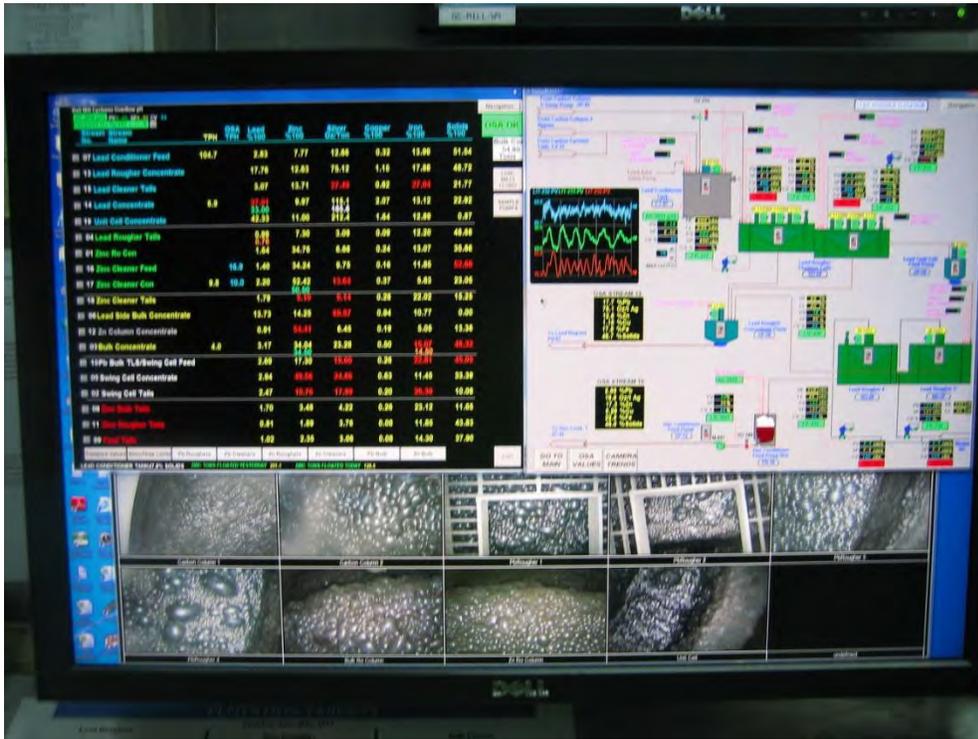
Photo 2. Monitor at the mill facility

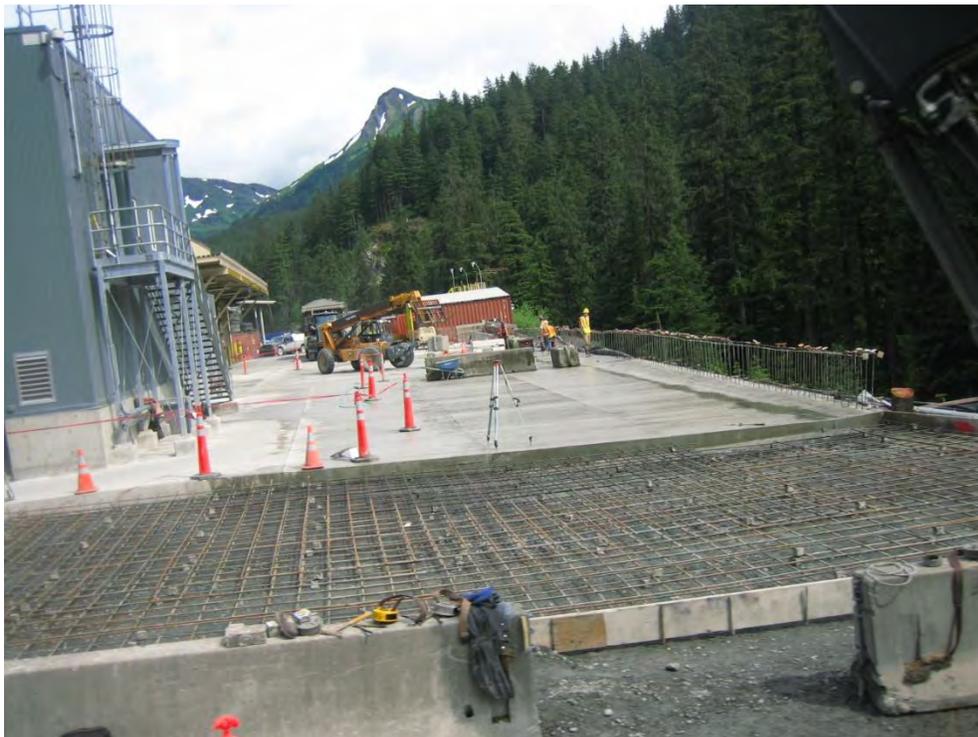
A tour was provided of the mill. The mill produces 300-400 tons of concentrate a day; zinc and silver provide the main sources of income. Concrete was being poured on the roadway between the mill and Greens Creek at the west end (Photo 2).

Photo 3. Concreting the road at the mill

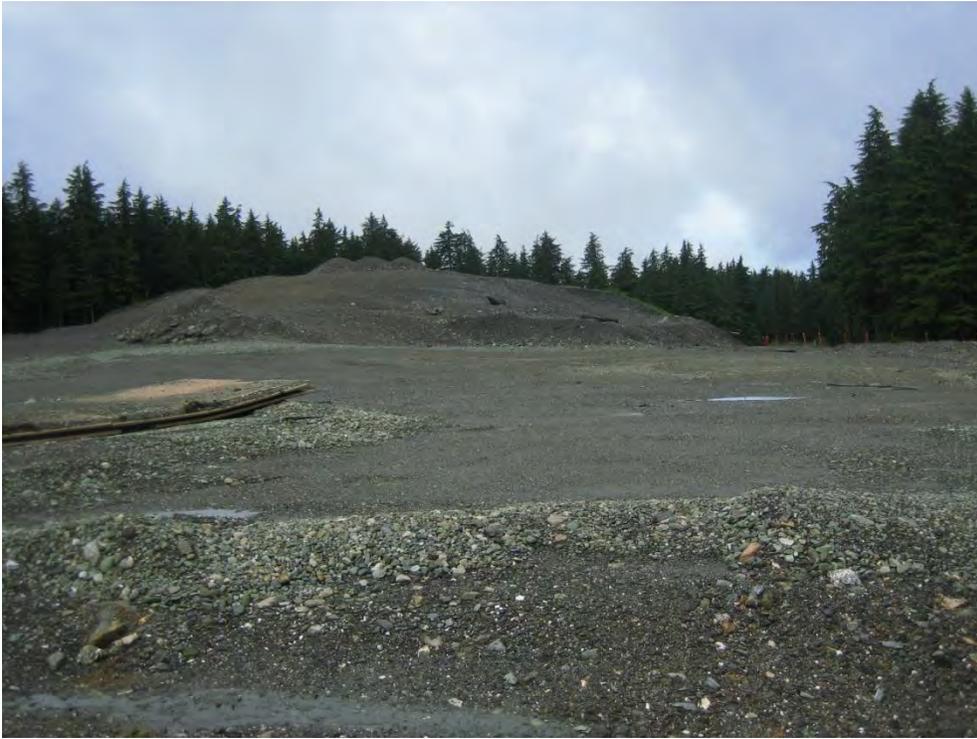
A stop was made at site E. Where material has been removed there still remains about 20 feet of potentially acid generating (PAG) material. Once the majority of the PAG material has been taken to the tailings site, site E will be graded to drain towards the pond at the NW end of the site.

Photo 4. Site E

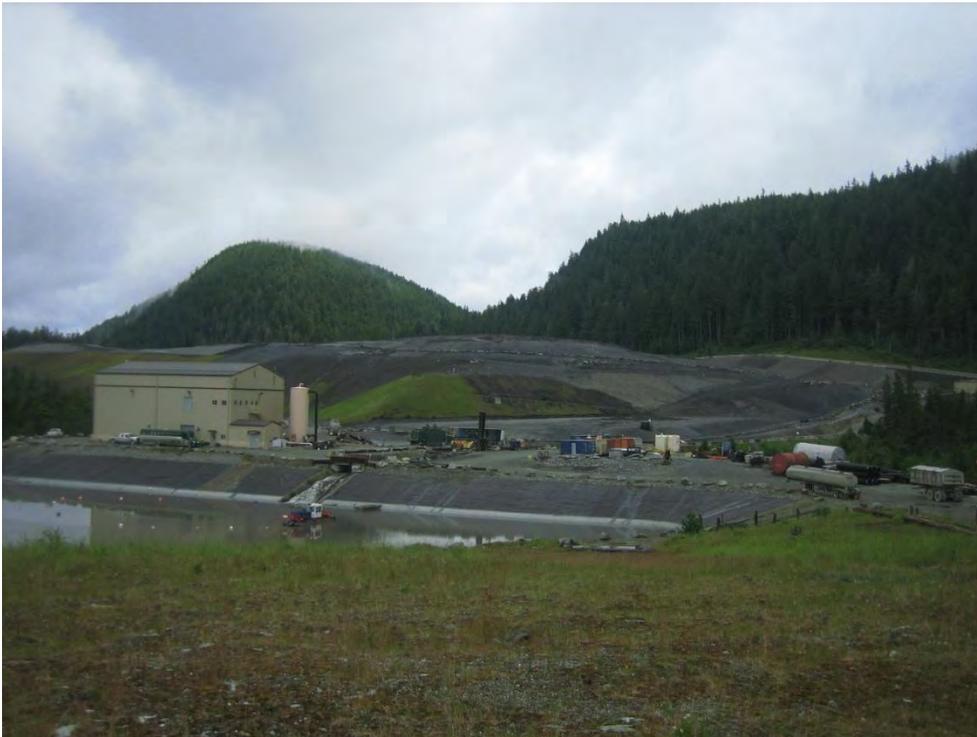
A tour was made of the tailings site, treatment plant, pond 7 and an overview of a possible expansion area within Tributary Creek to the south of the facility. A suction dredge was in Pond 7 to clean out sediment which is dewatered and taken to the tailings pile. The treatment plant can discharge up to 2300 gpm by gravity or 2500 when a booster pump is used.

Photo 5. Tailings facility, Pond 7 and water treatment plant

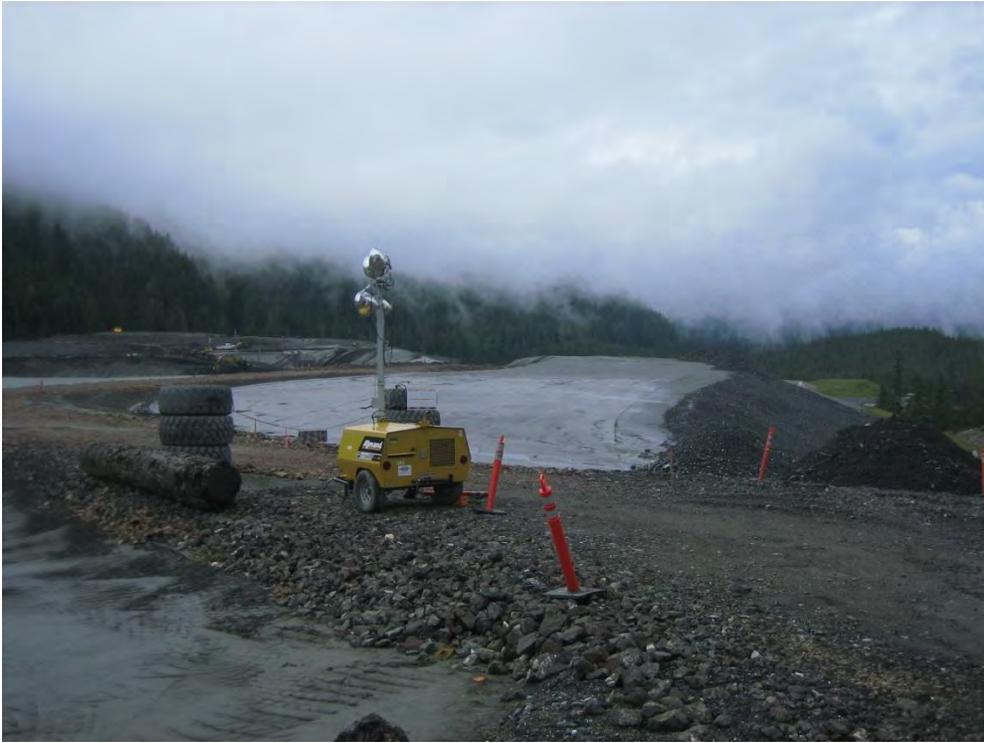
Photo 6. Tailings expansion in the NW corner

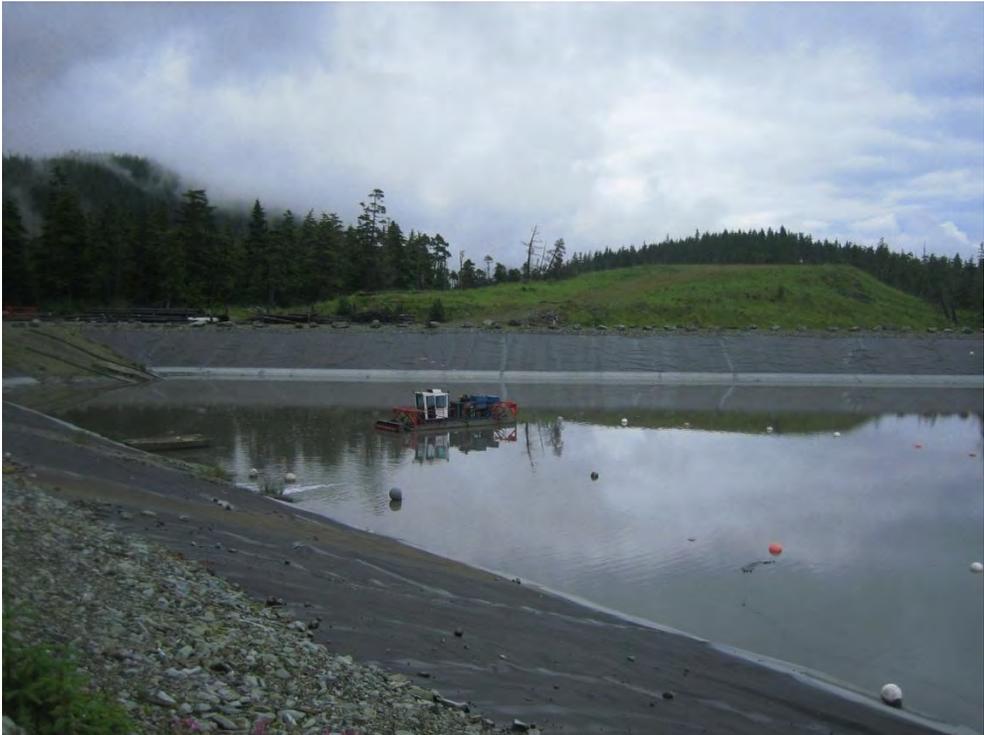
Photo 7. Sediment suction dredge in Pond 7.
