INSPECTION REPORT: GREENS CREEK MINE

Tongass National Forest Minerals Group
8510 Mendenhall Loop Rd
Juneau, AK 99801
(907) 789-6273 – office
(907) 586-8808 – fax

Date Of Inspection: Thursday, March 28, 2013
USDA FS Inspector: Jessica Lopez Pearce
Ranger Districts: Admiralty National Monument
Juneau Ranger District
Weather Conditions: partly cloudy, temps in the 40s.

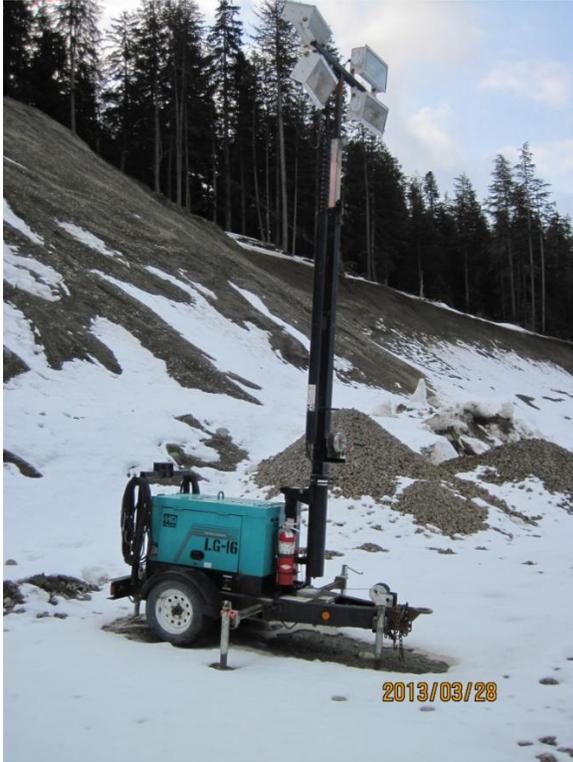
The first stop of the site visit was at the 1.4 Mile A Road aggregate pit. The pit contains stockpiles of unscreened, screened, and crushed material. A FY 2013 Contract for the Sale of Mineral Materials will be generated for the near future disposal of sand and gravel from this pit. Material from this pit is used for road maintenance, operational activities, and tailings expansion construction projects. The initial 5-acre authorization for the 1.4 Mile A Road Pit was granted in a Decision Memo dated May 7, 2004. All salvageable organic materials and topsoil are stockpiled in Pit 7 for use in future reclamation. A 10-acre expansion to the pre-existing 5-acre footprint of disturbance was authorized in a Decision Notice dated February 3, 2010. The current footprint and future expansion areas have been designated in drawings and flagged on the ground. Several pieces of equipment are stored there, including a mobile screen plant and a light plant (Photo 1). The light plant is powered by a diesel generator that lacked secondary containment.

Photo 1. Mobile light plant in 1.4 Mile A Road Pit lacks secondary containment.

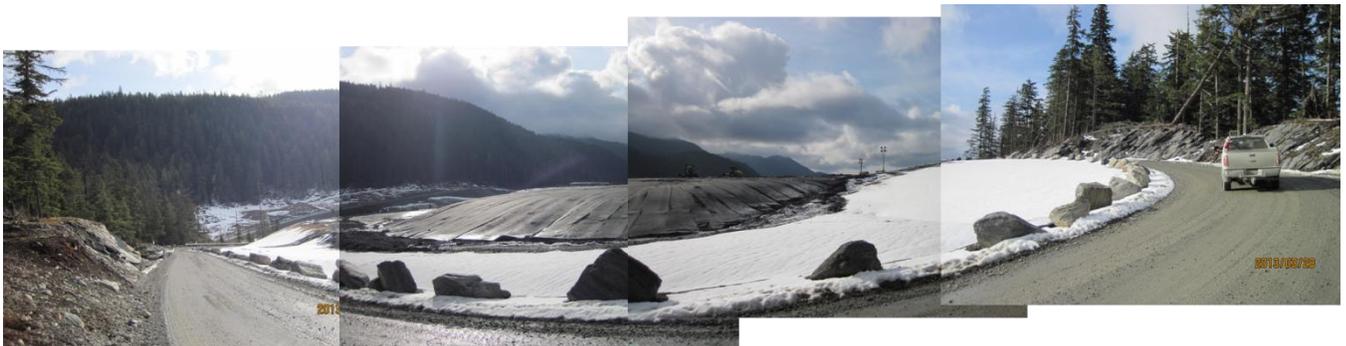
Tailings placement continues in a vertical and northerly direction. Photos were taken at each of the three tracking points established in February: the northern high point looking south (Photo 2); directly adjacent to the water treatment plant, looking northeast (Photo 3); and Mile 1 on the B Road looking west (Photo 4).

Photo 2. Tailings Facility taken from the northern photopoint.

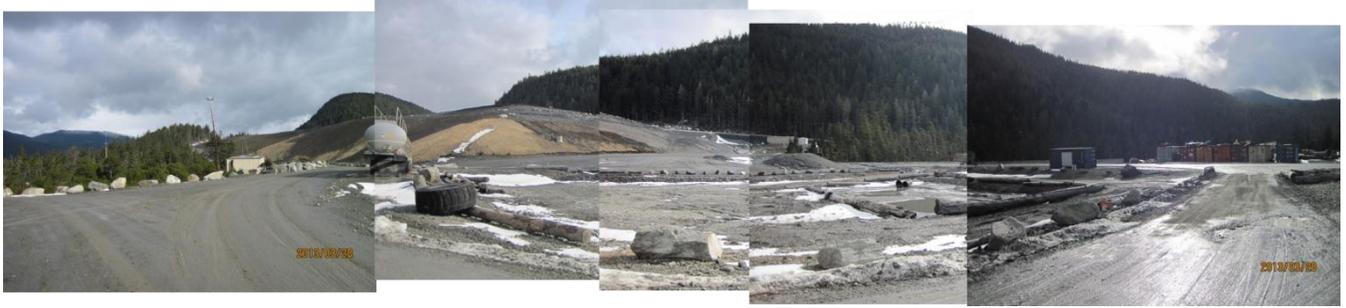
Photo 3. Tailings Facility taken from the Water Treatment Plant photopoint.

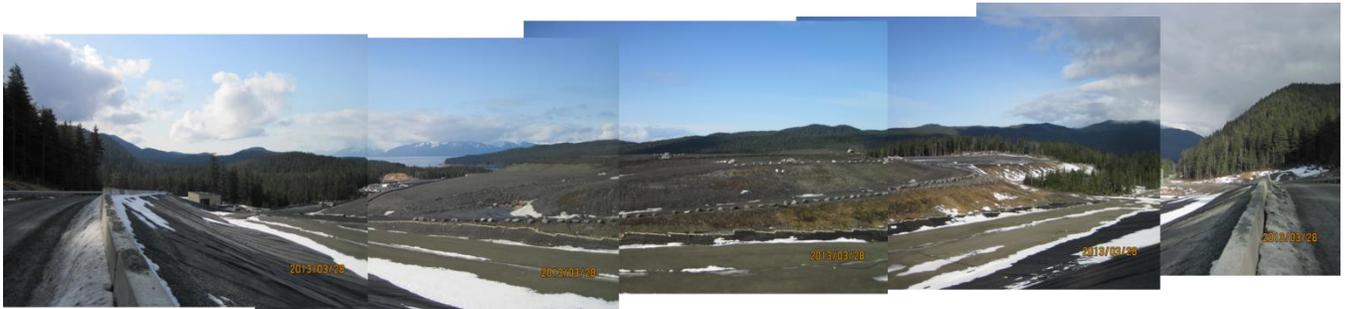
Photo 4. Tailings facility taken from Mile 1 B Road photopoint.

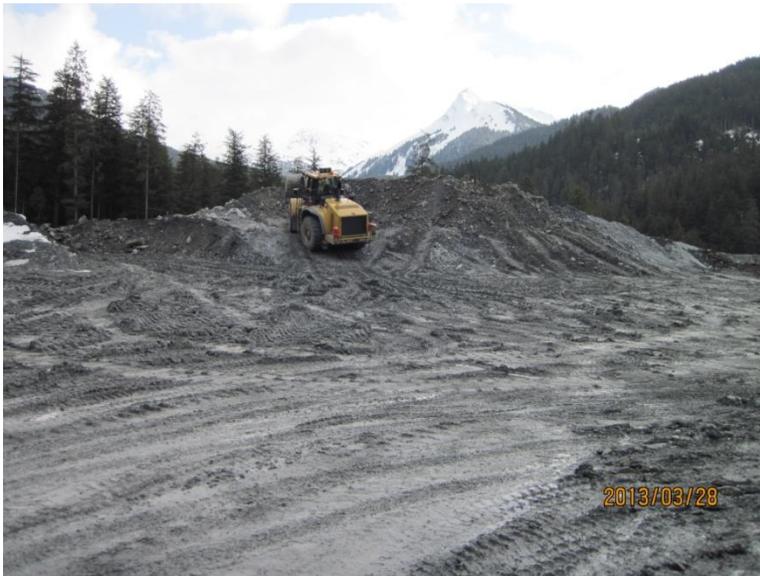
Current underground operations are removing predominately Class 2 and 3 waste rock. During the site visit, a sign indicating Class 1 waste rock was present, but signs for other classifications of rock was absent (Photo 5). Upon discussion with Mike, an equipment operator at the site, the Class 3 sign often gets buried by equipment operators as they dump the waste rock. A stockpile of signs is kept at the site to readily replace the buried signs.

Photo 5. Class 2 and 3 waste rock in Site 23.

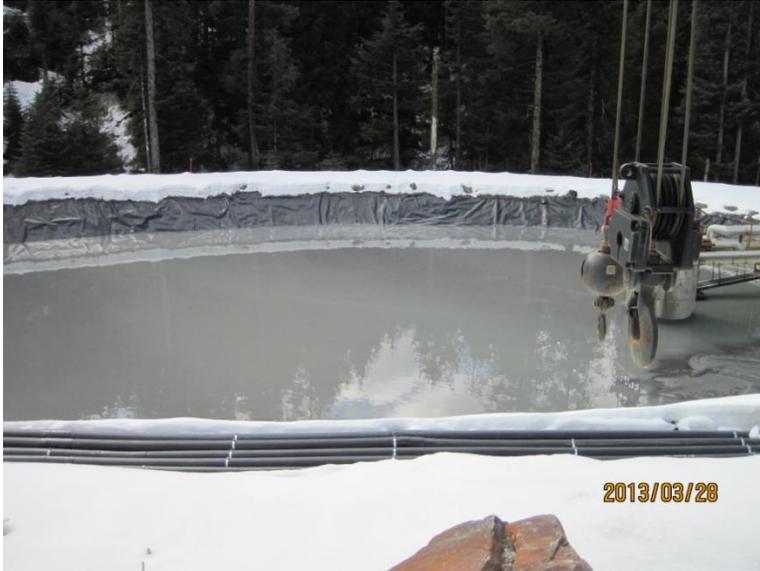
Pond A held a fairly high volume of water and sediment (Photo 6).

Photo 6. Pond A.

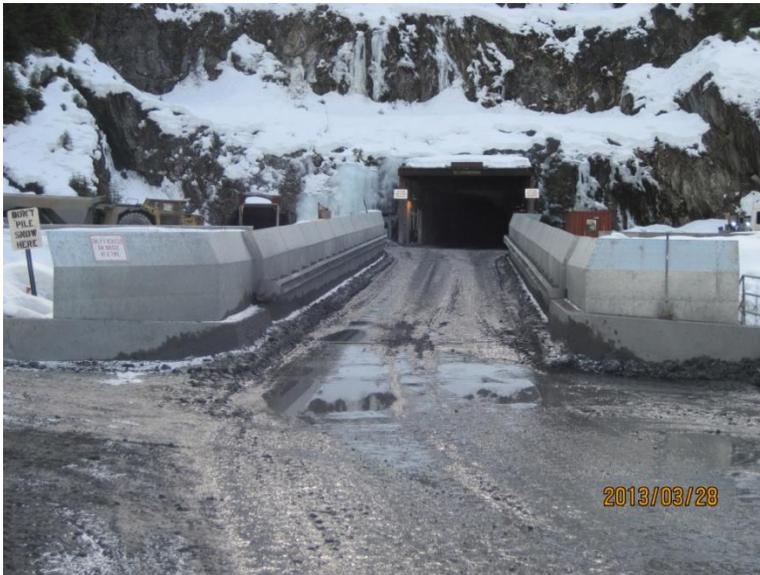
There are plans to continue drainage improvement projects this summer near the Greens Creek Bridge and portal (Photo 7). Drainage of waters near the portal report to Pond A. Contractors are scheduled to begin working on in mid-July.

Photo 7. An upcoming drainage improvement project will eliminate ponding around the Greens Creek bridge.

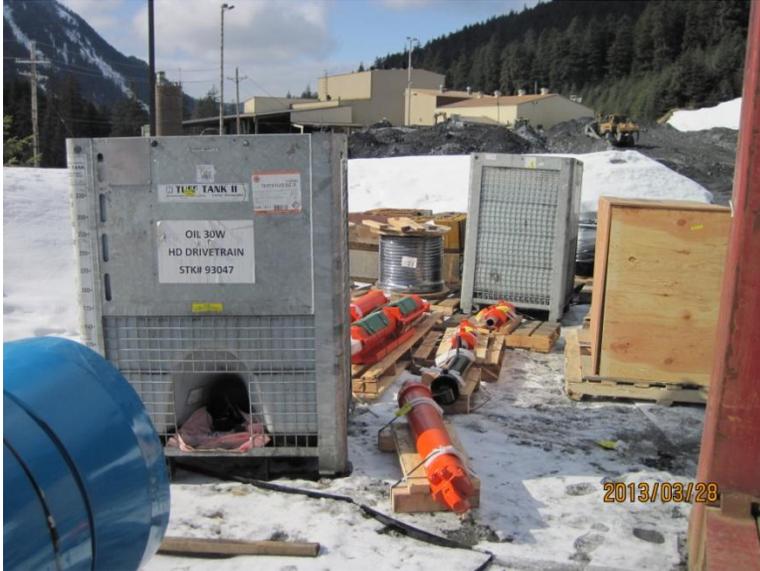
The warehouse had many liquid containment issues that have been noted in multiple previous inspections. Barrels and buckets of petroleum products within shipping containers and outside on pallets lacked secondary containment. Chemical totes containing oil and antifreeze and boxes of grease and lubricant were stored outside without secondary containment (Photo 8). Boxes of nitric acid were stored within shipping containers without secondary containment.

Photo 8. Examples of lack of secondary containment at the warehouse.

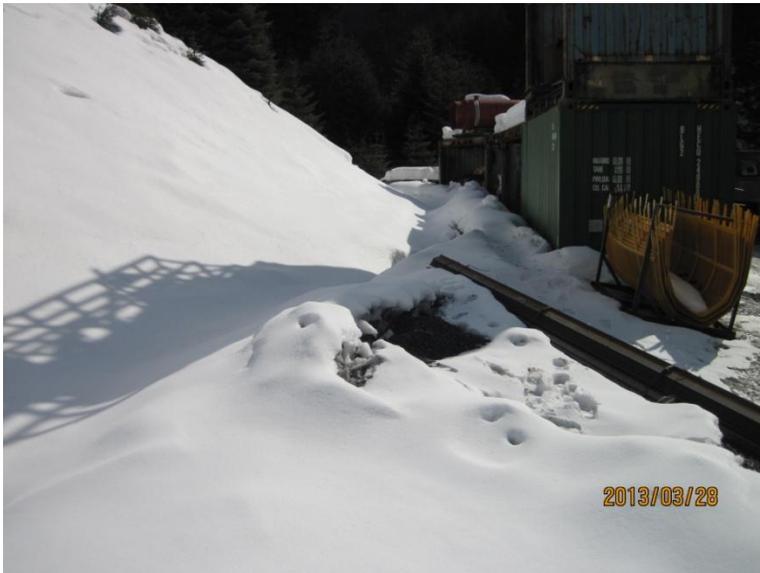
Issues with the placement of a snow push pile in the warehouse yard was apparent again during this visit. The snow pile, including dirt and gravels from the warehouse yard, was placed partially outside the internal 920 drainage system and had the potential to melt and transport contaminants out to Greens Creek (Photo 9).

Photo 9. Poor placement of snow push pile adjacent to drainage at the warehouse.
