INSPECTION REPORT: GREENS CREEK MINE

Date Of Inspection: Tuesday, April 16, 2013
USDA FS Inspector: Jessica Lopez Pearce
Ranger Districts: Admiralty National Monument
Juneau Ranger District
Weather Conditions: cloudy, light rain, temps in the 40s

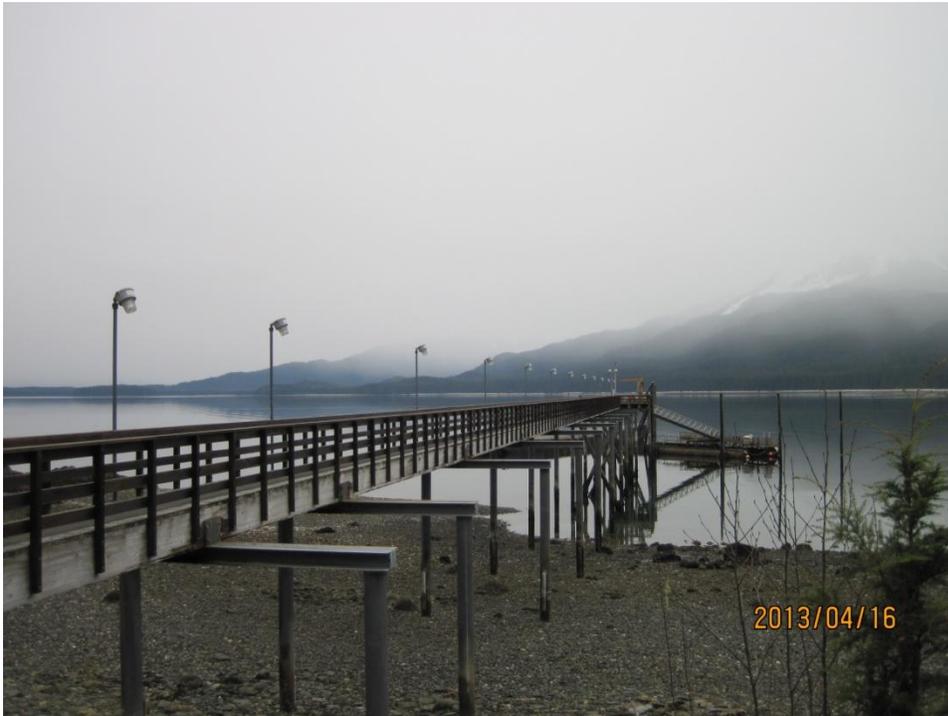
The inspection began with a drive down the A-Road to the Youngs Bay Ferry Dock. Good housekeeping practices were in place at this site (Photo 1).

Photo 1. Youngs Bay ferry dock.

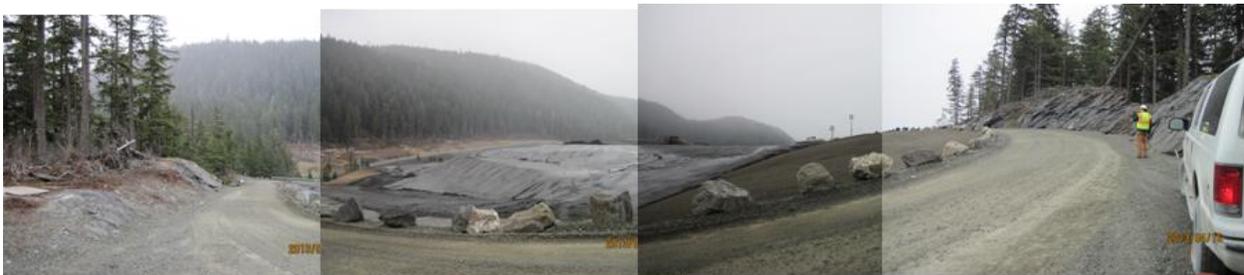
The tailings placement continues in a vertical and northerly direction. Photos were taken at two of the three tracking points established in February 2013: the northern high point looking south (Photo 2) and directly adjacent to the water treatment plant, looking northeast (Photo 3). The Mile 1 on the B-Road looking west photos were not taken due to time constraints.

Photo 2. Tailings Facility taken from the northern photopoint.

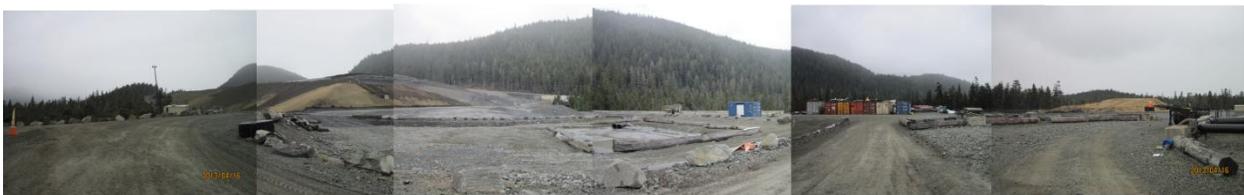
Photo 3. Tailings Facility taken from the Water Treatment Plant photopoint.

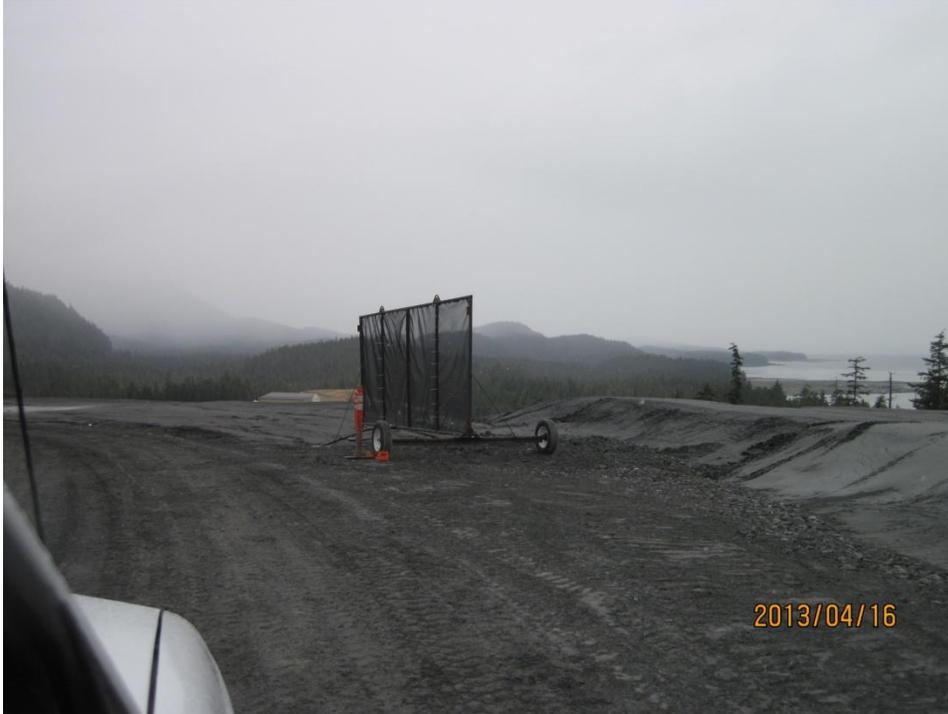
The large portable windscreen that was under construction and described in previous inspection reports is now in use at the TDF (Photo 4). The mesh fabric currently on the frame has 50% porosity. HGCMC intends to construct more screen panels and eventually use approximately 100 ft of windscreen. The longer windscreen may utilize a 30% porosity fabric instead. The windscreen has the potential to create a 75% reduction of windspeed directly adjacent to the leeward side of the screen. There is a ten-foot lateral reduction of windspeed for every one-foot of height of the panel. The pail tests within the fugitive dust program are collected every two weeks and will provide data as to whether the windscreens are contributing to less dust dispersion.

Photo 4. Large portable windscreen at the TDF.

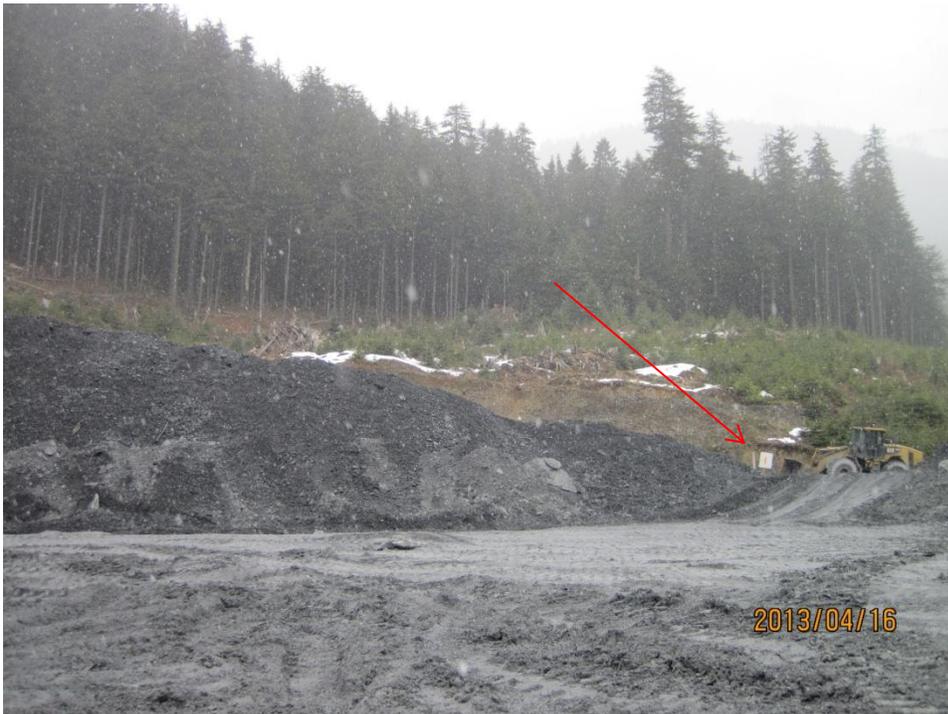
At Site 23, the sign indicating Class 1 waste rock was present, but signs for other classifications of waste rock were absent (Photo 5). Site 23 contains a large central pile of material approximately 15,000 cubic yards in volume (Photo 6). This pile is gradually being reduced and placed underground. Once this material has been completely removed, a new pad will be built for waste rock to be relocated from the 1350 area. The 1350 area held 40,000 to 60,000 cubic yards of material. To date, approximately 30,000 cubic yards have been placed underground. Approximately 10,000 to 30,000 cubic yards remain in the 1350 area. A portion of this material is within the road base, which currently will be left in place. The current storage facility at Site 23 was designed to hold 25,000 cubic yards of material; but, upon its rebuilding, it will only hold 10,000 cubic yards of material. This results in a decrease in the amount of material that can be removed on a yearly basis. HGCMC is planning on at least two more years for the completion of this project.

Photo 5. The sign indicating Class 1 waste rock was present at Site 23, but signs for other classifications of waste rock were absent.

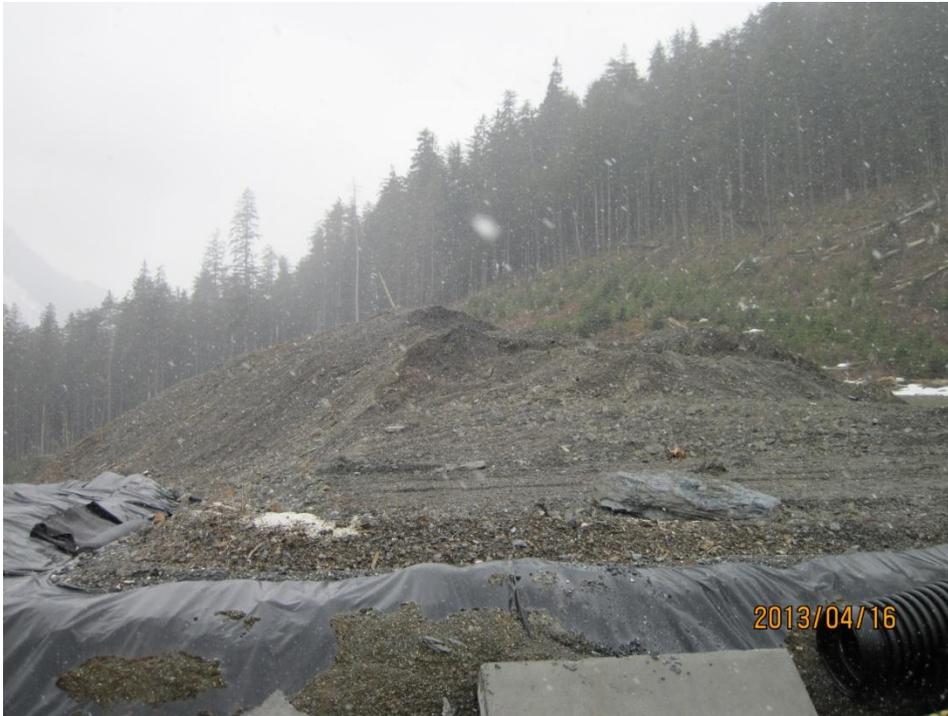
Photo 6. Approximately 30,000 cubic yards remain from the central pile of intermixed Class 2/3/4 waste rock in Site 23.

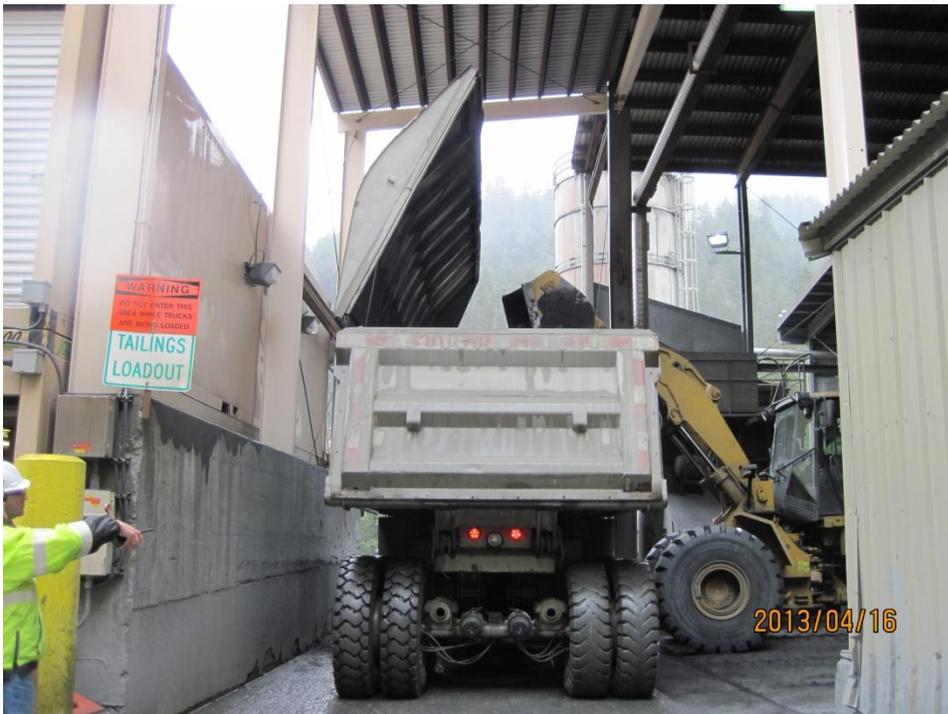
A walking tour around the 920 Mill buildings was informative. We observed the daily operations around the Mill including the loading of tailings into Max Haul trucks (Photo 7). Housekeeping practices in the Mill area were good. Five generators were running during the visit. Chris informed us that daily fuel needs are approximately 12,000 gallons per day for power generation.

Photo 7. Loading a Max Haul truck at the Tailings Loadout.
