INSPECTION REPORT: GREENS CREEK MINE

Date Of Inspection: Thursday, July 18, 2013
USDA FS Inspector: Jessica Lopez Pearce
Ranger Districts: Admiralty National Monument
Juneau Ranger District
Weather Conditions: overcast, temperatures in the 50s

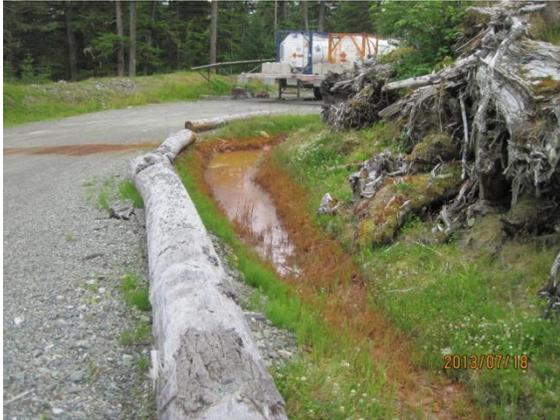
Reddish-brown staining was observed in water along the edges of the pit and across the access road near the explosives storage. Upon the use of a field test strip, the pH was determined to be approximately 7.

Photo 1a. Reddish-stained water emanating from the waste rock pile with ph of approx 7.

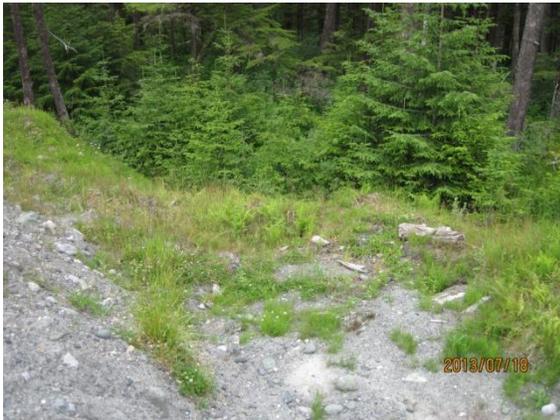
Pit. Mitch said that HGCMC employees had recently pulled approximately 8 large yard waste bags of invasive thistle. Another day of pulling thistle was being planned in the near future. Salamanders were again observed swimming in the shallow wetland pond on the north side of the Pit 7 entrance road (Photos 1a, 1b, and 1c).

Photo 1b. Small patch of invasive thistle.

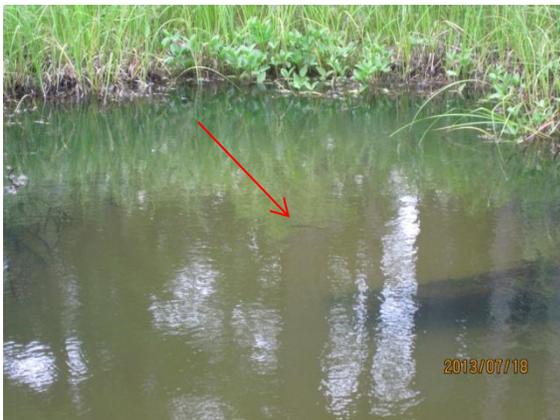
Photo 1c. Salamander swimming in pond on east side of the pit, in the wetlands on north of the access road (additional photos of salamander available).
Photos 1a, 1b, and 1c. Several observations within Pit 7.

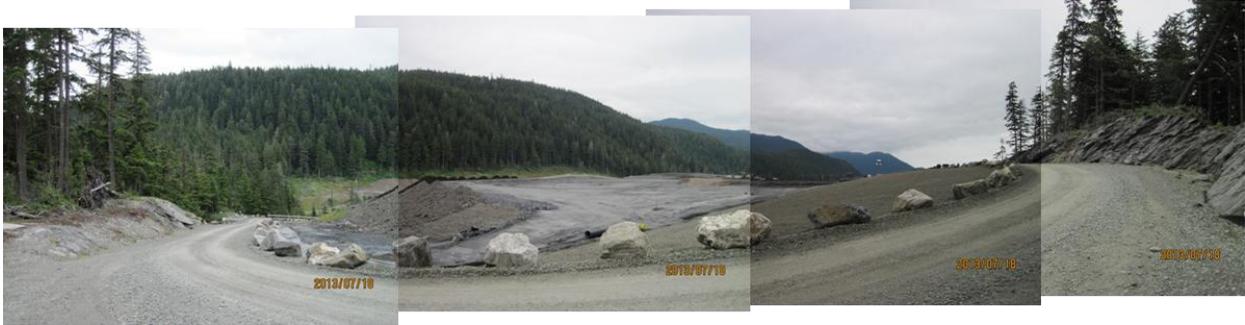
Waste rock was being placed along the northeastern sides of the TDF for slope armoring. Active tailings placement was occurring central in the facility. Photos were taken at all of the three tracking points established in February 2013: the northern high point looking south (Photo 2), directly adjacent to the water treatment plant, looking northeast (Photo 3), and from milepost 1 on the B Road looking west (Photo 4).

Photo 2. Tailings Disposal Facility taken from the northern photopoint.

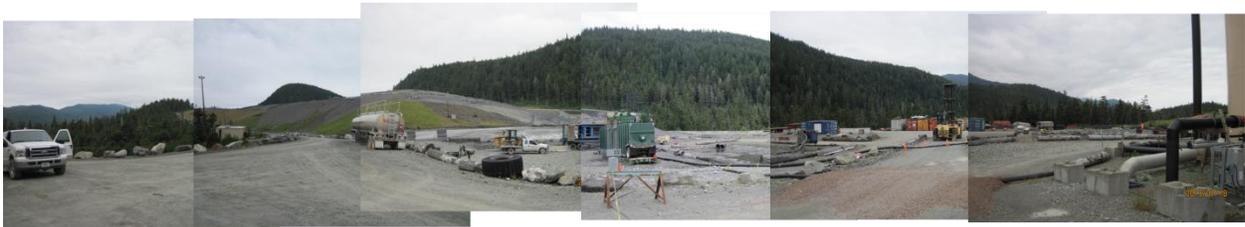
Photo 3. Tailings Disposal Facility taken from the Water Treatment Plant photopoint.

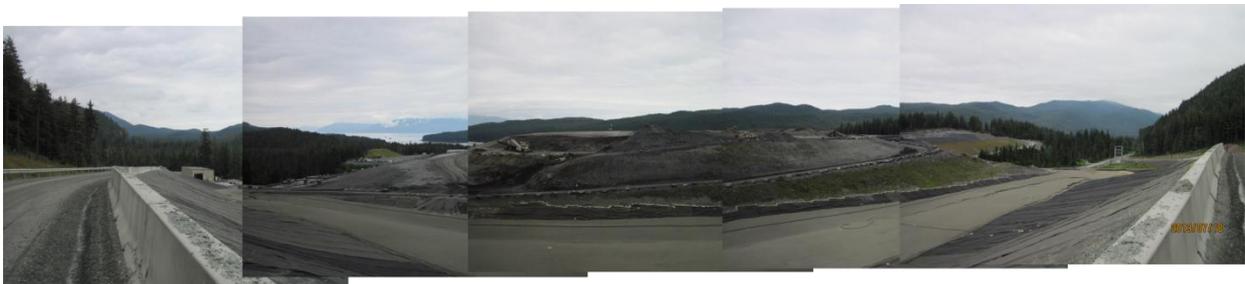
Photo 4. Tailings Disposal Facility taken from the eastern photopoint.

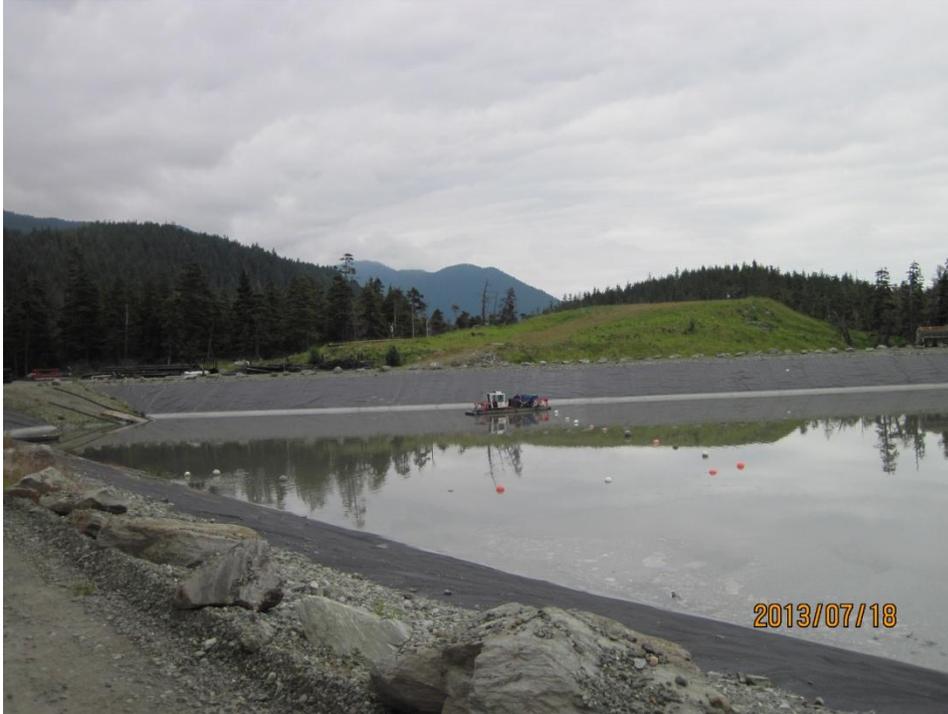
During the inspection, there was activity around the TDF Water Treatment Plant. Pond 7 was in the process of being drained and dredged. Two containers with filters and a press were in operation in the TDF. The resulting sediments from the press and filters were being placed on the southwest side of the tailings pile. Mitch said that this is the first time than Pond 7 has been dredged since its construction (Photo 5).

Photo 5. Pond 7 in the process of being dredged.

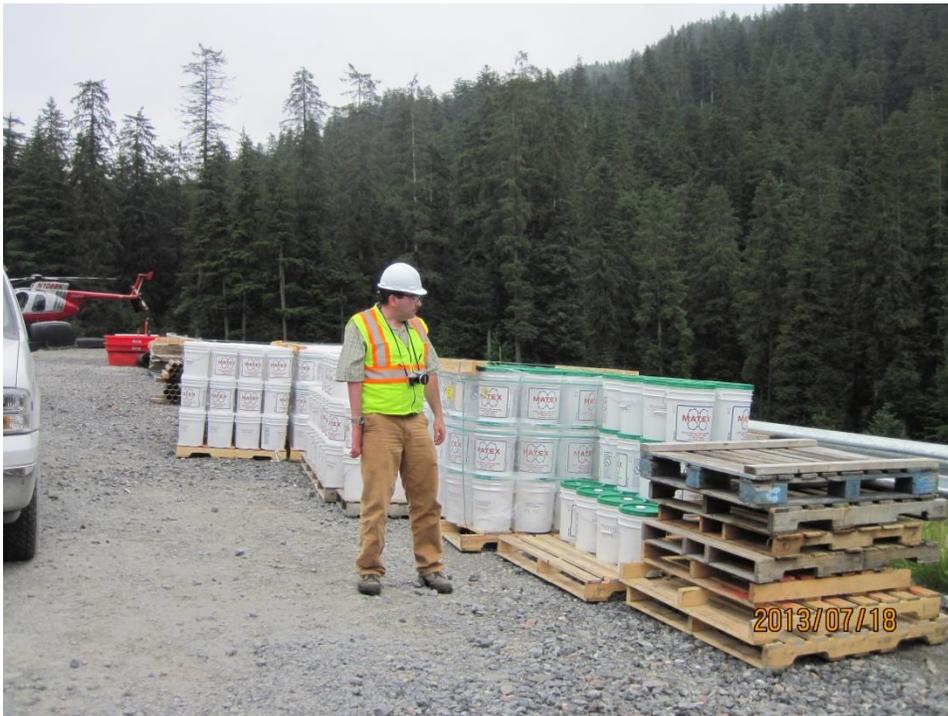
Equipment for the surface exploration drilling program was being stored here. Buckets of drilling materials were stored in pallets along the edges of the site, as were drill string and casing (Photo 6).

Photo 6. Surface exploration drilling program staging at the 860 Helipad.

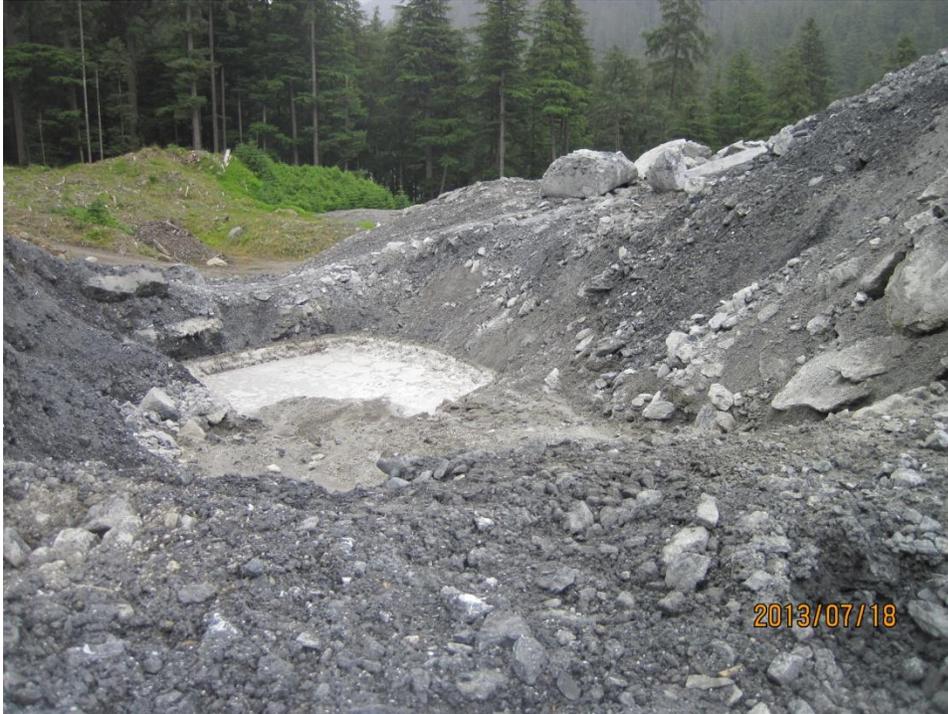
A small temporary pond was present on the northeast side of the site. This basin was being used for washing out the trucks that were supplying concrete materials for the 920 Area construction (Photo 7).

Photo 7. A temporary basin constructed at Site 23 to collect runoff from concrete truck washouts.

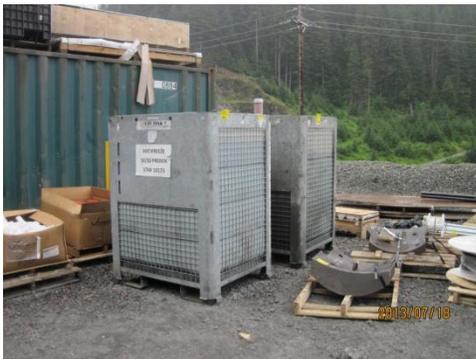
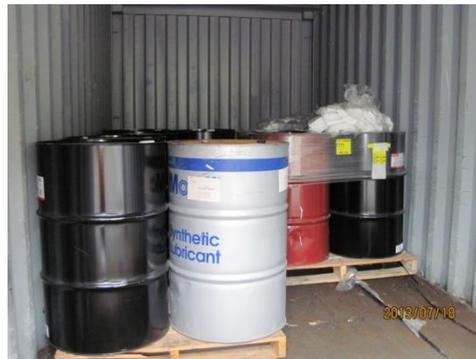
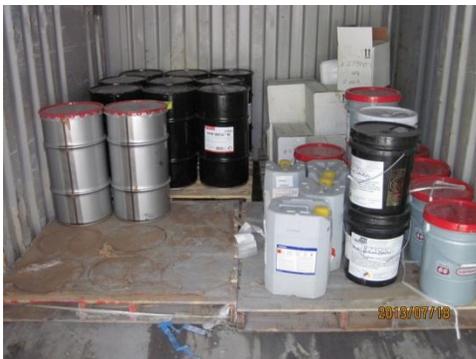
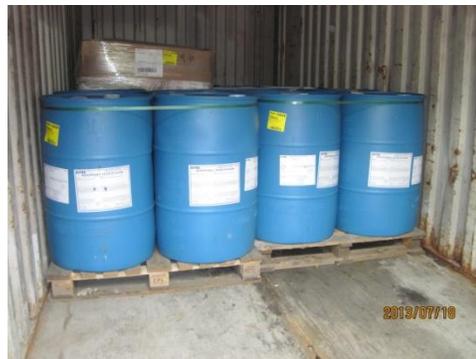
The warehouse area continues to have multiple secondary containment issues. Several shipping containers stored antifreeze, lubricant, grease, and promoter (3418) without secondary containment (Photos 8a, 8b, 8c, 8d). This is a recurring issue from past inspections. During a post-inspection phone conversation, Chris Wallace said HGCMC expected to have additional secondary containment structures for warehouse items by the fall of 2013.

Photo 8a. Antifreeze containers

Photo 8b. Barrels of lubricant

Photo 8c. Gear oil containers

Photo 8d. Barrels of promoter (3418)

Photos 8a, 8b, 8c, 8d. Multiple secondary containment issues at the 920 Warehouse.

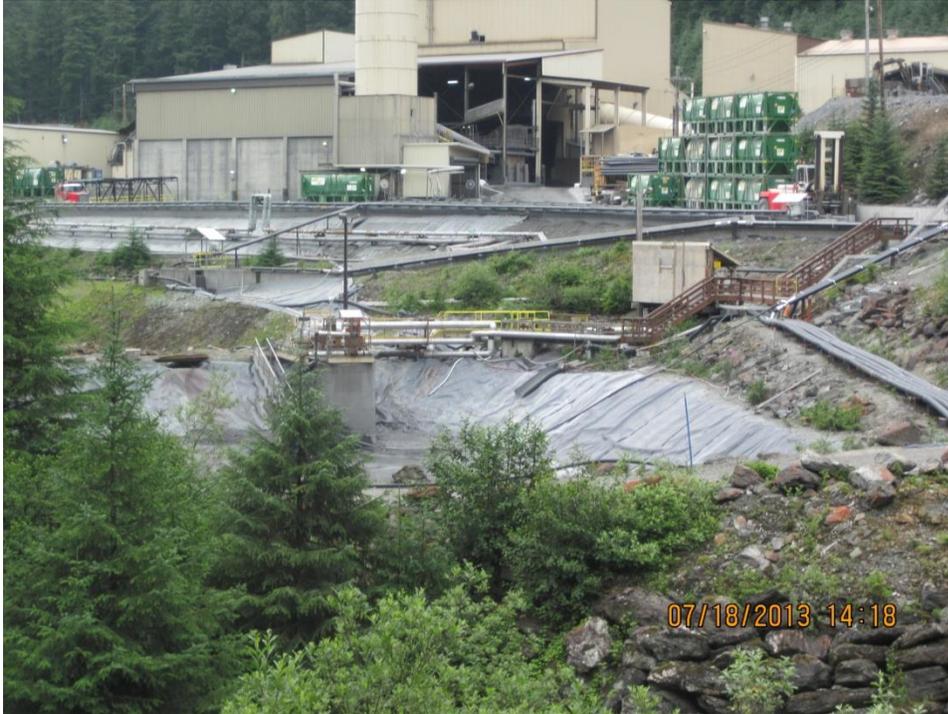
Pond A was in the process of being cleaned and was empty of water (Photo 9).

Photo 9. Pond A empty of water in preparation for cleaning.

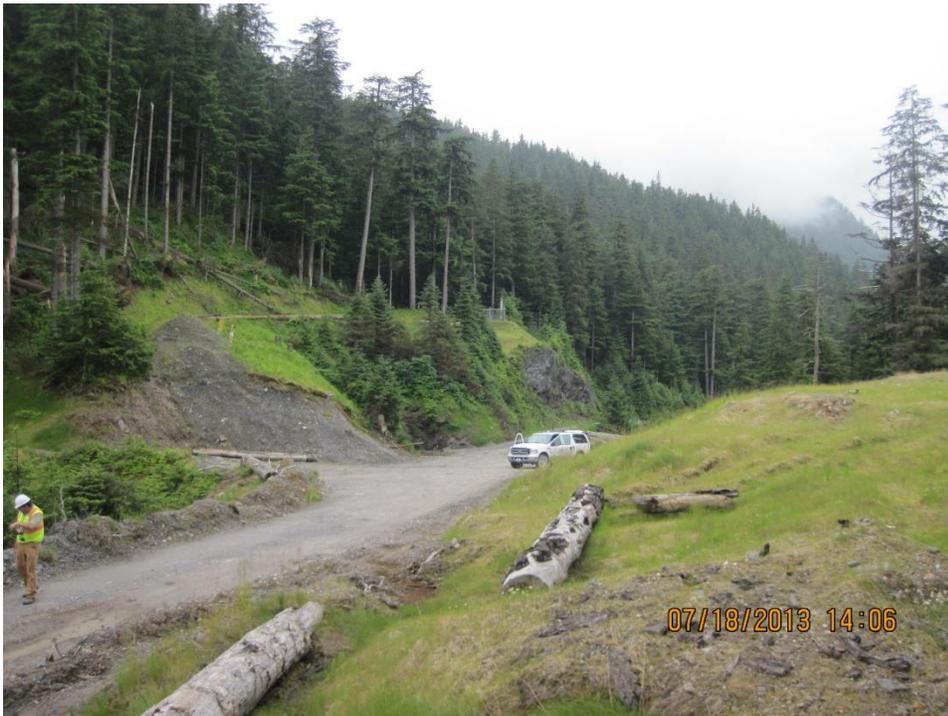
The 1350 access was free of snow and we drove up the road to look at the site. The material on the north side of the site has already been removed and this part of the site has been reclaimed. Mitch stated that the materials around the 1350 portal and on the west side of the site still need to be removed and taken to the reconstructed Site 23 (Photo 10).

Photo 10. Stockpiles of material at the 1350 level to be moved to Site 23.
