INSPECTION REPORT: GREENS CREEK MINE

Date Of Inspection: Thursday, August 22, 2013
USDA FS Inspector: Jessica Lopez Pearce
Ranger Districts: Admiralty National Monument
Juneau Ranger District
Weather Conditions: partly sunny, temperatures in the 50s

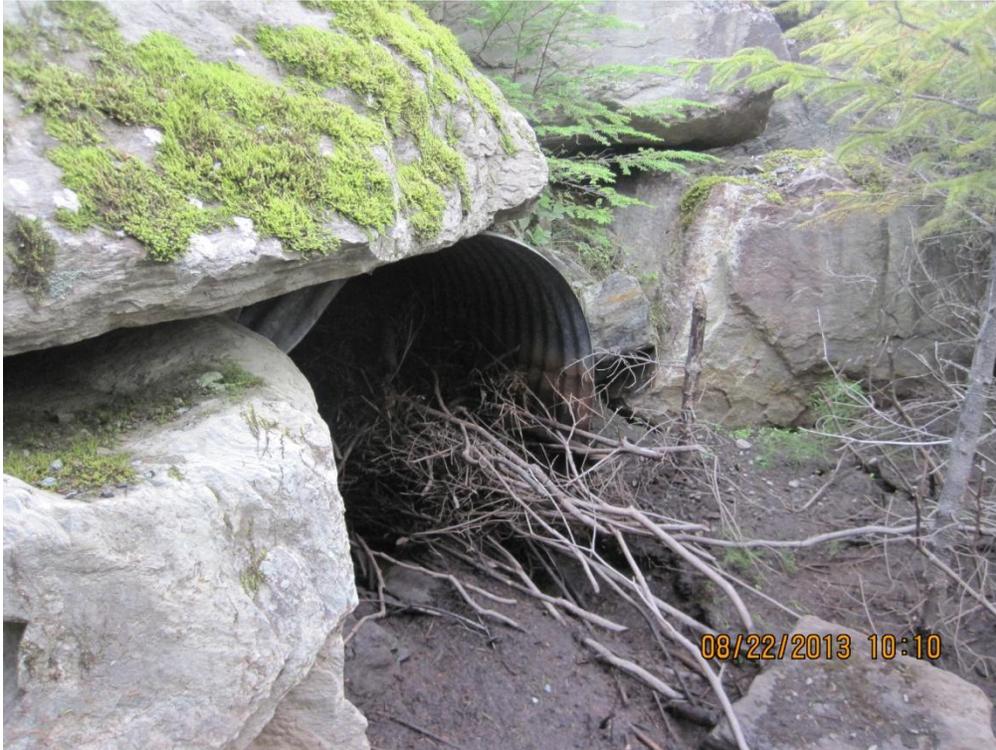
At milepost 2.2, we inspected a culvert with water flowing west to east in the Fowler Creek drainage. An old beaver dam was located downstream of the culvert and had caused flooding and backfilling behind it. The culvert was jammed with woody debris (Photo 1). It was recommended that the culverts under the A Road be checked for obstructions and cleaned if necessary. Wide mesh screen enclosures were also suggested in order to keep out debris from beaver activity.

Photo 1. The culvert at A Road milepost 2.2 was clogged with debris.

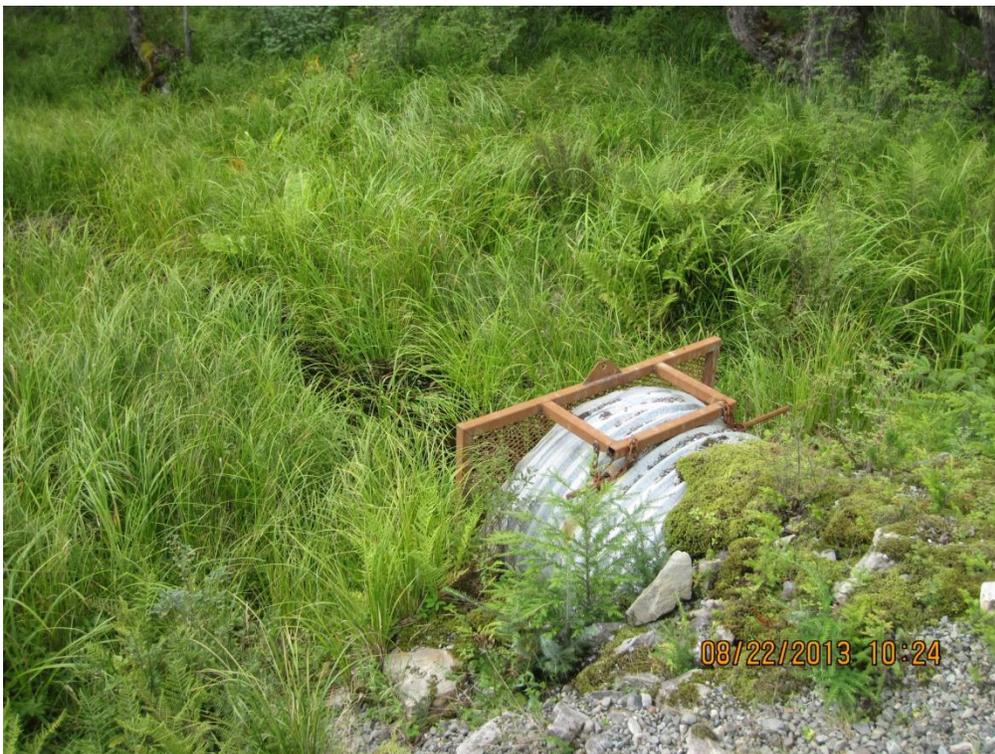
At milepost 2.5, a culvert under the road was clear and water was flowing through it (Photo 2). Pete remarked that this culvert may be undersized for the size of the upstream watershed.

Photo 2. The culvert at milepost 2.5 was draining freely.

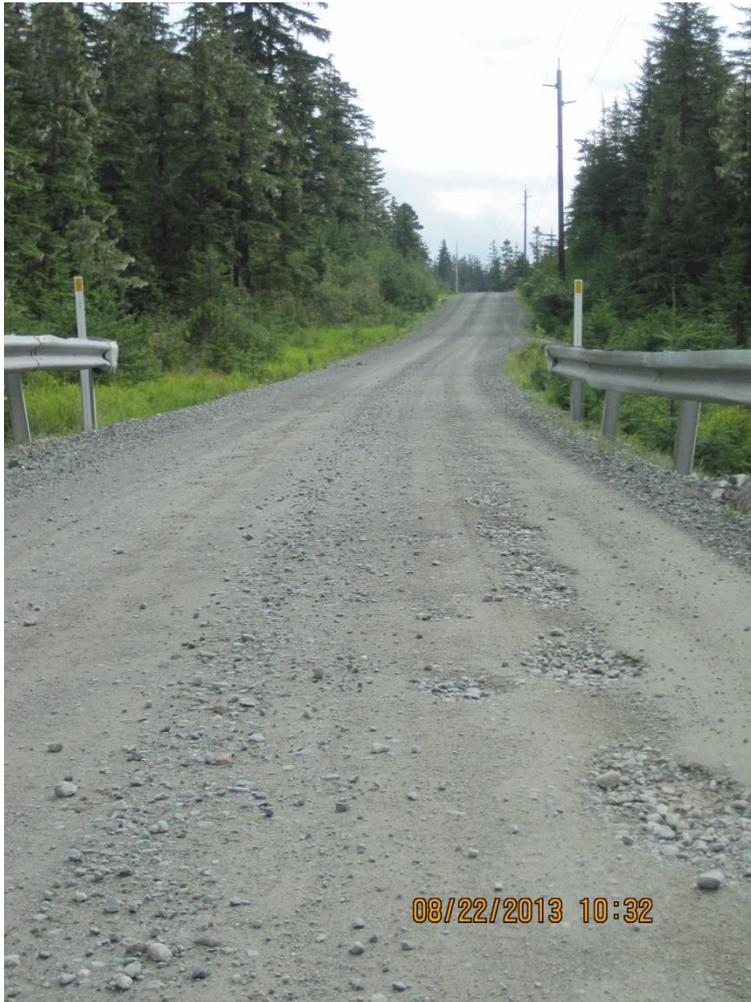
Since the A Road was last maintained in the spring of 2013, the road has again become rutted and road material has migrated to the shoulders (Photo 3). Mitch said the A Road would be graded again in the fall of 2013, if not before.

Photo 3. The A Road will require maintenance soon.

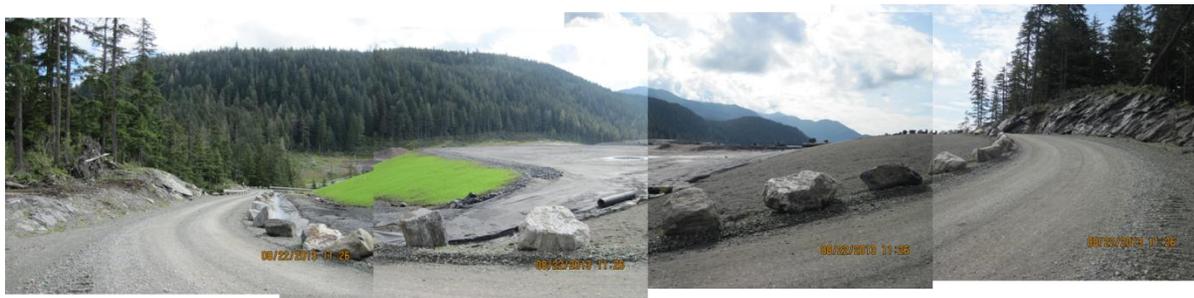
Photo 4. Tailings Disposal Facility taken from the northern photopoint.

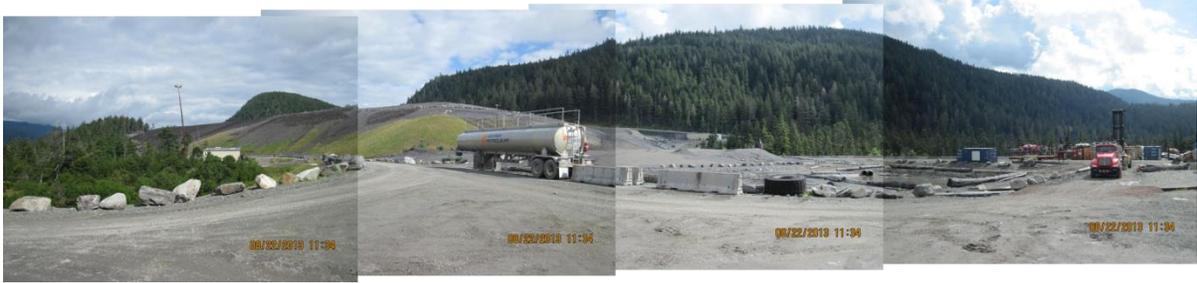
Photo 5. Tailings Disposal Facility taken from the Water Treatment Plant photopoint.

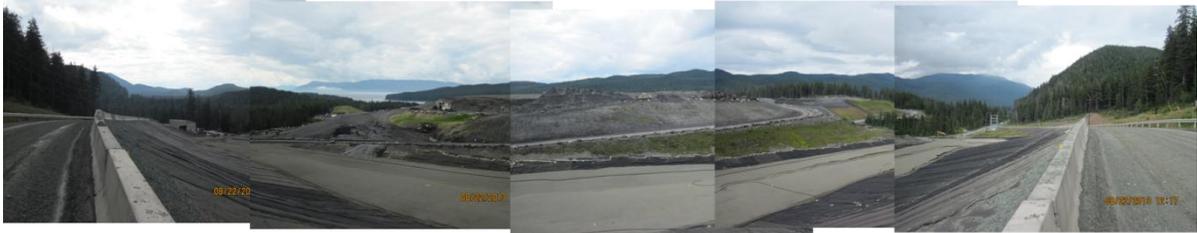
Photo 6. Tailings Disposal Facility taken from the eastern photopoint.

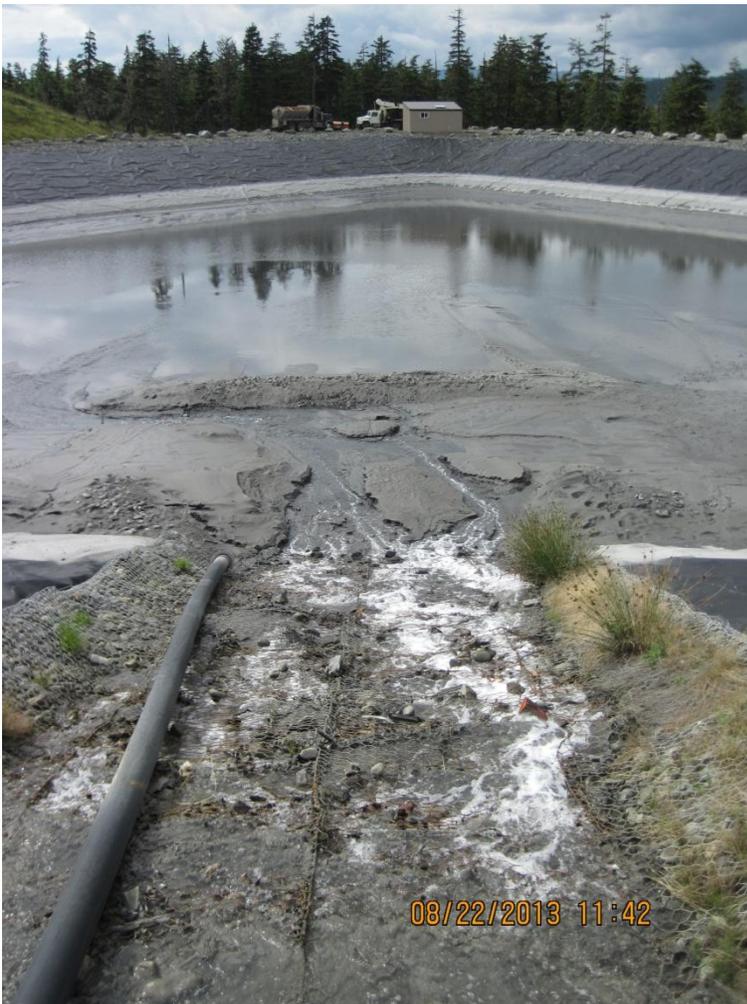
The dredging and cleaning of Pond 7 was completed earlier in the week and refilling was underway (Photo 7). The resulting sediments from the filter press were placed on the southwest side of the tailings pile and graded to the existing surface. Pond 7's liner was deemed to be in good condition and not replaced.

Photo 7. Pond 7 was recently cleaned for the first time.

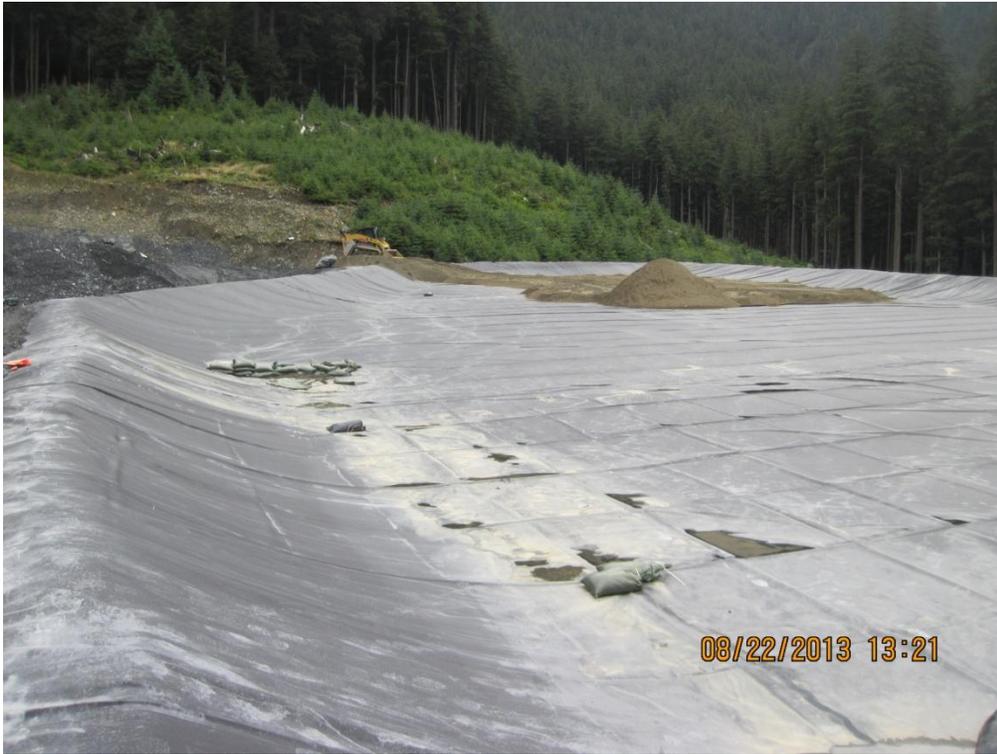
The access road to Site 23 was in poor condition, with deep ruts and thick mud. The Site 23 redesign and reconstruction continues. A new liner was installed on the northeast side of the site and material from 1.4-Mile A Road pit was being placed on top of the liner (Photo 8). The existing Class 1 waste rock pile is still located on the northern side and the Class 2/3 waste rock pile is on the southwest side of the site. The Class 2/3 pile was a smaller volume than it was during my last visit. Neither classification signs were present.

Photo 8. The new liner has been installed at Site 23.

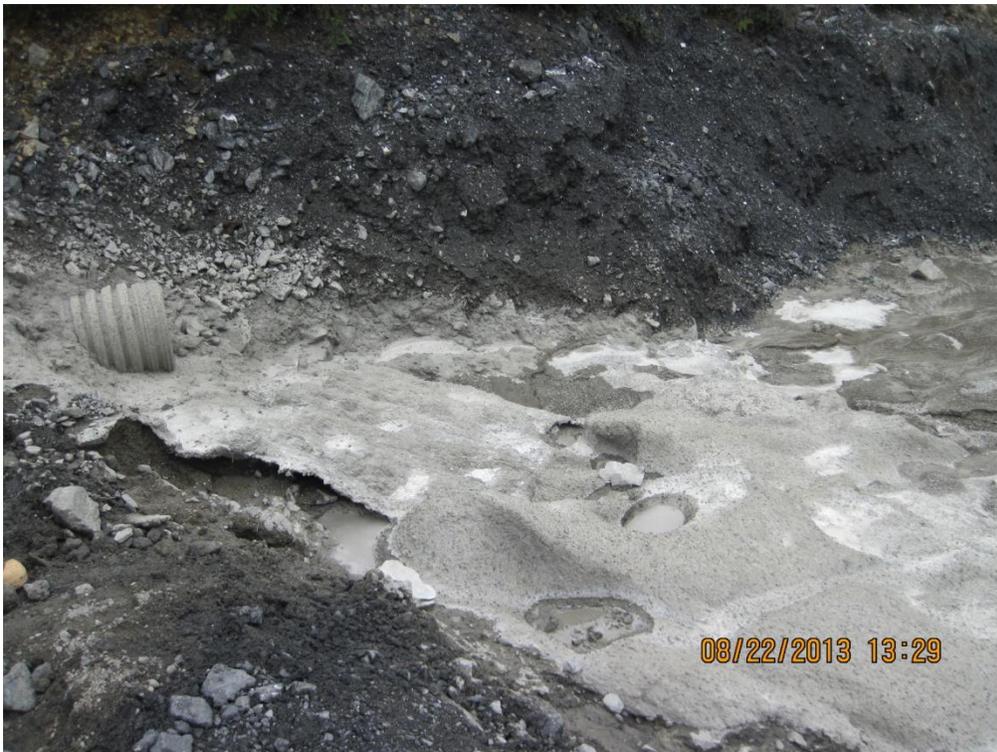
The small temporary pond that was noted during the July inspection was still present on the far northeast edge of the site. This basin was used for washing out the concrete trucks that were supplying materials for the 920 area construction (Photo 9). Mitch said HGCMC plans to use this temporary washout pit until the 920 construction is complete, then the remaining material will be codisposed with the rest of the materials at Site 23.

Photo 9. Concrete truck washout pit at Site 23.

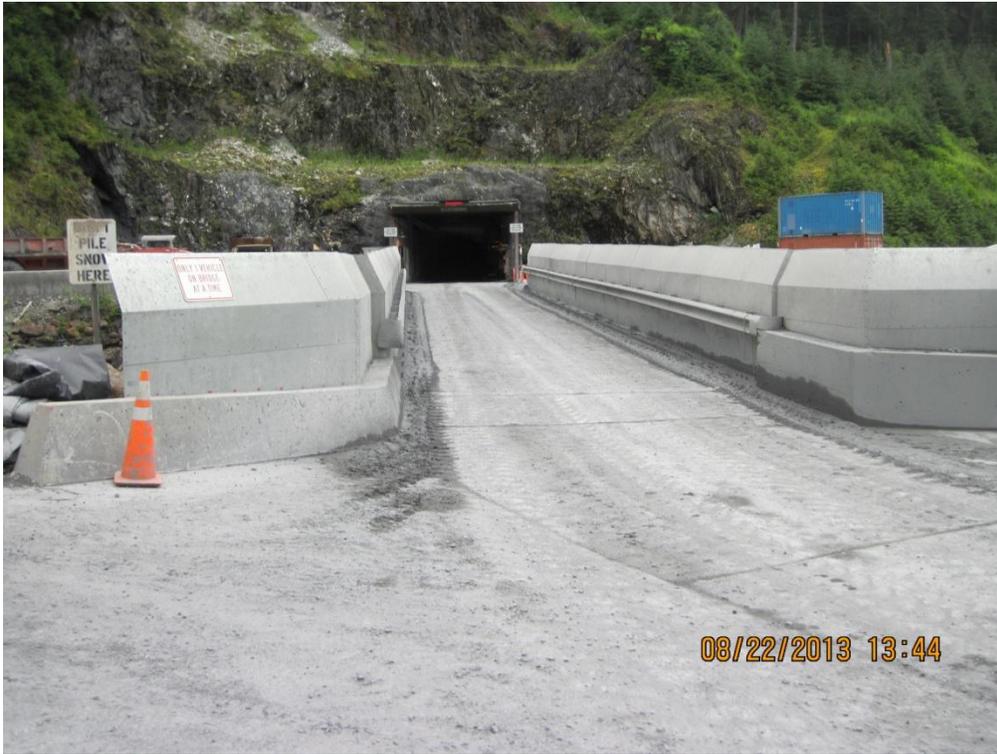
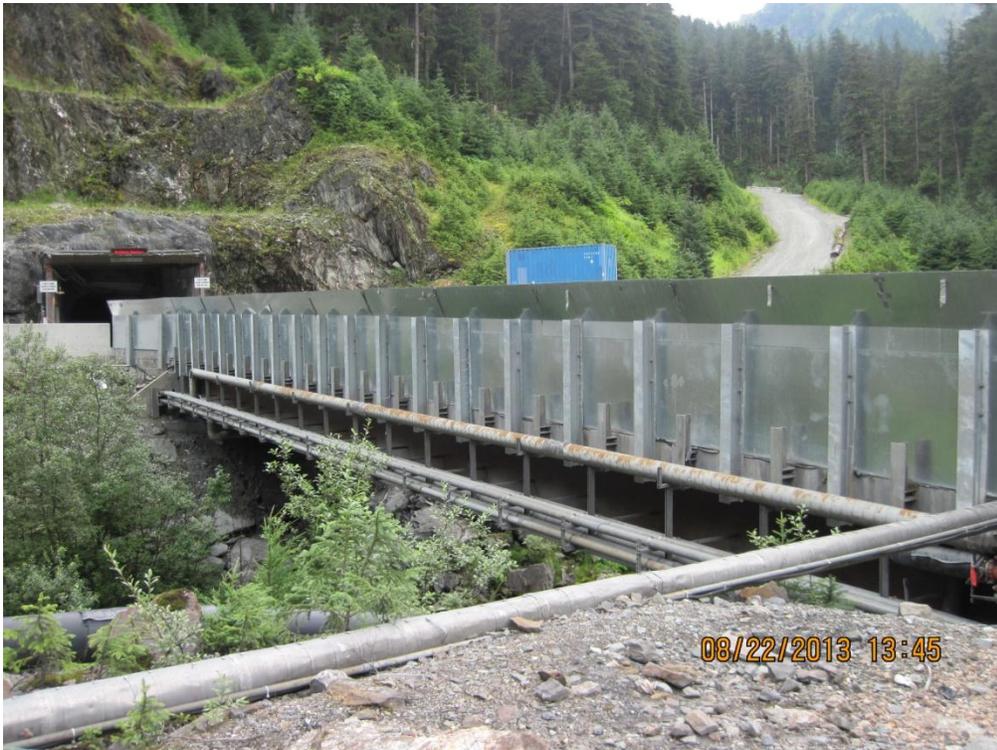
The new concrete pad around the 920 working area was still under construction and nearing completion. The maintenance and repair of the Greens Creek Bridge was complete (Photos 10a and 10b). The bridge roadbed now consists of poured concrete and all conduit is secured in pipeline under the bridge. Directly upstream from the Greens Creek Bridge, we observed a Dolly Varden Char attempting to jump above the fish barrier. The southern side of the creek had boulders placed along the bank and slopes were vegetated (Photo 11).

Photos 10a and 10b. The Greens Creek Bridge was recently repaired.

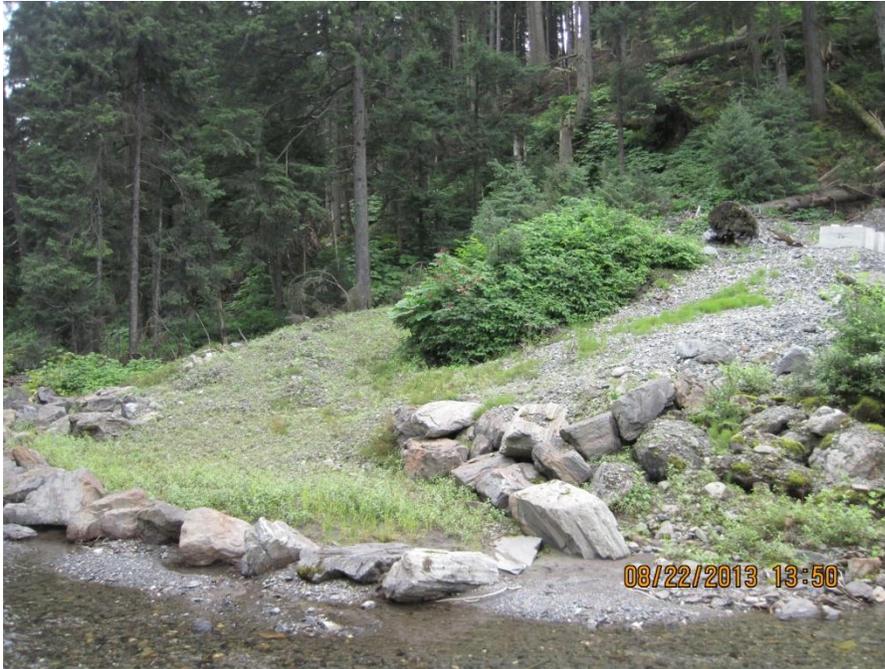
Photo 11. The southern bank of Greens Creek directly upstream from the portal.

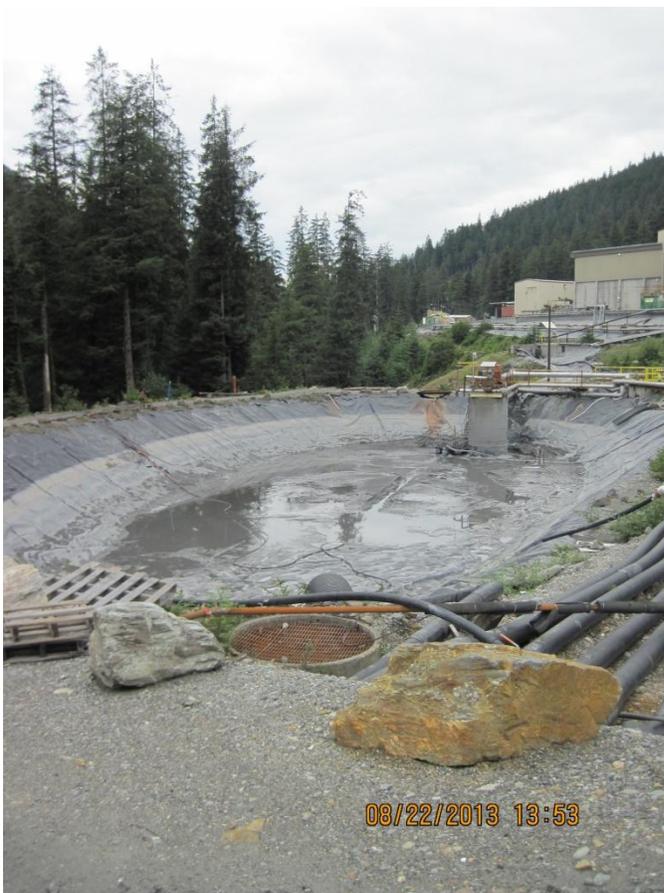
The Pond A cleaning project was still in progress; the pond was empty and sediment was being removed (Photo 12). While Pond A is undergoing cleaning, waters from the portal and mill area temporarily report to Pond 23.

Photo 12. Pond A cleaning in progress.

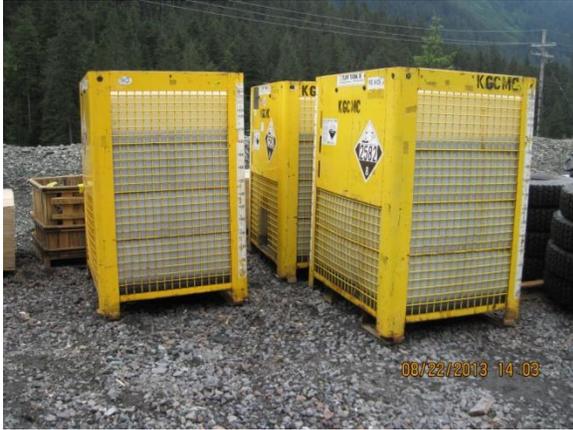
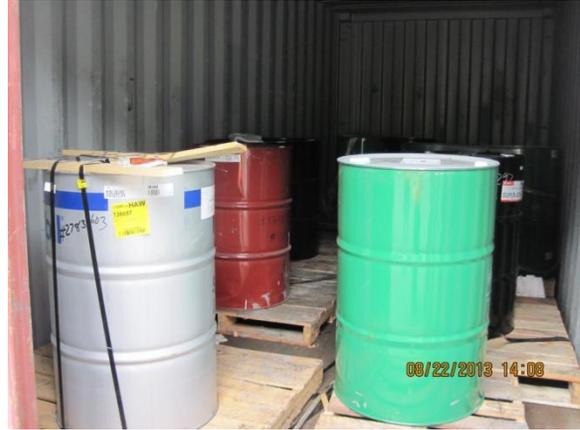
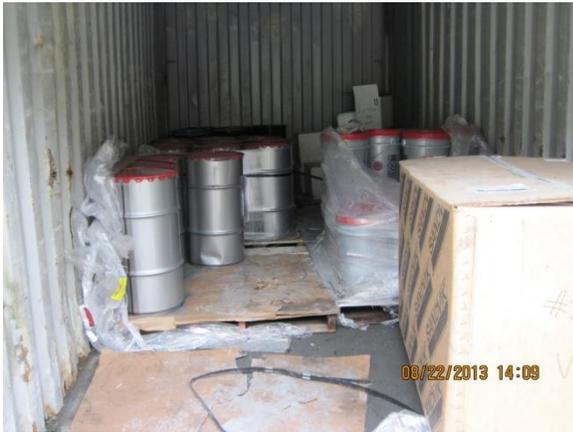
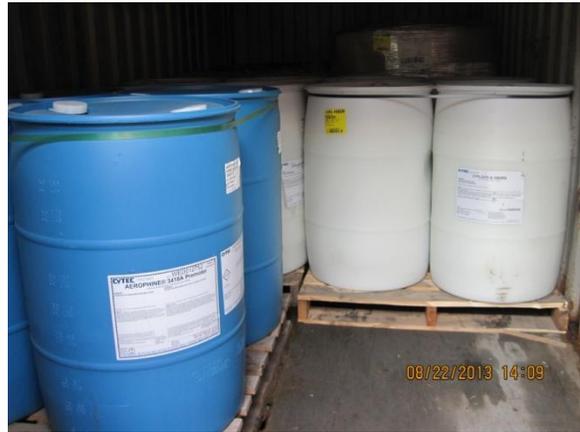
The warehouse contained multiple secondary containment issues. Several shipping containers stored ferric chloride, gear oil, transmission fluid, grease, and promoter (3418) without secondary containment (Photos 13a, 13b, 13c, 13d). This continues to be a recurring issue from past inspections. Mitch said that secondary containment structures for warehouse items will be installed in the fall of 2013.

Photos 13a, b, c, d. Multiple secondary containment issues at the Warehouse.
