INSPECTION REPORT: GREENS CREEK MINE

Date of Inspection: Thursday, January 23, 2014
Date of Report: Thursday, February 6, 2014
USDA FS Inspector: Curtis Caton

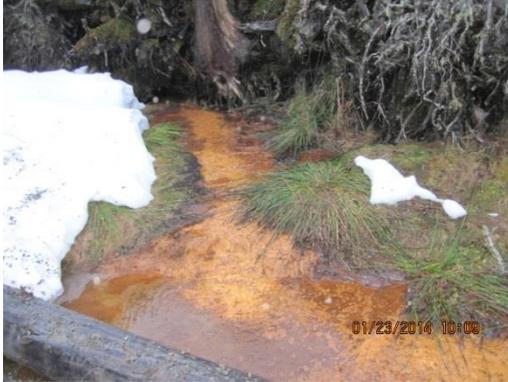
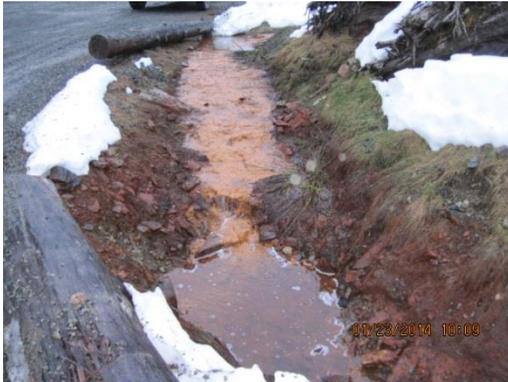
We noticed an iron colored staining in the outflow that originates from underneath the topsoil storage heap, into the ditch (Photos 01-02).

Chris Wallace provided a 2012 Inactive Sites Report to explain the iron staining found in the drainage near Pit 7. “Despite iron staining on the south pit wall, iron staining observed in the drainage from the pit is mostly due to dissolution of iron-rich oxide coatings in the peat and gravel fill rather than from the pit walls themselves.” The 2012 Inactive Sites Report also states that, “Dissolution of iron and manganese oxides in the fill stored in the pit has produced elevated concentrations of these metals in the drainage”.

Photo 01. Iron staining in ditch near Pit 7.

Photo 02. Iron staining in ditch near Pit 7.

It should be noted that in the General Plan of Operations, Appendix 5 BMP, page 5-46, that runoff from Pit 7 is monitored at storm water outfall site 004, as a non-point source pollutant. In the past there have been water quality exceedances, monitoring is currently active and needs to continue. Additionally, the Greens Creek Best Management Practices Plan is currently being updated and may provide additional information about Pit 7.

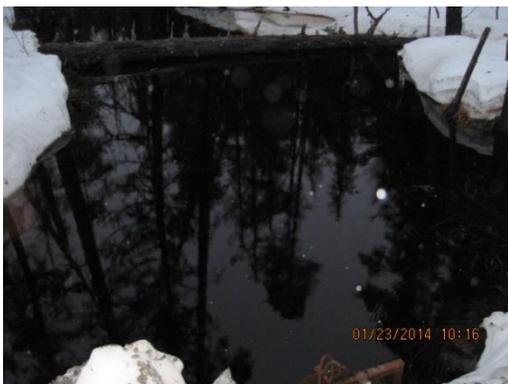
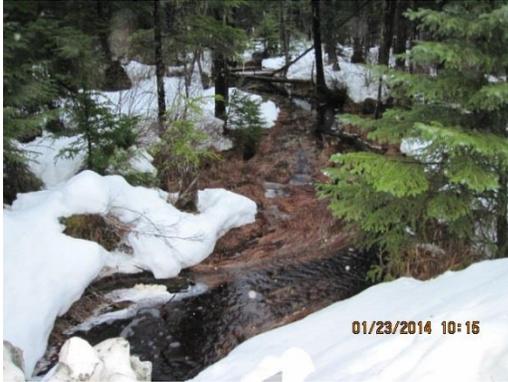
We walked down the access road to Pit 7 and looked for obstructions to the culvert (Photo 03). The culvert was not blocked and water flowed freely (Photo 04).

Photo 03. Unobstructed culvert near Pit 7.

Photo 04. Unobstructed culvert near Pit 7.

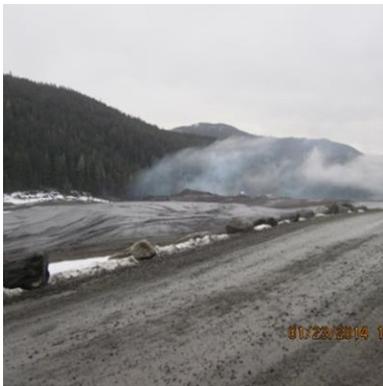
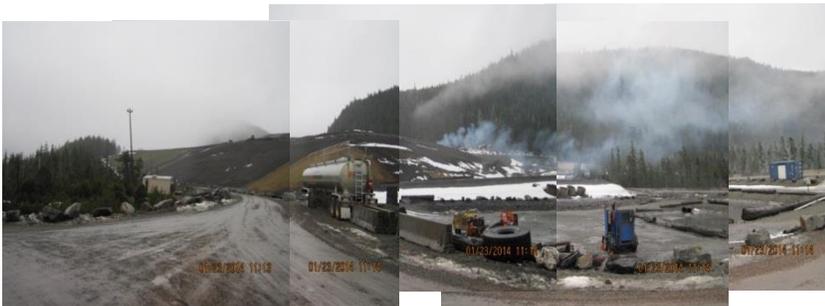
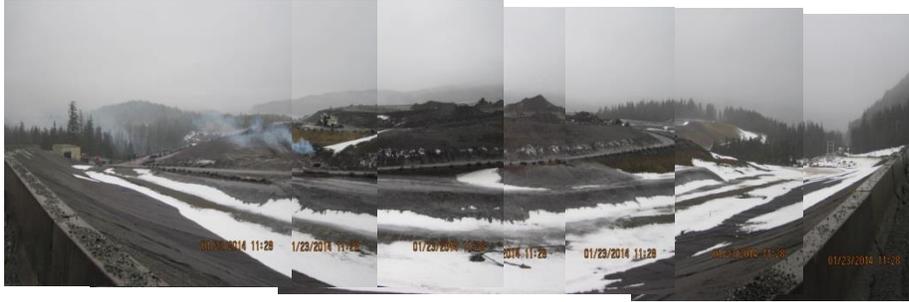
Mitch stated that moisture-laden tailings were being temporarily stockpiled at the TDF until they can be compacted efficiently in drier conditions. We stopped at the three tracking points established by the Forest Service in February of 2013 and took pictures of the TDF; the northern high point looking south (Photo 05), directly adjacent to the water treatment plant, looking northeast (Photo 06), and from milepost 1 on the B Road looking west (Photo 07).

Chris Wallace noted that tailings leave the mill at approximately 10%-12% moisture content, which does not vary. The reason tailings were being stockpiled was a result of the large amount of precipitation received the previous week and that a large precipitation event can saturate the surface of the tailings pile, limiting the areas that can be operated in.

Photo 05. Tracking point at TDF, looking south.

Photo 06. Tracking point at TDF looking northeast.

Photo 07. Tracking point at TDF looking west.

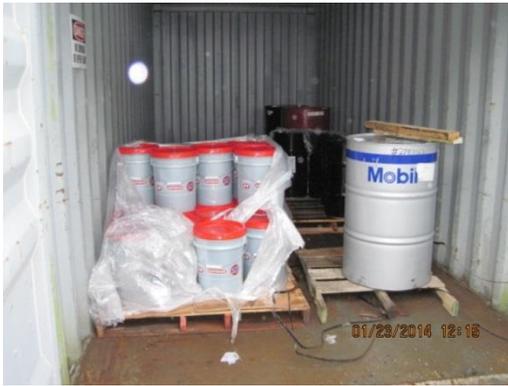
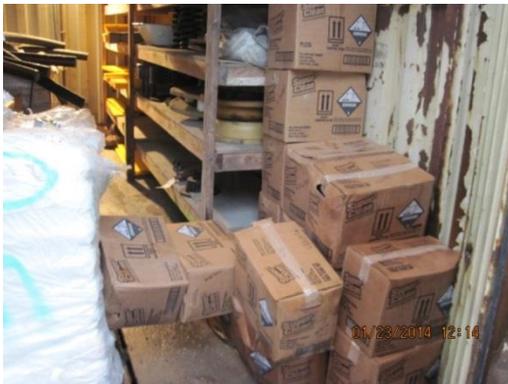
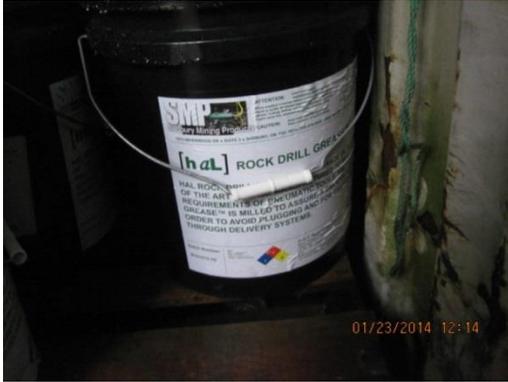
The 920 warehouse had several secondary containment violations. Petroleum products and cleaning agents were not in secondary containment (Photo 08-10). Water partly filled the containment basin, beneath the grated interior of a curtained sea van, allowing rain and snowmelt to accumulate in the basin diminishes the secondary containment of the sea van (Photo 11). We discussed draining the water from the basin while temperatures are above freezing.

Photo 08. Petroleum products not in secondary containment.

Photo 09. Cleaning agents not in secondary containment.

Photo 10. Petroleum product not in secondary containment.

Near the reclamation test plot (Photo 15), we met with Chris Wallace (Environmental Manager, Hecla Greens Creek Mining Company) while he was retrieving field data. We discussed his plans to remedy secondary containment problems at the 920 warehouse and his concerns about the localized geologic instability of Site 23.

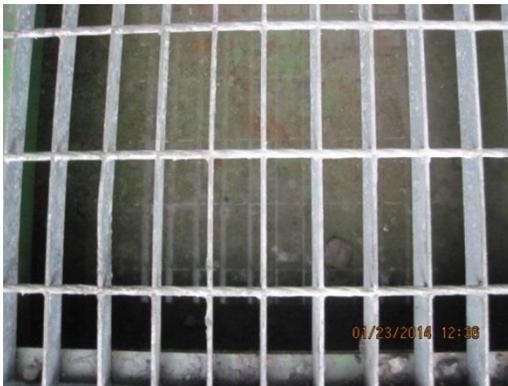
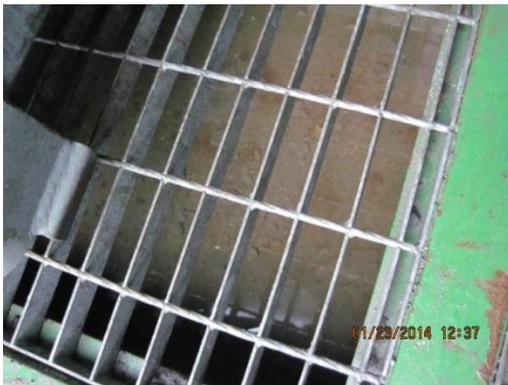
Chris Wallace noted that the volume of precipitation in the containment basin was approximately 200 gallons, and the volume of secondary storage in a curtained sea van is approximately 900 gallons, leaving approximately 700 gallons available for secondary containment. Additionally, Chris Wallace noted that the largest container stored is 330 gallons, which requires 363 gallons (110%) of secondary storage and the sea van in question would provide twice the amount of required secondary storage.

Photo 11. Precipitation in curtained sea van containment basin.

Photo 11a. Precipitation in curtained sea van containment basin.

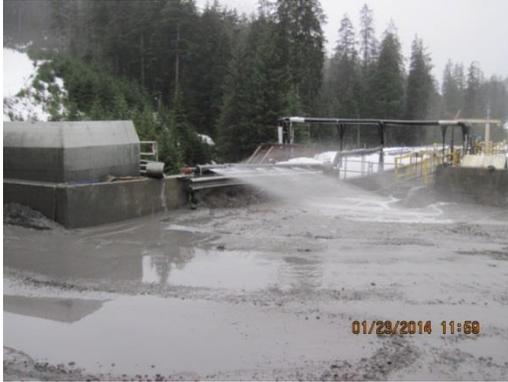
Plowed snow was being stored properly and melted in a sediment collection basin that drains to Pond A (Photo 12).

Photo 12. Snow melting.

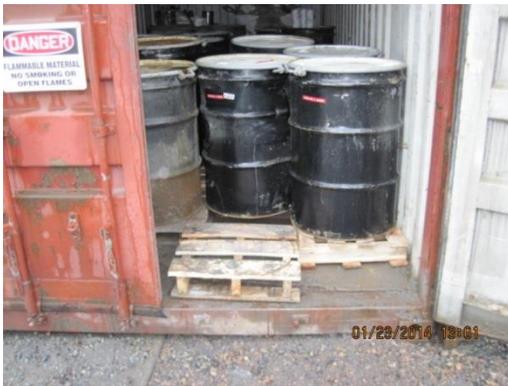
Near the Mill we located a sea van that was half on concrete and half on gravel. Moving the sea van onto concrete would fulfill secondary containment requirements (Photo 13).

Photo 13. Sea van half on concrete pad.

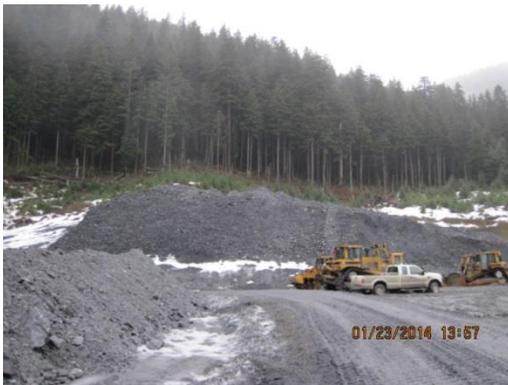
Photo 14. Site 23.

The access road to Site 23 was muddy and in the process of being maintained when we arrived. We stopped and spoke with a heavy equipment operator about the access road condition, the eventual removal of stockpiled sediment at Site 23 to the TDF and the plan to build an additional access road to Site 23 (Photo 14).

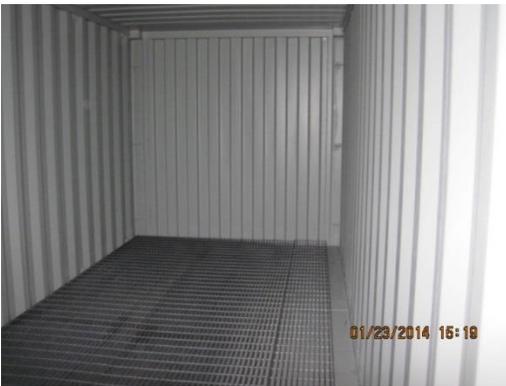
We looked at the 6 new sea vans Greens Creek Mine ordered for the 920 warehouse. The new sea vans are designed to comply with secondary containment requirements in the 920 area (Photo 16). The estimated containment volume of the new sea van (8'x20'x 0.25'), on a level surface, is approximately 299 gallons. This volume is sufficient for most of the containers in the 920 area, except for the larger 330-gallon reinforced totes, which will still need to be stored on concrete or in secondary containment with sufficient volume. Plans are in place to move all 6 sea vans to the 920 area, once weather and ground conditions allow.

Photo 16. New sea van.

Chris Wallace noted that a slight modification to the new sea van from a 3-inch lip to a 4-inch lip would allow for the storage of the larger 330-gallon totes and provide approximately 399 gallons of secondary storage.
