INSPECTION REPORT: GREENS CREEK MINE

Tongass National Forest Minerals Group
8510 Mendenhall Loop Rd
Juneau, AK 99801
Office (907) 789-6273
Fax (907) 586-8808

Date of Inspection: Thursday, February 27, 2014
Date of Report: Friday, March 14, 2014
USDA FS Inspector: Curtis Caton

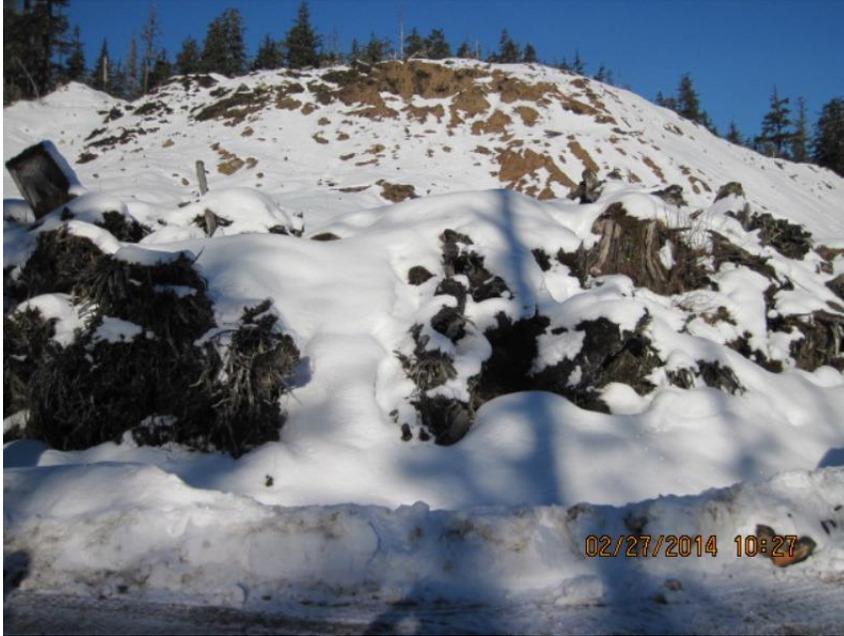
The area around Pit 7 was frozen and mostly covered with snow (Photo 1). The outflow from beneath the stored overburden heap was barely visible.

Photo 1. Top soil storage at Pit 7.

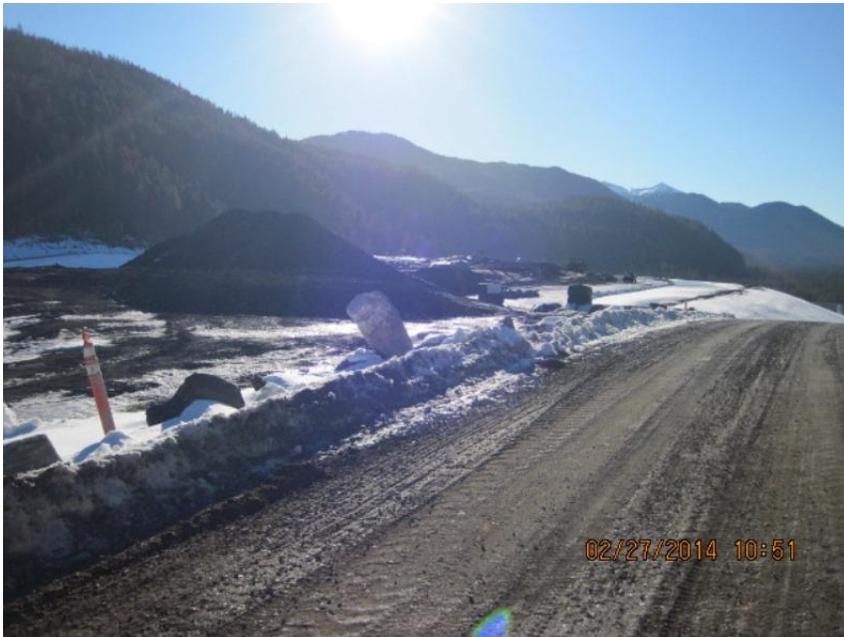
Photo 2. Looking from north to south at the TDF.

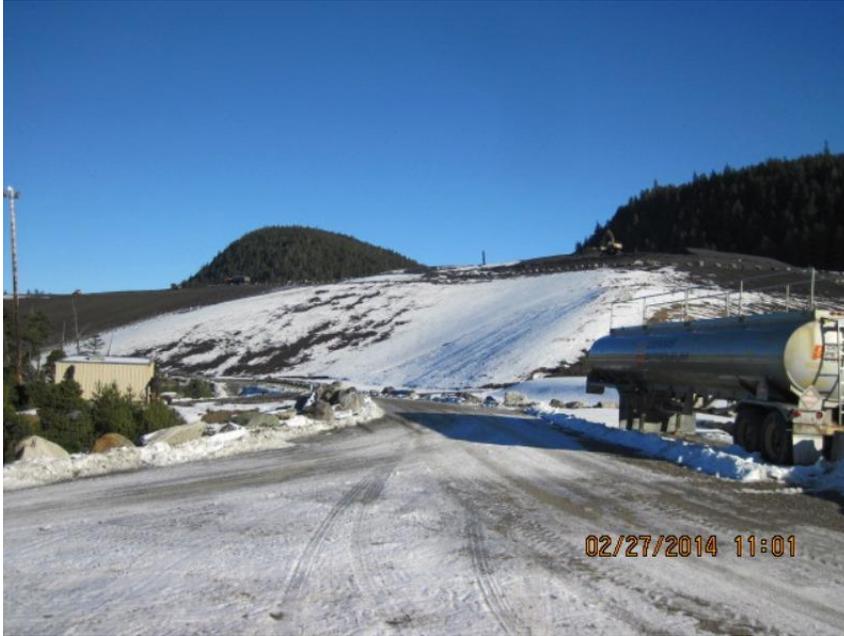
Photo 3. View from Water Treatment Plant looking northeast.

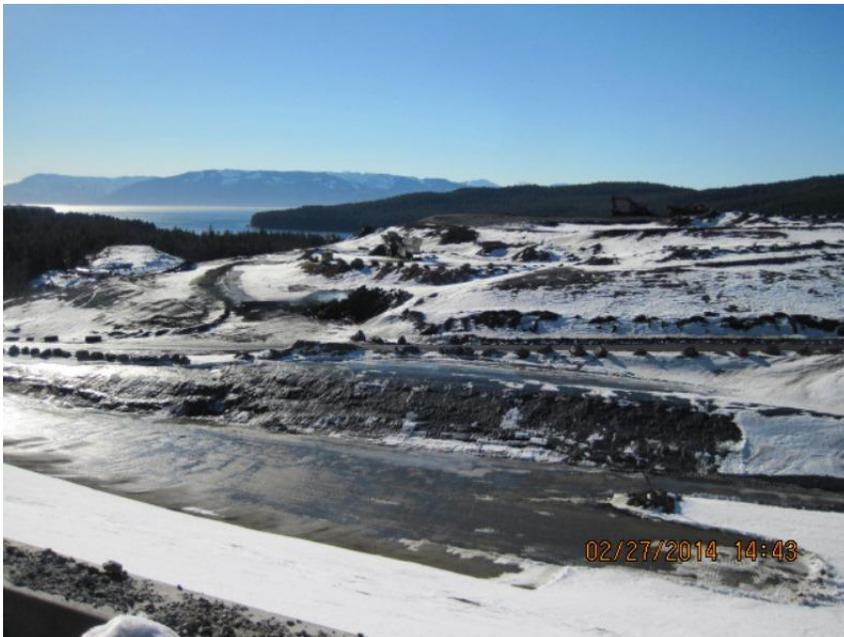
Photo 4. View from the east side of TDF looking west.

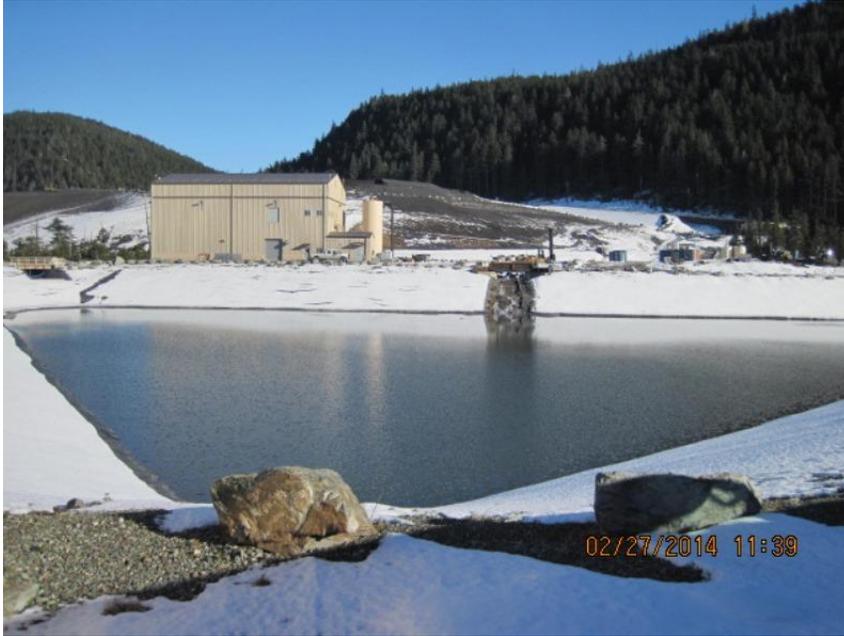
The team stopped at the three established TDF tracking photo points, from the north end of the TDF looking south (Photo 02), from the Water Treatment Plant looking north (Photo 03), and looking west across the TDF from the B road (Photo 04). We stopped on the southern edge of Pond 7 and took a photo of the TDF Water Treatment plant and the southern end of the TDF (Photo 05). Pond 7 was in good shape.

Photo 5. Water Treatment Plant and Pond 7, TDF in background.

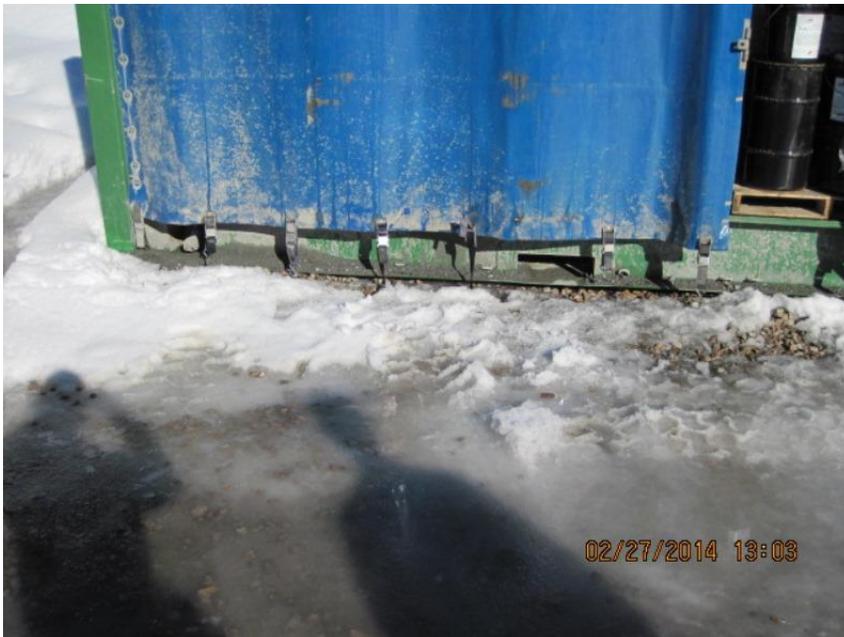
HGCMC plans to position the remaining 3 new sea vans at the 920 Warehouse after the ground thaws (Photo 06). The team walked past the Ore Pad en route to the 920 Portal from the warehouse (Photo 07).

Photo 6. Frozen ground behind 920 Warehouse.

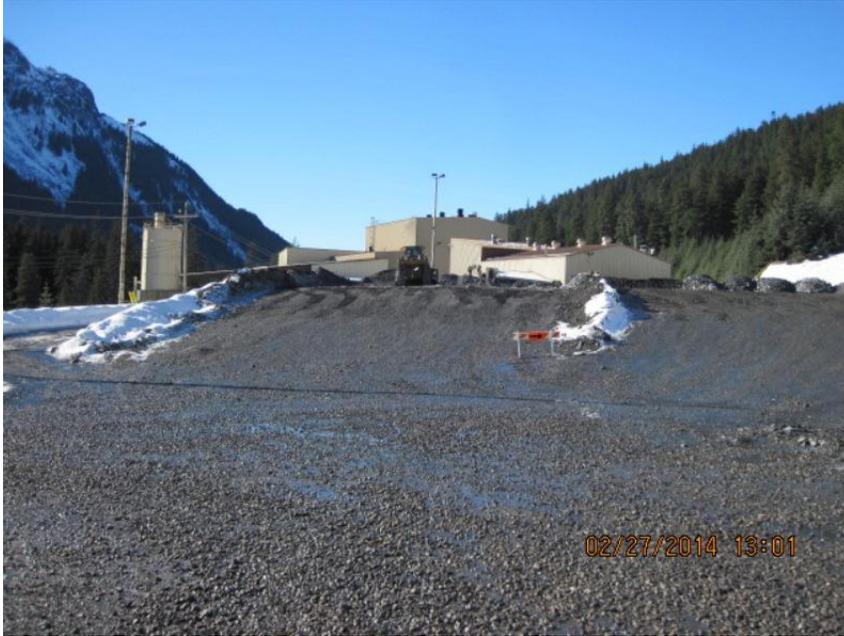
Photo 7. Ore pad and the Mill in the background.

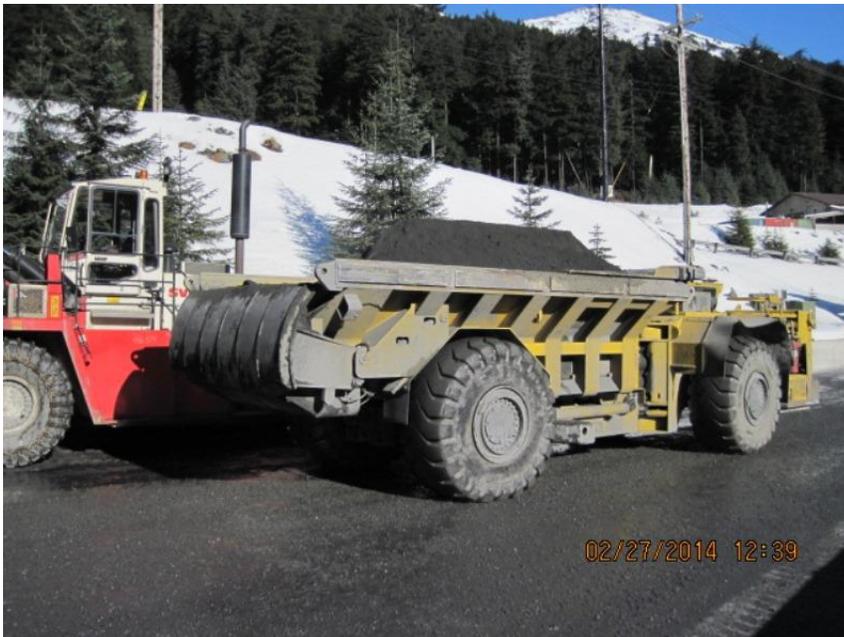
The team observed the loading of haul trucks with backfill tailings to see if they were loaded beyond capacity and then accidentally spilling tailings onto the road surface. The haul trucks were not overfilled and there was no evidence of spillage onto the road surface to the 920 Portal from the Mill area (Photo 08).

Photo 8. Properly loaded underground haul truck returning to the 920 portal.

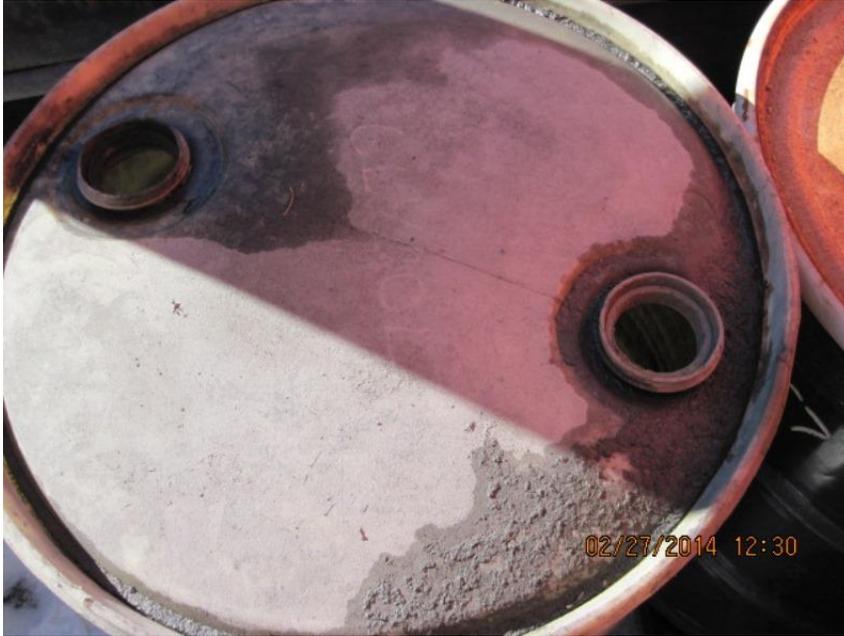
Only two notable issues existed during this inspection of the Mill area; a bung missing on a partly filled container of used glycol (Photo 9), and 3 (55-gallon) barrels of crushed oil filters not properly stored (Photo 10-11). The General Plan of Operations, Appendix 05, page 5-21 states that where all chemicals are stored, drain across concrete surfaces to the lined containment ditch which flows to Pond A.

Photo 9. Uncapped barrel of glycol near the powerhouse.

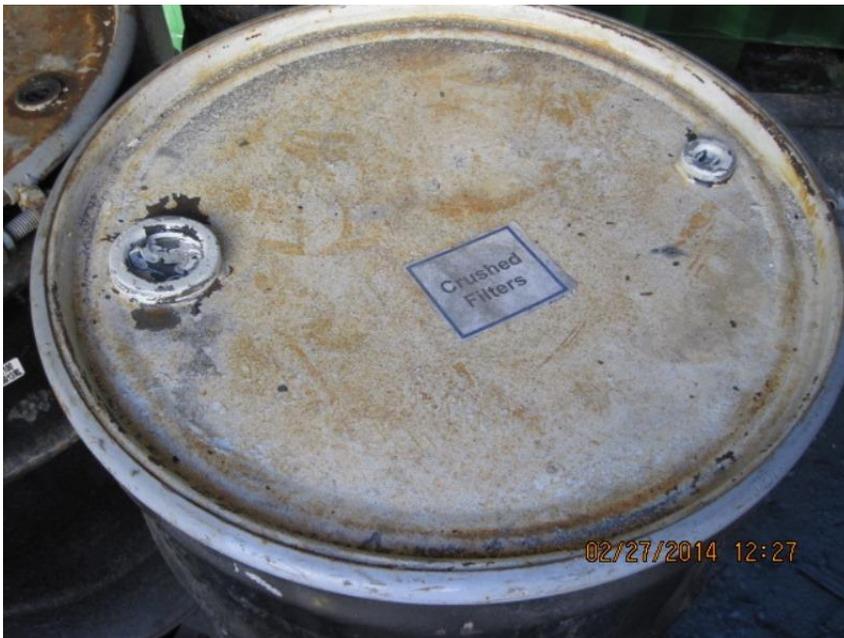
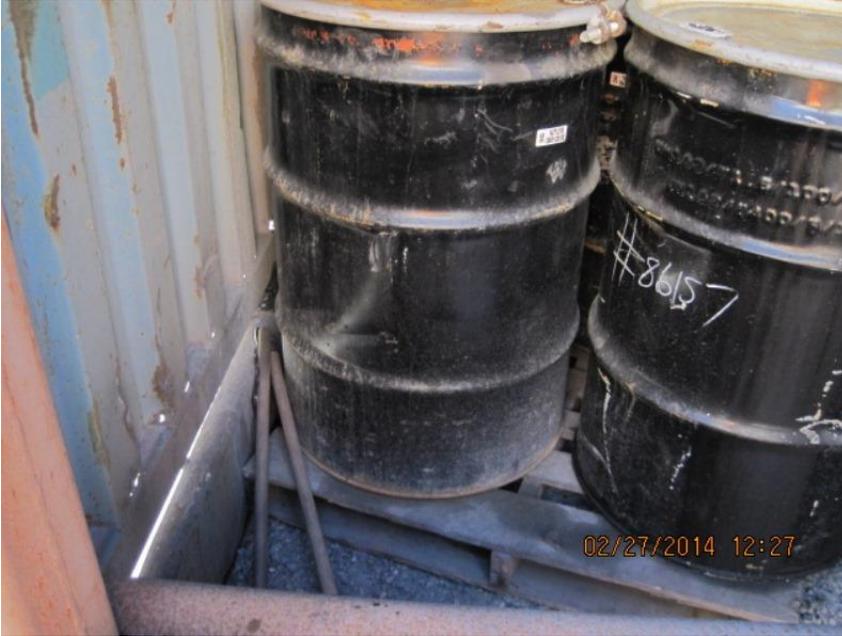
Photo 10. 55-gallon barrels stored on a wooden pallet over a gravel surface.

Photo 11. 55-gallon barrels stored on a wooden pallet over a gravel surface.

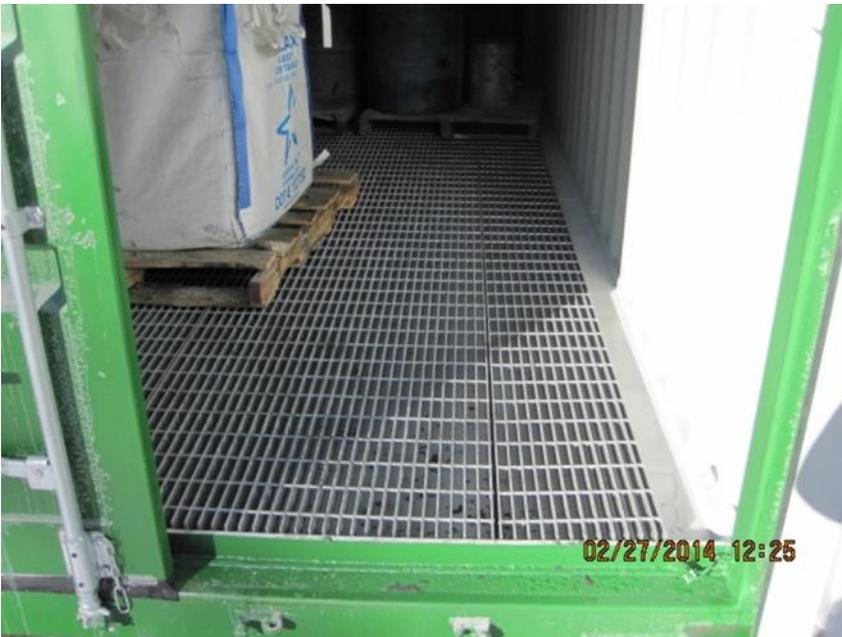
HGCMC positioned one new secondary containment sea van near the Mill (Photo 12).

Photo 12. New sea van with built in secondary confinement.
