INSPECTION REPORT: GREENS CREEK MINE

Date of Inspection: Tuesday, April 01, 2014
Date of Report: Monday, April 14, 2014
USDA Forest Service Inspector: Curtis Caton

Ranger District: Admiralty National Monument, Juneau Ranger District
Weather Conditions: partly cloudy. Temperatures in the upper 30s to low 40s.

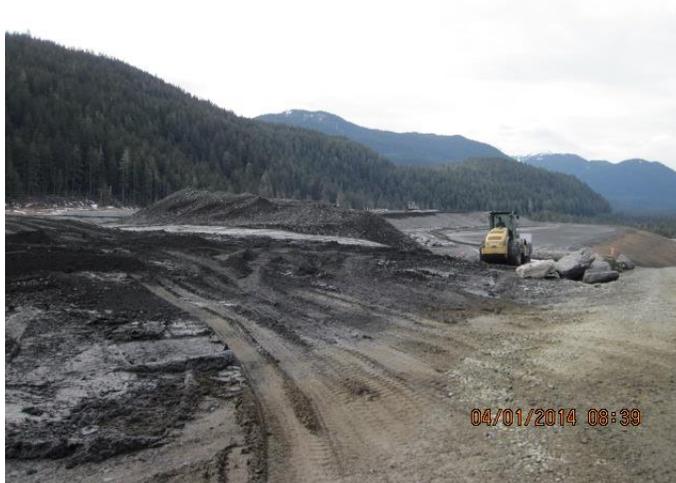
Pictures were taken from all three TDF tracking points (Photos 01-03). The access roads around the TDF are in good condition and show no signs of erosion. Mitch stated that HGCMC began deposition of tailings into the TDF East Ridge expansion within the last month (Photo 3).

Photo 01. TDF tracking point one. Looking southeast from the northern end of the TDF.

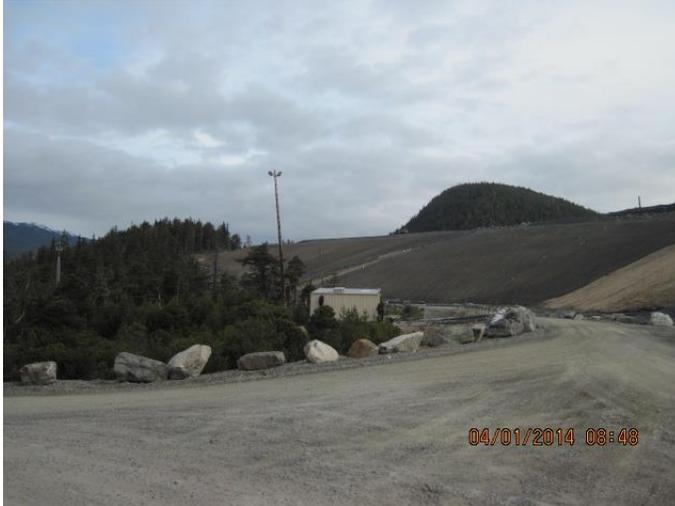
Photo 02. TDF tracking point two. Looking north from the Water Treatment Plant.

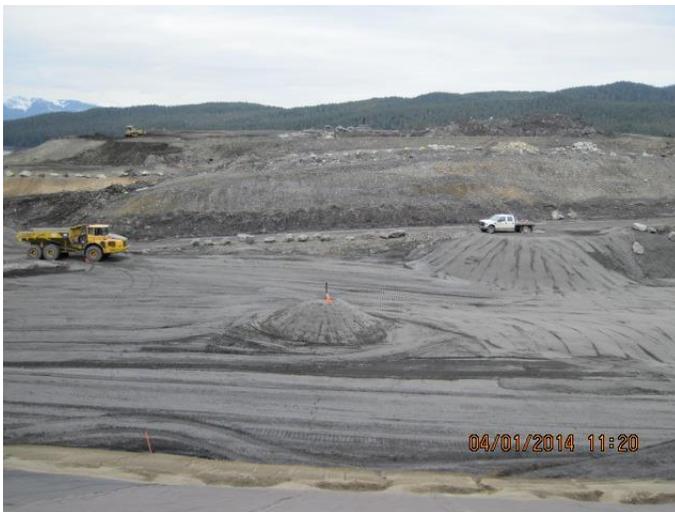
Photo 03. TDF tracking point three. View (west) across the East Ridge expansion.

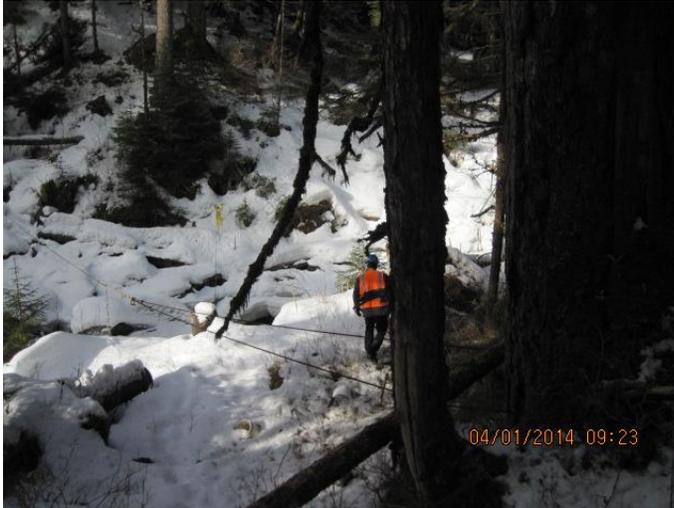
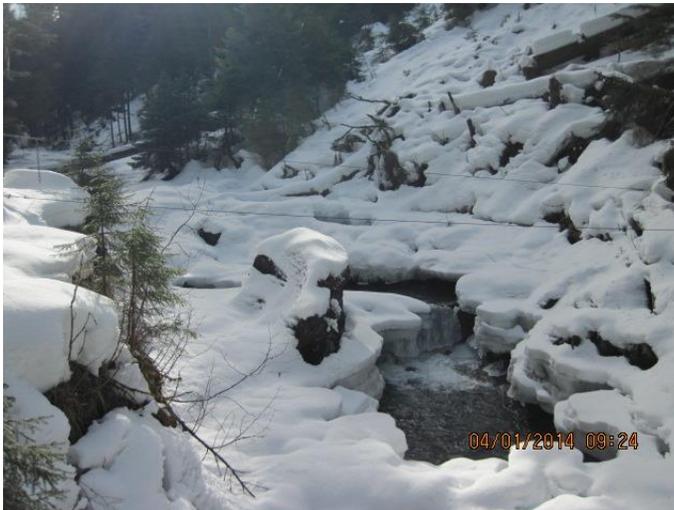
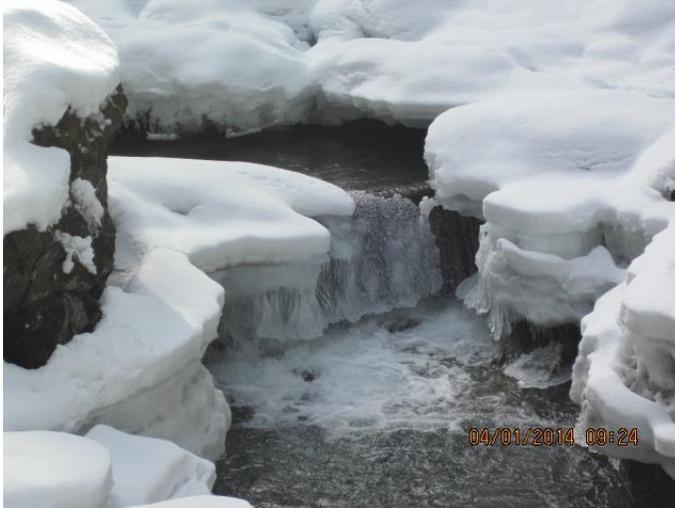
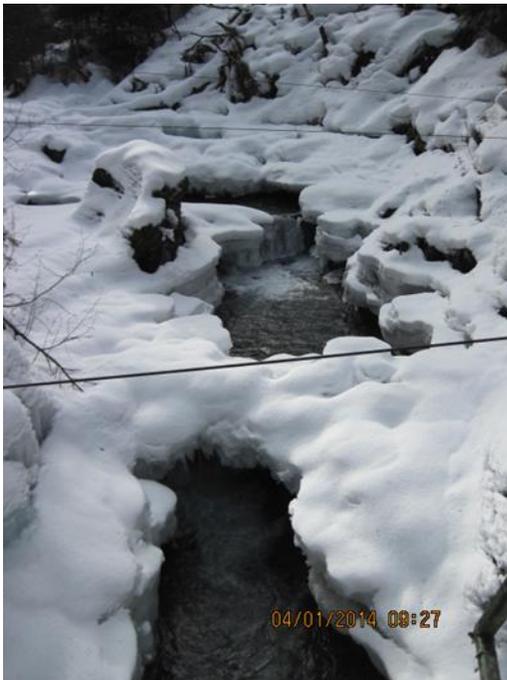
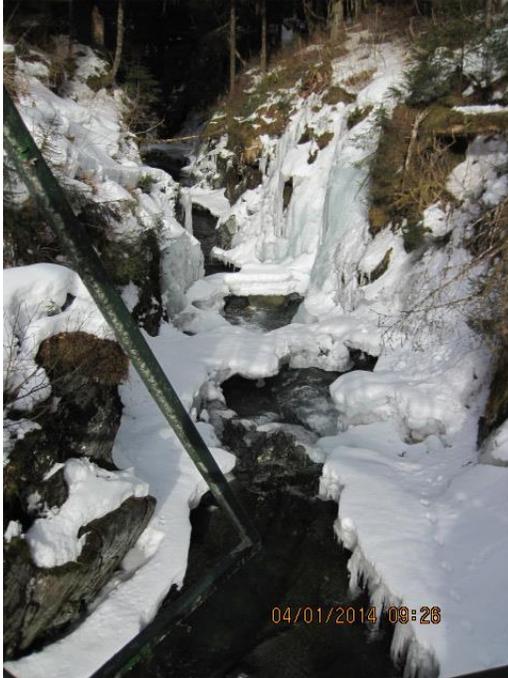
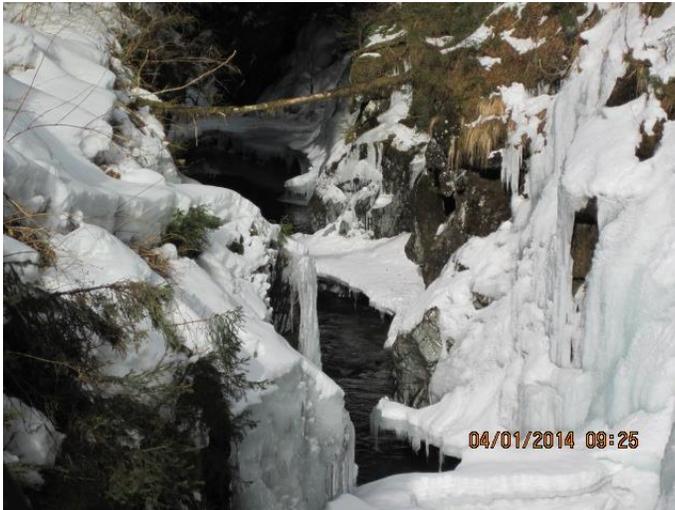
A thick layer of ice and snow covers the fish pass area. Mitch stated that an onsite HGCMC contractor had recently visited the fish pass in preparation for the upcoming repair project (Photos 04-09).

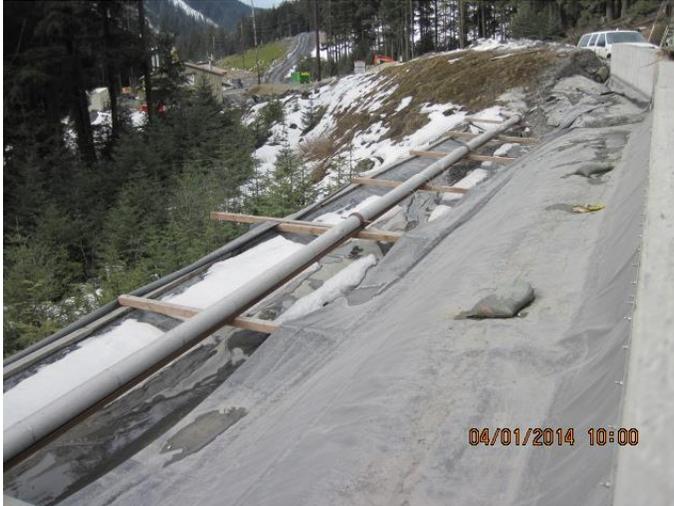
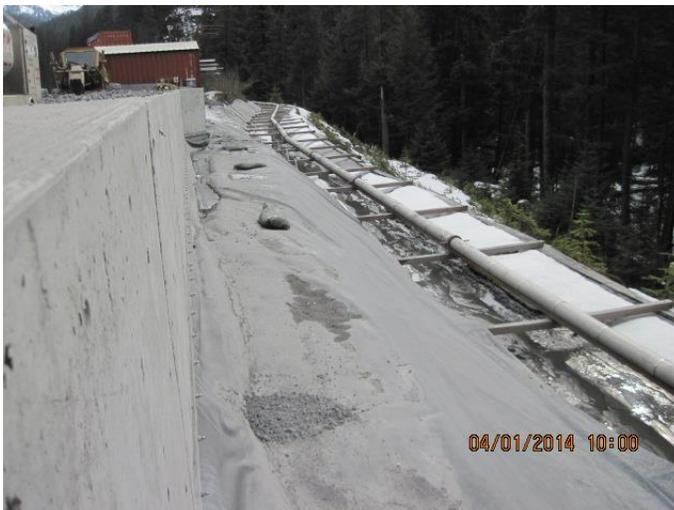
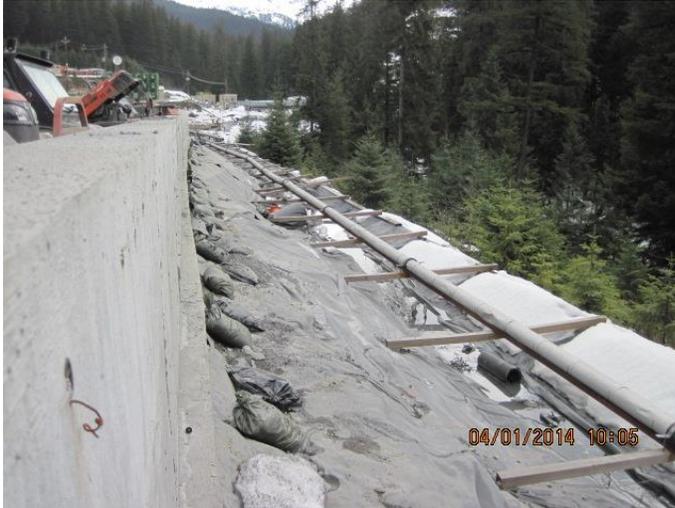
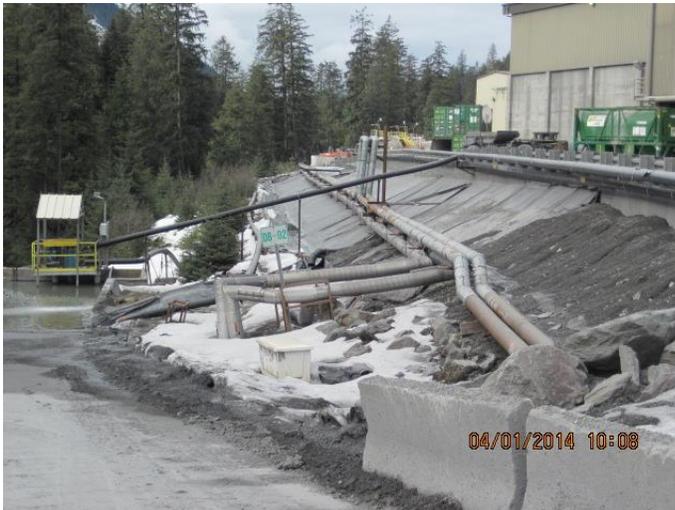
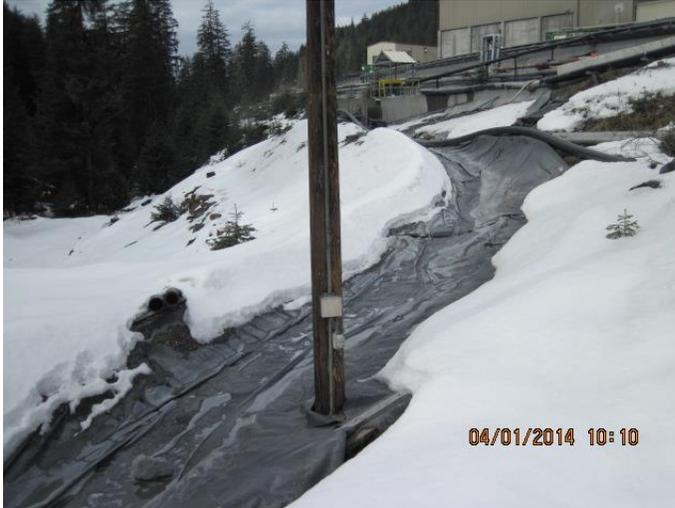
The 920 ditch is a gravity controlled, lined ditch that leads to a concrete settling basin (degrit basin) then to a lined retention pond. The ditch is located along the improved edge of the 920 footprint and runs from the administration building to Pond A. Surface runoff at the mine/mill site from all process areas, including areas where chemicals are stored, drain across concrete surfaces to the lined 920 ditch (Appendix 5, section 4.3.1 and in Appendix 6, section 5.2). The 920 ditch serves as secondary containment barrier by reporting all liquid draining from the improved surface to Pond A (Photos 10-14).

HGCMC surface operations 2014 work plan proposes a reconstruction of the 920 ditch. The project is to reconstruct the upper 600 feet of the ditch to prevent the accumulation of sediment, and frequency of required maintenance. A waste line will be relocated to allow better access to the ditch.

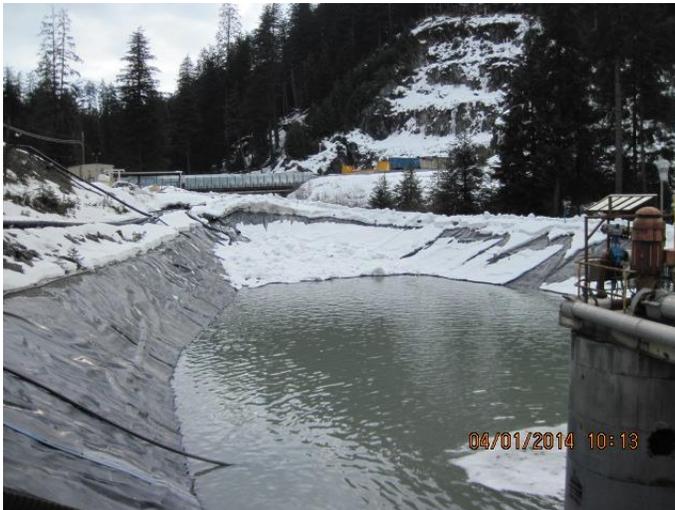
Photo 15. Pond A.

Pond A is lined with a synthetic liner and serves as a secondary settling basin and equalizing storage basin to eliminate release of collected storm water that may have come into contact with ore, concentrate, or other site materials.

HGCMC surface operations 2014 work plan calls for a stabilization project for the outer berm of Pond A. Greens Creek is undercutting the riprap, which is causing instability to the stream bank. HGCMC plans to repair the riprap within the existing Pond A footprint (Photos 15-20).

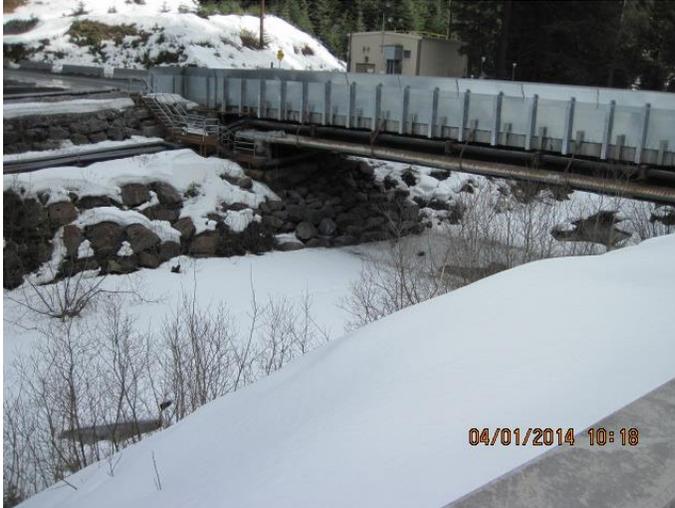
Photo 16. Bridge across Greens Creek. Rip rap near pond A.

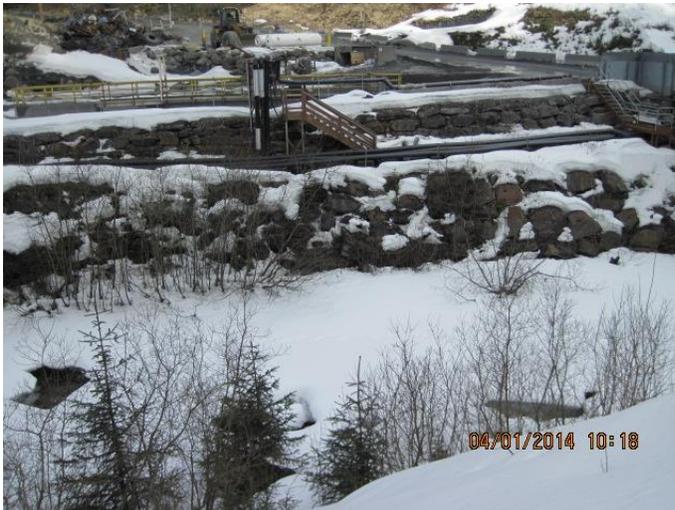
Photo 17. Rip rap between Pond A and Greens Creek Bridge.

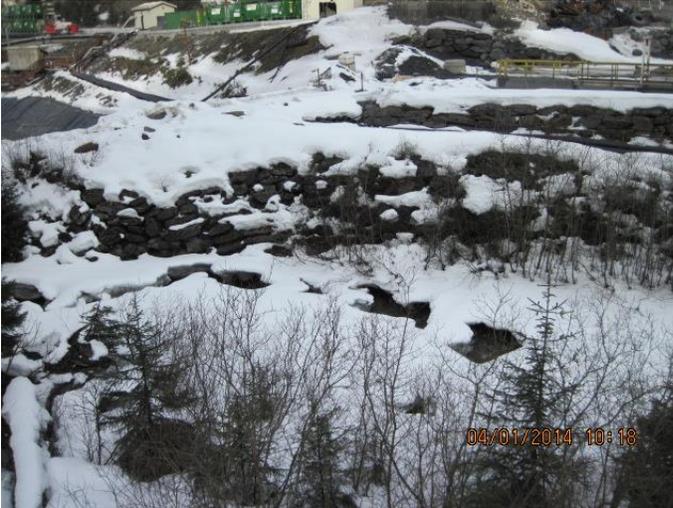
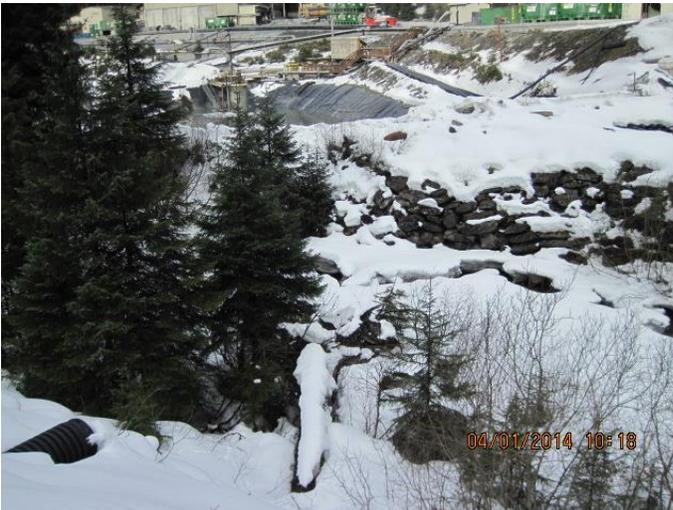
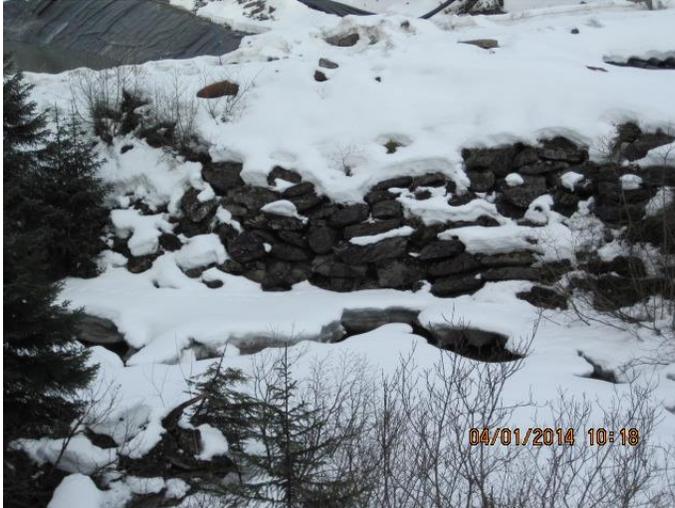
Photo 18. Riprap at Pond A undercut by Greens Creek.

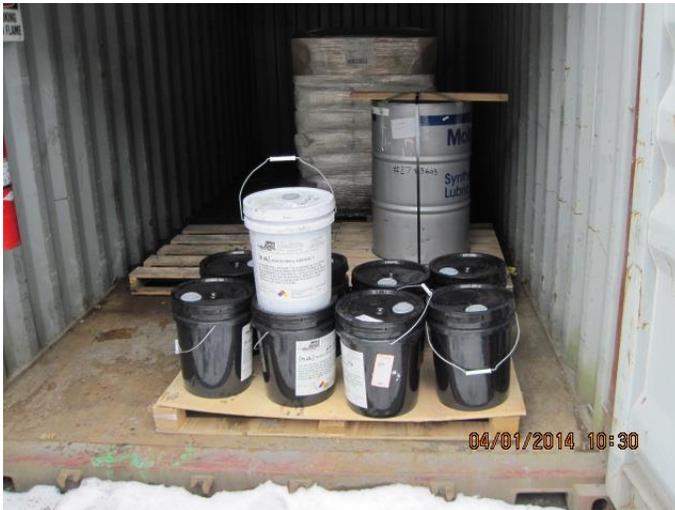
HGCMC is waiting for the ground to thaw to install two new secondary containment sea vans at the 920 warehouse. A 55-gallon drum of transmission fluid was improperly stored as required by the BMP plan (Appendix 5) (Photo 21). Section 4.3.1 of the BMP plan states that all process areas where chemicals are stored drain across concrete surfaces to the lined containment ditch, which flows to Pond A.

Photo 21. 55-gallon container of transmission fluid and other petroleum products.

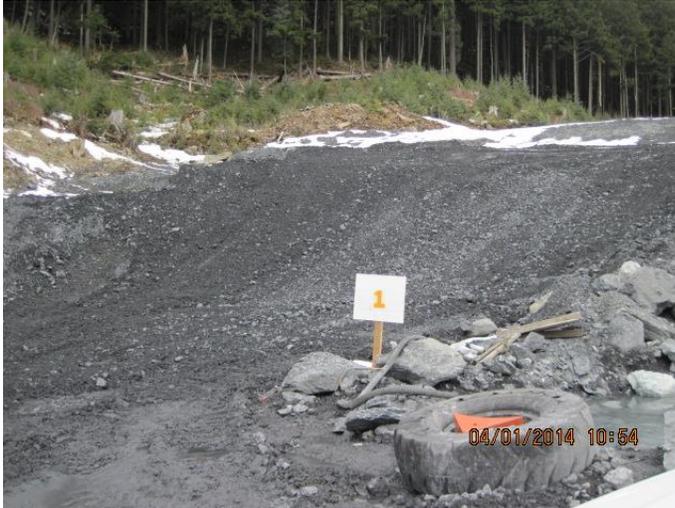
Waste rock brought to Site 23 by underground haul trucks is being sorted according to the Waste Rock Management Plan, section 3.3. Signs designating where the three classes of waste rock are to be placed are visible (Photos 22-23).

Photo 22. Class one material at Site 23.

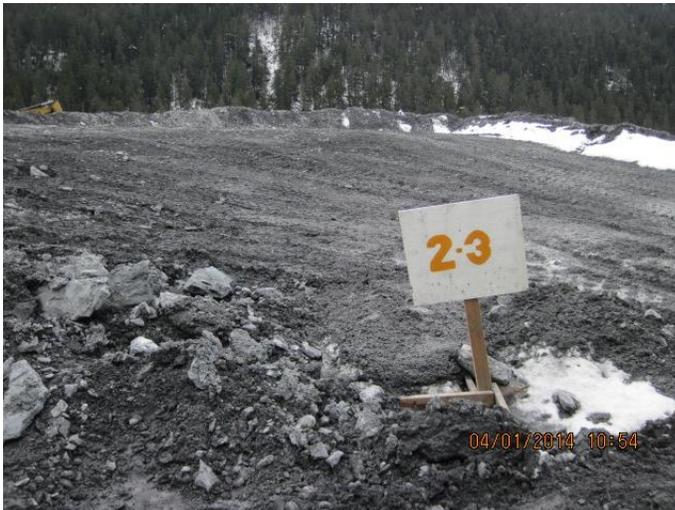
Photo 23. Class two and three material at Site 23.

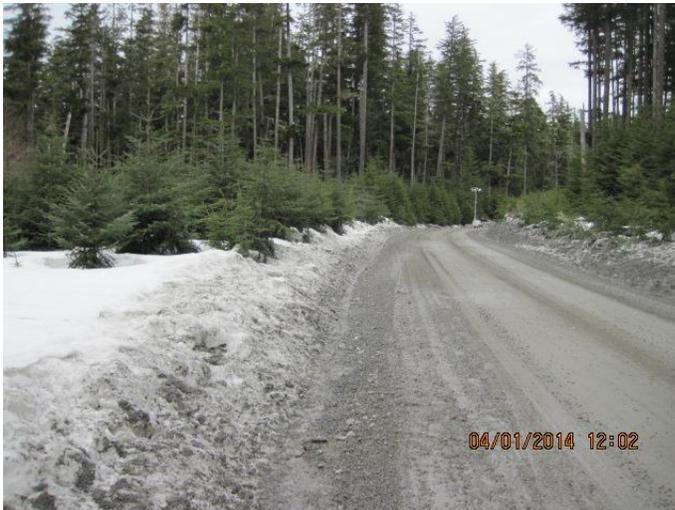
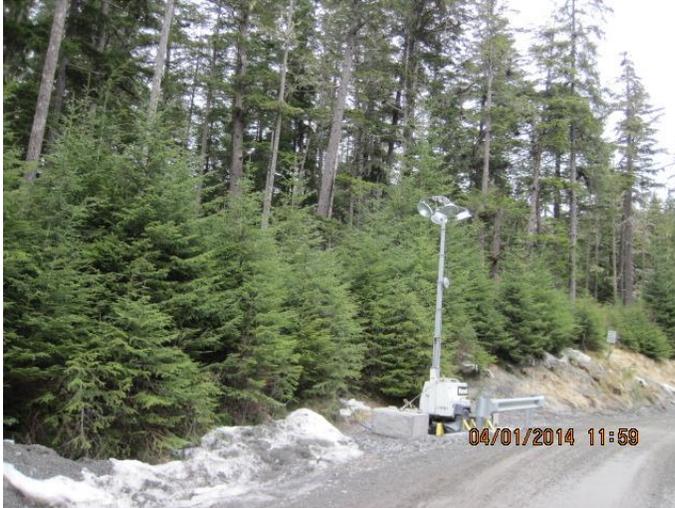
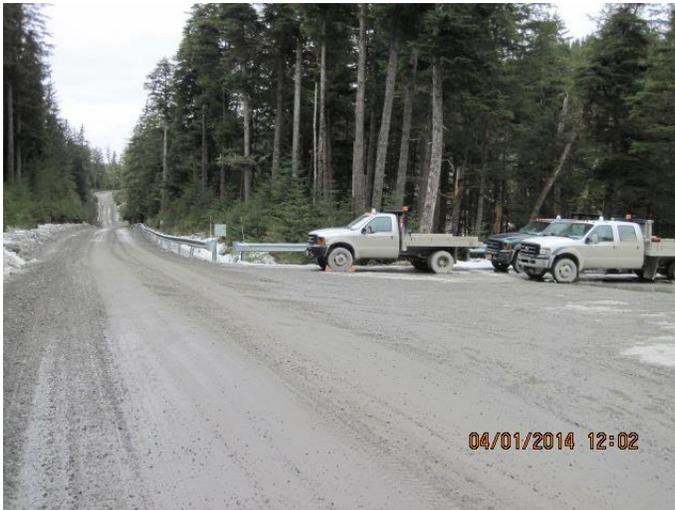
Photo 25. Lighting project area near Young Bay.

Photo 26. Temporary light.

HGCMC surface operations 2014 work plan proposes the addition of permanent lighting along the A road from Young Bay to the shale pit parking area. The permanent lighting would replace a generator powered portable light (Photo 25-27).
