Inspection Report: Hecla Greens Creek Mine

Date of Inspection: Wednesday, May 14, 2014
Date of Report: Tuesday, May 27, 2014
USDA Forest Service Inspector: David Schmerge

Ranger District: Admiralty National Monument, Juneau Ranger District
Weather Conditions: Cloudy, temperature in the upper 50s.

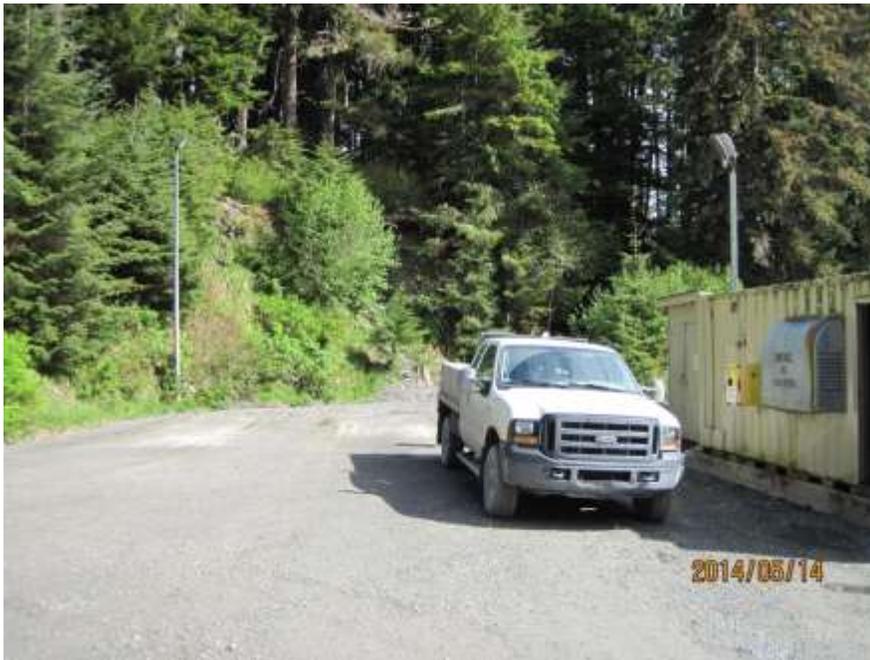
Hecla has submitted a proposal to the Forest Service to install additional lighting at Young Bay. An overhead aerial power cable is proposed. It may be necessary to cut down a few trees and/or bushes in order to install the proposed lights (photo 01).

Photo 01. An aerial power cable is proposed to be connected to the light pole on the left. It may be necessary to cut down a few trees and shrubs in order to safely do this.

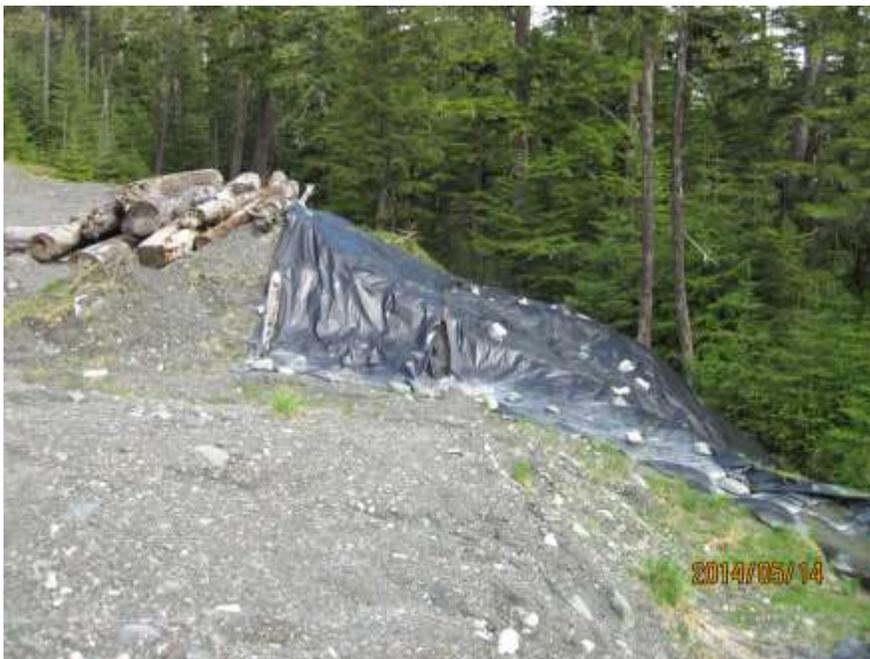
Canada thistle is an invasive plant that was found at Pit 7 in 2012. The area is covered with tarps in an effort to prevent further growth (photo 02). A few young canada thistle plants are present (photo 03). Invasive plants are not discussed in the Plan of Operations, but the 2013 Greens Creek Mine Tailings Disposal Facility Expansion Final Environmental Impact Statement (section 3.10.3.1) requires the removal of existing invasive plant populations. Hecla has been attempting to eradicate it by pulling the plants by hand. They would like to be able to use a chemical spray, but additional NEPA is needed before this can be approved by the Forest Service. Ellen Anderson and Patti Krosse have prepared a draft copy of a white paper discussing the issue, but

Photo 02. Tarps are being used at pit 7 in an effort to prevent the growth of Canada Thistle that was discovered in the area in 2012.

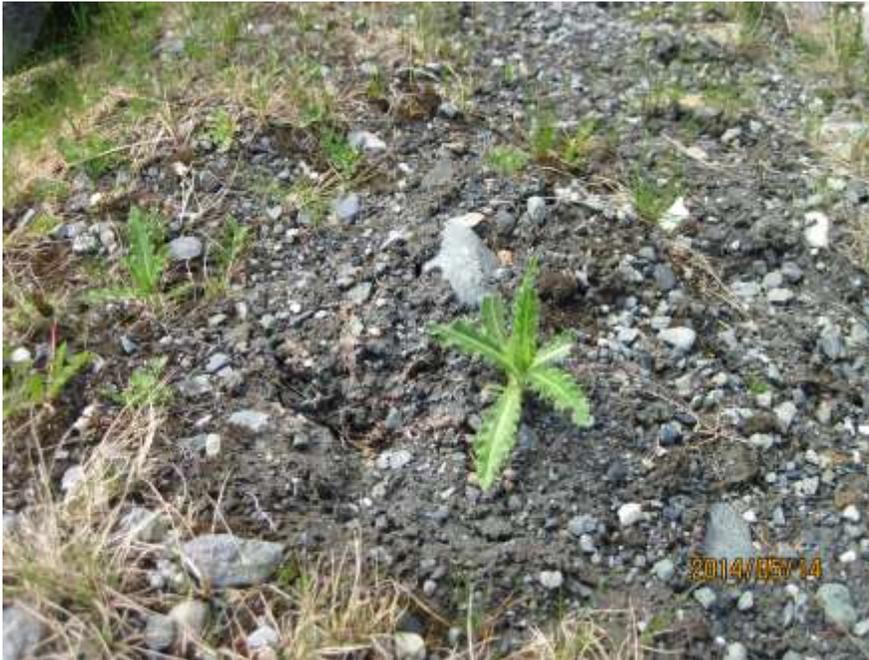
Photo 03. A few young Canada thistles are present. They should be pulled before they bloom in order to prevent further spreading.

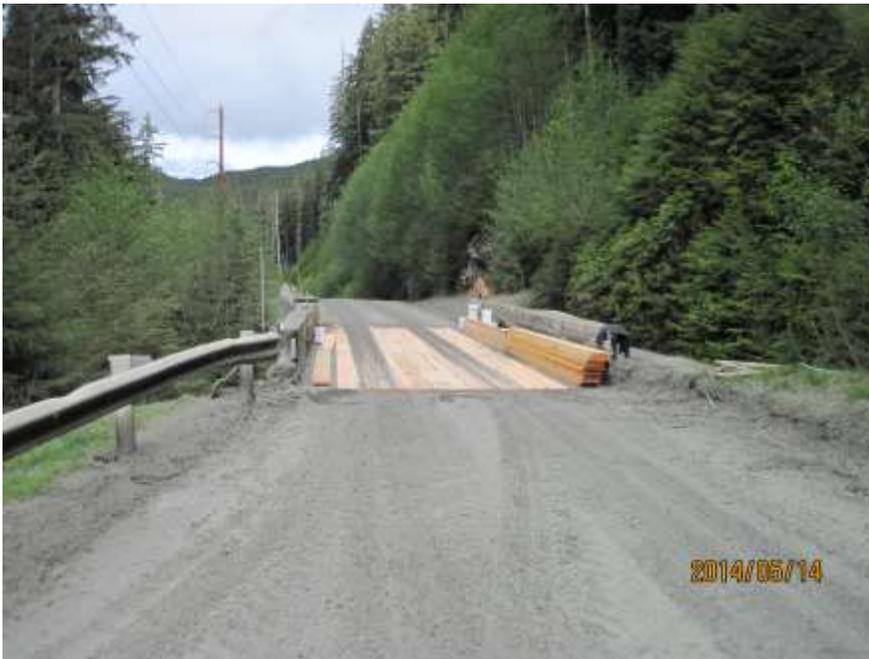
The planking on the bridge at mile 3.4 had just been replaced when we drove by (photo 04). Mitch informed me that this is routine maintenance that is done every year on the bridges. I reviewed the Plan of Operations and found no discussion on bridge repair. The Plan of Operations is scheduled to be updated soon. When the Plan is updated, I recommend including a section on bridge maintenance in appendix 8 (Road Operation and Maintenance).

Photo 04. The blanking on this bridge had been replaced just before we drove by.

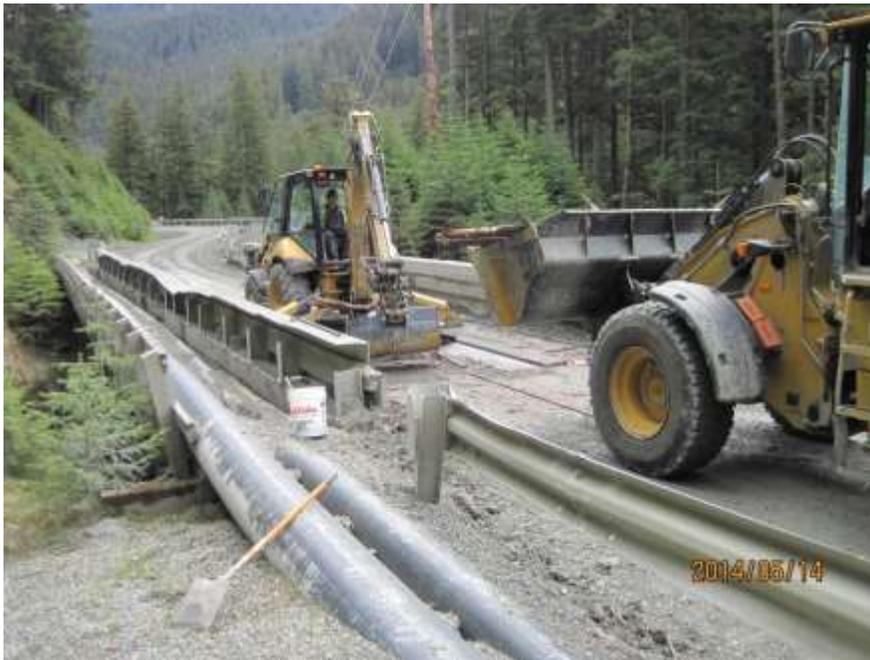
Photo 05. The planking of the bridge at mile 7.4 on the B Road was being removed by an excavator, and hauled away by a loader.

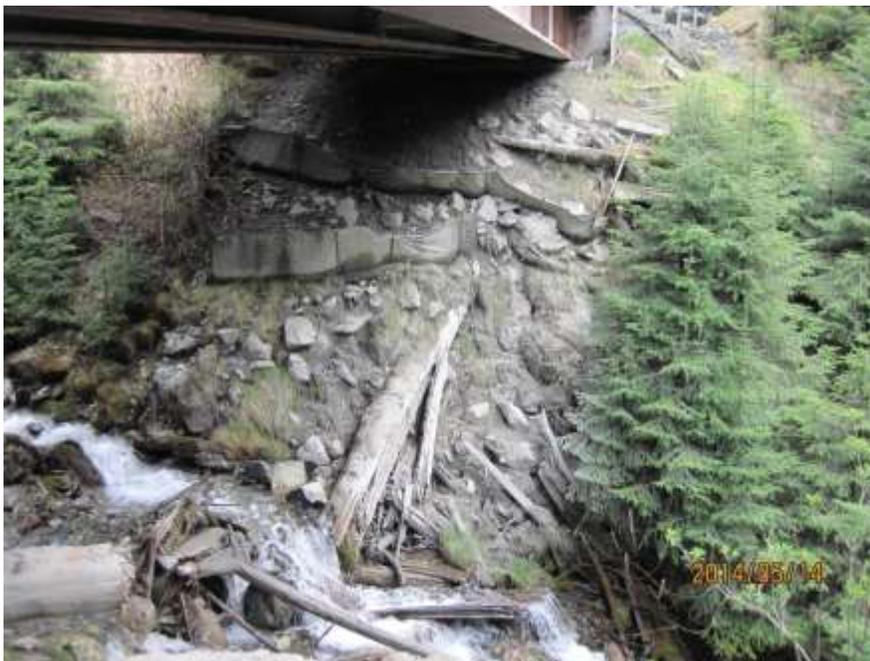
The planking on the bridge at mile 7.4 was being removed when we arrived (photo 05). A lot of fine grained sediment is visible underneath the bridge (photo 06). The sediment below the lowest silt fence will get washed into the creek when it rains. This situation could be improved by adding an additional silt fence closer to the creek. Some sediment is being splashed over the splash guard (photo 07) and into the stream. It is recommended that the splash guards be at least as tall as the tallest vehicle tire that regularly crosses the bridge. Some sediment is also falling through the cracks in the planking and into the stream (photo 08). It may not be feasible to seal all of the bridge planks because water on the bridge might not be able to properly drain, but one possibility is to at least seal the planks that are directly over the creek.

Photo 06. Silt Fences are capturing some of the sediment underneath the bridge, but there is a lot of sediment beyond the lowest silt fence that will get washed into the creek when it rains.

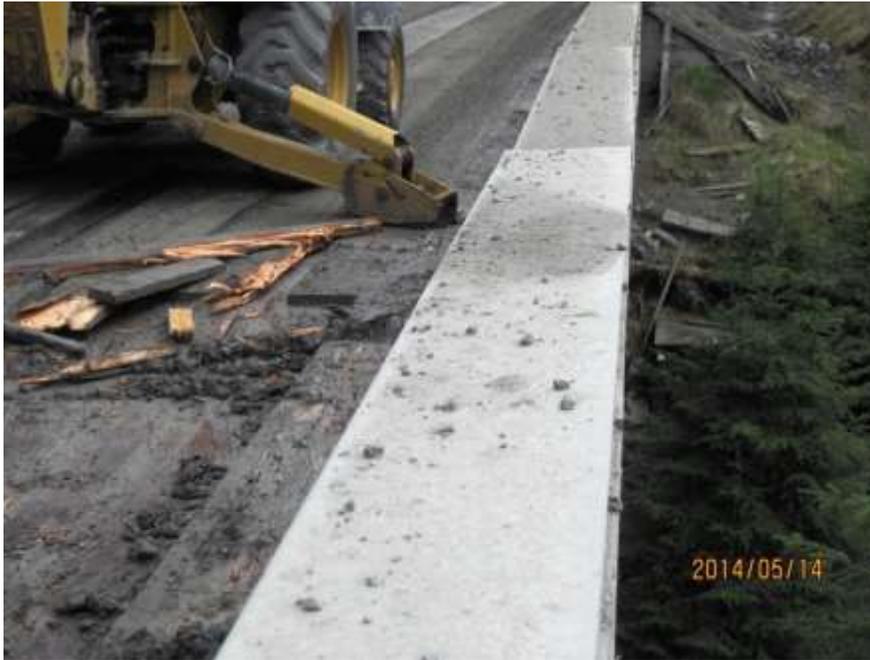
Photo 07. Sediment on top of the splash guard indicates that it should be taller in order to prevent sediment from getting splashed into the stream.

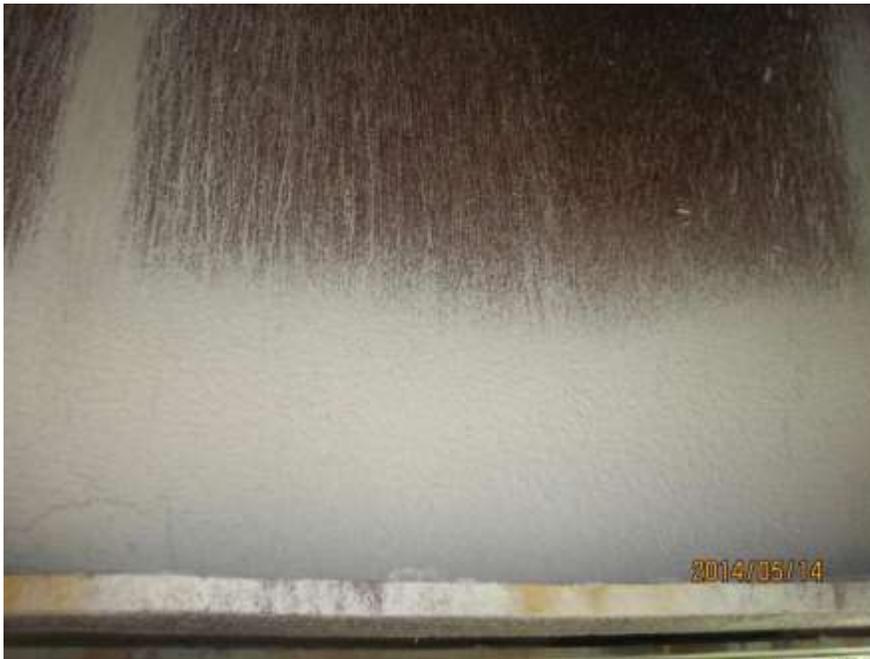
Photo 08. The mud on this girder has fallen through the cracks in the bridge planking. Some of the mud will fall directly into the stream.

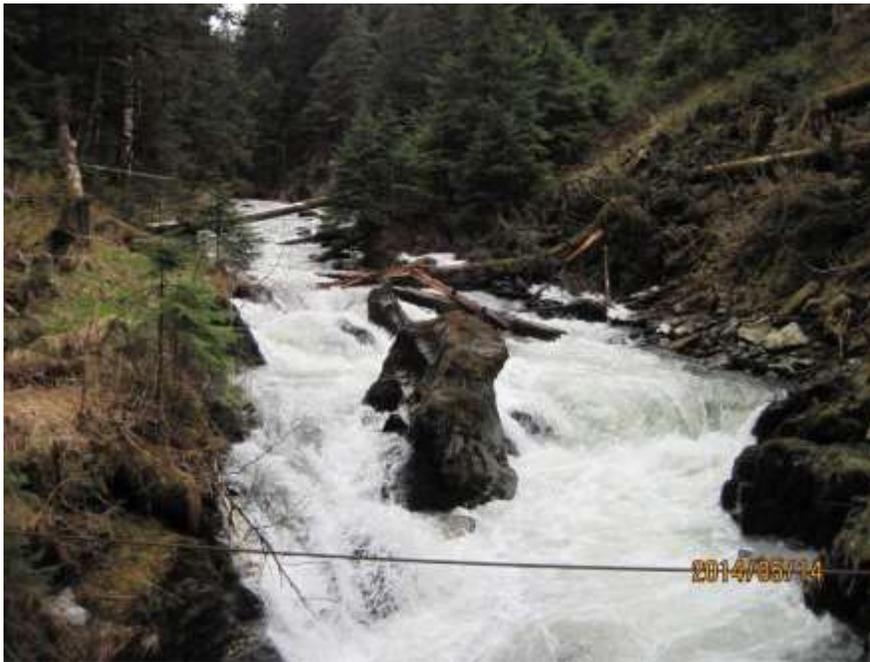
The snow has melted at the fish pass, but the flow rate is too high now to safely do the required repair work (photo 09).

Photo 09. The snow has melted at the Greens Creek fish pass.

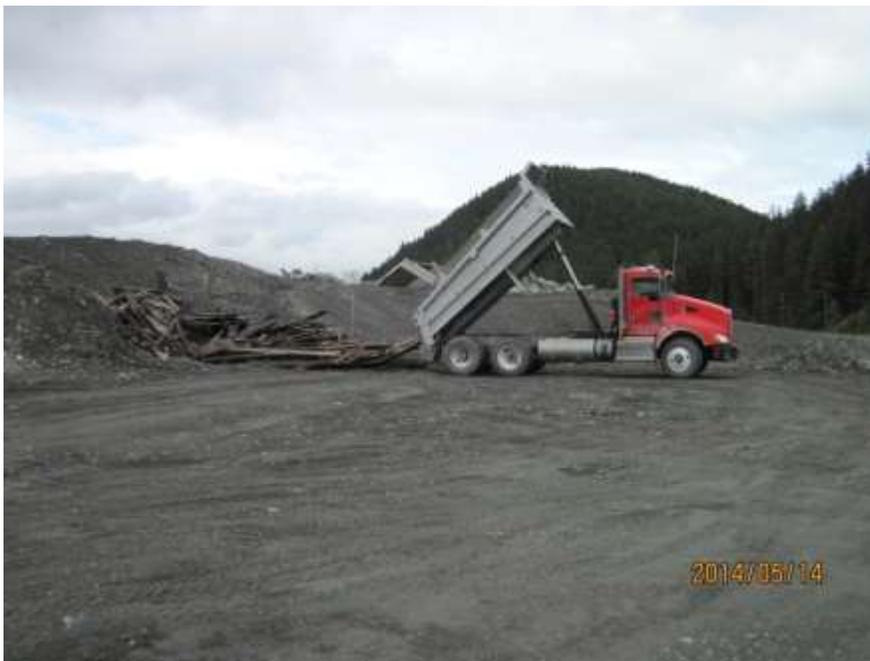
Debris from the bridge maintenance work was being hauled to the tailings facility to be burned (photo 10). According to chapter 8 (Solid Waste Disposal) of the General Plan of Operations (GPO), solid wastes are either burned at an incinerator at Hawk Inlet, or compacted at Hawk Inlet and then shipped to Juneau and incinerated. Appendix 3 (Tailings Impoundment) and Appendix 7 (Solid Waste) of the GPO both authorize the disposal of ash and residue at the tailings facility, but not the burning of scrap wood material at the tailings facility. The Integrated Waste Management and Disposal Plan (IWMDP) states that wood scrap can be incinerated or burned at the tailings facility, but the IWMDP is not part of the GPO. The GPO is presently being revised by Hecla. It is my recommendation that the IWMDP be submitted to the Forest Service as Appendix 7 of the GPO.

Photo 10. Wooden debris from the bridge maintenance work on the B road is being hauled to the burn pile at the tailings facility.
