INSPECTION REPORT: GREENS CREEK MINE

Date of Inspection: Thursday, July 17, 2014
Date of Report: Tuesday, July 23, 2014
USDA Forest Service Inspector: Curtis Caton

Ranger District: Admiralty National Monument, Juneau Ranger District
Weather Conditions: partly cloudy. Temperatures in the mid 50's (°F).

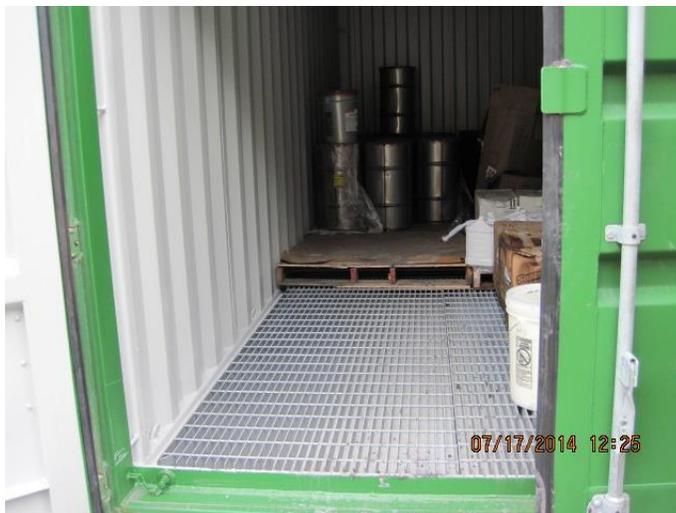
HGCMC has acquired new sea vans that fulfill secondary containment requirements (Photo 01-02). The new sea vans are more weather resistant than the curtained sea van (Photo 03). The estimated containment volume of the new sea van (8'x 20'x 0.25'), on a level surface, is approximately 299 gallons. This volume is sufficient for most of the containers in the 920 area except for the larger volume reinforced totes, which will still need to be stored on concrete or in secondary containment with sufficient volume (Photo 04-05). However, modifying the lip from 3" (.25') to 4" (.33') would increase

Photo 01. New sea van in use at the 920 Warehouse.

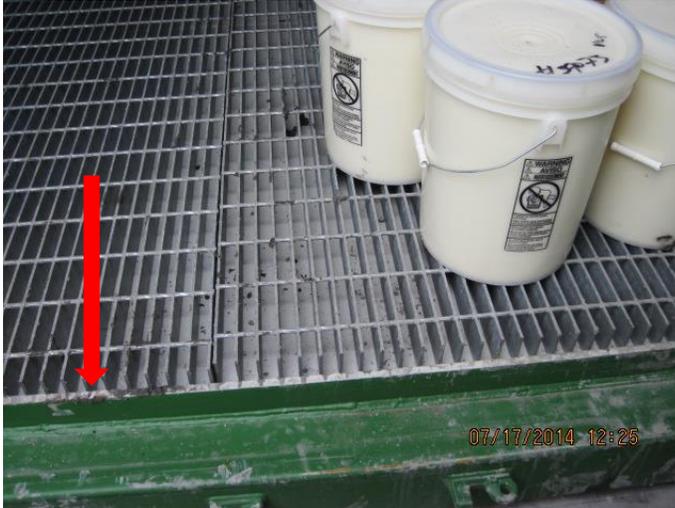
Photo 02. Front lip of sea van that could be modified.

the volume of the new sea van to approximately 400 gallons. Section 4.3.1 of the BMP plan states that all process areas where chemicals are stored, drain across concrete surfaces to the lined containment ditch, which flows to Pond A. Additionally, the General Plan of Operations states that secondary containment is considered 110% of the largest tank within the containment.

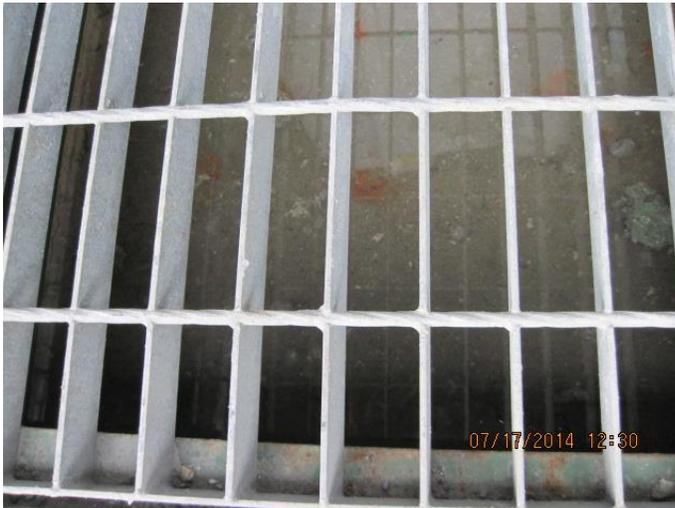
Photo 03. Moisture collecting in the basin of a curtained sea van.

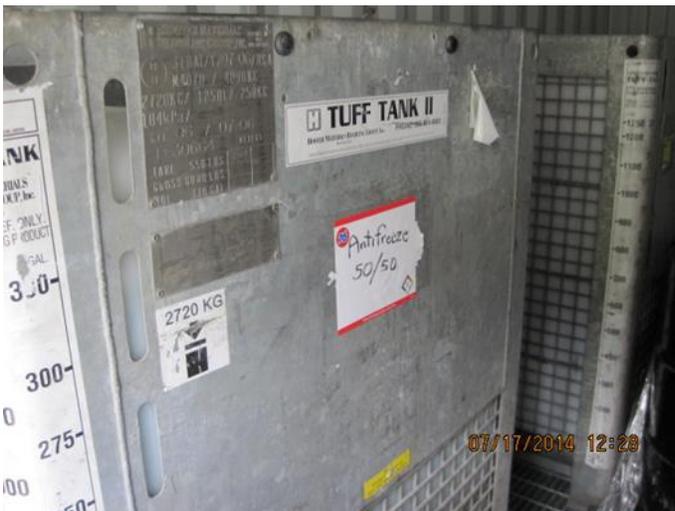
Photo 04. Large volume reinforced totes.

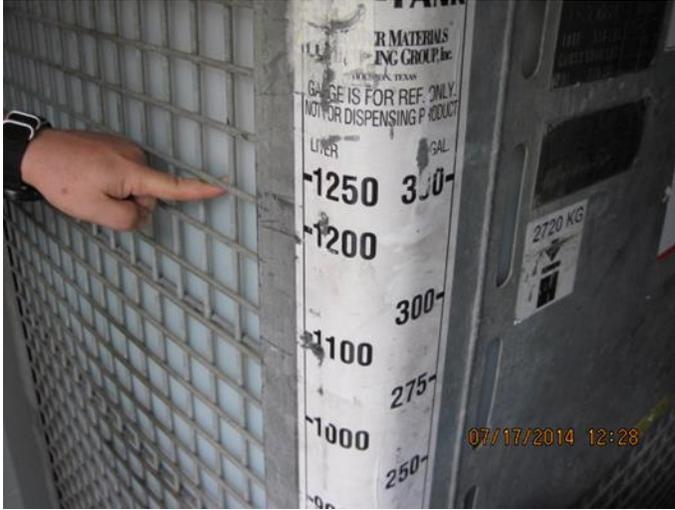
Photo 05. Tote with approximately 330 gallons stored in containment designed for 299 gallons.

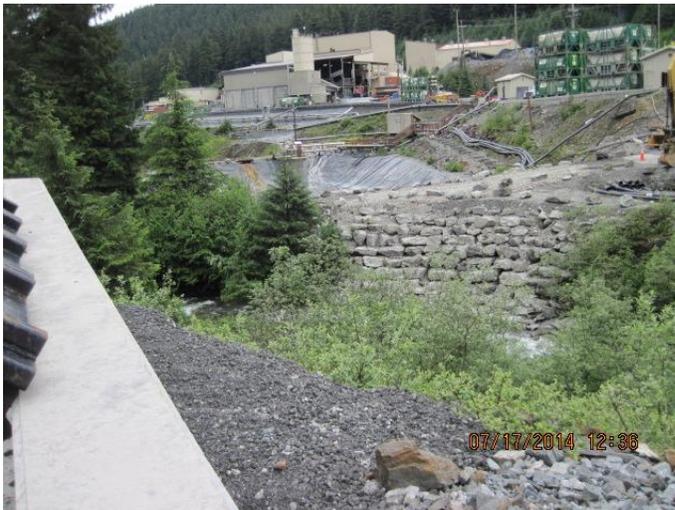
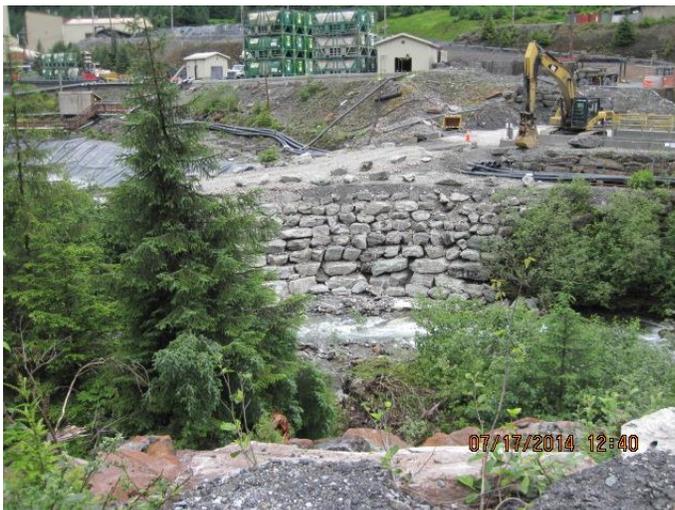
HGCMC recently stabilized the outer berm of Pond A. Greens Creek had undercut the riprap along the stream bank, causing instability in the outer berm of Pond A. HGCMC made repairs within the existing footprint of Pond A as approved in the surface operations 2014 work plan (Photos 06-07).

Photo 06. Repaired riprap along outer berm of Pond A.

Photo 07. Repaired riprap along outer berm of Pond A.

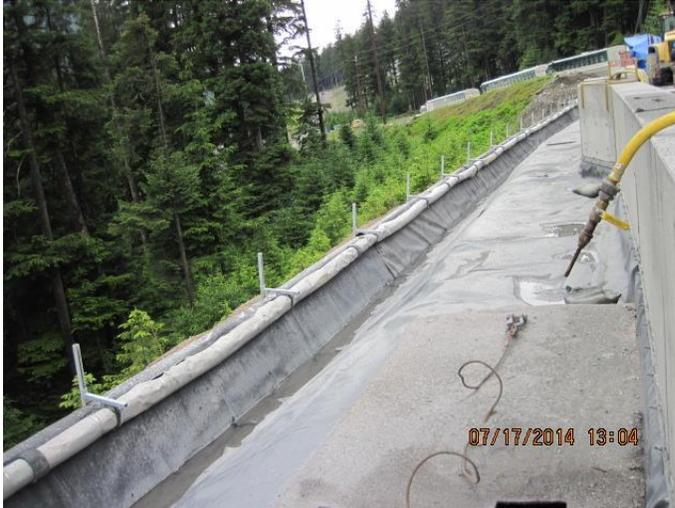
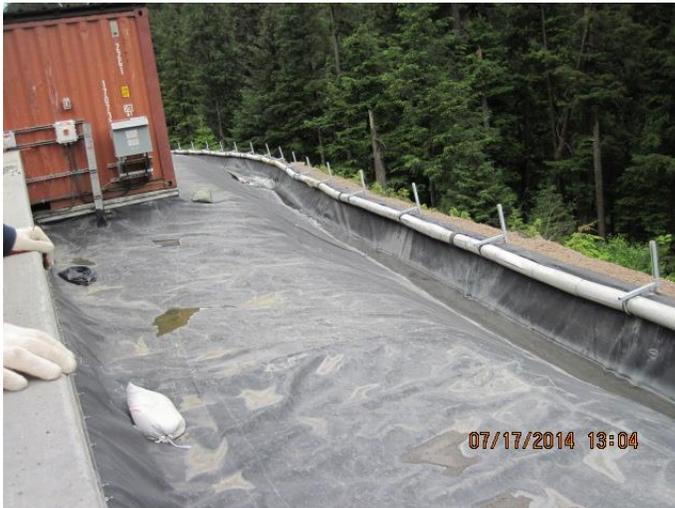
The 920 ditch was repaired as approved in the surface operations 2014 work plan (Photos 08-09). The repairs to the 920 Ditch eliminated sediment loading within the ditch, which will minimize reoccurring surface maintenance.

Photo 08. Repaired 920 ditch.

Photo 09. Repaired 920 ditch.

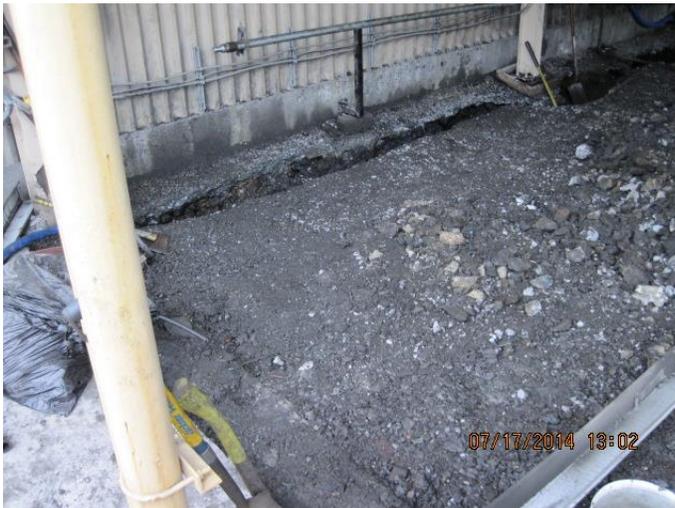
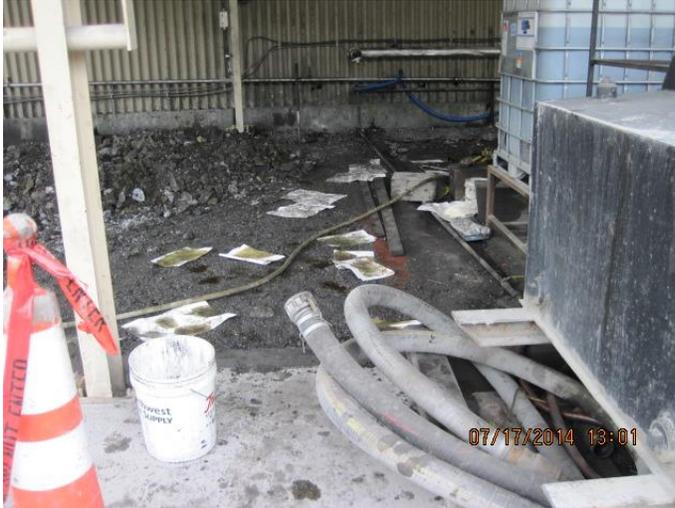
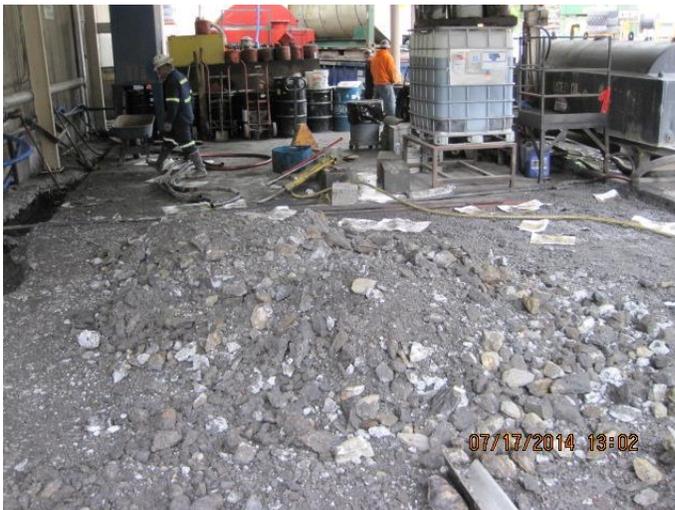
HGCMC reported a spill and cleanup was taking place during this inspection. Surface crews are excavating contaminated overburden for remediation (Photos 10-12).

Photo 10. Spill cleanup.

Photo 11. Spill cleanup.

Photo 12. Spill cleanup.

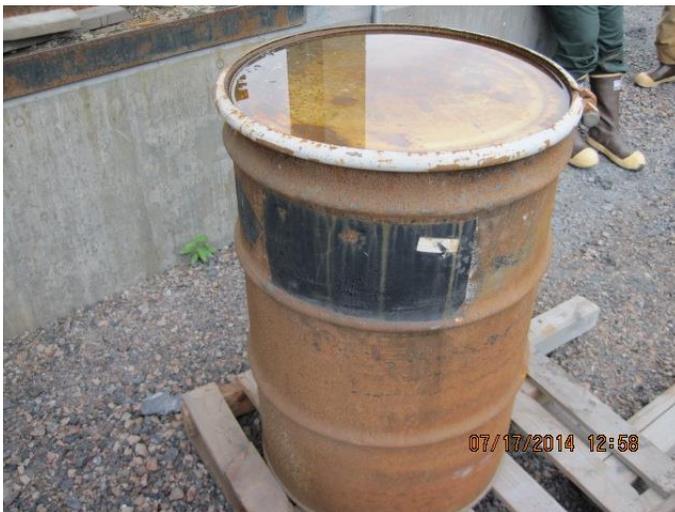
An unlabeled barrel with an unknown substance was not in secondary containment (Photo 13).

Photo 13. Unlabeled barrel not in secondary containment.

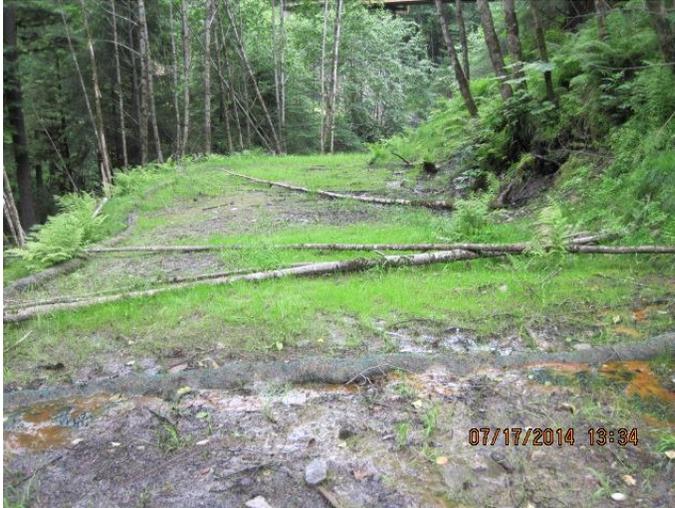
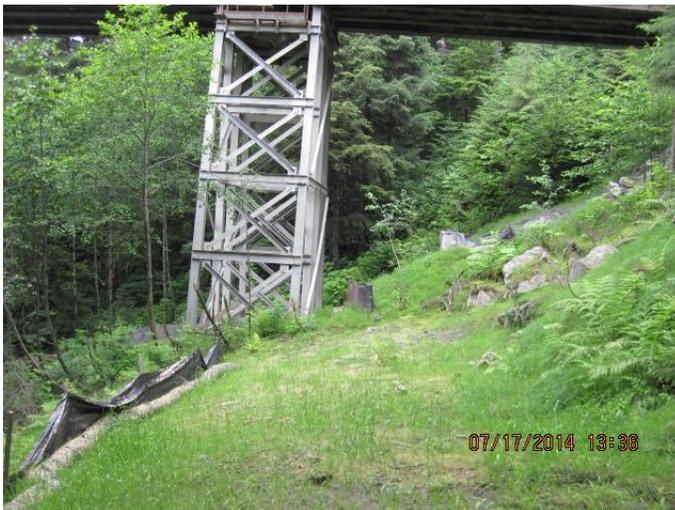
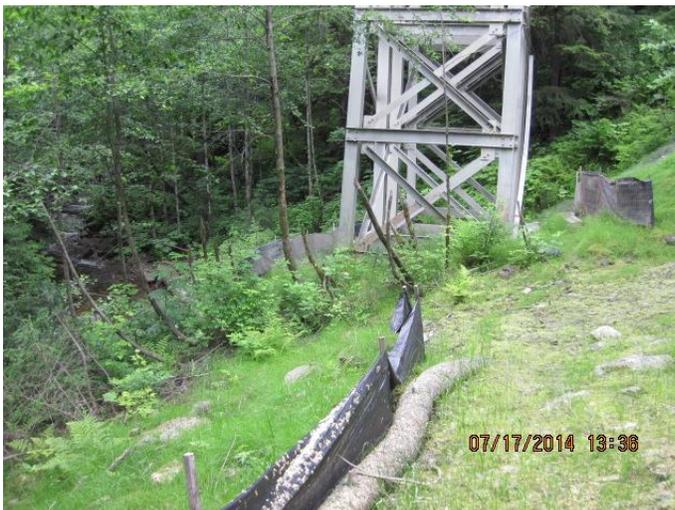
The B road crosses Zinc Creek at approximately mile marker 3.0. BMPs for stormwater outfall 005.2 (west side Zinc Creek Bridge) comply with Appendix 5 of the General Plan of Operations. Hydroseeding, silt fencing, and sediment barriers have minimized erosion on the Zinc Creek Bridge access road (Photos 14-16).

Photo 14. Zinc Creek Bridge access road.

Photo 15. Zinc Creek Bridge access road.

Photo 16. Zinc Creek Bridge access road.

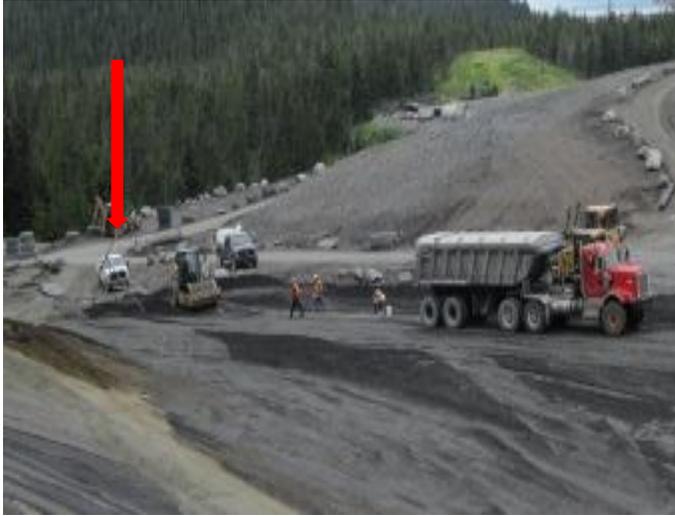
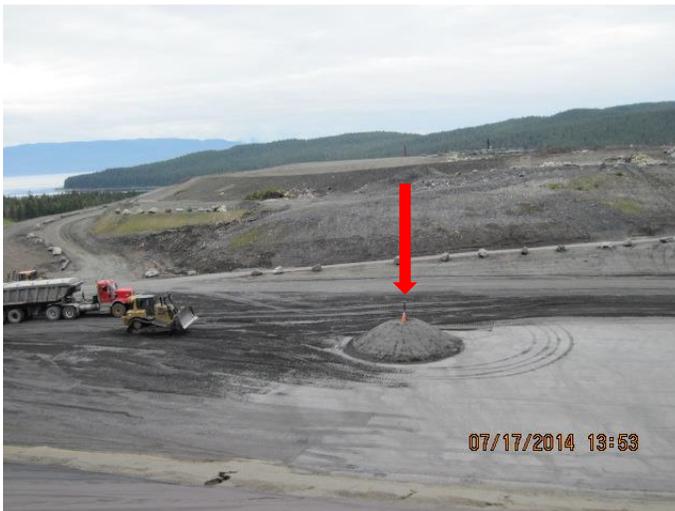
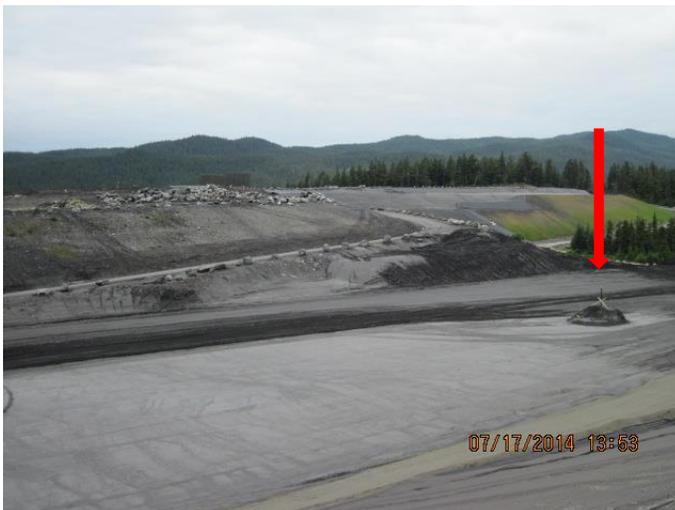
Surface crews are increasing the elevation of the monitoring stations in the East Ridge expansion to prevent burial by tailings (Photos 17-19). The monitoring stations are fixed locations where data from a vibrating line piezometer and suction lysimeter are collected.

Photo 17. TDF East Ridge Expansion monitoring locations.

Photo 18. TDF East Ridge Expansion monitoring locations.

Photo 19. TDF East Ridge Expansion monitoring locations.

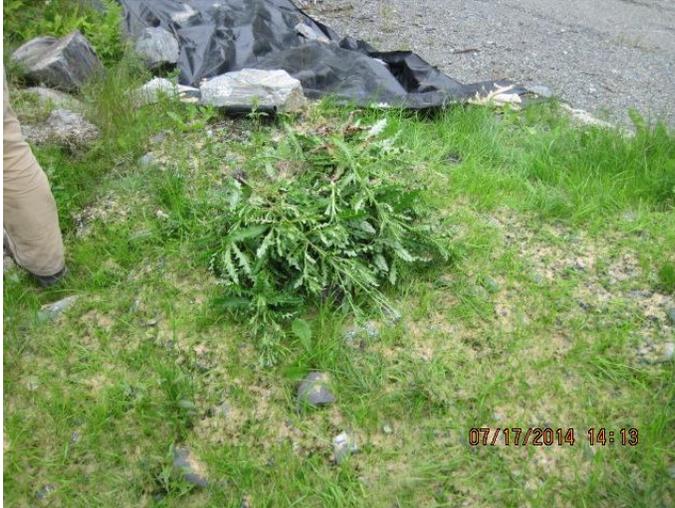
Canada thistle an invasive plant is growing near Pit 7 in previous inspections and has germinated again. Mitigation by HGCMC has been manual pulling and the use of tarps to cover the affected area (Photo 20). Both methods have been successful to prevent the spread of Canada thistle.

Photo 20. Canada thistle at Pit 7.
