INSPECTION REPORT: GREENS CREEK MINE

Date of Inspection: Wednesday, July 23, 2014
Date of Report: Friday, August 8, 2014
USDA Forest Service Inspector: Curtis Caton

Ranger District: Admiralty National Monument, Juneau Ranger District
Weather Conditions: partly cloudy. Temperatures in the mid 50's (°F).

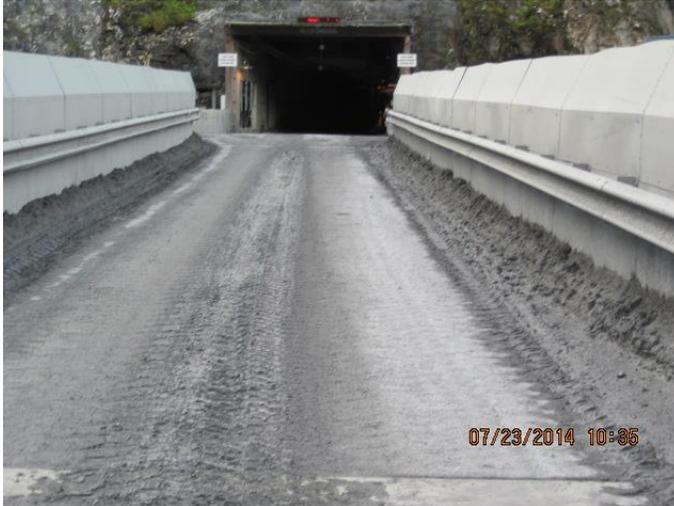
The 920 bridge across Greens Creek to the portal is good condition. The splashguards have been effective in preventing splash over into Greens Creek. Mucking may be needed to rid the bridge of excess sediment (Photo 01).

Photo 01. Accumulated sediment on the 920 bridge.

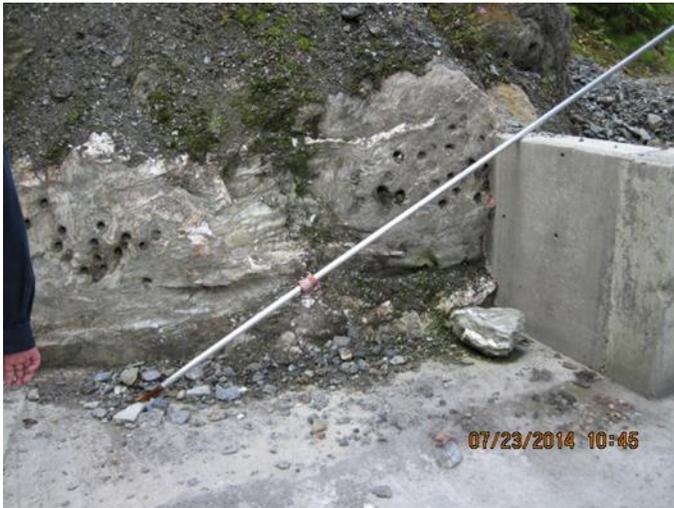
The area immediately surrounding the portal was in good condition and safe, recent scaling has removed overhead hazards (Photo 02). However, two issues were documented on the edge of the

Photo 02. Scaling bar near the portal.

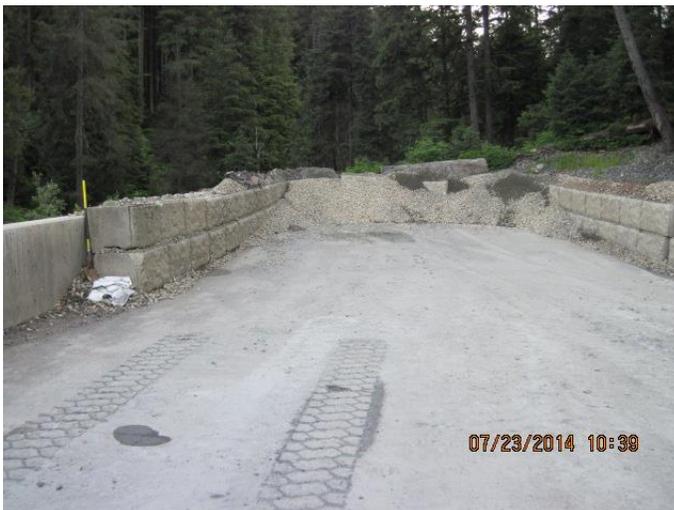
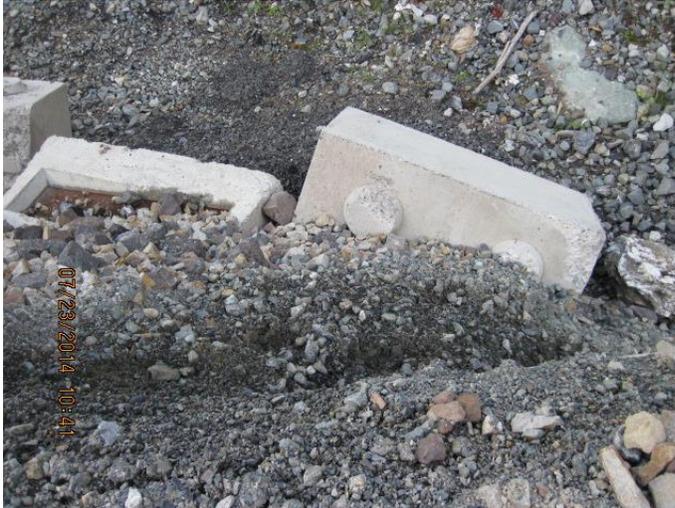
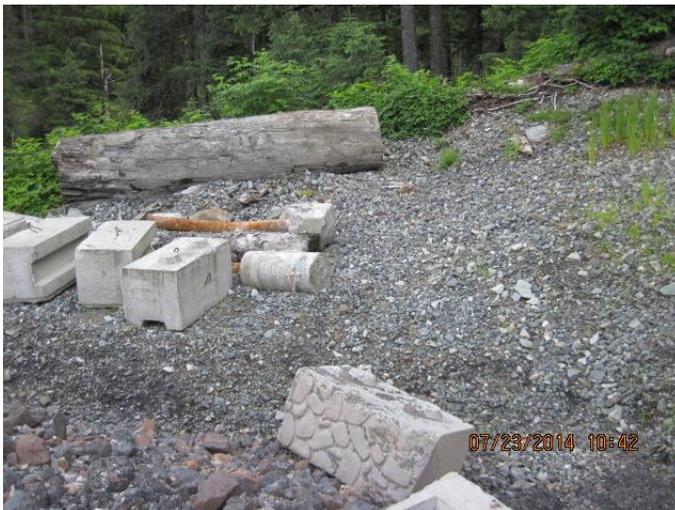
improved surface, near the portal. First, the containment barrier surrounding the underground road base heap needs to be reestablished in order to prevent accidental spillage of road base into Greens Creek (Photo 03-05). Second, is the need to correct the section of the road at the 920 portal that has developed a preferential flow path. This area should be graded or additional water bar added to minimize the surface runoff at the base of the road (Photo 06-07).

Photo 03. Underground road base storage area.

Photo 04. Retaining wall knocked over.

Photo 05. Retaining wall knocked over.

- **Inspect remaining facilities for compliance with the BMP Plan**
- **Measure slope of the 920 sea vans**
- **Underground road base storage area**
- **Pit 7 culvert**

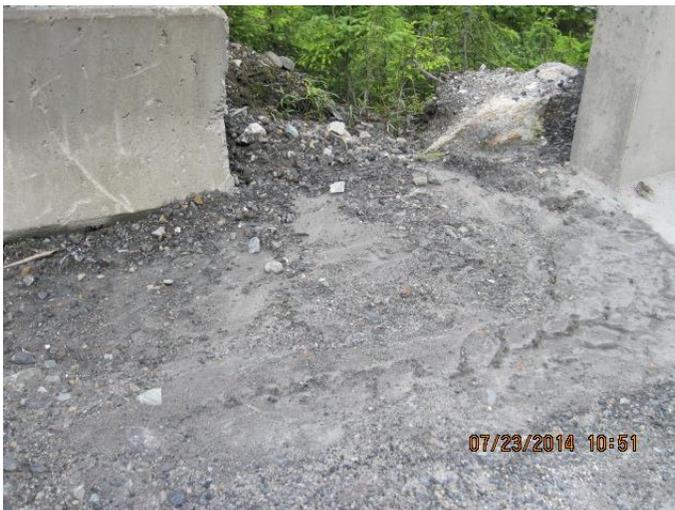
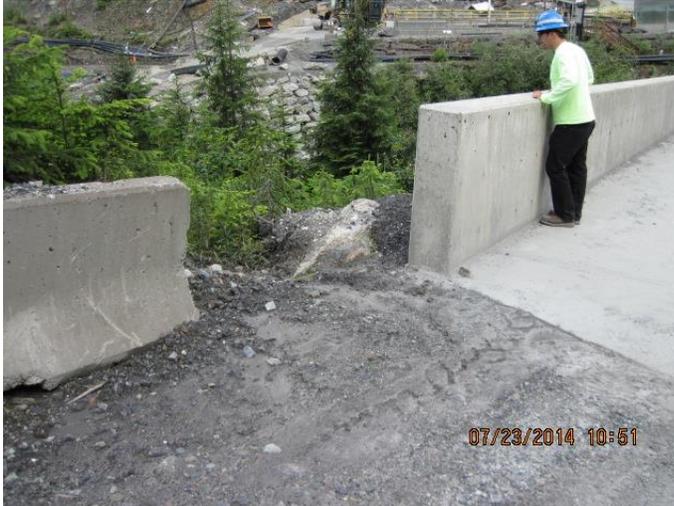
Photo 06. Preferential flow path developing.

Photo 07. Preferential flow path developing.

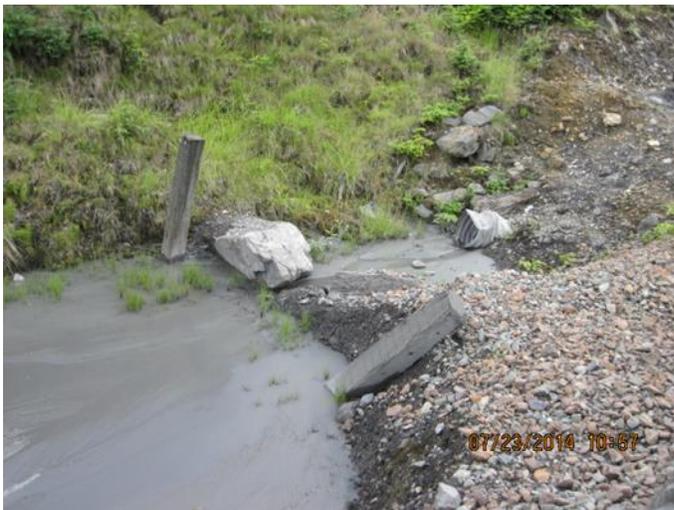
Settling basins between the warehouse and the degrit basin may need mucking to prevent excessive sediment accumulation (Photo 08).

Photo 08. Settling basin full of sediment.

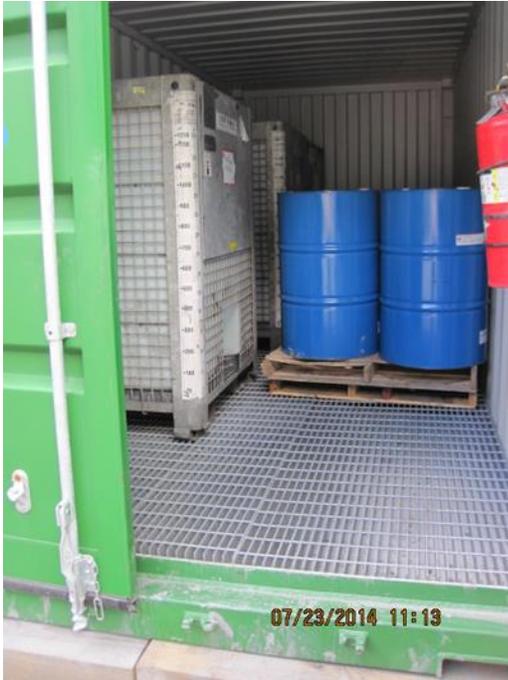
HGCMC has acquired new sea vans that fulfill secondary containment requirements. The estimated containment volume of the new sea van (8'x 20'x 0.25'), on a level surface, is approximately 299 gallons. This volume is sufficient for most of the containers in the 920 area except for the larger volume reinforced totes, which will need to be stored on non-porous concrete draining to the A Pond or in secondary containment with sufficient volume (Photo 09-10). The General Plan of Operations states that secondary containment must be capable of holding 110% of the largest container volume plus additional freeboard precipitation. HGCMC has stated that the sea vans were installed with the rear of the container sloping down gradient, which allows for the containment of approximately 500 gallons.

Photo 09. Reinforced totes stored with insufficient secondary containment.

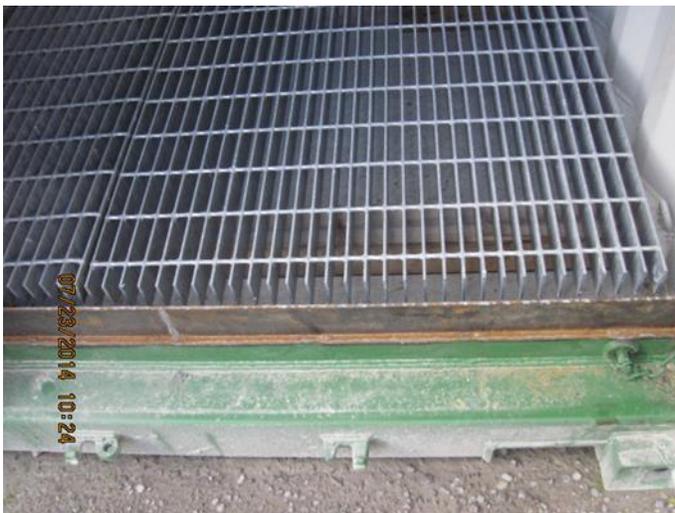
Photo 10. Example of modified lip.

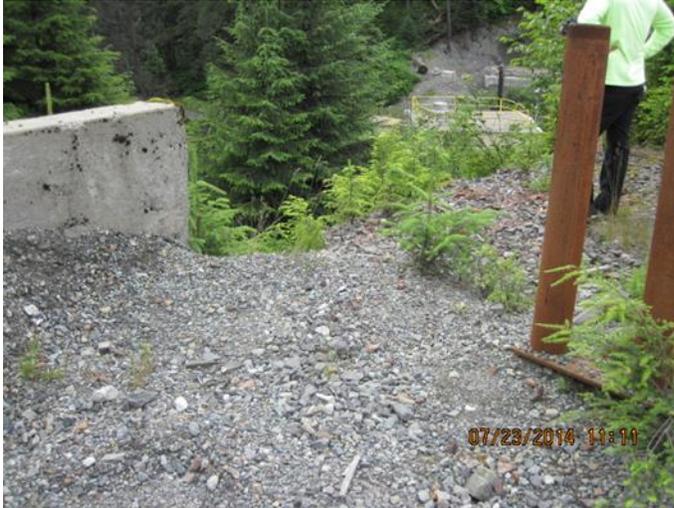
The potential for differential erosion by stormwater runoff near the southwest corner of the 920-warehouse yard exists but is not evident (Photo 11).

Photo 11. South West corner of 920 Warehouse.

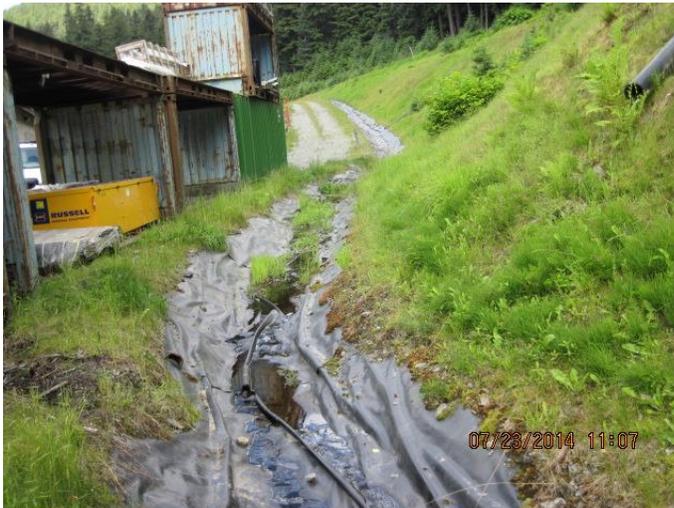
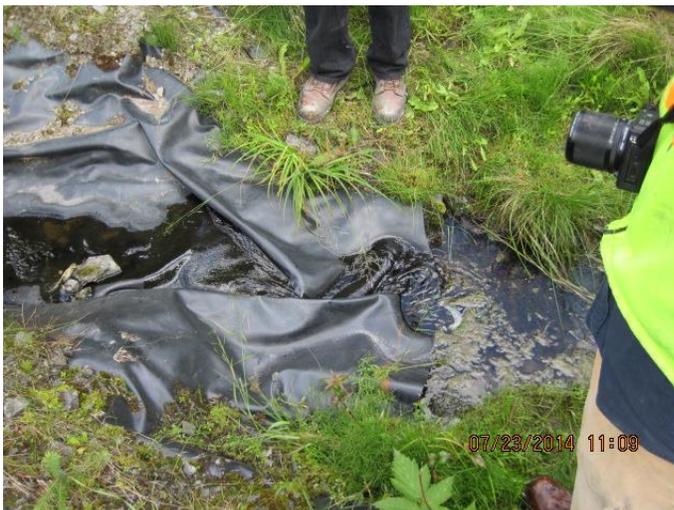
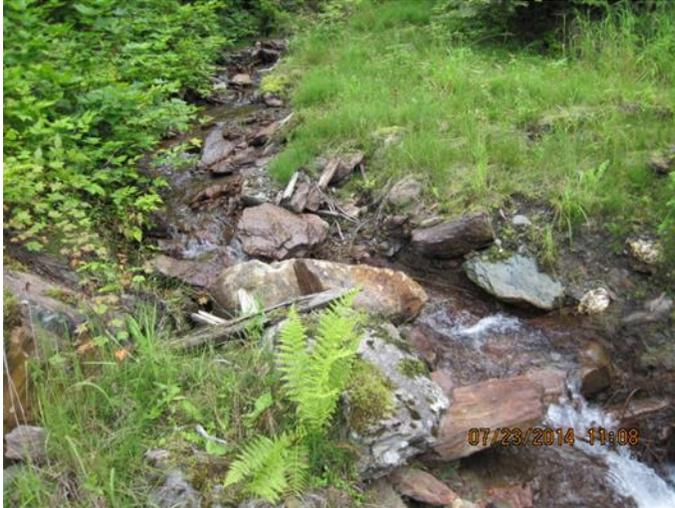
Figure 4 in HGCMC BMP Plan indicates that the ditch behind the 920 Warehouse does not discharge into cub creek; however, in the field, the 920 Warehouse ditch does appear to discharge into Cub Creek (Photo 12-14). This water in the ditch appears to be non-contact water and is being diverting around the localized area of the footprint towards Cub Creek. The diversion ditch has increased the localized potential of stormwater runoff from the preexisting natural conditions; however, no sediment loading was documented during this visit. Recommended mitigation at this site would be the addition of a settling pond or a rock check dam, which would help reduce sediment loading during a large storm event. Additionally, Figure 4, Appendix 5, should be updated to reflect existing field conditions.

Photo 12. Ditch behind the 920 Warehouse.

Photo 13. Ditch behind the 920 Warehouse.

Photo 14. Cub Creek.

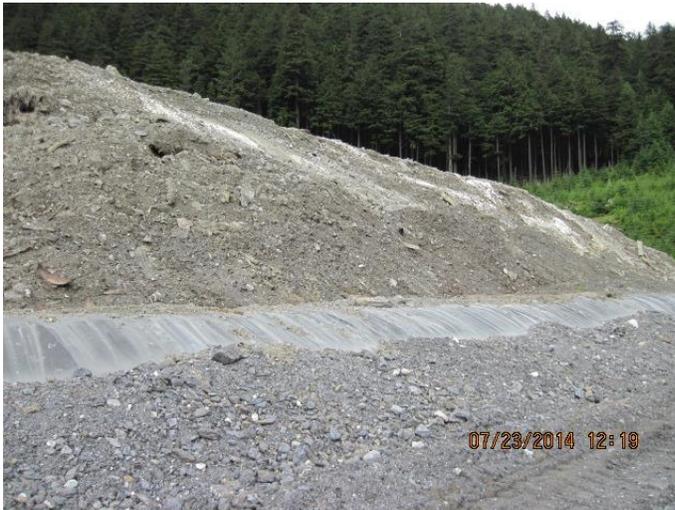
Recently, waste rock from the 1350 area has been moved to site 23 for temporary storage and eventual disposal in the TDF. The waste rock from the 1350 has been contained and placed on a lined surface that is bermed to prevent comingling with other material (Photo 15).

Photo 15. Waste rock from the 1350 area stored at Site 23.

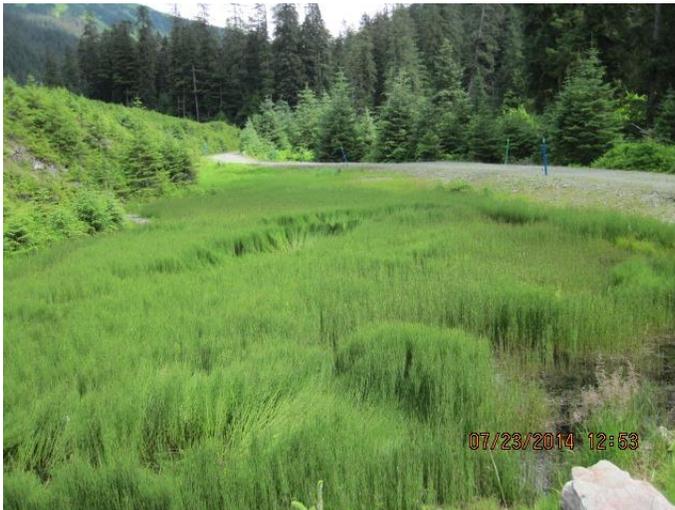
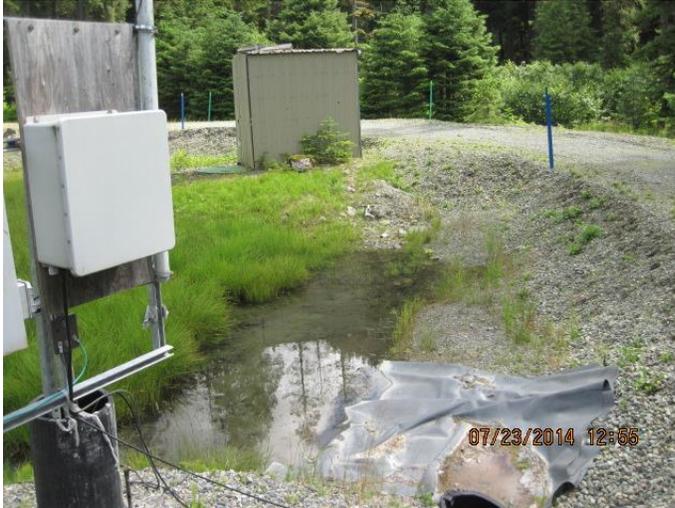
The purpose of D Pond is to collect stormwater from a waste rock storage pile (Photos 16-17). The waste pile (D) is designed so that surface runoff does not pick up contaminants. Waste rock pile D was phased out in 1991. During normal operations, this water is pumped from Pond D to the water treatment facility. However, large storm events used to exceed the capacity of Pond D and overflow. Larger pumps have been installed in the caisson, which minimizes the chance of overflow. Site-specific BMP for this site (Outfall 006) include diversion ditches, hydroseeding, natural revegetation, check dams, and settling ponds, which have all reduced erosion and runoff at this site.

Photo 16. D Pond.

Photo 17. D Pond.

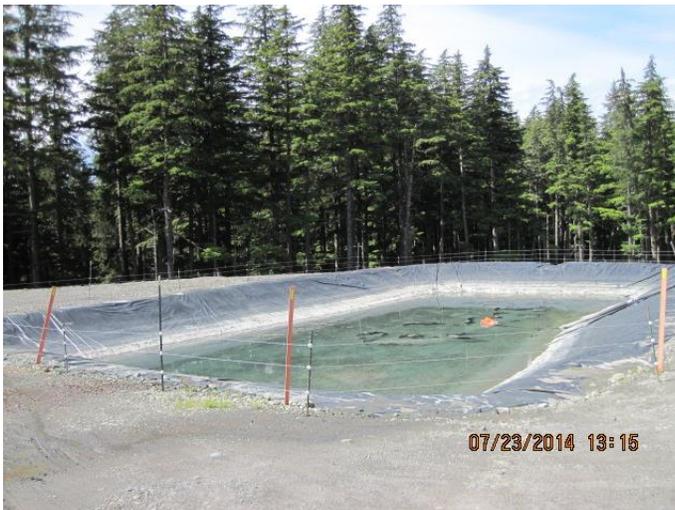
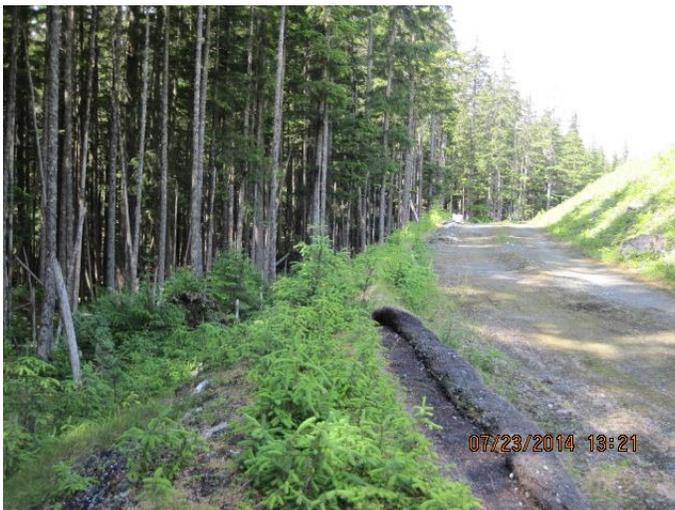
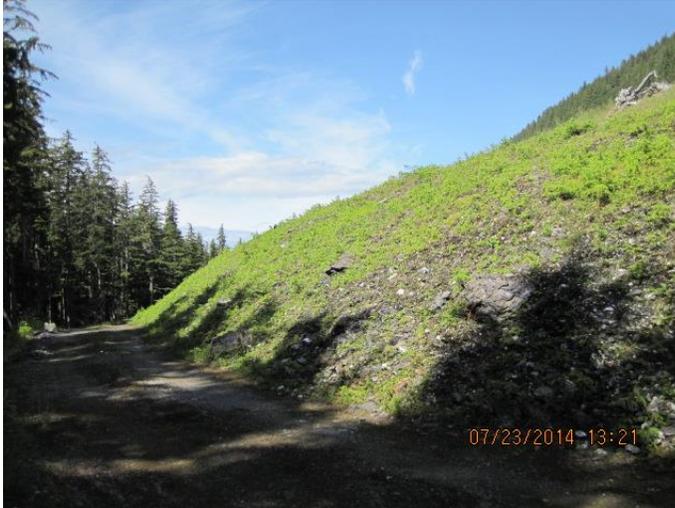
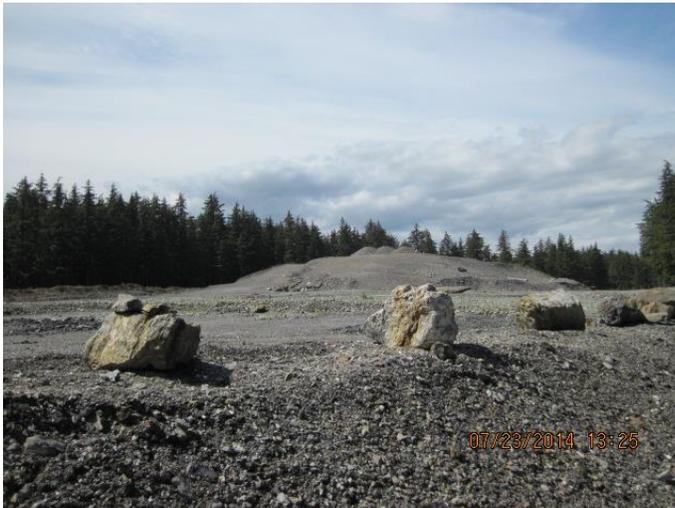
Deposition of waste rock began at Site E in 1988 and continued through 1994. Site E is currently inactive and the waste rock is planned for deposition in to the TDF. Vegetated ditches, check dams, settling ponds, hydroseeding, and natural revegetation have minimized surface runoff (Outfall 005.3). Exposed areas of Site E that are not vegetated are covered during the winter months with a liner to reduce infiltration into the pile (Appendix 5, Measures and Controls, Capping pg. 65). The settling basins have been properly maintained and the settling pond at the North West end of the facility is stable (Photos 18-21).

Photo 18. Site E pond.

Photo 19. Sediment barrier disturbed by bear activity at Site E.

Photo 20. Site E.

Photo 21. Site E.

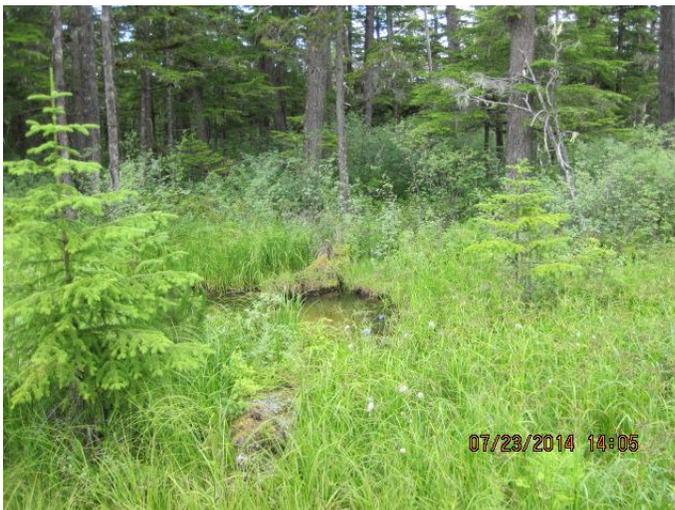
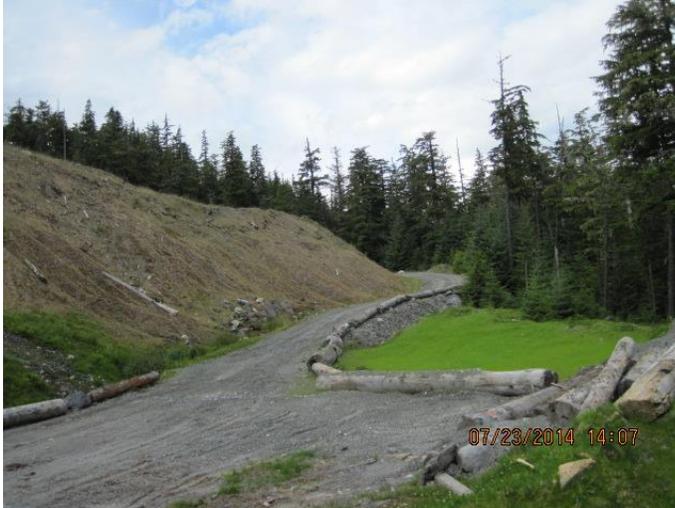
Outfall 004 is located at the discharge site from a reclamation material storage area in an old road construction quarry called Pit 7. Most of the runoff from this area is first diverted into settling basins and then is discharged into a constructed wetland consisting of two ponds linked by a vegetated swampy area. Site-specific BMP have been effective in reducing erosion and runoff from this site (Photos 22-23).

Photo 22. Settling pond at Pit 7.

Photo 23. Pit 7.

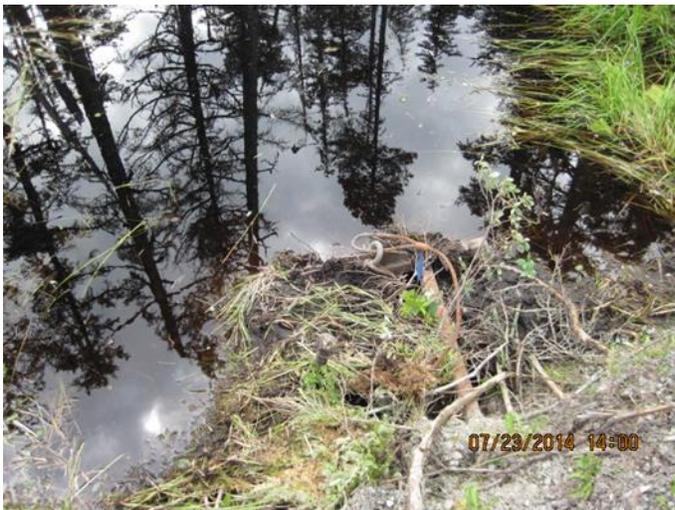
The culvert that crosses Pit 7 access road has been clogged due to beaver activity (Photo 24).

Photo 24. Beaver dam blocking culvert.
