## July 23<sup>rd</sup> Inspection of the Greens Creek Mine

This report covers the July 23, 2014 inspection of the Greens Creek Mine. The inspection team consisted of David Wilfong from the Alaska Department of Natural Resources (ADNR) and Curtis Caton from the United States Forest Service (USFS). The team was accompanied by Mitch Brooks from the Hecla Greens Creek Mining Company Environmental Department for the entire duration of the inspection. The team was transported to the mine via a USFS chartered Ward Air De Havilland Beaver, and back to Juneau International Airport float pond on a Cessna 185 floatplane. This inspection was focused on the mine's Best Management Practices (BMP) and covered the Beach, the Tailings Disposal Facility, 920, Site 23, D Pond and Site E on the B Road "side". The team also traveled on the A Road to Pit 7.

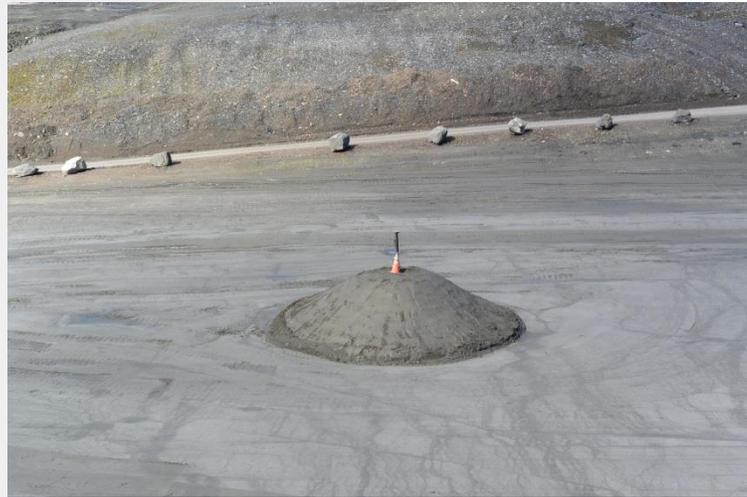
As the team drove past the Tailings Disposal Facility (TDF), we stopped quickly near the East Ridge Expansion to photograph some monitoring stations that were placed in the still growing pile (Figure 1). The monitoring equipment consists of vibrating wire piezometers and suction lysimeters. An approximately 10' X 10' pile of refuse was being burned near the southeast end of the pile. Mitch stated that the burning was allowed under a permit issued by the Alaska Department of Environmental Conservation (ADEC).

Figure 1 Monitoring site in the TSF

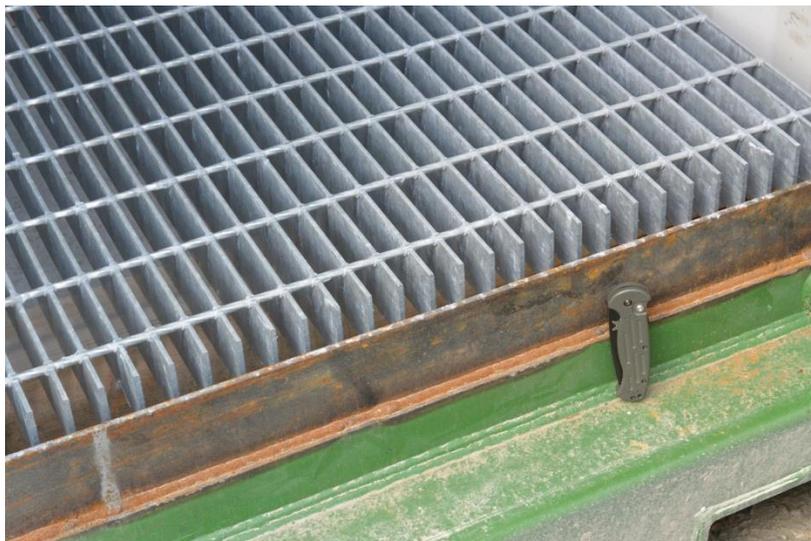
Figure 2 Added freeboard to the integrated secondary containment.

in the mill facility. This design flaw was rectified by the addition of a short bar of metal welded across the front of the container by Hecla's millwrights (Figure 2). The modified containers will now hold a large volume of liquid should a primary container be punctured and the fluid leak out. The arrival and retrofitting of these containers supply a long-awaited remedy for the lack of secondary containment that has been noted in previous inspections.

Upon arrival at the 920 area, the inspectors stopped near the mill and looked inside one of the new 20 foot "Sea Vans" built with integral secondary containment. Several of the containers were ordered by Hecla to ensure that chemicals and hydrocarbons are properly stored. When the new containers arrived, it was found that the volume held by the secondary containment was insufficient to allow for the storage of the large totes used in the mill facility. This design flaw was rectified by the addition of a short bar of metal welded across the front of the container by Hecla's millwrights (Figure 2). The modified containers will now hold a large volume of liquid should a primary container be punctured and the fluid leak out. The arrival and retrofitting of these containers supply a long-awaited remedy for the lack of secondary containment that has been noted in previous inspections.

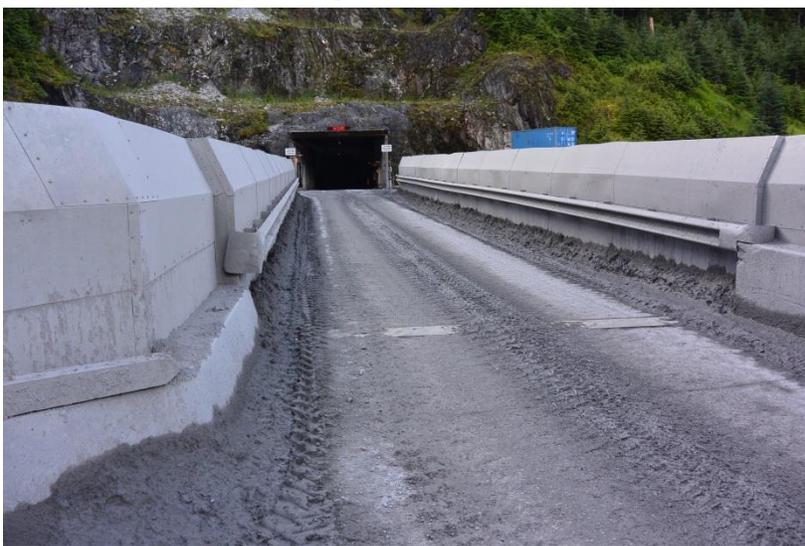
Figure 3 Sediment on the bridge leading to/from the portal.

The primary objective of this inspection was to review the BMP's in place throughout the mine site. Many of these practices include controlling erosion, run on, and runoff of water within the mine's disturbance footprint. For that reason, the inspectors moved around the perimeter of the mine. The truck was parked at the north end of the bridge leading to the portal, and the inspectors got out and moved on foot toward the mine opening. A large amount of sediment had accumulated on the bridge deck (Figure 3). The tall splash guards installed above the guard rails on each side of the bridge are designed to prevent ore that is tracked out of the mine from being splashed into Greens Creek. The underside of the bridge was

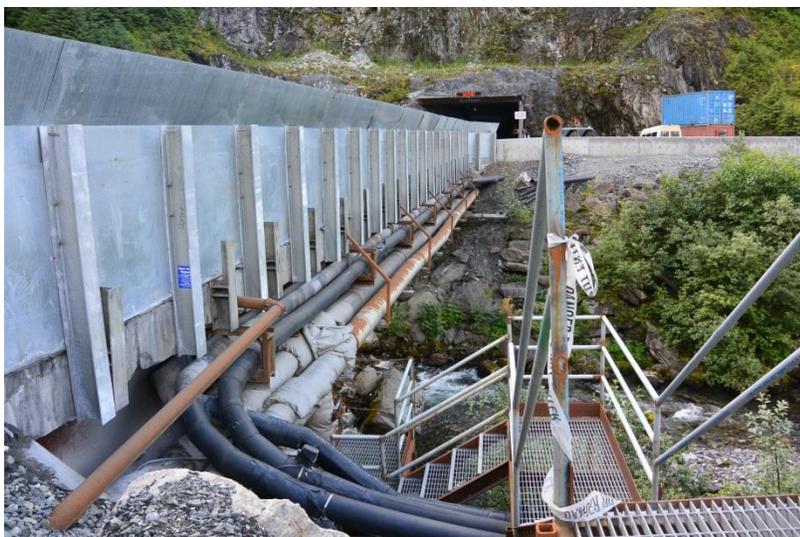
Figure 4 The underside of the bridge crossing Greens Creek.

clean (Figure 4), and it appeared that the splash guards were working as designed to prevent sediment from entering the creek.

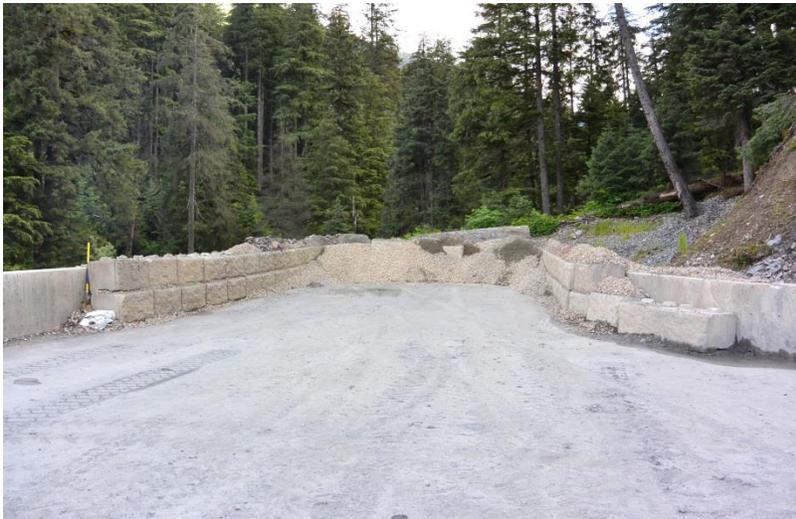
Figure 5 Road rock storage area.

The storage area was lined with ecology blocks stacked two high, and some of the rock had spilled over the side and partway down the embankment to Greens Creek.

After crossing the bridge, the inspectors noted an area to the left of the portal which is used to store crushed rock that has been imported from off-site (Figure 5). The imported rock is more durable than rock that can be found near the mine site, and is used to build long-lasting underground roads in the mine.

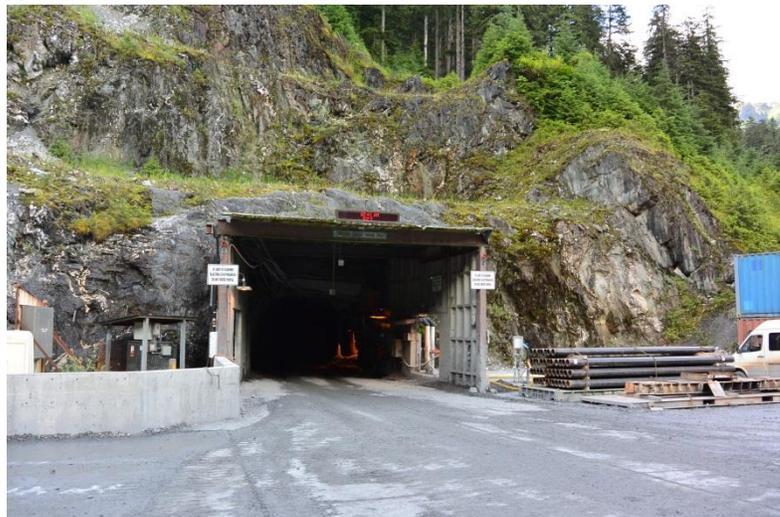
Walking around the entrance to the portal (Figure 6), there appeared to be piles of loose rock on the ground at the base of the high walls. Mitch stated that a scaling bar is used to periodically dislodge loose rocks from the wall to prevent safety hazards, and a scaling bar was found nearby showing that it may have been done recently. Additional wire mesh covering the highwall may alleviate the need for this

Figure 6 The 920 Portal.

maintenance, but frequent scaling of the loose rock will prevent any safety issues. Walking up the road towards the 1350 adit, it was noted that runoff traveling down the access road had begun to develop a preferential flow path down the embankment and into Greens Creek (Figure 7). A safety berm runs along the north edge of the seasonal access road, but there was an approximately 4 foot wide gap between the

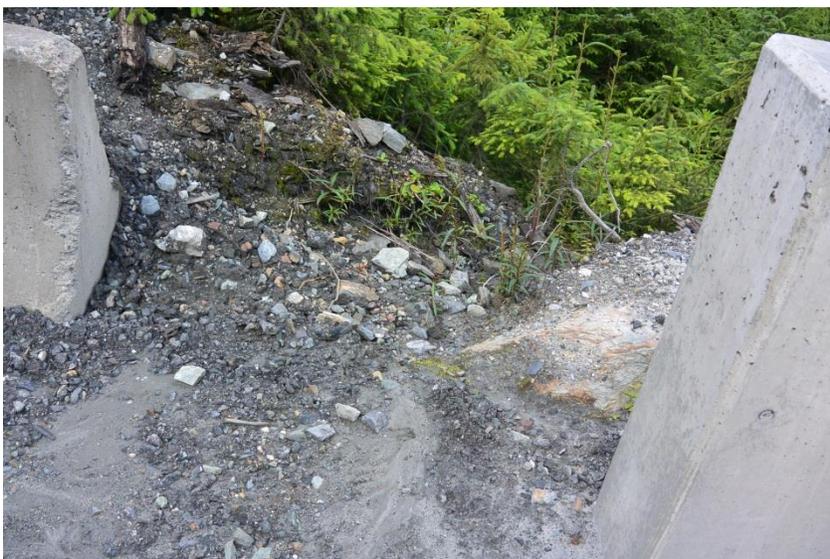
Figure 7 A preferential flow path into Greens Creek.

- Repair the berm along the 1350 access road so that sediment from the 1350 access road does not enter Greens Creek. **Several diversions have been installed to lower the flow of water to the gap in the berm. This successfully stopped the flow of sediment .**
- Clean out all debris and sediment, to the extent feasible, in all drainage and diversion ditches.
- Excavate the oil-contaminated soil near the mill building. **The soil has been excavated and properly disposed of.**
- Drain the water from secondary containment basins. **Draining the water from secondary containment in an ongoing maintenance procedure.**
- Clear the debris from the culvert under the Pit 7 access road. **The debris was cleared.**

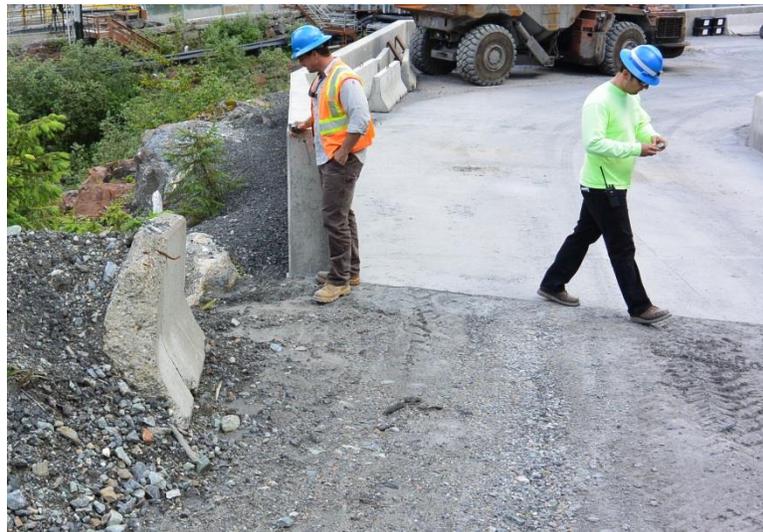
dirt safety berm, and a vertical wall at the edge of a concrete pad (figure 8). The water flowing down the access road is considered diversion water. The water on the concrete pad is considered contact water, and is collected in a sump near the portal and pumped through a pipe (seen in Figure 4) beneath the bridge to “A Pond”<sup>1</sup> where it is pumped to Pond 23, and then to a treatment plant.

Figure 8 Gap in the berm near the concrete pad.

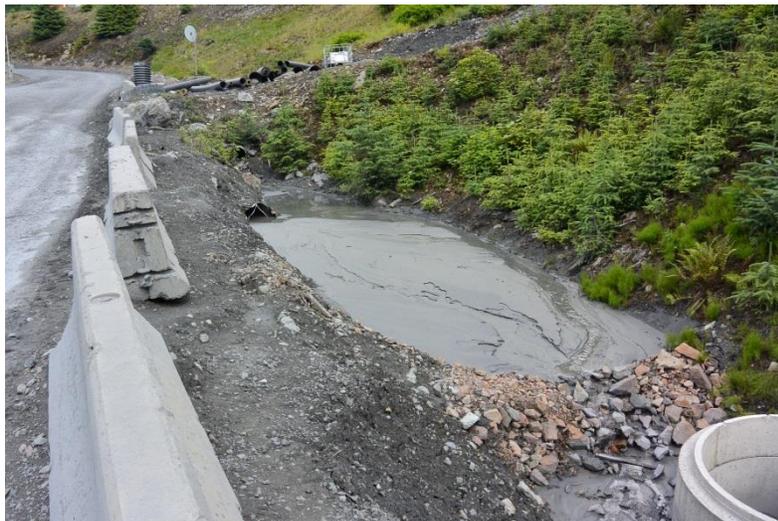
Figure 9 Settling pond full of sediment.

that carries contact water to a sump where it is pumped to A Pond. The ditch contains several check dams that allow water to create small pools and drop heavier sediment particles out before it reaches A Pond. These small settling basins had reached their capacity and were no longer functioning as designed (Figure 9). Moving up the haul road toward the ore pad, a small amount of erosion and slope movement could be seen on the uphill side of the road (Figure 10). When asked whether or not

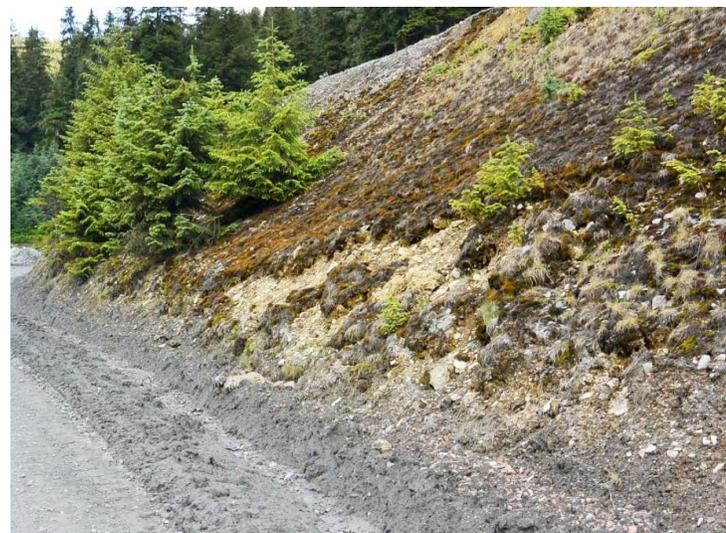
the slope had been seeded with grass, Mitch indicated that it likely had not been. Despite the fact that it had not been artificially seeded, a large amount of moss had volunteered to grow on the slope, and was doing a fairly good job of holding the slope together. Evergreen trees (also volunteers) could be seen growing along the slope, further stabilizing it. As can be seen in Figure 10, parts of the lower slope show signs of movement. Upon closer

Figure 10 Slope next to the Haul Road showing signs of movement.

investigation, it was found that the soil along the eroded area was formed by a majority of coarse grains. This may indicate that the fine-grained soil had been washed away during heavy rain events. At this time, there appeared to be no concern for the stability of the slope. However, revegetation the slope with the approved reclamation seed mix may reduce the possibility of further erosion.

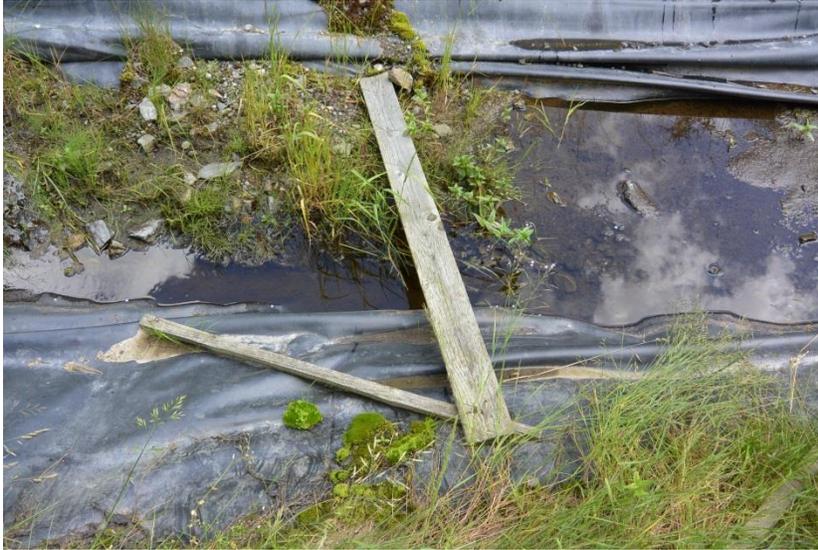
Figure 11 Vegetation and debris in a diversion ditch.

(PAG) wasterock from the mine. The back slope was well vegetated and appeared stable. Runoff from the slope flows into a lined ditch that runs along the north side of the ore pad and warehouse building. The water in the ditch flows west, and eventually makes its way to A Pond. There was some debris including wood and plastic, along with a moderate amount of vegetation in the diversion ditch (Figure 11). This debris may cause the water in the ditch to run slowly and lead to drainage problems. The containers with integrated secondary containment were put to good use behind the warehouse. Chemicals and petroleum products were properly stored in these containers.

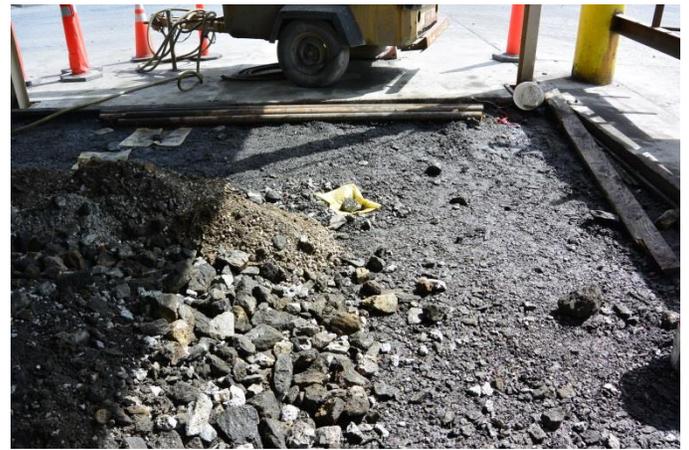
Figure 12 Spill site near the mill.

A Pond was under repair during the inspection. The liner was being removed, and preparations to reline the pond were underway (Figure 13). Water that normally would have flowed to A Pond was being stored in a degrit basin and pumped to Pond 23, then to Pond 7 at the TDF. Soil was being excavated from an area near the mill building after a failed fitting led to a

moderate sized hydraulic oil spill (Figure 12). Current excavation been temporarily halted because crews had inadvertently removed soil from under some building support footings. The remainder of the contaminated soil was to be excavated as soon as an engineer had looked at the support footings. At other oil storage tanks, water had accumulated in the secondary containment basins. Oil could be seen floating on top of the water inside the basins (Figure 14). At the time of the inspection, there was no danger of the secondary containment

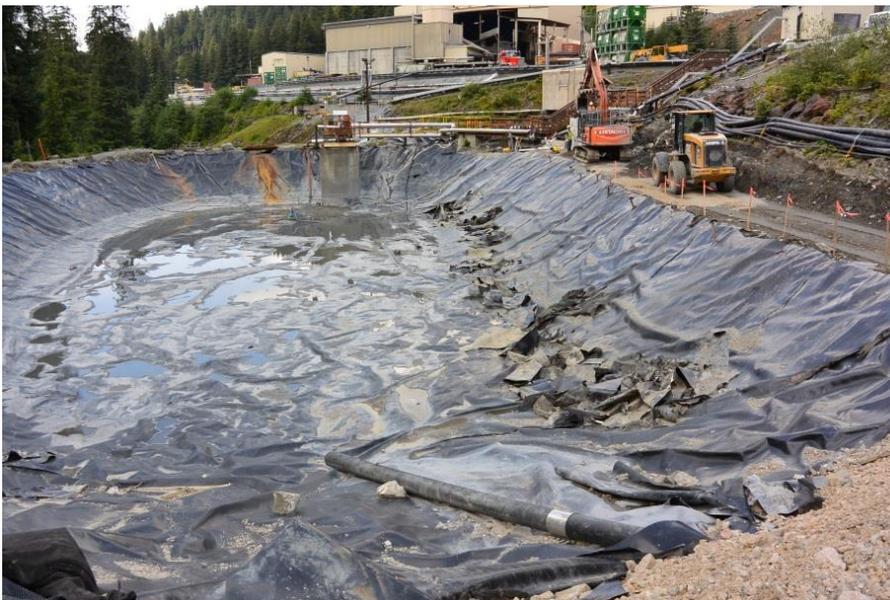
Figure 13 "A Pond" under construction.

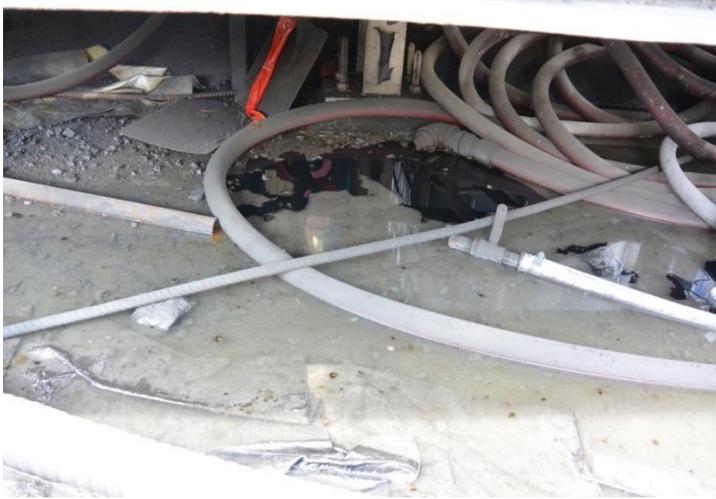
Figure 14 Oil floating on water in secondary containment.

overflowing into the environment.

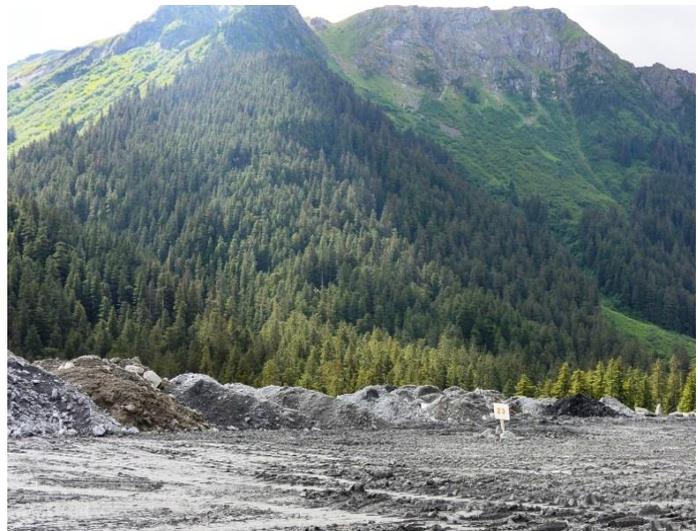
No wasterock was placed at Site 23 during the inspection, and the bulldozer that is normally present pushing piles was also absent. There were small piles of waste rock waiting to be spread out and shaped into the pile (Figure 15). PAG material mixed with overburden excavated from the 1350 Level was waiting in lined containment to be transferred to the TSF for co-disposal. Hecla decided to keep the material from the 1350 separate from the rest of the Wasterock at site 23 as the 1350 material is further along in its oxidation process.

Figure 15 Piles of wasterock at Site 23.

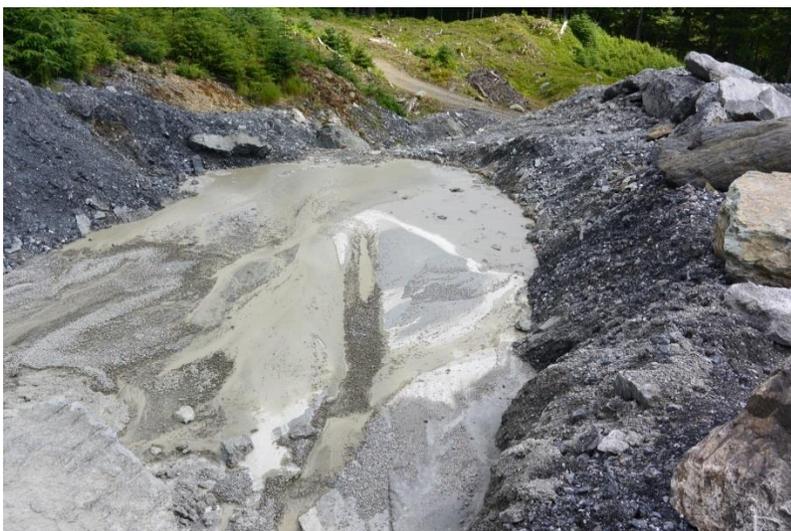
Figure 16 Settling basin full of sediment at Site 23

to tell whether the orange stains were due to organic iron bacteria, or acid generation/metals leaching. The in situ settling basins at Site 23 were also full, and not performing as designed (Figure 16). The team walked along the drainage path that carries water from Site 23 down to Pond 23, and then walked across the B Road to the pipe outlet that delivers water to D Pond. D Pond is overgrown with vegetation. Much of the vegetation had been pressed flat,

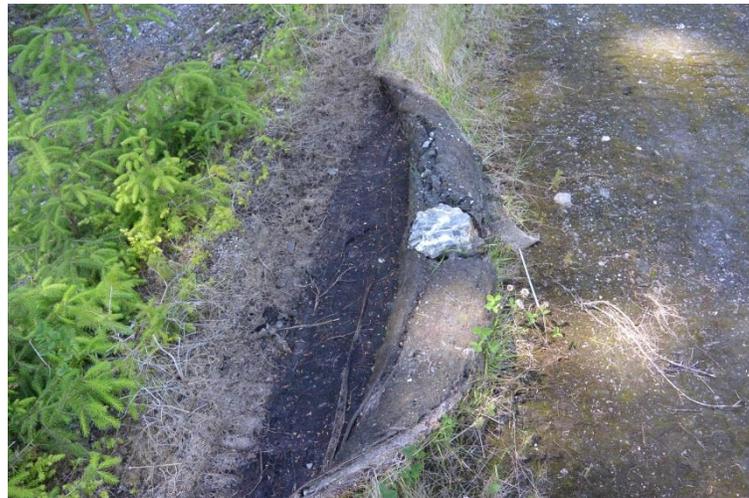
The team left, and traveled to Site E. This area is the site of a historic wasterock dump. The PAG wasterock is being excavated and disposed of in the tailings pile as space allows. Walking around the perimeter, a disturbance in a straw waddle was found (Figure 17). It appeared as though a bear may have peeled the waddle back in the search for insects, grubs, and other edibles.

Figure 17 Permeable mesh pulled back by bears.

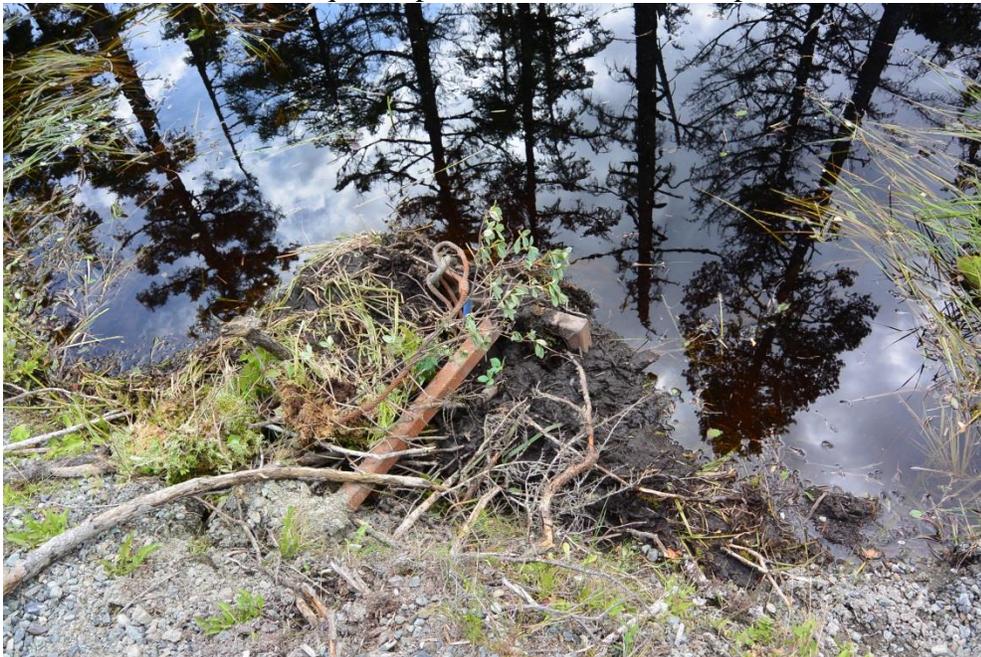
The team left the area, and made the short journey back to the Tailings Disposal Facility. Tailings were actively being placed in the northwest area of the drystack pile. After leaving the TDF, Pit 7 off of the A Road was visited. Beavers had been hard at work damming up the culvert under the access road in an attempt to raise the water level in the adjacent swamp (Figure 18). It appears as though their efforts had been successful as woody debris was seen on the road where water levels may have risen and flowed across it during a recent large rainfall event. At this time, it is unclear whether or not the beavers will require a permit to construct and operate a dam.

Figure 18 Debris placed at a culvert inlet by beavers.
