INSPECTION REPORT: GREENS CREEK MINE

Date of Inspection: Wednesday, September 24, 2014
Date of Report: Tuesday, September 30, 2014
USDA Forest Service Inspector: Curtis Caton

The purpose of this inspection was to verify compliance of reclamation at HGCMC 2014 exploratory drilling sites in accordance with HGCMC 2014 Surface Exploration Annual Work Plan, the requirements of the State of Alaska, and the 2014 Decision Memo issued by the Admiralty Monument Ranger.

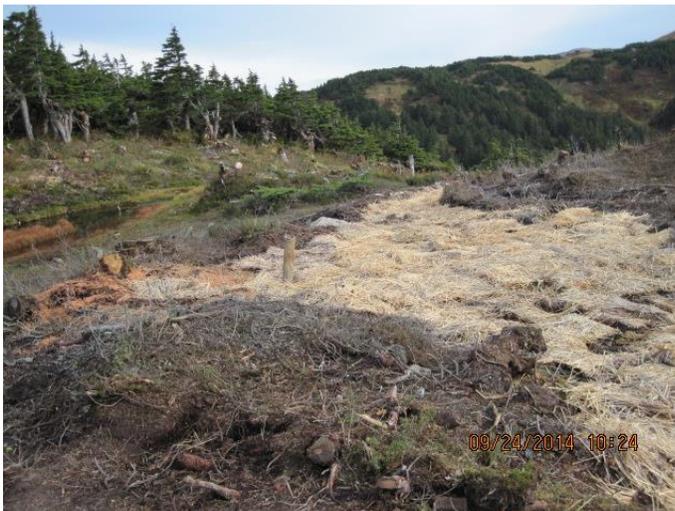
Site Killer 48 complies with with HGCMC 2014 Surface Exploration Annual Work Plan and reclamation is complete except for removal of one drill collar and the communications repeater. Rebecca Goddard stated that removal of the collar would occur before close of the 2014 season. No visible sign of erosion, garbage, or environmental damage was documented and revegetation will occur naturally at this site (Photo 01-05).

Photo 01. Killer 48, pad location.

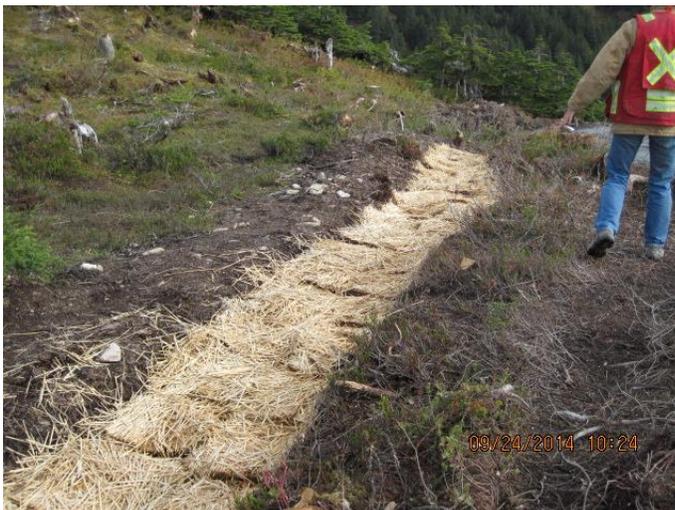
Photo 02. Killer 48, trench to sump.

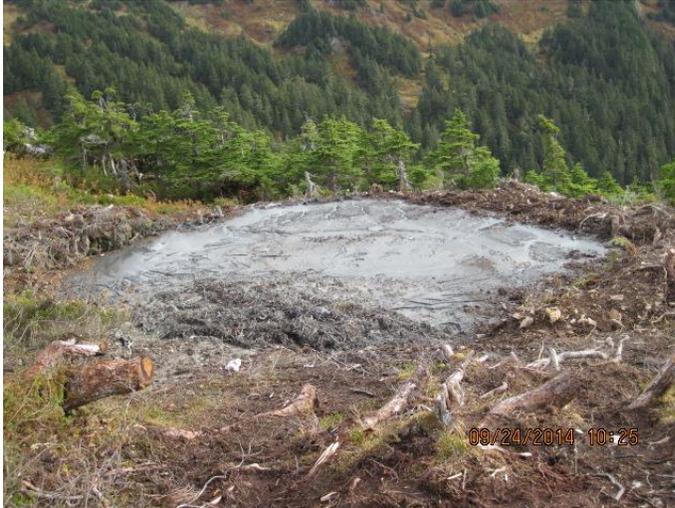
Photo 03. Killer 48, sump.

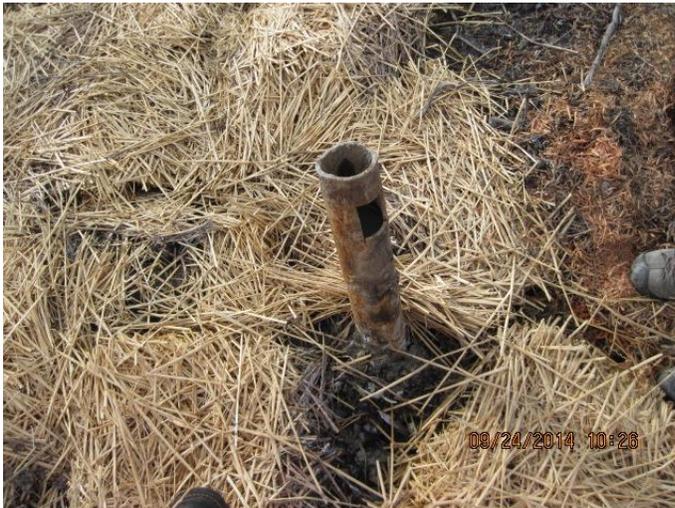
Photo 04. Killer 48, drill collar.

- Requested dated (before and after) pictures of all three drill sites (Killer 23, 48, and 57) from HGCMC exploration.
- Photo documenting removal of the drill collar at Killer 48.
- Repeater removal from Killer 48 at project completion.
- Subsequent reclamation of Killer 57.

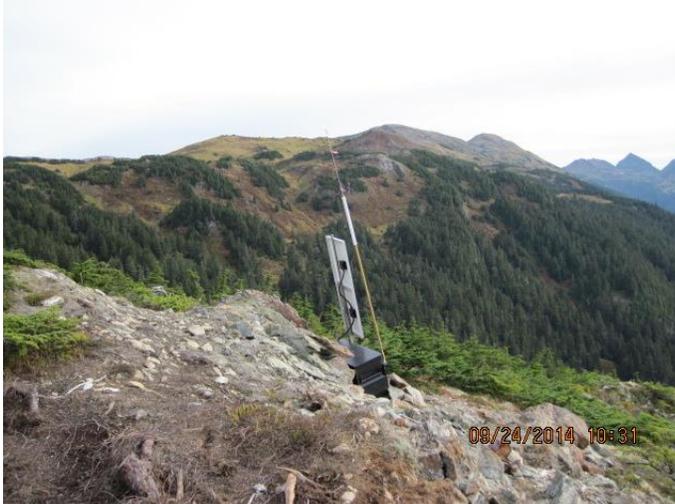
Photo 05. Killer 48, communications repeater.

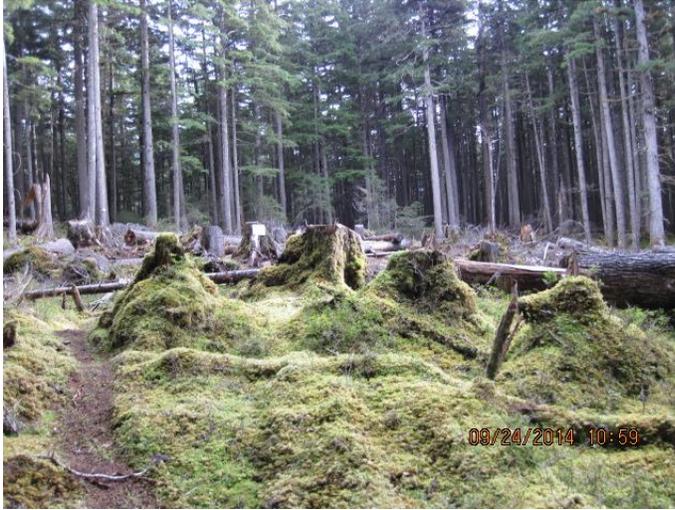
Reclamation at Killer 23 complies with with HGCMC 2014 Surface Exploration Annual Work Plan. No visible sign of erosion, garbage, or environmental damage was documented and revegetation will occur naturally at this site (Photo 06-10).

Photo 06. Killer 23, tree removal for long line slinging and pad construction.

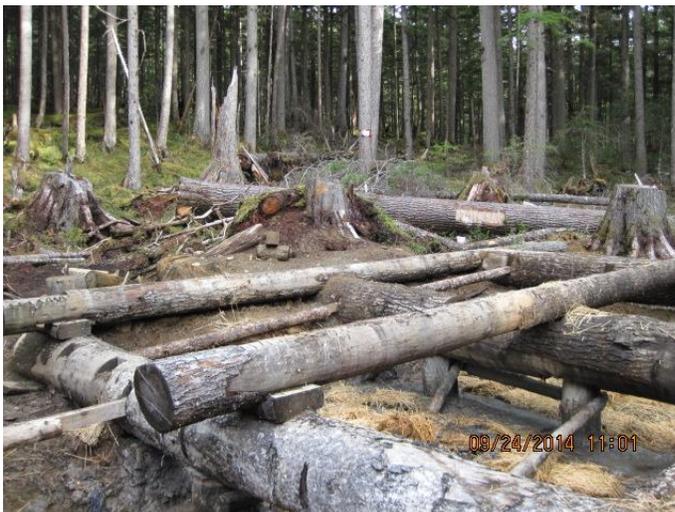
Photo 08. Killer 23, pad partly constructed of cut trees. Dimensioned lumber removed.

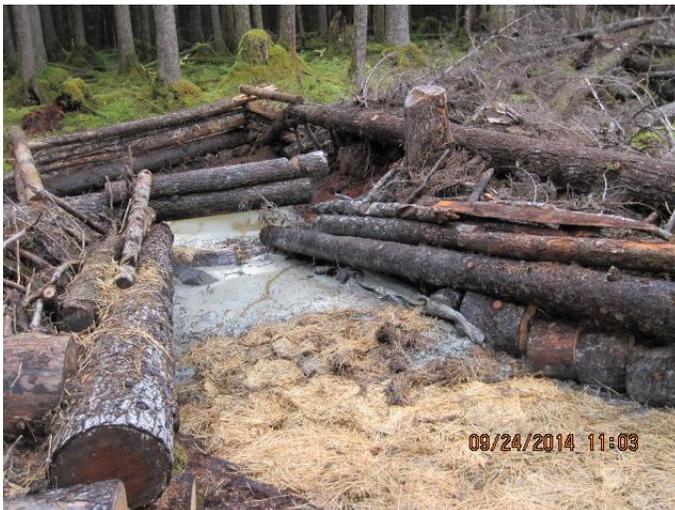
Photo 10. Killer 23, sump.
