April 20, 2015

## The April 8, 2015 Inspection of the Greens Creek Mine

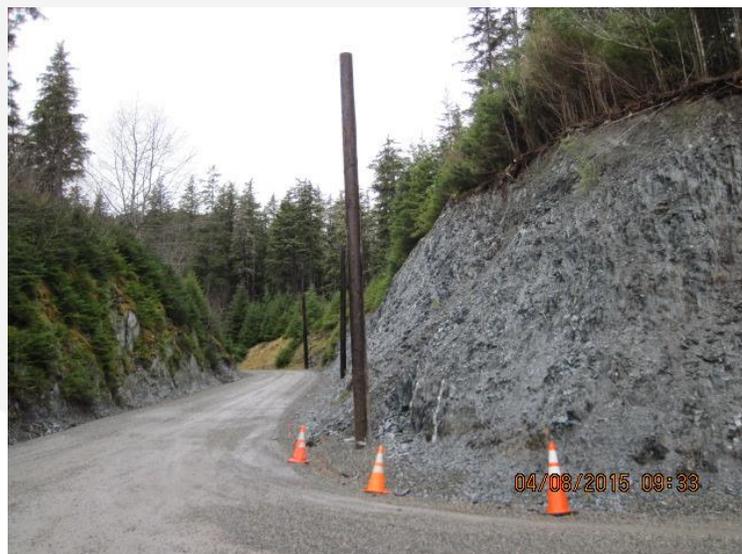
The team was met at the dock by Chris, and was escorted to the Environmental Building to gather some personal protective equipment and watch a short safety video. The team then loaded into the Ford Excursion owned by the USFS and drove about 5 miles out the A Road to the Young Bay Marine Terminal. HGCMC has begun installing lighting along the A Road for increased safety during the dark winter months (Figure 1). The light poles were installed and the rock cut had been laid back from a near vertical orientation, but electricity had not yet been run. Sediment controls were in place, but no standing or flowing water was present. The lighting project is temporarily on hold because there is no need for artificial lighting during the summer.

Figure 1 Newly constructed infrastructure for lighting

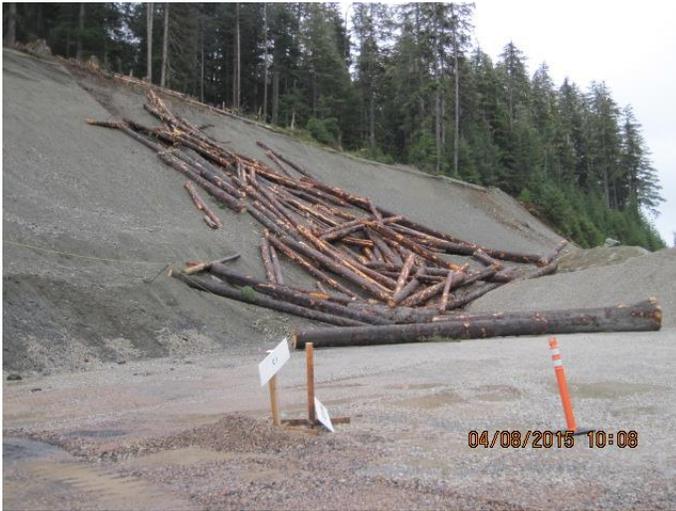
Figure 2 Logs awaiting removal

The team turned around and drove back down the A Road to the Sand Pit at Mile 1.4. Some trees had been felled at the top edge of the pit so that more sand and gravel may be removed (Figure 2). The material will have various uses during the construction of the Tailings Disposal Facility (TDF) expansion in the summer of 2015. The logs will be hauled or flown to the Hawk Inlet Marine Facility and shipped to a mill to offset some of the cost of removing the trees. After the logs and gravel have been removed, the Sand Pit may be used to store reclamation material.

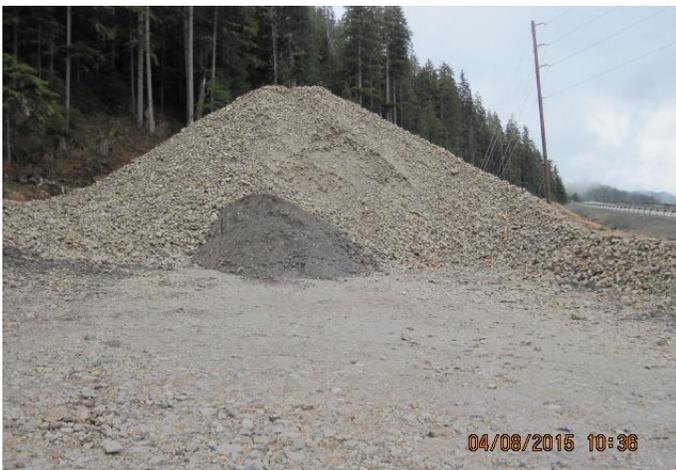
Figure 4 Proposed staging area

The team left Pit 7, traveled back past the camp area to the B Road, and stopped near the northeast end of the tailings facility. Across the road from the TDF, a small gravel parking area exists where a small pile of gravel is stored (Figure 4). Chris asked about the permitting procedures that may be required to expand the gravel lot by a small amount, upgrade the drainage and stormwater system related to the

pad, and use it as a parking and staging area during construction of the tailings facility expansion. ADNR would likely require a minor amendment to the Reclamation Plan, and permits may be required by other agencies.

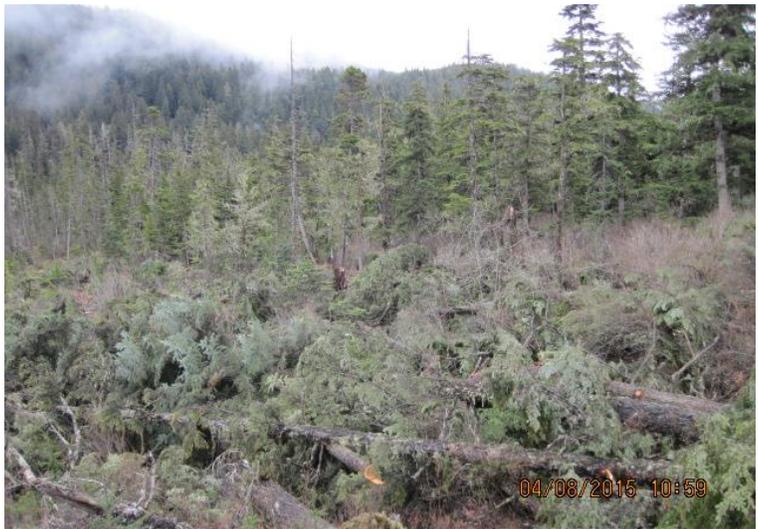
After leaving the gravel pad, the team was shuttled around the south end of TDF, and stopped near the reclamation material stockpile close to Pond 7. The larger trees that remained in the southern expansion area have been felled, but still needed to be removed (Figure 5). The geotechnical drilling program was near completion and at the time of the inspection. Secon, a local construction company, had been contracted to perform the construction for Phase 1 of the Stage 3 Expansion. Construction is expected to begin in May 2015.

Figure 5 Trees awaiting removal

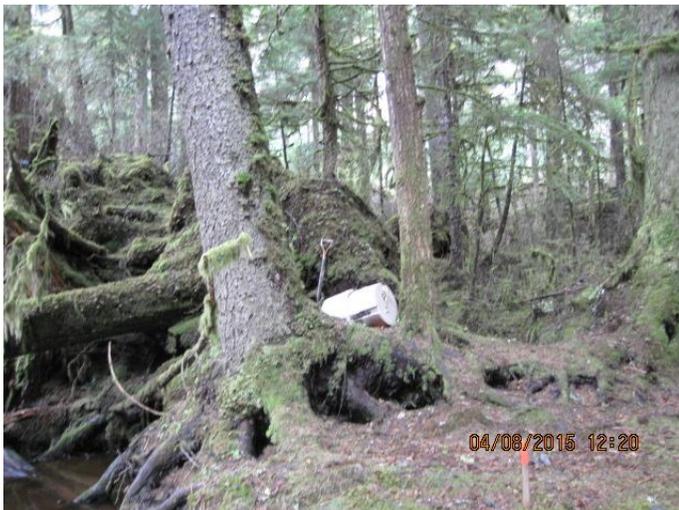
Figure 6 A shovel and container near Site 9 on Tributary Creek

The team walked around Pond 7, stopped at a wet well used to monitor water quality, and then hiked down the trail leading to water monitoring Site 60 on Althea Creek. The creek was very small and Chris stated that it dries up in spots during times of low precipitation. After returning to the Excursion, the team continued along the B Road to the access trail leading to Site 9 on Tributary Creek. The trail was steep, wet and slippery. After trekking down the trail for several minutes, we emerged into a secluded glade containing a shovel and a container (Figure 6), along with Tributary

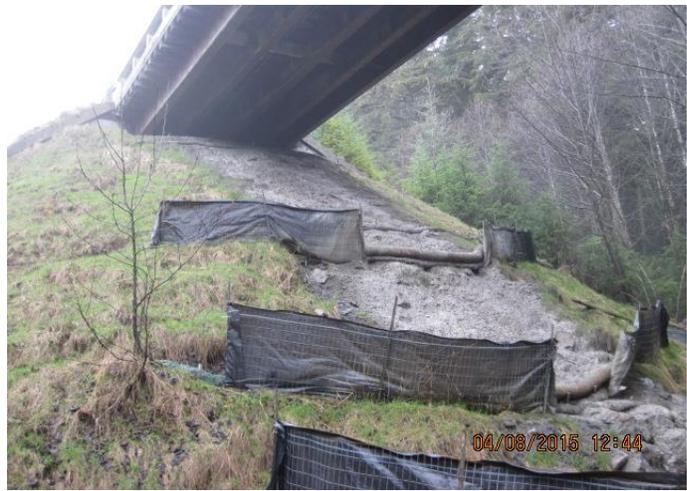
Figure 7 Sediment controls under the Zinc Creek Bridge

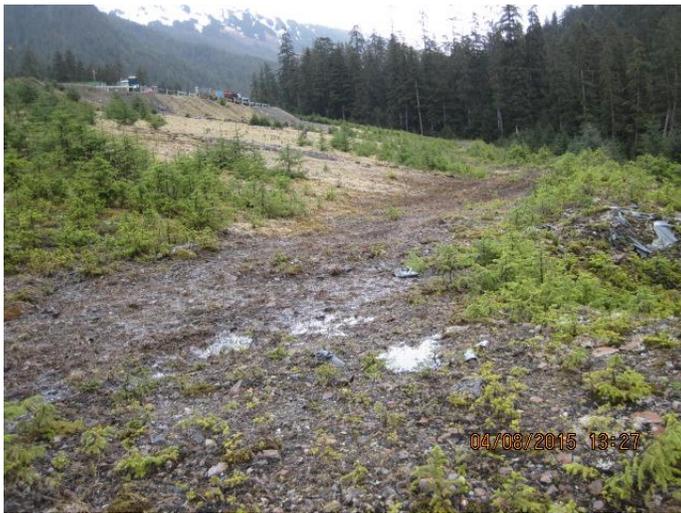
The team moved on to Site D where HGCMC has proposed to store cores from the underground drilling program (Figure 8). Some of the cores may be potentially acid generating, but runoff from the area flows to D Pond, where it would be collected and eventually pumped to the water treatment plant. The agencies are evaluating the proposal. The team then traveled around the 920 area, and then drove back to the camp to end the inspection. On a closing note, as the inspectors traveled back to camp, a very large Brown Bear was spotted near Zinc Creek. Undoubtedly, the newly awoken Brown Bear had mischief on its mind, and to pass up the sediment traps under the bridge would be unbearable ....

Figure 8 Proposed core storage area
