## INSPECTION REPORT: GREENS CREEK MINE

Date of Inspection: Thursday, June 11, 2015  
Date of Report: Tuesday, June 16, 2015  
USDA Forest Service Inspector: Curtis Caton

Ranger District: Admiralty National Monument, Juneau Ranger District

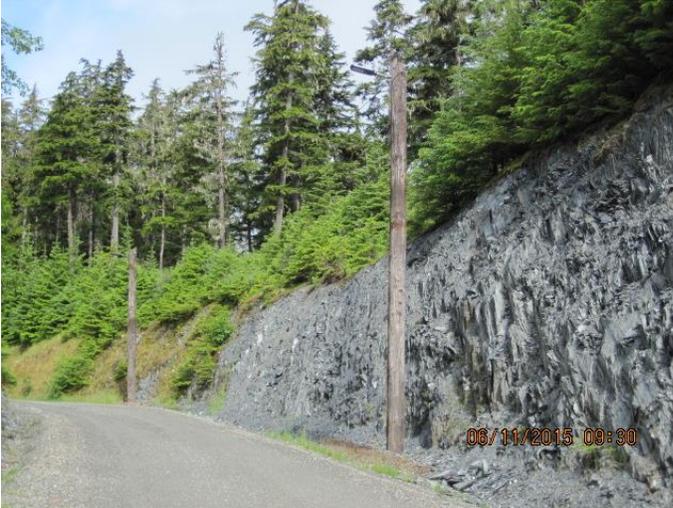
LED lights have been installed on the light poles; the light poles were installed earlier this spring near the Young Bay crew ferry terminal. The lights will illuminate the corner of the A road between Young Bay and the contractor parking area for safety (Photo 01-02).

Photo 01. Lighting project at Young Bay.

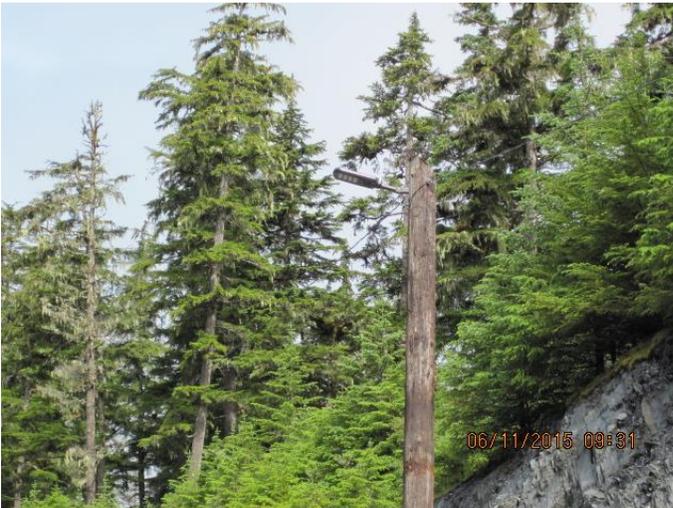
Photo 02. Lighting project at Young Bay, LED light shown.

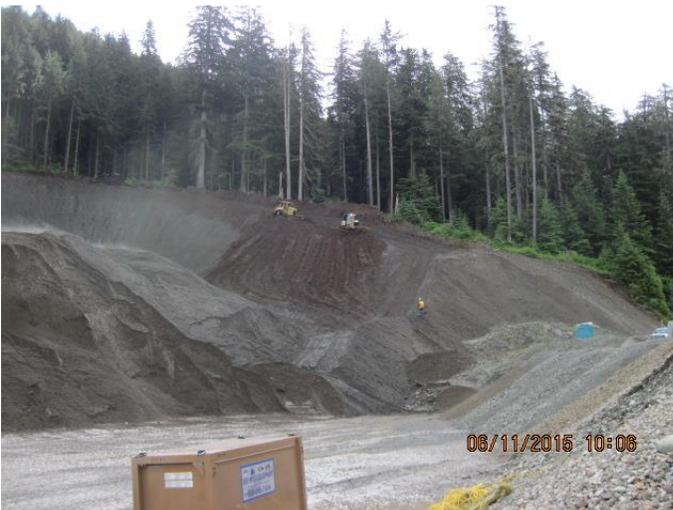
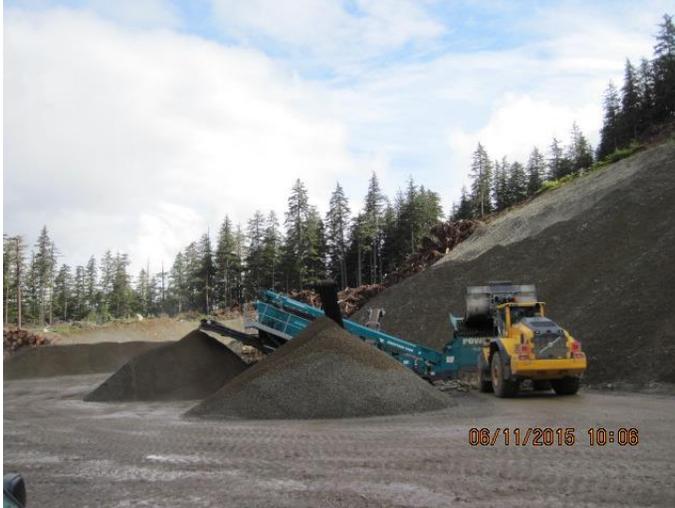
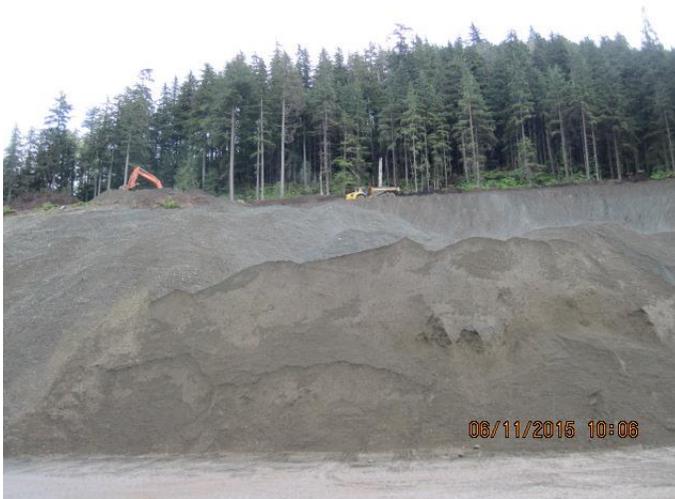
Expansion of the A road sandpit is progressing; felled timber has been moved and stacked. Heavy equipment has formed a cut at the location of the old pit wall for excavation of the sandpit material. Upon excavation, the material is run through a sorter and stockpiled for future use at the mine (Photo 03-05).

Photo 03. A Road Sandpit.

Photo 04. A Road Sandpit.

Photo 05. A Road Sandpit.

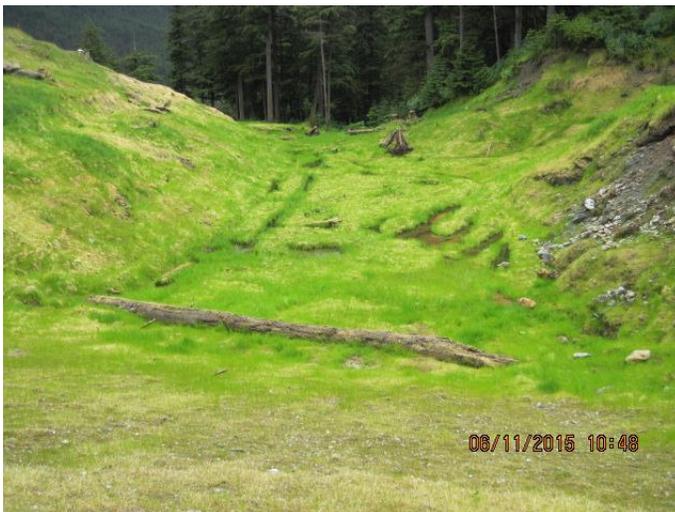
No recent activity to report at the 1350, area has stabilized from reclamation activities last season (Photo 06).

Photo 06. 1350 reclamation area.

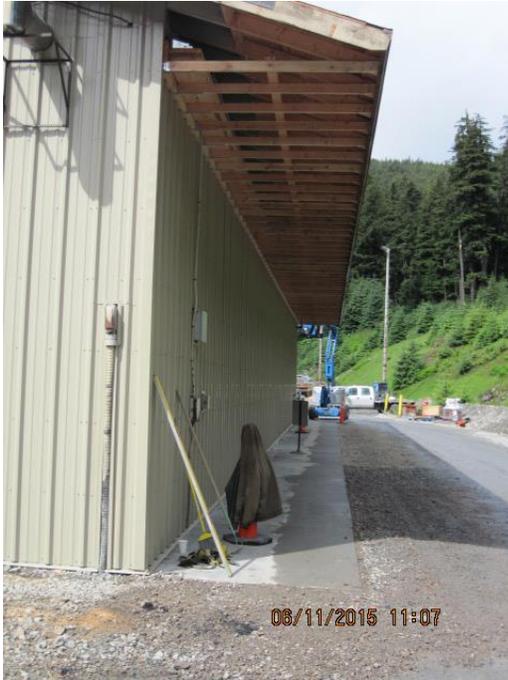
The 920 warehouse yard has been reorganized; the wooden storage shacks have been removed and a concreted slab has been added along the building. The addition of an overhanging roof extending from the warehouse will cover the concreted slab from precipitation. Shelves will be installed on the concrete slab along the warehouse wall for better organization of yard supplies (Photo 07).

Photo 07. 920 Warehouse storage project location.

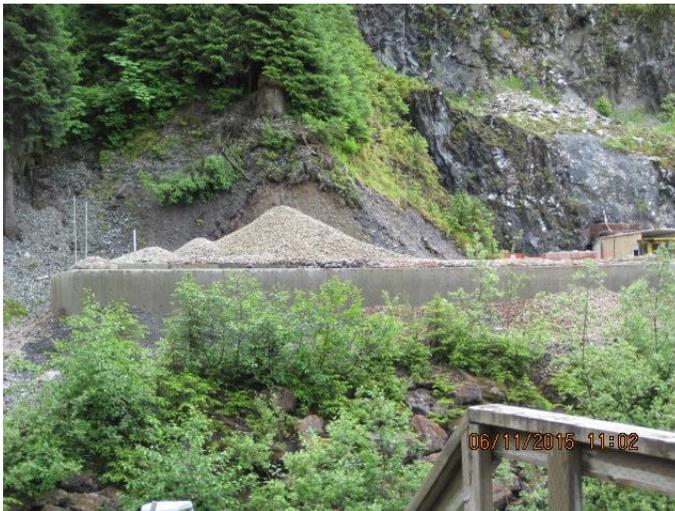
The 920 underground road base pile has been corrected at the portal; the barriers have been reestablished, and the surrounding area cleaned up (Photo 08).

Photo 08. 920 underground road rock storage area.

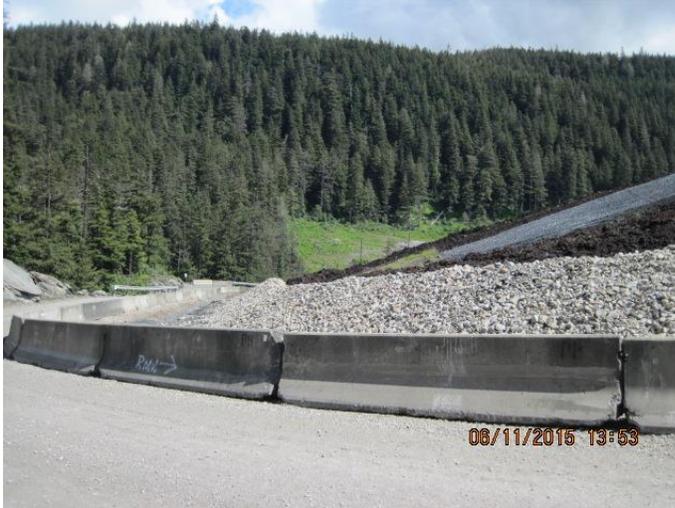
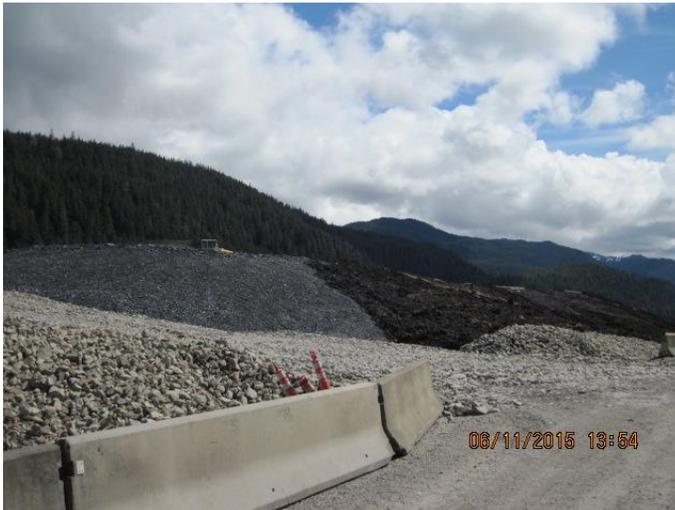
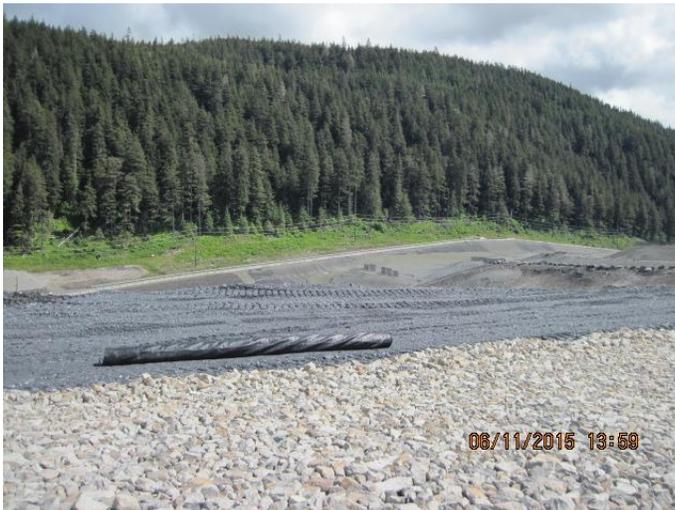
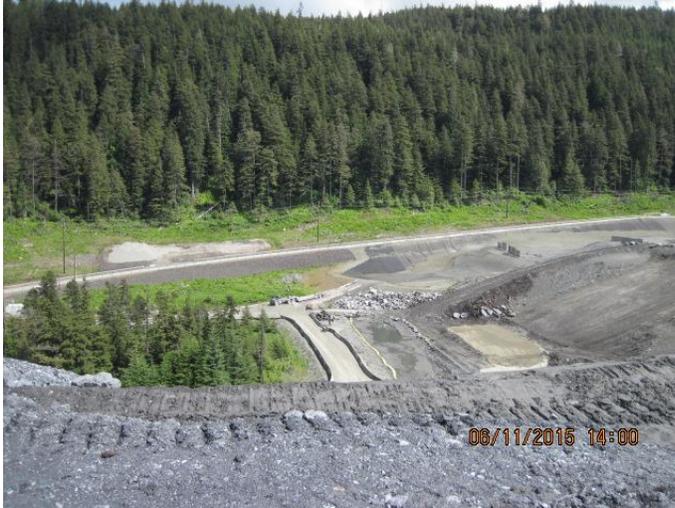
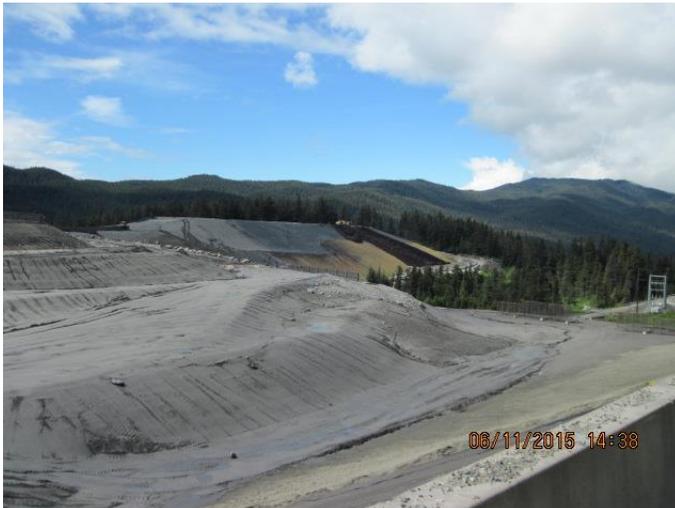
Deposition of tailings on the northwest expansion of the TDF has concluded and interim reclamation activities are stabilizing that portion of the TDF (Photo 09-13).

Photo 09. Northwest expansion of TDF.

Photo 10. Northwest expansion of TDF.

Photo 11. Northwest expansion of TDF.

Photo 12. Northwest expansion of TDF.

Photo 13. Northwest expansion of TDF.

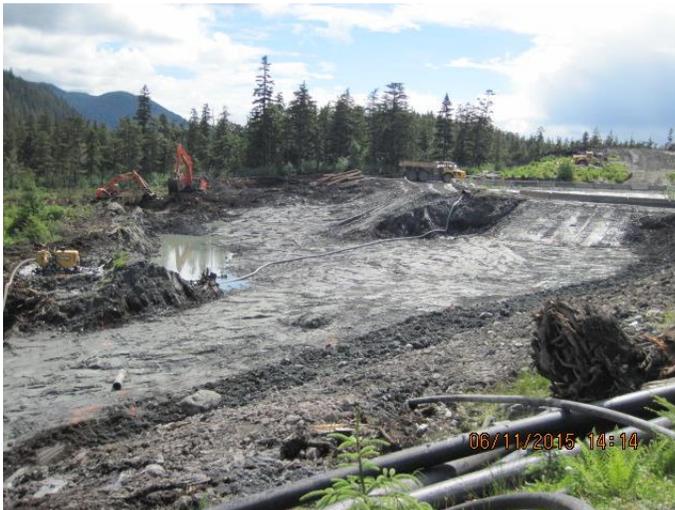
The southern expansion of the TDF is progressing with heavy equipment stripping the vegetative layer/soil. HGCMC plans to only open narrow strips of ground to minimize storm water runoff and to avoid creating a large open area that would become a muddy hazard (Photo 14-15).

Photo 14. Excavation of soil at southern end of TDF.

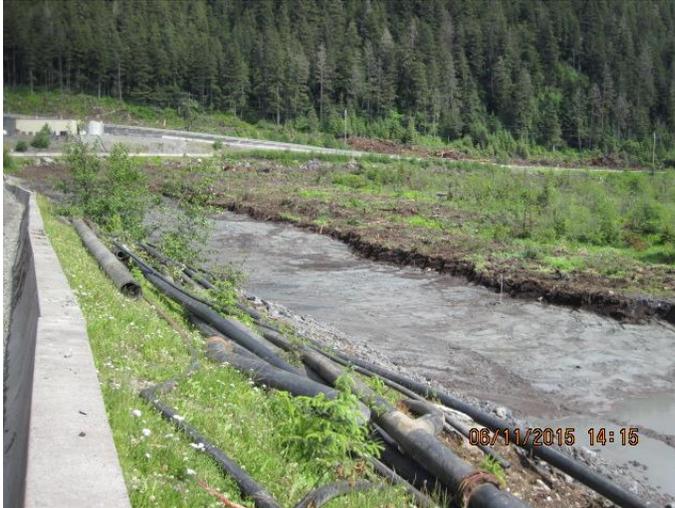
Photo 15. Southern TDF.

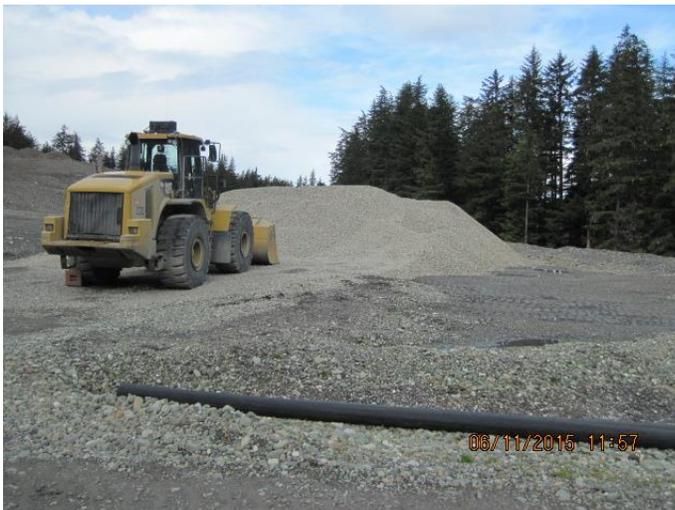
HGCMC has stockpiled operational aggregate at site E. The operational aggregate will be stockpiled at Site E until needed for underground mining operations (Photo 16).

Photo 16. Site E.
