INSPECTION REPORT: GREENS CREEK MINE

Date of Inspection: Thursday, August 06, 2015
Date of Report: Friday, August 14, 2015
USDA Forest Service Inspector: Curtis Caton

The site inspection included the A and B access roads, Young Bay, Pit 7, A Road Sandpit, 1350, 920, Site 23, Tailings Disposal Facility (TDF), and Site E.

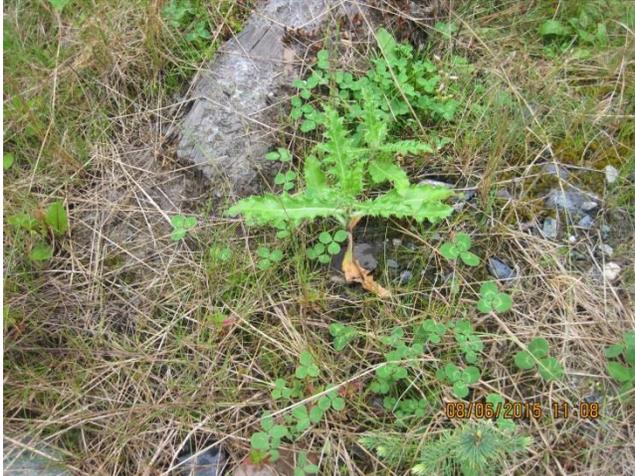
Canada thistle has germinated at Pit 7. HGCMC has begun manual pulling to mitigate the spread of the invasive plant species. Mitch pulled several small plants during the inspection (Photo 01).

Photo 01. Canada thistle at Pit 7.

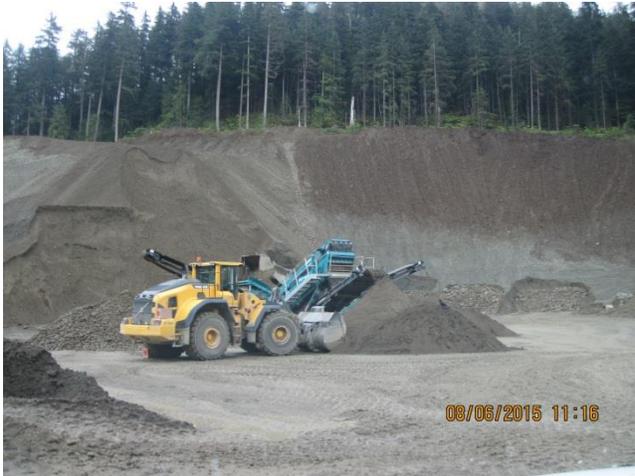
Heavy equipment continues to excavate and sort material for use during construction projects on site (Photo 02).

Photo 02. A-Road Sand Pit.

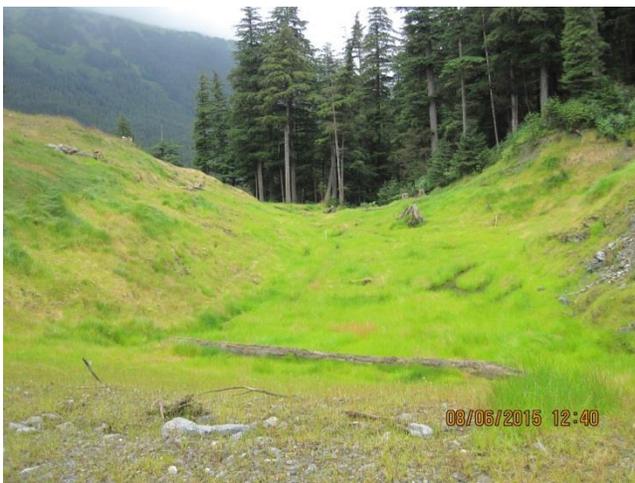
No recent activity to report at the 1350, surrounding area has stabilized from reclamation activities last season (Photo 03).

Photo 03. 1350 reclamation area.

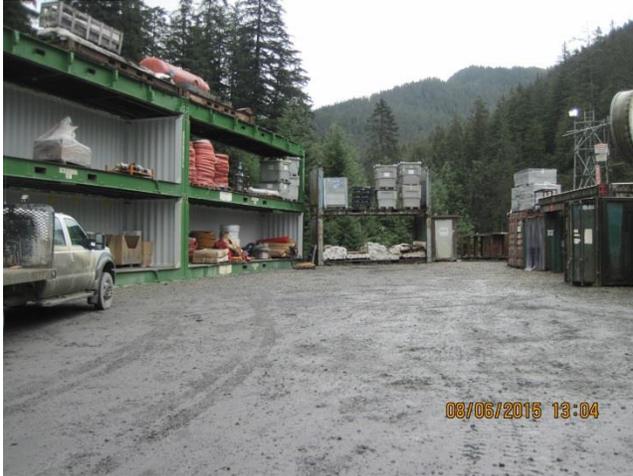
Heavy-duty shelving has been installed within the recently constructed storage area that is located along the exterior of the 920 warehouse. The improved storage area and reorganization of the warehouse yard has been a major improvement that will keep the area clean and orderly. All items in storage have been labeled and all liquids have been stored properly within secondary containment (Photo 04).

Photo 04. 920 warehouse yard.

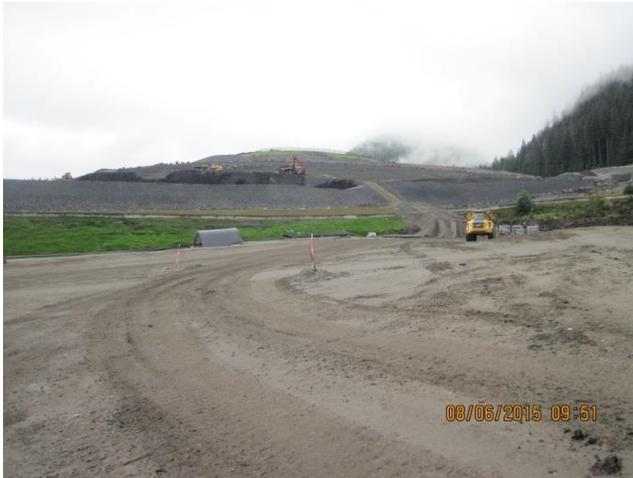
Heavy equipment continues to grub and strip the vegetative layer off to the underlying sediment layer within the TDF expansion area. After vegetative stripping, underdrains constructed of Geotextile Permeatex liner and coarse rocks are added before installation of the impervious HDPE liner. The HDPE liner will prevent both ground water infiltration into the TDF and exfiltration of contact water into the environment (Photo 05-06).

Photo 05. TDF expansion area.

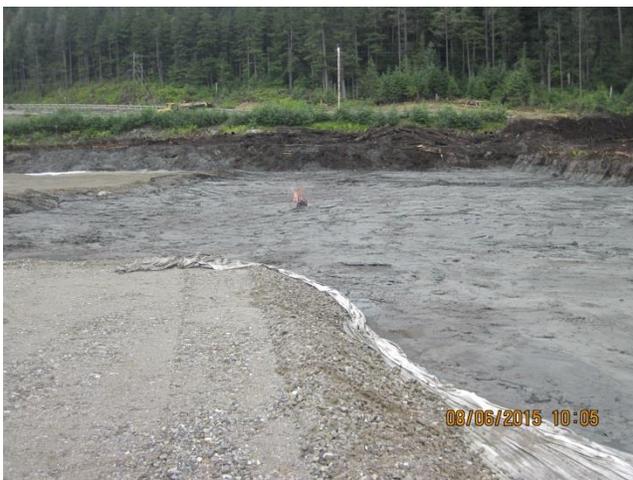
Photo 06. TTF expansion, underdrain construction.

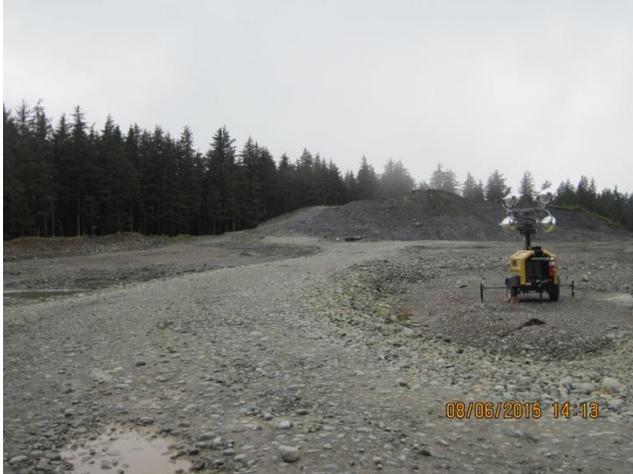
According to HGCMC 2014 Annual Inactive Report , approximately 168,600 yards of waste rock was stored at Site E. HGCMC has removed 20,498 cubic yards of this material, leaving approximately 148,102 cubic yards at Site E. The material was removed from Site E for construction of a berm within the TDF that will be used to retain peat that was excavated from the stage 3 phase 1 expansion area (Photo 07).

Photo 07. Site E.
