INSPECTION REPORT: GREENS CREEK MINE

Tongass National Forest Minerals Group
8510 Mendenhall Loop Rd
Juneau, AK 99801
(907) 789-6273 – office
(907) 586-8808 – fax

Date of Inspection: Friday, October 16, 2015
Date of Report: Friday, October 23, 2015
USDA Forest Service Inspector: Curtis Caton

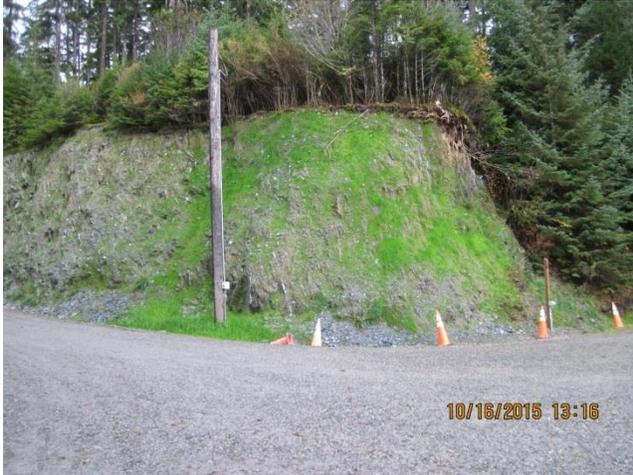
No recent activity to report at Young Bay, the area is well maintained and orderly. Hydroseeding has germinated on the disturbed areas around the light poles that were installed during the 2015 lighting project (Photo 01). Waddles are in position to intercept stormwater runoff from the crew bus loading area.

Photo 01. Young Bay lighting project, hydroseeding.

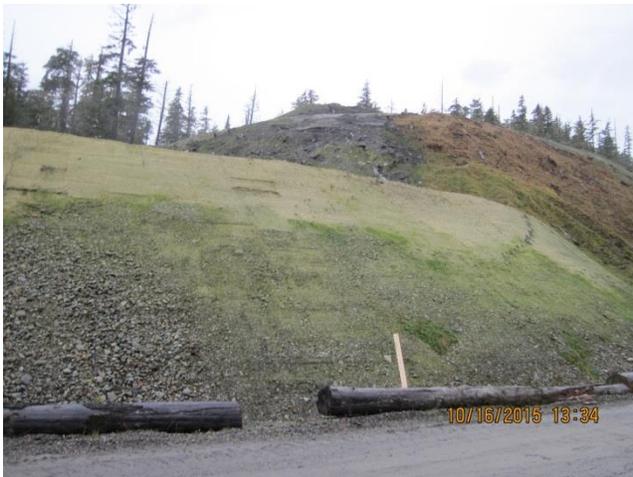
Reclamation vegetative matter adjacent to Pond 07 has been excavated and stockpiled at Pit 7 (Photo 02). The stockpile of reclamation material was originally excavated for the construction of Pond 7. The stockpile had to be relocated so that construction of Pond 10 can occur, which was approved in the 2013 TDF expansion ROD.

Photo 02. Pit 7.

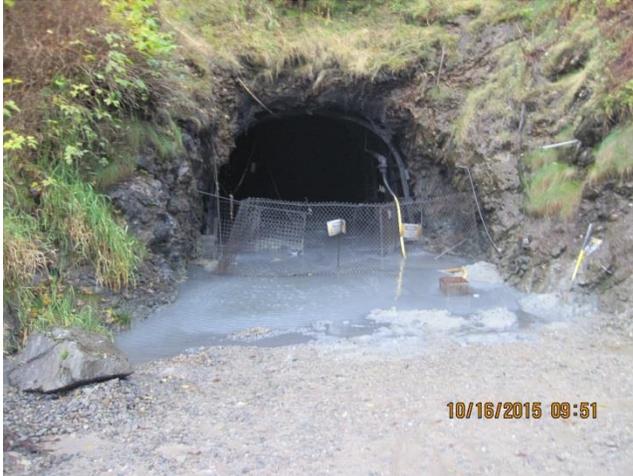
Maintenance or mucking is required at the entrance to the 1350 adit. Stormwater has collected around the opening of the 1350 adit, a stormwater water recirculation pump may have gone out or the adit drain has become clogged (Photo 03).

Photo 03. 1350 Adit.

- **1350 Adit drains possibly clogged**
- **Site E pond needs to be relined or repaired**

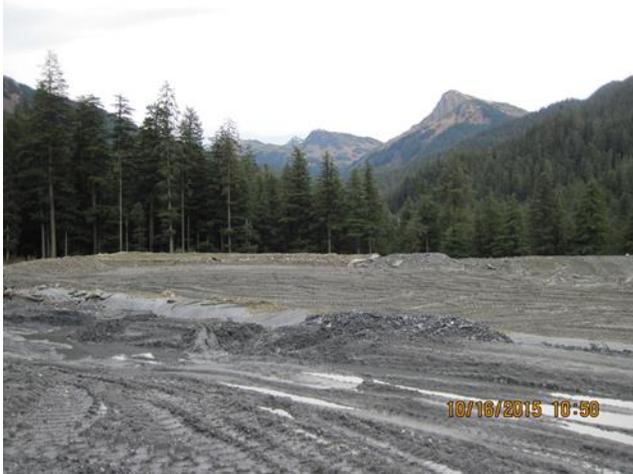
The class three material that originated from the 1350 reclamation project had been stockpiled at Site 23 but was recently hauled underground and backfilled for permanent storage (Photo 04).

Photo 04. Site 23. Waster rock from 1350 moved to underground storage.

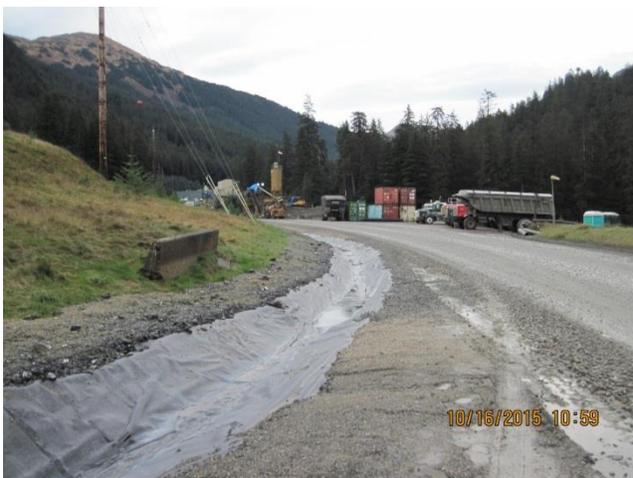
Site 23 ditch has been relined this summer (Photo 05). The interception ditch collects all stormwater runoff from Site 23 footprint along the B road. The stormwater collecting in settling pond 23 is pumped to the TDF water treatment plant before discharge.

Photo 05. Site 23 stormwater interception ditch relined.

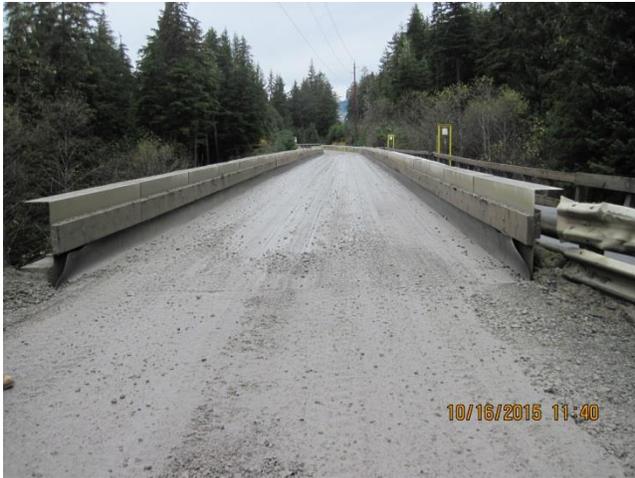
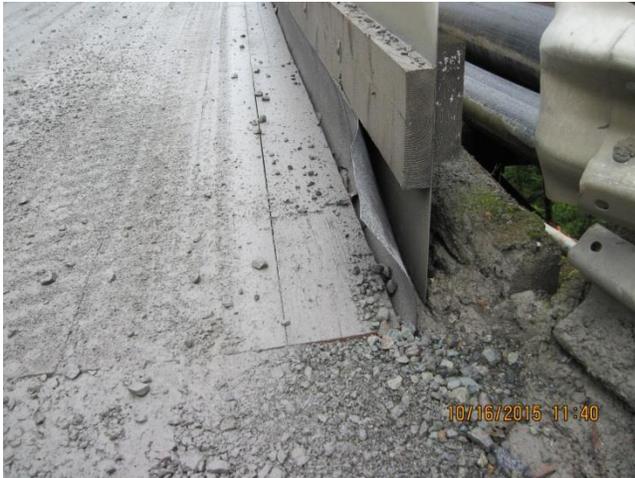
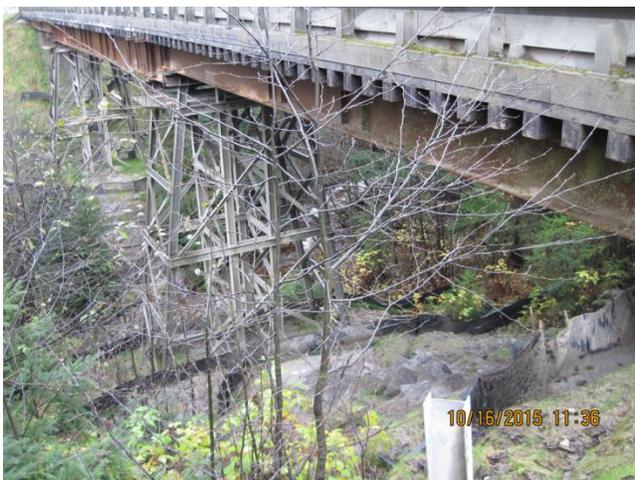
To reduce sediment from reaching Zinc Creek, HGCMC has lined the Zinc Creek Bridge with an 80-mil piece of HDPE underneath the timbered surface. The liner has visibly reduced the amount of sediment seeping between the timbered bridge surface to the vegetation and surface area beneath the bridge (Photo 06-08). The slit fencing has received some maintenance and the excess sediment has been mucked out from behind the barriers.

Photo 06. Zinc Creek Bridge lined with HDPE.

Photo 07. Zinc Creek Bridge lined with HDPE.

Photo 08. Zinc Creek Bridge.

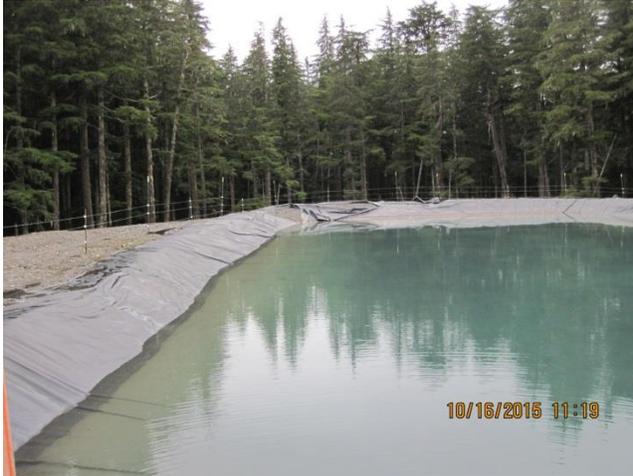
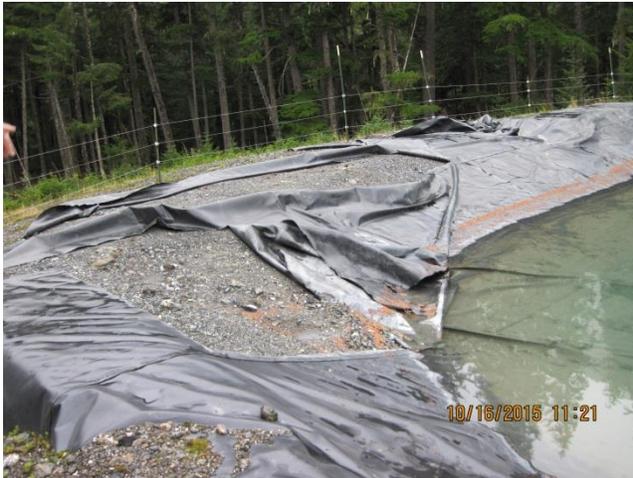
Site E settling pond is in disrepair and does not comply with the BMP plan strategies listed for Site E in Appendix 5, Figure 8. The pond needs to be relined or repaired to prevent stormwater and sediment discharge into the watershed (Photo 09-10).

Photo 09. E pond. Torn liner.

Photo 10. E pond. Torn liner.
