INSPECTION REPORT: GREENS CREEK MINE

Date of Inspection: Thursday, February 25, 2016
Date of Report: Monday, March 7, 2016
USDA Forest Service Inspector: Edward Gazzetti

The site inspection included A/B-access roads, Zinc Creek Bridge, Zinc Creek, Tailings Disposal Facility (TDF), Waste Site E, Pit 7, 1.4 Mile A-road Sand Pit, and Young Bay Terminal.

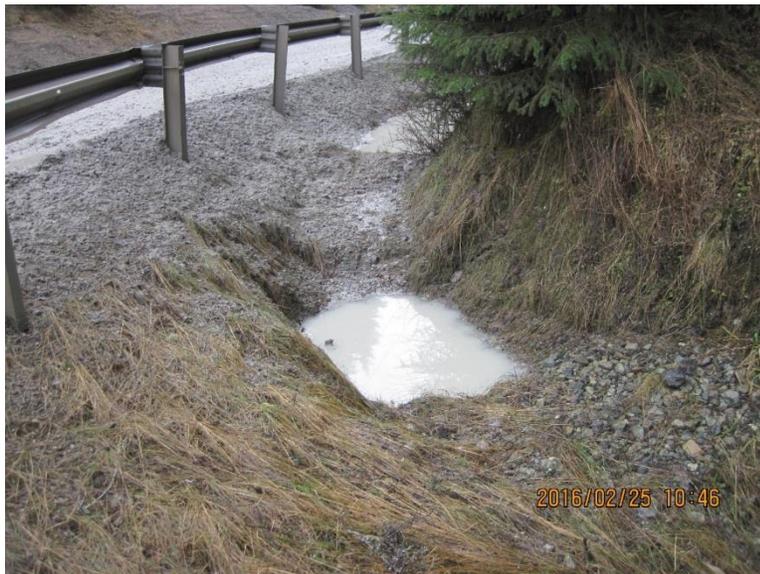
Ruts and potholes were present on B-road during the inspection. Maintenance in accordance with Section 3.1 of Appendix 8, including grading and road rock placement, regularly improve road conditions. Turbid stormwater in roadside ditches is proof of erosion taking place on B-road (Photos 1 and 2). The US Forest Service and Alaska Department of Environmental Conservation recently approved a dust suppressant field-test on three sections of B-road. Polymer dust suppressants could be useful in mitigating road erosion and, as a result, turbidity in stormwater runoff.

Photo 1. Turbid stormwater along B-road near Waste Site E. Sumps and rock check dams do a good job of slowing and retaining turbid stormwater.

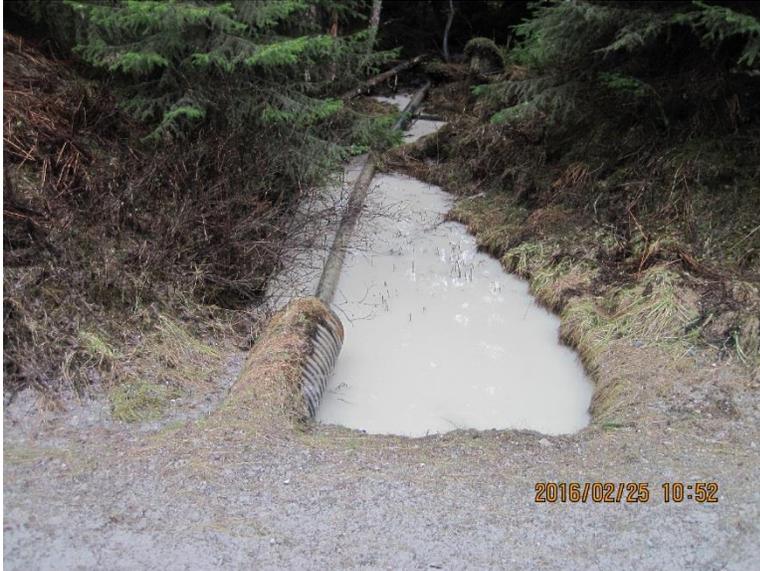
Turbid runoff from B-road enters the drainage that runs between Waste Site E and the road near Outfall 005.3, as shown in Appendix 5, Figure 8 (Photos 2 and 13). Approximately 6-8 inches of fine sediment has accumulated in a settling pond adjacent to a culvert that empties into the drainage. Settling pond/culvert may need mucking this spring to ensure its effectiveness (Section 3.4 of Appendix 8).

Photo 2. Turbid water enters the drainage that runs between B-road and Waste Site E. HGCMC monitors stormwater in this drainage at Outfall 005.3.

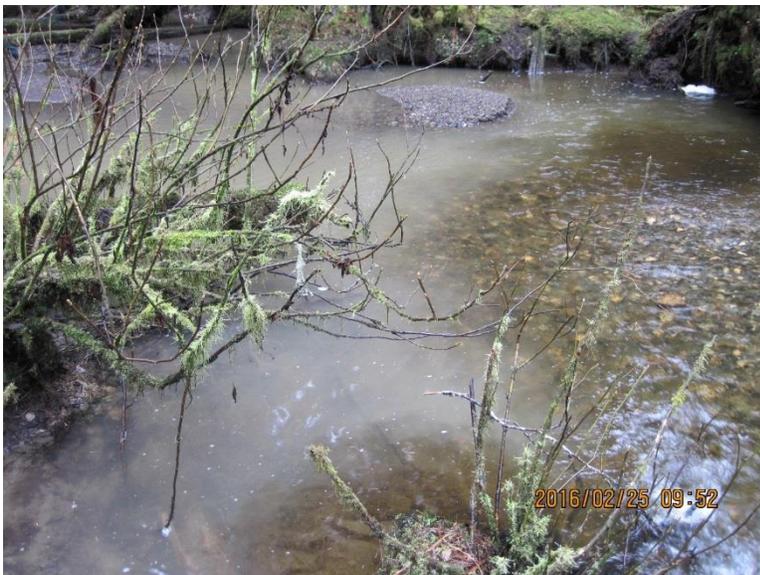
Inspection Report 368 (January 22, 2016) incorrectly stated that a Zinc Creek offshoot entered Greens Creek. The February 25 inspection revealed that the offshoot merged with Falls Creek and eventually rejoined Zinc Creek downstream (Photo 3). During the inspection, multiple red areas of groundwater upwelling were observed along the banks of Zinc Creek, the Zinc Creek offshoot, and Falls Creek. Note that while Inspection Report 368 associated a ditch-water outfall with one of these red areas, there is no evidence to suggest the ditch-water actually caused the red water/staining.

Photo 3. Confluence of Falls Creek (left side of image) and Zinc Creek (right side of image). The offshoot of Zinc Creek mentioned in Inspection Report 368 merges with Falls Creek before entering Zinc Creek at this location.

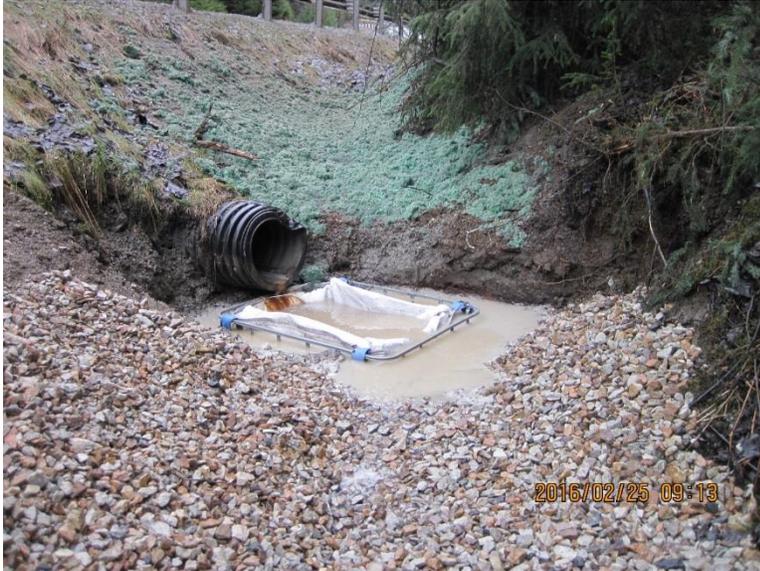
HGCMC has implemented mitigation measures at Zinc Creek Bridge with the goal of reducing sediment discharge into the forest. A filtration bag screens turbid ditch-water as it exits a culvert that runs beneath B-road (Photo 4). HGCMC crews can replace the bag when it reaches capacity. Ditch-water then enters a series of silt fences, straw wattles, and rock check dams before entering a sump (Photos 5-7). A standpipe drains the sump and discharges water into the forest at a new location approximately 20 meters south of the previous discharge point shown in Photo 8. By diverting ditch-water into a new flow path, the forest duff can be more effective as a sediment filter and the old flow path will have time to revegetate. HGCMC hopes to supplement their current BMP strategy with dust suppressants on B-road in the future.

Photo 4. New sump below culvert near Zinc Creek Bridge. Sump has a replaceable filter bag to trap sediments.

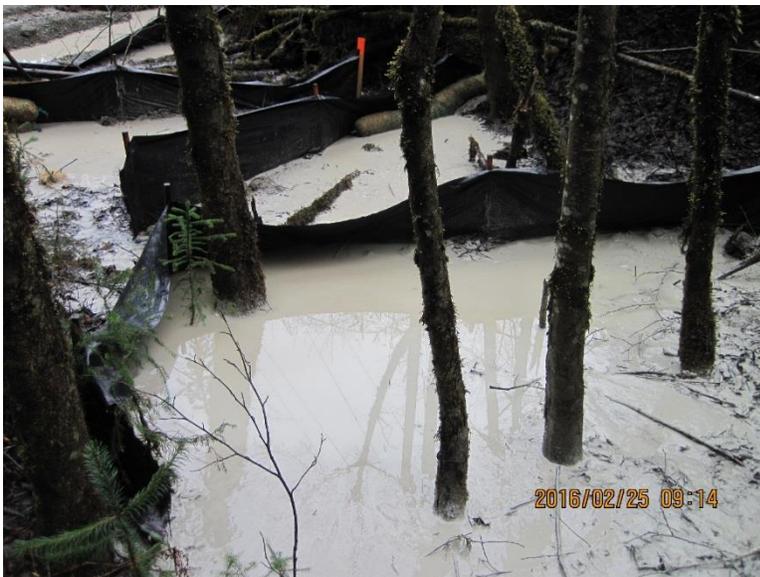
Photo 5. New BMP strategies (downgradient of Photo 4). Turbid water is slowed and filtered by a series of silt fences and straw wattles.

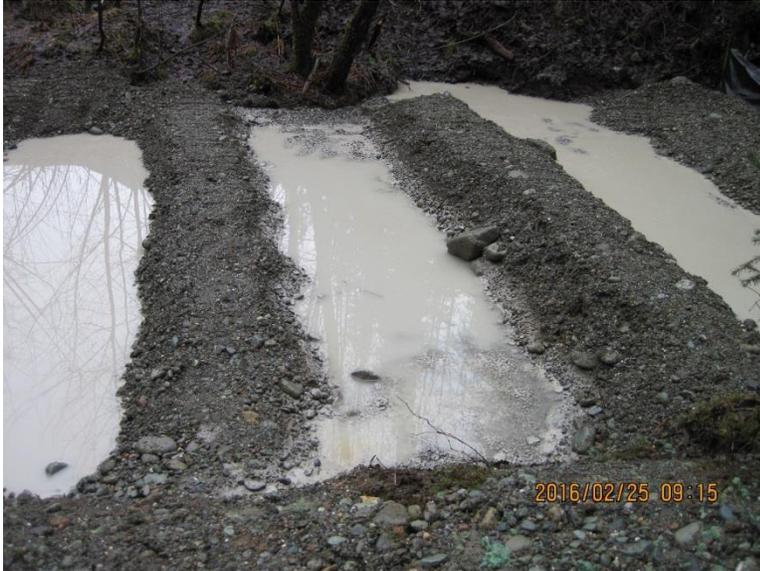
Photo 6. Rock check dams (downgradient of Photo 5) slow turbid water and provide additional stormwater storage.

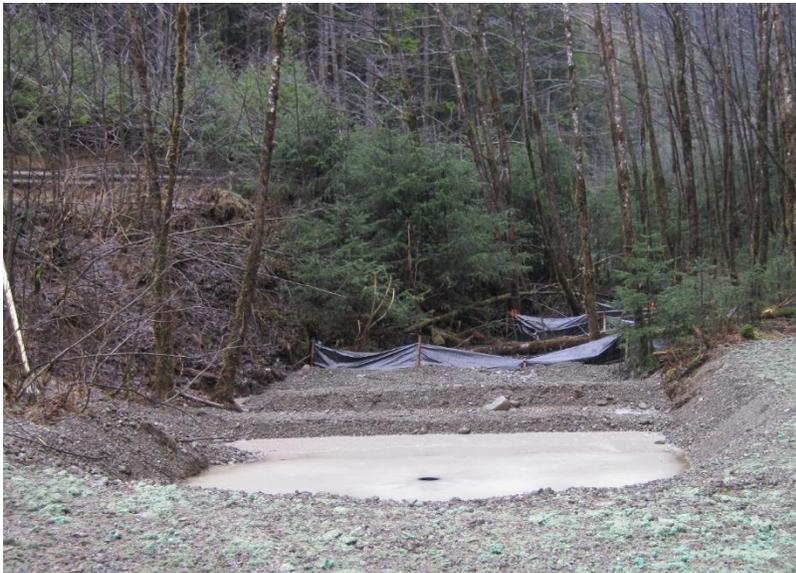
Photo 7. Sump with standpipe. Photo looking upgradient towards rock check dams, silt fences, and culvert with filter bag at its base.

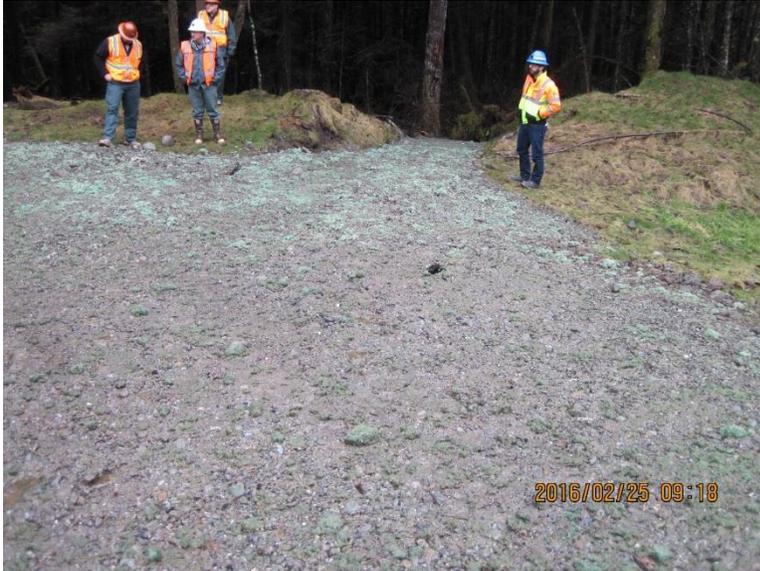
Photo 8. Ditch-water previously discharged into forest at this location. Area is contoured and hydroseeding applied. Stormwater now exits the sump through a standpipe and enters the forest approximately 20 meters south (to the left) of this location.

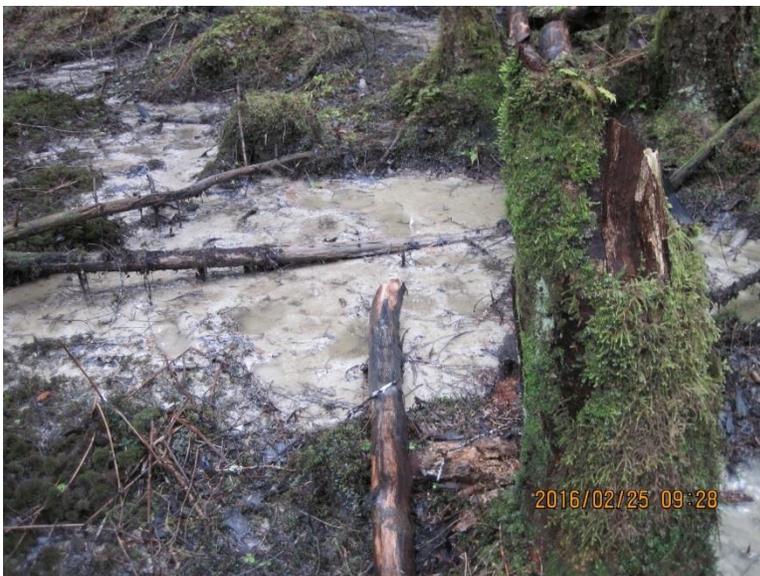
The ditch-water outfall mentioned in Inspection Report 368 was observed again during this inspection and turbid water was present. There is a fair amount of sediment stored along the old ditch-water flow path within the forest (Photo 9), so turbidity will continue to enter the Zinc Creek offshoot. However, the recently employed mitigation measures should reduce discharge along the old flow path and, as a result, reduce sediment loading to the stream.

Photo 9. Sediment buildup in forest duff along old ditch-water flow path. Runoff may mobilize sediment over time. However, the diversion of ditch-water by the standpipe, combined with other newly employed BMP strategies, should reduce sediment loading into the Zinc Creek offshoot.

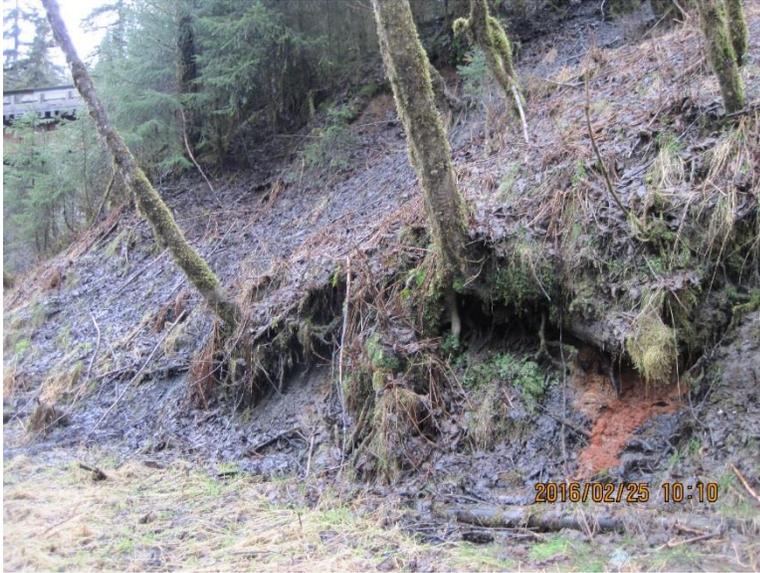
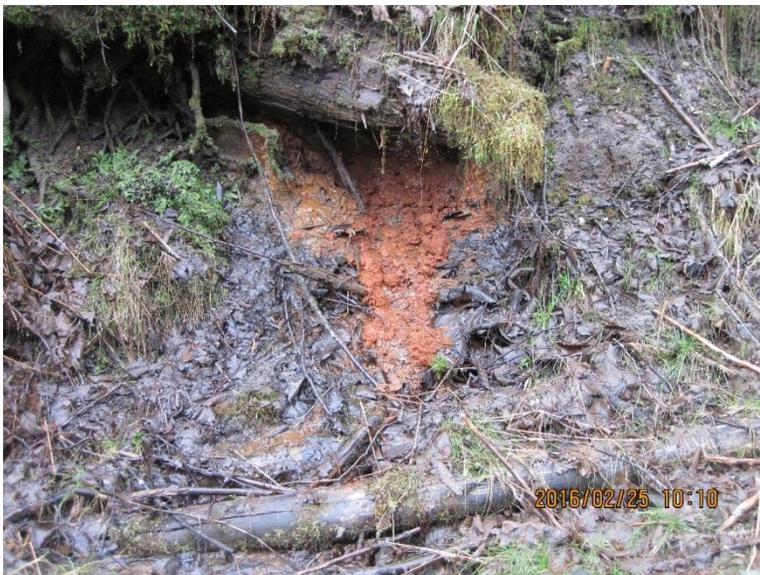
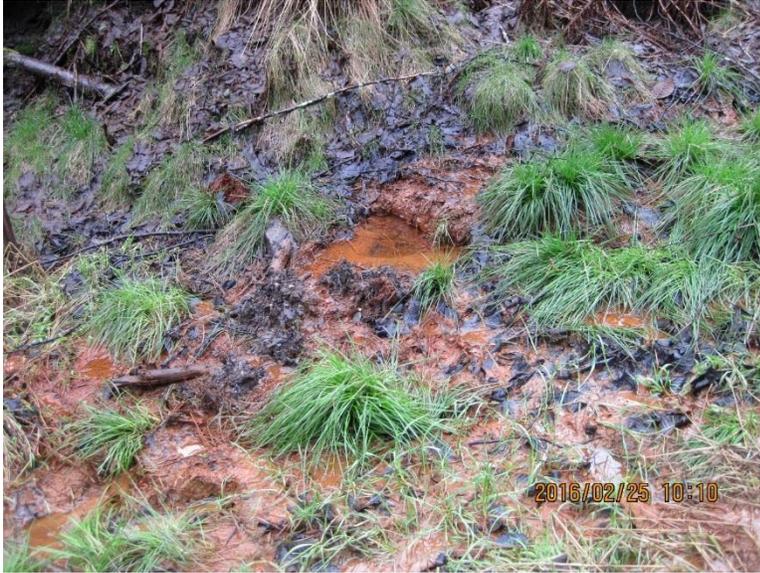
Multiple red seeps are present on the south abutment of Zinc Creek Bridge (Photos 10-12).

Photo 10. Seep at the base of Zinc Creek Bridge’s south abutment. Note the bridge in the top left corner of this image.

Photo 11. Close-up of seep from Photo 10.

Photo 12. Red seep about five meters downgradient of seep shown in Photos 10 and 11.

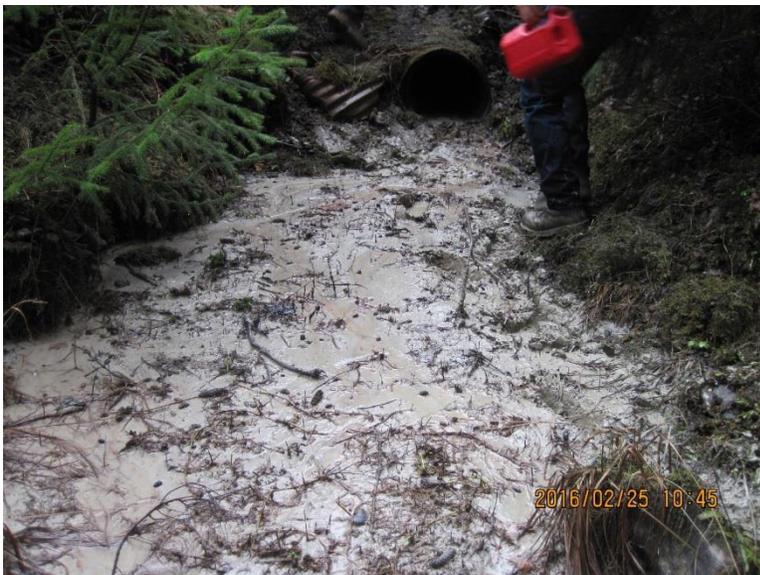
Photo 13. Fine sediment buildup from stormwater discharge. Culvert empties stormwater into drainage that runs between B-road and Waste Site E. Sediment accumulation approximately 6-8 inches.

- Spring maintenance - Muck culverts at Pit 7, Waste Site E
