INSPECTION REPORT: GREENS CREEK MINE

Date of Inspection: Thursday May 19, 2016
Date of Report: Tuesday June 14, 2016
USDA Forest Service Inspector: Richard Dudek

Ranger District: Admiralty National Monument
Weather Conditions: Sunny. Temperature: Mid 60's °F.

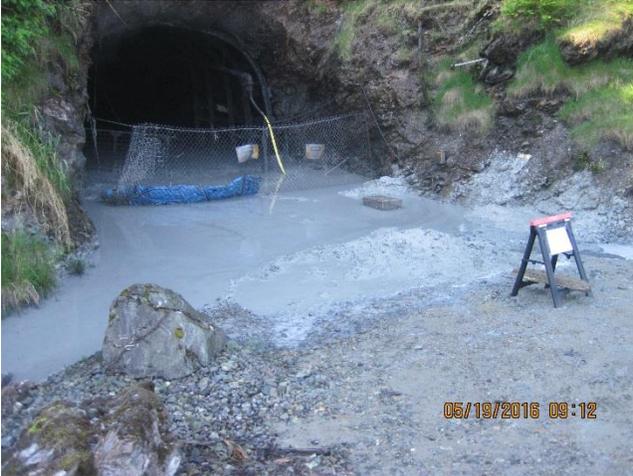
The 1350 adit (Photo 1) is the original adit at Greens Creek and is approximately 430 feet higher in elevation from the 920 portal. The 1350 adit is inactive and HGCMC has reclaimed the area by hydroseeding and contoured the surface adjacent to the adit. The 1350 adit now serves as an exhaust ventilation system and as a secondary escape way for miners. HGCMC has a groundwater monitoring well (Photo 2) across from the 1350 adit. A sump near the 1350 adit fence, covered by a screen appears to have sediment build up. HGCMC's Environmental Manager Chris Wallace stated that HGCMC's surface department inspects the 1350 area (when accessible) and cleans the sump when deemed necessary. HGCMC also stated they would eventually re-hydroseed exposed rock near the 1350 adit (Photo 3). The 1350 access road's water bars are in need of repair (Photo 4). The six water bars located on the access road are not effectively diverting water and need to be reconstructed.

Photo 1. 1350 adit.

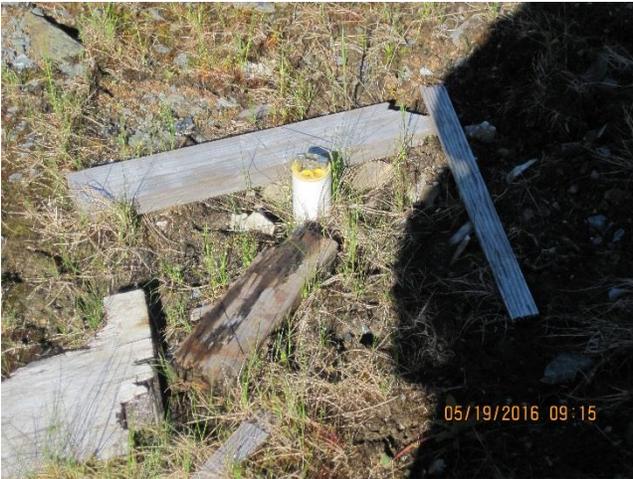
Photo 2. 1350 monitoring well.

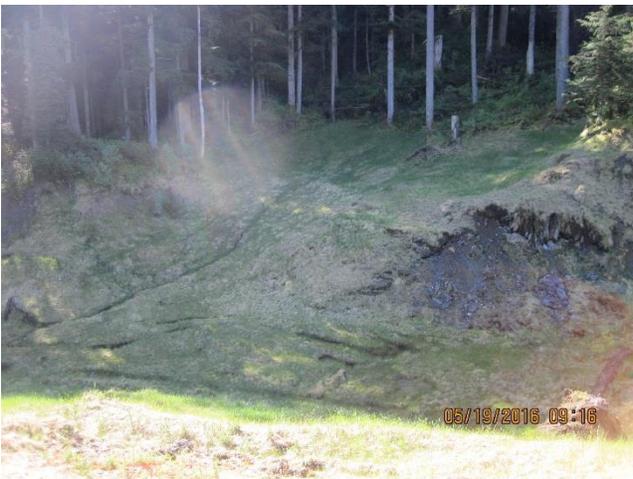
Photo 3. 1350 re-hydroseeding for exposed rock pile.

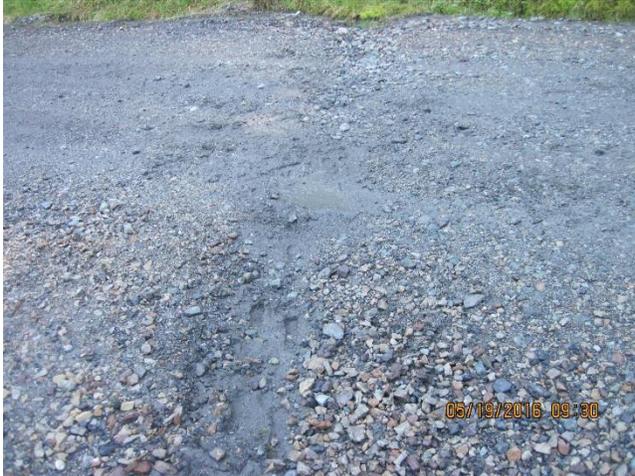
Photo 4. 1350 access road water bar.

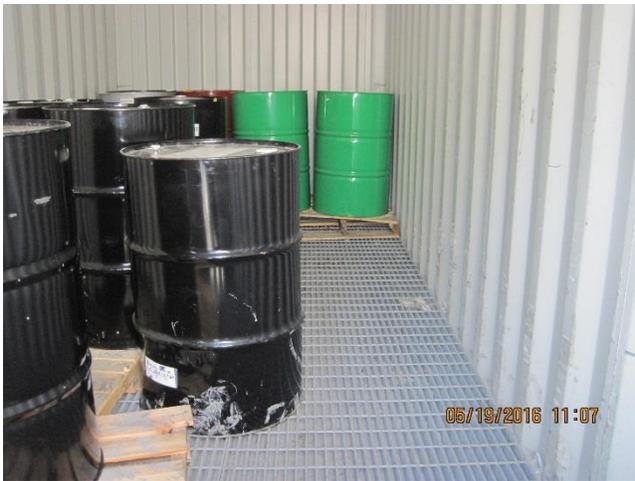
The 920 warehouse storage area was clean and in order. All liquid chemicals and petroleum products were properly stored in storage containers with appropriate secondary containment (Photo 5). The sump and rock check dam across from DB-01 needs mucking (Photo 6). Sediments have accumulated and may affect functional operations of the rock check dam and sump.

Photo 5. Storage containers at the 920 warehouse.

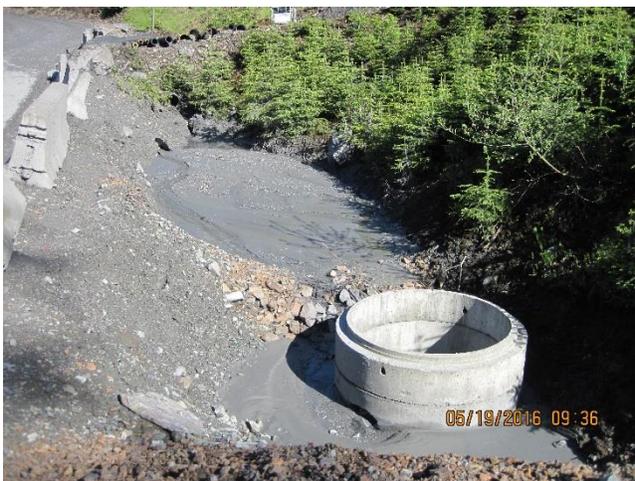
Photo 6. Rock check dam and sump across from DB-01 need mucking.

- 920 area: A rock check dam and sump across from DB-01 needs mucking.
- 1350 access road water bars are in need of maintenance
- Falls Creek Bridge: Immediate removal of sediments from underneath Bridge.
- Falls Creek Bridge: A liner needs to be installed underneath the wood planks.
- Falls Creek Bridge: Culvert needs mucking.
- Back-up pumps need to be in place as a mitigation at all site locations in the event any of the main water pumps fail during operation.
- Water Pumps: Develop a mitigation strategy to assess workload capacity for water pumps.

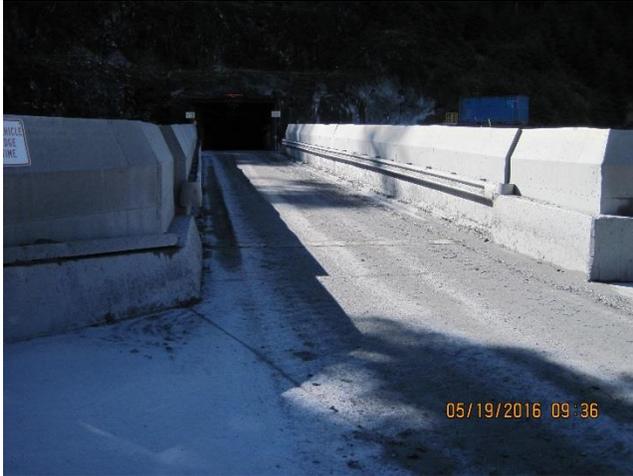
The 920 bridge splashguards appear to be working, and are preventing sediments from entering Greens Creek (Photo 7). The storage area for underground road base material (Photo 8) is properly maintained by HGCMC personnel to prevent road base gravel was entering into Greens Creek.

Photo 7. 920 Bridge.

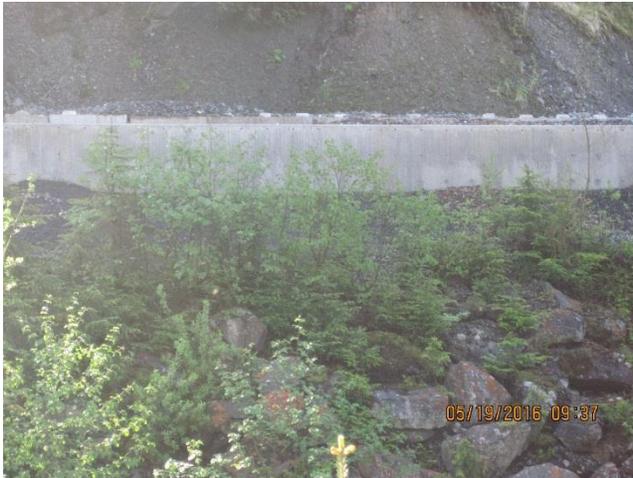
Photo 8. Storage for road base material for the underground mine roads.

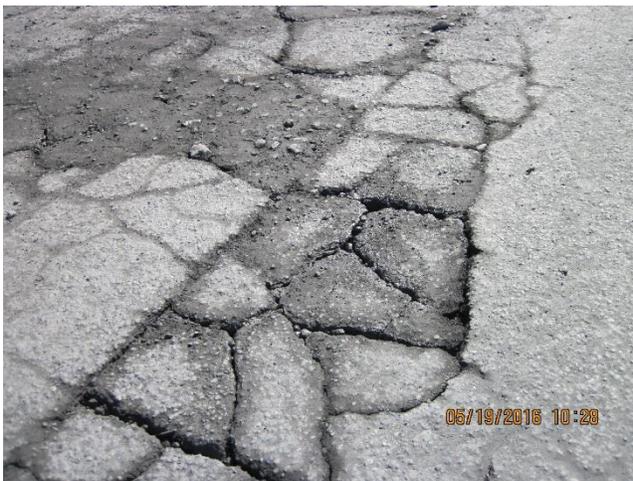
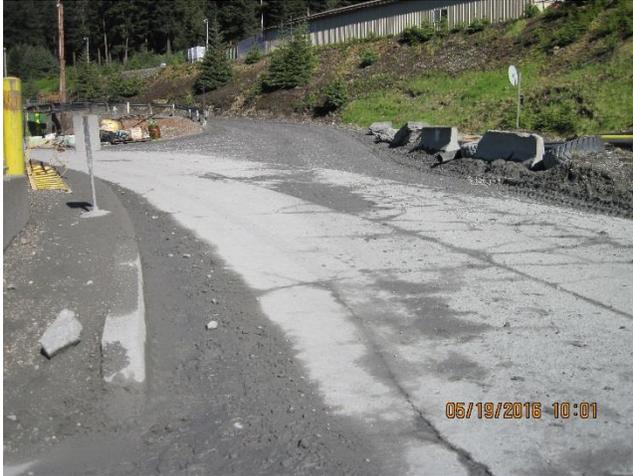
In February 2016 HGCMC reported that a section of the 920 concrete overlay was damaged (Photos 9-10). The damaged concrete overlay may be from a broken potable waterline, HGCMC has plans to repair the damaged section of concrete in 2017. In addition to the damaged section, HGCMC will be sampling the underdrain at Pond A for lead signatures via the damaged road. HGCMC's Environmental Manager Chris Wallace stated that HGCMC personnel monitor for lead concentrations in Greens Creek upstream from Pond A and may conduct a tracer test. A tracer test would introduce a nontoxic organic dye to track the flow paths below the broken concrete to identify if water infiltrating the broken concrete is reporting to Greens Creek.

Photo 9. Zoomed in image of the cracks in the 920 concrete overlay.

Photo 10. Cracks in the 920 concrete overlay.

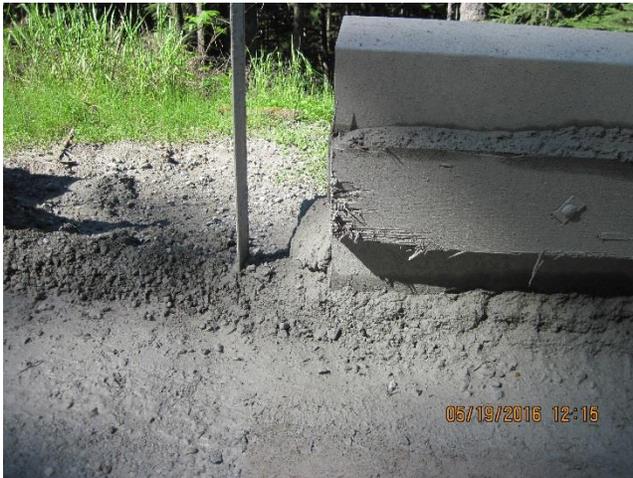
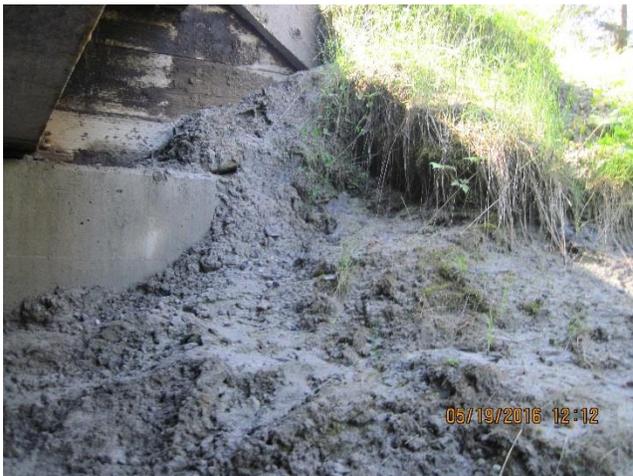
During the 4/4/16 inspection, it was documented that turbidity was observed at the confluence for Falls Creek and Zinc Creek. During this inspection, the USFS observed high amounts of sediments along the abutments of Falls Creek Bridge and underneath the bridge (Photos 11-12). The sediments deposited at this location may be from road grading or plowing along B-road. The sediments had accumulated onto the ground through the wood planks of the bridge (Photo 13). A nearby culvert is covered in sediments and needs to be mucked (Photo 14). Across the road from the culvert, a collapsible drainpipe was covered in sediments and possibly entering the forest (Photo 15).

Photo 11. Sediment buildup at the edge of Falls Creek Bridge.

Photo 12. Sediments from B-road accumulating below the bridge.

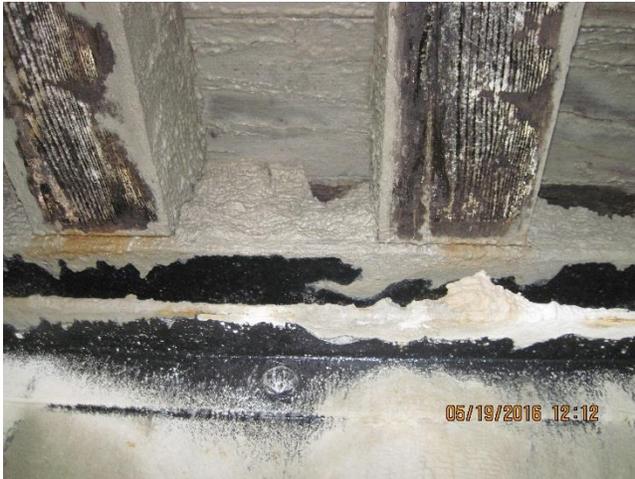
Photo 13. Sediments from B-road permeating through the wood planks.

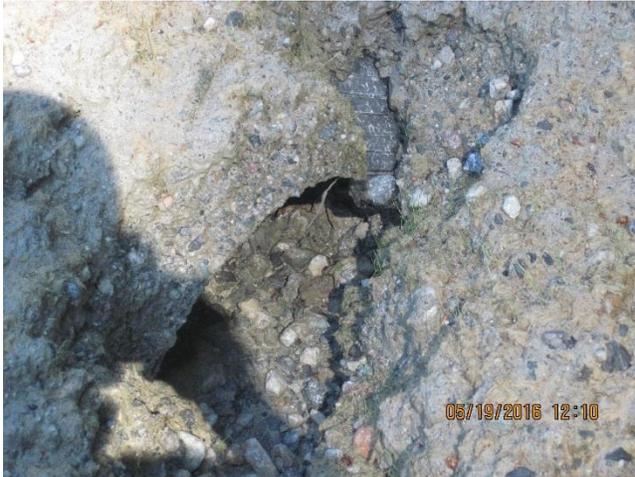
Photo 14. A culvert near Falls Creek Bridge needs mucking.

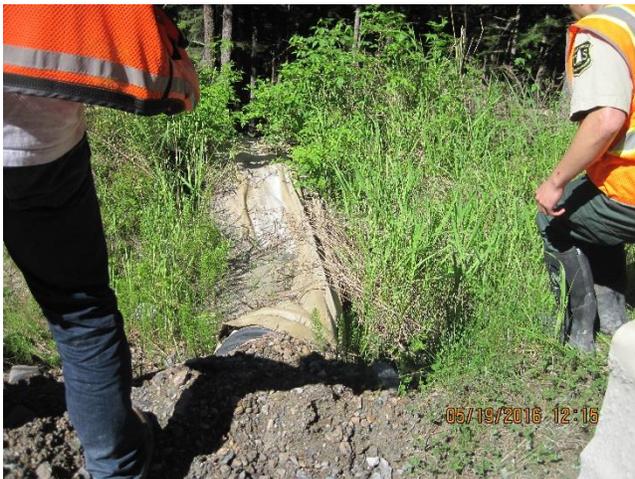
Photo 15. Collapsible drainpipe south of the Falls Creek Bridge.

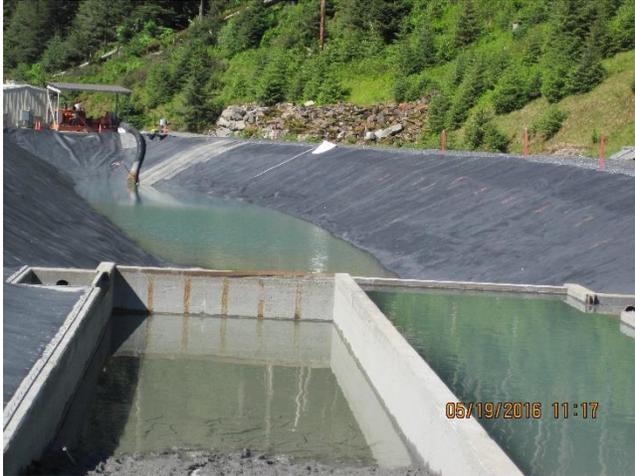
Pond 23 was constructed to receive water from Site 23, Pond D, and stormwater pumps PP-09, and PP-10 at Pond A. Pond 23 has been recently re-lined, and is receiving water (Photo 16).

Photo 16. Pond 23 has been relined and is currently active.

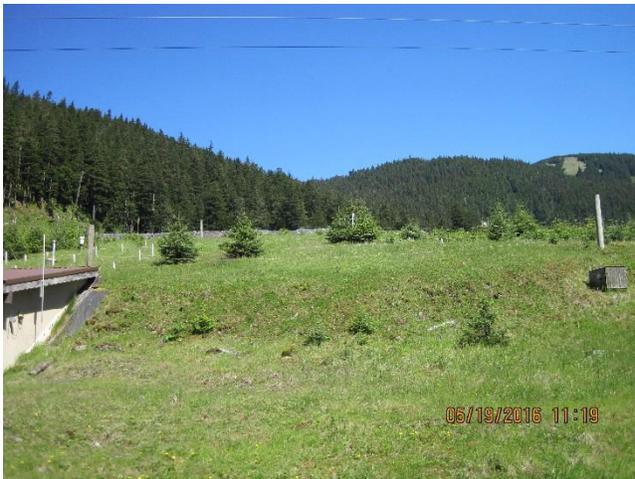
The Site 23 test cover is a one-acre test of a reclamation cover design. (Photo 17). The Site 23 test cover building is for monitoring pH, water chemistry, infiltration, and drainage from the test cover area (Photo 18). This site was clean and in order.

Photo 17. Site 23 reclamation test cover.

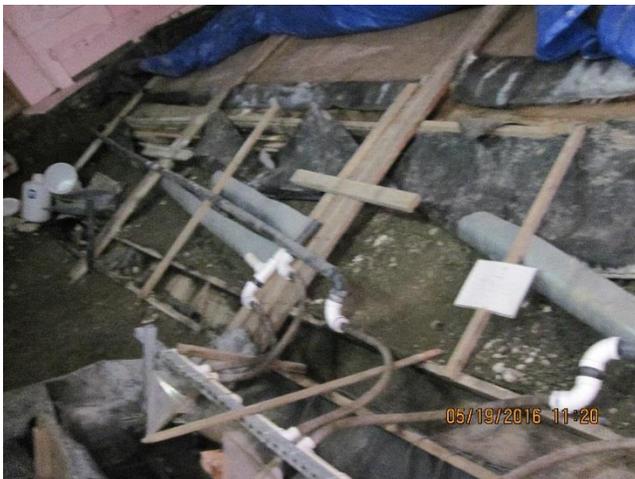
Photo 18. Site 23 test cover building.

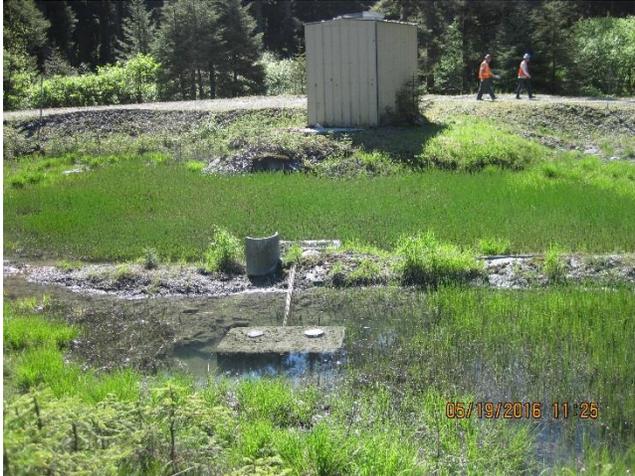
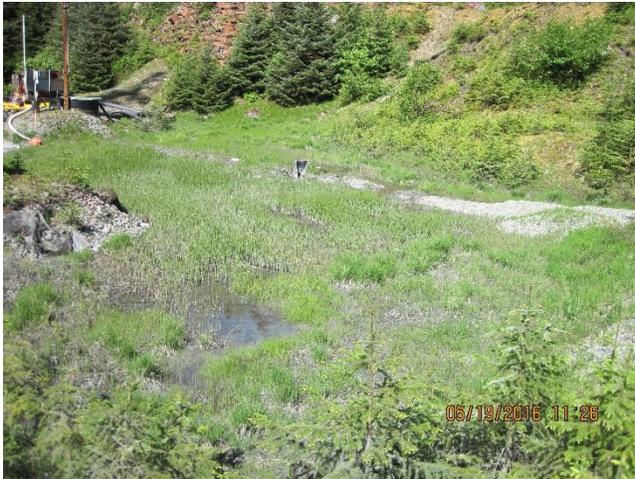
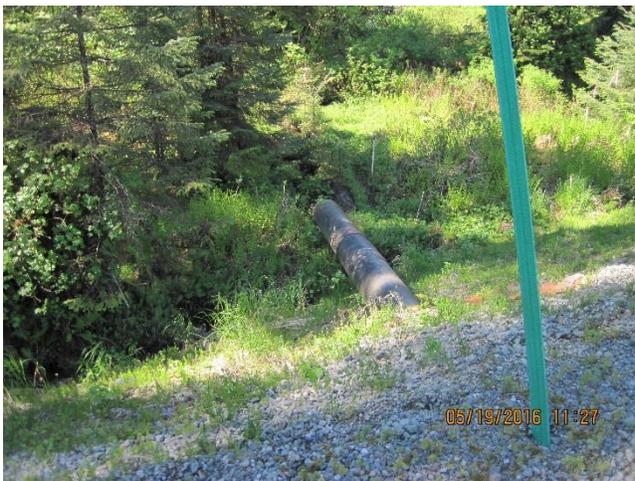
Pond D is the location for the APDES outfall 006. On May 6, 2016 during a large storm event, the main electric pump at Pond D failed. This failure may be a result of overloading the pumps workload capacity, which caused storm water to overwhelm Pond D (Photos 19-21). The discharge of water was approximately 300,000 gallons of storm water over a twelve-hour period. The discharge was reported to the Alaska Department of Environmental Conservation (ADEC) as a precautionary step, as water does not routinely discharge at this outfall location. When the results of subsequent water quality testing were completed, HGCMC reported the exceedance to ADEC as a non-compliant discharge. The concern was that the discharged storm water contained elevated lead concentrations. The lead concentration limit, according to the Alaska Water Quality Standards, is 6.44 µg/L (for chronic aquatic life). The sample result was 14.7 µg/L. HGCMC currently has a diesel powered pump in place at Pond D until the electric pump is repaired. The Forest Service recommends that HGCMC put in place a mitigation strategy to prevent electrical/mechanical failures for all water pumps at the mine.

Photo 19. Pond D

Photo 20. Pond D area.

Photo 21. Pond D Outfall 006 drainage pipe adjacent to a wetland.

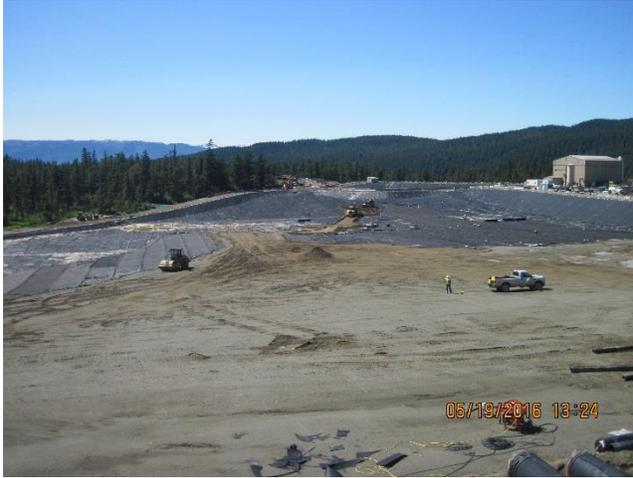
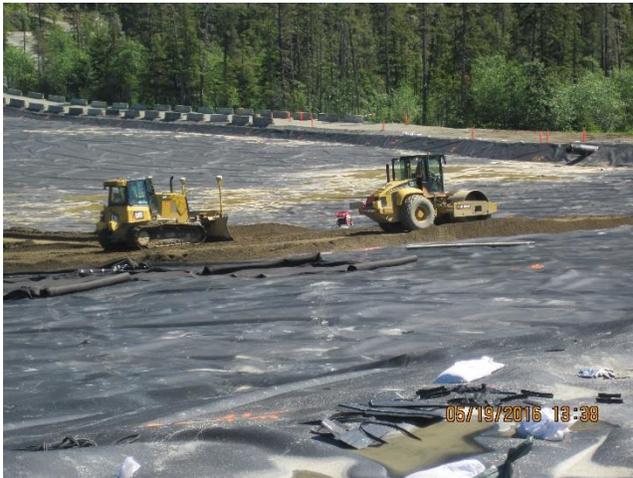
The TDF expansion is currently underway with SECON installing HDPE liners for the base of the TDF (Photos 22-23). HGCMC also installed drainage systems for under liner flow, above liner flow and drainage systems for an inner ditch and outer ditch. The drainage systems will divert water to four caissons (Photo 24). From there, all contact water will be pumped to Pond 7. HGCMC also constructed a TDF perimeter ditch for non-contact water (Photo 25).

Photo 22. HDPE liner installation at the TDF expansion site.

Photo 23. Zoomed in image of the HDPE liner installation.

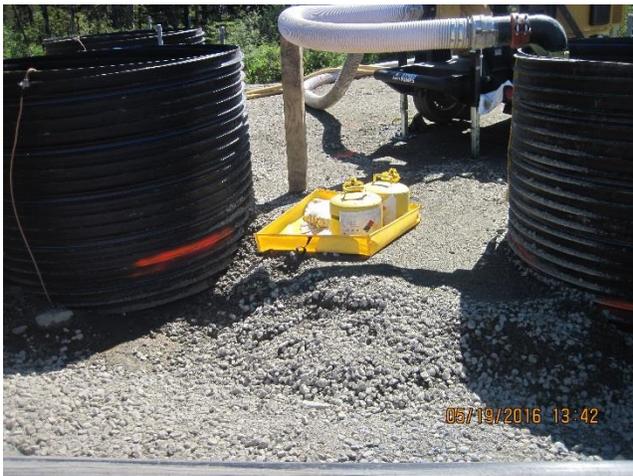
Photo 24. Two of the four caissons used for water management in the TDF expansion.

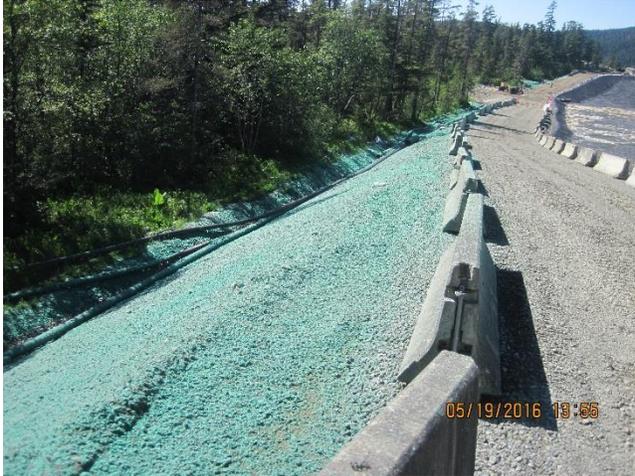
Photo 25. Perimeter ditch system designed to collect non-contact storm water.

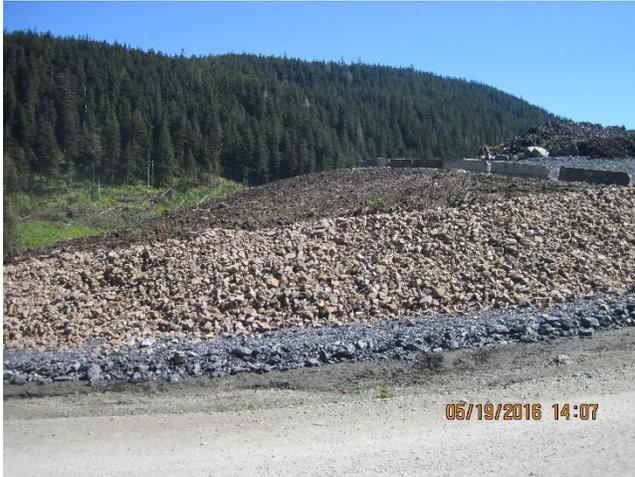
The excavated material from the TDF expansion was relocated to the northern section of the TDF (Photo 26). HGCMC eventually plans to use the excavated material as reclamation material for tailings disposal.

Photo 26. Excavated material stockpiled at the northern section of the TDF.

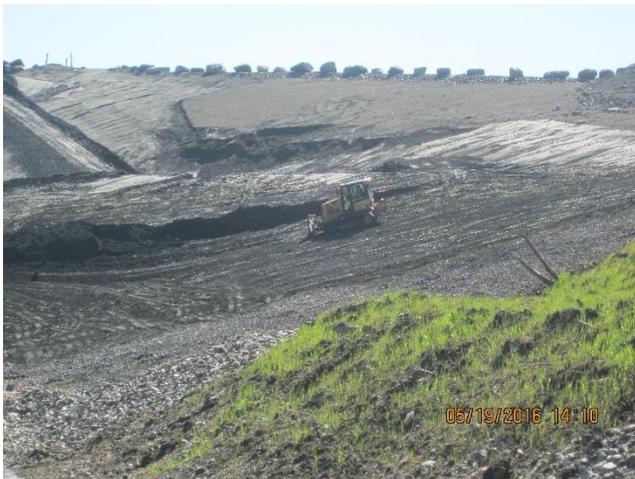
Near Pond 9, HGCMC personnel were removing tailings along an old road within the TDF to improve contact water drainage (Photo 27).

Photo 27. HGCMC personnel excavating tailings to improve contact water drainage into Pond 9.
