APDES INSPECTION REPORT

Section 1: General Data

Name of Facility: Hecla Greens Creek Mine Tailings Storage Facility

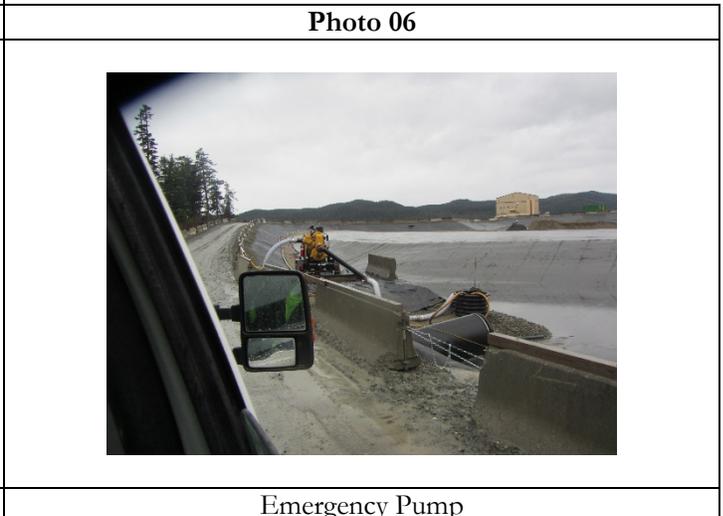
Emergency Pump

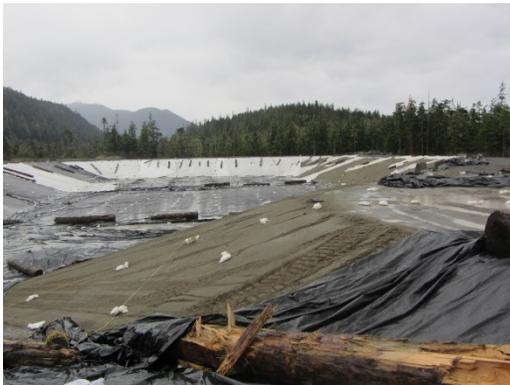
Photo 07

- No sheen or scum was observed.
- Temporary pumps and emergency pumps are installed and accessible.
- Pond 10 has temporary plastic stabilization.
- Some of the plastic tore during a windstorm.
- Gullies are developing on the slopes facing towards the wetlands.

Temporary Stabilization and Wind Torn Liner

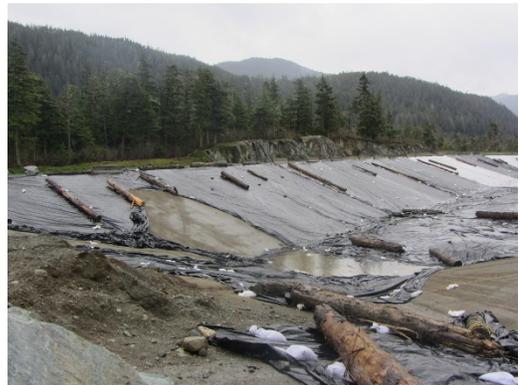
Photo 08

Temporary Stabilization and Wind Torn Liner

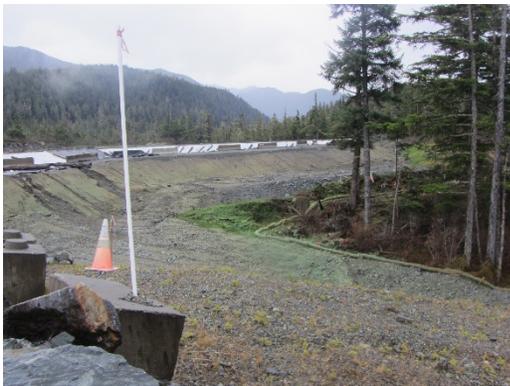
Photo 09

Slope Erosion
