INSPECTION REPORT: GREENS CREEK MINE

Date of Inspection: Friday November 18, 2016
Date of Report: Thursday December 1, 2016
USDA Forest Service Inspector: Richard Dudek

This inspection included A/B access roads, 1350 area, 920 area, Site 23, 7.4 mile B-road Bridge, Fish Pass, Falls Creek Bridge, Zinc Creek Bridge, Tailings Disposal Facility (TDF), Pit 7, and the 1.4 mile A-Road Sand Pit.

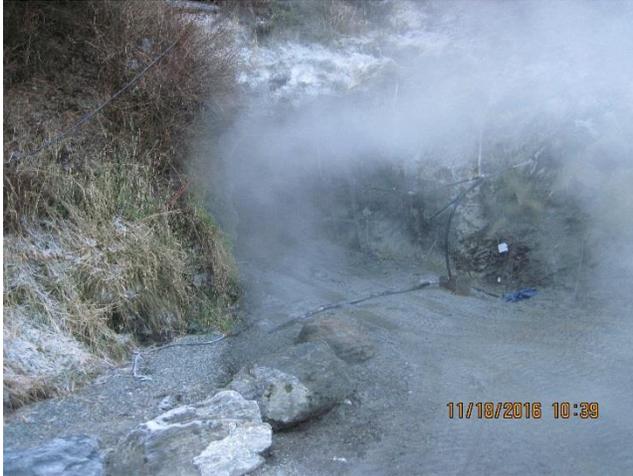
HGCMC Surface operations (Photo 1) are properly maintaining the 1350 adit. A pump for the 1350 caisson was removed to prevent ice damage during the winter (Photo 2).

Photo 1. 1350 adit used for mine ventilation and as a secondary escape way.

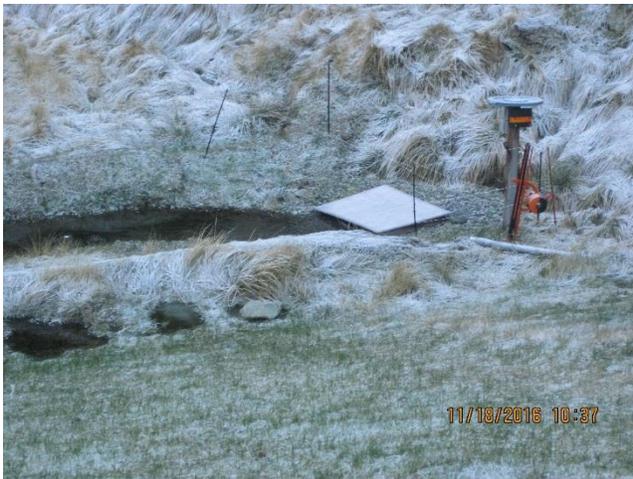
Photo 2. 1350 caisson's pump was removed for the winter.

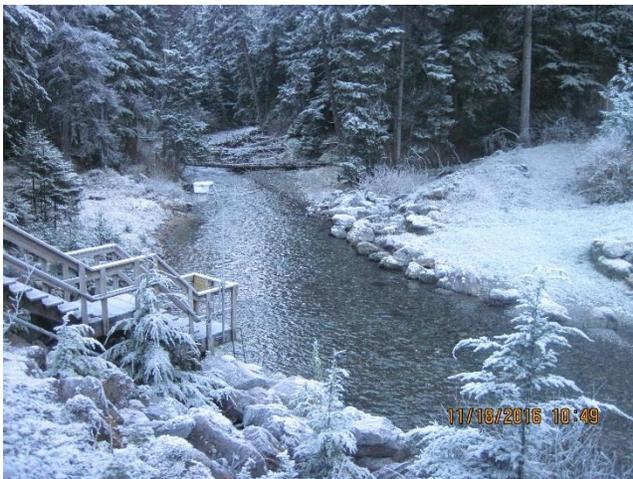
The flow rate for Greens Creek (Photos 3-4) on 11/18/2016 was 32.4 cubic feet per second (cfs). The 920 Bridge (Photo 5) is being maintained by HGCMC Surface operations. The 920 warehouse storage containers (Photo 6) were tidy and all chemical and petroleum products were properly stored within secondary containment (Photo 7).

Photo 3. Greens Creek (920 area).

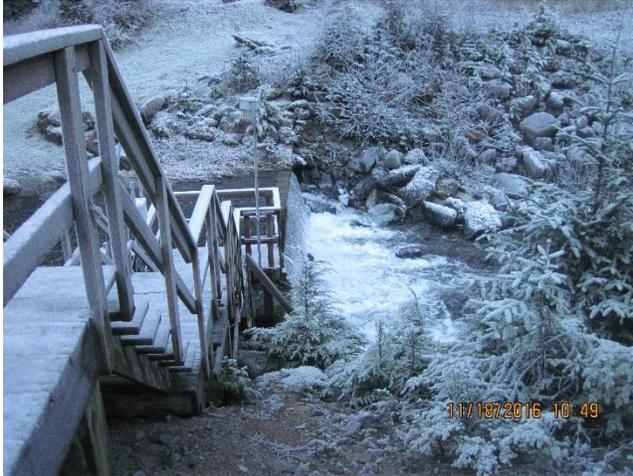
Photo 4. Greens Creek weir located at the 920 area.

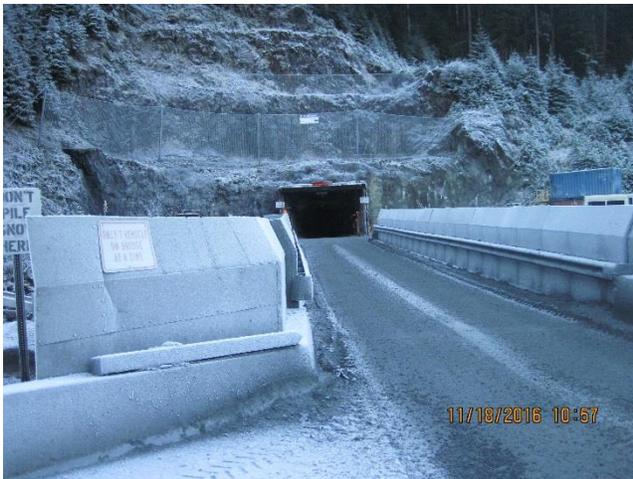
Photo 5. 920 bridge and adit.

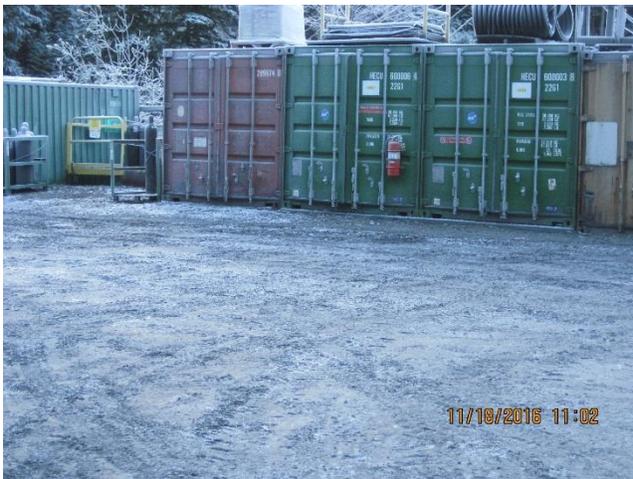
Photo 6. 920 warehouse area. All the storage containers were tidy.

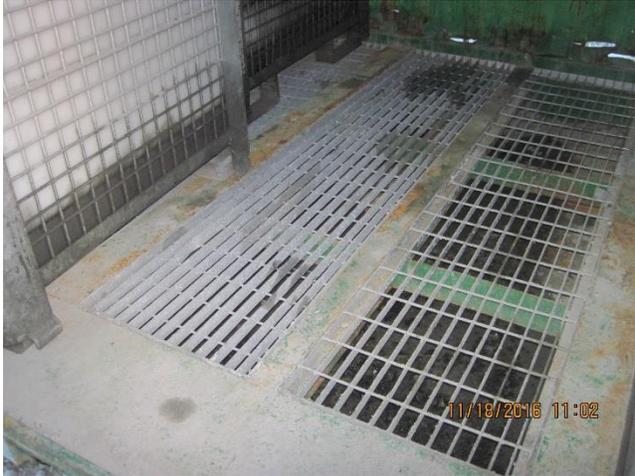
Photo 7. 920 warehouse chemical storage container with secondary containment.

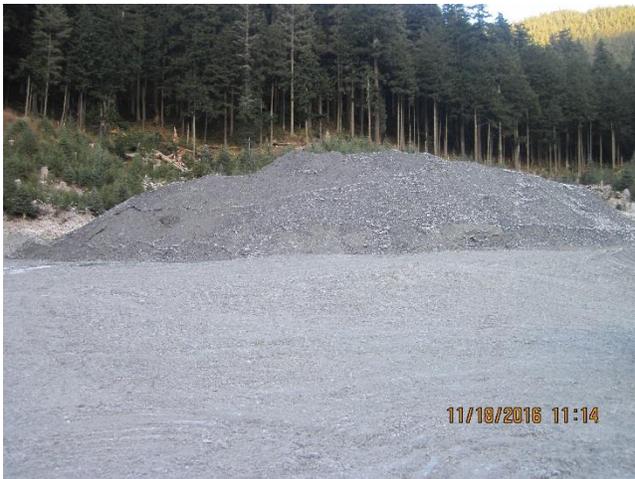
Site 23 is currently the only active location for waste rock storage. The Class-1 (Photo 8) waste rock is stockpiled separately from the Class-2 and 3 waste rock (Appendix 1 Integrated Monitoring Plan page 3-1). During the site visit, a bulldozer (Photo 9) was compacting Class-2 and Class-3 waste rock in the active lift area.

Photo 8. Site 23 Class-1 waste rock stockpile.

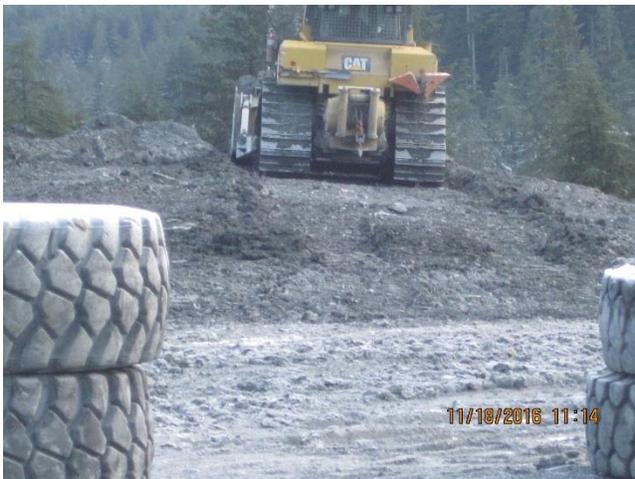
Photo 9. Class-2 and 3 waste rock stockpile.

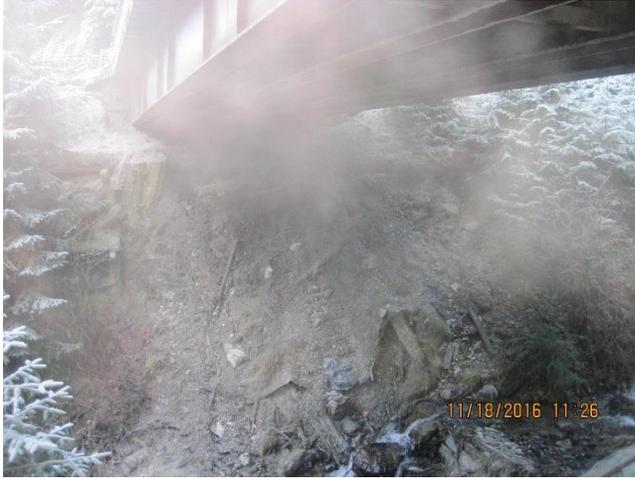
Photo 10. 7.4 mile B-road Bridge (Killer Creek Bridge).

It was identified in previous inspections that a silt fence on the downhill side abutment (Photos 10) needs to be replaced in order to prevent sediments from flowing into Killer Creek. HGCMC is aware of this issue, and are currently investigating mitigation options. The liner underneath the bridge on the uphill side abutment (Photo 11) is in good working condition. HGCMC Surface operations continue to monitor sediment accumulation. Sediments are removed when accumulation is greater than 50 percent of the structure's design depth (2015 BMP Plan Appendix 5 page BMP 24-25).

- 7.4 mile B-road Bridge: Repair or replace liner on the downhill side abutment.
- 7.4 mile B-road Bridge: Remove sediment accumulation on the splashguard rails.
- Falls Creek Bridge: Sand bags washed out, some sand bags remain downstream of the bridge.
- Falls Creek Bridge: Remove sediment accumulation on the splashguard rails and underneath the bridge.
- Zinc Creek Bridge: White precipitate was observed in the abutment drain.

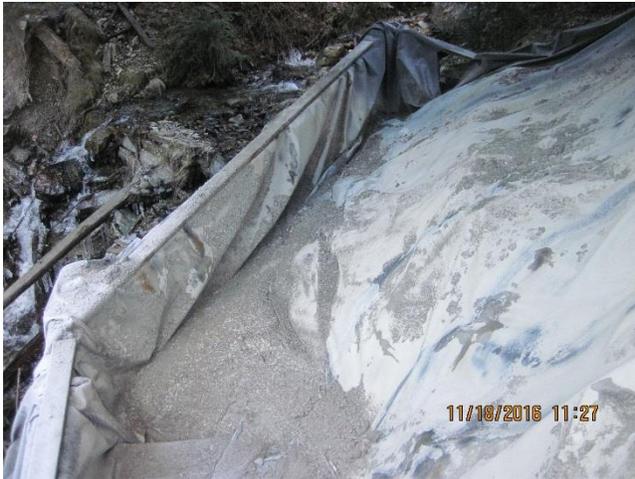
Photo 11. A liner is in place underneath the uphill side of the bridge.

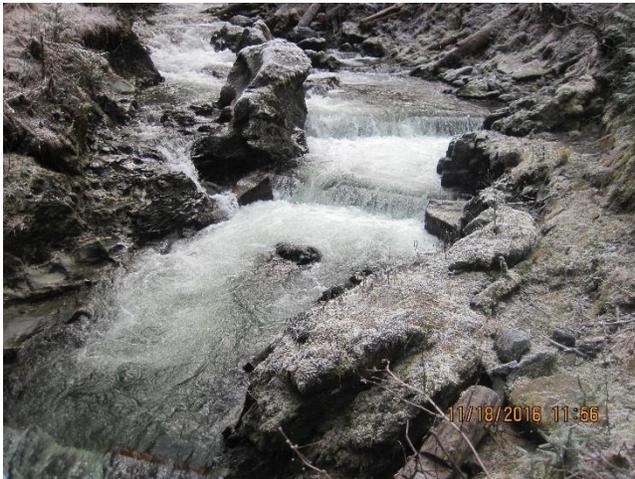
Photo 12. Greens Creek Fish Pass.

The reconstruction of the fish passage on Greens Creek (Photo 8) was a required mitigation included in 2013 TDF Expansion Final Environmental Impact Statement and Record of Decision. The construction included the installation of three concrete, steel-capped weirs (Photos 12-13). In 2012, the Alaska Department of Fish and Game (ADF&G) issued a fish permit (FH-11-1-0123) to HGCMC. This permit gives HGCMC the authorization to maintain the fish pass in perpetuity. Prior to the reconstruction of the fish pass, Bio-monitoring observed juvenile Coho 3 miles upstream of the fish pass. Yearly Bio-monitoring at Greens Creek will continue upstream to determine the success of fish passage.

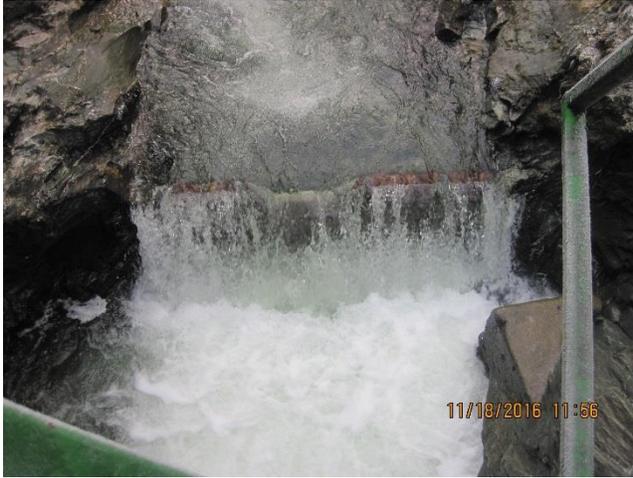
Photo 13. Image shown is one of three weirs at the Fish Pass.

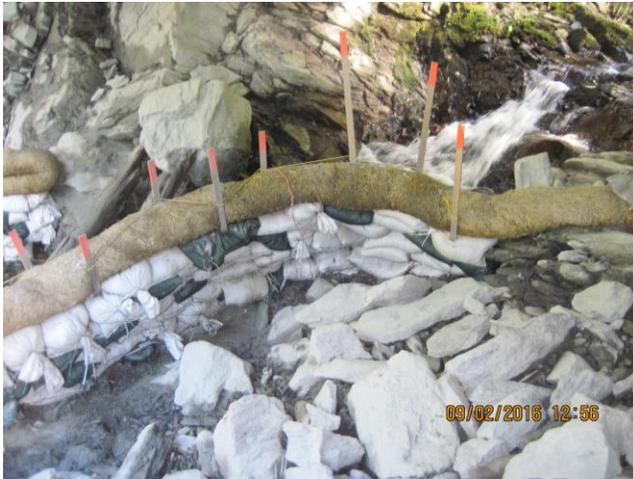
Photo 14. Image is from a previous inspection on 9/02/2016 at Falls Creek Bridge.

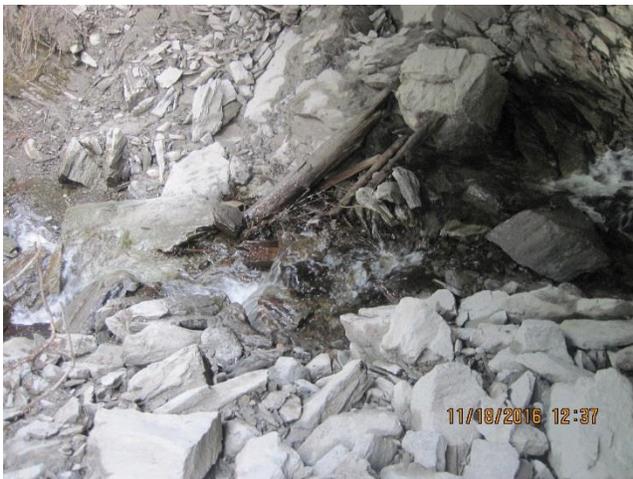
Sand bags were installed underneath the bridge (Photo 14) as a mitigation to prevent sediments from entering Falls Creek. During an inspection on 10/07/2016, it was documented the sand bags were washed out (Photo 15). HGCMC is currently investigating the safest method for removing the washed out sand bags. HGCMC will continue to monitor sediment accumulation underneath the bridge and remove the sediments when necessary. Surface Operations are maintaining a temporary barrier (Photo 16), on the downhill/streamside of the bridge. This barrier complies with the BMP recommendations for silt fencing (2015 BMP plan page BMP 12-13). Although a long-term solution is desired, this temporary barrier has shown to be effective.

Photo 15. Sand bags underneath Falls Creek Bridge were washed out.

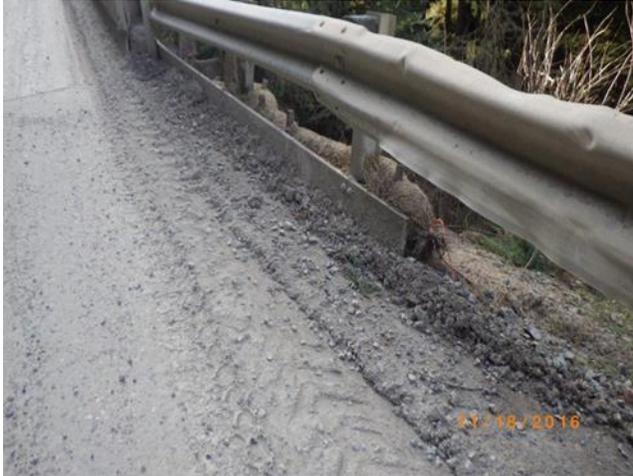
Photo 16. A temporary wooden barrier located on the downhill/downstream side of Falls Creek Bridge.

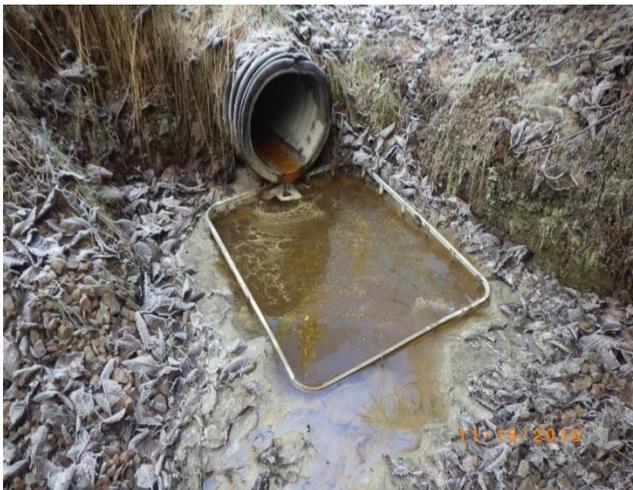
Photo 17. 3.1 mile B-road removable sediment screen.

The 3.1 mile B-road removable sediment screen (Photo 17) should be frequently monitored to prevent turbid water runoff. The screen is replaced when sediment accumulation is 50 percent of the design structures depth (2015 BMP plan Appendix 5 page 24-25). HGCMC recently installed weed free straw wattles (Photo 18) near the standpipe drain. The straw wattles will help filter out sediments from the drainpipe prior to entering the forest. A small amount of a white precipitate was observed at the uphill/downstream abutment drainpipe (Photo 19). HGCMC Environmental Operations are currently investigating the cause of the precipitate.

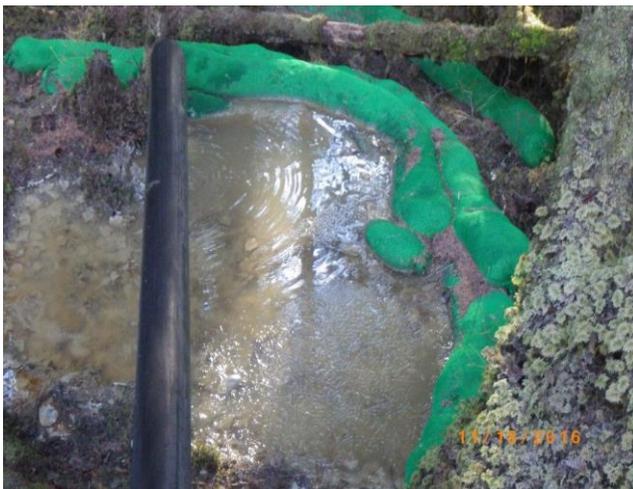
Photo 18. Weed free straw wattles installed near the standpipe drain.

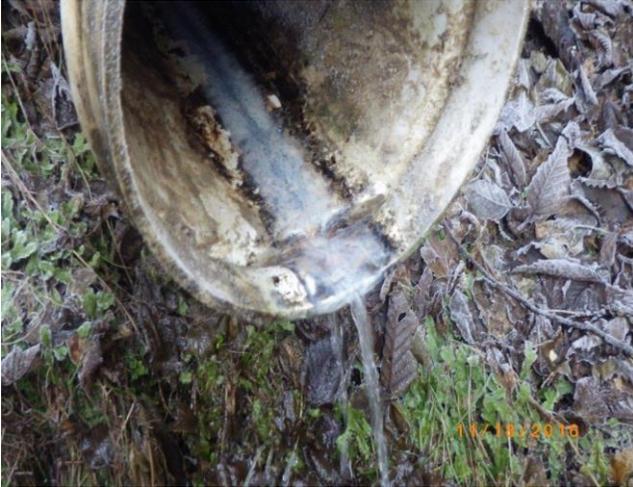
Photo 19. White precipitate observed in the Zinc Creek Bridge uphill abutment drain.

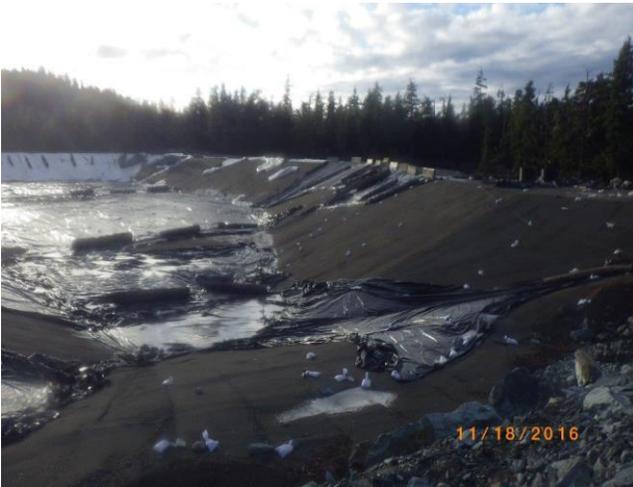
The temporary liner was installed at Pond-10 to prevent erosion and any reworking of the site this spring. Due to recent high winds, sections of a temporary liner have been separated (Photo 20). HGCMC continues to deposit tailings in the expansion area (Photos 21-22). Construction for Pond-10 has stopped, and contractors have moved off site for the winter.

Photo 20. Sections of temporary liner covering Pond-10 have separated.

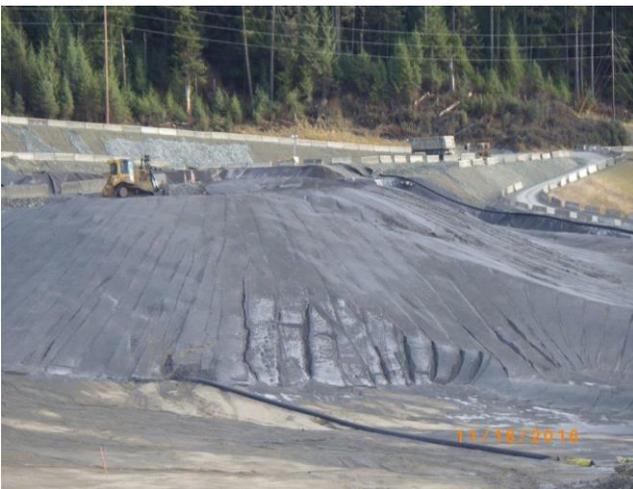
Photo 21. Tailings are being deposited in the TDF expansion area.

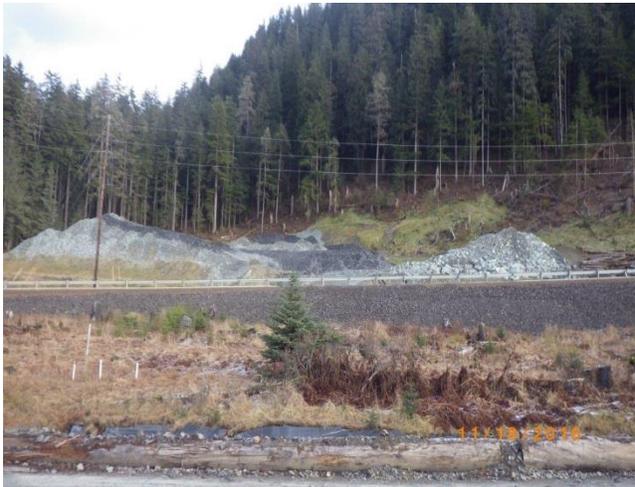
Photo 23. 0.9 mile B-road stockpile area.

The bedrock that was blasted out during the construction of Pond-10 is stockpiled at this location (Photo 23). The rock was crushed and will be used as fill material on the southern sections of the outer TDF access roads.

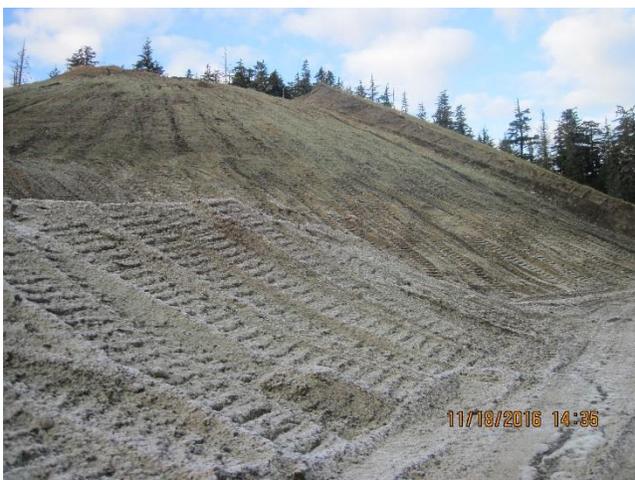
Photo 24. Pit 7 has been contoured and mulched.

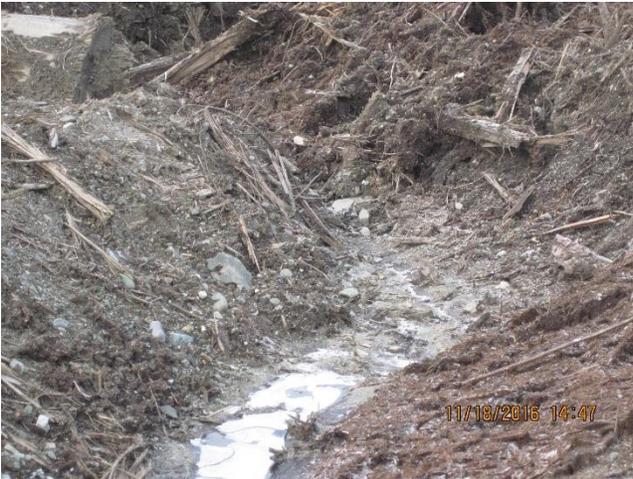
Photo 26. A trench at the Sand Pit is used for conveying stormwater runoff.

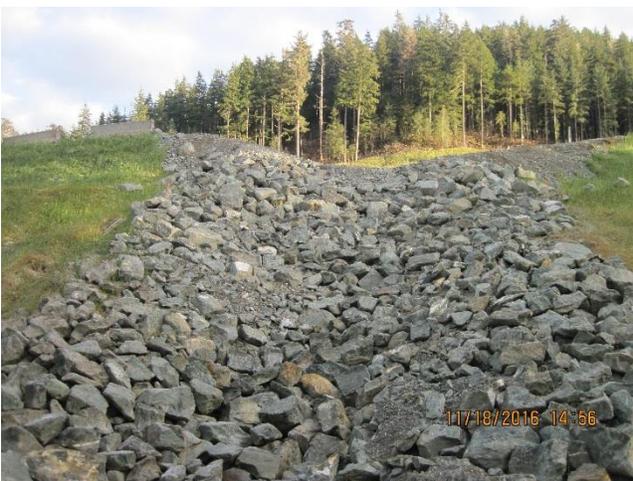
Photo 27. Riprap channel at the Sand pit is primarily used for filtering out sediments from stormwater runoff.

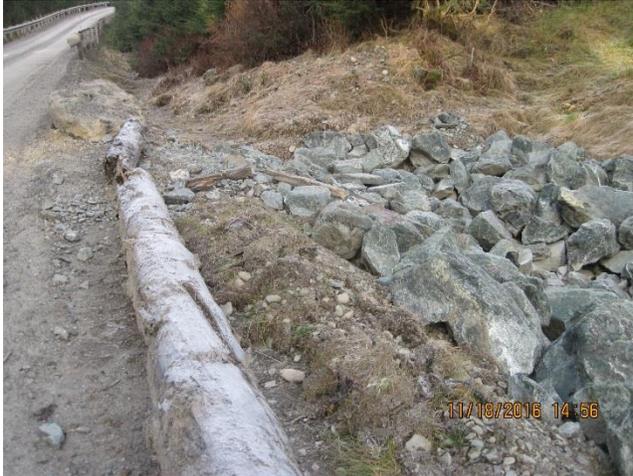
Photo 28. Stormwater runoff is routed from the riprap channel to a culvert, then into the forest duff.
