## INSPECTION REPORT: GREENS CREEK MINE

Date of Inspection: Friday, December 16, 2016  
Date of Report: Friday, January 6, 2017  
USDA Forest Service Inspector: Richard Dudek

Ranger District: Admiralty National Monument

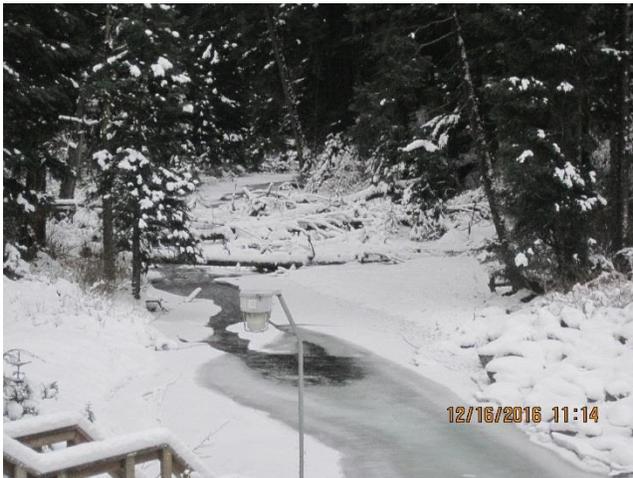
The flow rate for Greens Creek (Photo 1) on 12/16/2016 was 16.4 cubic feet per second (cfs). HGCMC Surface Operations are properly maintaining the 920 Bridge (Photo 2), DB-01 (Photo 3) and DB-02 (Photo 4). Sediments are captured in DB-01/02 and the melt water drains into Pond-A. The water is then routed to Pond-7 for treatment and discharged under the APDES permit. The material stockpiled at the 920 recycling laydown is being reduced (Photo 5-6). Not all material is able to be recycled. Some material may have lead levels that prevent recycling and is utilized as underground backfill. Material with no lead levels is shipped offsite for recycling. The 920 warehouse storage vans are tidy and all chemical and petroleum products are properly stored with secondary containment (Photo 7).

**Photo 1. 920 area Greens Creek.**

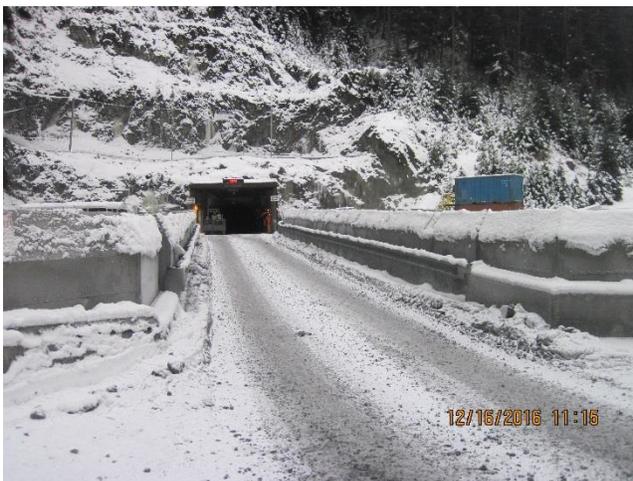
**Photo 2. 920 Bridge and 920 portal.**

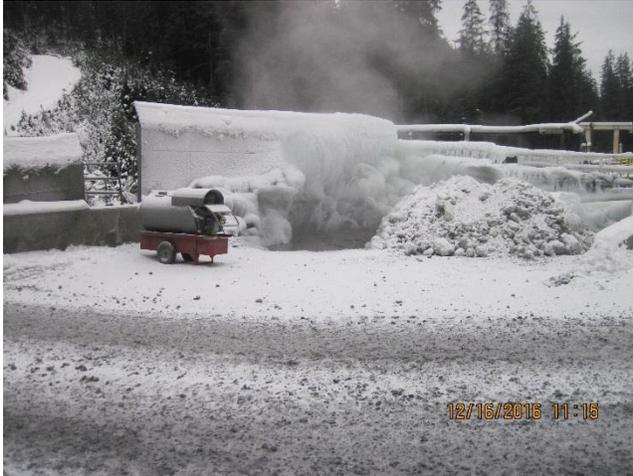
**Photo 3. DB-01 with snow mixed with sediments from plowing. The sediments are captured and the melt water drains into 920 Pond-A.**

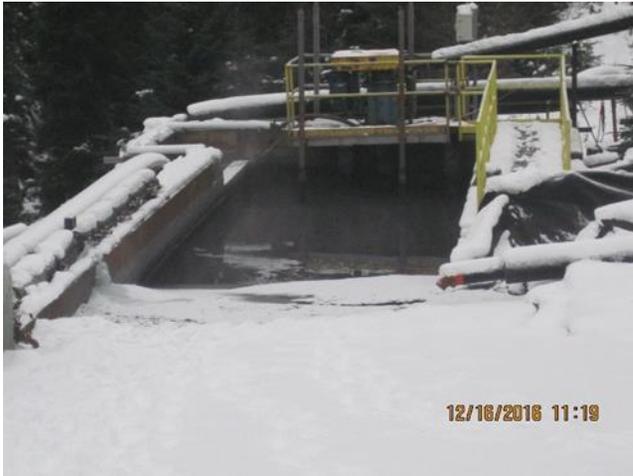
**Photo 4. DB-02 sediments are captured and the water drains into 920 Pond-A.**

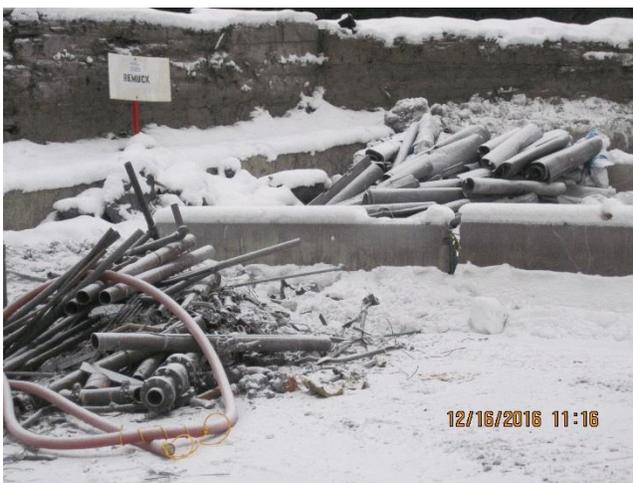
**Photo 5. 1 of 2 images for the 920 recycling laydown.**

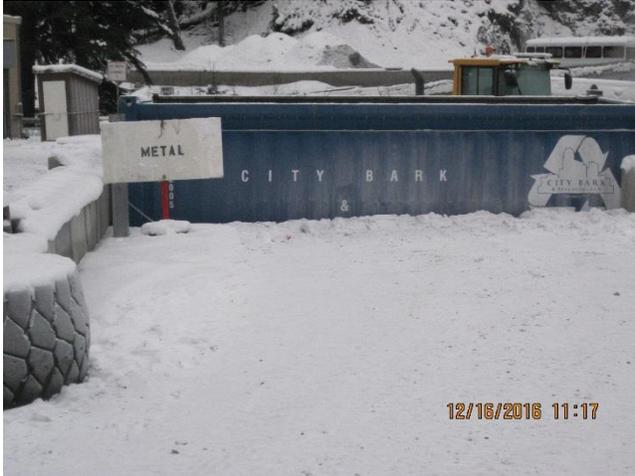
Photo 6. 2 of 2 images for the 920 recycling laydown.

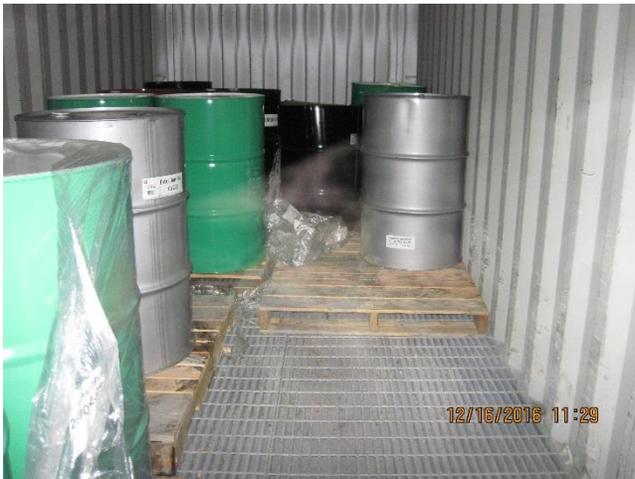
Photo 7. A 920-area storage container with secondary containment.

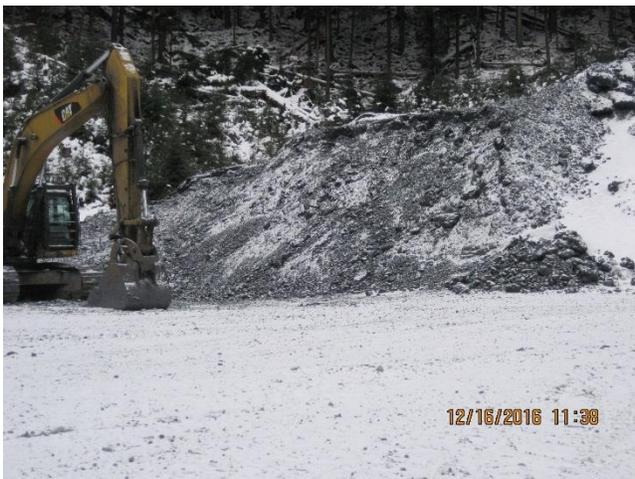
Class-1 waste rock (Photo 8) stockpile is utilized on the outer slopes of the TDF. Since the previous inspection on (11/18/2016), additional Class-2 and Class-3 waste rock has been stockpiled (Photo 9) at this location (Appendix 1 Integrated Monitoring Plan page 3-1). Surface Operations properly maintaining DB-03 (Photo 10). Sediments are captured in DB-03 and the melt water drains into Pond-23. From there, the water is routed to Pond-7 for treatment and discharged under the APDES permit.

Photo 8. Site 23 Class-1 waste rock.

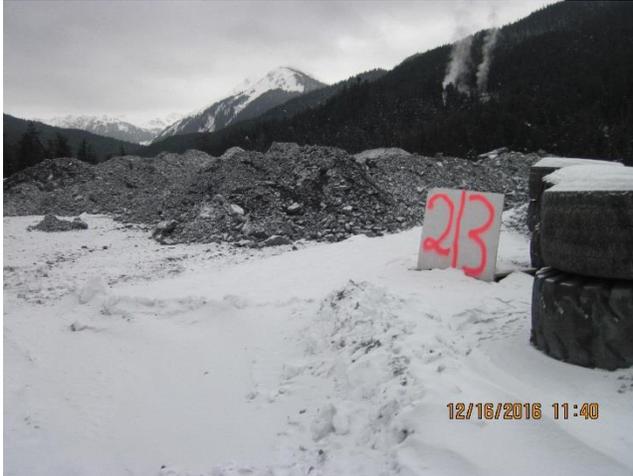
Photo 9. Site 23 Class-2 and 3 waste rock.

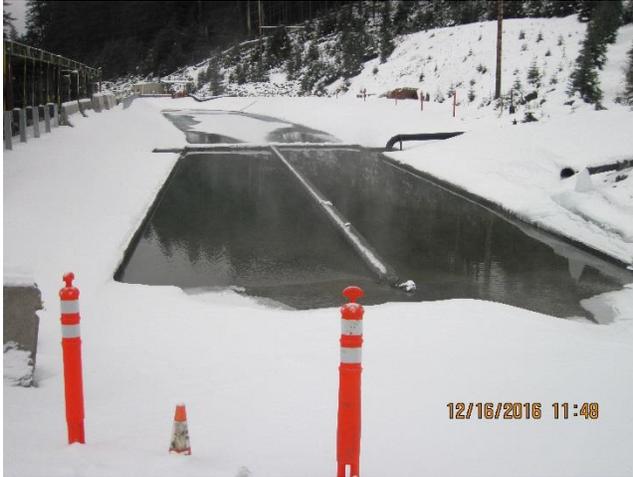
Photo 10. DB-03 at Pond-23.

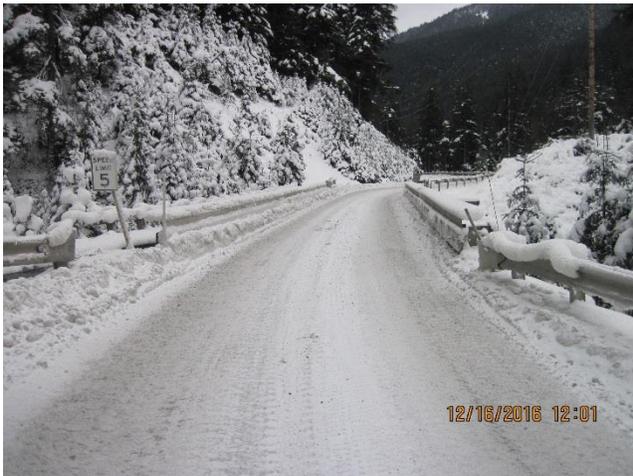
HGCMC Surface Operations are properly maintaining and plowing snow from the bridge decking during the winter months (Photo 11). Below the bridge, Killer Creek was mostly covered in snow and ice (Photo 12).

Photo 11. 7.4-mile B-road Bridge (Killer Creek Bridge).

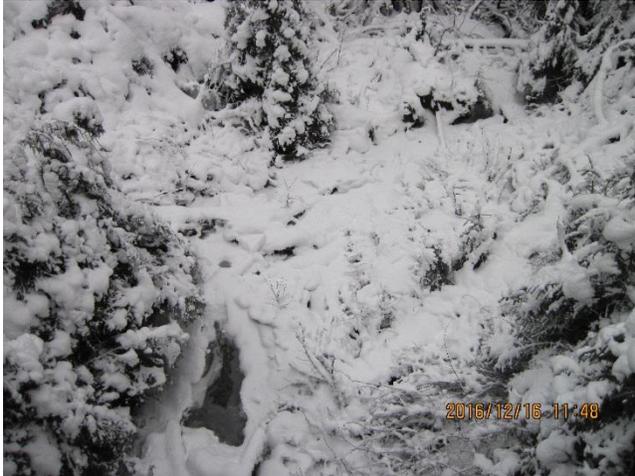
**Photo 12. Killer Creek covered in snow and ice.**

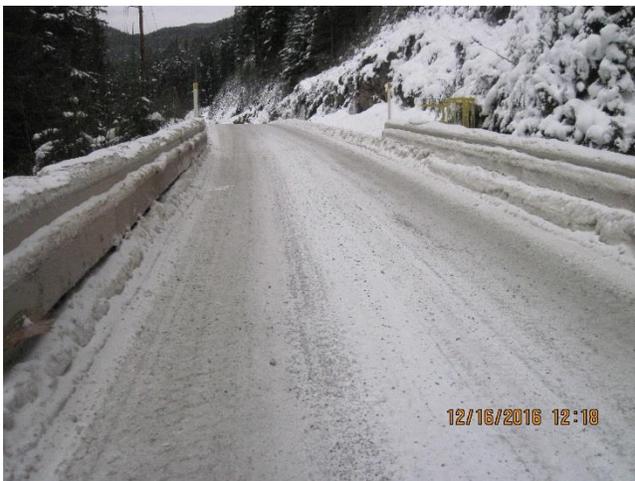
HGCMC Surface Operations are plowing snow from the bridge decking (Photo 13). Below the bridge, Falls Creek was mostly frozen over and covered in snow. It was documented in inspection report 377 the sandbags and straw waddles below the bridge were washed out. Some sandbags were washed downstream and the removal of these sandbags will take place in the spring of 2017. HGCMC Environmental and Surface Operations are investigating the safest approach for removing the sandbags.

**Photo 13. Falls Creek Bridge.**

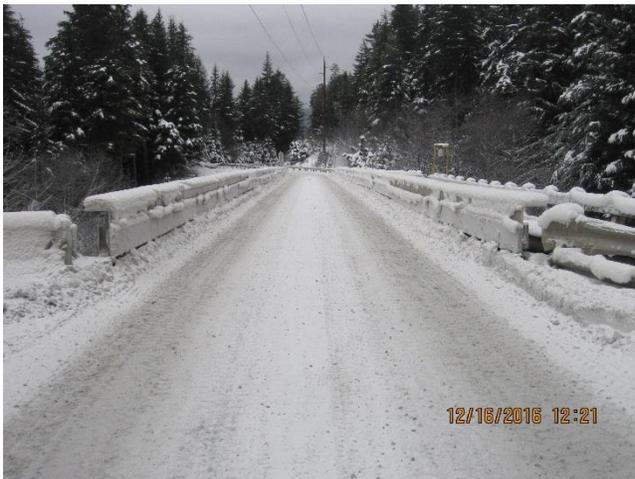
HGCMC Surface Operations are maintaining and plowing snow from the bridge decking (Photo 14). The 3.1-mile B-road removable sediment screen and other structural BMP's for mitigation are covered in snow (Photos 15-16). HGCMC is currently investigating the composition of the white precipitate found inside the abutment drain.

**Photo 14. Zinc Creek Bridge.**

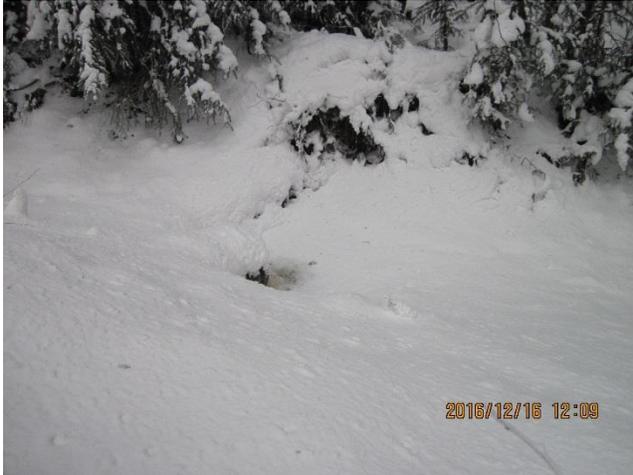
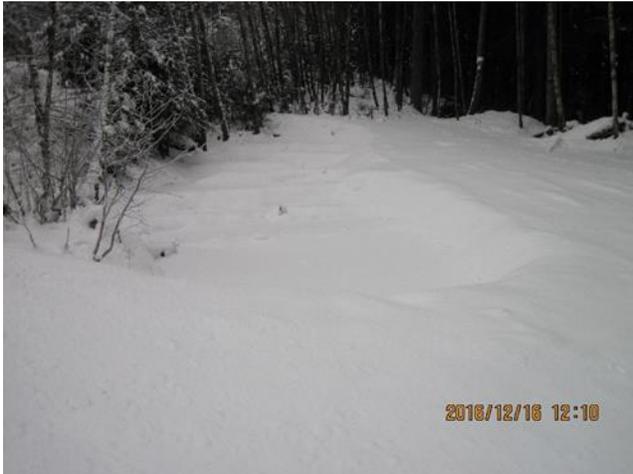
**Photo 15. 3.1-mile B-road removable sediment screen covered in snow.**

**Photo 16. Snow covered rock check dams and sumps for mitigations (Zinc Creek Bridge).**

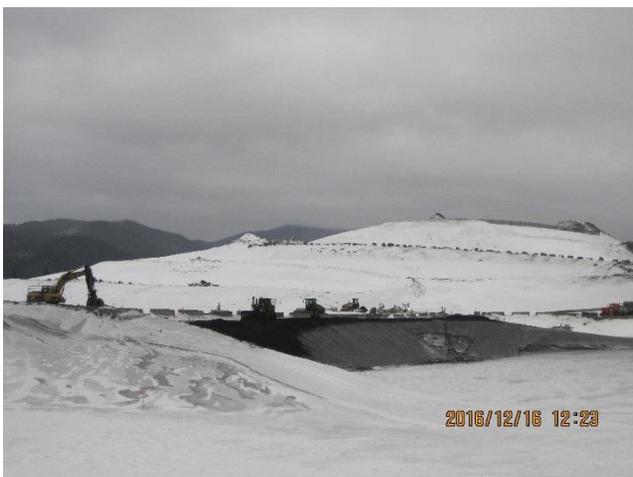
HGCMC continues placing tailings in the eastern (Photo 17) section of the S3P1 TDF expansion area. HGCMC is currently using a number of dust mitigation control measures such water, minimizing the active placement areas, and windscreens. HGCMC has positioned portable windscreens at the crest and at the south end of the TDF (Photos 19). Additional fixed windscreens have been positioned along the southern TDF perimeter access road concrete barriers (Photo 20). The TDF water treatment plant was tidy and in order (Photo 21).

**Photo 17. Tailings placement in the eastern section of the TDF expansion area.**

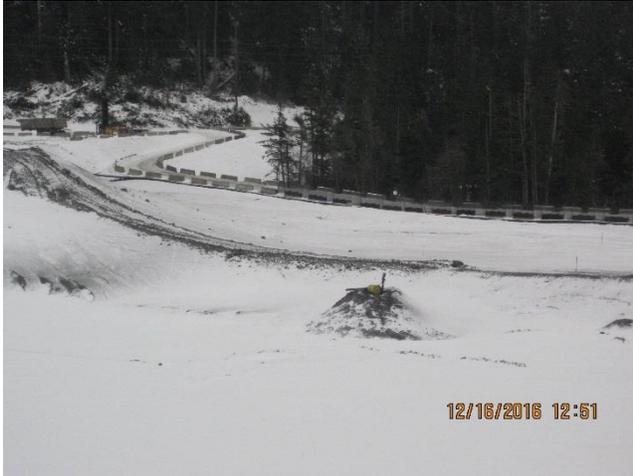
Photo 18. The western section of the S3P1 TDF expansion area.

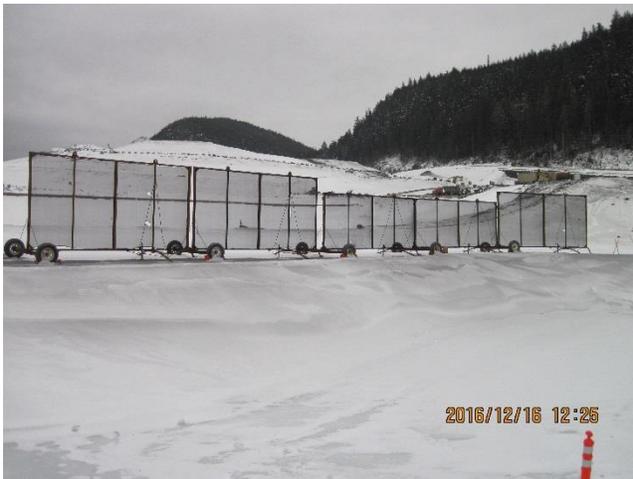
Photo 19. Portable windscreens are staged in the southern end of the S3P1 TDF expansion area.

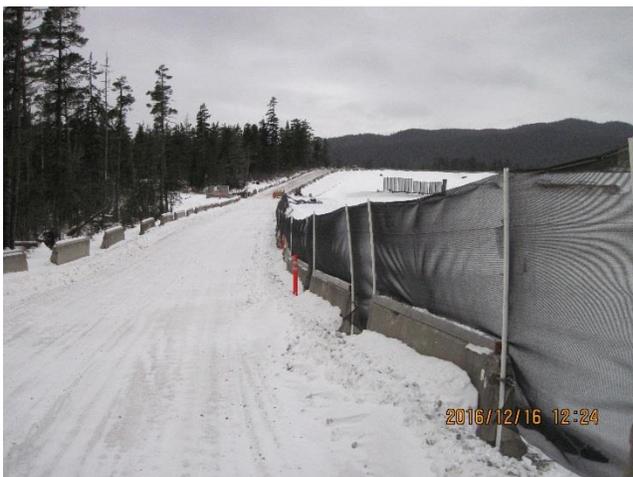
Photo 20. Fixed windscreens are positioned along the southern TDF perimeter access road.

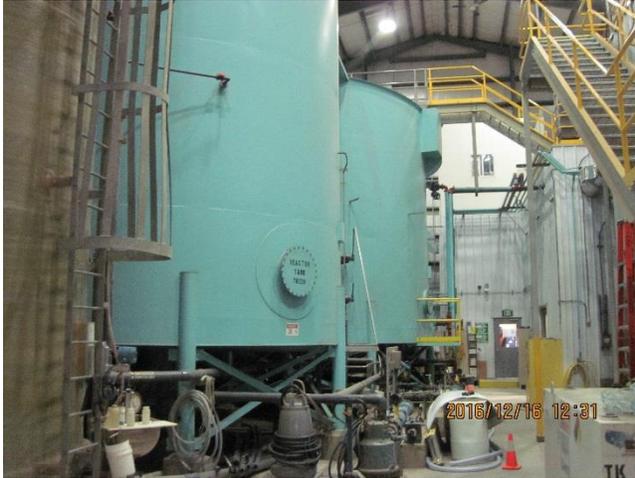
Photo 21. TDF water treatment plant.

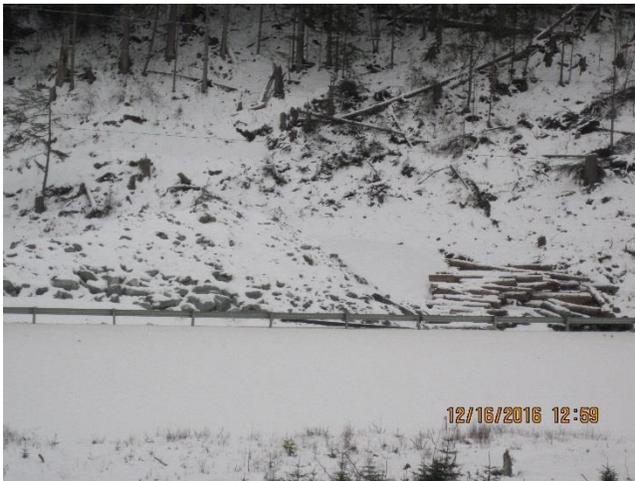
The 0.9-mile B-road rock storage area is currently inactive during the winter months (Photo 22).

Photo 22. 0.9-mile B-road rock stockpiles.

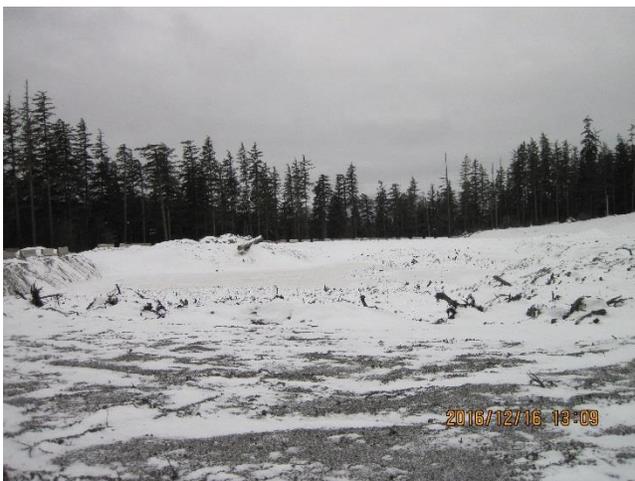
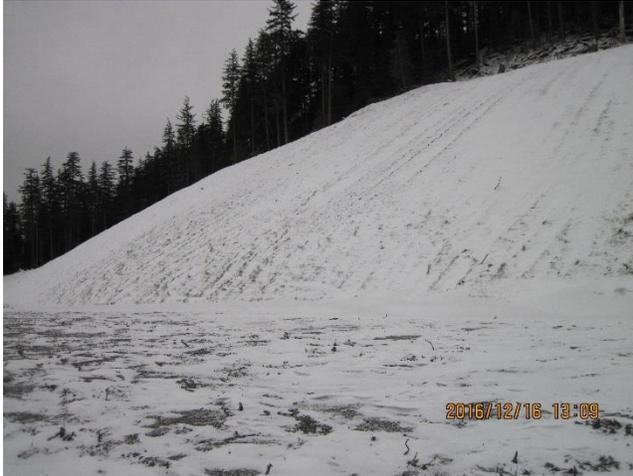
The Sand Pit is currently inactive during the winter months (Photos 23-24).

Photo 23. Sand Pit 1 of 2 images.

**Photo 24. Sand Pit 2 of 2 images.**
