**TAILINGS AND PRODUCTION ROCK SITE
2003 ANNUAL REPORT**

Kennecott Greens Creek Mining Company

December 2004

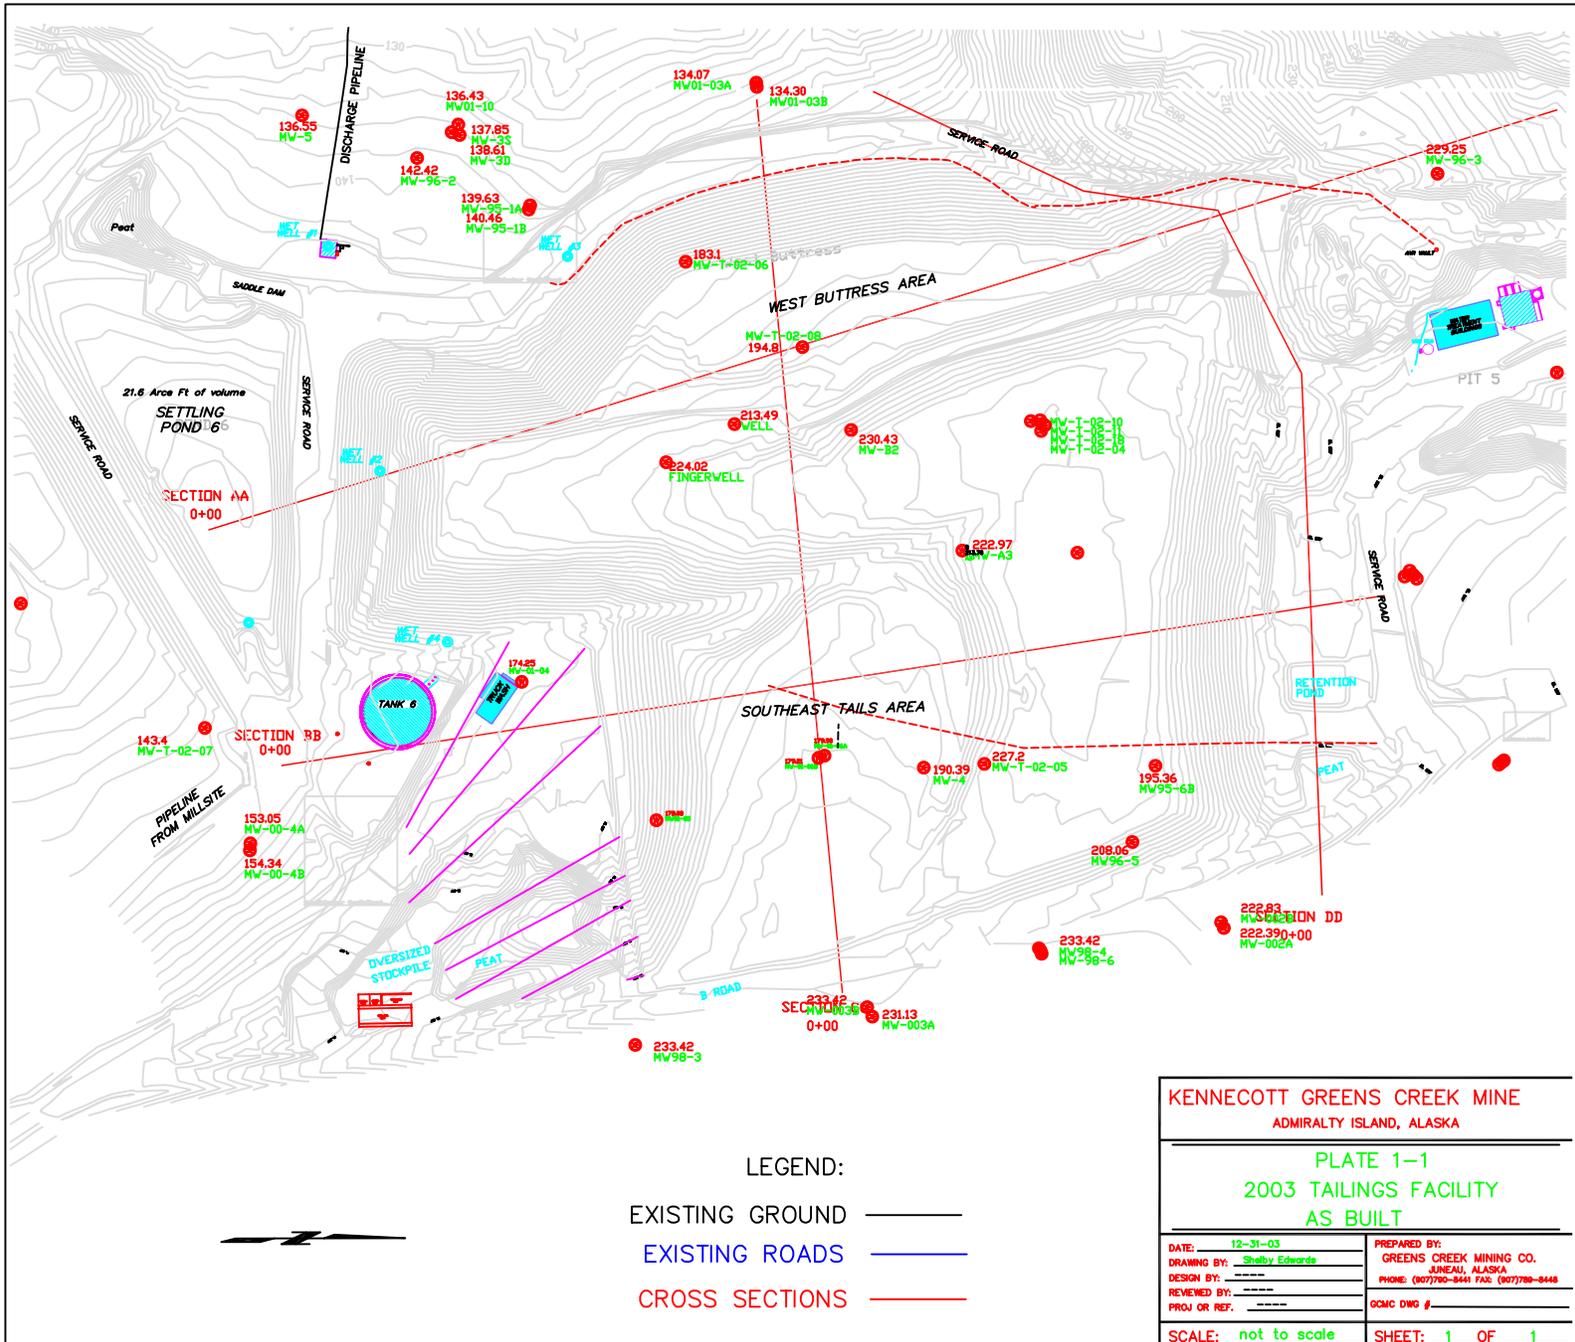
Tailings Facility 2003 As-built and Cross Sections

Section CC of the tailings facility as-built shows the inferred water table in the tailings pile. The maximum saturated thickness (approximately 45 feet) occurs near the center of the main portion of the pile. However, that water table level does not extend close to the down-slope toes of the pile. The foundation of the West Buttress and southern portion of the pile is well drained, as indicated by typically consistent unsaturated conditions in the blanket drains (MW-T-00-05A, Figure 2.14) and at the base of the West Buttress (piezometers 74 and 75 in Figures 2.8 and 2.9). Low head elevations near the pile toe maximize the pile's geotechnical stability. The head increases observed in 2003 appear to be localized and of short duration and should not have an adverse effect on pile stability; however, KGCMC will continue to monitor and evaluate these conditions closely.

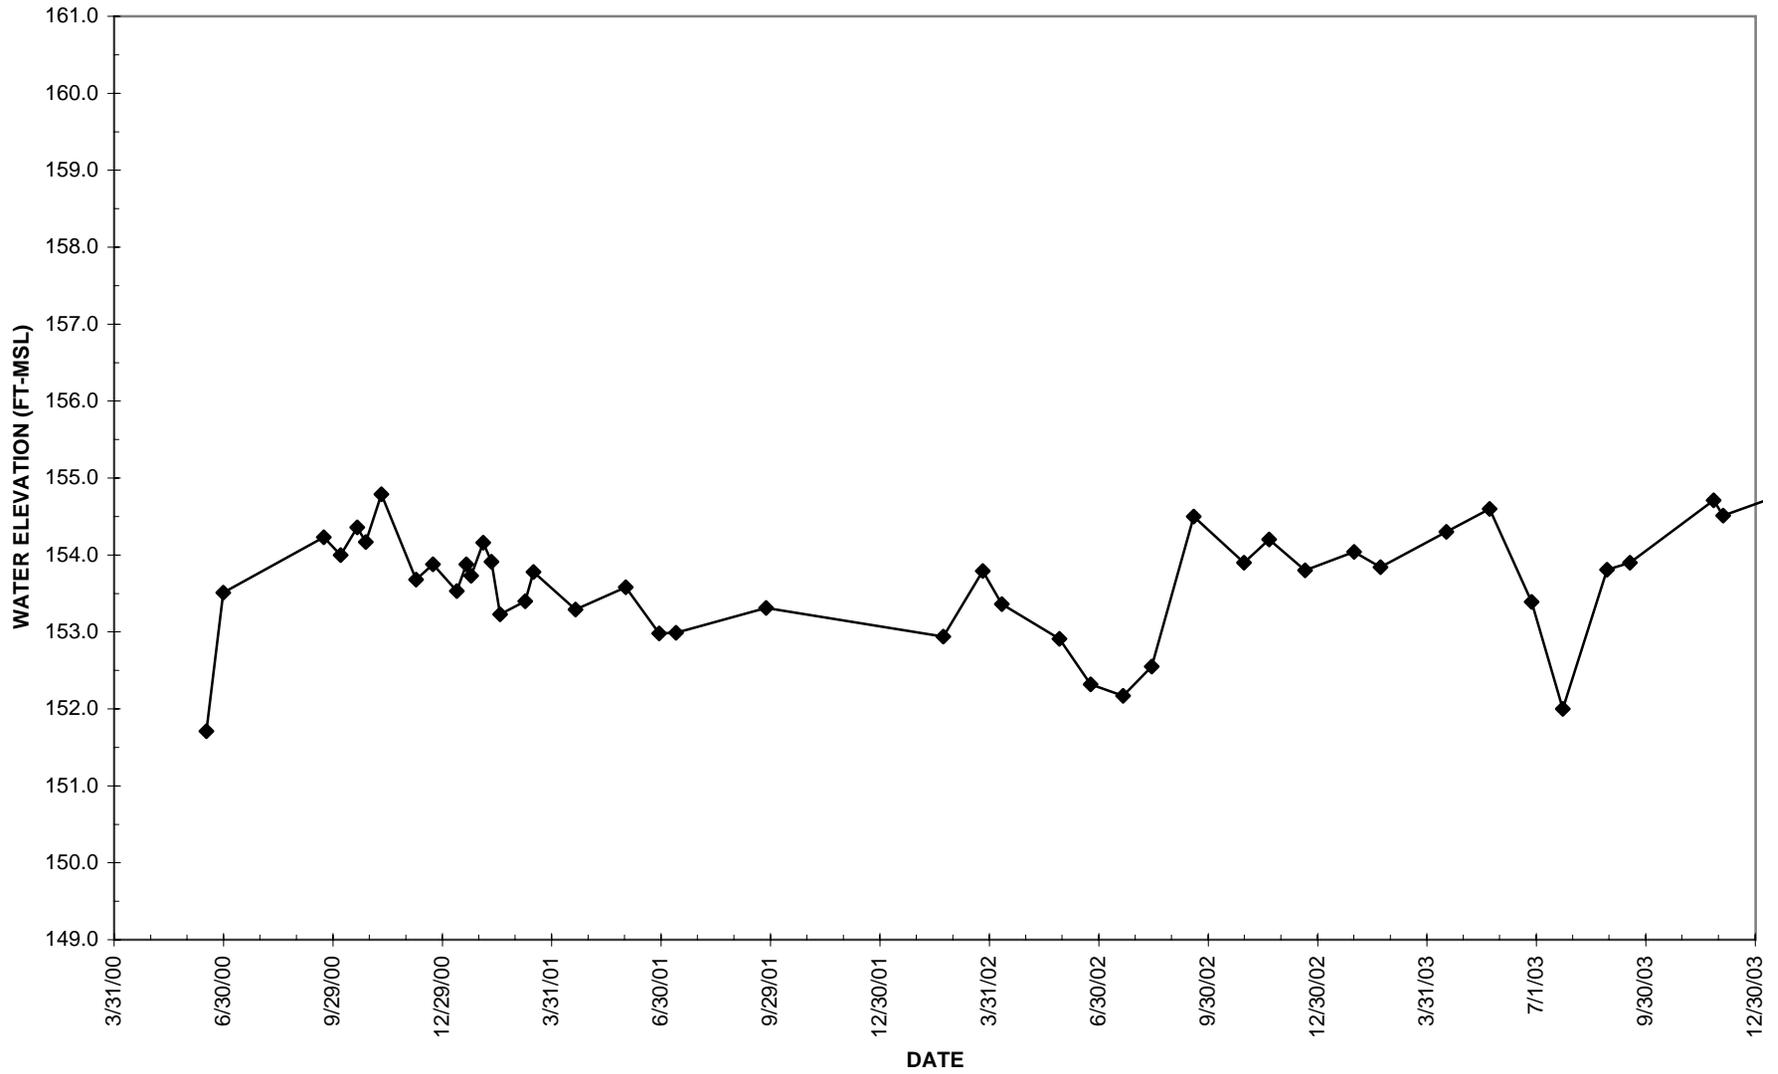
FIGURE 2.11 WATER LEVEL DATA FOR STANDPIPE PIEZOMETER PZ-T-00-01

The data from standpipe piezometers completed above the blanket drain (PZ-T-00-01, PZ-T-00-02, PZ-T-00-03 in Figures 2.11, 2.12, 2.13) indicate that the water perches above the unsaturated underdrains to a thickness of approximately 12 feet. This is consistent with the low permeability of the tailings and the un-capped condition of the pile. Covering the pile will help minimize the saturated zone in the pile. This was demonstrated by the 10+ foot decrease in the water table that occurred from 1995 to 1997 when the pile was covered (see Figures 2.1 to 2.7). Water levels have rebounded to, and in some cases above, 1994 elevations in most areas. Areas where water levels exceed their 1994 values are areas where the pile is considerably thicker than it was in 1994.

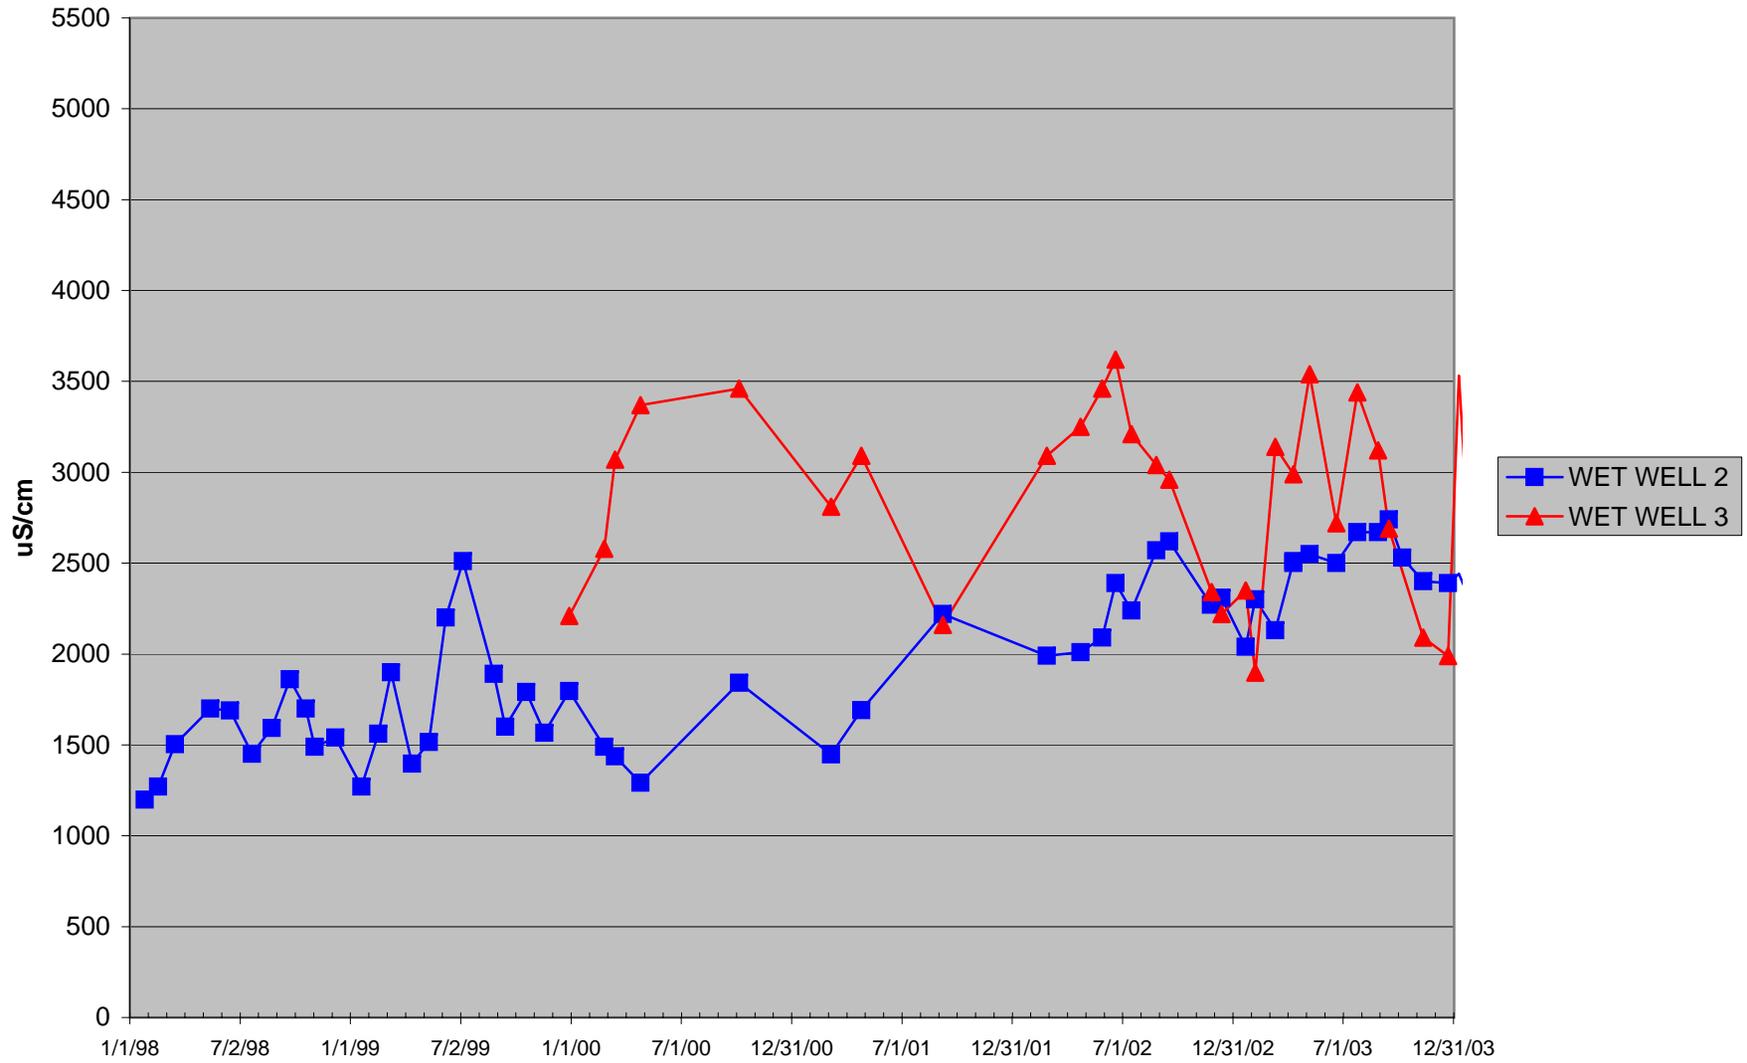
**FIGURE 2.22a GREENS CREEK TAILINGS INTERNAL MONITORING SITES:
WET WELLS - CONDUCTIVITY DATA**

The conductivity results from internal monitoring site waters are presented in Figure 2.22a, b, and c. 2003 conductivity measurements are between 1898 (wet wells) and 7350 (suction lysimeters) uS/cm. The higher conductivity of the site contact waters reflects a larger dissolved load caused by weathering of the tailings. Pyrite oxidation and carbonate dissolution contribute dissolved ions such as sulfate, bicarbonate, calcium and magnesium to the contact waters, increasing their conductivity. Wet Well 3 has a different capture area than Wet Well 2 and shows a different pattern with respect to conductivity. The changes in conductivity observed in Wet Well 3 probably reflect changes in the relative contributions from runoff, addition of the Northwest Diversion Ditch flow, infiltration and groundwater as the West Buttress was constructed. The suction lysimeters have conductivity values ranging from 3320 to 7350 uS/cm. Suction lysimeter samples are drawn from the smallest pore spaces of the unsaturated zone. Water held in these pores is often isolated from flow paths and thus has higher dissolved constituent concentrations than water from the saturated zone and foundation drains.

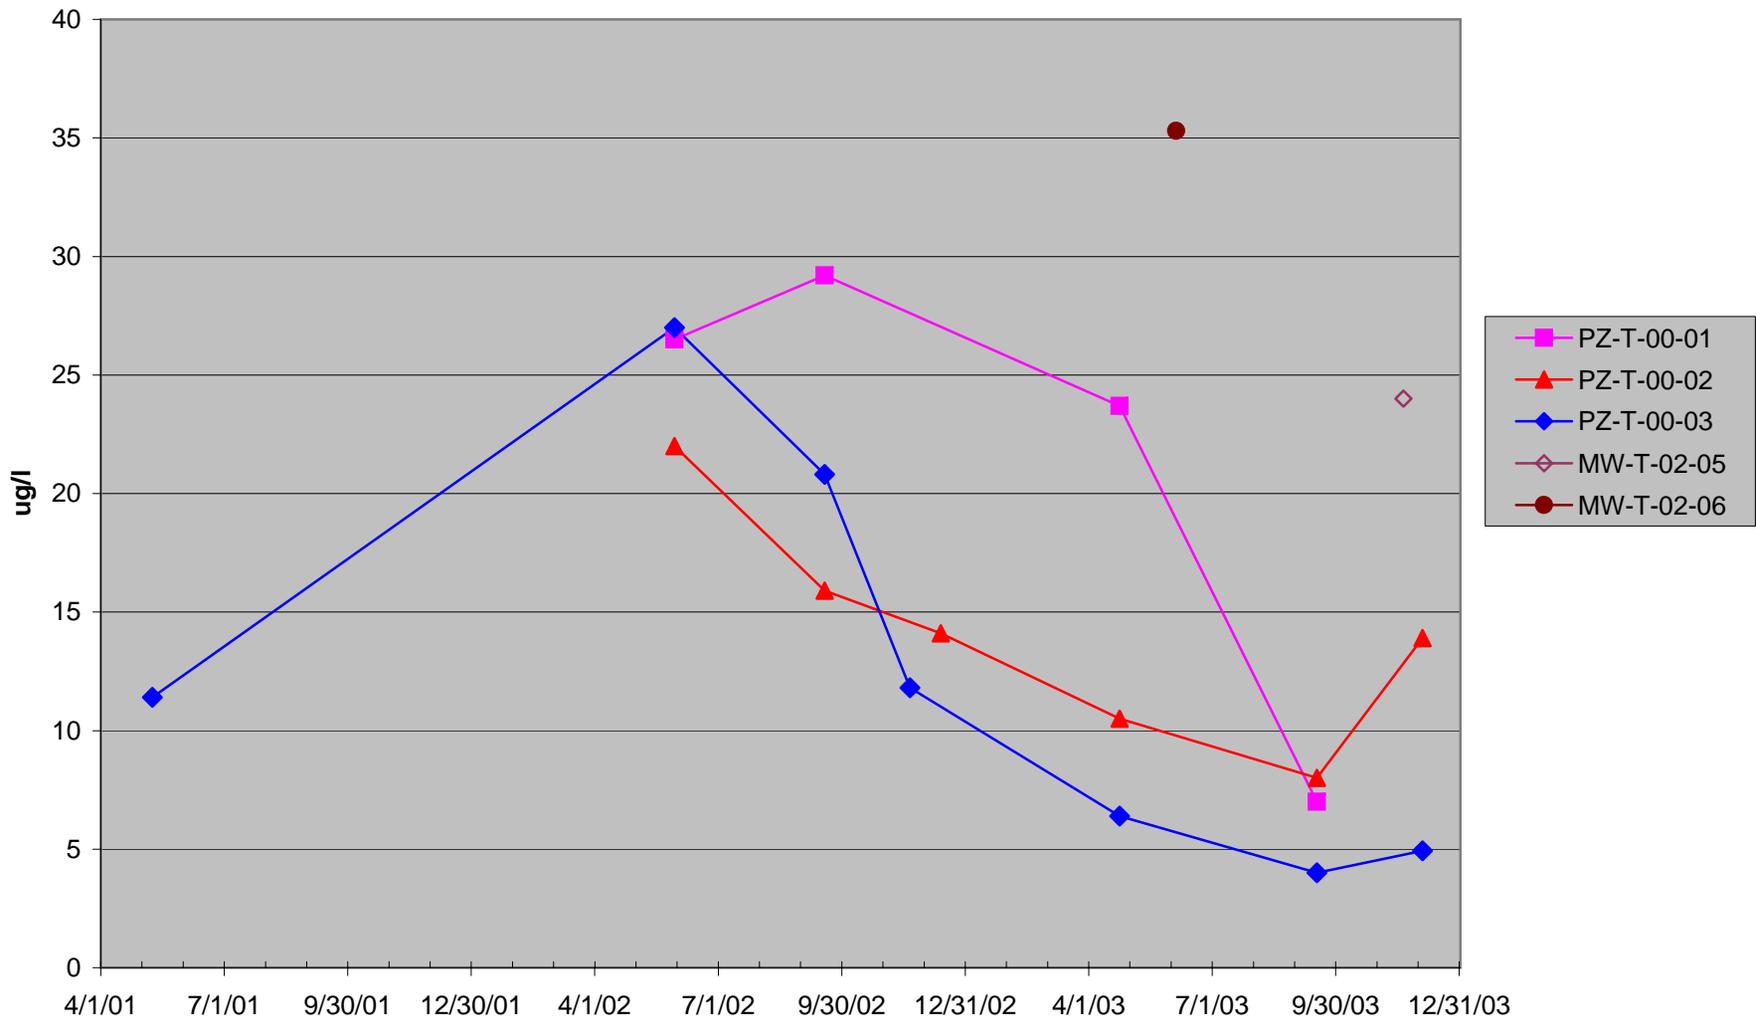
**FIGURE 2.25b GREENS CREEK TAILINGS INTERNAL MONITORING SITES:
TAILINGS COMPLETIONS - ARSENIC DATA
(Non-detectable analyses plotted as zero)**

Arsenic data are presented in Figures 2.25a, b and c. The data, especially for Wet Well 2 (and other sites to a lesser extent) show a distinct increasing trend. As arsenic-bearing minerals such as tetrahedrite/tennantite (and to a lesser extent pyrite) weather, the arsenic that is released is typically co-precipitated with iron oxy-hydroxides. As the pile grows, reducing conditions overtake areas that were once oxidizing. This was particularly true as the water table rose following removal of the temporary PVC cover that was placed on the pile in 1995 (removal began in 1997). Dissolution of oxyhydroxides (and possibly sulfates) should occur as the waters respond to the changing redox conditions. This will contribute arsenic (and iron) to the drainage water. Arsenic concentrations in the drainage will decrease when redox conditions in the pile stabilize.

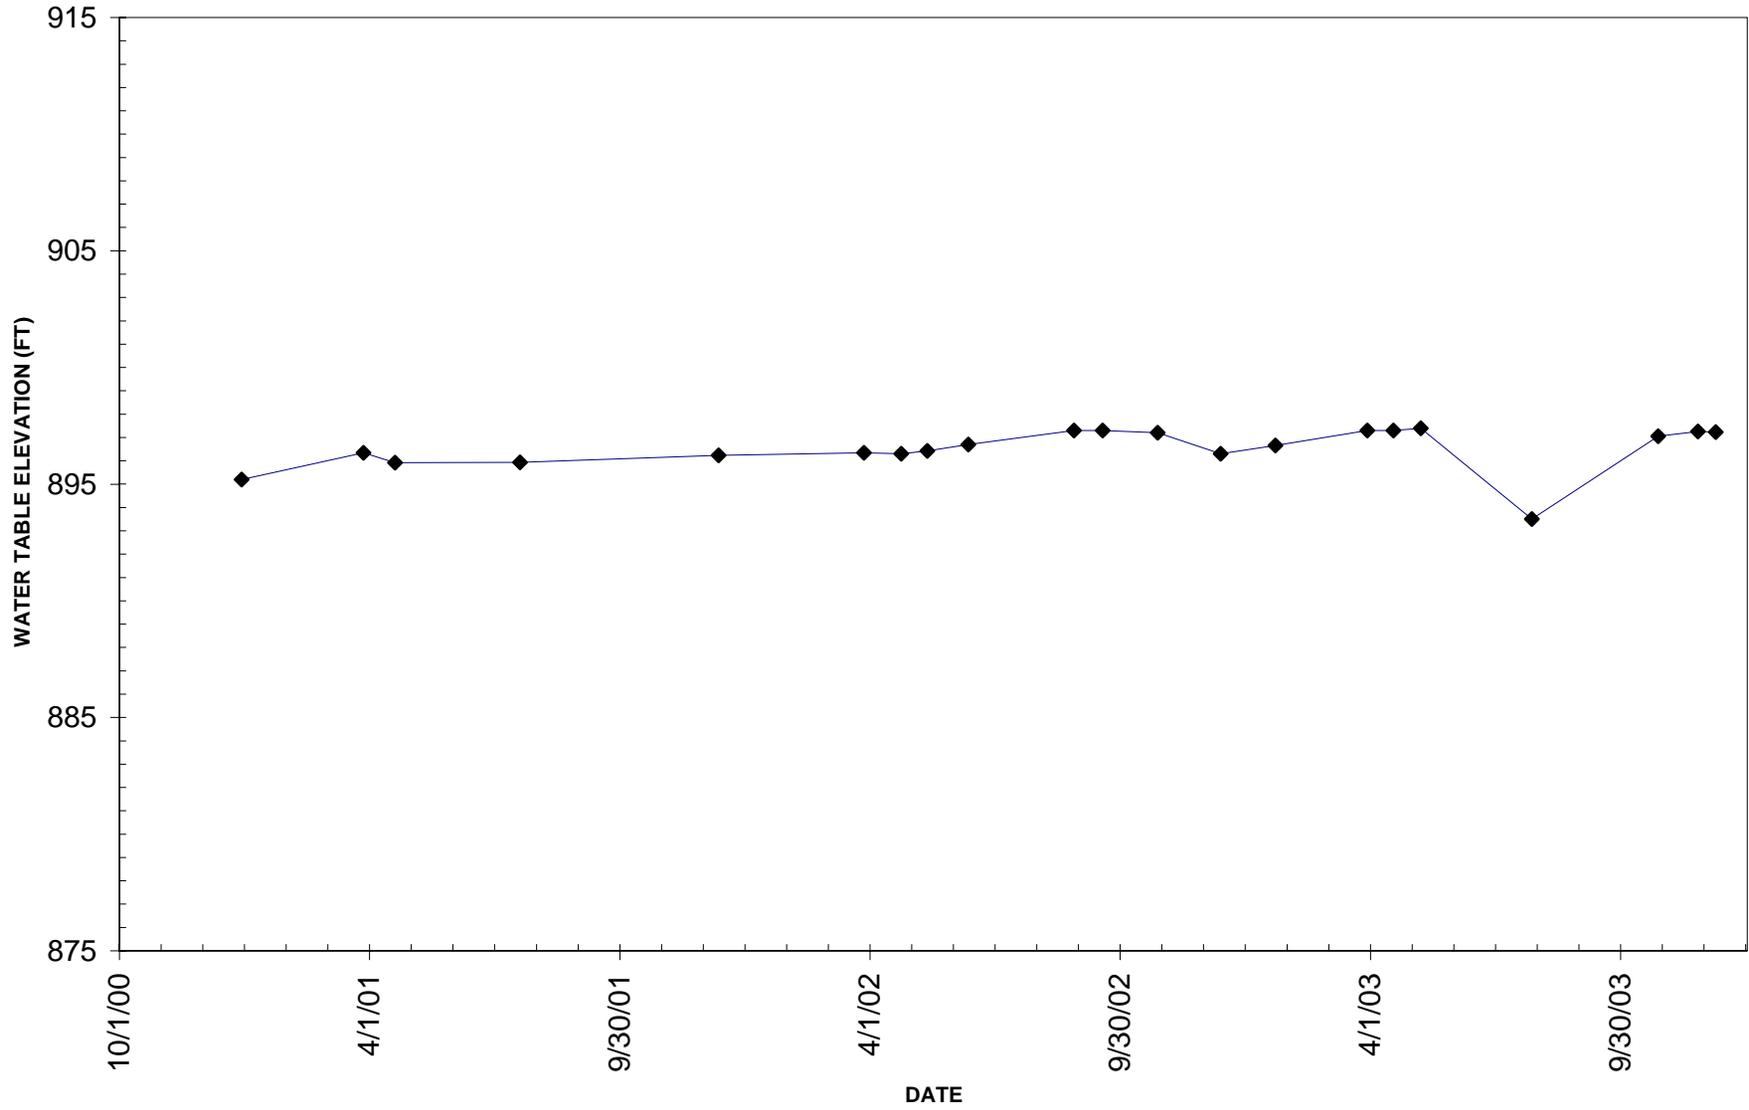
FIGURE 3.8 DEPTH TO WATER DATA FOR WELL MW-23-98-01

The silty/clay till that underlies the colluvial unit impedes downward flow and has an upward hydrologic gradient caused by confining the more permeable bedrock below it. MW-23-98-01 (Figure 3.8) is completed in the till unit and indicates a water table near the top of the till, which is approximately 100 feet below the existing topographic surface. Alluvial sands occur between the colluvial unit and the silt/clay till near the toe of Site 23 and under Site D. Data from MW-23-A4 and MW-D-94-D3 (Figures 3.9 and 3.11) indicate that the sands are saturated. A curtain drain installed in between Site D and Site 23 in 1994 collects water that flows at the base of the colluvial unit and the top of the alluvial sands (see as-built and Section CC for locations). This drain helps reduce pore pressures in the foundation of Site D, as well as capturing infiltration waters from Site 23.

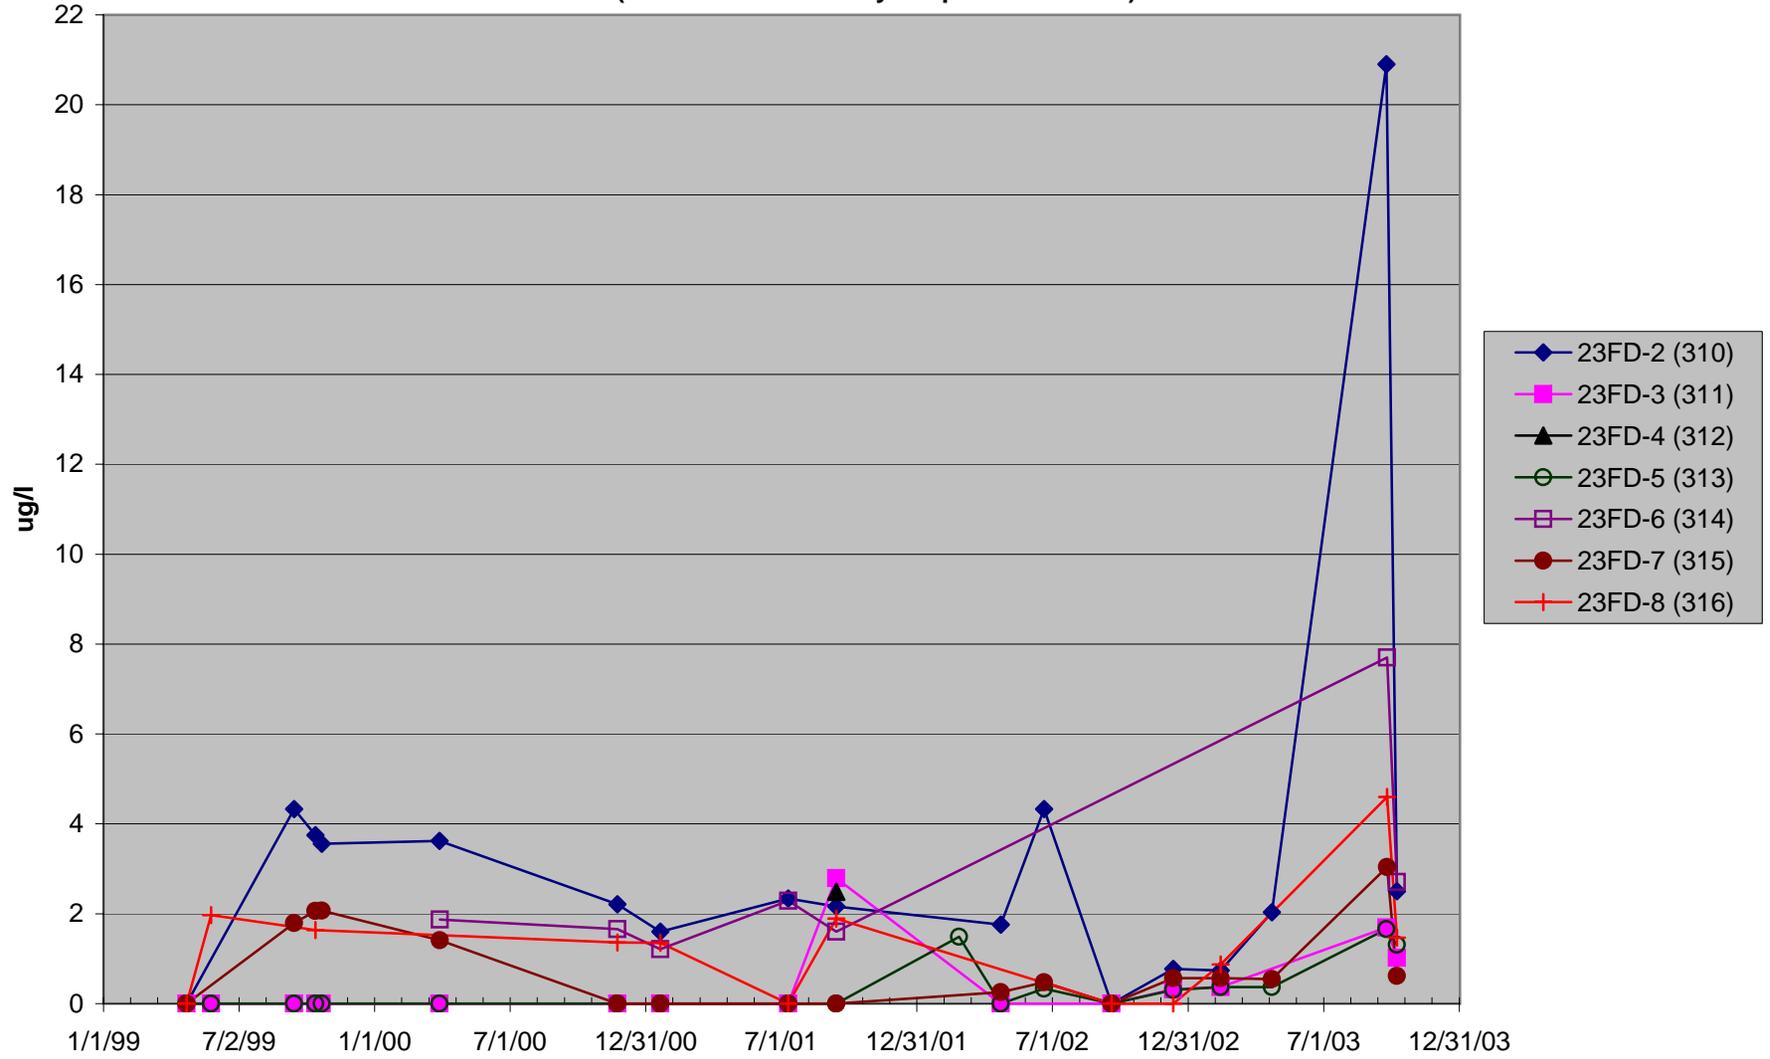
**FIGURE 3.19a GREENS CREEK SITE 23/D INTERNAL MONITORING SITES:
FINGER DRAINS - ARSENIC DATA
(Non-detectable analyses plotted as zero)**

Arsenic data are presented in Figure 3.19a and b and are generally quite low. All finger drains and MW-23-A4 experienced increases in their arsenic concentrations in September, with subsequent decreases to historical levels in October. The flows in the finger drains positively correlate with these changes. Fluctuations in arsenic values in 23FD-2 are likely due to changes in redox conditions. Low arsenic and iron concentrations indicate that these metals are precipitating as oxyhydroxides on rock surfaces inside the pile.

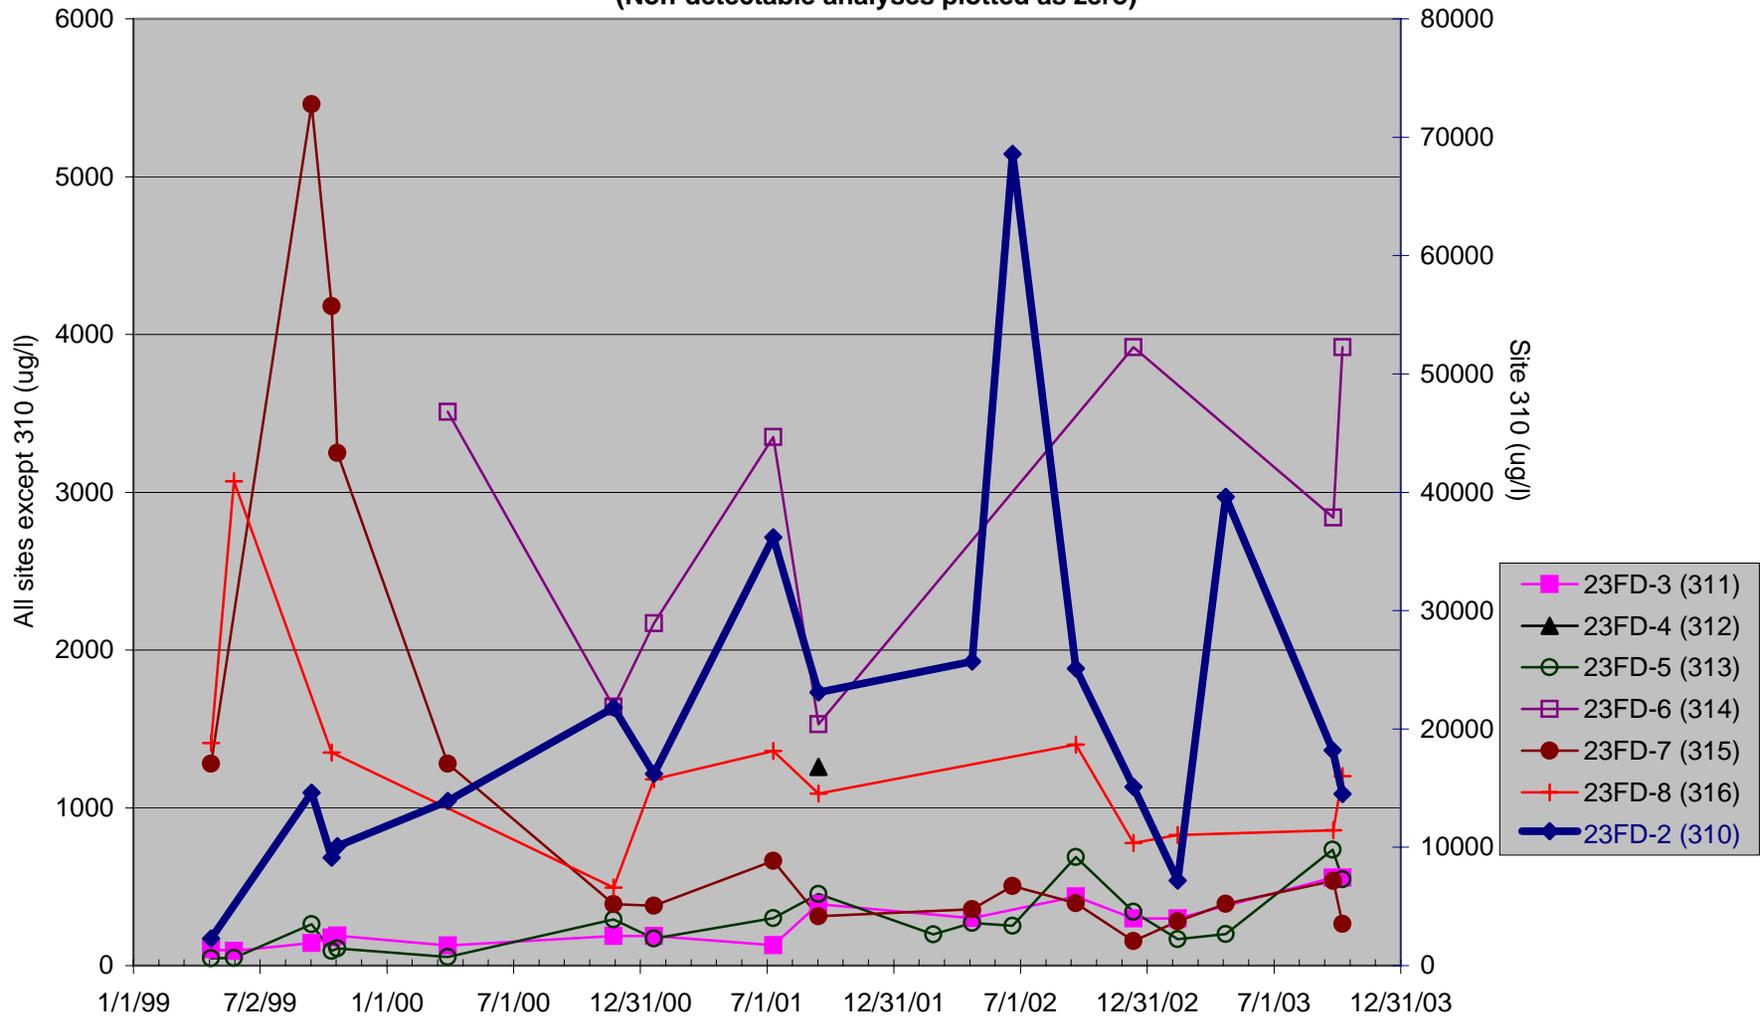
**FIGURE 3.20a GREENS CREEK SITE 23/D INTERNAL MONITORING SITES:
FINGER DRAINS - ZINC DATA
(Non-detectable analyses plotted as zero)**

Figure 3.20a and b shows the concentration of zinc in the internal monitoring locations at Site 23/D. Zinc levels appear to be controlled by seasonal conditions. The changes in zinc concentrations mimic those for conductivity and sulfate. 23FD-2 had a zinc concentration of approximately 70 mg/l in June 2002. In 2003, the zinc concentration averaged 20 mg/l. Zinc concentrations in the range of 20 to 70 mg/l are consistent with kinetic weathering tests performed on samples of argillite and serpentinite (Vos 1993). The zinc concentrations recorded for Pond D are generally below 0.7 mg/l and reflect contributions from several source waters. Pond D receives water from Site D surface runoff, seeps on the slope and at the toe of the site and the effluent from the curtain drain that KGCMC installed between Site D and Site 23.

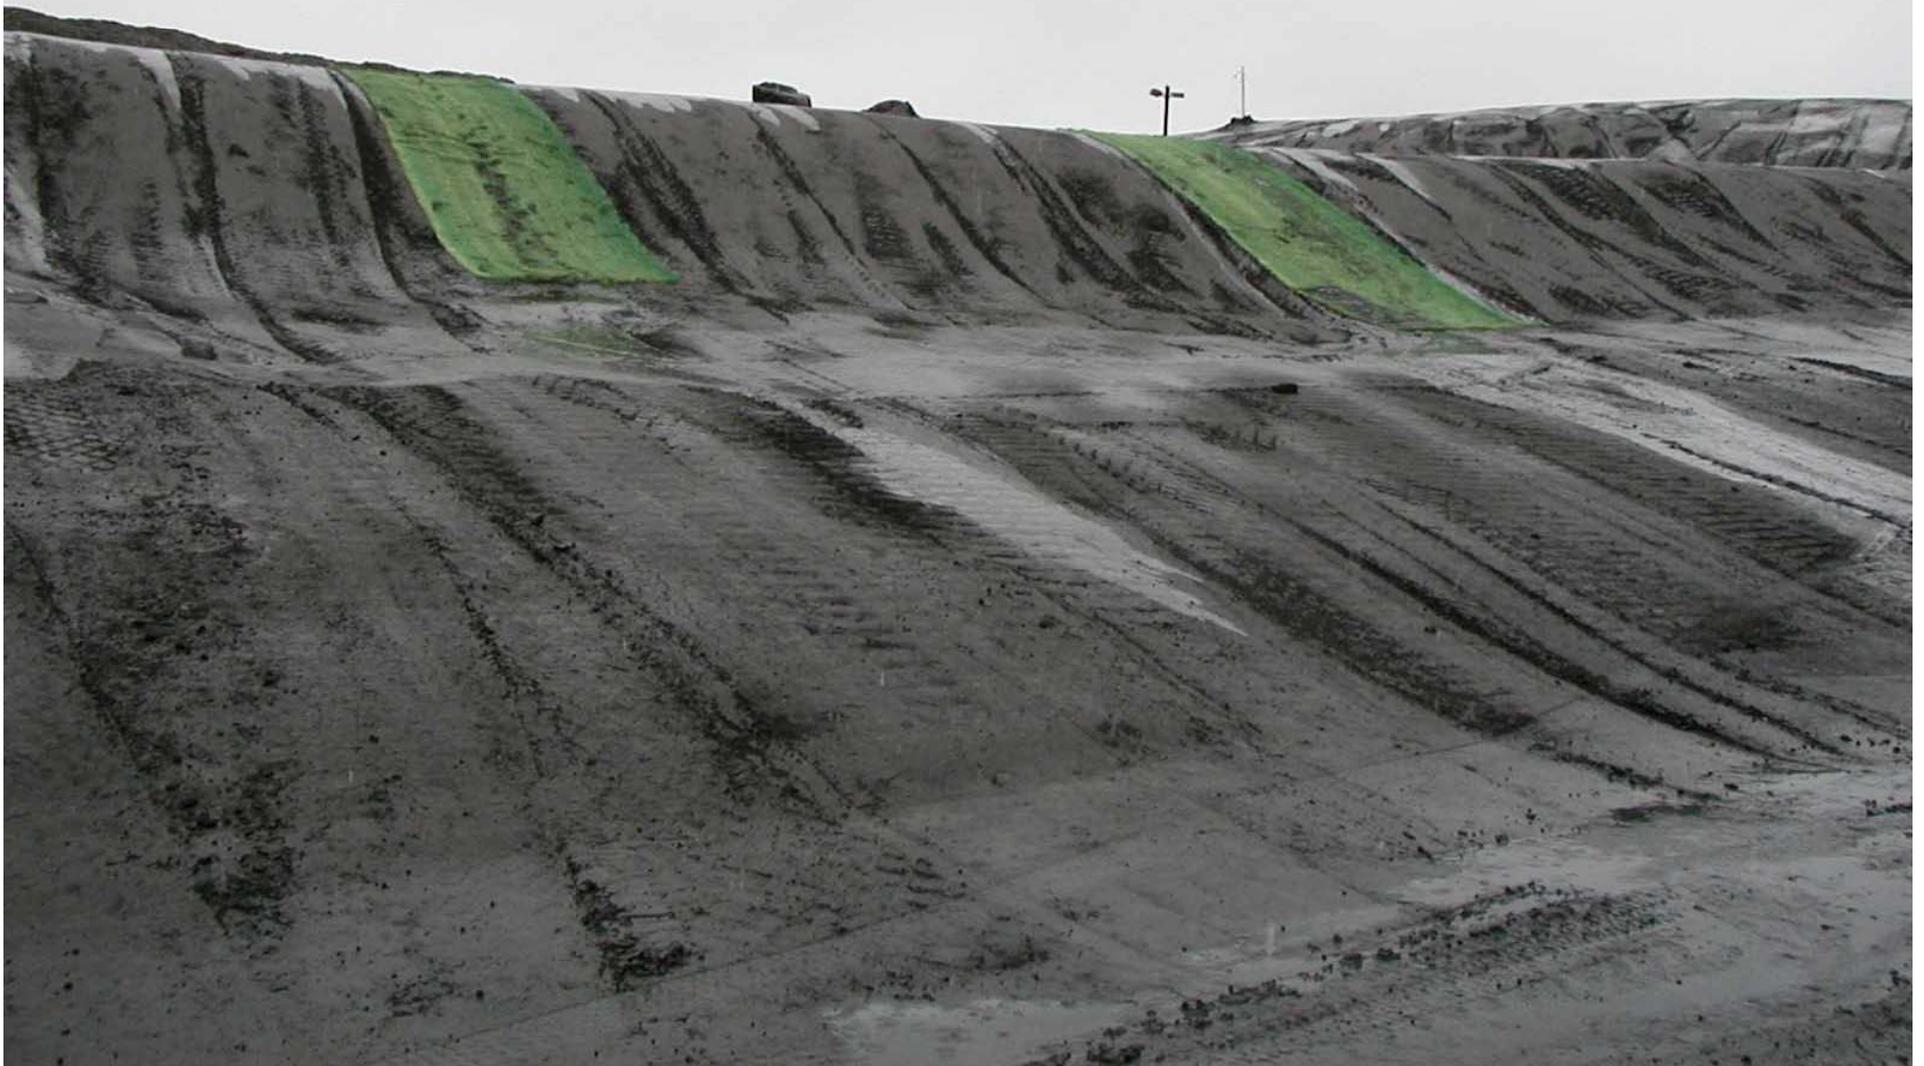
Figure 2.31 Erosion Test Mats at Tailings Facility April 2003

Photographs taken during routine site inspections in 2003 are presented in Figures 2.31 to 2.33 (Appendix 4). Figure 2.31 shows Curlex blankets or erosion mats that had been placed on a slope of the tailings pile to test their ability to control erosion from storm water runoff. The blankets are made of a biodegradable wood fiber. This photo was taken on April 17, 2003.
