**TAILINGS AND PRODUCTION ROCK SITE
2007 ANNUAL REPORT**

Kennecott Greens Creek Mining Company

April 15, 2008

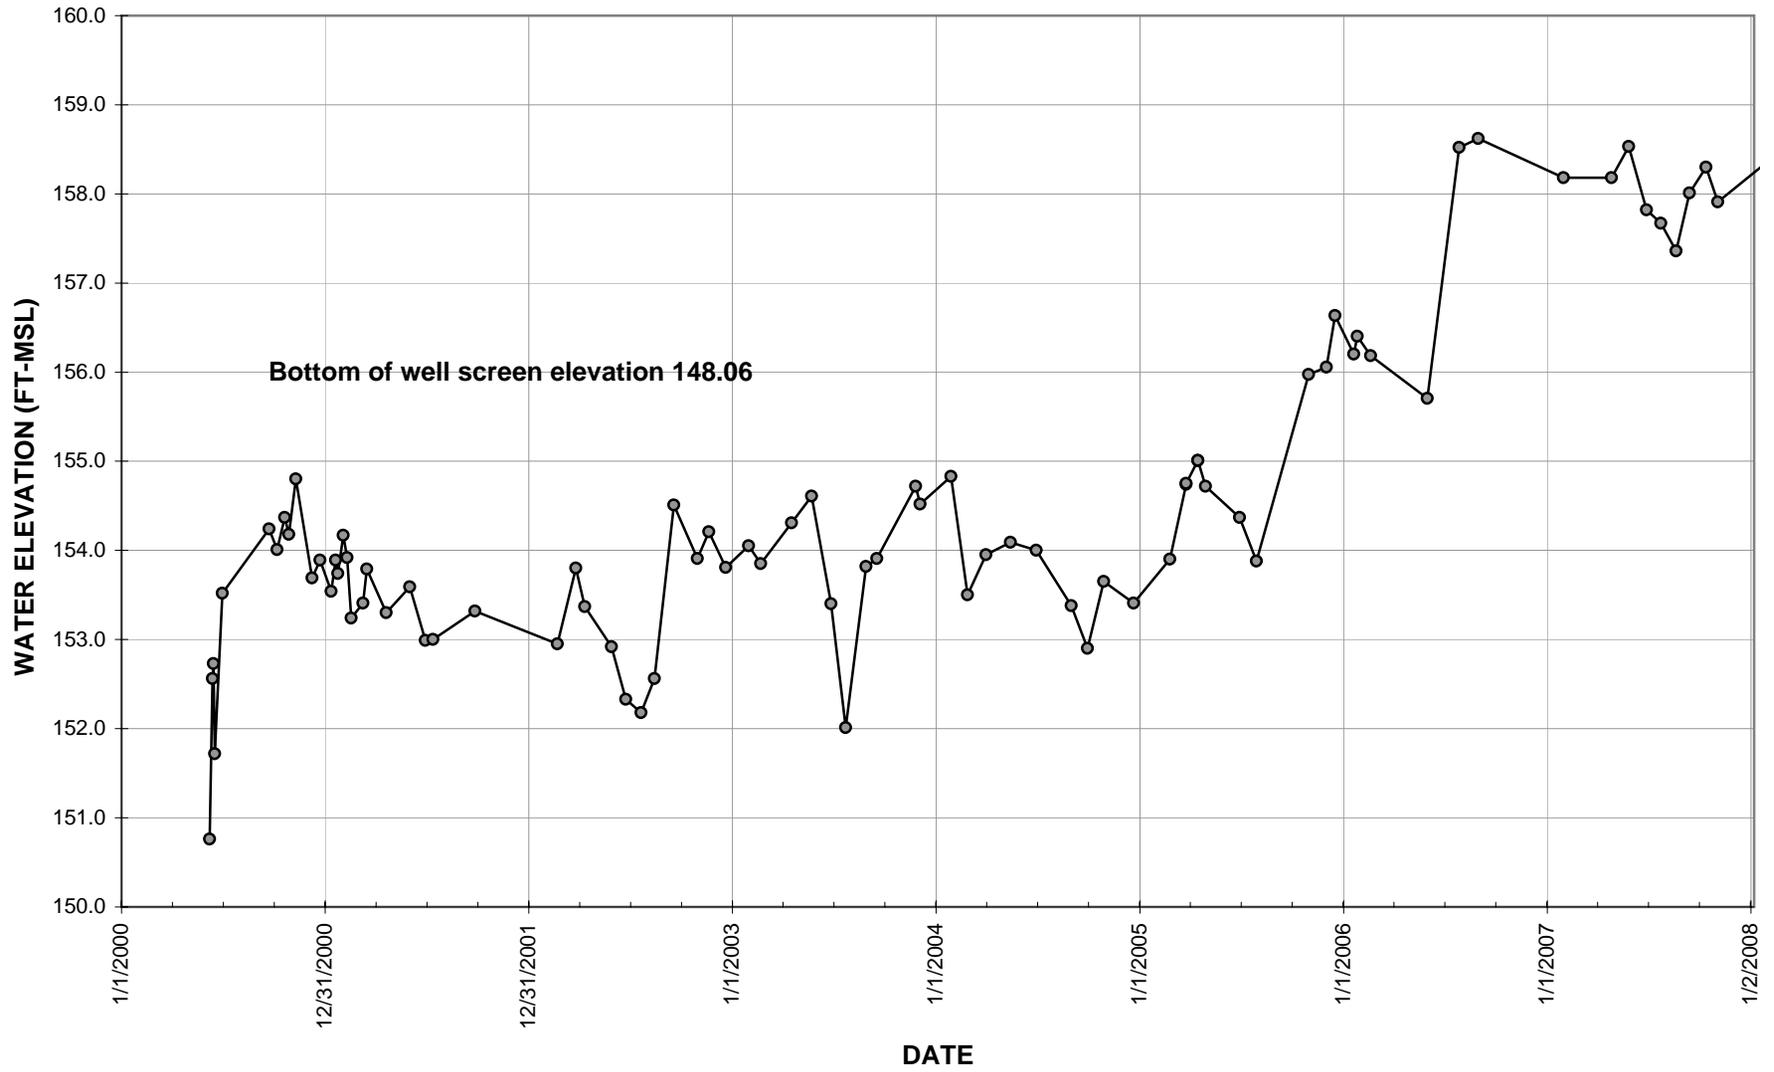
Figure 2.11 Water Level Data for Standpipe Piezometer PZ-T-00-01

The data from standpipe piezometers completed above the blanket drain (PZ-T-00-01, PZ-T-00-02, PZ-T-00-03 in Figures 2.11, 2.12, 2.13) indicate that the water perches above the unsaturated underdrains to a thickness of approximately 12 feet. This is consistent with the low permeability of the tailings and the un-capped condition of the pile. Covering the pile will help minimize the saturated zone in the pile. This was demonstrated by the over 10 foot decrease in the water table that occurred from 1995 to 1997 when the pile was covered (see Figures 2.1 to 2.7). Water levels have rebounded to, and in some cases above, 1994 elevations in most areas. Areas where water levels exceed their 1994 values are areas where the pile is considerably thicker than it was in 1994.

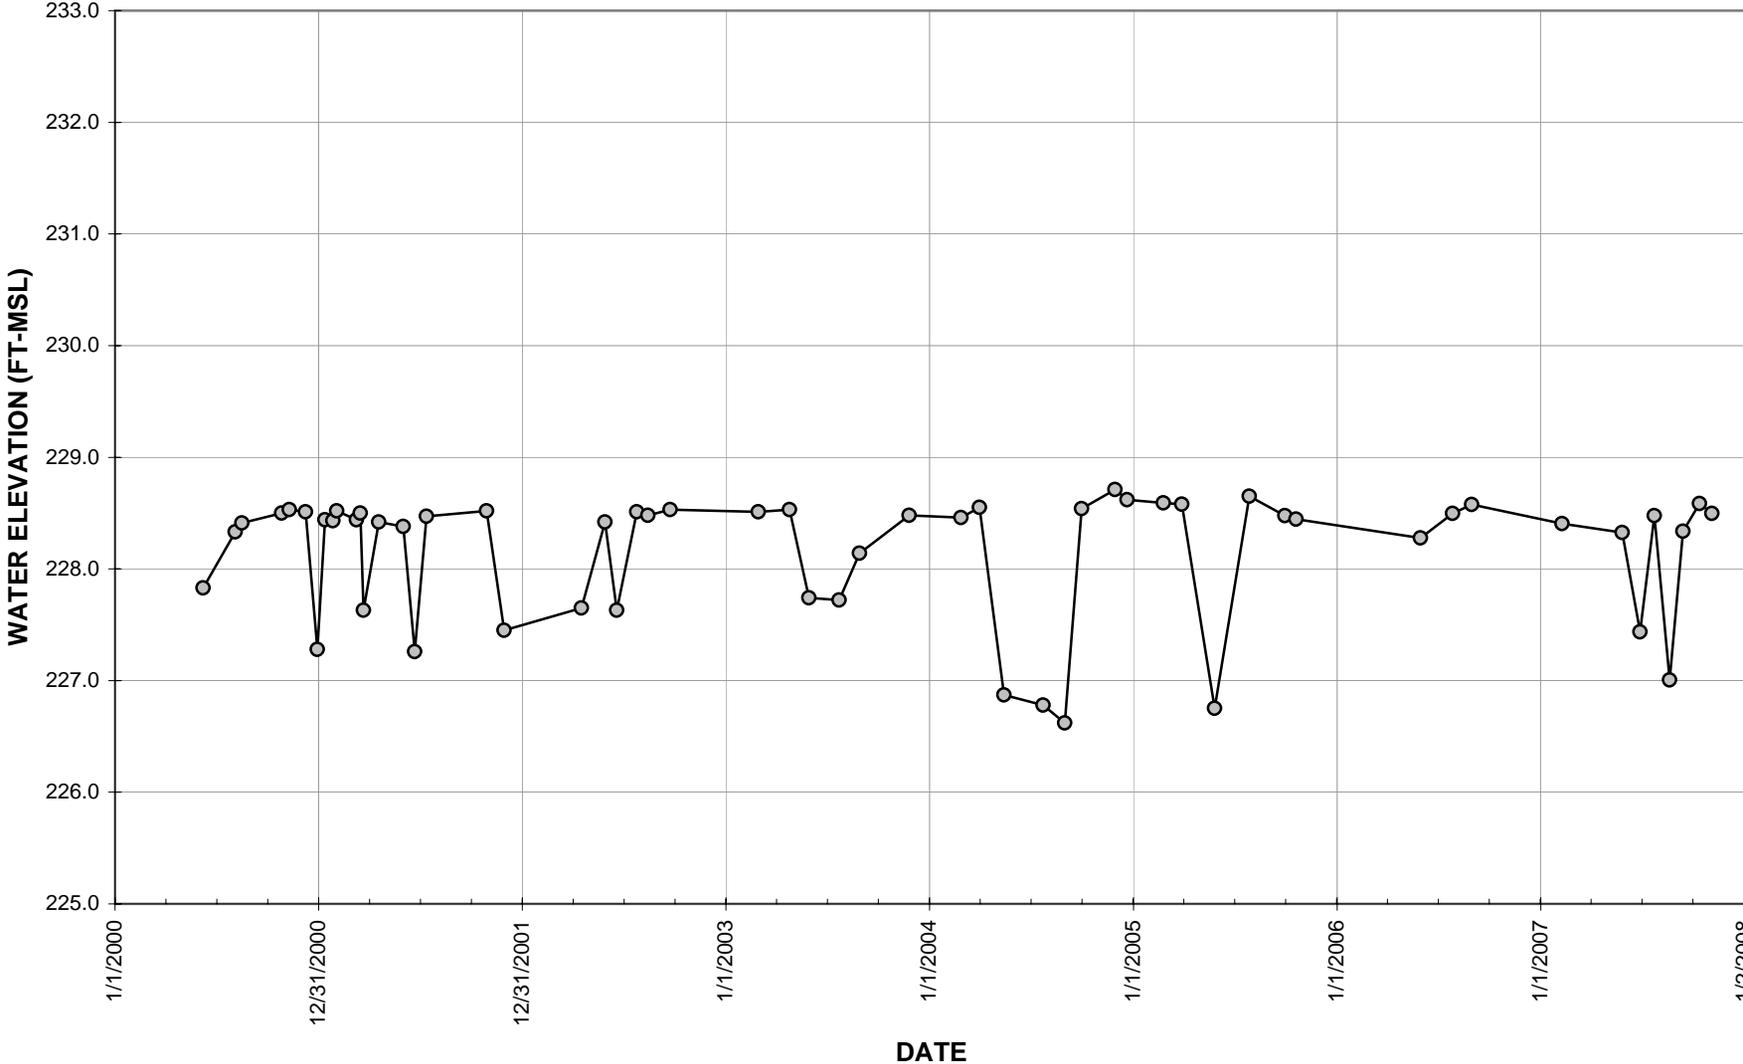
Figure 2.15 Water Level Data for Well MW-T-00-3A

Water levels for four wells completed east and west of the pile are shown for comparison in Figures 2.15 to 2.18. The eastern wells, MW-T-00-03A (Figure 2.15) and MW-T-00-03B (Figure 2.16), are completed in the shallow sands 12 and 17 feet, respectively, below ground surface. The figures for these wells show that the water elevation in shallow completions in native materials can be readily influenced by abnormal weather conditions. Wells MW-T-01-03A and MW-T-01-03B are installed west of the pile. Their water levels are shown in Figures 2.17 and 2.18, respectively. MW-T-01-03A is completed in bedrock to a depth of 20 feet and MW-T-01-03B is completed in clayey silt to a depth of 12 feet. These wells show similar water level fluctuations with weather conditions as the two eastern wells. However, the water level in MW-T-01-03B shows a larger differential than MW-T-01-03A because silts and clays hold more water in tension, so a small increase in water content causes a large change in head. The ground surface elevation is 134 feet in the proximity of these two wells. Both MW-T-01-03A and MW-T-01-03B were damaged, likely by wildlife, in the summer of 2006. Several attempts were made to repair the wells in 2007, but they could not be recovered. Therefore, no data were obtained from those wells in 2007. KGCMC will make another attempt to repair the wells in 2008 and if unsuccessful, will consider replacing them during a future drilling program.

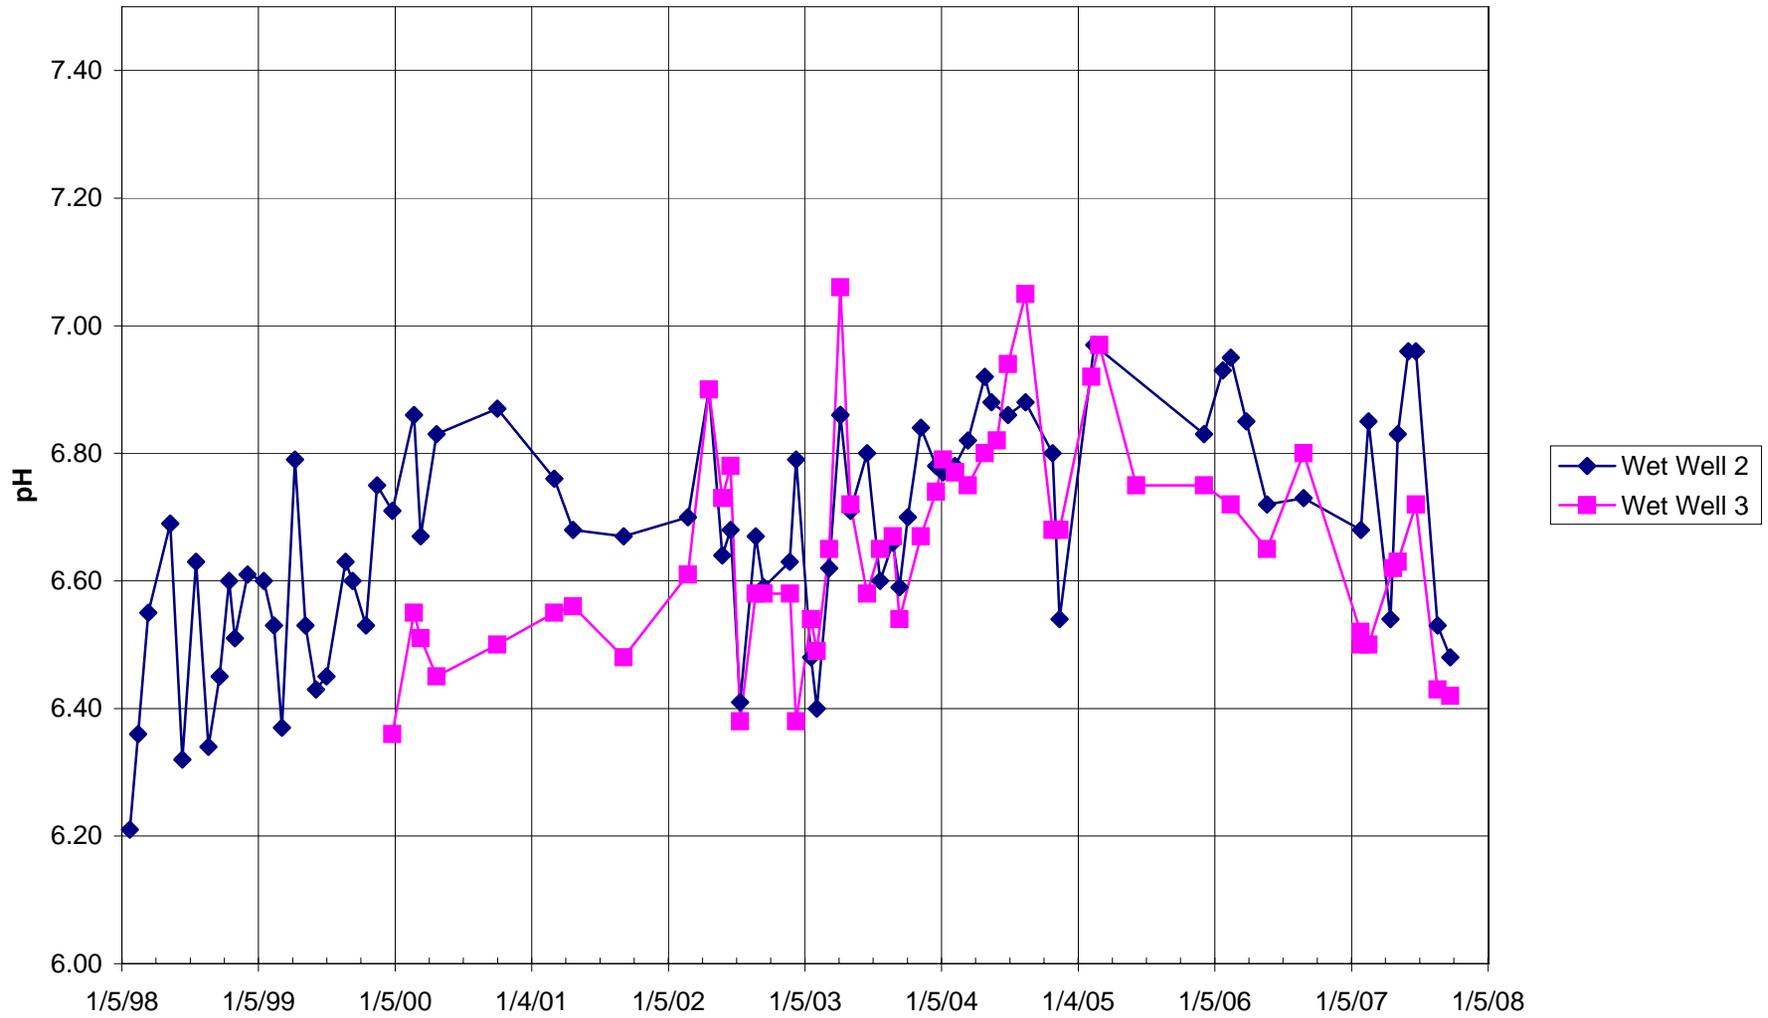
**FIGURE 2.20a GREENS CREEK TAILINGS AREA INTERNAL MONITORING SITES:
WET WELLS - pH DATA**

The analytical results of KGCMC's internal site monitoring plan are summarized in Figures 2.20 to 2.31. Sites were distinguished between foundation wet wells (Wet Well 2 and Wet Well 3), wells completed in tailings (PZ-T-00-01, PZ-T-00-02, PZ-T-00-03, MW-T-02-5 and MW-T-02-6) and suction lysimeters (SL-T-02-4, SL-T-02-5, SL-T-02-6, and SL-T-02-7). These lysimeters are installed at various depths within the pile's vadose zone. These groups are separated on Figures 2.20 through 2.31 with the suffix a, b or c, respectively. For example, a figure number such as 2.20a would show the data for the wet wells group, 2.20b would show the data for the tailings completion wells, and 2.20c would show the data for the suction lysimeters.

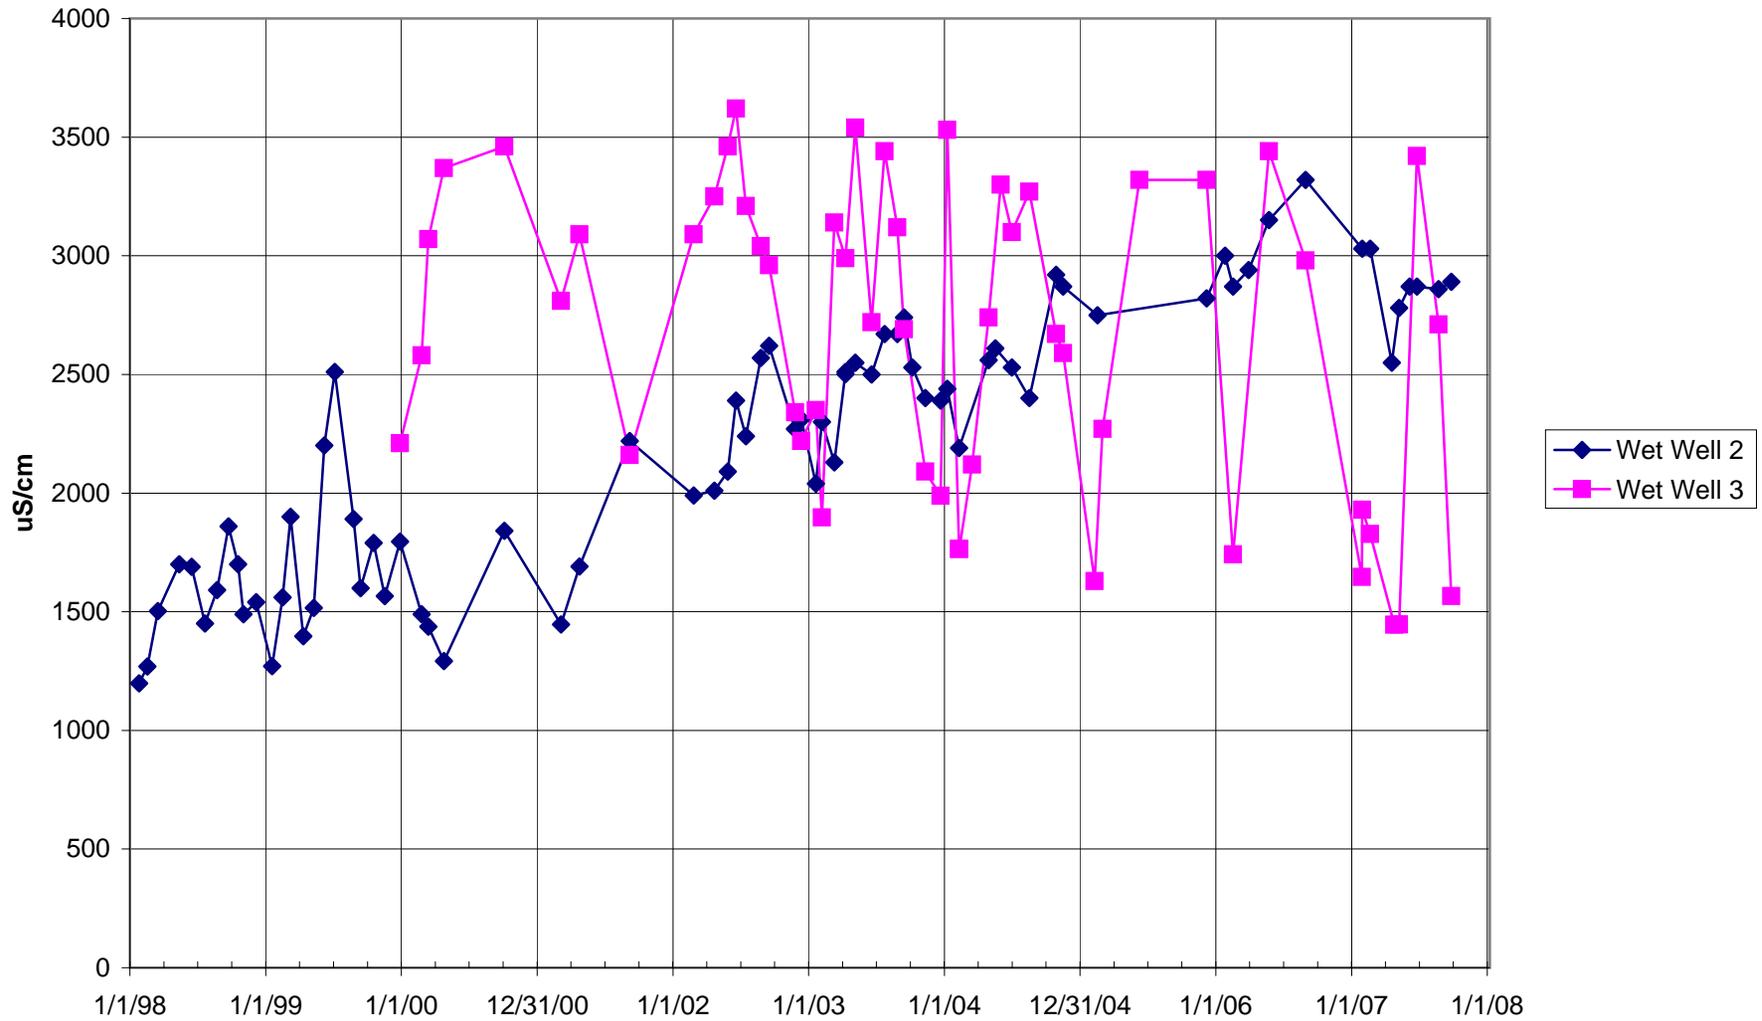
**FIGURE 2.22a GREENS CREEK TAILINGS INTERNAL MONITORING SITES:
WET WELLS - CONDUCTIVITY DATA**

The conductivity results from internal monitoring site waters are presented in Figures 2.22a, b, and c. The 2007 conductivity measurements were between 1,446 (wet wells) and 6,610 (suction lysimeters) $\mu\text{S}/\text{cm}$. The higher conductivity of the site contact waters reflects a larger dissolved load caused by weathering of the tailings. Pyrite oxidation and carbonate dissolution contribute dissolved ions such as sulfate, bicarbonate, calcium and magnesium to the contact waters, increasing their conductivity. Wet Well 3 has a different capture area than Wet Well 2 and shows a different pattern with respect to conductivity. The changes in conductivity observed in Wet Well 3 suggest changes in the relative contributions from runoff, addition of the Northwest Diversion Ditch flow, infiltration and groundwater as the West Buttress was constructed. The increase in conductivity seen in Wet Well 2 over the past several years likely reflects an increasing contribution from contact water in the drain system and an increase in the dissolved load from migration/remobilization of oxidation products in the pile. In 2007 the suction lysimeters had conductivity values ranging from 1,398 to 6,610 $\mu\text{S}/\text{cm}$. Suction lysimeter samples are drawn from the smallest pore spaces of the unsaturated zone. Water held in these

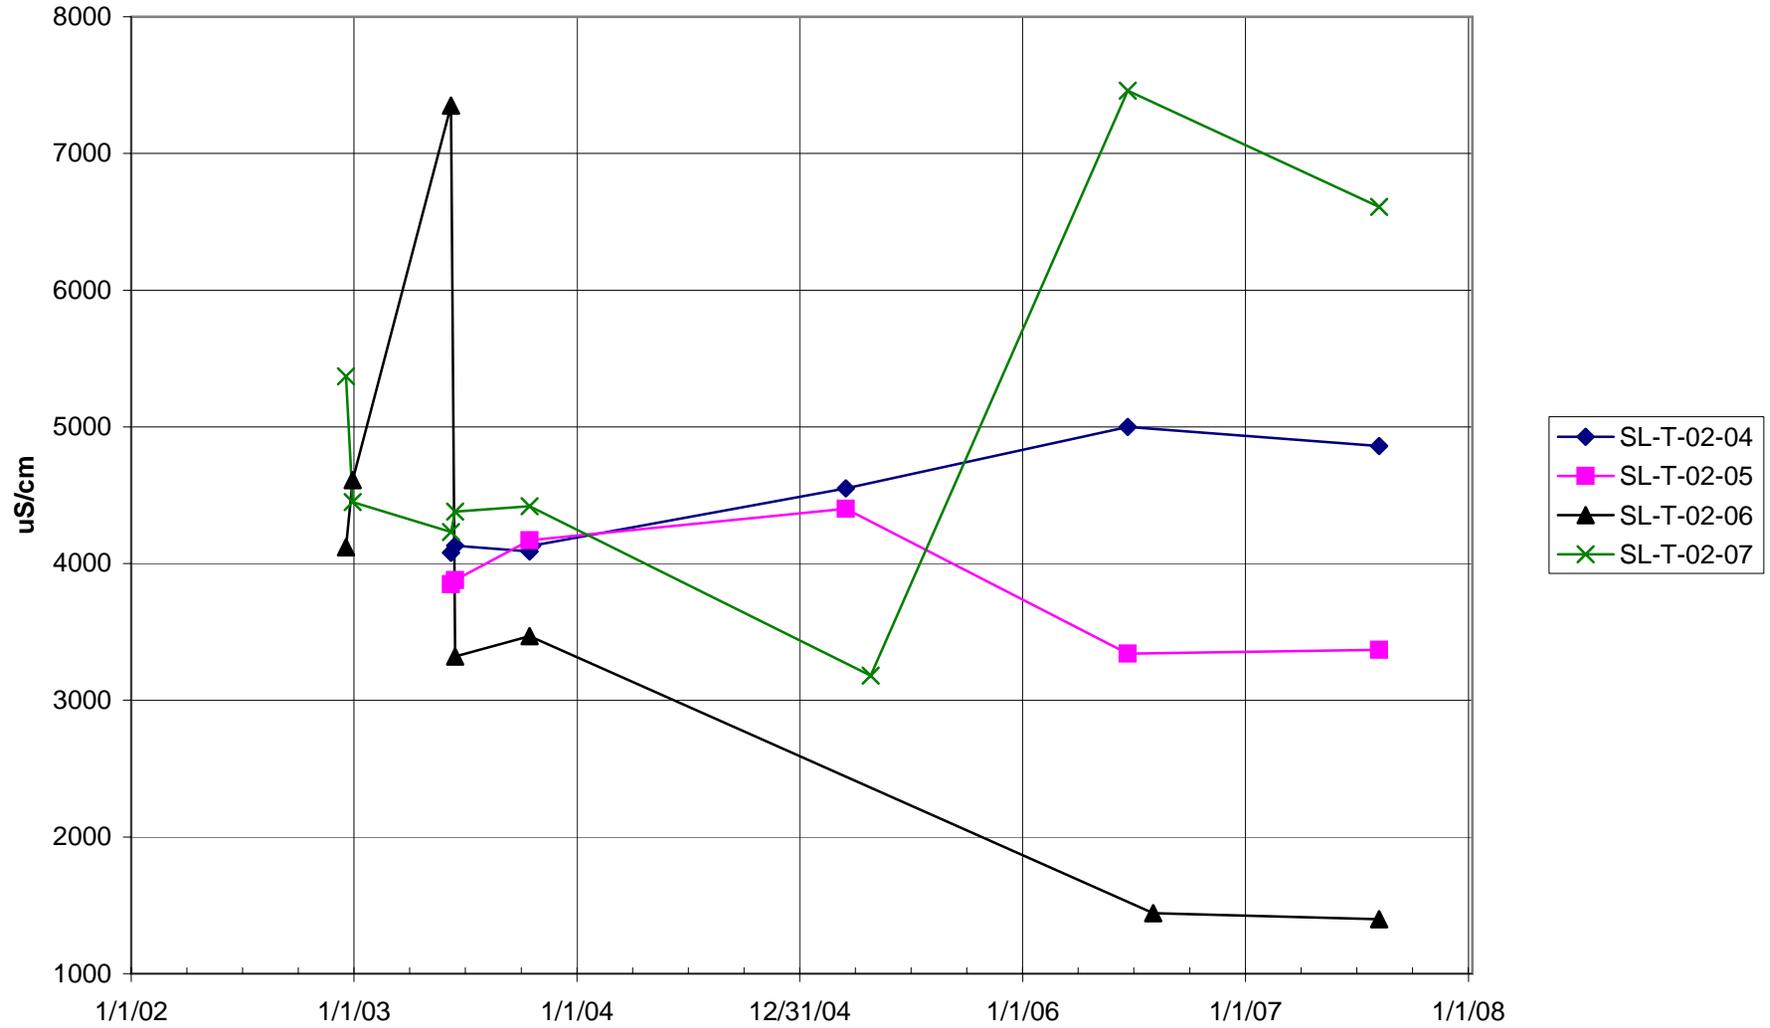
**FIGURE 2.22c GREENS CREEK TAILINGS INTERNAL MONITORING SITES:
SUCTION LYSIMETERS - CONDUCTIVITY**

pores is often isolated from flow paths and thus has higher dissolved constituent concentrations than water from the saturated zone and foundation drains.

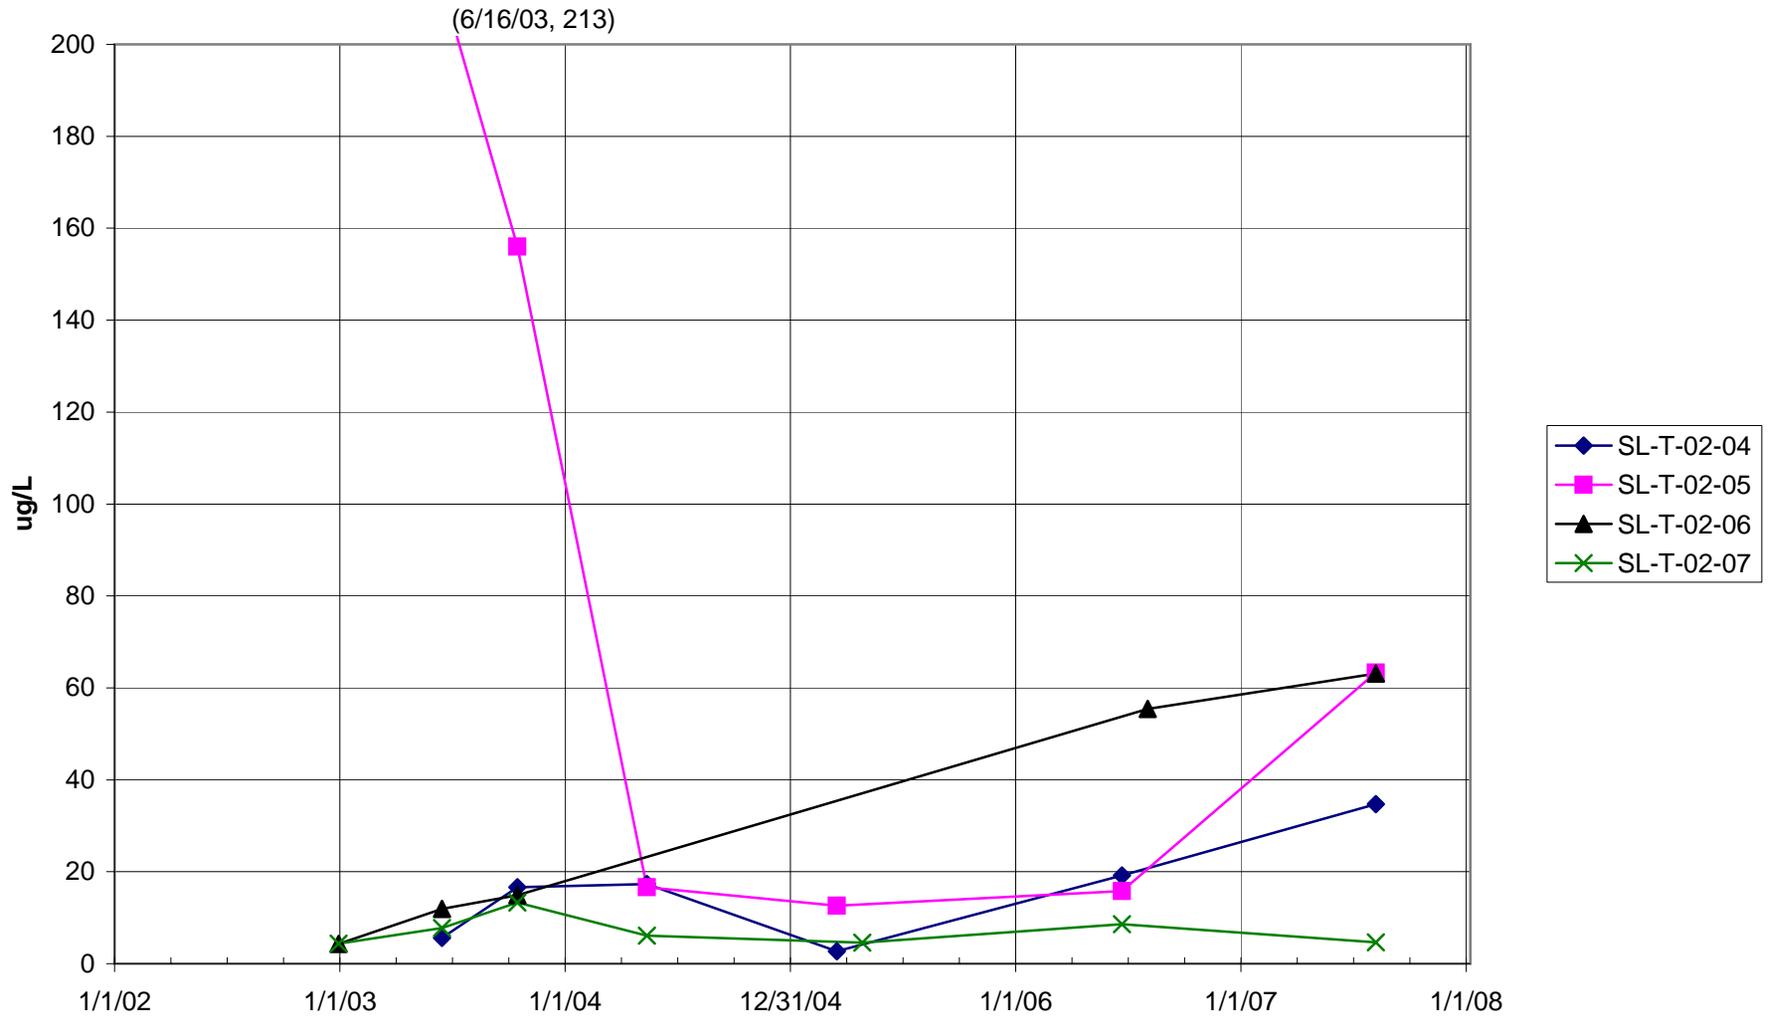
**FIGURE 2.25c GREENS CREEK TAILINGS INTERNAL MONITORING SITES:
SUCTION LYSIMETERS - ARSENIC DATA
(Non-detectable analyses plotted as zero)**

Arsenic data are presented in Figures 2.25a, b and c. The variability in arsenic concentrations observed in Wet Well 2, MW-T-02-06, and some suction lysimeters is related to evolving redox conditions in the pile. As arsenic-bearing minerals such as tetrahedrite/tennantite (and to a lesser extent pyrite) weather, the arsenic that is released is typically co-precipitated with iron oxyhydroxides. As the pile grows, reducing conditions overtake areas that were once oxidizing. This was particularly true as the water table rose following removal of the temporary PVC cover that was placed on the pile in 1995 (removal began in 1997). Dissolution of oxyhydroxides (and possibly sulfates) is expected as the waters respond to the changing redox conditions. This will contribute arsenic and iron (Figures 2.30a, b and c) to the drainage water. Arsenic concentrations in the pile drainage will therefore decrease when redox conditions in the pile stabilize (e.g. with closure and capping of the pile). Sulfate reduction may also lower arsenic concentrations. This is apparent in the composition of waters from the saturated zone and in some of the SRMP test cells, which are discussed in more detail below.
