INSPECTION REPORT

Alaska Department of Environmental Conservation
 Division of Water
 410 Willoughby Ave, Juneau, AK 99811

Name and Location of Site/ Facility Inspected		Entry Time	Permit Effective Date												
Kensington Lower Slate Lake (LSL) Dam construction and Acid Rock Drainage area adjacent to LSL.		08:00	September 1, 2005												
		Exit Time 17:00	Permit Expiration Date August 31, 2010												
On-Site Representative Kevin Eppers (Env. Superintendent)		Additional Participants: Jennifer Saran, USFS Brock Tabor, ADEC nonpoint source program.													
Responsible Official(s): Clyde Gillespie, Surface Operations Manager, Kevin Eppers (Env. Superintendent) x Contacted LSL: Jen Stetz, Tetra Tech

PHOTO ADDENDUM – KENSINGTON TAILINGS DISPOSAL FACILITY –DECEMBER 10, 2009

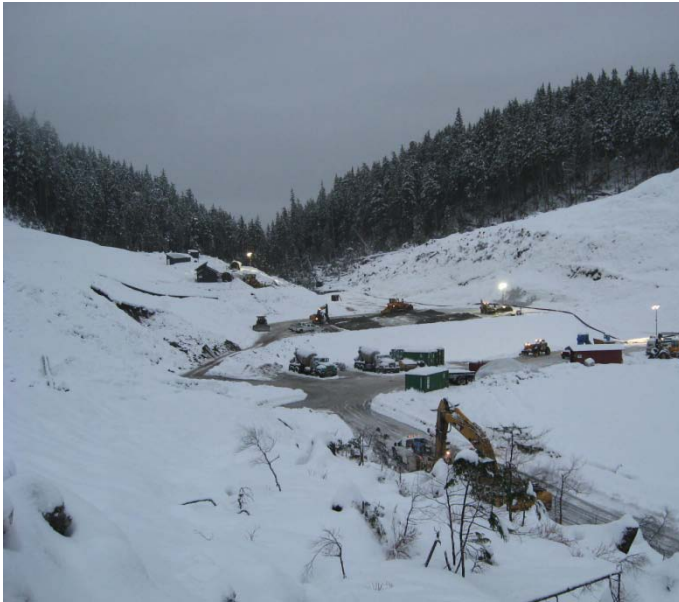
PHOTO 1. DAM SITE

The lake was ice covered. No pumping is occurring at the lake at the present time.

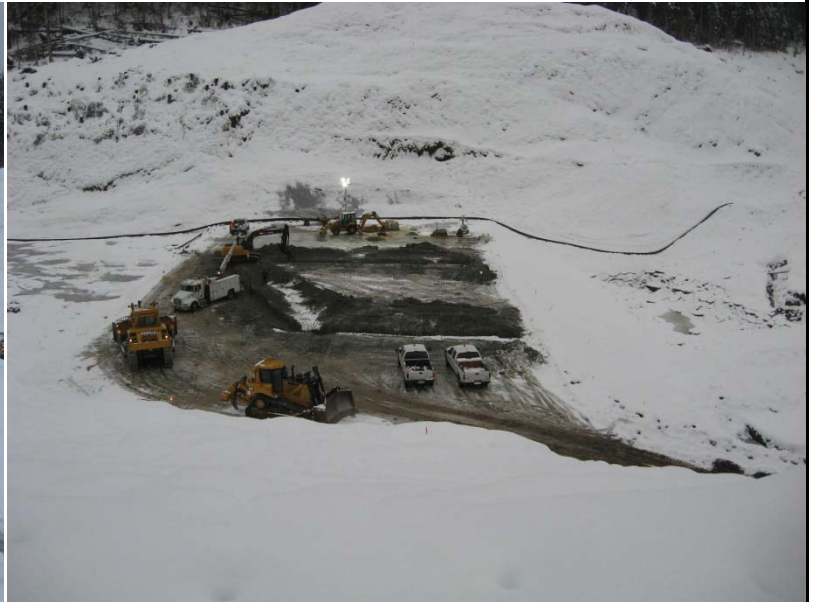
PHOTO 2. DAM FROM EAST EMBANKMENT

The rock crusher was not removed from the site. The trench to the sump for the dam has been shotcreted and filled in and the dam constructed to within 30 feet of final grade for Phase I.

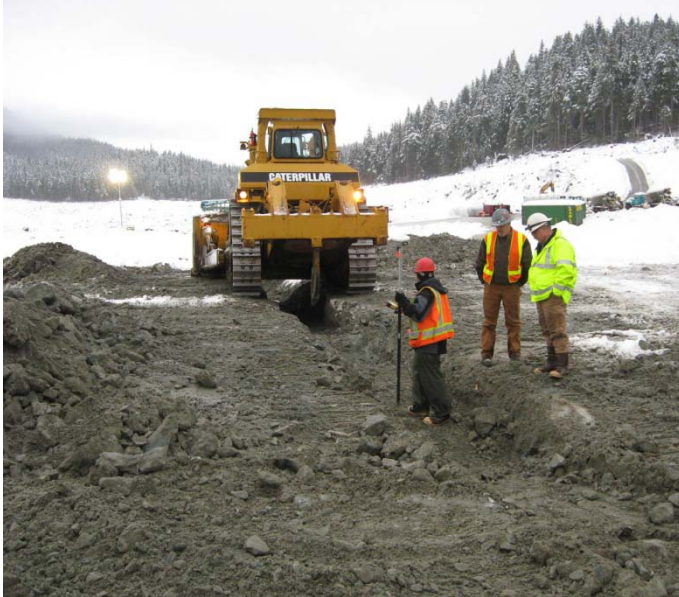
PHOTO 3. TRENCH FOR PIEZOMETER

Trenches for piezometers were being excavated by ripping with a dozer. This was more difficult than expected since the rock had been well compacted. A ring density test, also called a water replacement test (<http://www.astm.org/Standards/D5030.htm>) was being conducted on the dam surface for the A1 material. This necessitates the excavation of a hole about 2 feet deep, measuring the amount of water required to fill this (polyethylene lined) hole, then determining the amount of rock by weight, and the percent of 3"-minus rock present. Three ring tests were conducted in the Zone A material and three in the Zone A1 material.

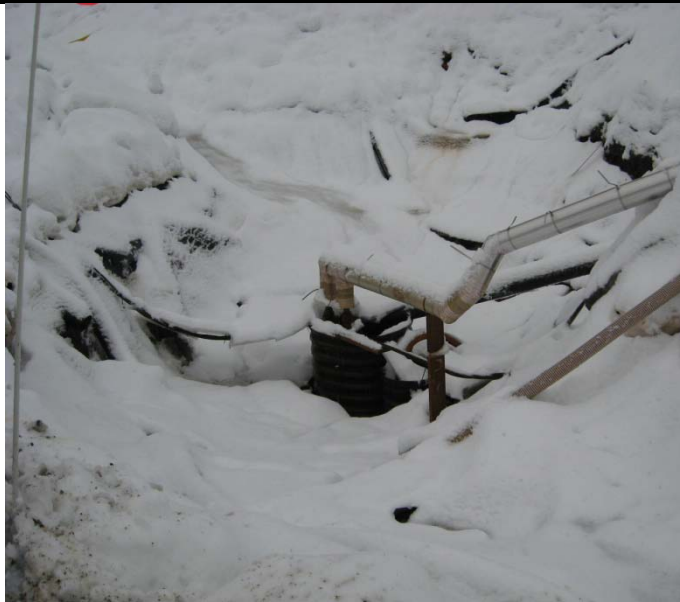
PHOTO 5. SUMP AT THE GRAPHITIC PHYLLITE SEEP

There is a total of 12,400 – 13,000CY of graphitic material on the pile. The more permanent temporary cover has not yet been placed on the pile; it presently has a lighter weight cover. No protection of the sump is yet provided in the event of a snowslide off the pile smothering the drainage water sump. The 20,000 gallon tank has been moved to a level location where it will collect water from the sump. This water will then be trucked to the Seep water treatment plant.

1. Construct protection for the sump at the graphitic phyllite storage area to prevent it from being buried under snow from the pile.
2. Cover the graphitic phyllite pile with 60 mil HDPE. This may occur after the installation of the grout trench for the dam since 1500 CY of graphitic phyllite material from this trench may be placed on the pile at that time.
