<b>APDES INSPECTION REPORT</b> Alaska Department of Environmental Conservation Division of Water 410 Willoughby Ave, Juneau, AK 99811	DEC APDES Inspection Form Last updated (4/08)
		Phone:(907) 465-5257 Fax: (907) 465-5274

Inspection Date	Permit #	Borough	Receiving Waters	Weather	Facility Type
January 27, 2011	AKR05CA54 AK0050571	Juneau	Slate Creek	Current Conditions:	Mine
Discharges to: Surface Water <input checked="" type="checkbox"/> Ground Water <input type="checkbox"/>				<b>ANNOUNCED</b> Inspection

**PHOTO ADDENDUM – KENSINGTON MINE**

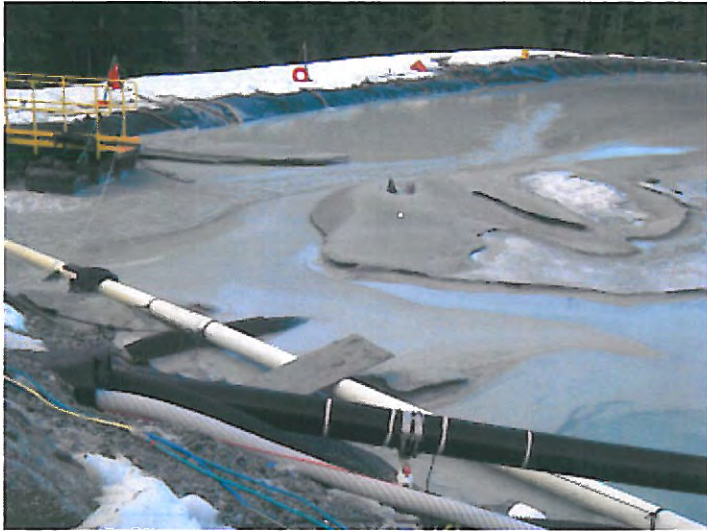
Pond 1 appears very close to storage capacity. Sediment appears to continue to accumulate in Pond 1 (Photo 1). An unknown substance is flowing into Pond 1, through one of approximately nine orange collapsible hoses (Photo 2). Available

Sediment in Pond 1 appears to be accumulating more quickly than it is being removed.

- High volume of visible solids in Pond 1 continues to be an area of concern. If this accumulation of sediment continues and Pond 1's capacity is effectively diminished, then equalization capacity (the Pond's stated use), will not exist. Additionally, if Pond 1 becomes filled to capacity with sediment, the high sediment load would then be deposited in Pond 2. If influent volumes are such that Pond 2 cannot accommodate flow (especially if it begins to accumulate sediment in effluent formerly received by Pond 1), then bypass may result. **In this case, bypass would likely not be construed as unanticipated.** Part IV.F.3 of AK0050571 states:

PHOTO 1: ACCUMULATED SEDIMENT IS VISIBLE ON SURFACE OF POND 1

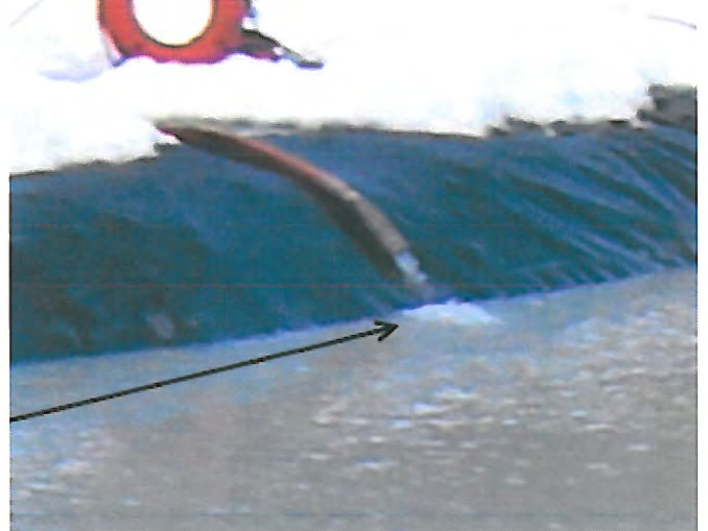
- The function of the orange collapsible hoses (Photos 1, 2, 3, 4, 9, and 10) is unknown. The hose in Photo 2 appears to be discharging into Pond 1 (Photo 2). DEC is unsure how the volume and quality of influent are measured since it appears the discharge may circumvent influent monitoring.
- Some hoses, for example the hose pictured to the left of the hose in Photo 2 (visible in Photos 1, 3, and 4), appear to be full, rather than collapsed. It is unclear whether hoses are discharging **from** Pond 1.
- The function of the collapsible orange hose in Photos 9 and 10 is unclear.

PHOTO 2: UNKNOWN SUBSTANCE FLOWS INTO POND 1. CLOSE-UP OF PHOTO 1

Submit a clear, up to date process flow diagram for existing mine water treatment plant. In addition to the diagram, please provide an explanation of the function of the orange collapsible hoses, and list any "part time" discharges to or from Ponds 1 and 2. Please direct correspondence to:

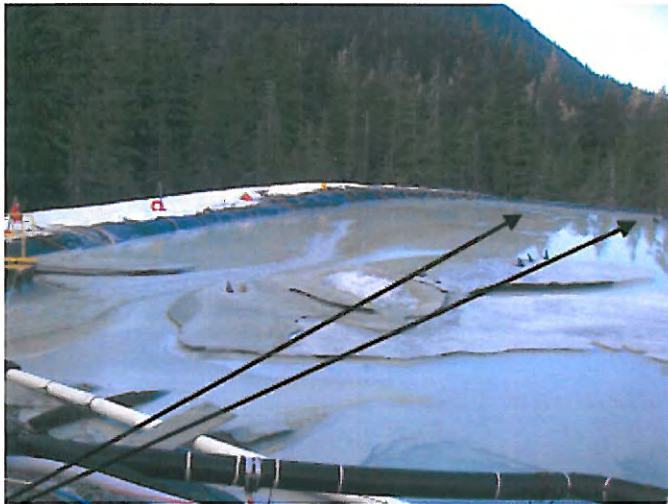
freeboard is limited (Photo 3) in Pond 1. Refuse and sediment is visible in some areas at perimeter of Pond 1 (Photos 4 and 5). Water level in Pond 1 appears close to cresting spillway (Photos 6 and 7). The truck that pumps sediment from Pond 1 was onsite (Photo 8) and operational during inspection. KGM personnel were pumping from Pond 1 during inspection (Photo 9). Orange collapsible hoses similar to those referenced above appear to enter Pond 2 and rest at perimeter of Pond 1 (Photos 9 and 10). **The purpose and function of these collapsible orange hoses is unknown.**

PHOTO 3: POND 1 APPEARS TO HAVE EXTREMELY LIMITED FREEBOARD AVAILABLE

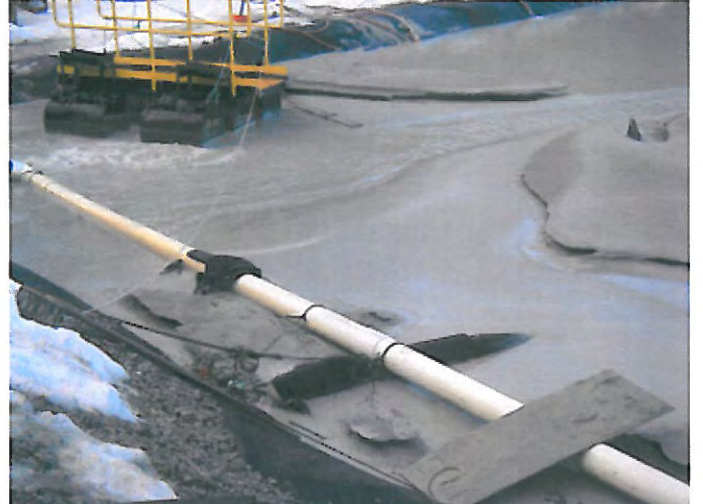
PHOTO 4: WASTE ACCUMULATES AROUND PERIMETER OF POND 1 IN SOME AREAS

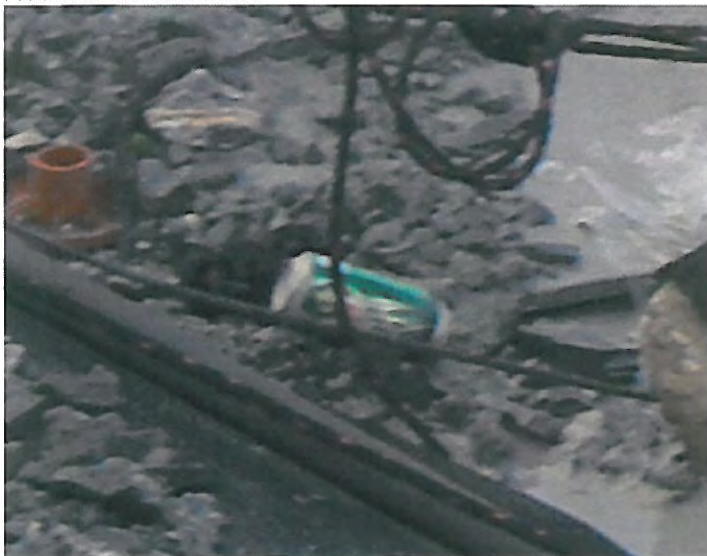
PHOTO 5: PHOTO 4, ENLARGED

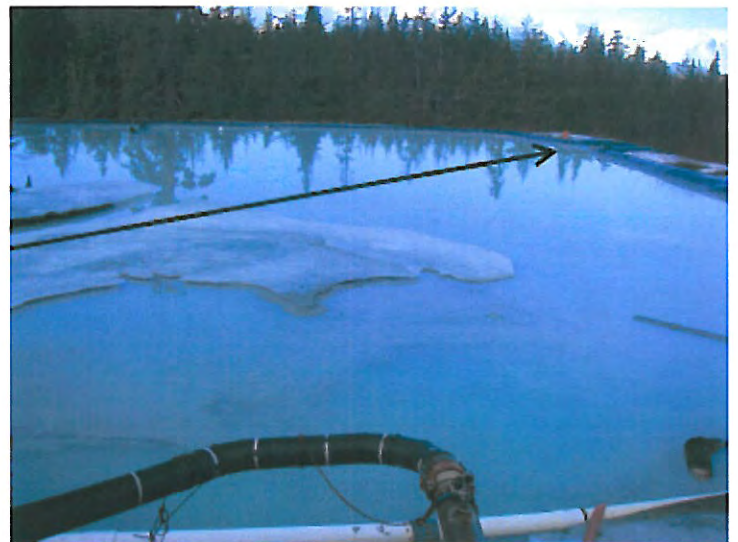
PHOTO 6: POND 1 LEVEL APPEARS CLOSE TO CRESTING SPILLWAY TO POND 2

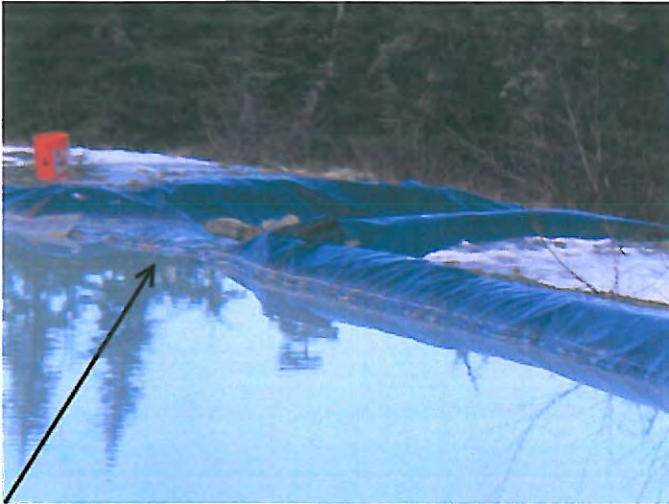
PHOTO 7: CLOSER VIEW OF SPILLWAY FROM POND 1 TO POND 2

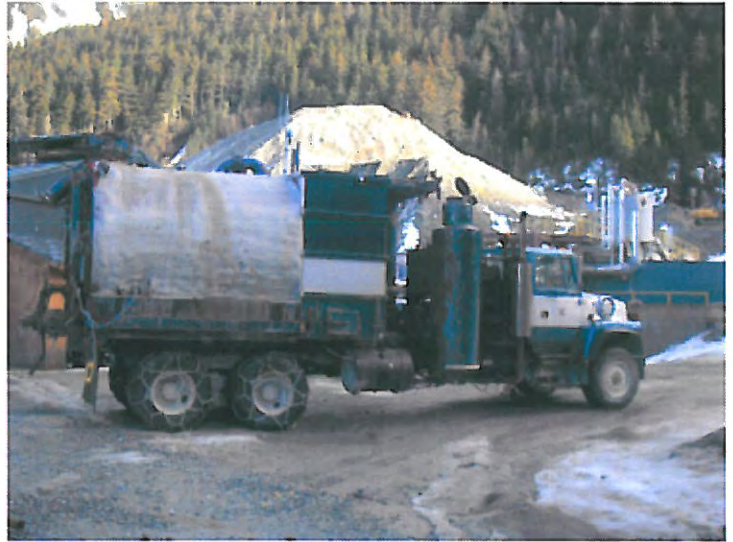
PHOTO 8: "PUMPER TRUCK" USED TO REMOVE SEDIMENT FROM POND 1

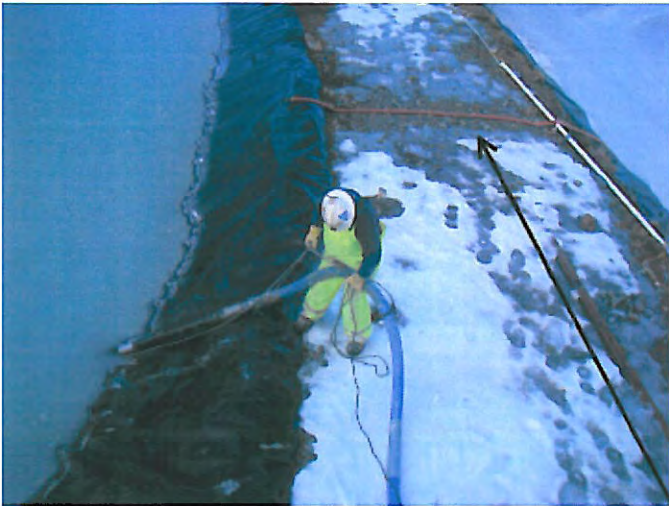
PHOTO 9: PERSONNEL USE EQUIPMENT TO PUMP SEDIMENT FROM POND 1. SEE HOSE HIGHLIGHTED BY ARROW

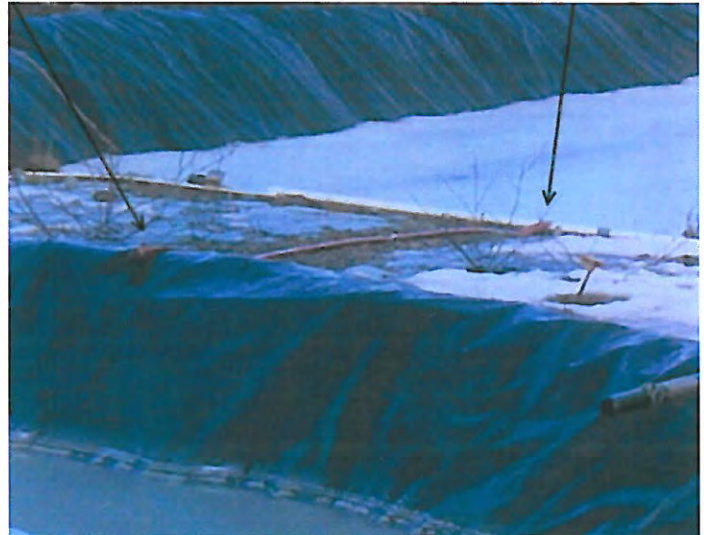
PHOTO 10: HOSE APPEARS TO GO FROM POND 2 TO POND 1

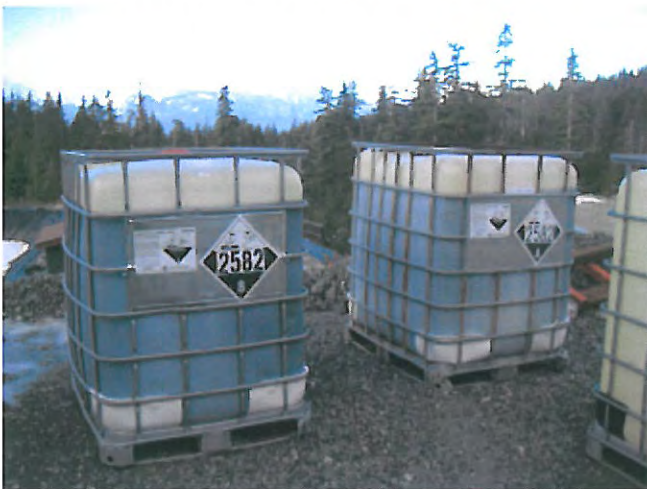
As we walked toward the Comet Water Treatment Plant (CWTP), Mr. Eppers explained that a Connex trailer has been modified to provide secondary containment for totes of chemicals stored onsite. During inspection, totes located on a gravel pad above the CWTP were observed (Photo 11). Mr. Eppers explained that the totes were being moved to the Connex in accordance with KGM's Best Management Practices (BMPs).

PHOTO 11: TOTES TO BE STORED IN CONNEX (NEW) WITH SECONDARY CONTAINMENT

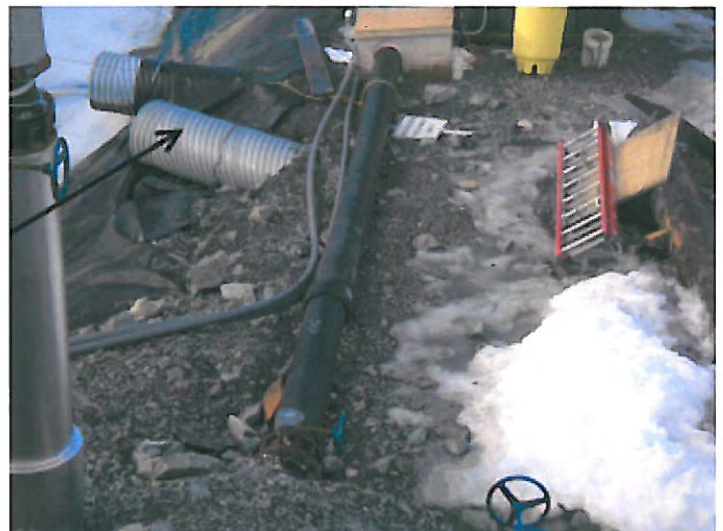
We observed the effluent line conveying treated effluent to the composite sampler (Photo 12). Mr. Eppers explained that the sampler is in the middle of the pipe, and low flows required KGM to close the valve to get enough flow to collect a sample. KGM believes a recent iron exceedance may have been the result of iron/ sediment build-up from repeatedly opening and closing the valve. We discussed a recent manganese exceedance and Mr. Eppers stated KGM must study treatability, and a compliance schedule would likely be a component of KGM's re-issued APDES permit. Pond 2's overflow connects to a corrugated pipe that also conveys stormwater from a ditch along the Comet development rock stockpile.

PHOTO 12: ARROW POINTS TO POND 2 OVERFLOW. BLACK PIPE CONVEYS EFFLUENT TO COMPOSITE SAMPLER
