INSPECTION REPORT: KENSINGTON GOLD MINE

Tongass National Forest Minerals Group
8510 Mendenhall Loop Rd
Juneau, AK 99801
(907) 789-6275– office
(907) 586-8808 – fax

Date of Inspection: Thursday, July 27, 2017
Date of Report: Wednesday, August 2, 2017
USDA Forest Service Inspector: Richard Dudek

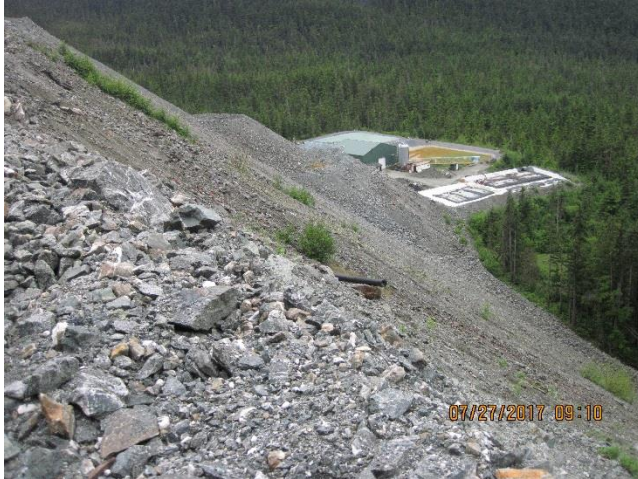
Coeur Alaska continues to stockpile waste rock from the Raven drift at the southwest end of the development pile (Photo 1).

Photo 1. The Comet Development Pile.

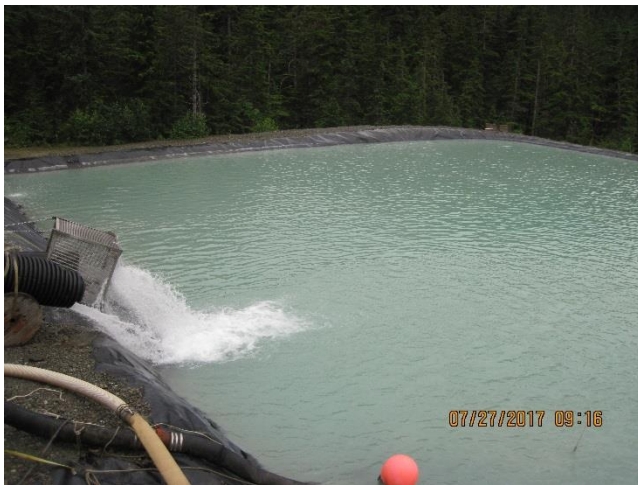
At the time of the inspection, the CWTP was treating 1600 gallons of water per minute (gpm). Due to its ineffectiveness, the CWTP personnel removed the silt curtain from Pond 1 (Photo 2). Coeur Alaska has no plans to reinstall another silt curtain in Pond 1. The silt curtain was originally installed to help minimize the sediment deposition area for Pond 1. However, sediments were still depositing throughout the pond.

Photo 2. Image shown is Pond 1 at the Comet water treatment plant.

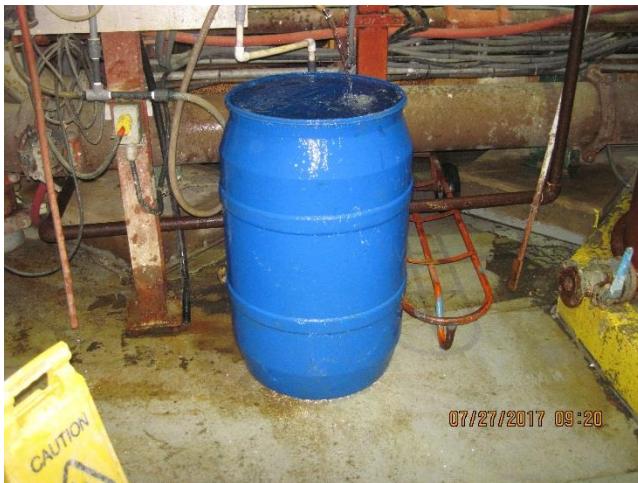
The CWTP is using a new test barrel (Photo 3) for measuring white material accumulation below the discharge turbidity meter.

Photo 3. The test barrel used for white material observations located inside the Comet water treatment.

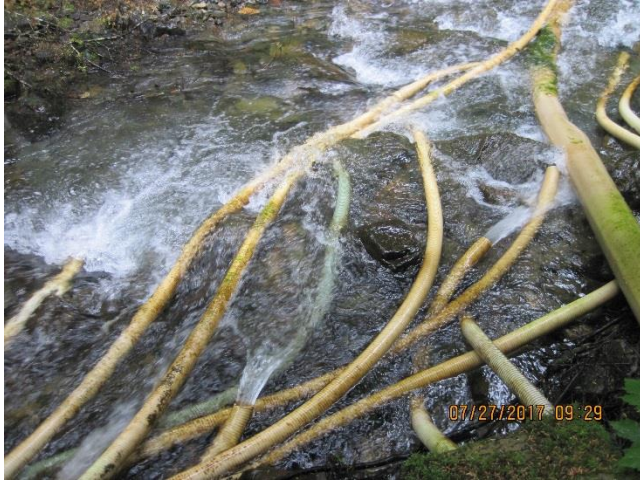
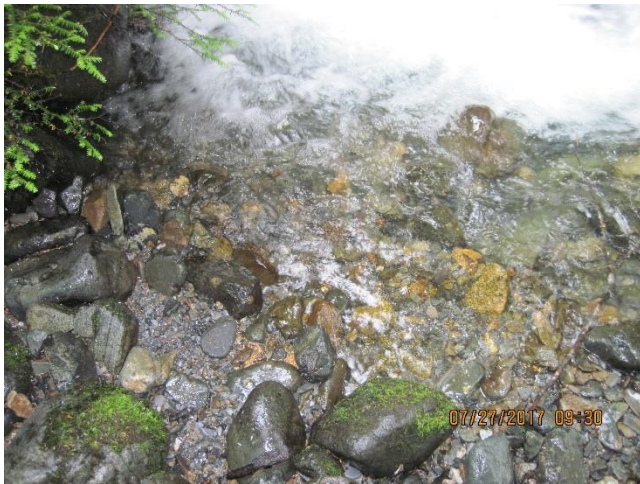
White material was not observed in Sherman Creek (Outfall 001) during this inspection (Photos 4-5).

Photo 4. Sherman Creek (outfall 001) image 1 of 2.

Photo 5. Sherman Creek image 2 of 2.

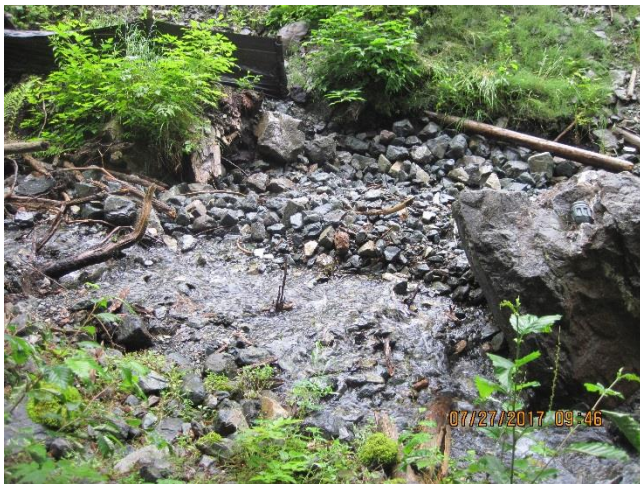
Coeur Alaska personnel placed riprap (Photo 6) along the creek's cut bank to help reduce erosion. The area where the riprap was placed is adjacent to the fill material used for the Comet development pile.

Photo 6. Riprap placed along the cut bank of Ophir Creek.

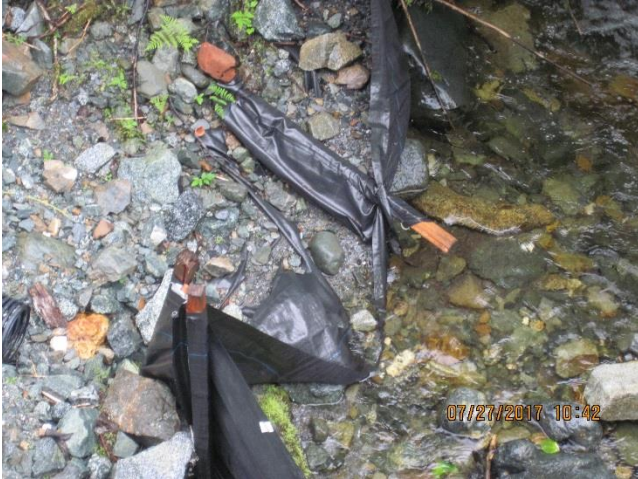
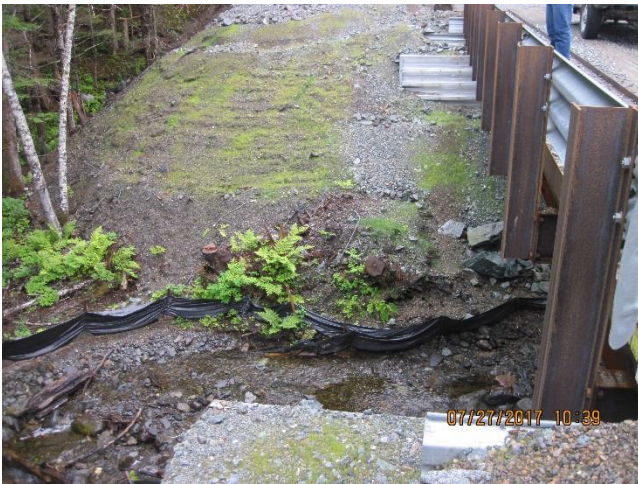
South Fork Sherman Creek Bridge: Sediment buildup has exceeded the maximum capacity for silt fencing and requires maintenance.

Sections of the silt fencing (Photos 7-8) require maintenance along the South Fork Sherman Creek Bridge abutments. A section of silt fencing has fallen over, and another section has sediment and woody debris buildup that has exceeded the maximum height of nine inches for the silt fencing (Coeur Alaska BMP Plan; page C-11).

Photo 7. Silt fencing for the South Fork Sherman Creek Bridge is pushed over.

Photo 8. There is sediment buildup along a section of silt fencing at South Fork Sherman Creek Bridge.

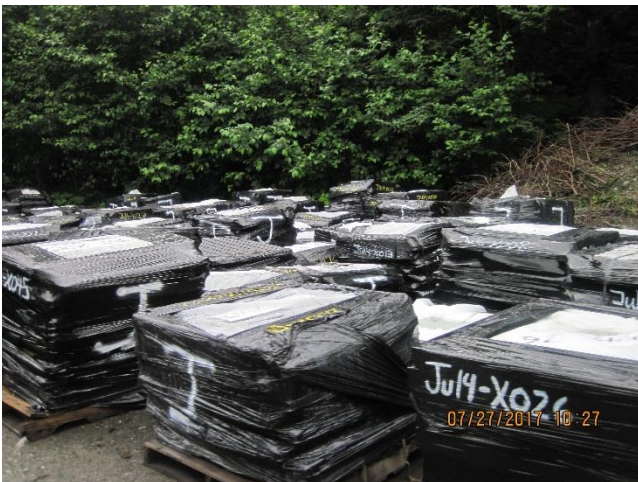
The rock core (Photo 9) that is staged at this location will be stored inside the large shop building at Comet Beach. Coeur Alaska has plans to install storage racks, and make some improvements to the building, prior to moving the core inside the building for long-term storage.

Photo 9. Palletized drilling core staged at the Comet Beach area.

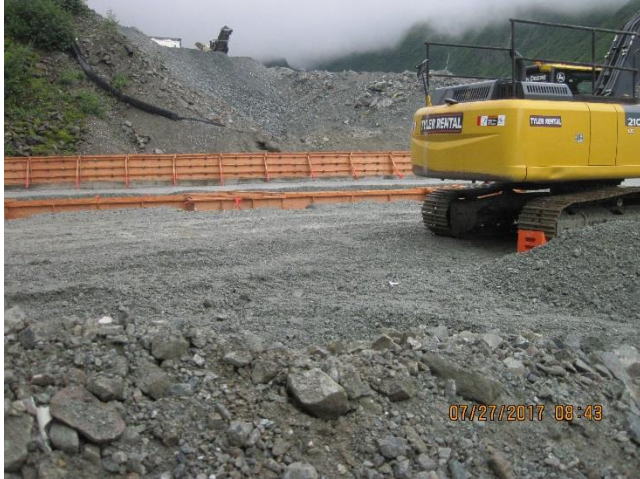
The construction for the concrete foundation pad and powerhouse is ongoing (Photo 10). The concrete foundation will support the four new (4-megawatt) generators, the 30,000-gallon "day tank", and the refueling pad.

Photo 10. Image shown is the construction for the concrete foundation pad.

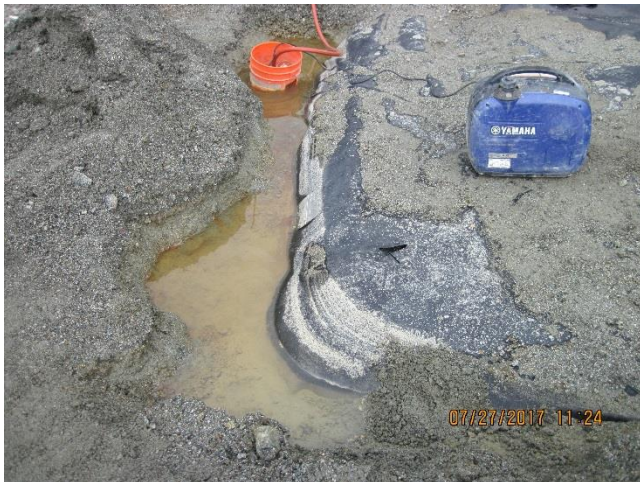
Surface operations recently hand dug a small trench (Photos 11) near the HDPE liner for a Graphitic Phyllite (GP) stockpile. The trench was installed because water under the HDPE liner was not flowing into an existing drain. Coeur Alaska personnel cut a hole into the HDPE liner and pumped the water into the trench. The water was then pumped into a water truck and sent to the seep plant for treatment and discharge. The hole was patched (Photo 12) after the water was pumped out.

Photo 11. The hand dug trench at the Mud dump.

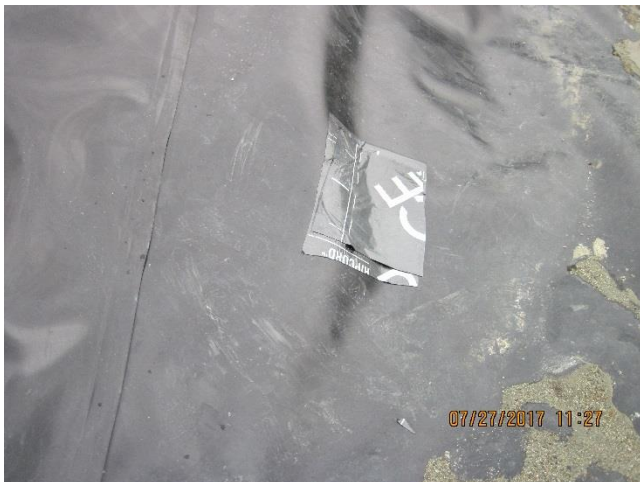
Photo 12. The patches covering the hole where water was pumped out.

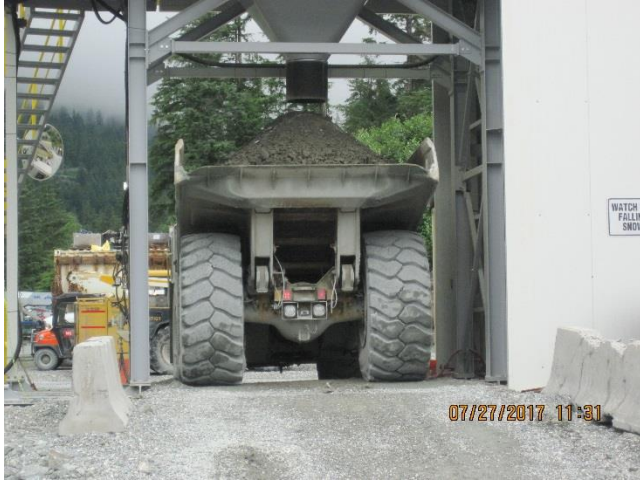
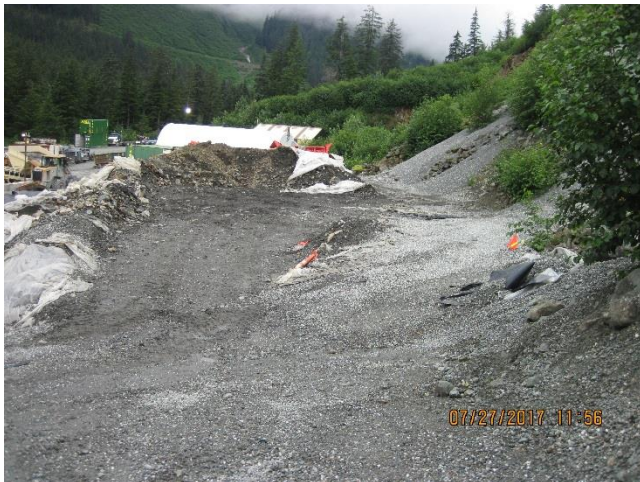
The Pug plant is online (Photo 13) and the temporary GP stockpile that is being worked into the cement is almost gone (Photo 14). Once this GP stockpile has been completely removed, the Pug plant operators will begin utilizing GP material stockpiled at Pit 7.

Photo 13. A haul truck at the Pug plant is receiving cement for underground backfill.

Photo 14. The GP stockpile that is being utilized at the Pug plant.

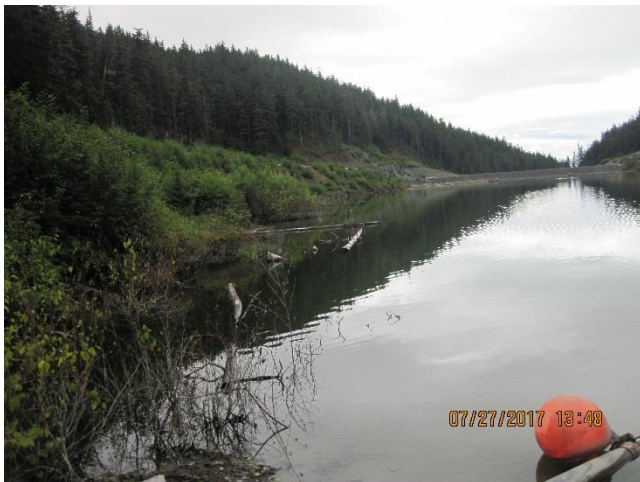
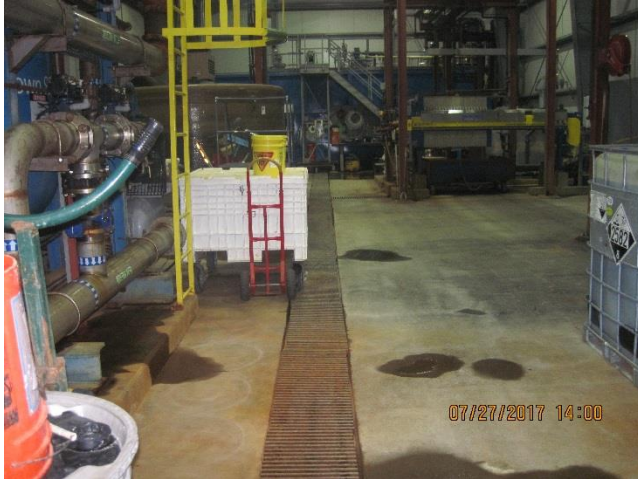
The water level for the TTF was 697.1 feet (Photo 15). During the site visit, the water treatment plant (Photo 16) was treating 700 gallons of water per minute. Good Housekeeping practices were observed inside the water treatment plant (Appendix 4g BMP Plan; Table 4-1).

Photo 15. The Tailings Treatment Facility (TTF).

Photo 16. The TTF water treatment plant.

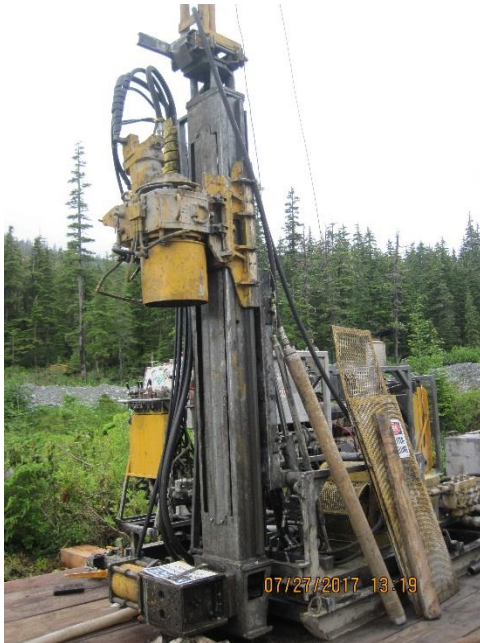
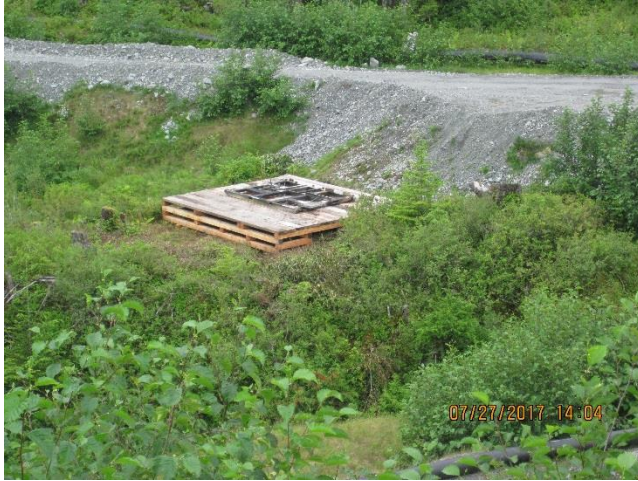
Coeur Alaska continues geotechnical drilling (Photos 17-18) in the northern TTF area. This drilling is to evaluate stability and other baseline geotechnical factors, as well as determine whether underlying rocks may potentially be acid generating. Approximately one-hundred linear feet is drilled from each geotech pad.

Photo 17. Geo-tech drill BH-006.

Photo 18. A constructed drilling pad located in the northern TTF area.

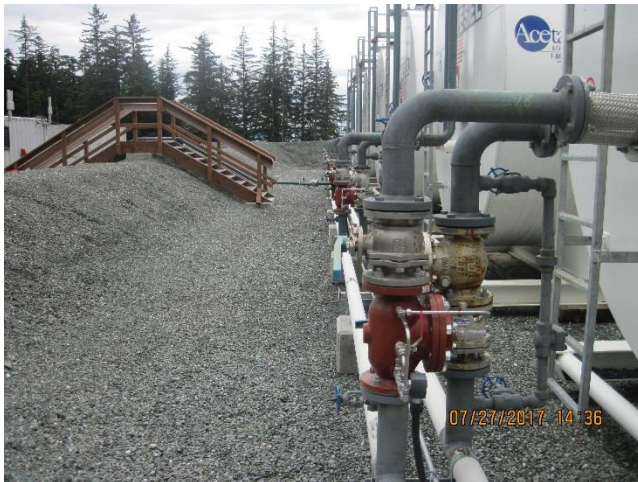
The fuel depot is well kept and in order (Photo 19).

Photo 19. Coeur Alaska's fuel depot.

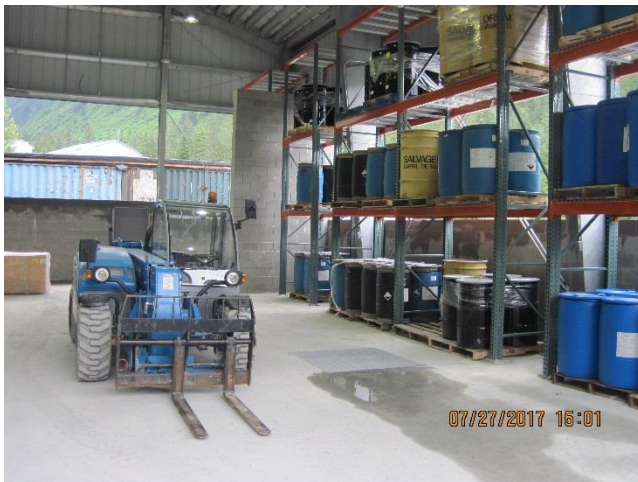
Coeur Alaska personnel have installed steel shelving inside the facility (Photo 20).

Photo 20. Image shown here is steel shelving that was installed in the chemical cold storage warehouse.
