INSPECTION REPORT: KENSINGTON GOLD MINE

Tongass National Forest Minerals Group
8510 Mendenhall Loop Rd
Juneau, AK 99801
(907) 789-6275– office
(907) 586-8808 – fax

Date of Inspection: Thursday November 15, 2018
Date of Report: Wednesday November 28, 2018
USDA Forest Service Inspector: Richard Dudek

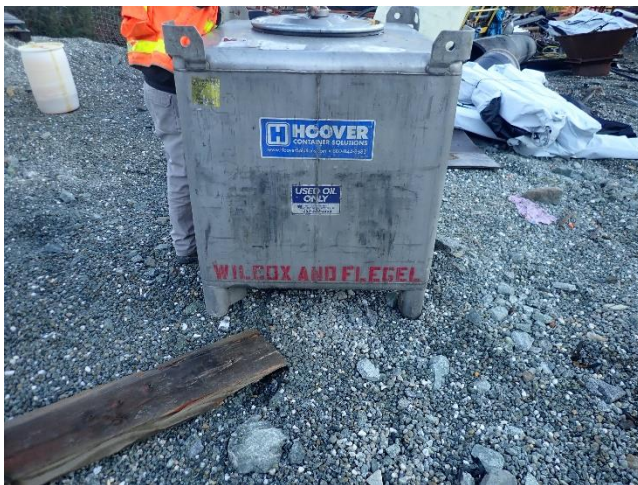
Photo 1. Steel container for used oil.

- **A stainless steel tank containing used oil should be relocated to a safer location within the TTF laydown yard (Photo 1).**

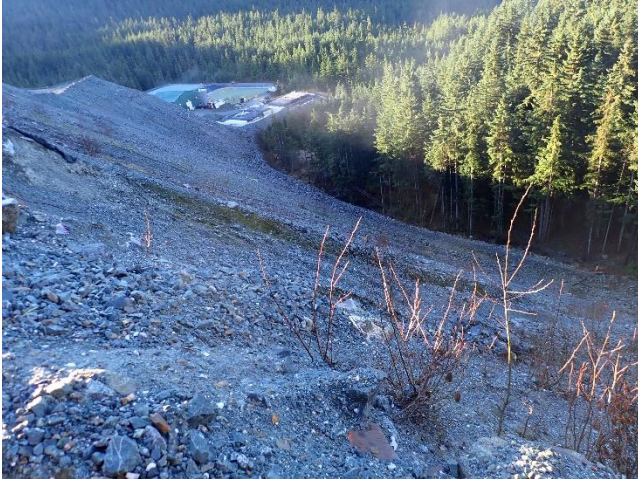
Currently, waste rock from the Raven drift is deposited at this location (Photos 2).

Photo 2. Comet Development pile.

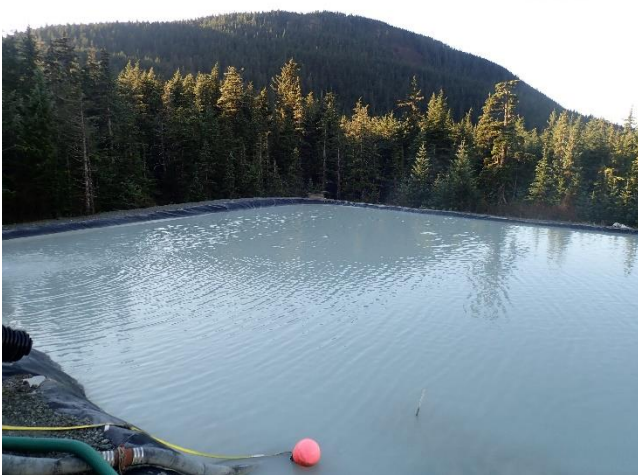
On 11/15/2018, the CWTP was treating 1400 gallons per minute (gpm). Pond-1 (Photo 3) was receiving mine site water along with recirculation water from Pond-2. Pond-2 (Photo 4) was receiving backwash from the CWTP.

Photo 3. Pond-1.

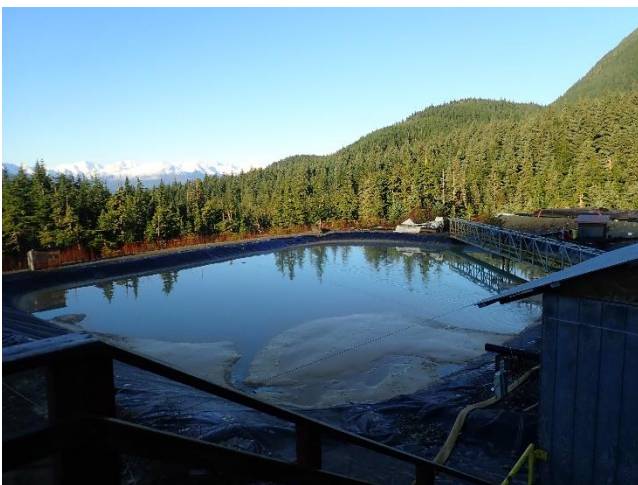
Photo 4. Pond-2.

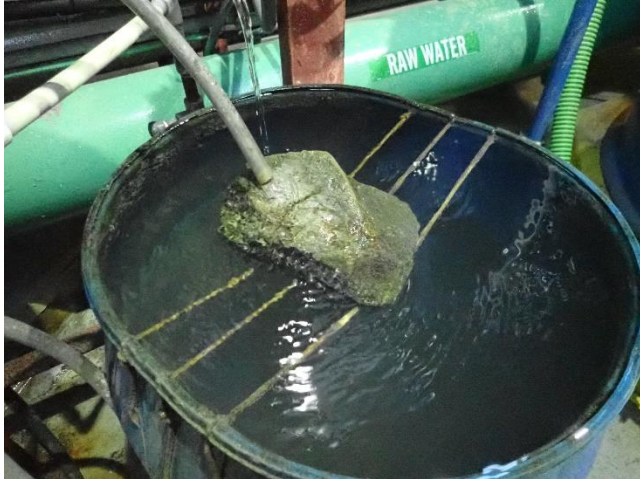
No white material was observed on the test rocks used for monitoring the formation of white material from treated mine site water (Photo 5).

Photo 5. CWTP test rock.

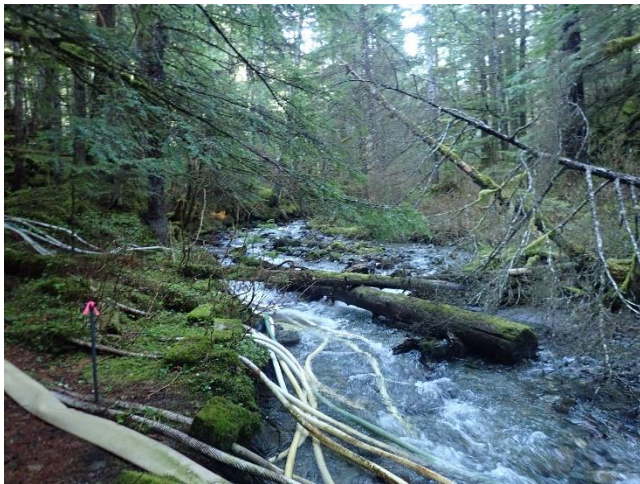
Photo 6. Sherman Creek (Outfall 001)

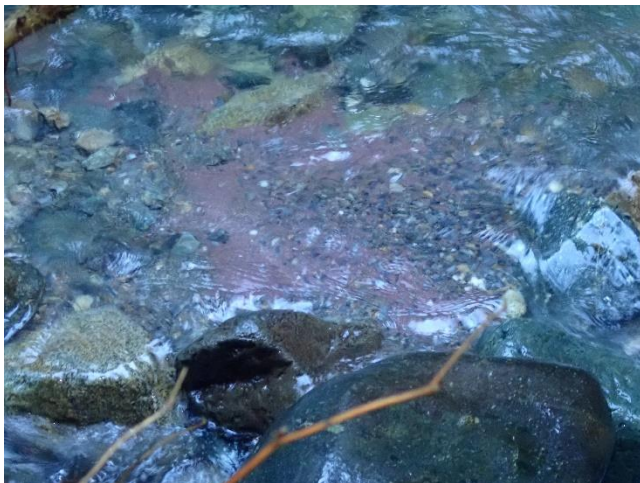
No white material was observed in Sherman Creek Outfall 001 (Photo 6). Two faulty air actuated valves from the water treatment plant caused red garnets to escape the filters and deposit in the creek bed. (Photo 7). The valves have been fixed to prevent garnets from flowing out and depositing into the creek bed.

Photo 7. Red garnets in the creek bed (Sherman Creek).

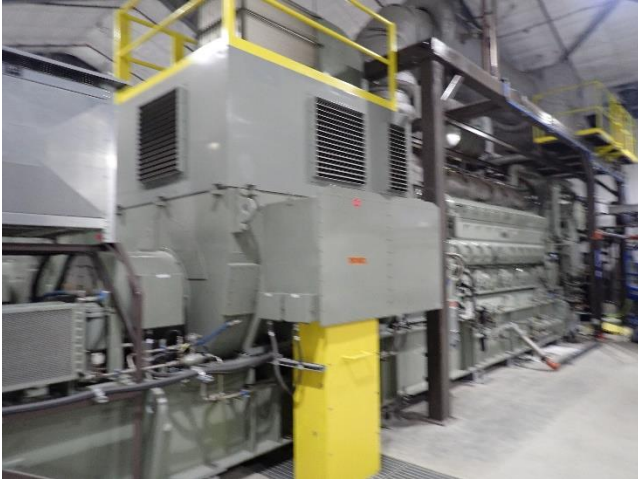
Coeur Alaska plans to bring the new generators (Photo 8) online in January 2019. The old generator site will serve as the new location for the pug plant (Photo 9).

Photo 8. One of four new 4.0-megawatt generators.

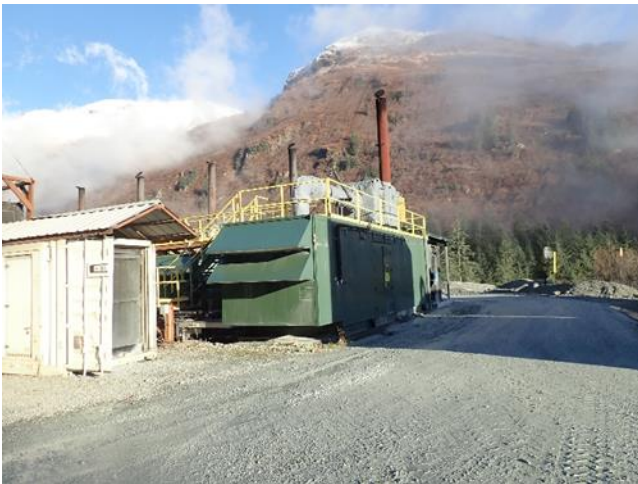
Photo 9. The old generator/new pug plant site.

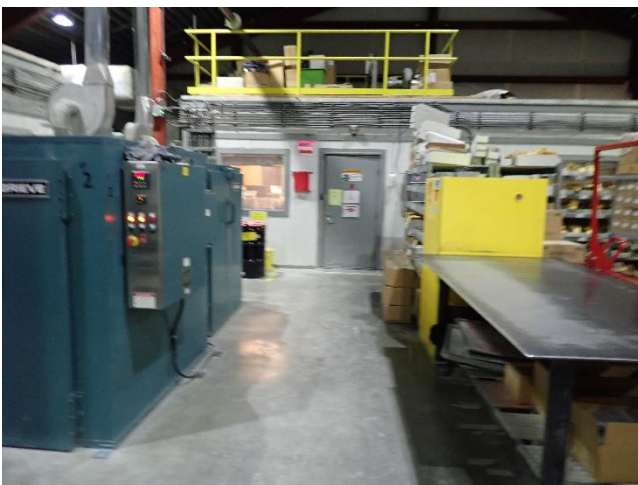
Good housekeeping practices were observed inside the assay laboratory (Photo 10) (Appendix 4g BMP Plan; Table 4-1).

Photo 10. Assay laboratory.

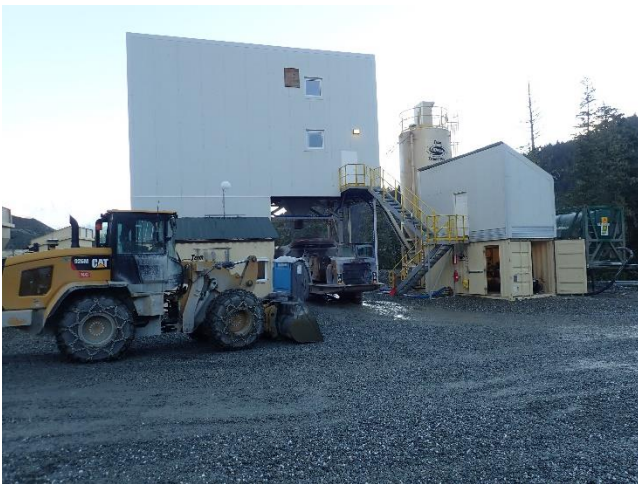
Photo 11. Pug Plant.

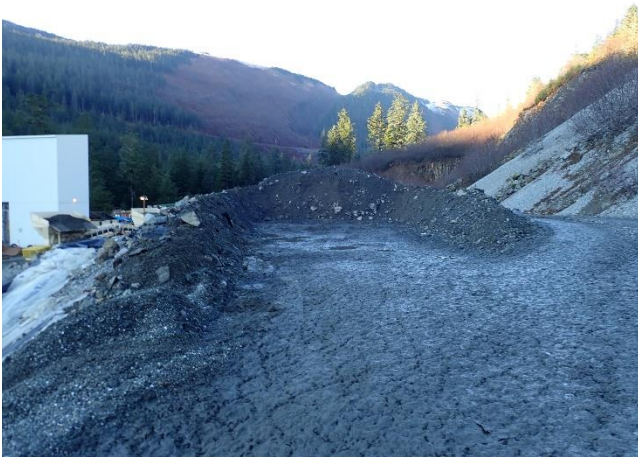
Photo 12. Pug plant's GP feedstock pile.

The Pug plant (Photo 11) was in operation at the time of the inspection. Coeur Alaska recently added heat traces to the water and concrete lines for the pug plant. Coeur Alaska plans to operate the pug plant until weather related driving conditions require haul trucks to have tire chains. When not in use, the graphitic phyllite (GP) feedstock pile should remain covered to reduce the oxidation potential for acid generation (Photo 12).

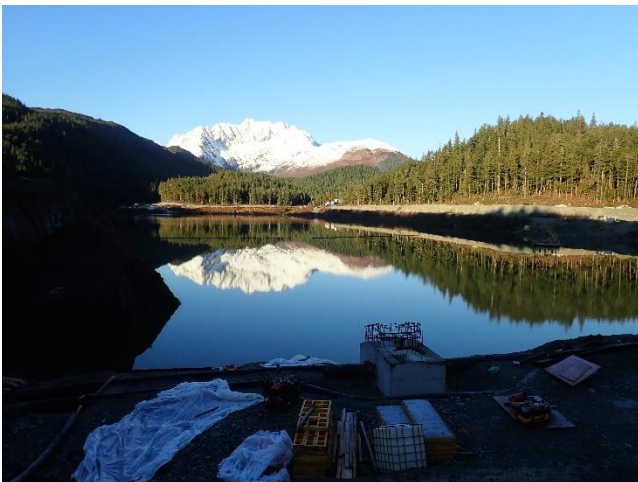
The TTF's recorded water level on 11/15/2018 was 705 feet (Photo 13).

Photo 13. Tailings treatment facility (TTF).

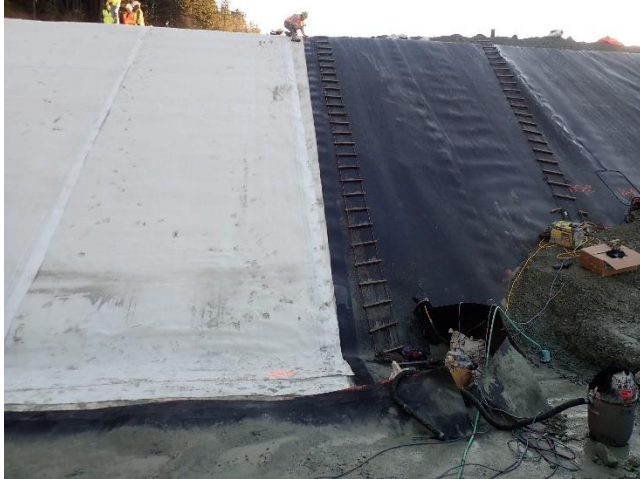
Contractors were in the final stages of the stage 3 dam construction liner installation (Photo 14). Once the liner installation is completed, contractors will cover the liner with bedding material.

Photo 14. Stage 3 dam liner installation.

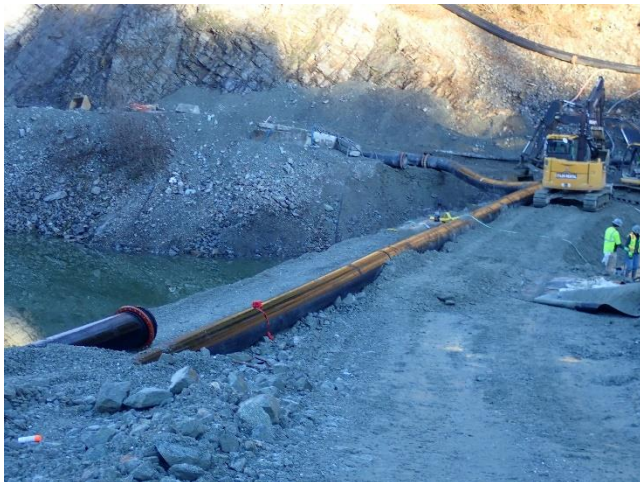
The second 28 inch diversion pipeline is not fully connected (Photo 15). Coeur Alaska plans to have the pipeline fully connected this spring.

Photo 15. Upper Slate Lake diversion pipeline will have two 28-inch pipes.

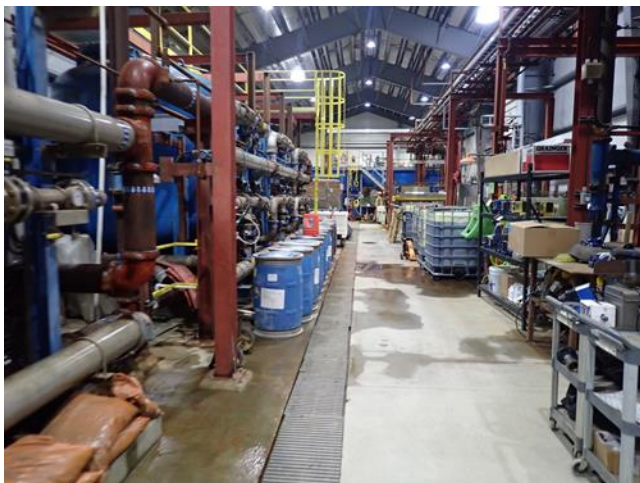
The TTF water treatment plant was treating 610-gpm including 210-gpm from the reverse osmosis system. At the time of the inspection, the water treatment plant was tidy and in order (Photo 16).

Photo 16. TTF water treatment plant.

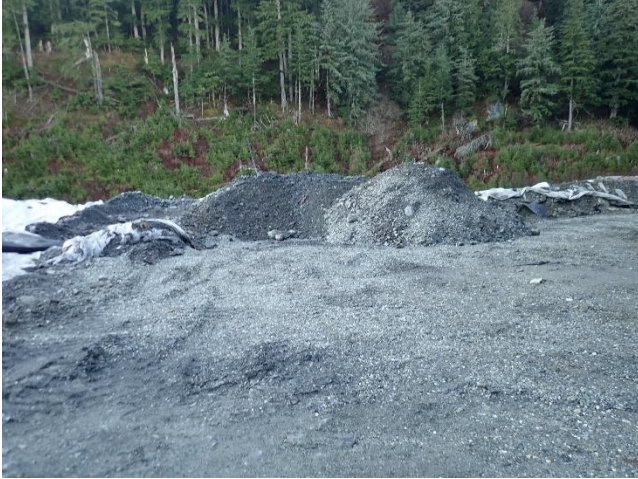
In the northern TTF staging area, the GP material has been mostly removed (Photo 17). The material is hauled over to Pit 4's pug plant, where it is processed for underground disposal along with material from other GP stockpiles.

Photo 17. GP material staged in the northern TTF area.
