## INSPECTION REPORT: KENSINGTON GOLD MINE

Date of Inspection: Wednesday, November 16, 2022  
Date of Report: December 15, 2022  
USDA Forest Service Inspector: Pat Dryer

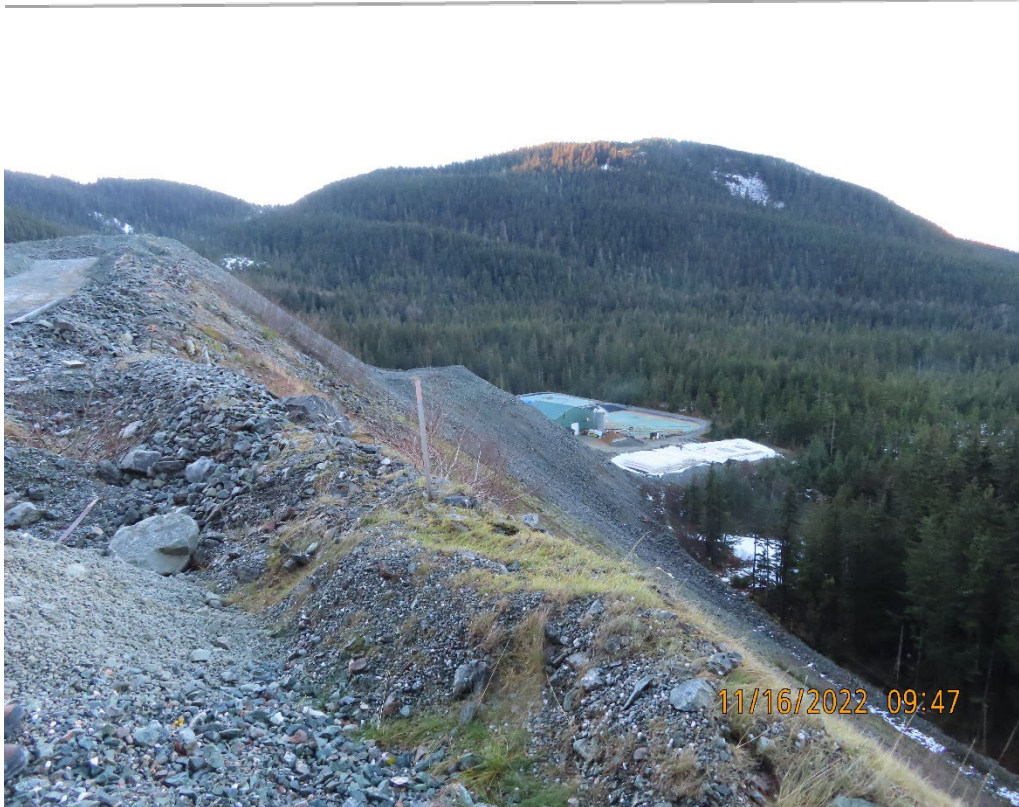
The slopes of the Comet waste rock storage area appeared stable (Photo 1). There has been no recent waste rock placement at this site.

**Photo 1. Comet waste rock storage area.**

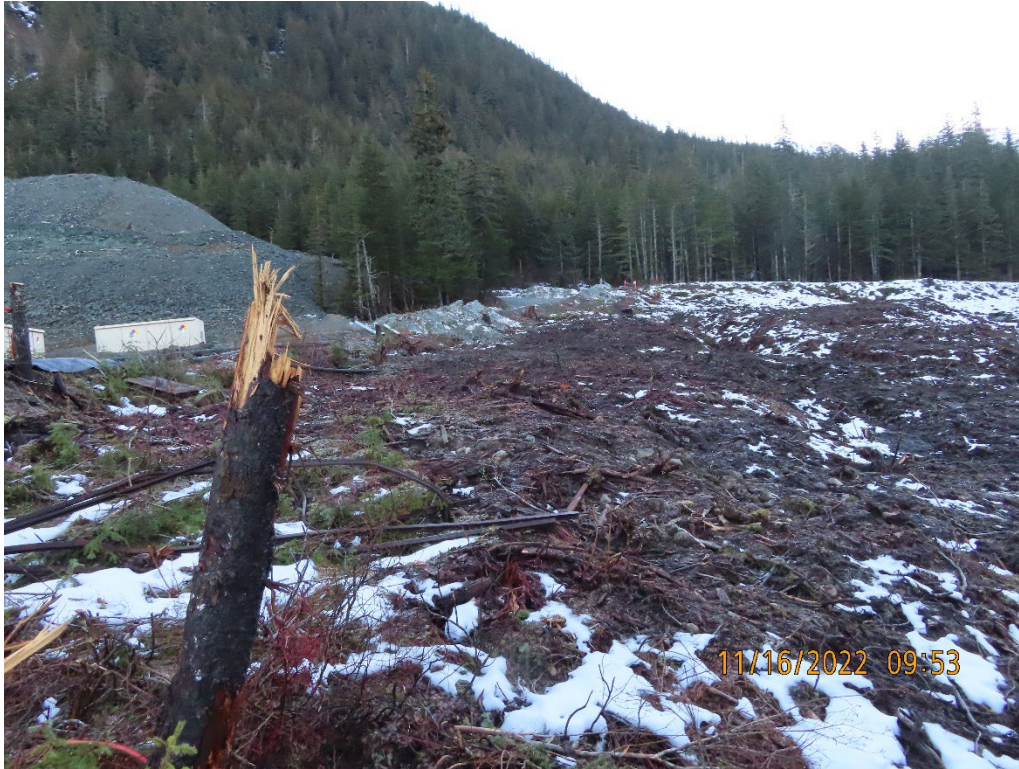
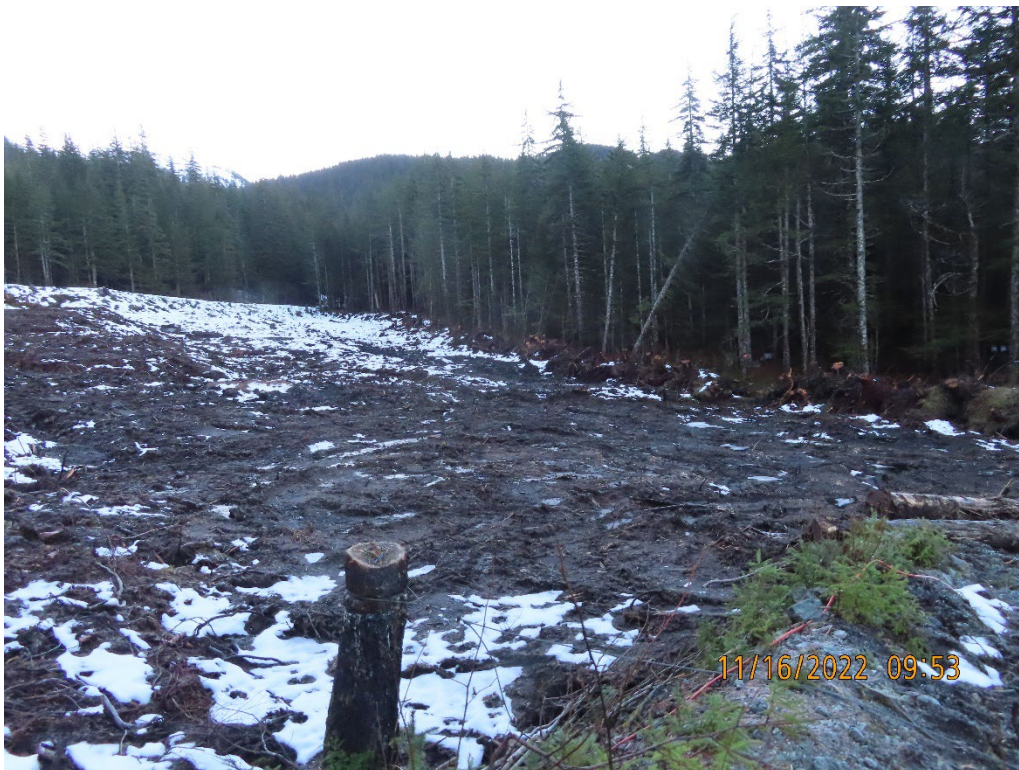
Timber clearing and grubbing is complete for this season in the area adjacent to Pond 1. (Photos 2-3).

**Photo 2. View of the area adjacent to Pond 1 that was cleared and grubbed.**

**Photo 3. View of the area adjacent to Pond 1 that was cleared and grubbed.**

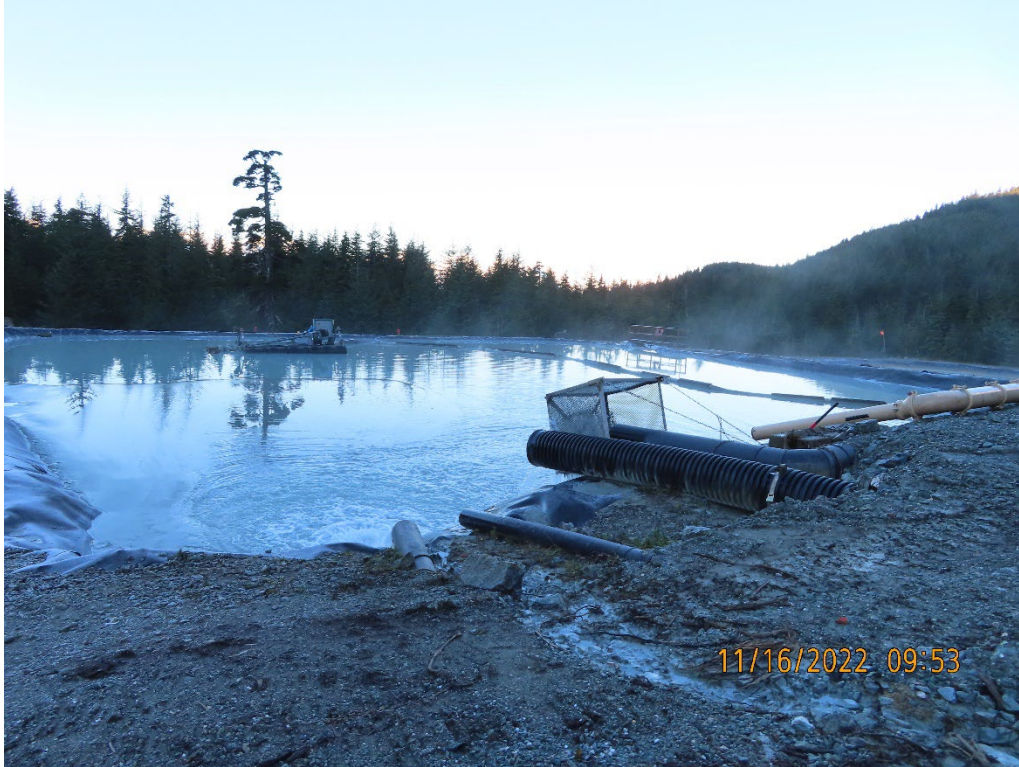
The CWTP treatment rate was approximately 2466 gpm. A dredge was located in Pond 1 (Photo 4) and was not operating at the time of the inspection. Pond 2 was receiving waters pumped from Pond 1 (Photo 5).

**Photo 4. Comet Water Treatment Plant (CWTP) Pond 1.**

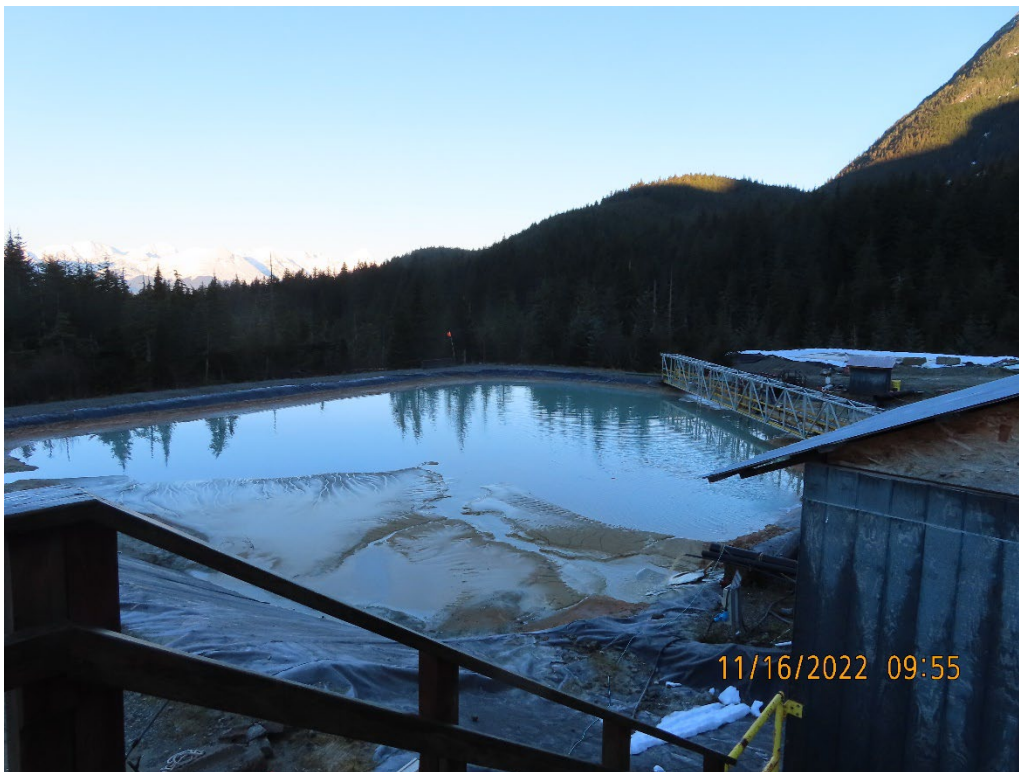
**Photo 5. CWTP Pond 2.**

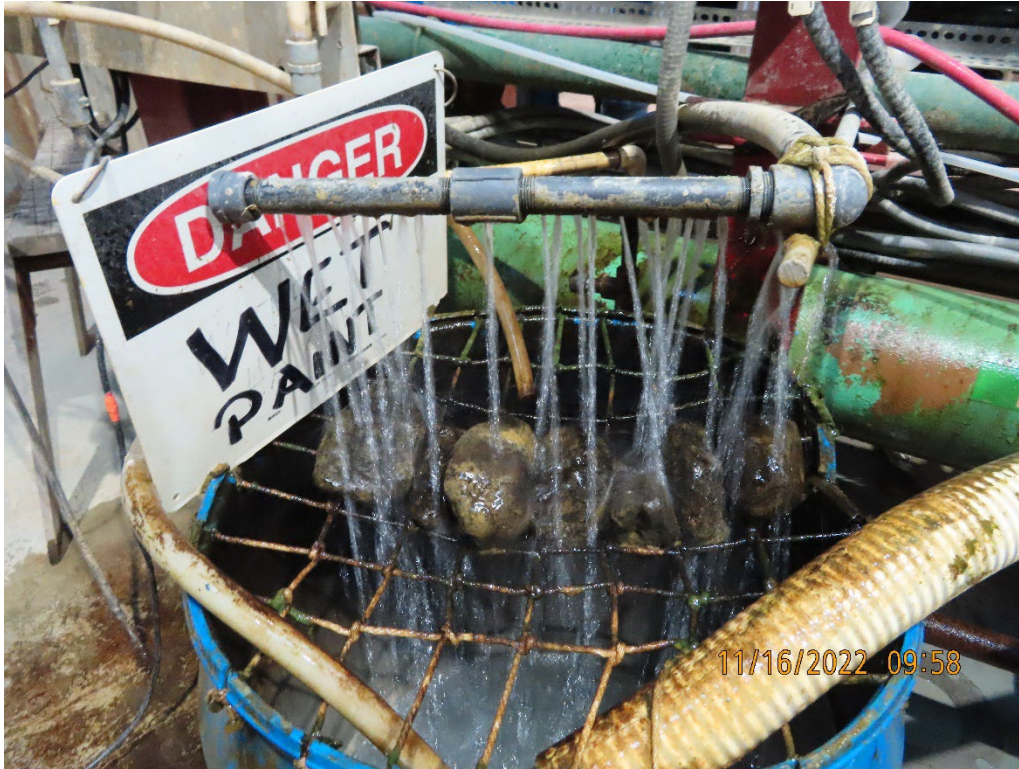
White material was not observed on the test rocks used for monitoring in the CWTP (Photo 6).

**Photo 6. CWTP white material test rocks.**

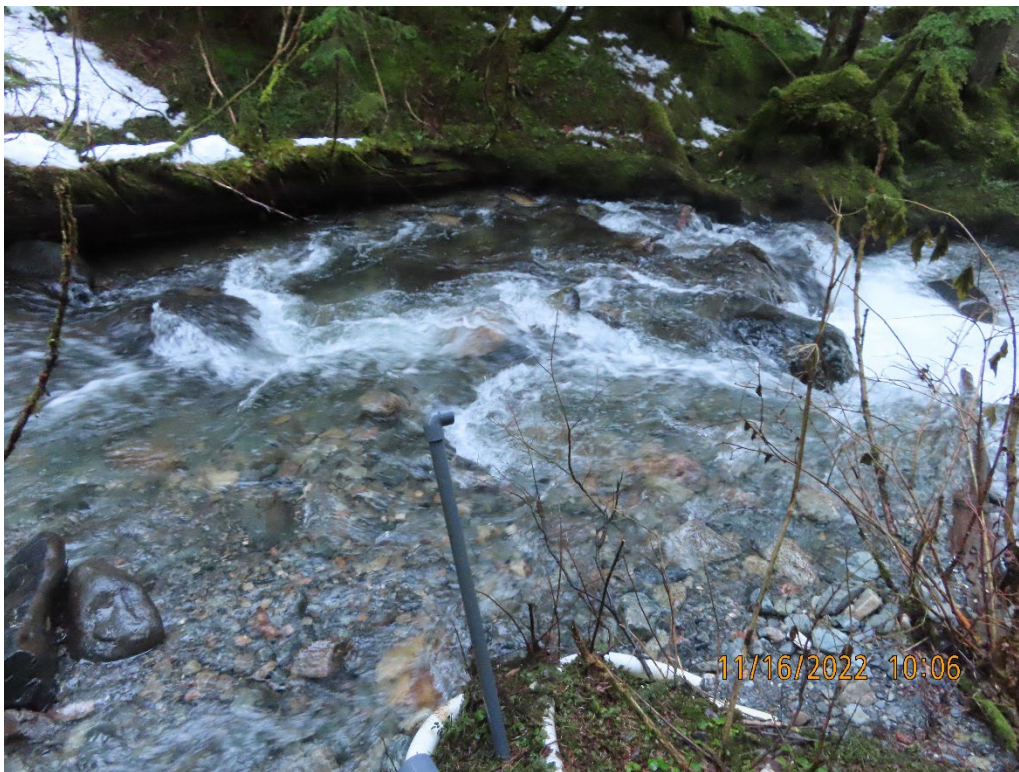
No white material was observed at Outfall 001, where treated water from the CWTP is discharged (Photo 7).

**Photo 7. Sherman Creek Outfall 001.**

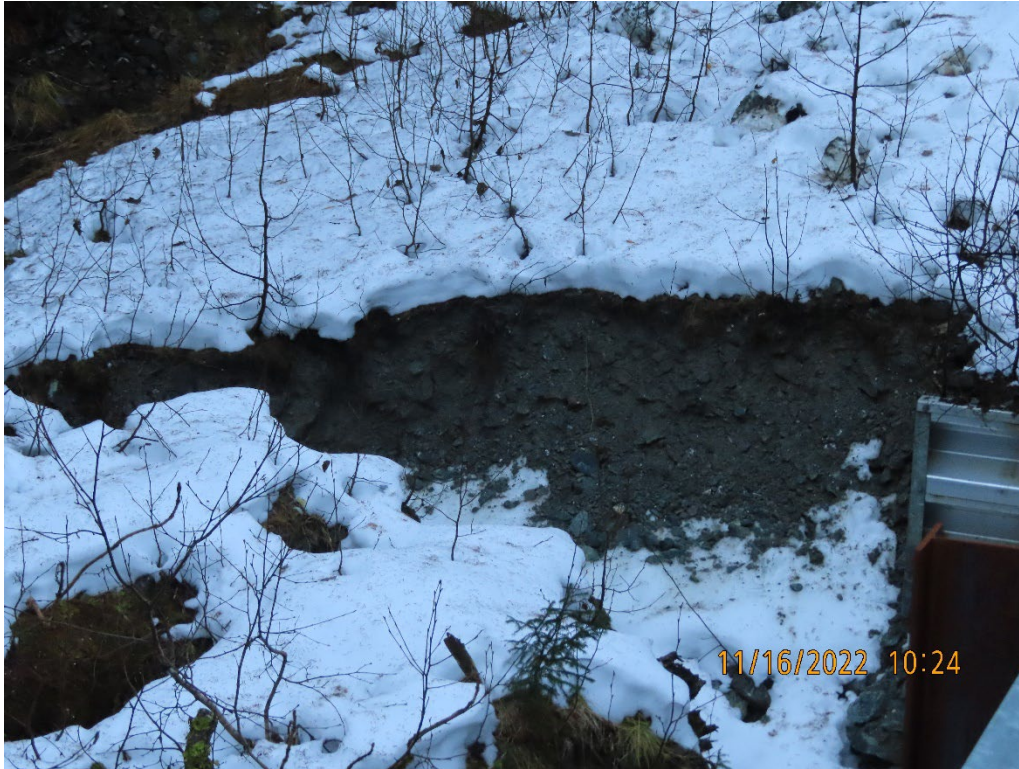
Stream bank erosion has occurred during recent heavy rainfall and elevated stream discharge near the Sherman Creek Bridge abutments. Coeur Alaska submitted a request to remove the historic log stringer bridge that remains in the stream and is likely causing the erosion (Photos 8 and 9). This work was recently authorized by the USFS and subsequent inspection reports will document the removal.

**Photo 8. Bank erosion near the Sherman Creek bridge abutment caused by a historic log stringer bridge in Sherman Creek. Coeur Alaska has requested to remove the bridge to prevent further erosion.**

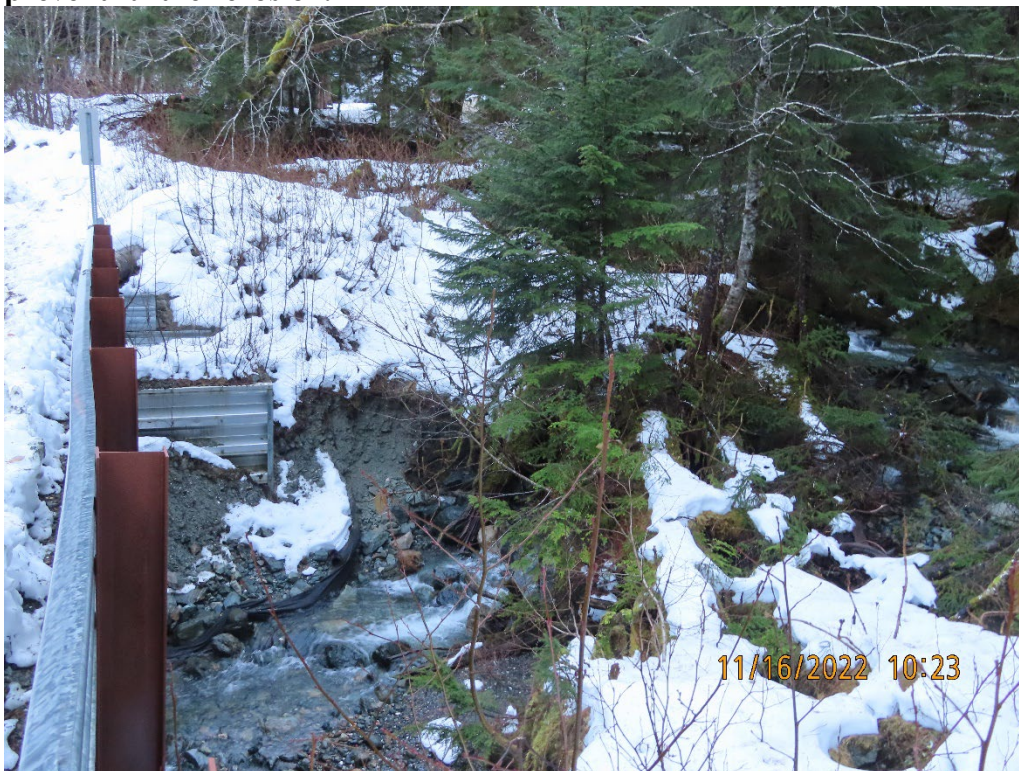
**Photo 9. Additional stream bank erosion near the Sherman Creek bridge abutment caused by a historic log stringer bridge in Sherman Creek.**

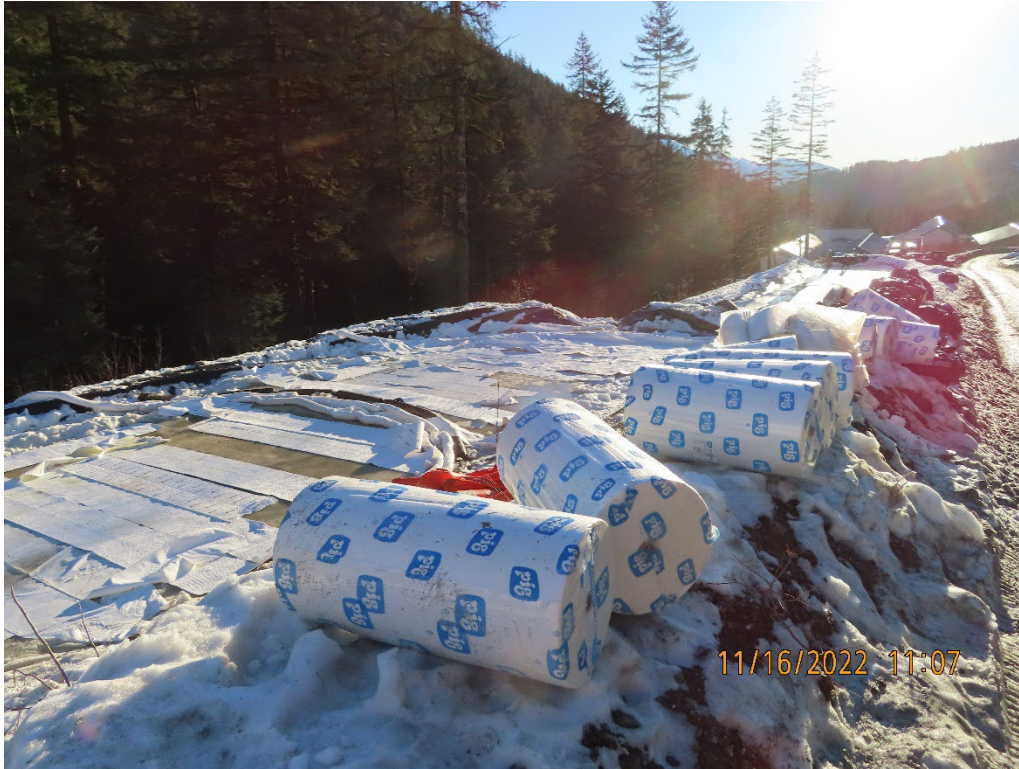
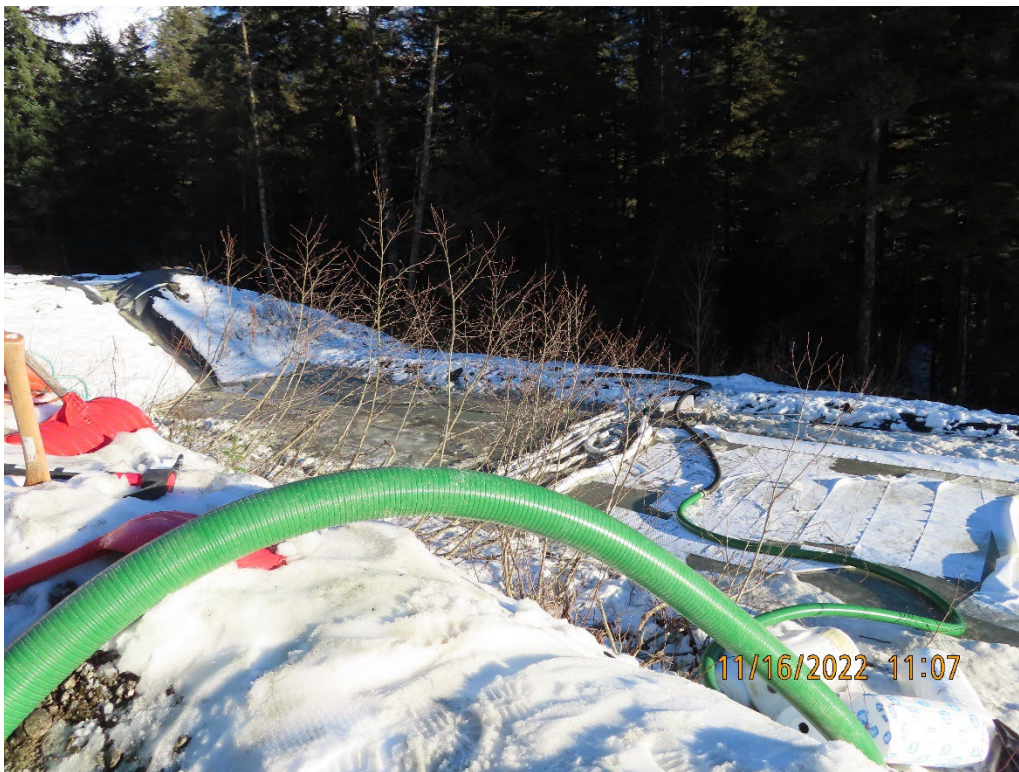
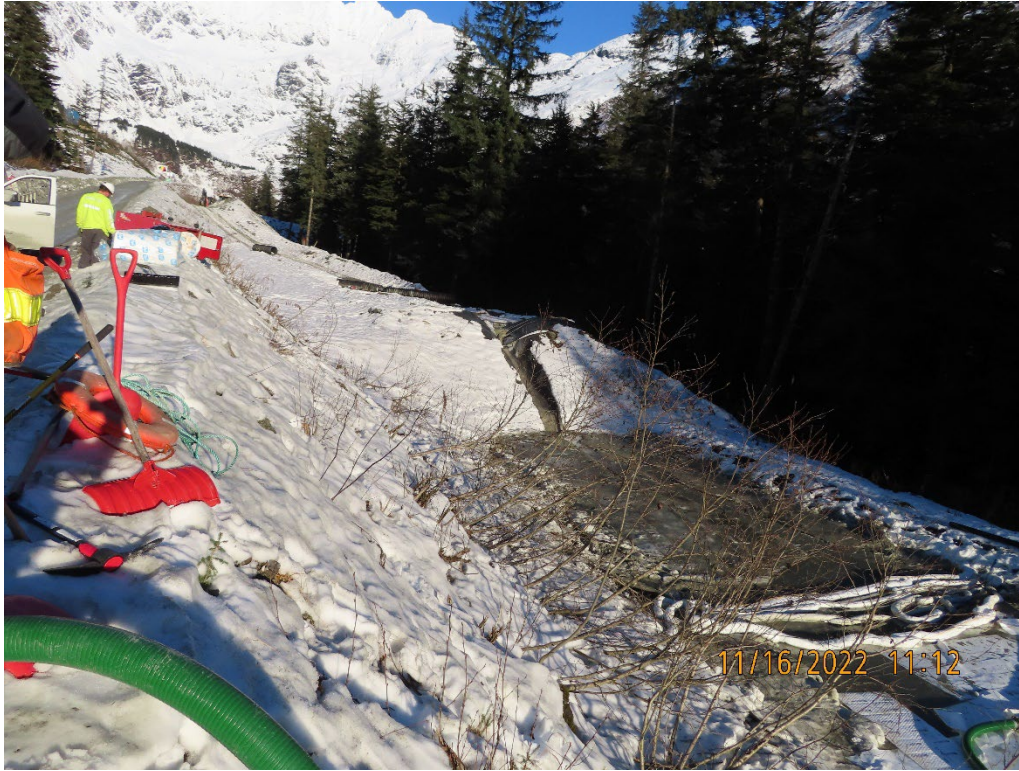
A fuel spill occurred on private lands prior to the inspection and was reported to ADEC. During the inspection we observed the cleanup efforts at the Wolf ponds. Absorbent pads, booms, and a vac trailer were being used to recover the spilled fuel (Photos 10-12). All recovered materials were being placed into isotainers or covered containment at Pit 4 (Photo 13) prior to being shipped offsite for disposal.

**Photo 10. Absorbent pads placed in the Wolf ponds.**

**Photo 11. Absorbent pads placed in the Wolf ponds.**

**Photo 12. Absorbent pads and boom placed in the Wolf ponds.**

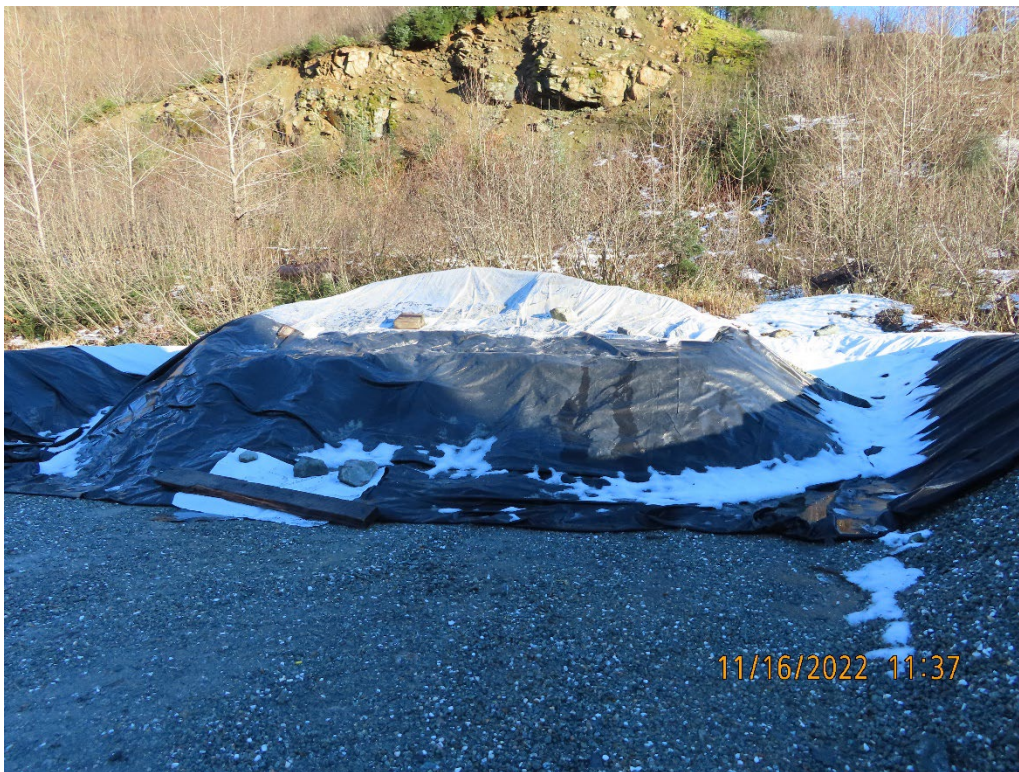
**Photo 13. Materials excavated from Wolf ponds that will be shipped offsite for treatment.**

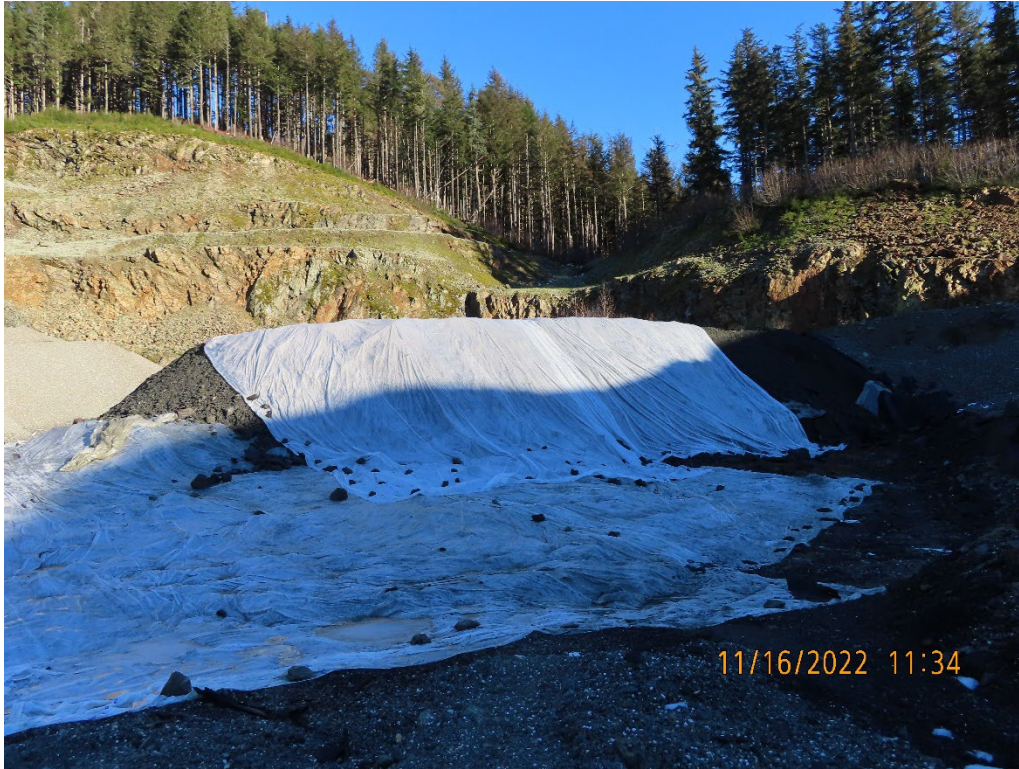
**NEW ACTION ITEM 194-1:** Graphitic phyllite stockpiled at Pit 4 was not covered as required to prevent water infiltration into the stockpile (Photo 14).

**Photo 14. Graphitic phyllite stockpile at Pit 4 that requires cover.**

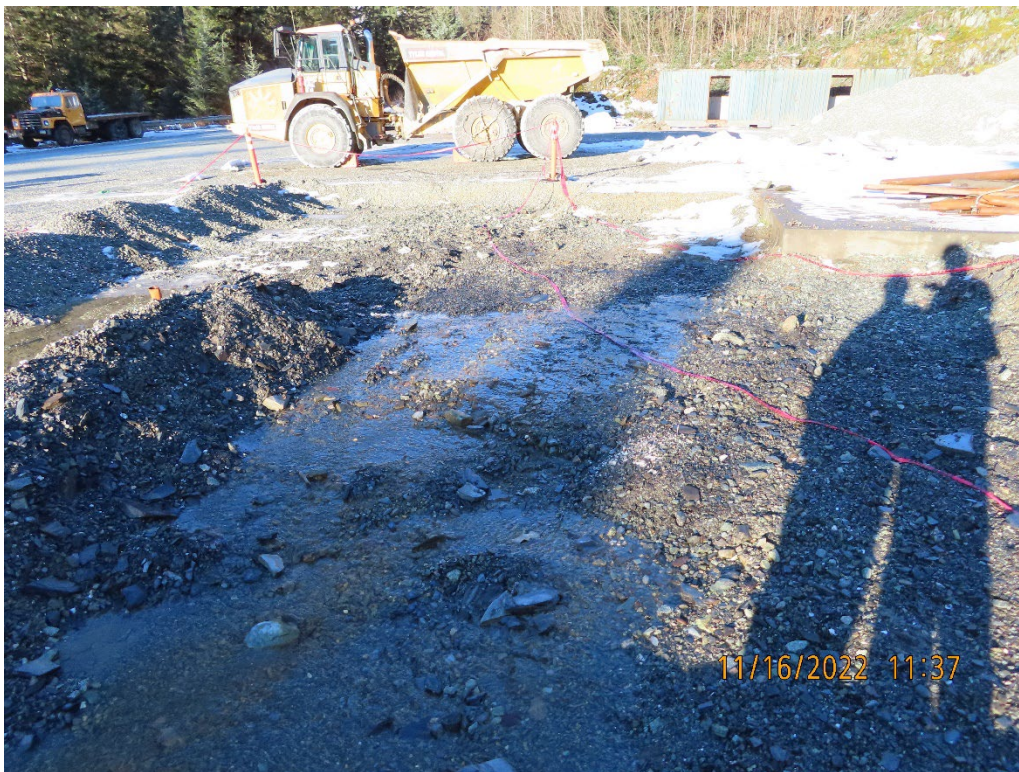
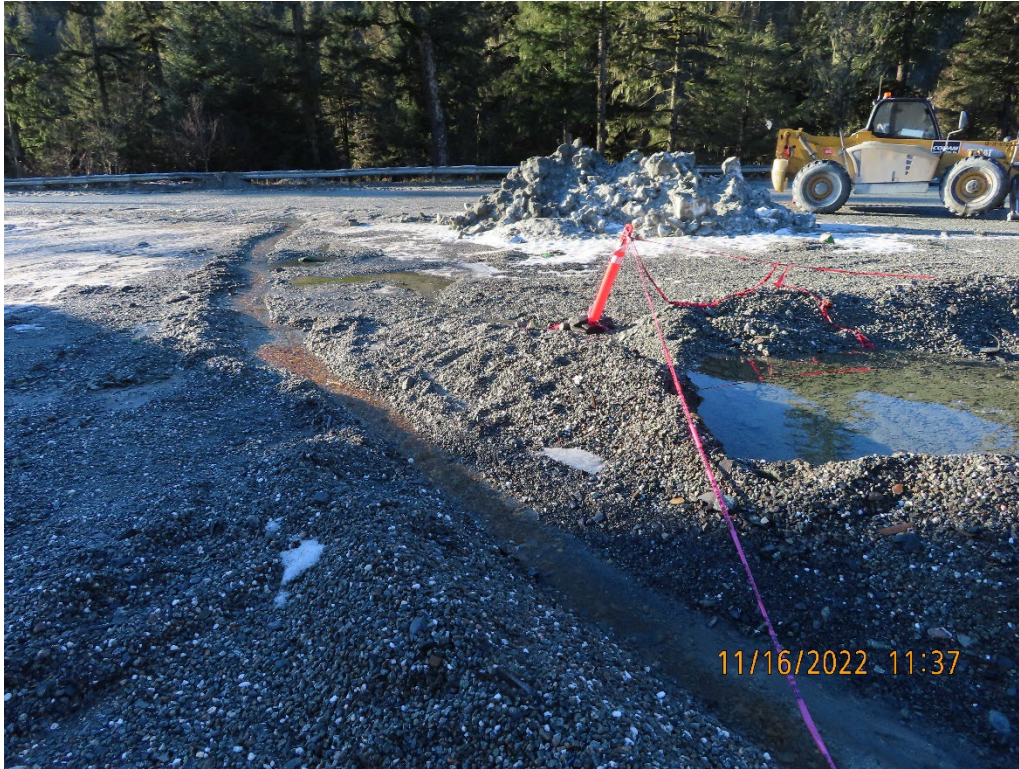
Diamond core exploration drilling was conducted in the spring of 2022 near Pit 4. The borehole appeared to have intercepted groundwater which was discharging to the surface in previous inspection reports (Report 189). Action item 189-3 was to ensure Coeur reclaimed and plugged the bore hole in compliance with 18 AAC 80, and the “Alaska Best Management Practices, for Maintaining or Decommissioning Water Wells and Boreholes”, which includes measures specific to holes that encounter artesian flow. This action item was marked as resolved in July 2022 after the borehole was decommissioned in compliance with the Alaska Best Management Practices, for Maintaining or Decommissioning Water Wells and Boreholes. However, during this inspection a spring/surface discharge near the abandoned drill casing was observed (Photos 15-16).

**Photo 15. Surface discharge near the abandoned drill casing in Pit 4.**

**Photo 16. Surface discharge near the abandoned drill casing in Pit 4.**

**NEW ACTION ITEM 194-2:** Investigate source of surface discharge near abandoned borehole in Pit 4. Further investigation is necessary to determine if groundwater was intercepted during surface drilling operations and if borehole was properly abandoned (Photo 15).

**NEW ACTION ITEM 194-2:** Investigate source of surface discharge near abandoned borehole in Pit 4. Further investigation is necessary to determine if groundwater was intercepted during surface drilling operations and if borehole was properly abandoned.

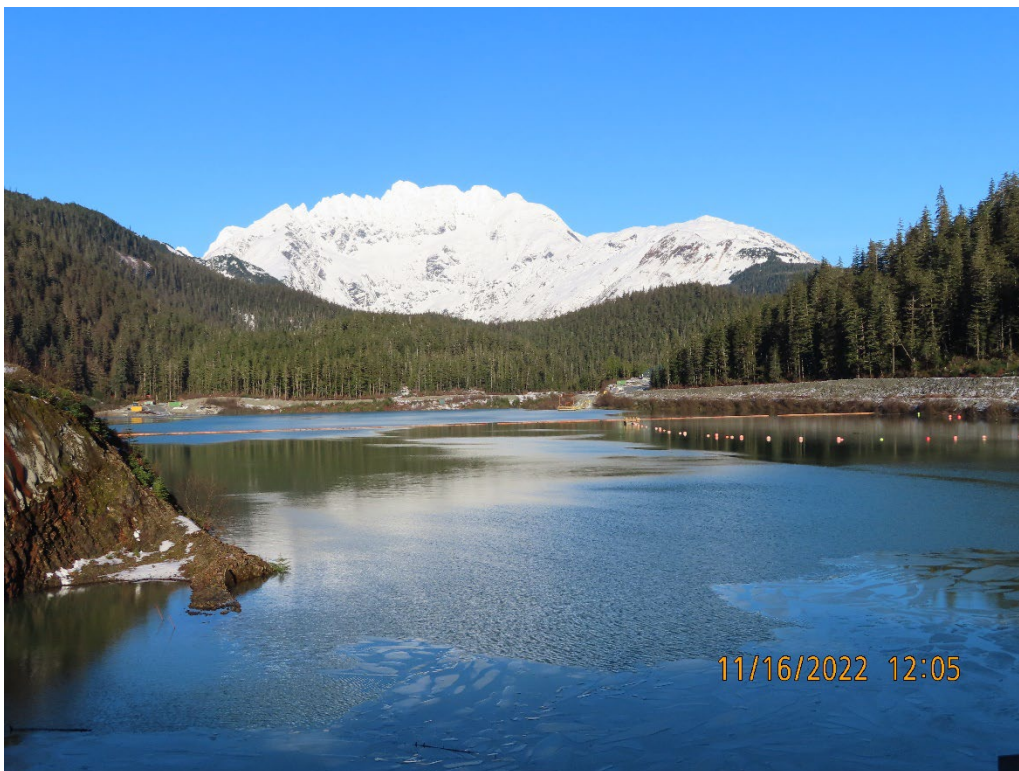
The water level for the TTF (Photo 17) was 720.6 feet.

**Photo 17. TTF looking north**

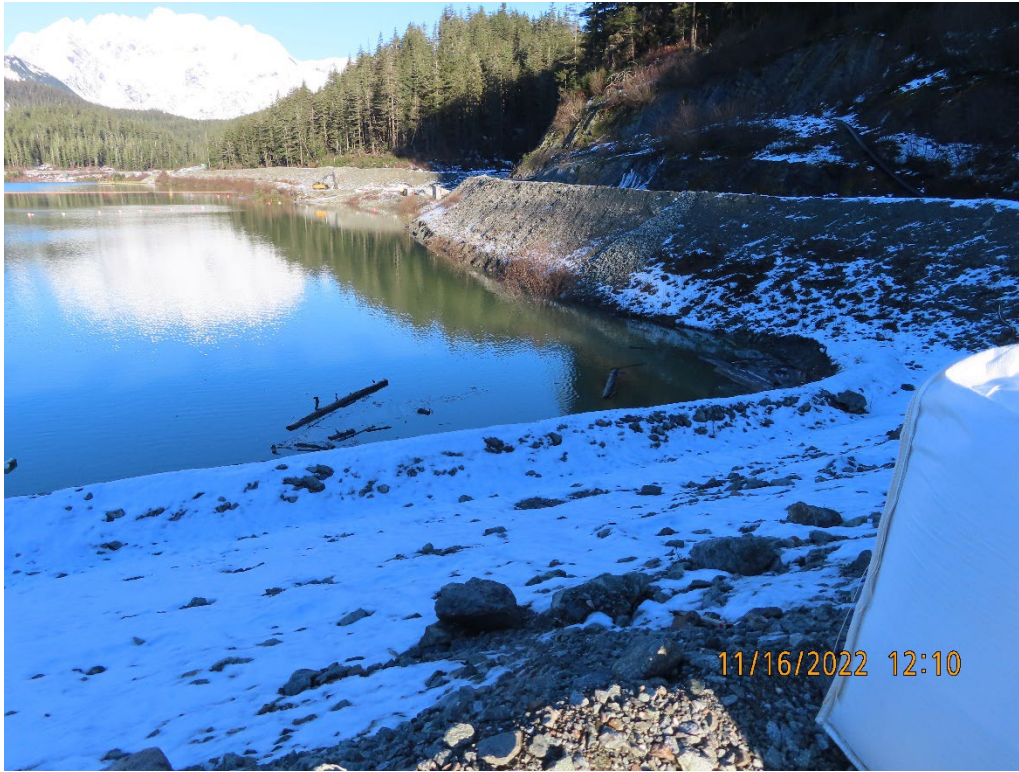
**NEW ACTION ITEM 194-3:** Large woody debris was observed along the face of the TTF dam. Large woody debris should be removed from the face of the dam to prevent damage to the liner (Photo 18).

**Photo 18. TTF dam face with large woody debris present.**

**NEW ACTION ITEM 194-3:** Large woody debris was observed along the face of the dam. Large woody debris should be removed from the face of the dam to prevent damage to the liner (Photo 18).

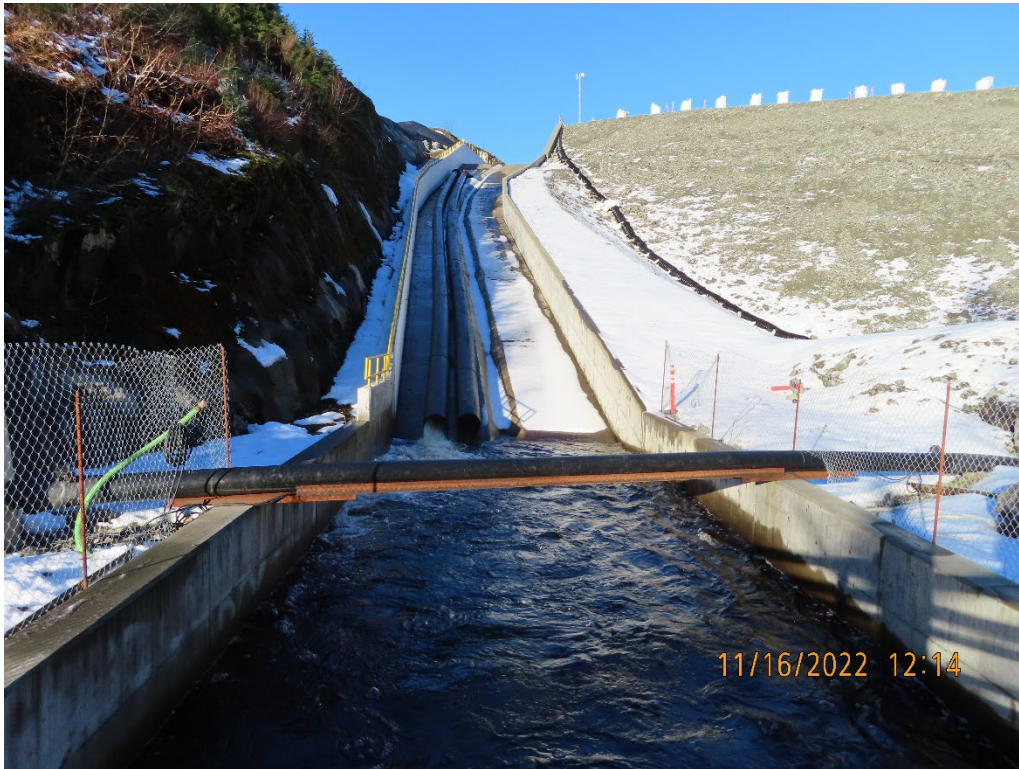
The TTF dam spillway appeared in good condition and there was no visual indication of ARD seepage reaching the spillway (Photo 19).

**Photo 19. TTF dam spillway.**

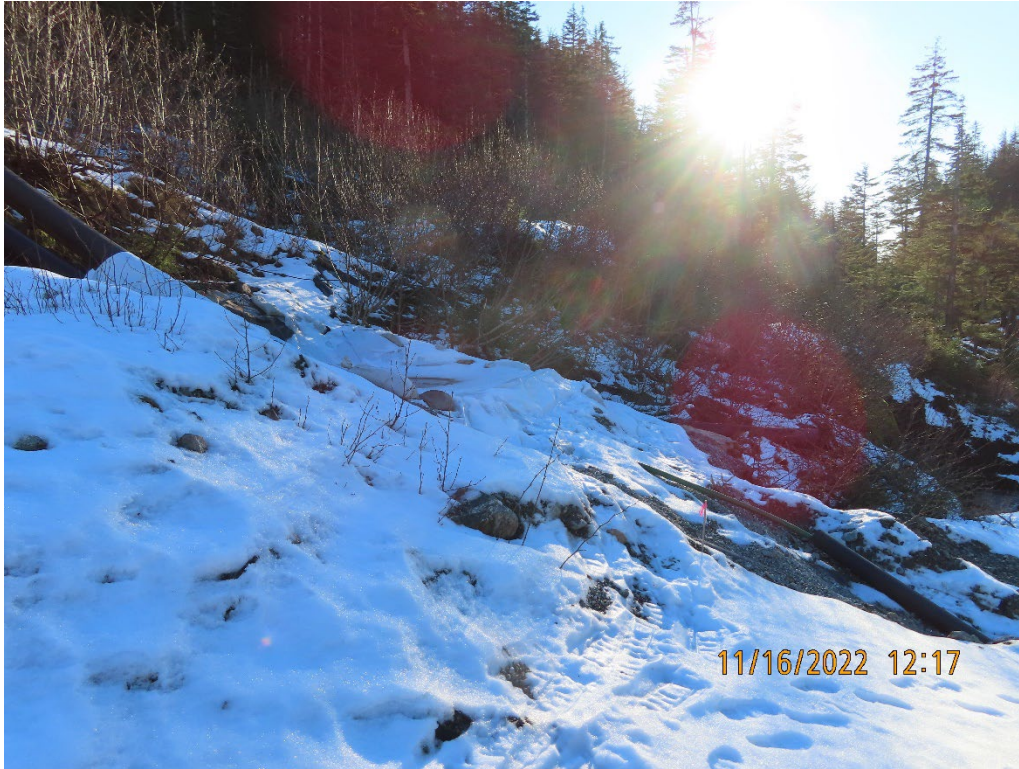
**PENDING ACTION ITEM 191-1:** Adjacent to and running across the lower TTF dam access road, reddish staining from a seepage is present. Due to the presence of ARD-generating graphitic phyllite, groundwater in this vicinity is captured in wells and transported to the ARD seepage treatment plant. Additionally, Coeur has constructed a containment sump (Photo 20) and collected water quality samples. Preliminary field sampling results indicated elevated metals and further sampling will be conducted. A hardline hose was placed from the ARD sump to this temporary sump to convey water collected for treatment until more sampling can be completed. This location will be monitored, and water quality testing results summarized, in a subsequent inspection report.

**Photo 20. Seepage near the TTF dam access road and constructed containment sump.**

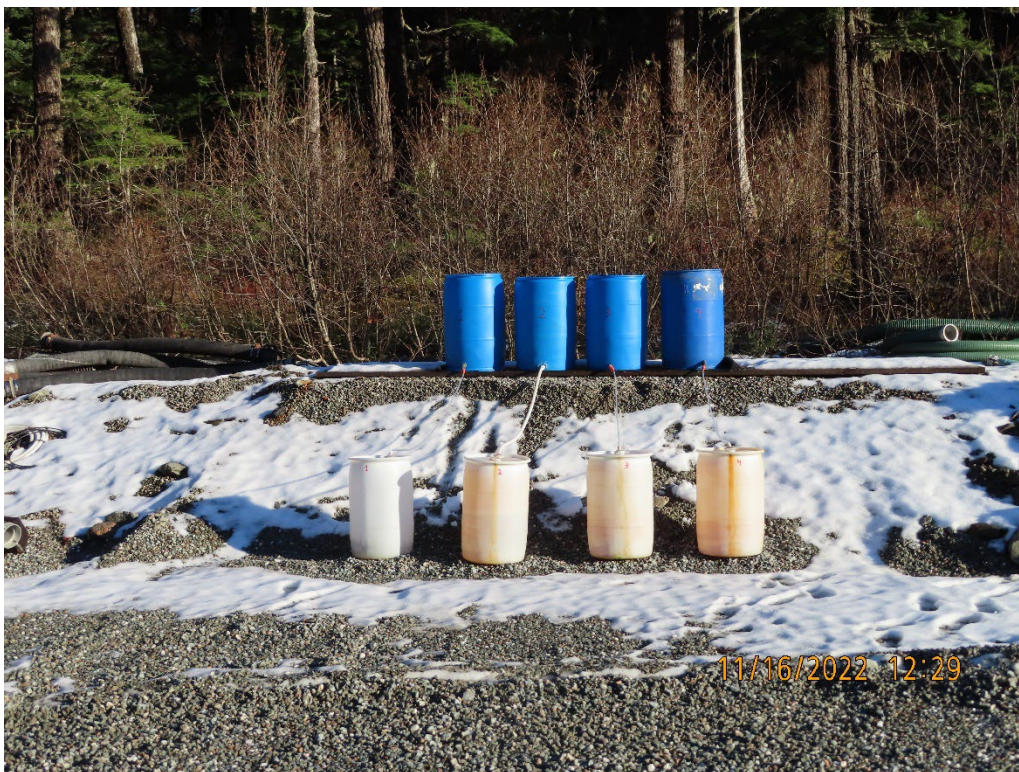
The graphitic phyllite test barrels were moved to higher ground to prevent being submerged (Photo 21).

**Photo 21. The graphitic phyllite test barrels were moved to higher ground to prevent from being submerged.**

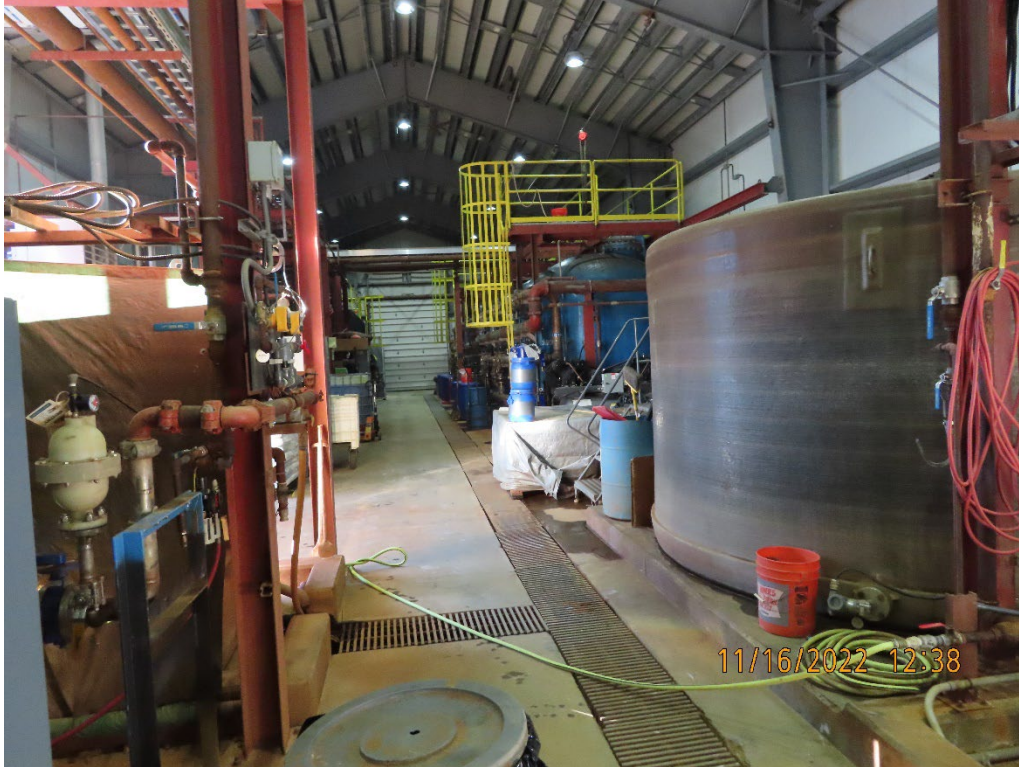
Good housekeeping practices were observed inside the TTF water treatment plant (Photo 22, Appendix 4g BMP plan; Table 4-1). The TTF water treatment plant was treating 720 gpm, and the water discharged to Outfall 002 measured 7.13 pH and .707 NTU.

Photo 22. TTF water treatment plant interior.

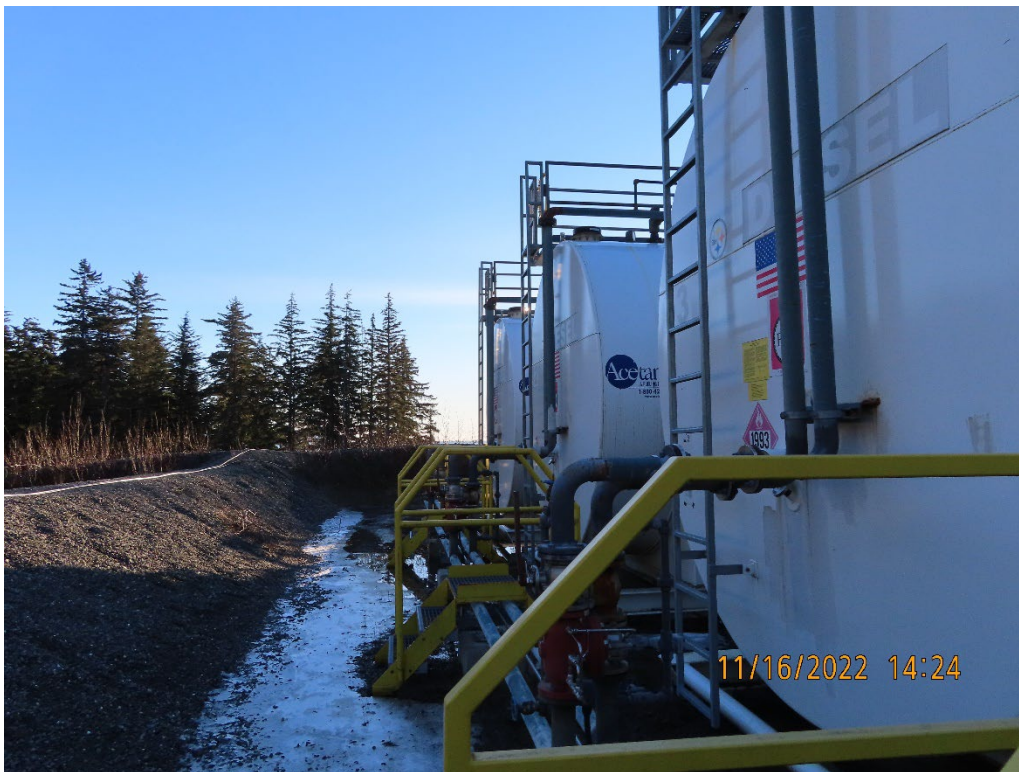
The fuel depot appeared in good condition with functional BMP’s and no sheening observed inside containment (Photo 23).

Photo 24. Fuel Depot

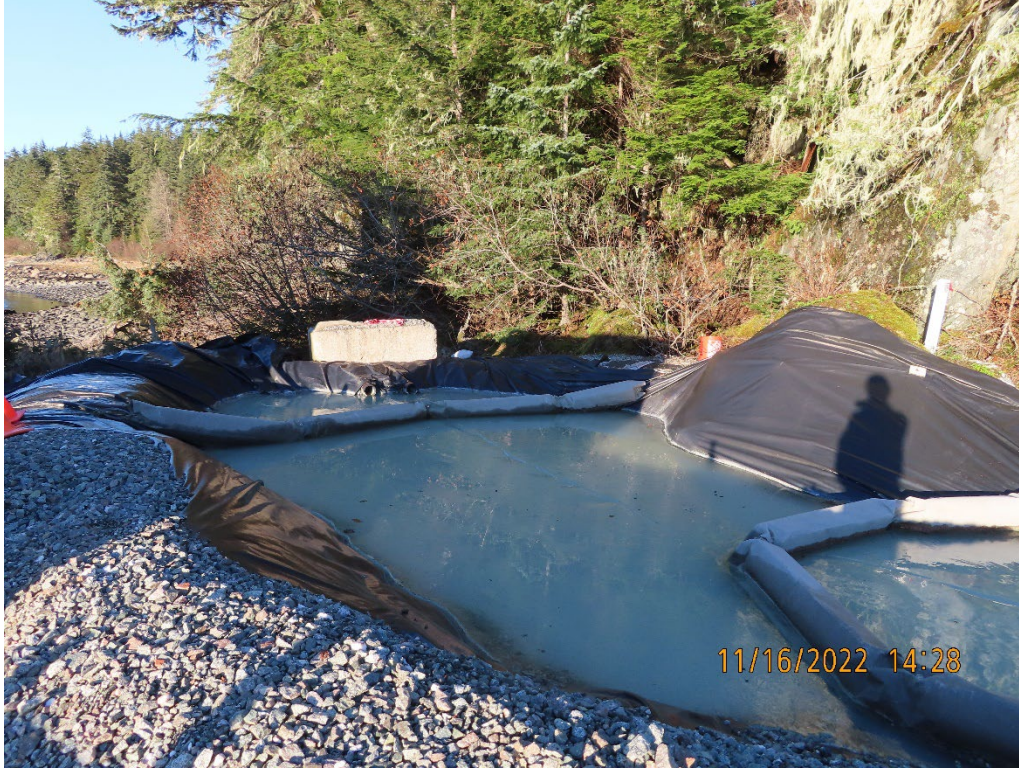
The port facility appeared in good condition with stormwater BMP's functioning and in good repair (Photo 24).

**Photo 23. Port facility stormwater pond.**
