## TECHNICAL MEMORANDUM

**Reference No.** 31405631.1516-006-TM-0

### NITROGEN SOURCE CONTROL OUTFALL 002 – TASK 2 IMPLEMENTATION AND EVALUATION

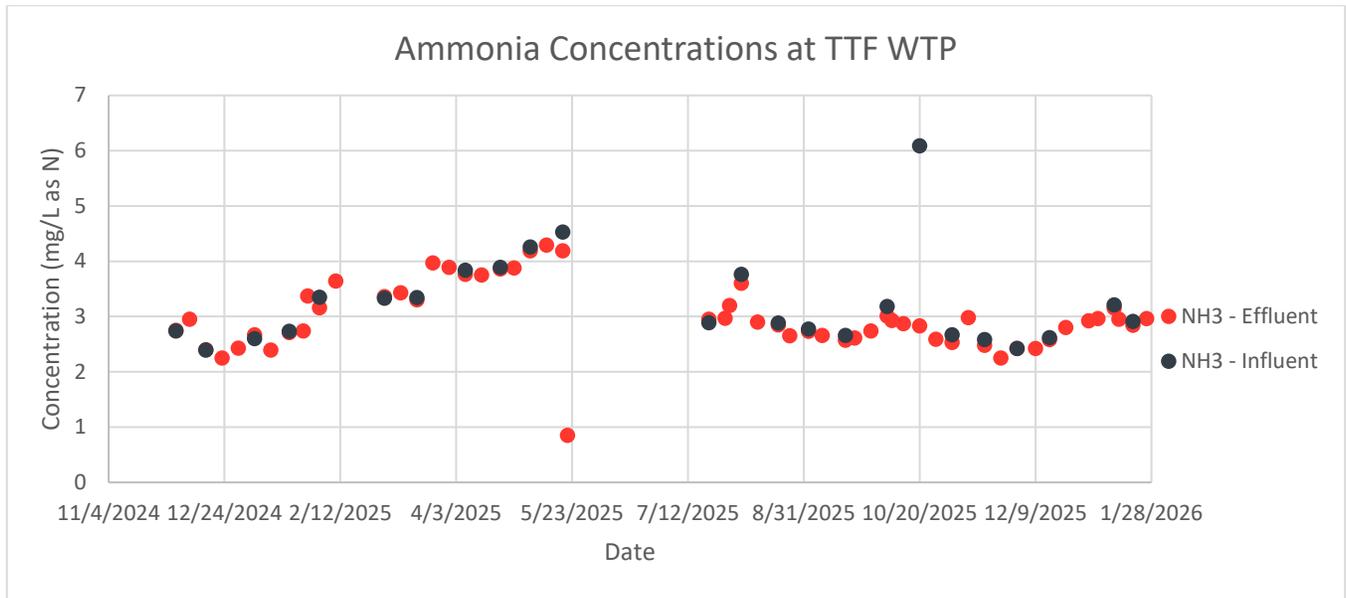
Figure 1: Concentration of Ammonia (mg/L as N) at the Influent of the TTF and at the Outfall 002 (effluent)

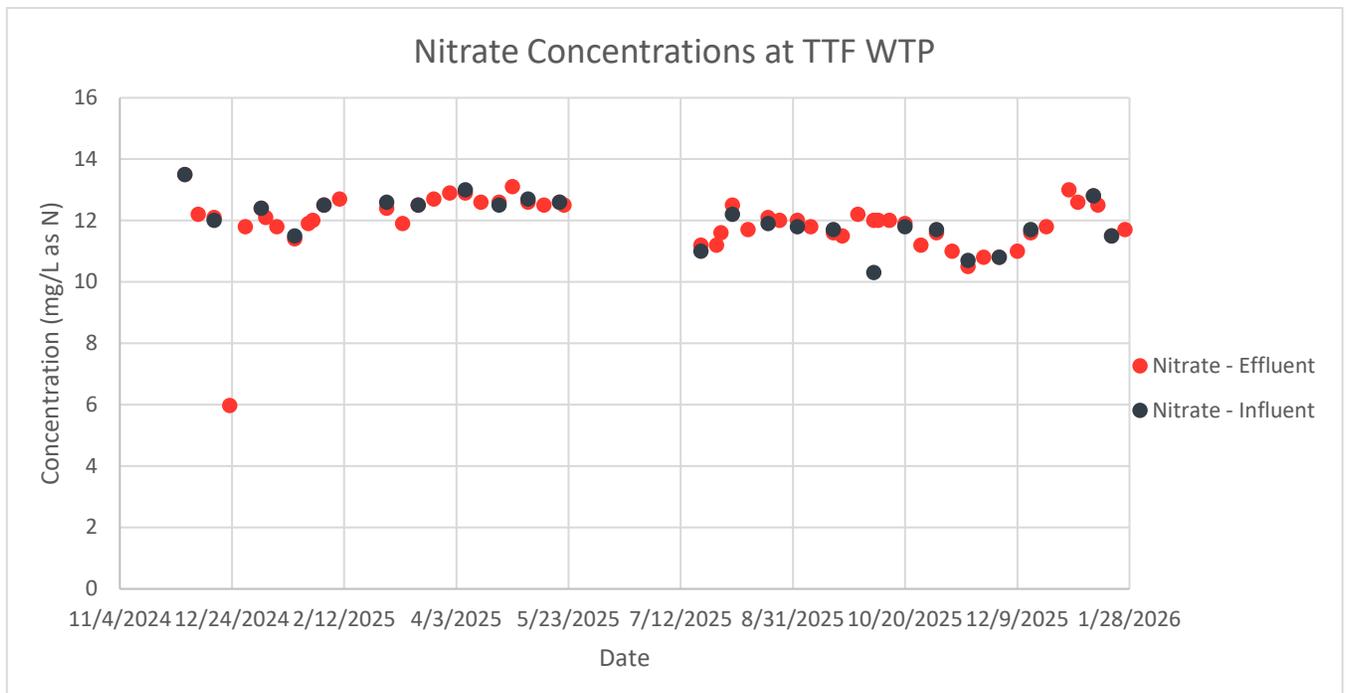
Figure 2: Concentration of Nitrate (mg/L as N) at the Influent of the TTF and at the Outfall 002 (effluent)

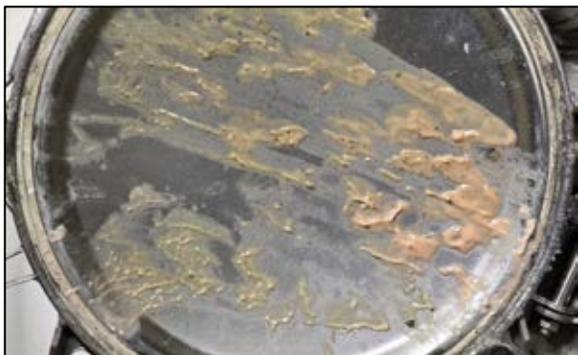
WSP, under supervision of and with approval from Kensington personnel, cut the cable and opened the tank to observe the storage conditions of the emulsion. Figure 2.1 shows deteriorated explosive on the lid of the bulk tank.

**Figure 2.1. Deteriorated Explosive on Bulk Tank Lid**

The deterioration is indicated by the discoloration – yellowy-white rather than pink – and crystallization on the surface of the material. The signs of deteriorated explosive were limited to the lid of the bulk tank. The explosive in the bulk matrix in the tank had the appropriate consistency, surface tension, color, and showed no signs of crystallization<sup>1</sup>. Figure 2.2 shows the emulsion inside the bulk storage tank and there are no indications of improper storage or deterioration.

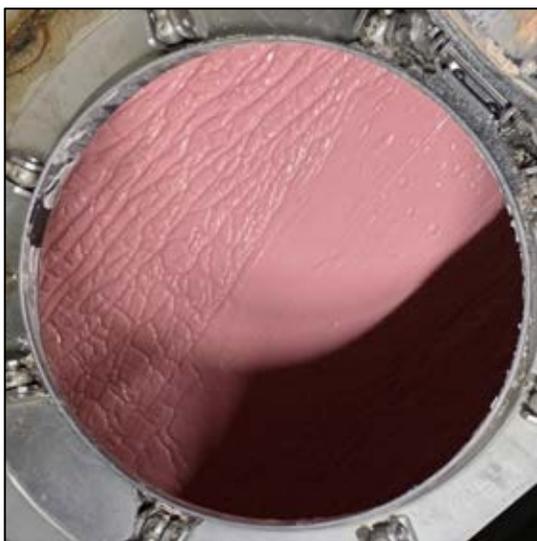
**Figure 2.2. Homogenous Mixture in Bulk Tank**

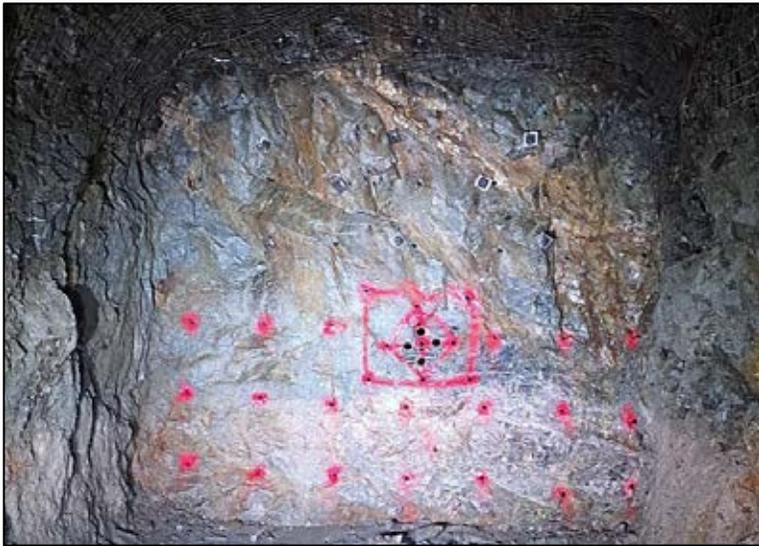
Drilling performance was determined based on two aspects: rough measurements of relative collar locations and downhole deviation measurements. WSP staff, when available and safe to do so during inspections, completed rough measurements of the relative collar locations. WSP found no significant deviations in the relative collar locations. The collar locations were consistent, as displayed in Figure 2.3.

**Figure 2.3. Development Heading Drillhole Layout**

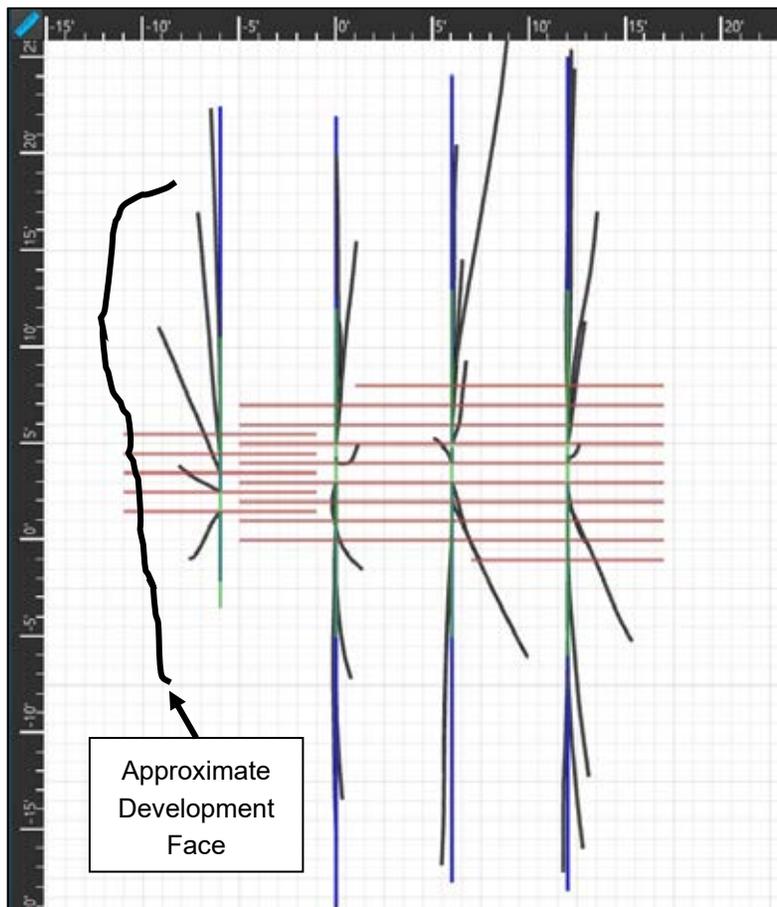
Azimuth deviation varied much higher in stope 2345-262. The data was visually inspected and the deviation in Ring 1 varies from that in Rings 2–4. This variation in azimuth deviation direction is attributed to the development face location limiting set-up capability, i.e. field conditions constraining appropriate collaring procedures. The deviation of azimuth is displayed based on a top-down view of 2345-262 in Figure 2.4 and the annotations are:

**Figure 2.4. 2345-262 Azimuth Deviation Plan View**

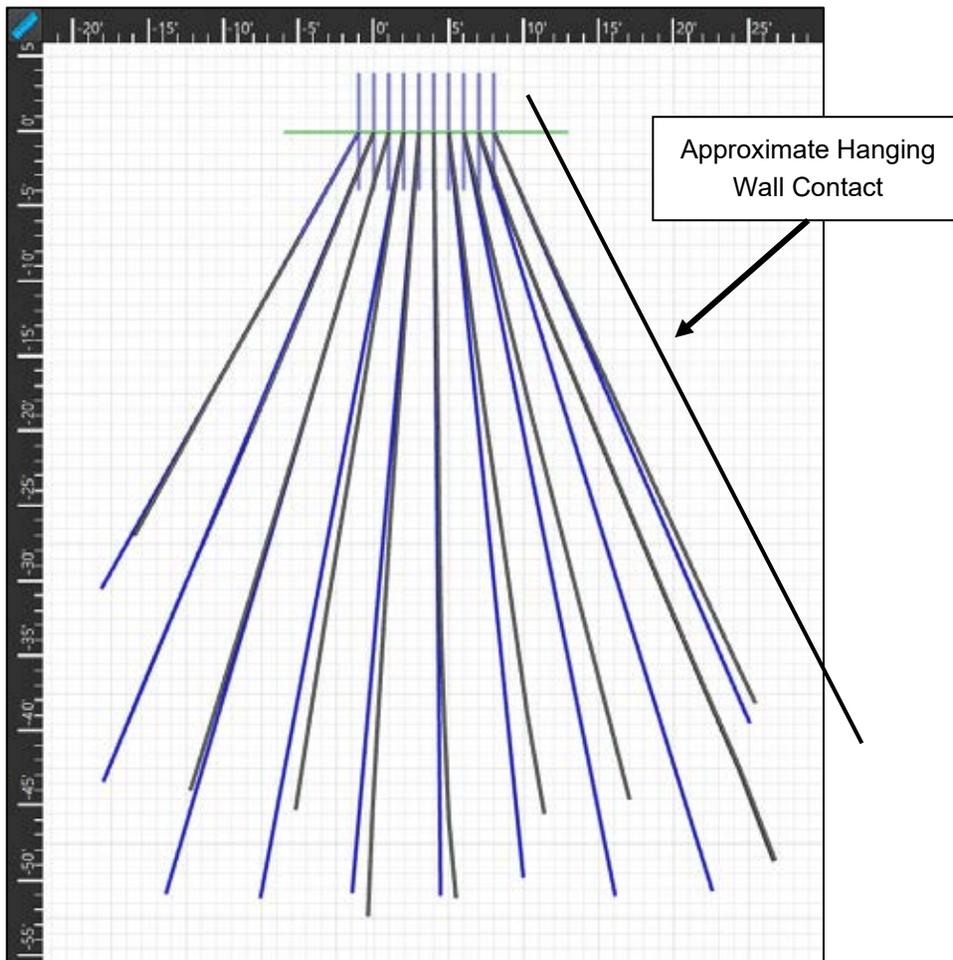
**Figure 2.5. 2345-262 Ring 4 Deviation Cross Section**

The deviation is near zero in Holes 1–3 and increases in the direction of the hanging wall. WSP notes that the bottom of hole location is not well documented. All holes were truncated to a measurement above full depth to account for inaccuracies present in the collected data due to the lack of capability to determine the exact depth which the probe reached beyond the breakthrough of the drillhole. These findings were substantiated by accounts from Kensington personnel and observations by WSP regarding overbreak into the hanging wall and underbreak on footwall. Kensington personnel noted that overbreak into the paste backfill decreased when the standoff distance was increased from 2 ft to 3 ft.

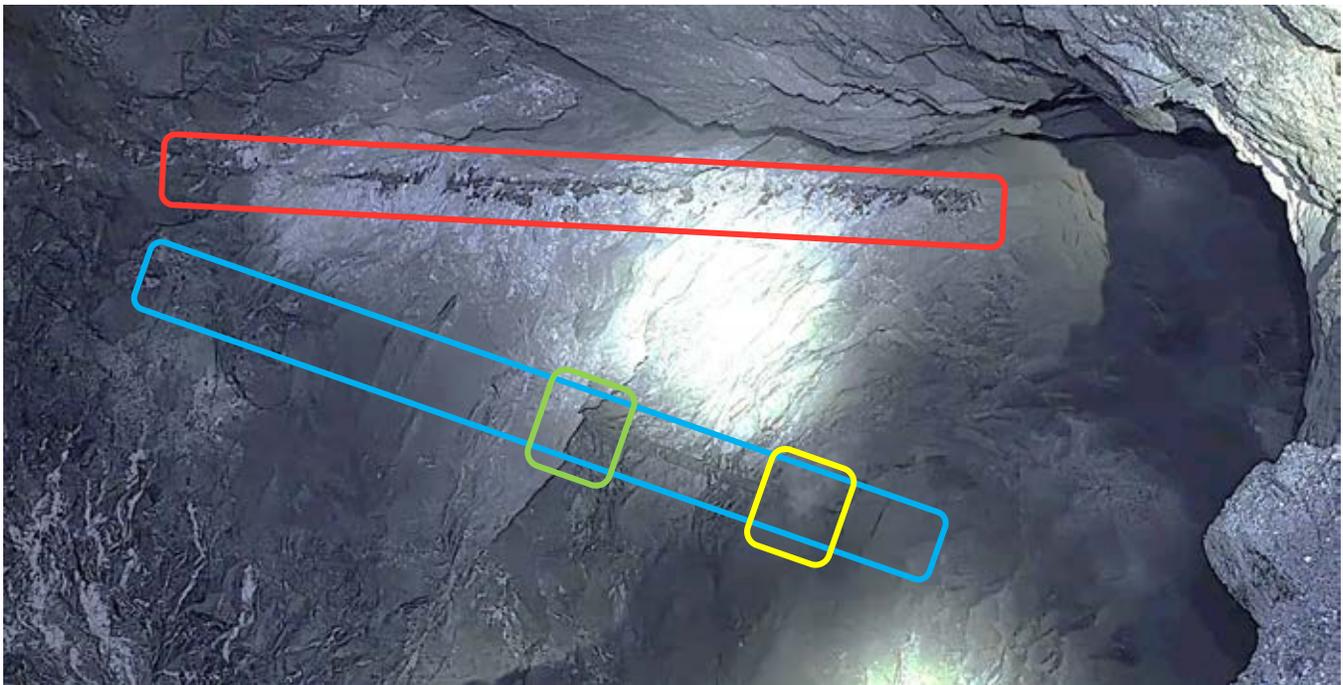
- The red outline indicates a borehole crushed along the full length.
- The blue outline shows the designed location of a blast hole with a portion of a half barrel.
- The green box indicates the location of where the half barrel disappears behind rock.
- The yellow box indicates where the booster detonated and caused crushing.

Figure 2.6. K1555-083 Stope Half Barrels

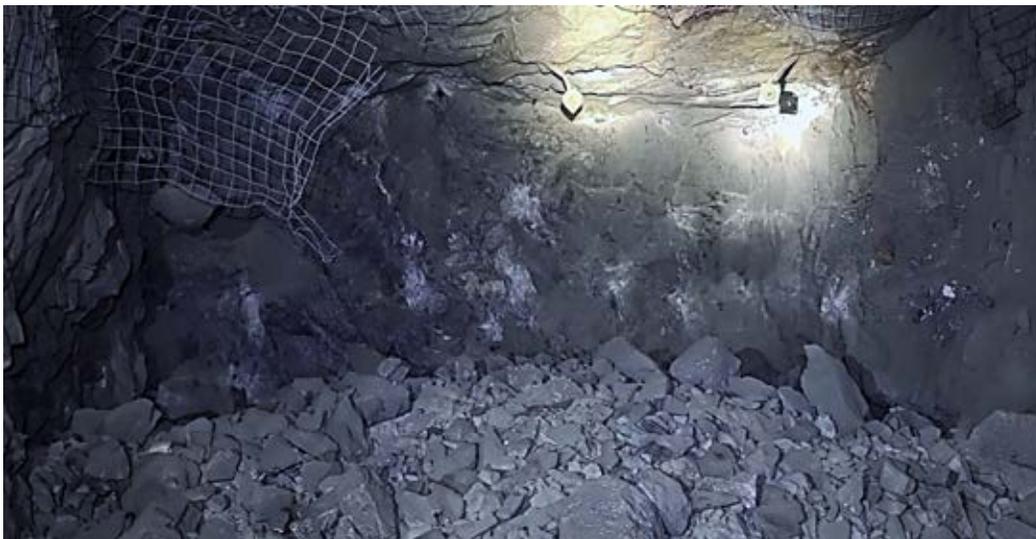
The inspections of development blasts indicated good blast performance and occasional adverse blasting conditions that could or did cause explosive wastage. Signs of good blast performance were low fumes, crushing surrounding the boot of the blasthole, and consistent fragmentation. Adverse blasting conditions were mostly due to high groundwater in the face. This adverse condition causing wastage was confirmed with the observation of undetonated explosive being discovered during post-blast inspection of the face. Figure 2.7 shows a developmental face on the 2720 level that displays good crushing in the back of the hole, indicating proper detonation of the explosives.

Figure 2.7. Back of Hole Crushing

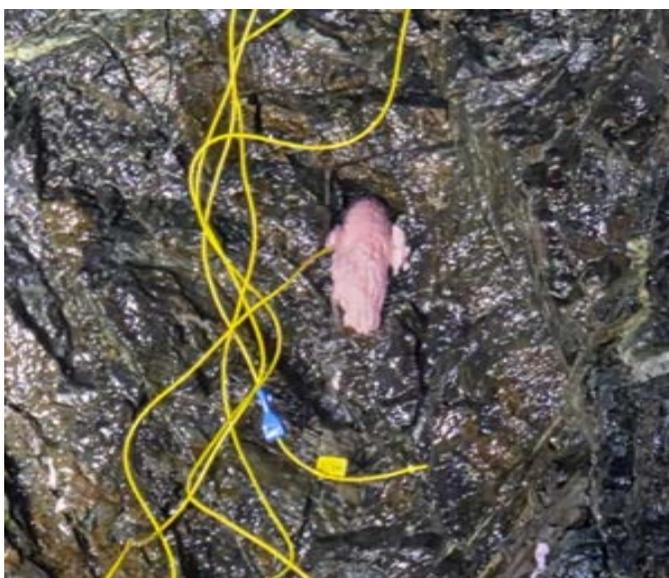
Occasionally there are holes loaded with bulk emulsion that were originally thought to be dry. WSP observed this occurring on multiple occasions, and the explosive was pushed out of the blasthole due to water pressure, as shown in Figure 2.9

**Figure 2.9. Emulsion Seepage Due to Water Pressure**

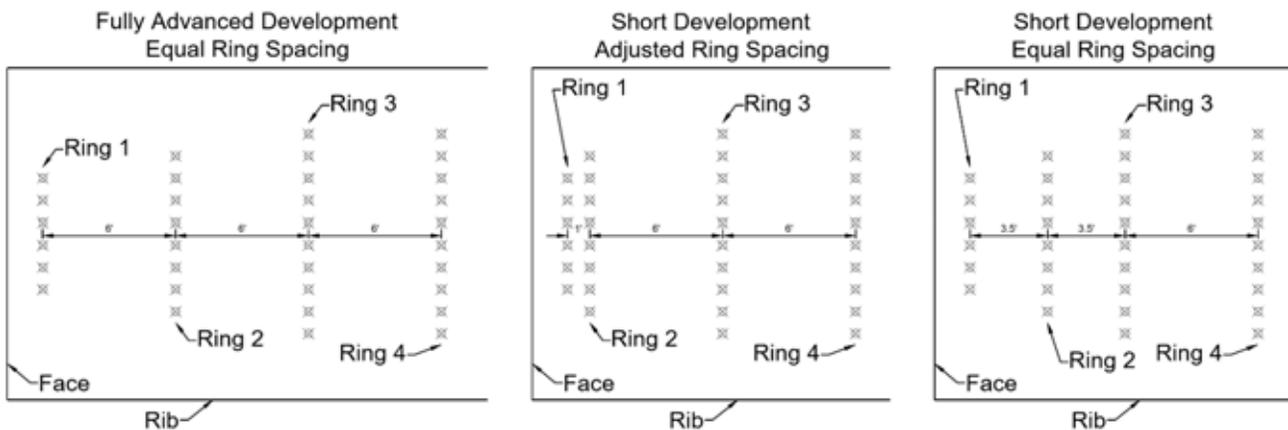
- Limit decreasing the ring-to-ring distance:
  - Typical intra-ring distance is 6 ft and designs should strive to stay nearest to this number to minimize deviation causing hole interactions. This can cause deadpressing and therefore explosive wastage. When the area is tight designs have decreased ring-to-ring distances. An example comparing typical ring spacing, to current typical designs in short development drives and proposed typical designs in short development drives is provided in Figure 3.1.

Figure 3.1. Ring Spacing Comparison

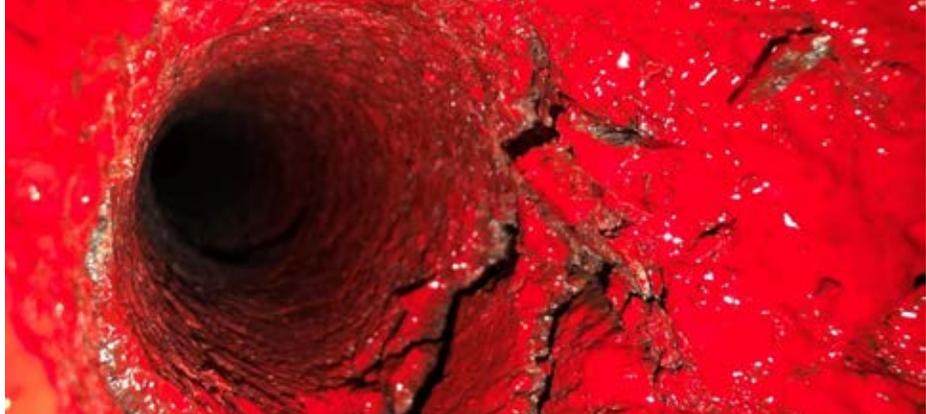
<p><b>PHOTO 5</b> Location: 2 Type: Development</p> <p>Downhole view of borehole showing slight fracturing and small cavities around boundaries.</p>

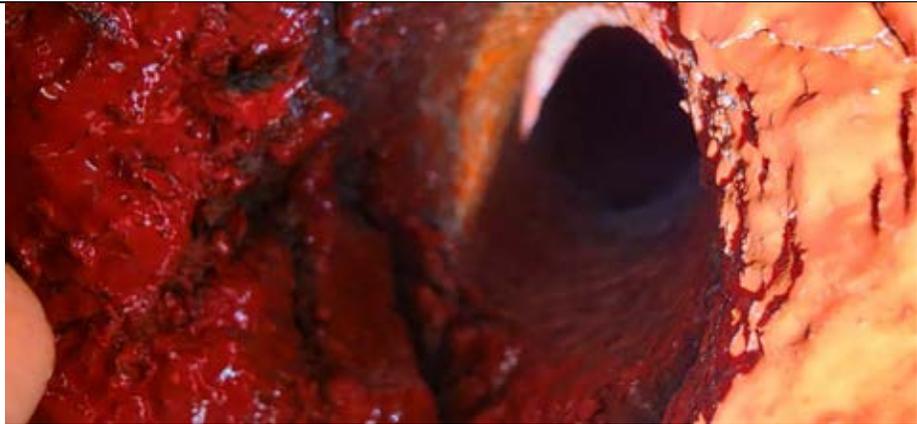
**PHOTO 7**  
Location: 2  
Type: Development

Downhole view of borehole showing slight fracturing and small cavities around boundaries

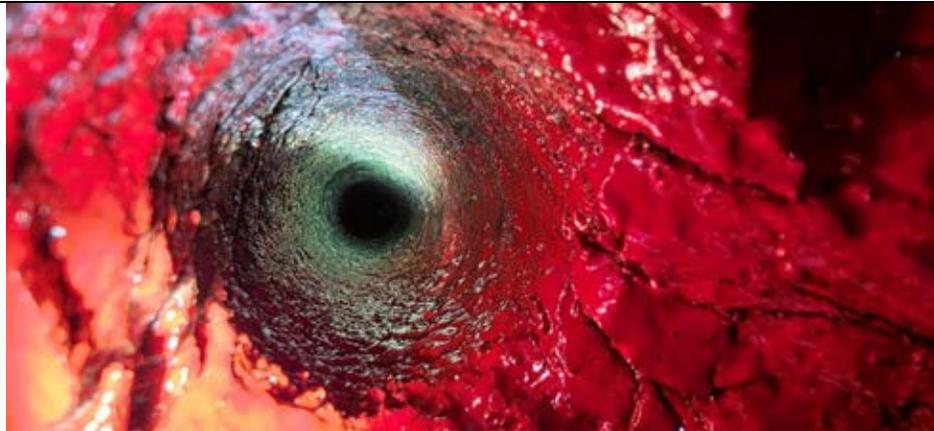
**PHOTO 8**  
Location: 2  
Type: Development

Downhole view of borehole showing slight fracturing and small cavities around boundaries

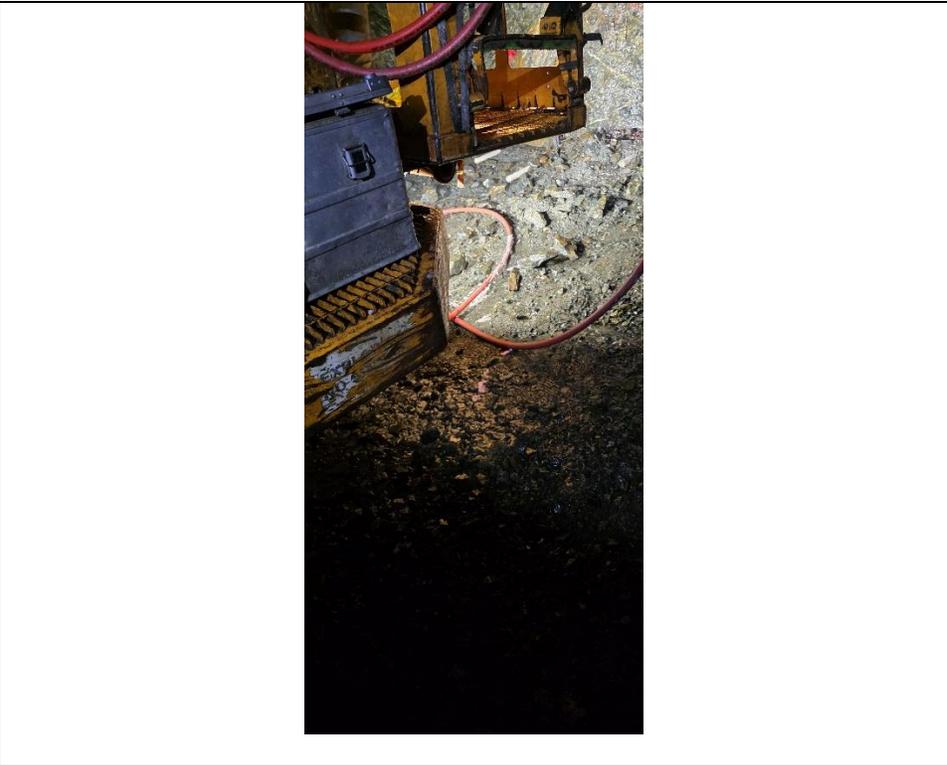
**PHOTO 12**  
Location: 3  
Type: Development  
Emulsion spillage

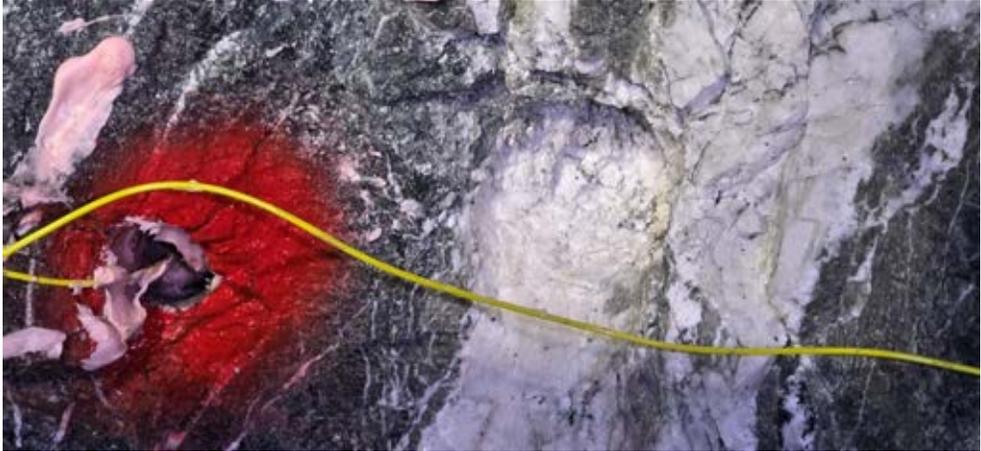
<p><b>PHOTO 3</b> Location: 2495-246 Type: Development</p> <p>Boot that shows significant crushing and slight radial fracturing</p>

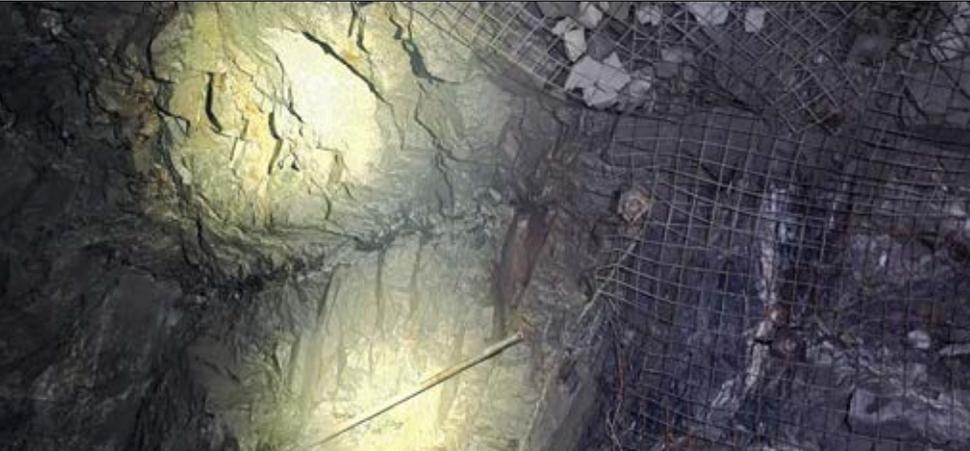
<p><b>PHOTO 8</b> Location: 2720 Type: Development  Carbon Staining in Upper Corners</p>

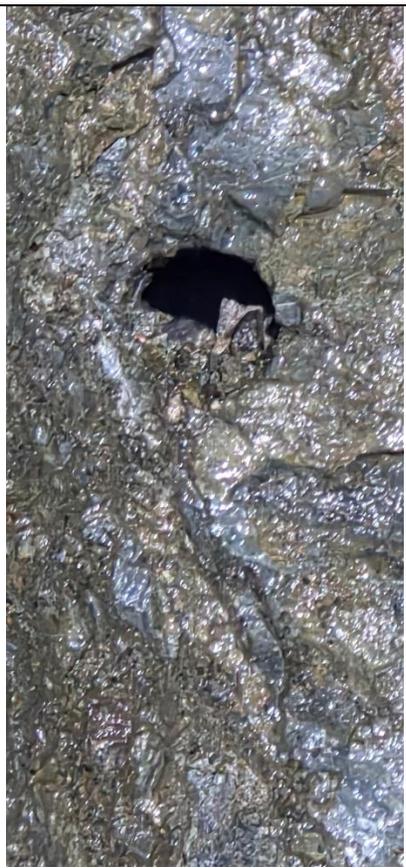
**PHOTO 10**  
Location: 3  
Type: Development

Boot that shows  
minimal crushing or  
radial fracturing

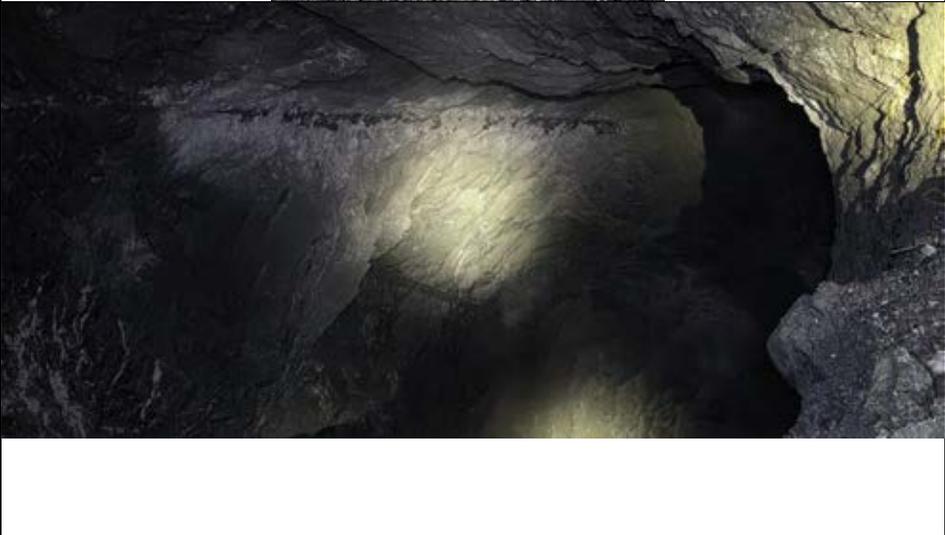
**PHOTO 3**  
Location: K1555-083  
Type: Top of Stope

Carbon staining in R2 and half barrel in R1.

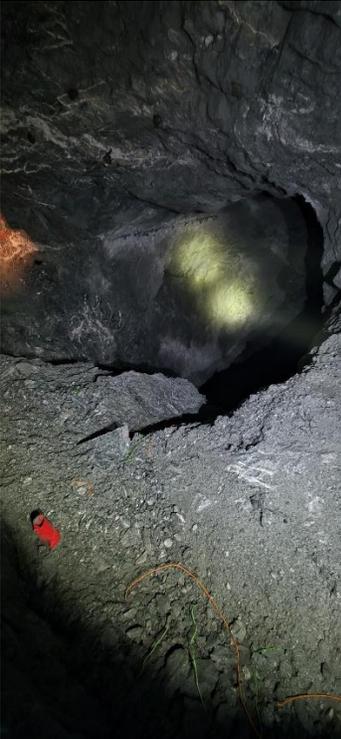
<p><b>PHOTO 4</b> Location: K1555-083 Type: Top of Stope</p> <p>Carbon staining in R2 and half barrel in R1, that show varied crushing</p>

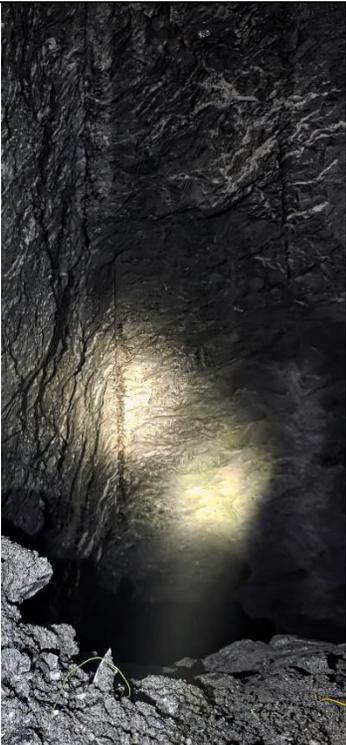
<p><b>PHOTO 6</b> Location: K1555-083 Type: Top of Stope</p> <p>Carbon staining in R2 and half barrels in R1, that show varied crushing.</p>

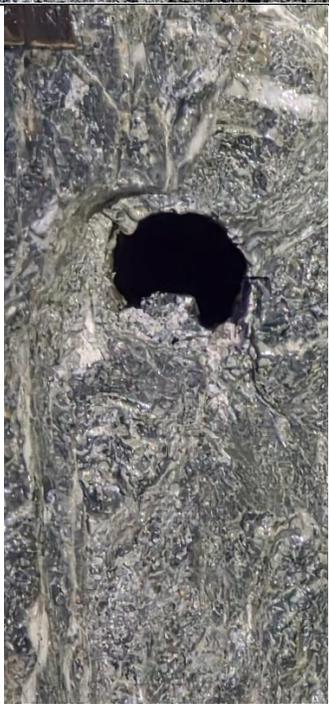
<p><b>PHOTO 7</b> Location: 2495-254 Type: Development</p> <p>Boot that shows slight radial fracturing</p>

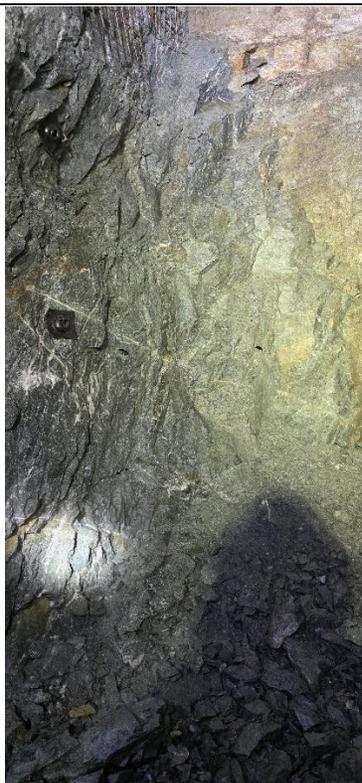
**PHOTO 8**  
Location: 2495-254  
Type: Development

Multiple boots that shows no crushing or radial fracturing

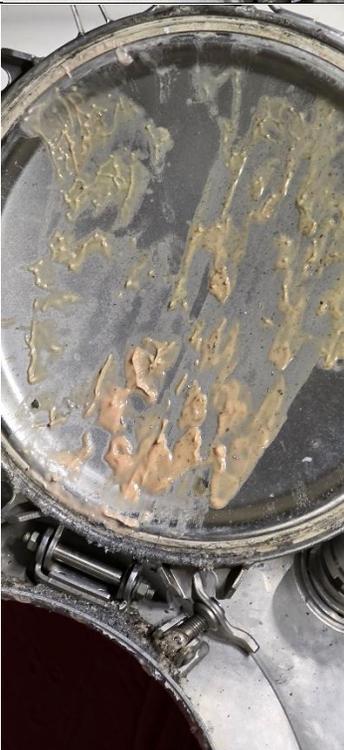
<p><b>PHOTO 7</b> Location: Emulsion Magazine Type: Tank</p> <p>Deteriorated explosive on tank lid</p>
