APDES INSPECTION REPORT

Alaska Department of Environmental Conservation

PHOTO ADDENDUM – KENSINGTON MINE, LOWER SLATE LAKE

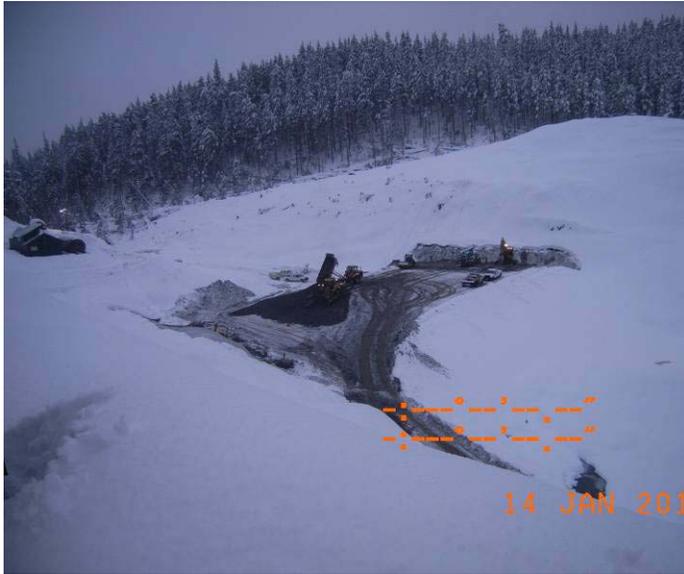
Prior to entering the Lower Slate Lake site we stopped at the Alaska Interstate Construction (AIC) job trailer for a safety briefing and a progress report by Dave Domingus. Dave reported that the current elevation of the "A" layer was 669.0 feet. The final design elevation

of the "A" fill will be 690.0 feet. Dave estimated that an additional ten days of work would be required to complete the "A" fill.

DESCRIPTION: "A" LAYER CONSTRUCTION. ABOVE LOWER SLATE LAKE OUTFALL LOOKING SOUTHEAST TOWARDS DAM.

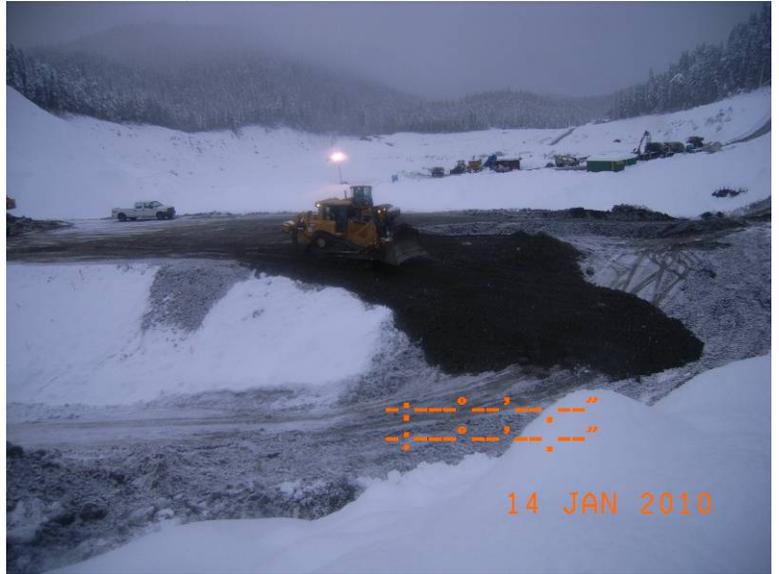
Suitable fill material is being placed in two foot lifts and compacted by ten passes with a vibratory roller. The suitable fill was excavated during the foundation excavation phase and stockpiled at the north end of Lower Slate Lake. AIC seals the edge of the most fill layer via the roller before construction stops due to snow. Any snow that accumulates on the fill area is plowed off before fill activities resume.

DESCRIPTION: DOZER SPREADING SUITABLE FILL AND VIBRATORY ROLLER COMPACTING FILL. FROM WTP LOOKING NORTH.

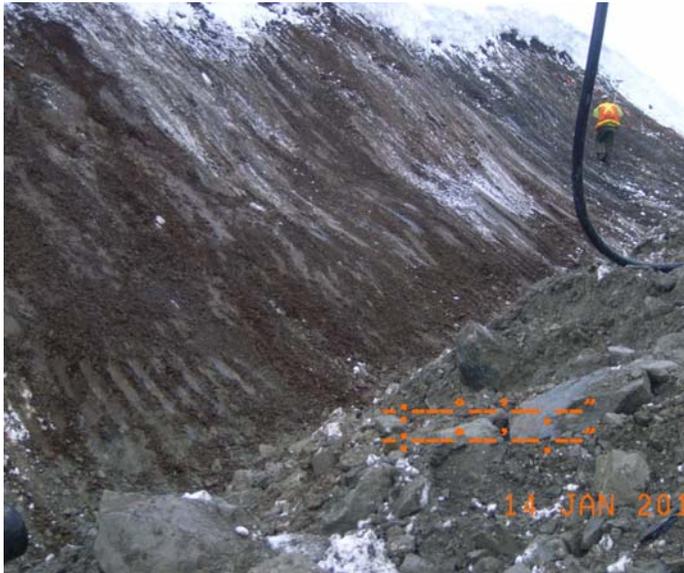
AIC was applying shotcrete to the western abutment and prepping the eastern abutment for shotcrete. Shotcrete is being applied for two reasons. The first being that the exposed bedrock does not meet the hardness requirement. The second reason is to seal the rock face to reduce geochemistry issues, i.e., ARD generation.

DESCRIPTION: WESTERN ABUTMENT PREPARED FOR SHOTCRETE. FROM SOUTHWESTERN CORNER OF DAM.

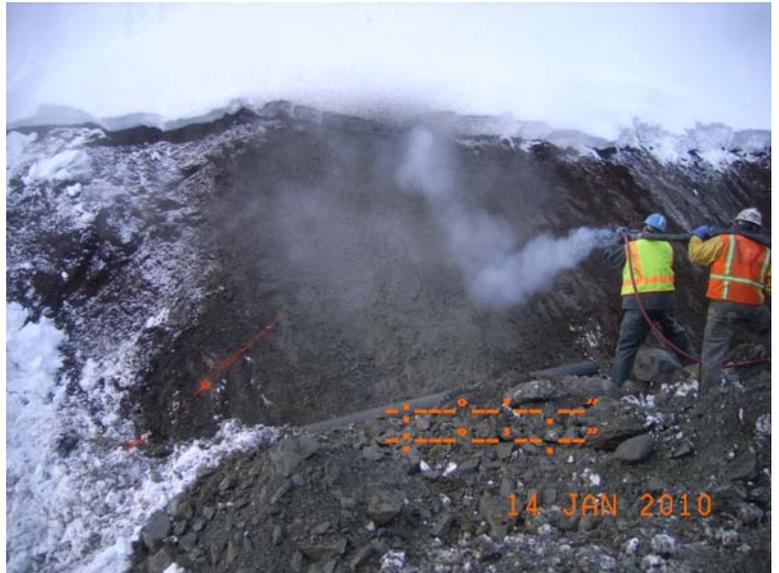
DESCRIPTION: SHOTCRETE APPLICATION TO WESTERN ABUTMENT.
